# Alpine Facilities 2001 Spring Breakup and Hydrologic Assessment

Submitted to:  
**PHILLIPS Alaska, Inc.**  
A Subsidiary of PHILLIPS PETROLEUM COMPANY

Michael Baker Jr., Inc.  
Anchorage, Alaska 99503  
907-273-1600

August 2001  
25010-MBJ-RPT-001

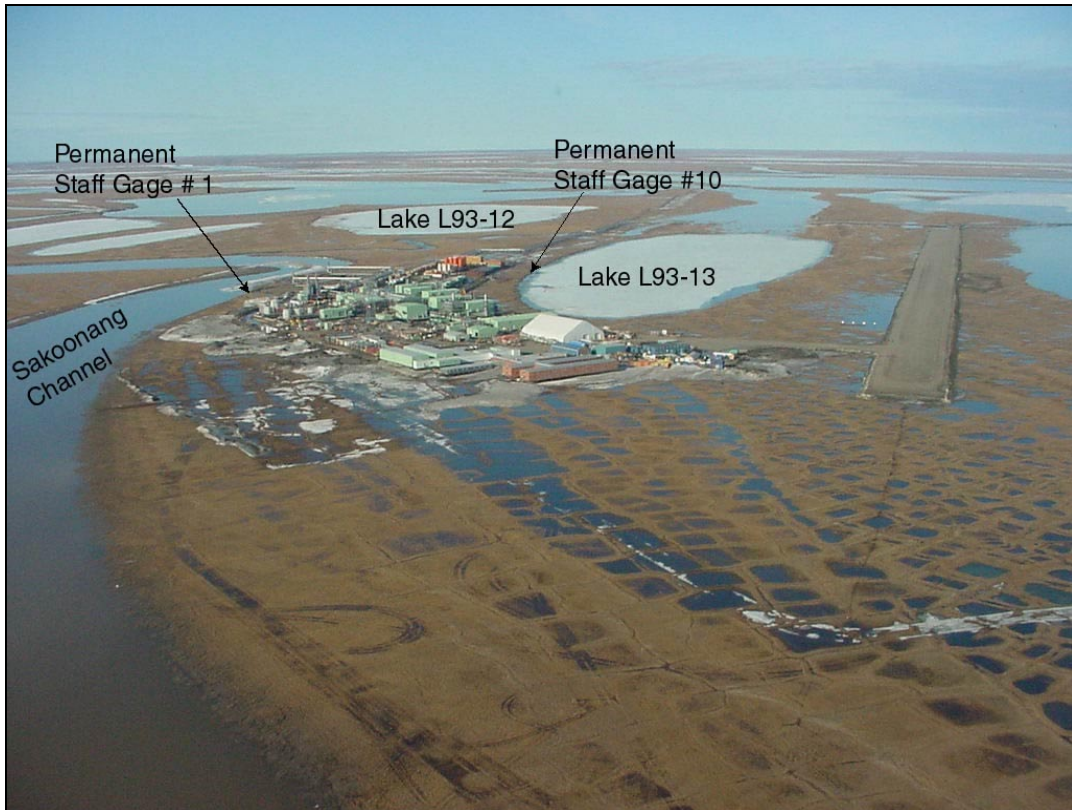
**Photo 2-1 a Flooding Conditions at Alpine June 11, 2001, looking southwest at CD-1.**

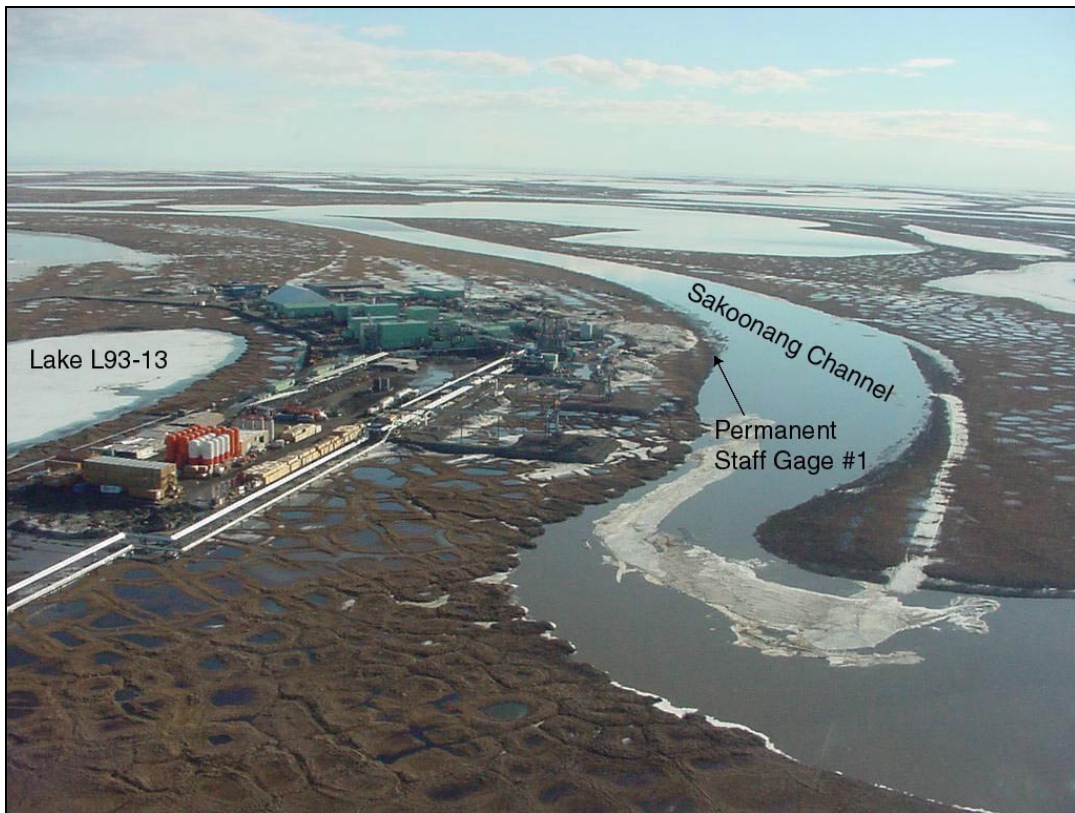
**Photo 2-1 b Flooding Conditions at Alpine June 11, 2001, looking north at CD-1.**

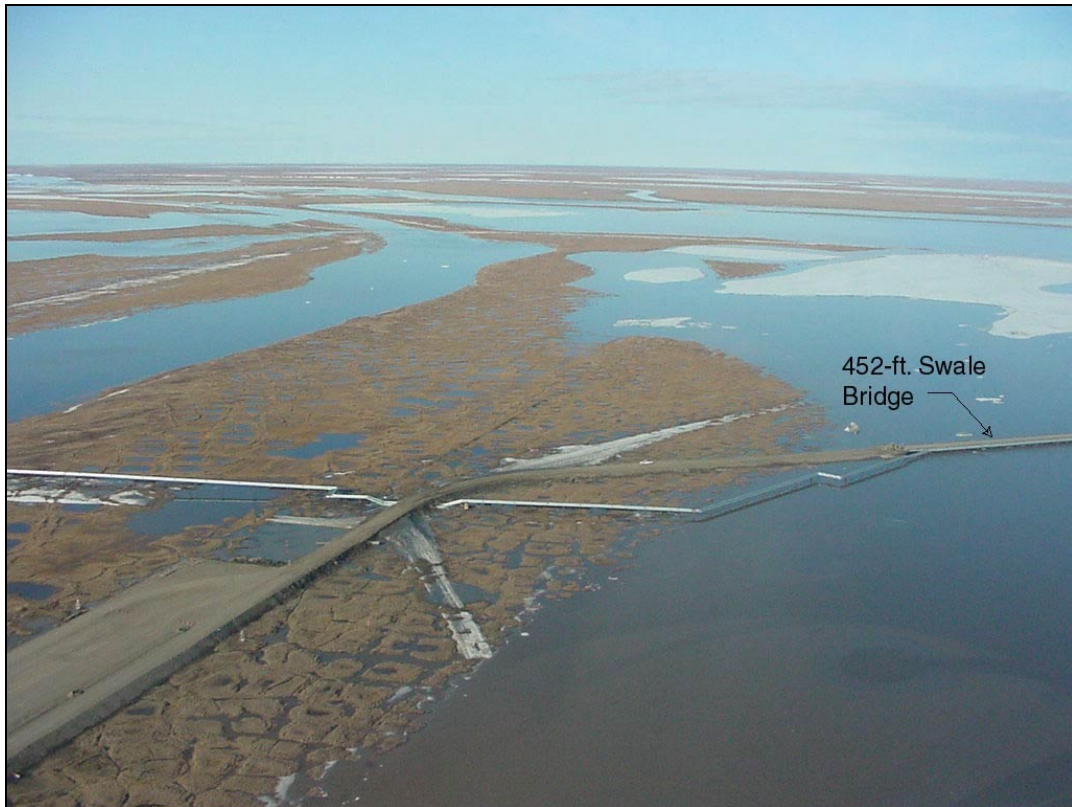
**Photo 2-1 c Flooding Conditions at Alpine June 11, 2001, looking south-southwest at the end of the airstrip.**

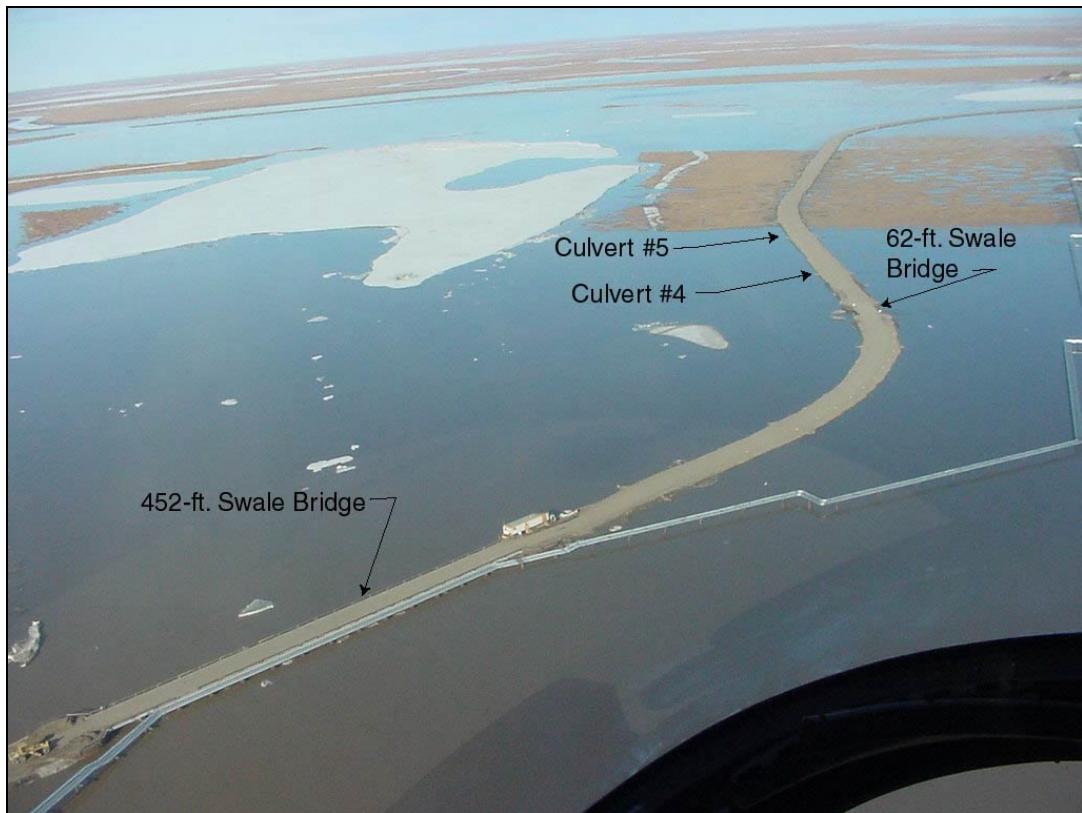
**Photo 2-1 d Flooding Conditions at Alpine June 11, 2001, looking southwest along the CD-2 access road.**

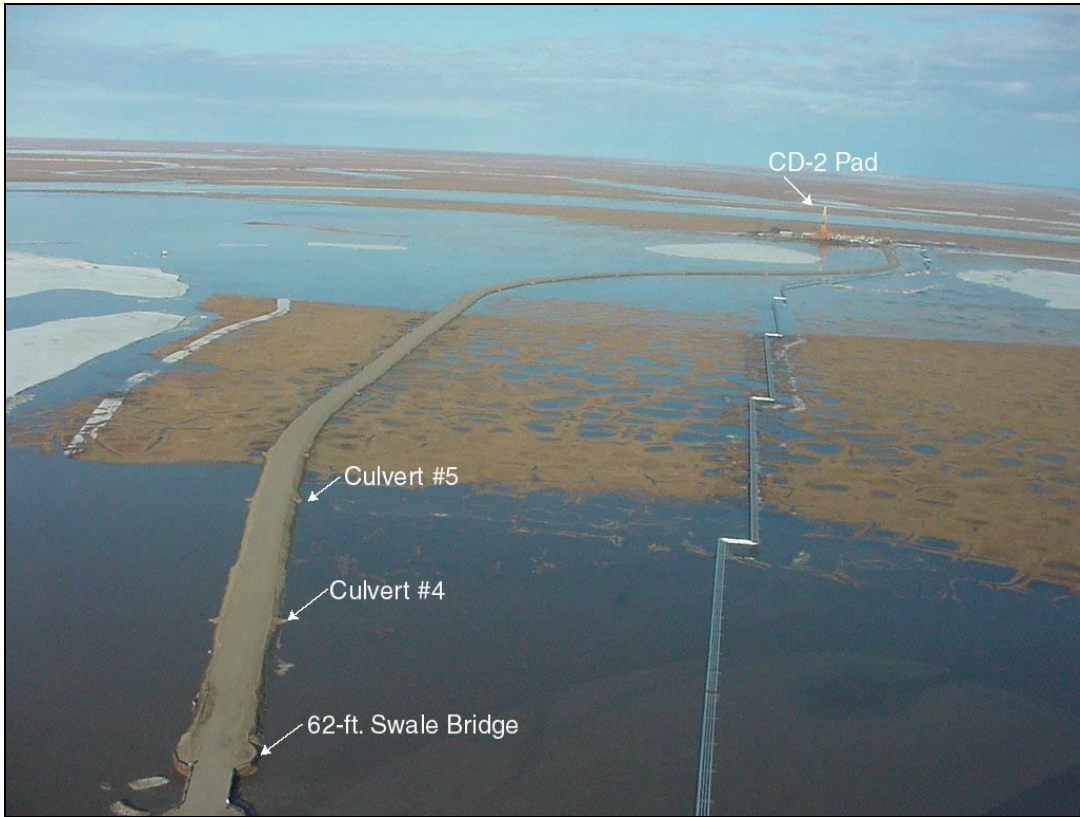
**Photo 2-1 e Flooding Conditions at Alpine June 11, 2001, looking west along the CD-2 access road.**

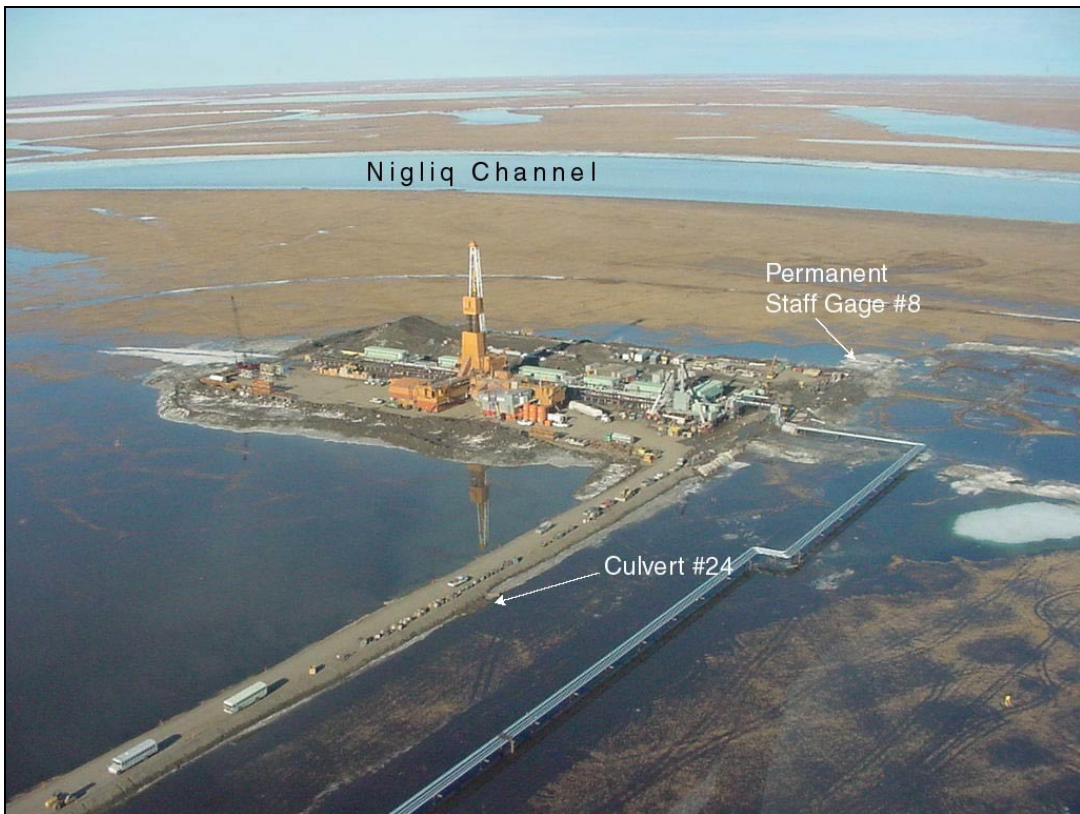
**Photo 2-1 f Flooding Conditions at Alpine June 11, 2001, looking southwest at CD-2.**

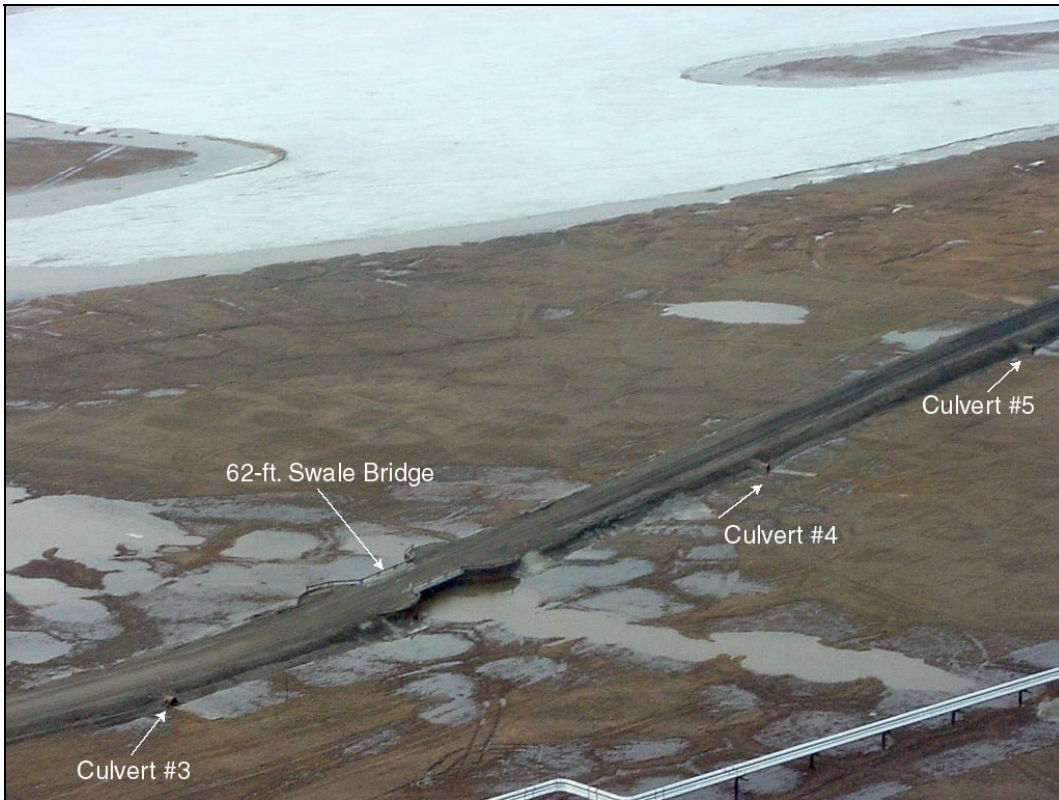
The peak discharge estimated through the 62-foot swale bridge is 620 cfs and the peak discharge estimated through the 452-foot swale bridge is 3,900 cfs, and is estimated to have occurred on the evening of 11 June. Peak discharges were estimated using peak water surface elevations and normal depth computations. At the time the discharge measurements were made (11 June), the ice pads in the vicinity of the bridges had cleared and did not affect the discharge through the bridges. Based on the water surface elevations and the timing of the discharge measurements, the conditions observed at the time of the measured discharge can be considered to be reasonably representative of flow conditions at the bridges at the time of the peak discharge.

**Photo 2-3 c Flooding Conditions at Alpine June 14, 2001, looking southwest at the 62-ft. swale bridge.**

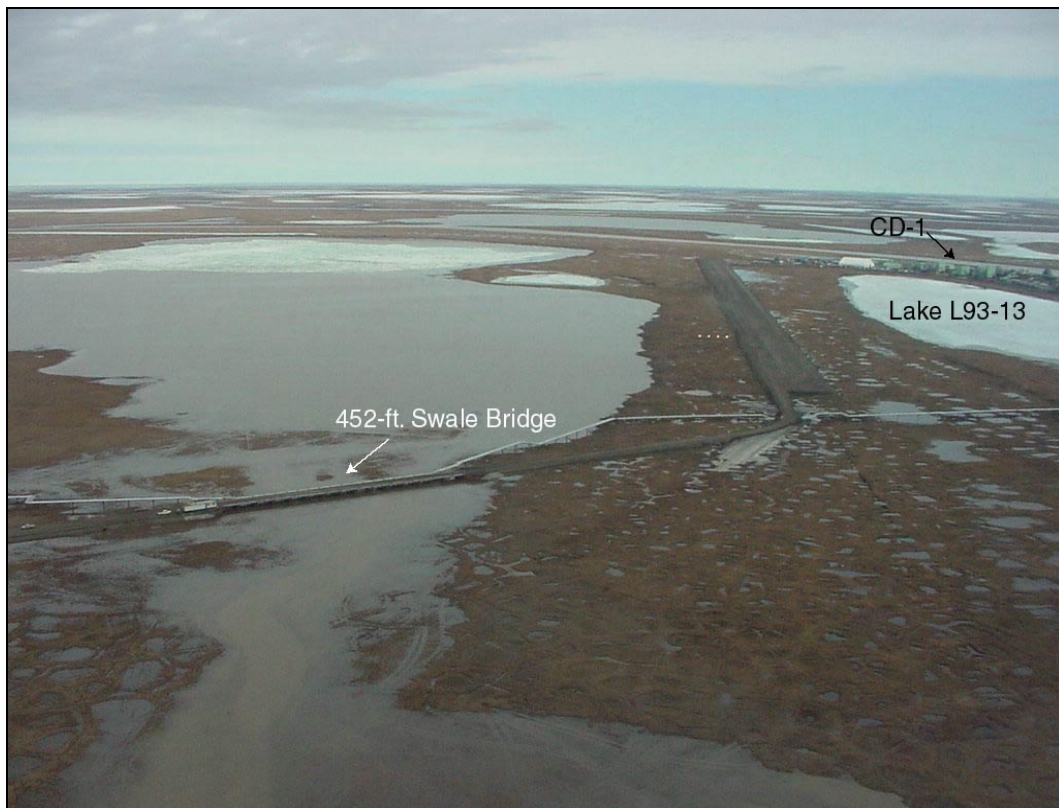
**Photo 2-3 d Flooding Conditions at Alpine June 14, 2001, looking northeast at the 452-ft. swale bridge and airstrip.**

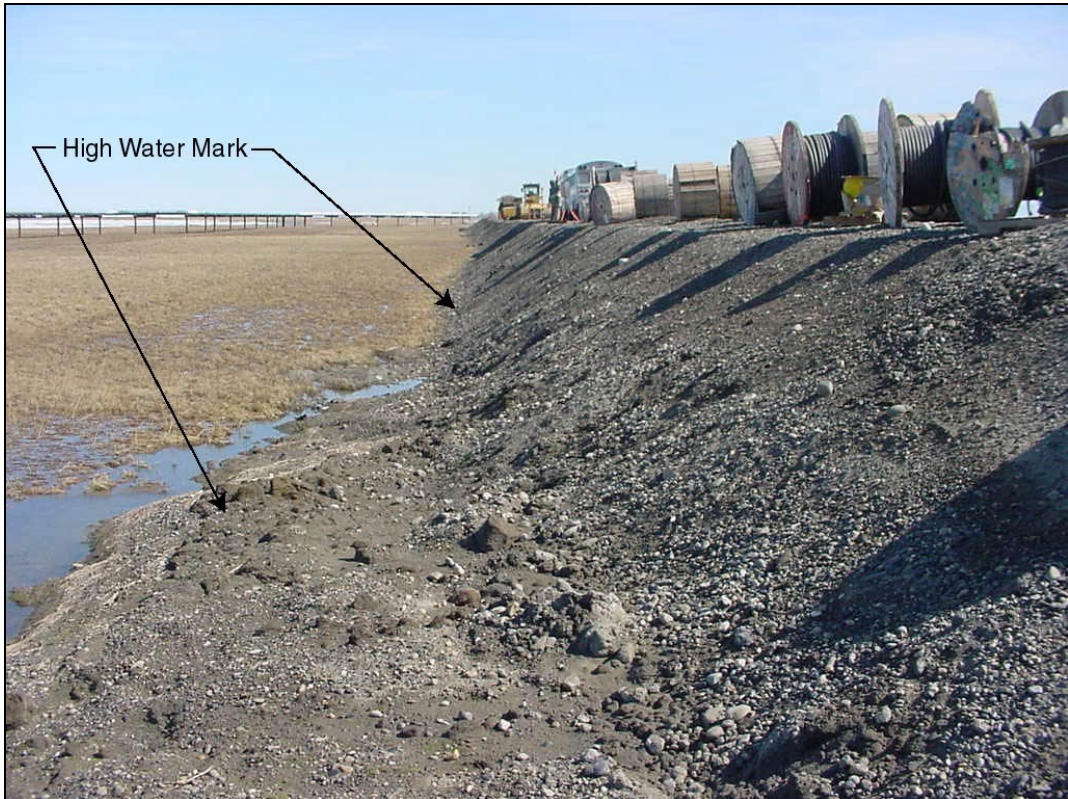
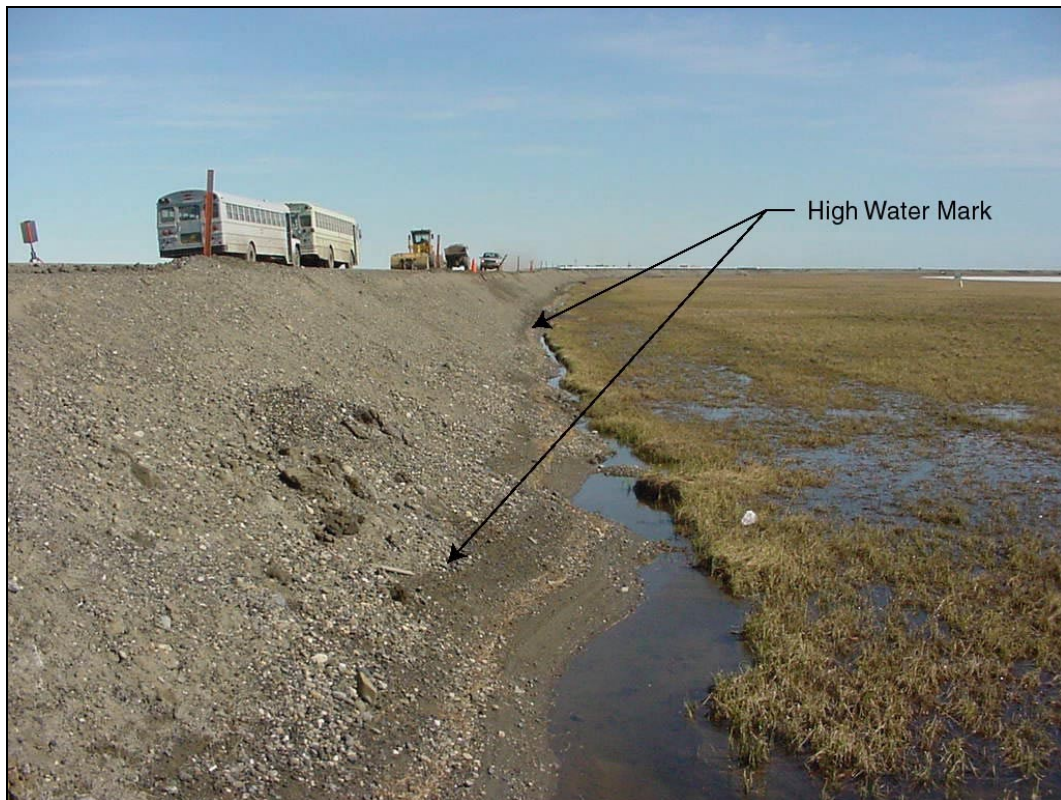
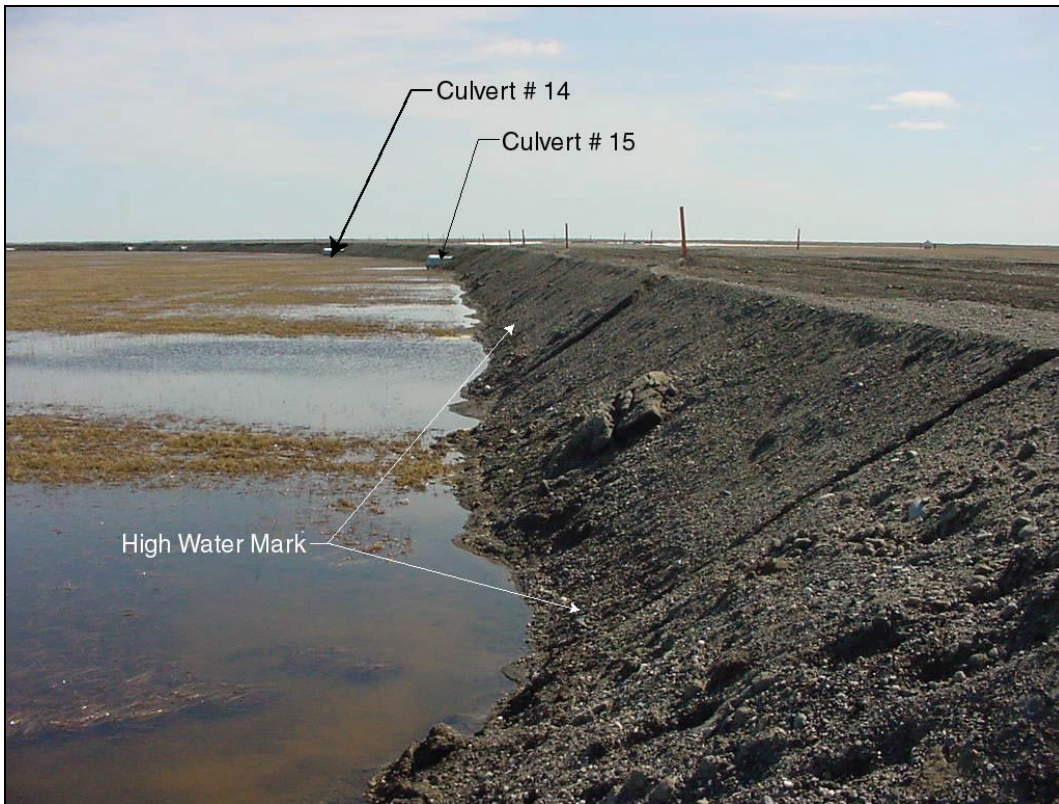
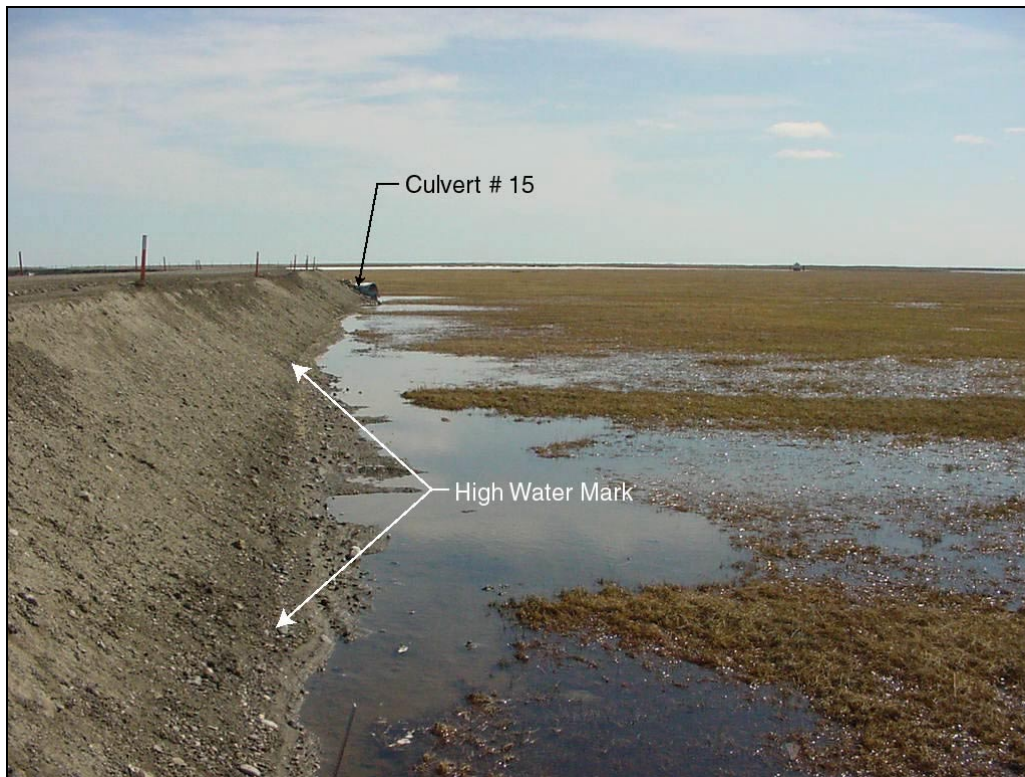
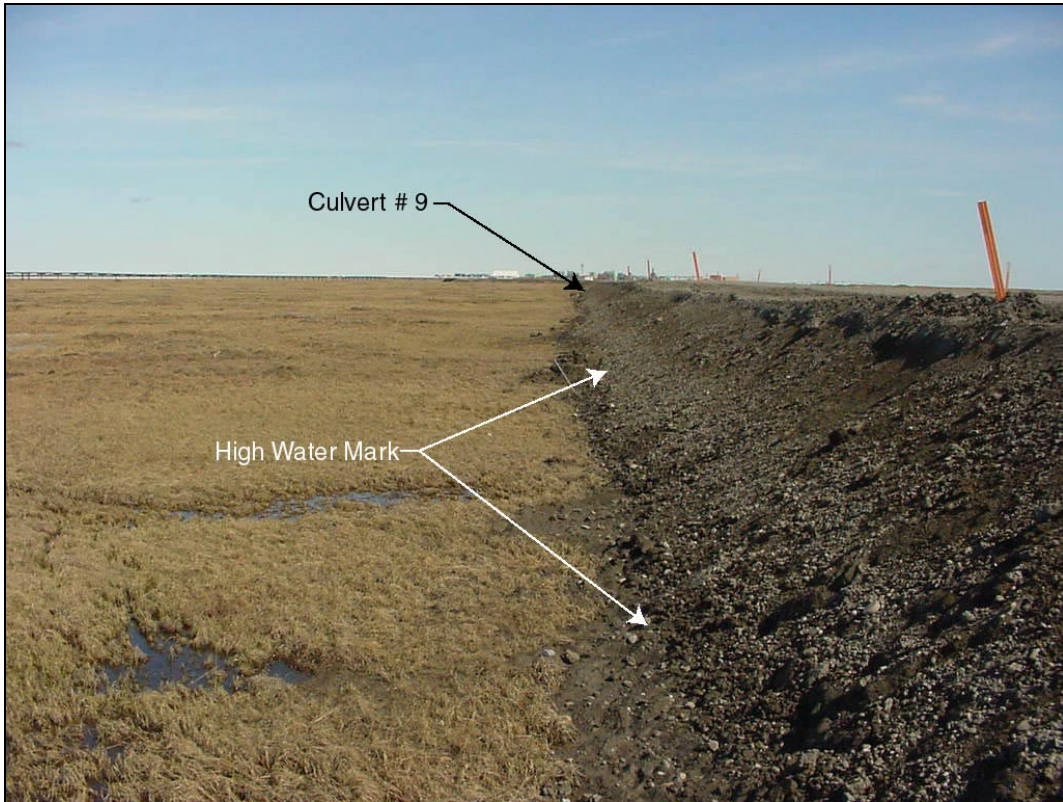
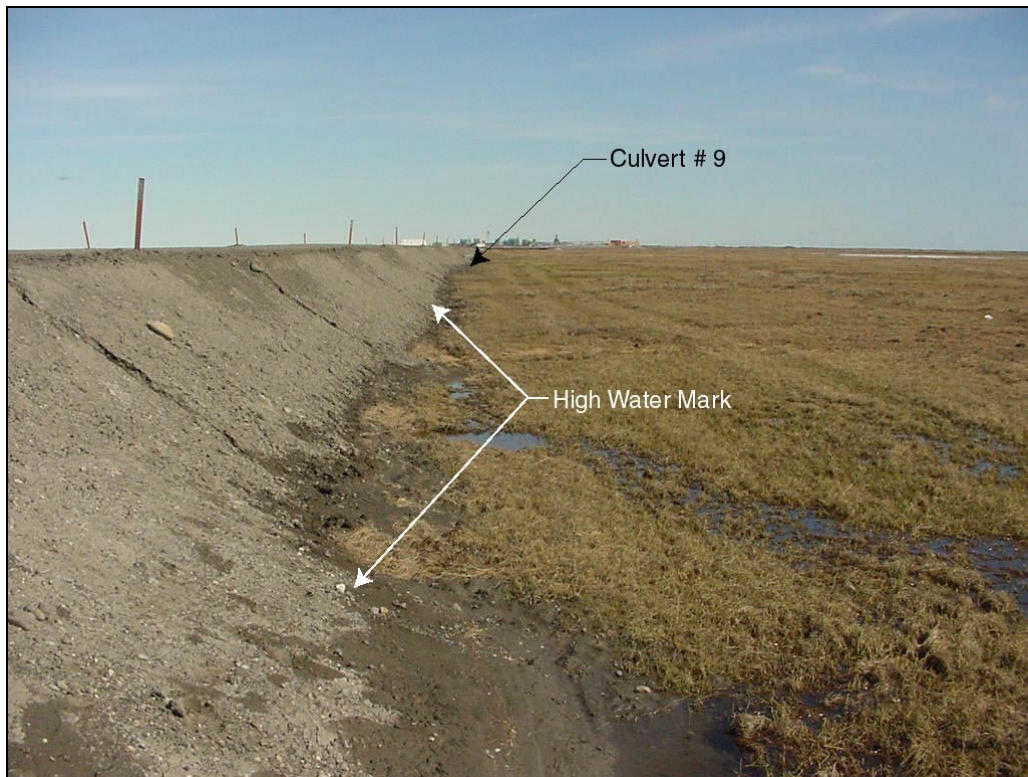
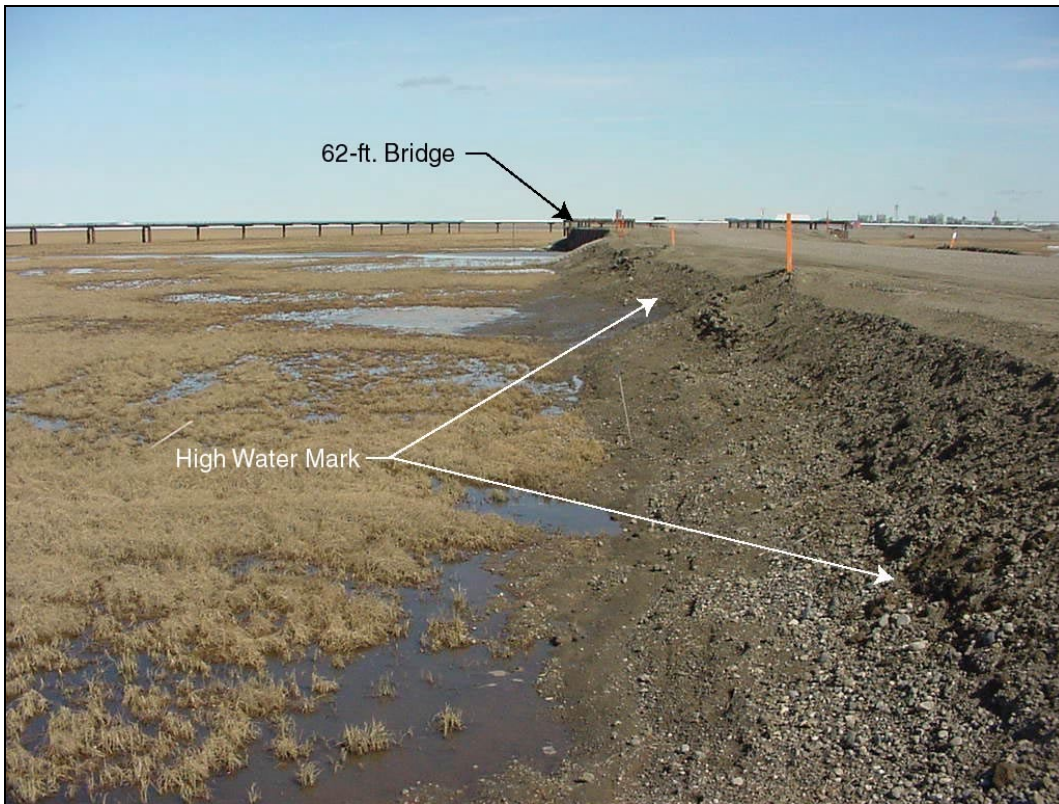
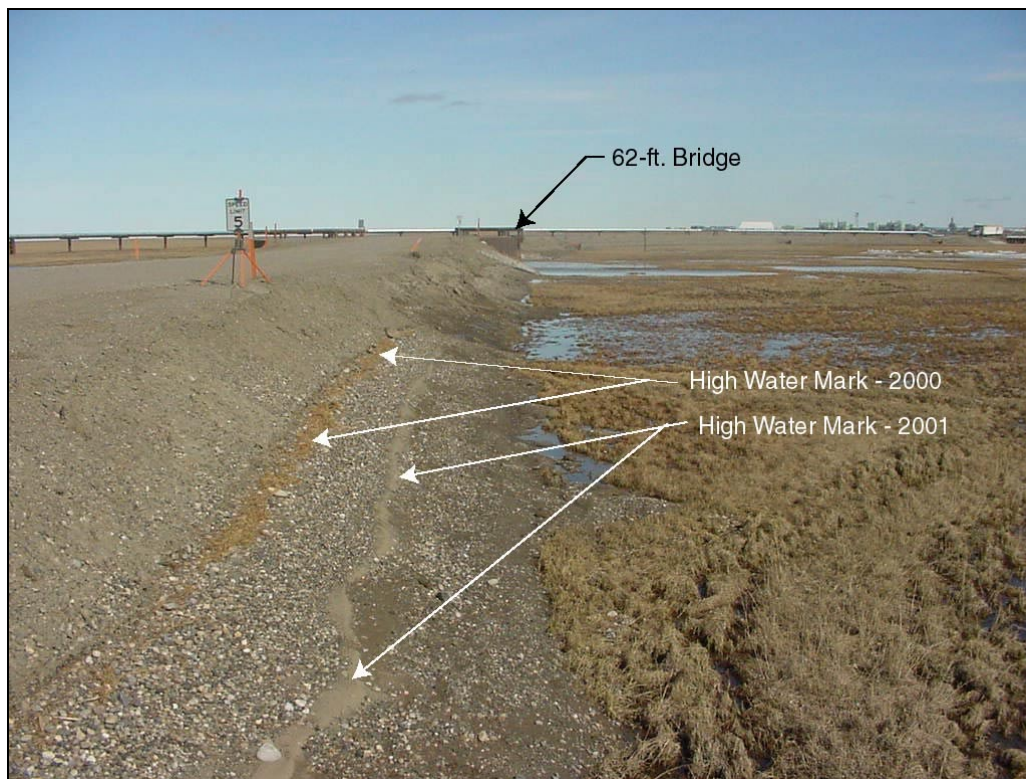
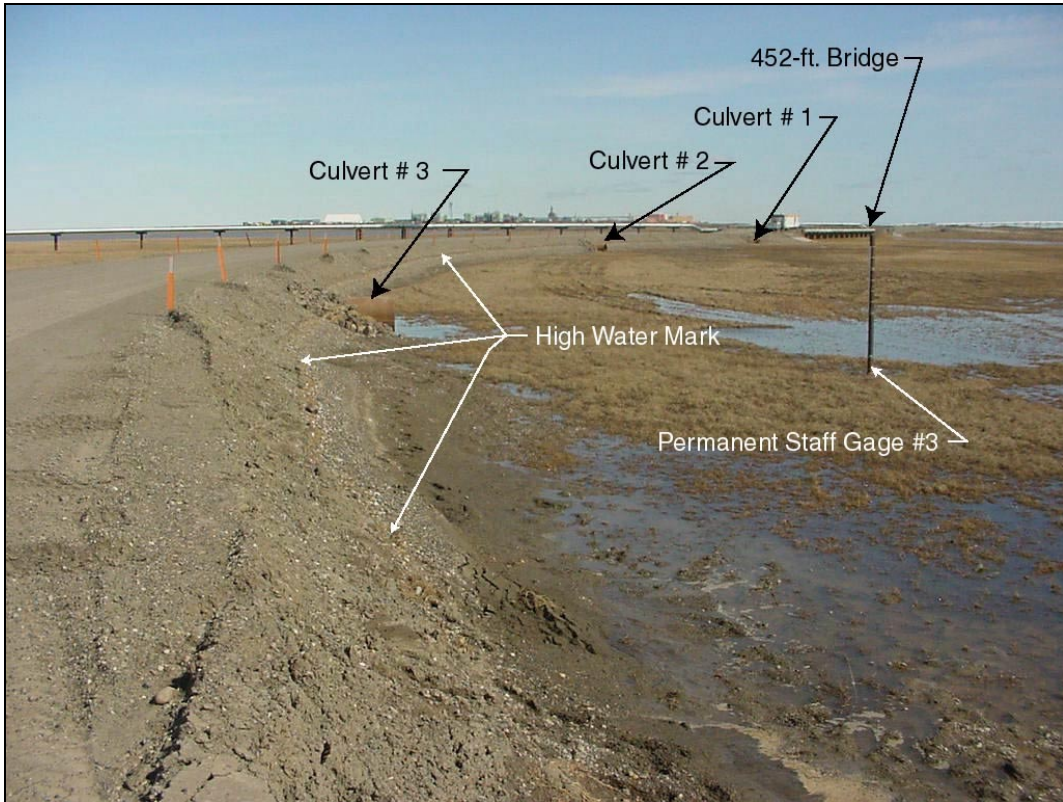
No indications of significant erosion due to breakup flows were observed anywhere along the gravel structures. Areas where inundation did occur had some minor settlement of fine-grained material from the surface course, however, no slumping or side slope deterioration was observed. At no location was 20 cubic yards of gravel estimated to have been eroded, thus the requirements of USACE 2-96087 are met and additional reporting or remedial action plans are not required at this time.

High water marks along the CD-2 access road are presented on Photo 4-1 through Photo 4-9.

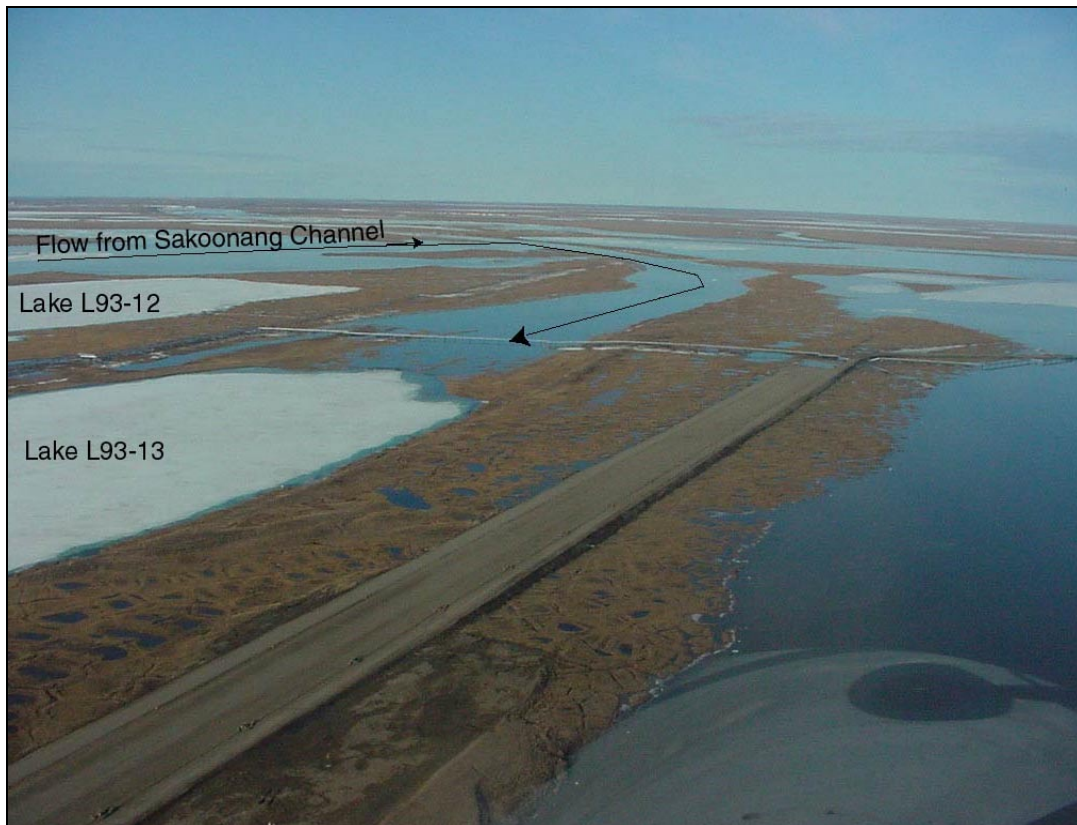
Prior to breakup, the water surface elevation in Lake L93-13 was 5.55 feet, measured on 12 May. On 11 June, water was observed flowing from the Sakoonang Channel into Lake M9525 and then into Lake L93-13 through the low divide separating these lakes. The water surface elevation reached a peak of 8.31 feet sometime late on 11 June or early on 12 June. The water surface elevation then began to recede as river waters dropped. Recharge into Lake L93-13 is shown in Photographs 5-1 through 5-4.

**Photo 5-1** Looking south at recharge into Lake L93-13. Photo taken June 11, 2001.

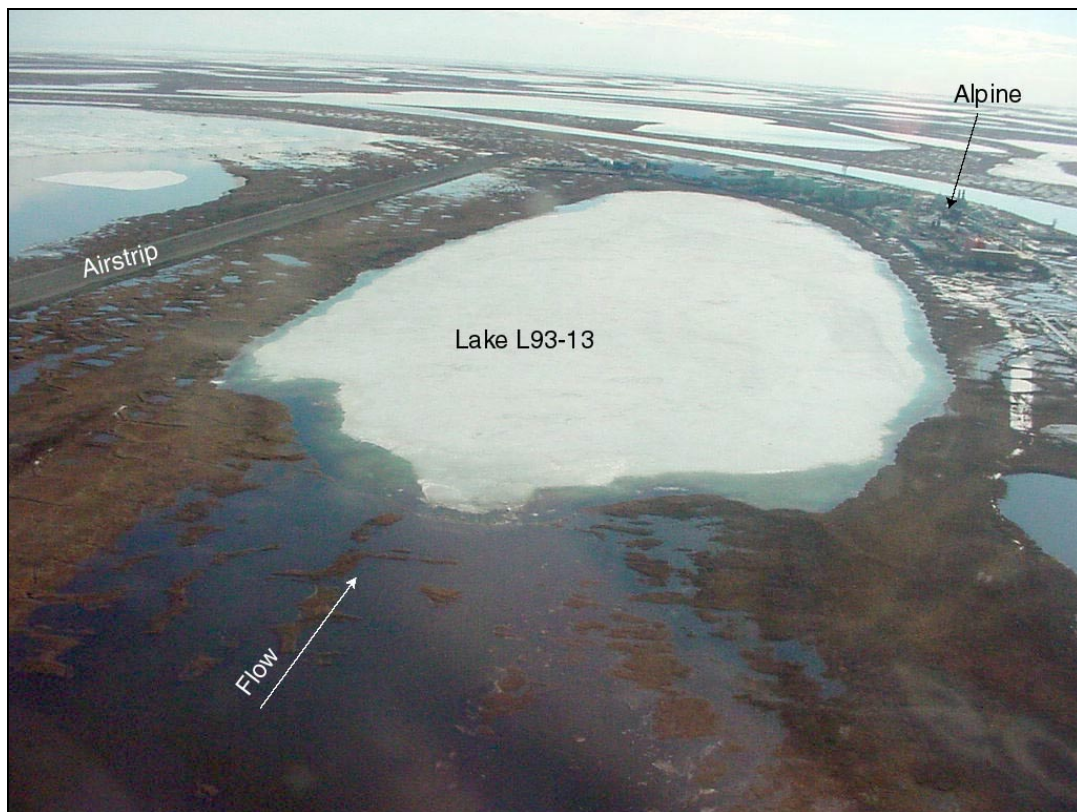
**Photo 5-2** Looking north at Lake L93-13. Note hydraulic connection into lake. Photo taken June 11, 2001.

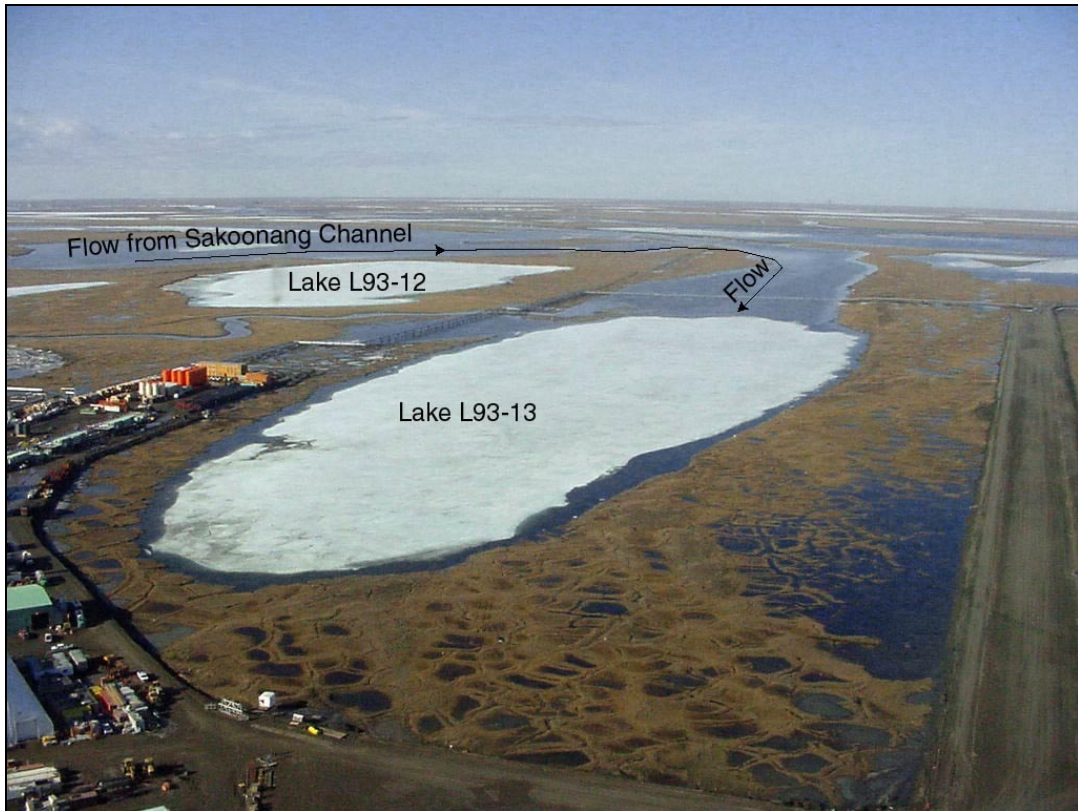
**Photo 5-3** Looking south at Lake L93-13 and Lake L93-12. Photo taken June 12, 2001.

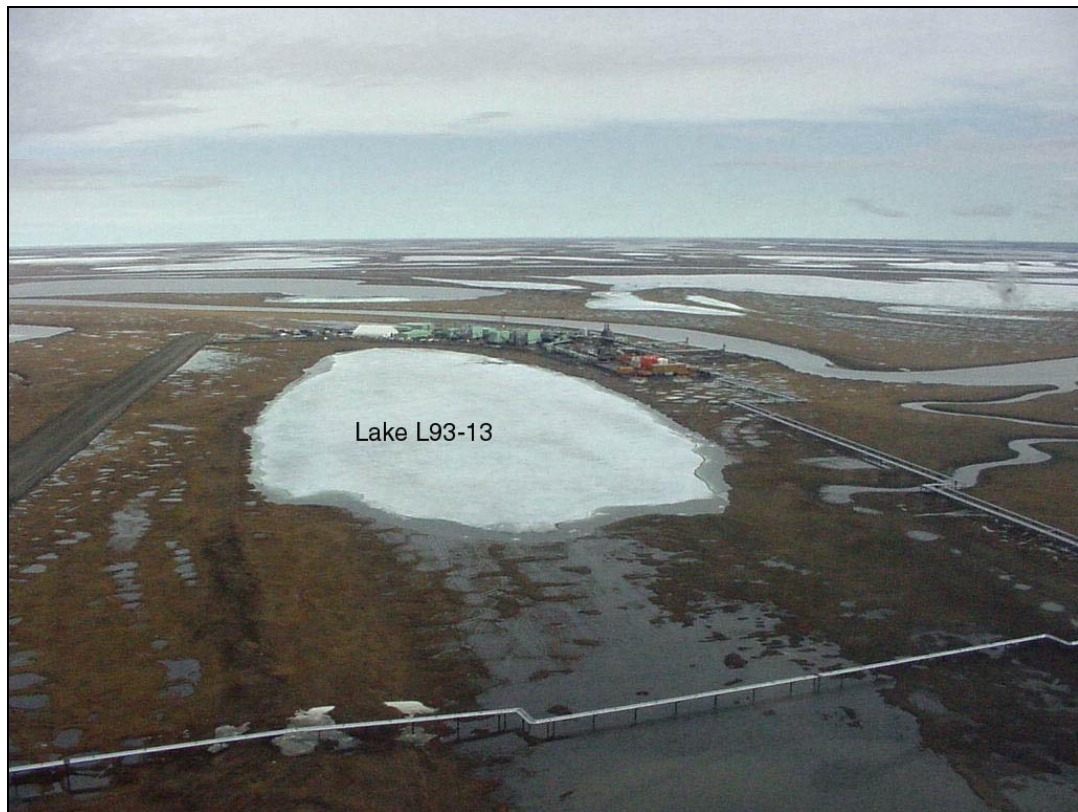
**Photo 5-4** Looking north at Lake L93-13. Note hydraulic connection into lake. Photo taken June 14, 2001.
