# Alpine Facilities 2002 Spring Breakup and Hydrologic Assessment

**ConocoPhillips**

October 2002  
25436-MBJ-DOC-001

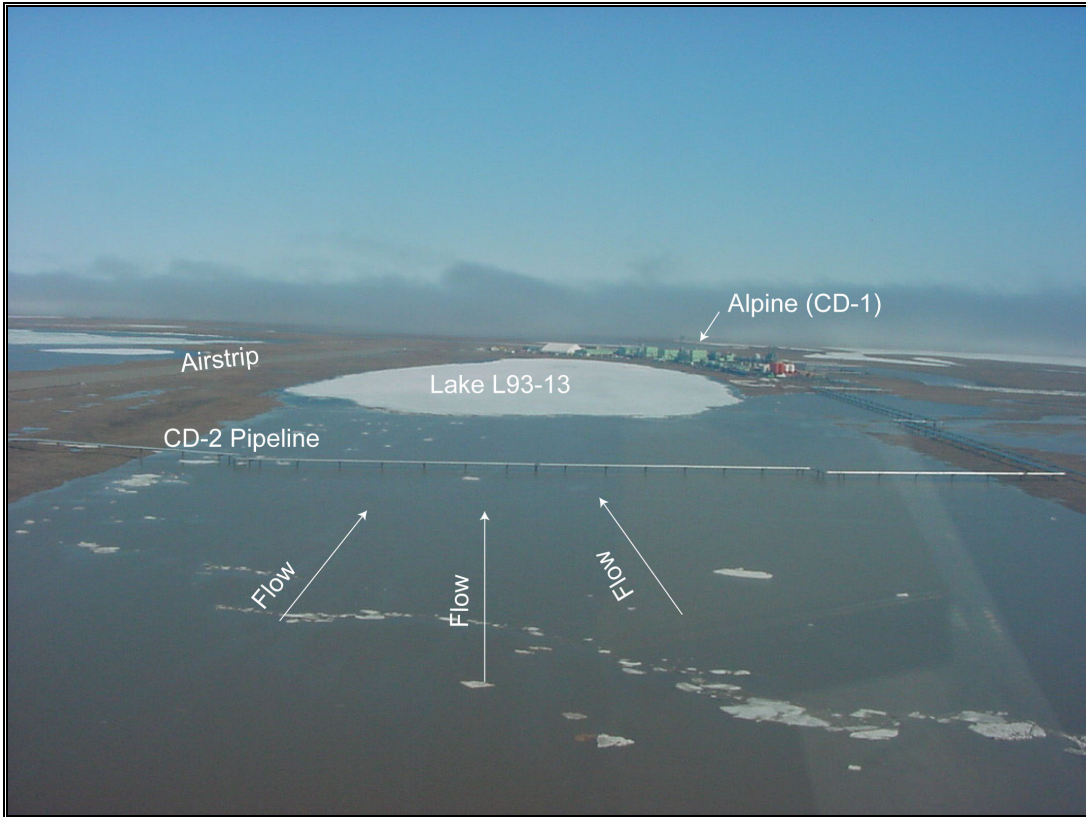
**Photo 2-1 a Flooding conditions at Alpine looking northeast at CD-1 pad.**

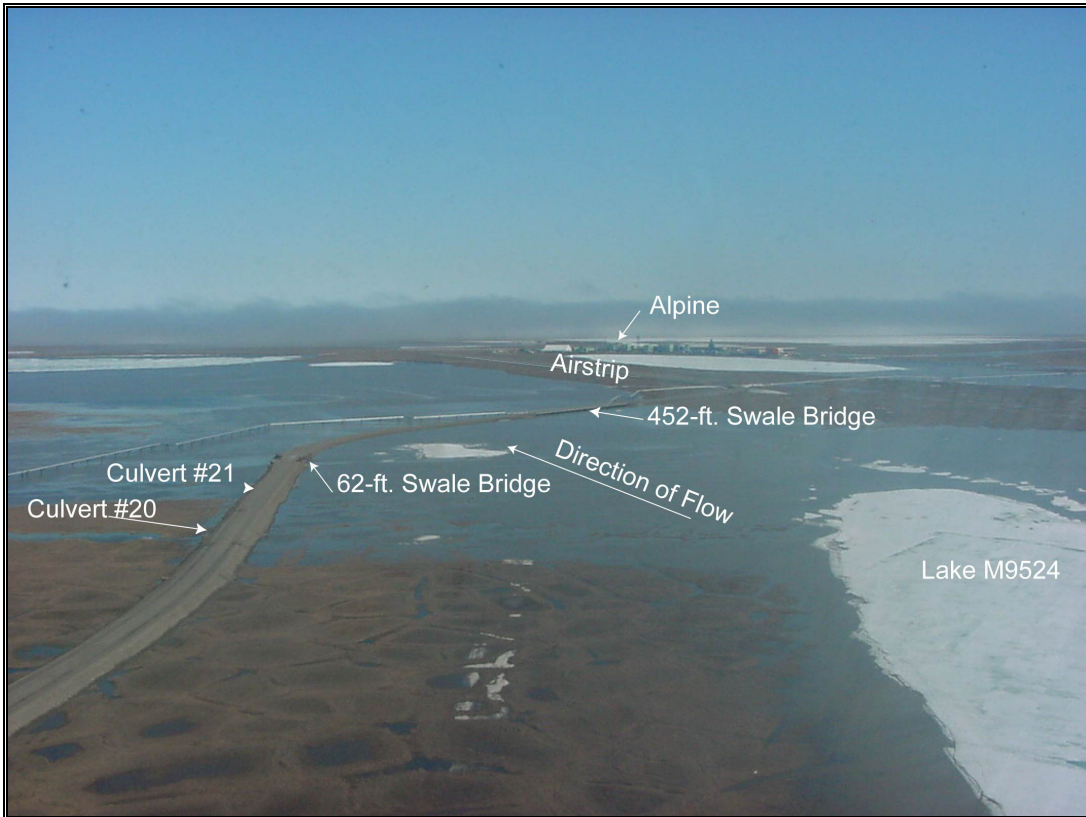
**Photo 2-1 b Flooding conditions at Alpine looking northeast at swale bridges.**

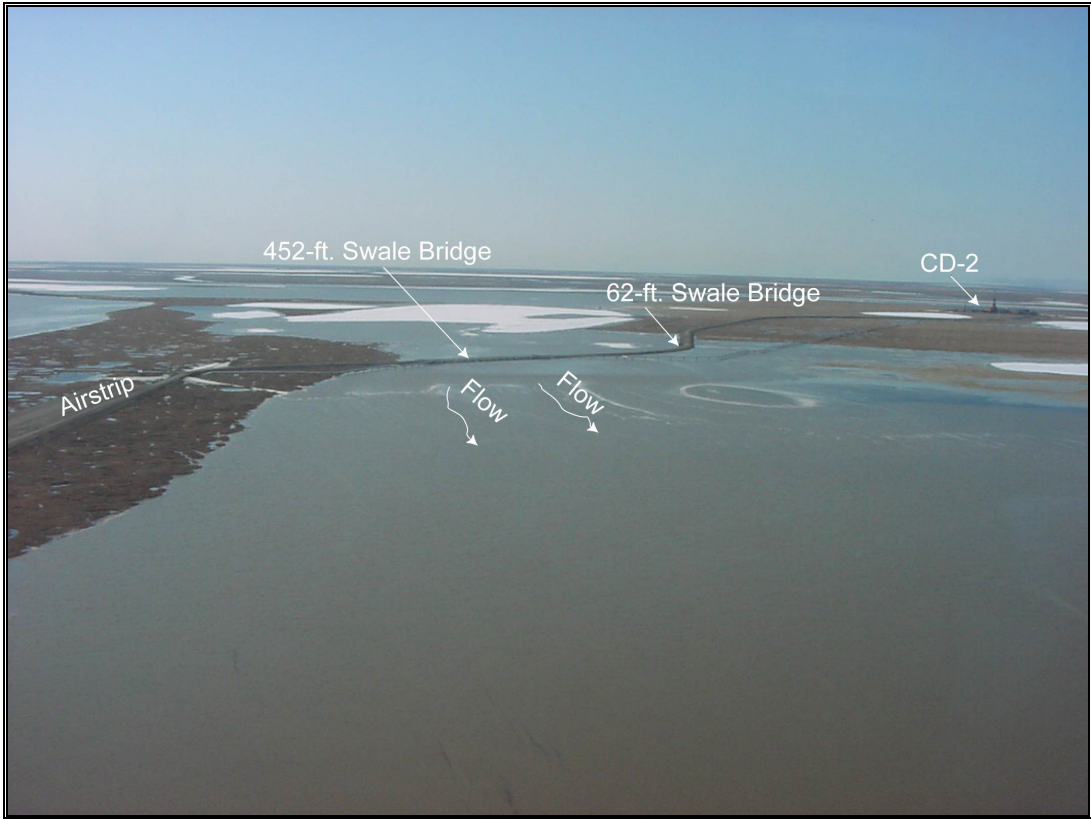
**Photo 2-1 c Flooding conditions at Alpine looking southwest towards swale bridges.**

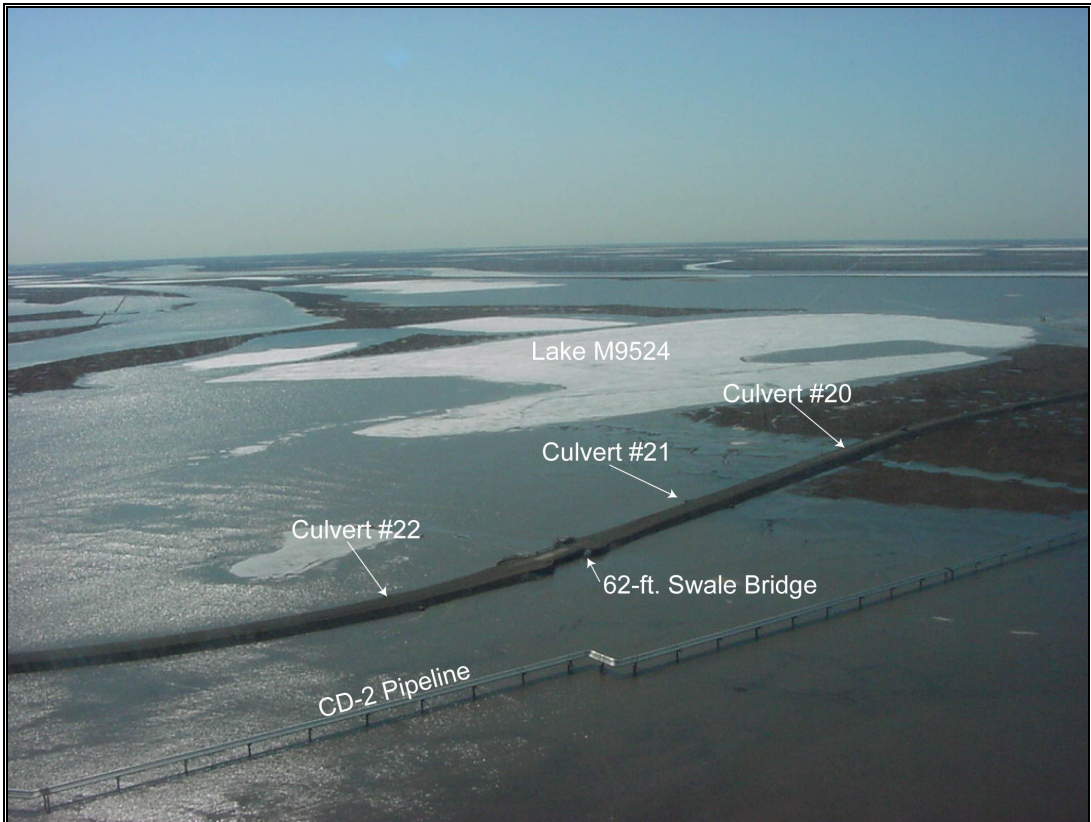
**Photo 2-1 d Flooding conditions at Alpine looking southwest at the 62-ft. swale bridge.**

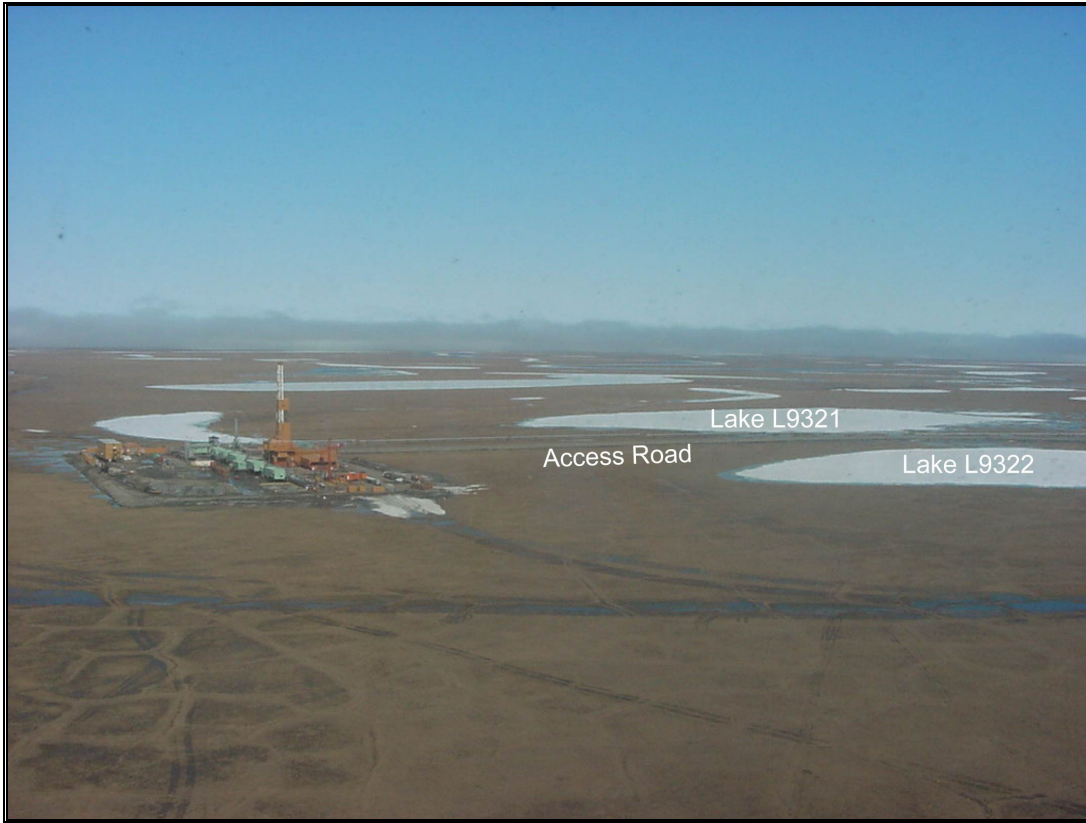
**Photo 2-1 e Flooding conditions at Alpine looking north towards CD-2.**

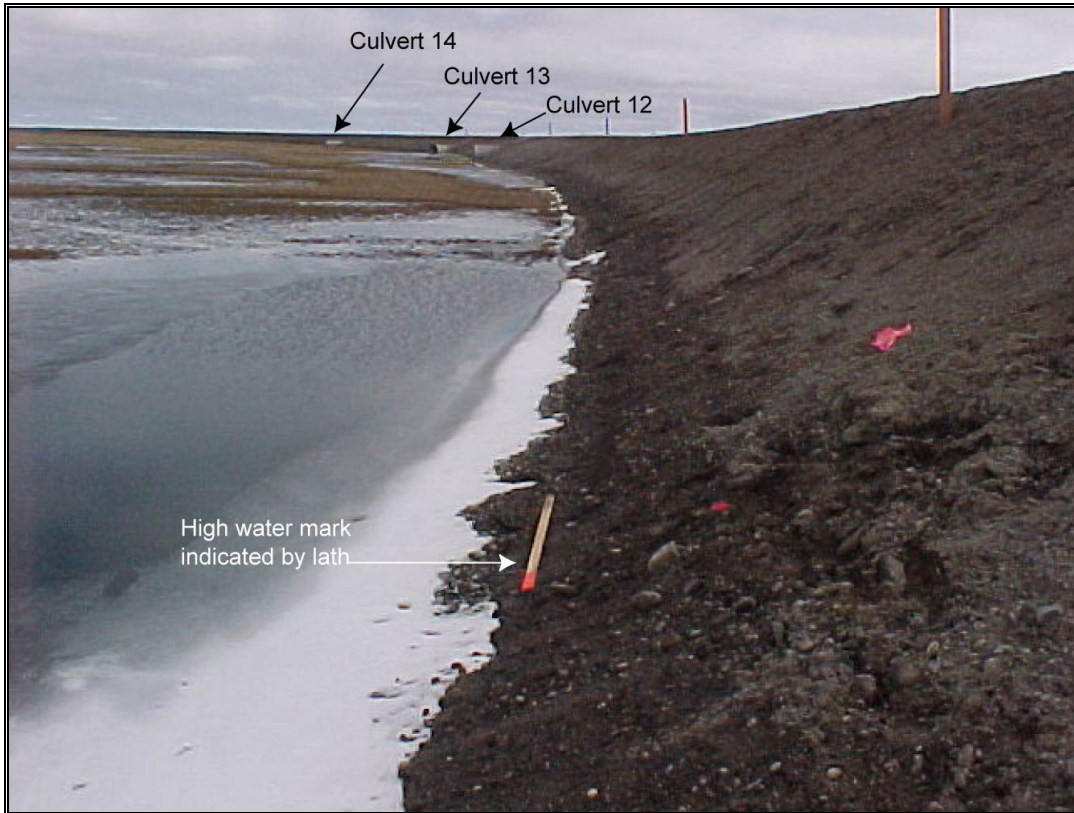
In areas where inundation did occur, some minor settlement of fine-grained material was noted, however, no slumping or side slope deterioration was noted. High water marks were noted on the gravel structures. Such marks were identified by grasses and other debris stranded on the gravel side slopes, or where fine-grained materials had been washed from the gravel. High water marks along the CD-2 access road are presented on Photos 4-1 through 4-7.

**Photo 4-1** Facing east from Culvert 11 along the north side of the CD-2 access road.

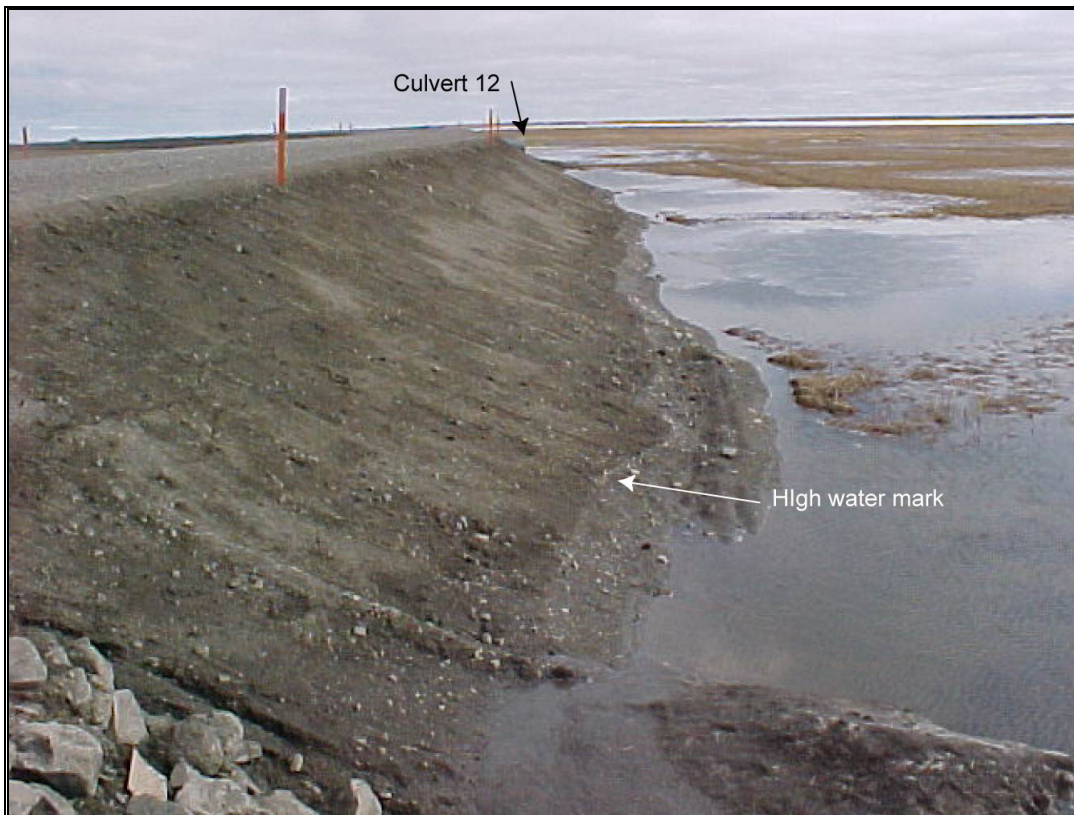
**Photo 4-2** Facing east from Culvert 11 along the south side of the CD-2 access road.

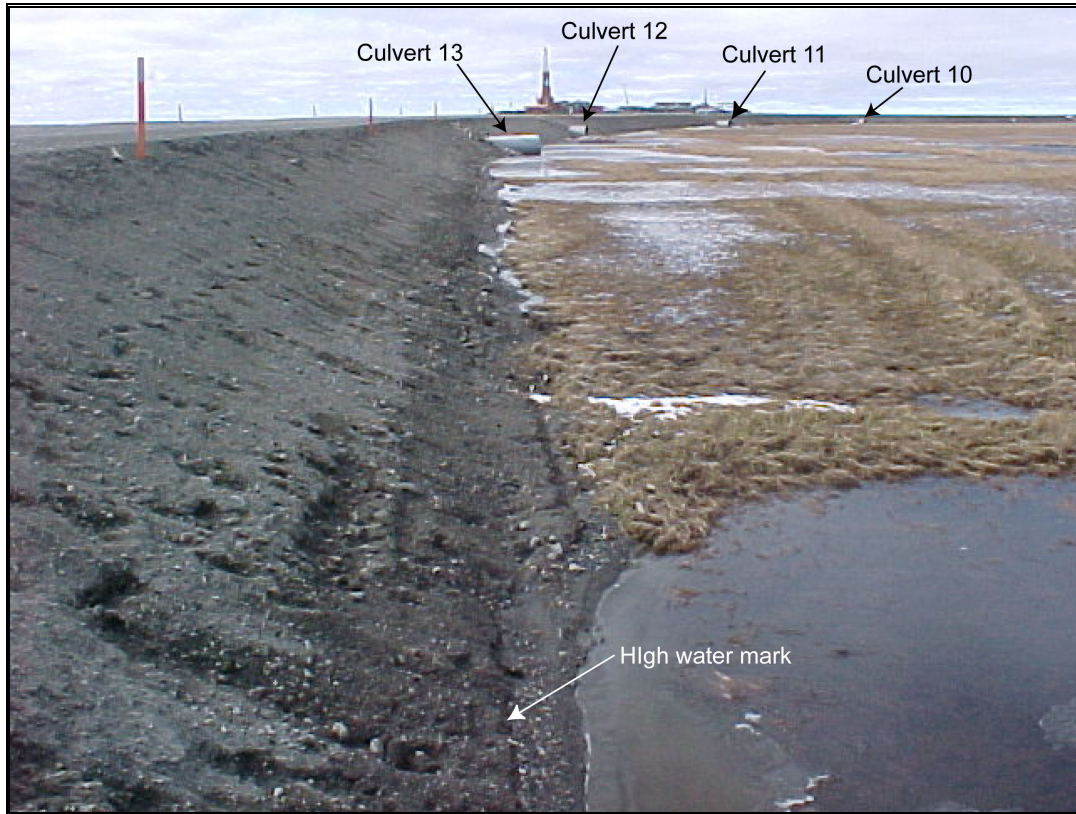
**Photo 4-3** Facing west from Culvert 14 along the north side of the CD-2 access road.

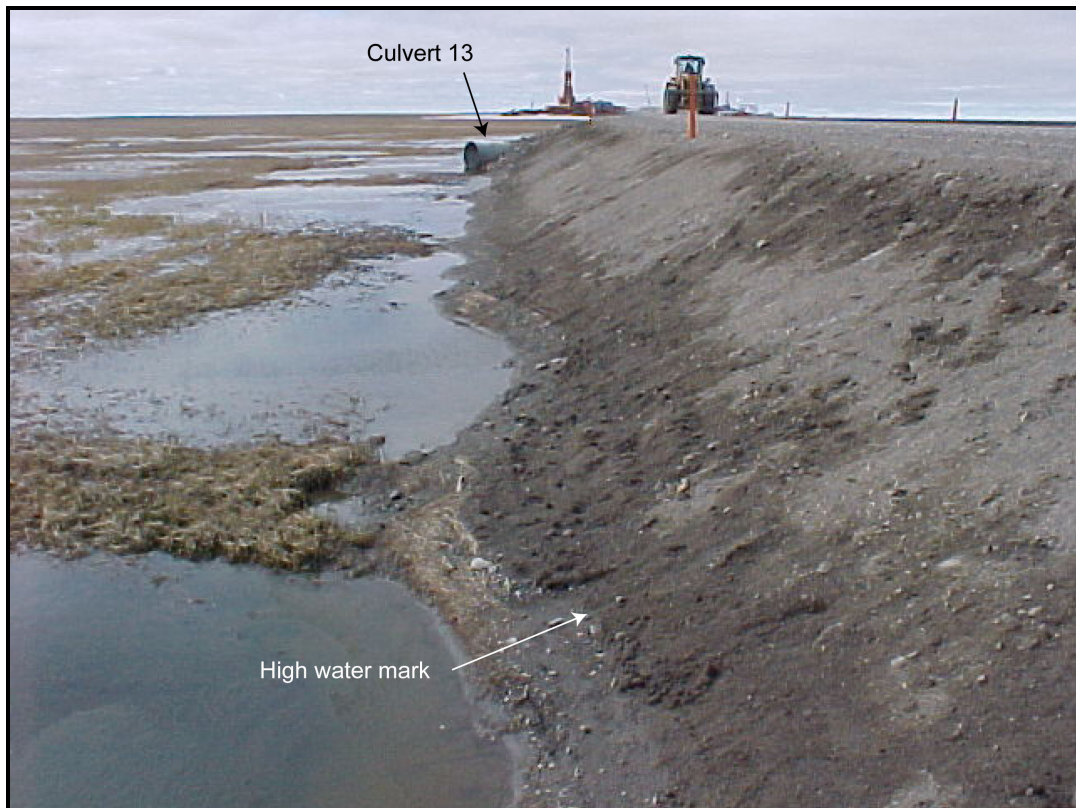
**Photo 4-4** Facing west from Culvert 14 along the south side of the CD-2 access road.

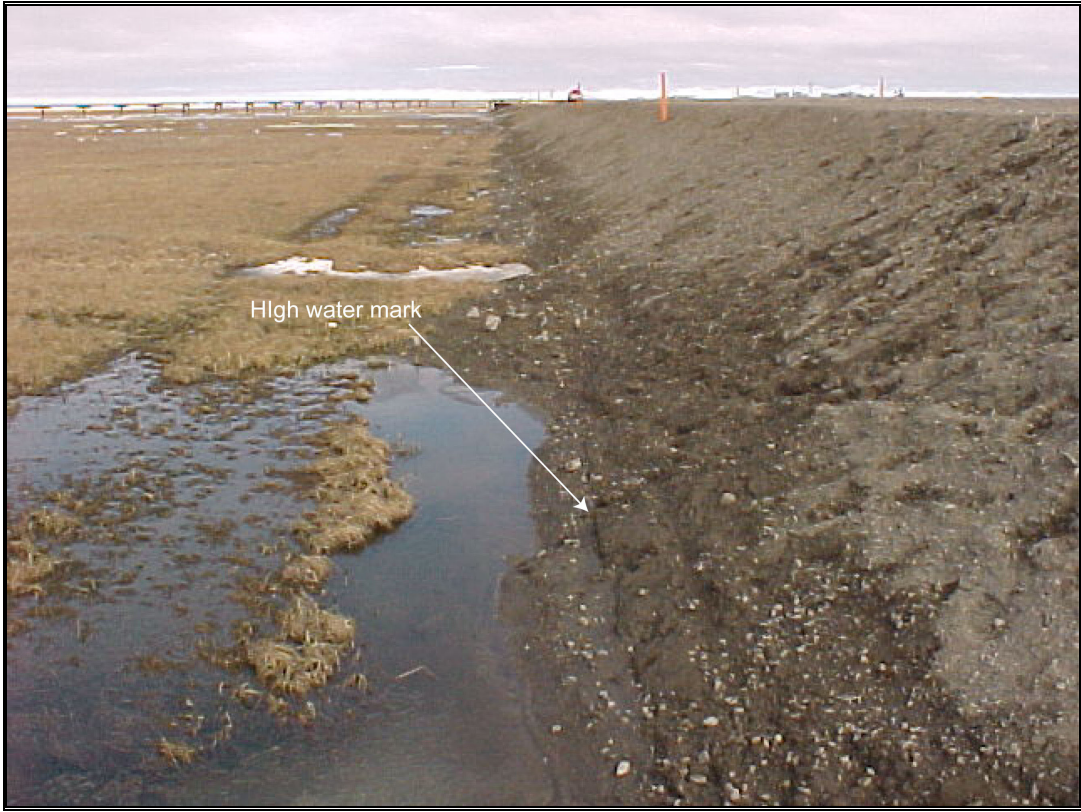
**Photo 4-5** Facing east from Culvert 20 along the north side of the CD-2 access road.

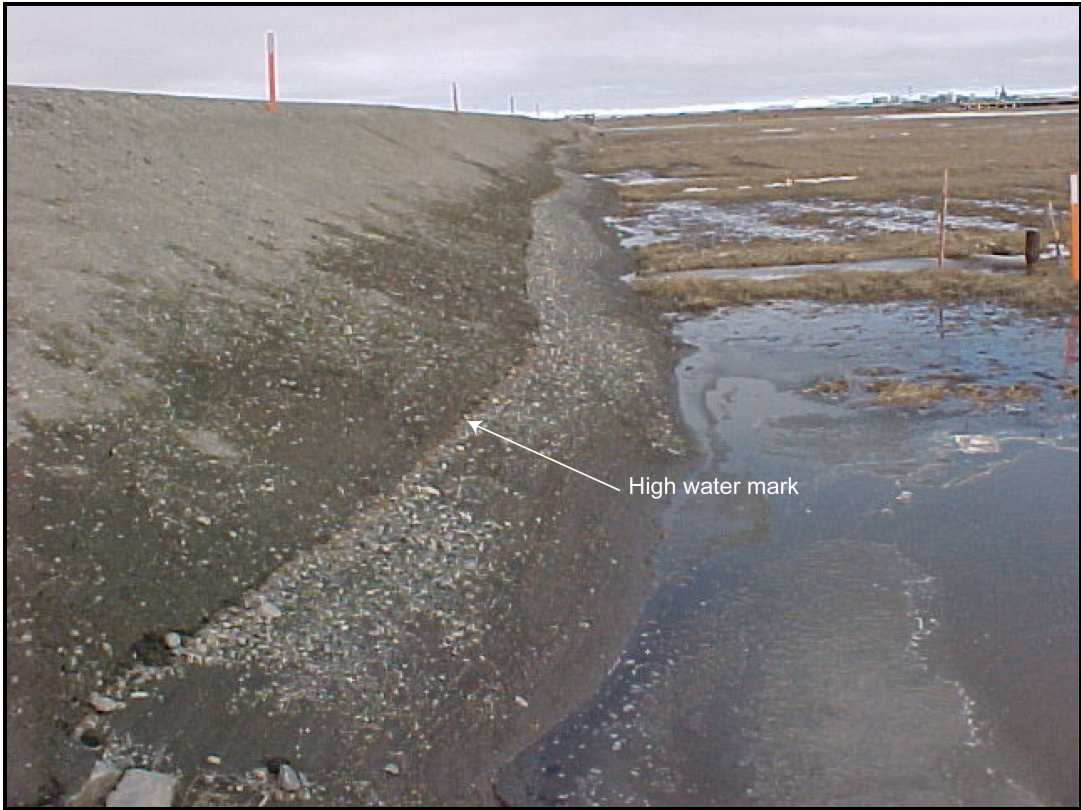
**Photo 4-6** Facing east from Culvert 20 along the south side of the CD-2 access road.

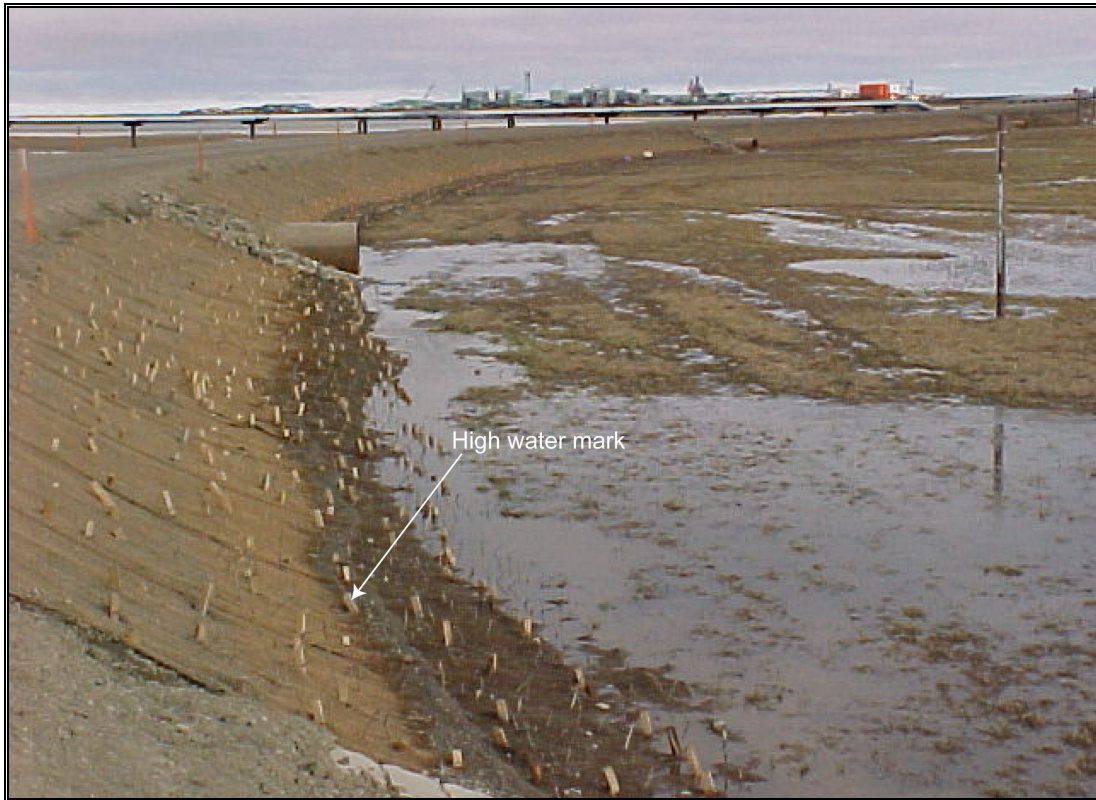
**Photo 4-7** Facing east along the south side of the CD-2 access road from the 62-ft. bridge.

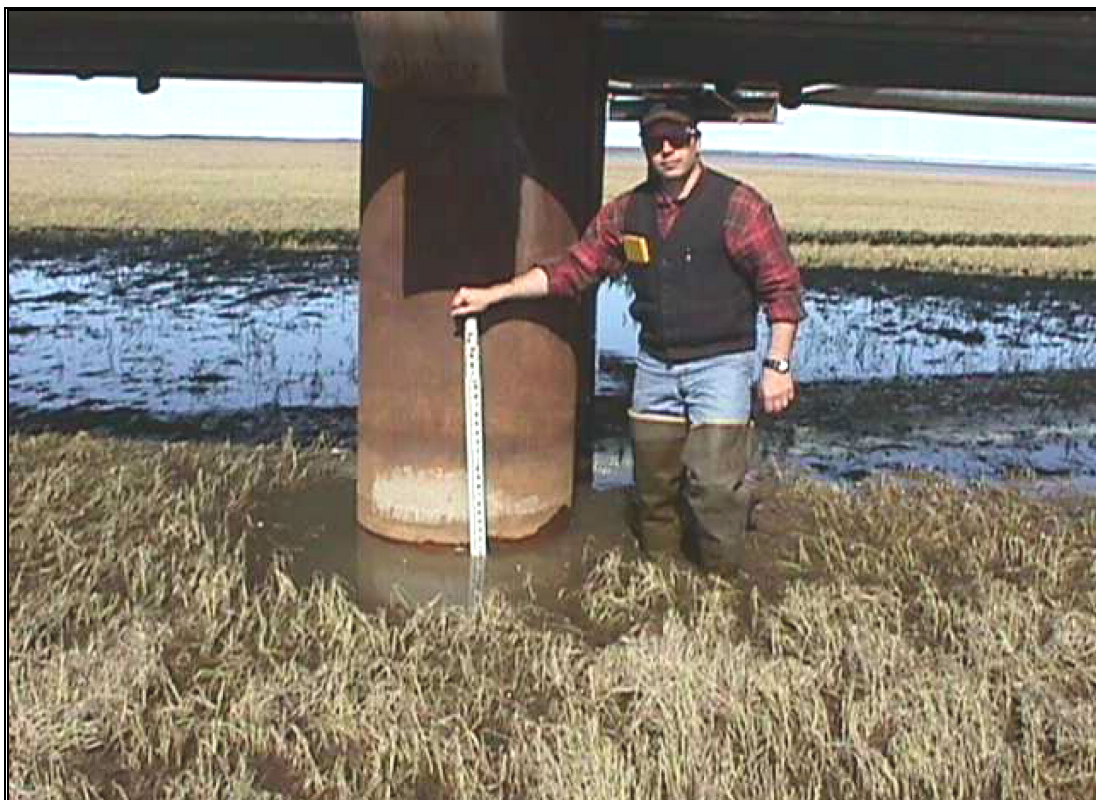
Vegetation throughout the swale area was intact and has evidently been able to withstand the flows experienced to date. The only noteworthy scour observed was adjacent to the bridge piers. Scour measured at random piers was generally two to three feet deep (measured from the ground surface) (see Photo 4-8a). Depths were relatively consistent at both the large and small bridges and at both the upstream, downstream, and sides of the piers.

Scour observed around the bridge piers appeared to be a result of construction techniques used to install the piers rather than erosion of the natural ground materials. Scour holes did not have the characteristic shape of typical scour holes caused by the erosion of loose material around piers by high velocity flows. Instead, the scour appeared to be the result of degradation of the top two

**Photo 4-8** Typical depth of scour at bridge pier.

Reading on rod is 3.2 feet and scour depth is approximately 2 feet (depth of water adjacent to pier is 1.2 feet).

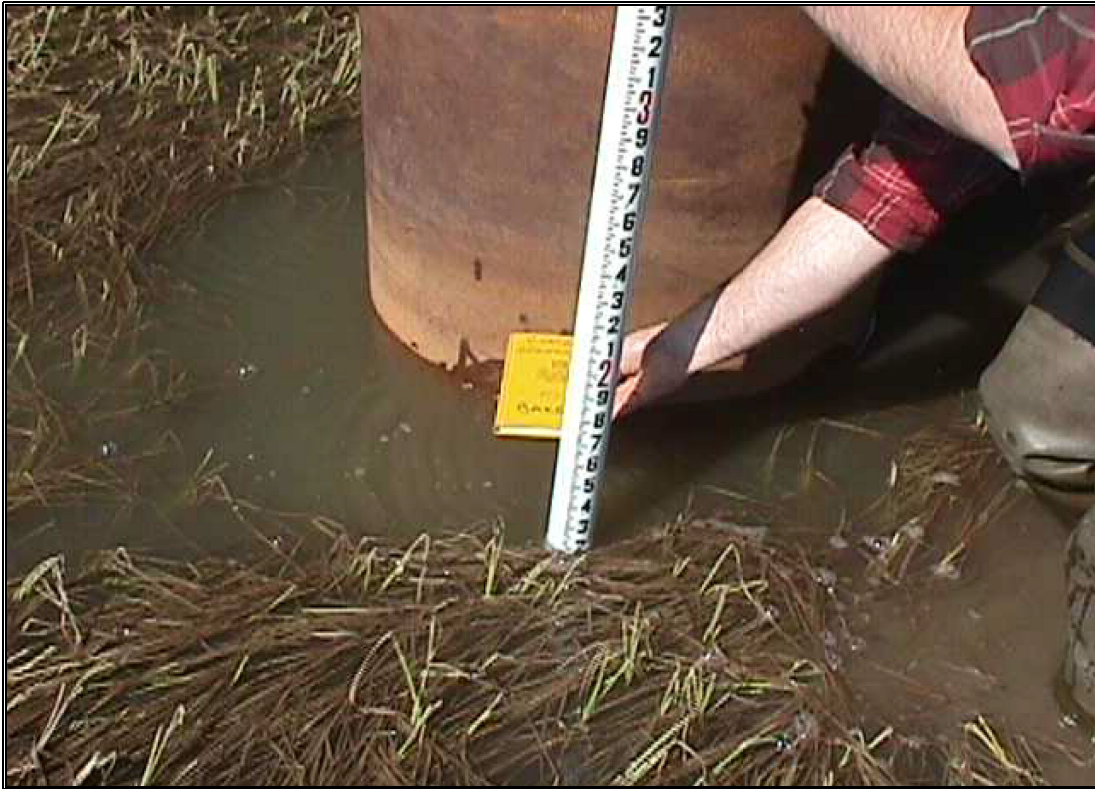
to three feet of the slurry that was used to backfill the pre-drilled pier holes. This can be seen in Photos 4-9 and 4-10. In Photo 4-9, the rod was on natural ground approximately 6 inches from the pier and the depth of water was 1.2 feet. In Photo 4-10, the rod was moved against the pier and the depth was 3.2 feet. The natural ground and vegetation was intact right up to the edge of scour, where it dropped vertically for a depth of approximately two feet. This suggests that although the natural ground is holding up well, the top few feet of backfill slurry has degraded and been scoured during flood events.

**Photo 4-9** Depth of water approximately 6 inches from pier.  
Reading on rod is 1.2 feet.

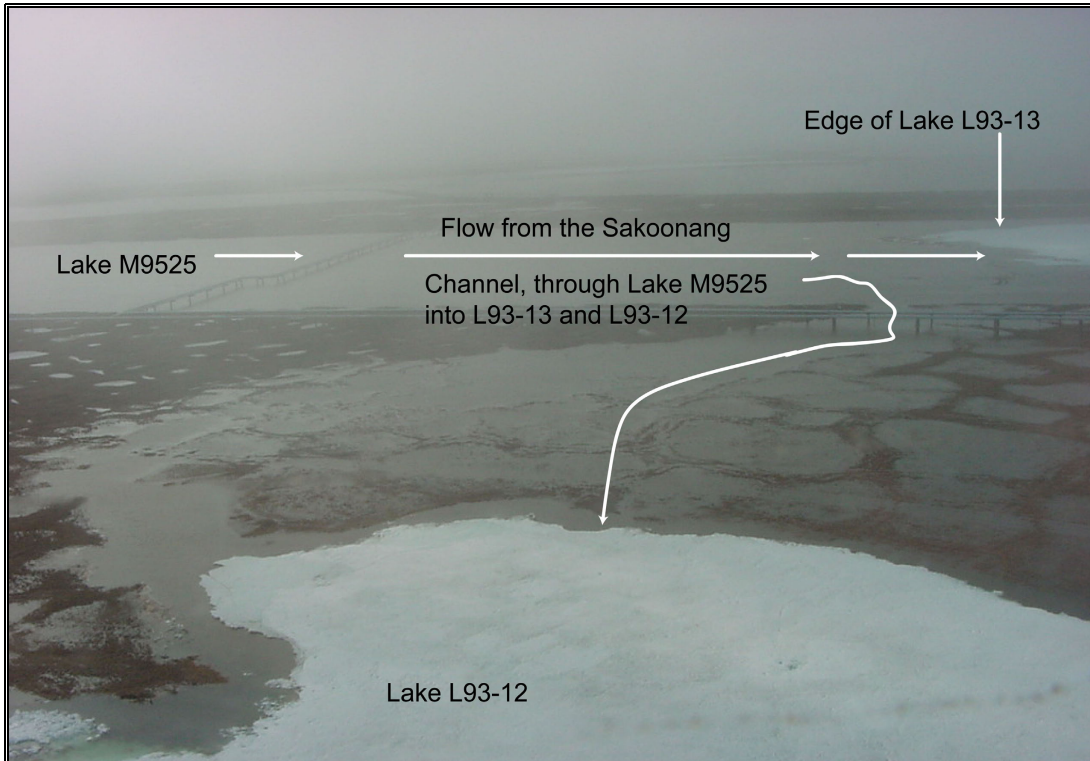
Prior to breakup, the water surface elevation in Lake L9312 was 7.31 feet, measured on April 6. Recharge flow into Lake L9312 was first noted on May 25 when water was observed flowing from the Sakoonang Channel into Lake M9525, and eventually into Lake L9312. A peak water surface elevation of 8.21 feet was recorded on May 26 at Lake L9312. As the water surface elevation of the Sakoonang Channel began to drop, the water surface elevation in Lake 9312 began to recede. Water surface elevations and recharge of Lake 9312 are shown on Table 5-1 and on Photographs 5-1 and 5-2.

**Photo 5-1** Looking west from Lake L93-12.

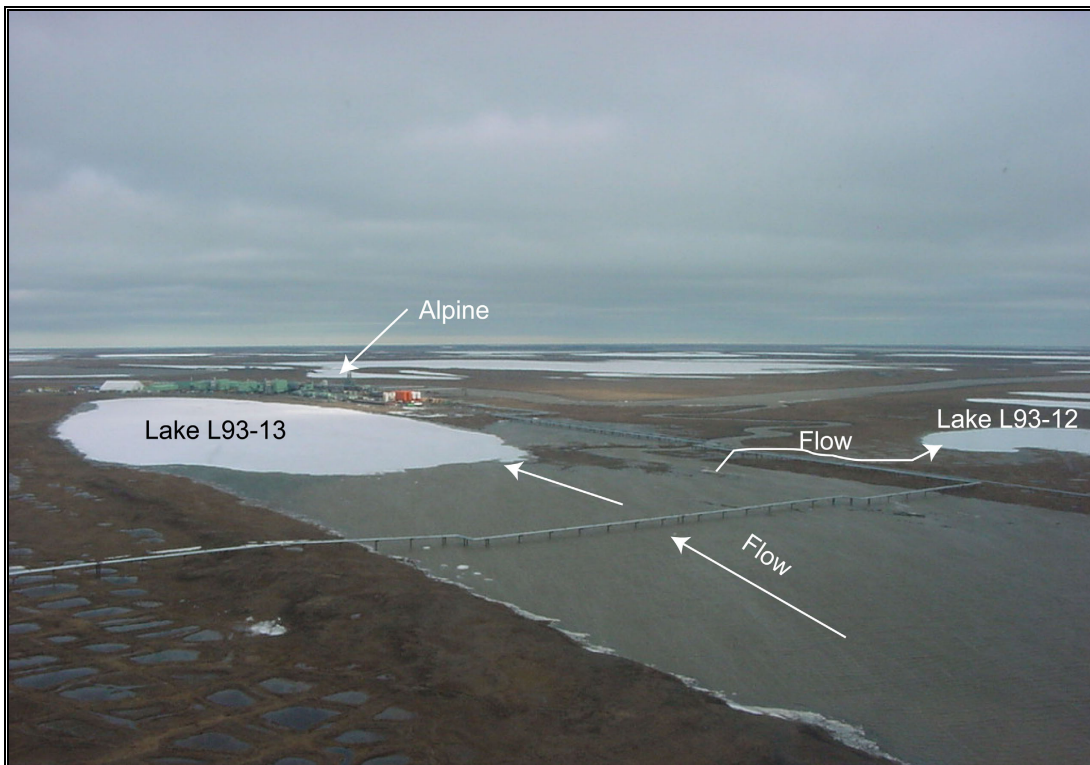
**Photo 5-2** Looking northeast at Lake L93-13 and L93-12.

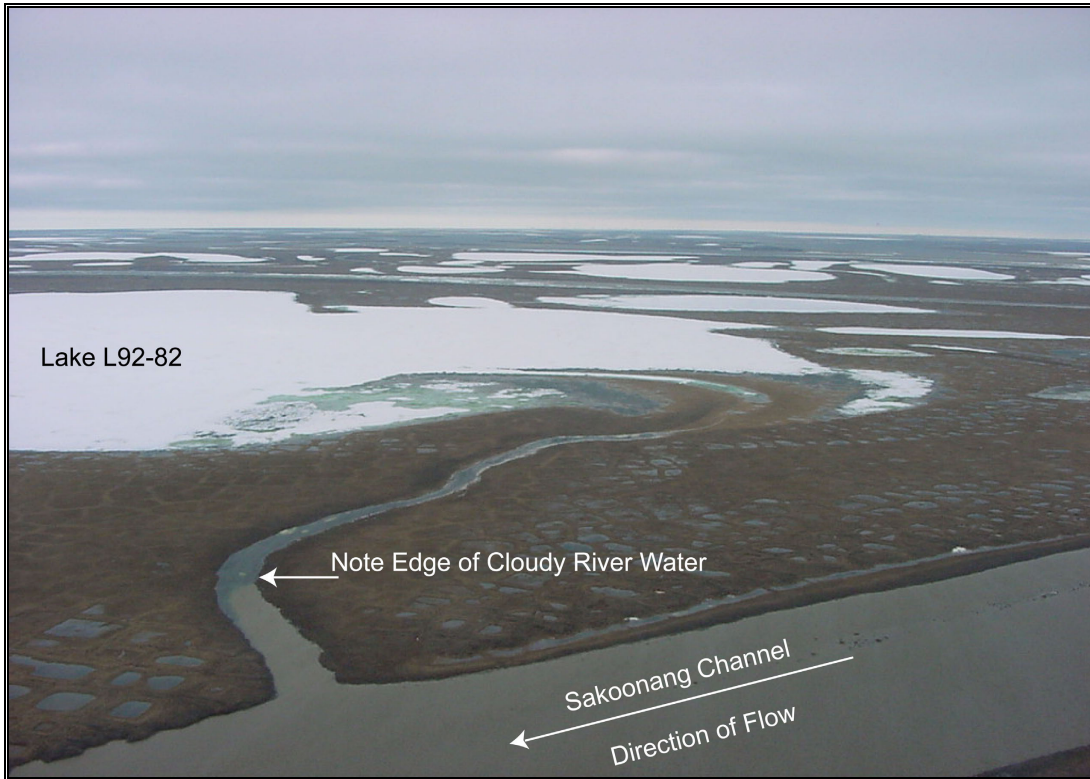
**Photo 5-3** Looking northeast towards Lake L92-82.

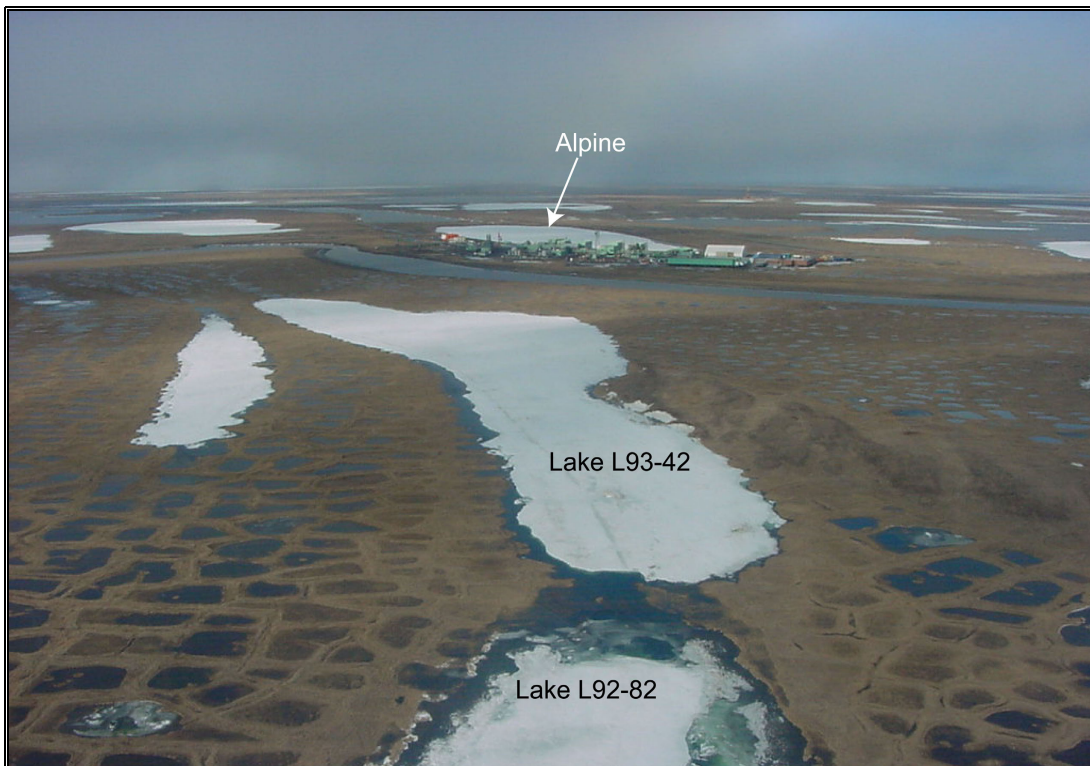
**Photo 5-4** Looking west at Lake L93-42.  
Note hydraulic connection to Lake L92-82.
