Alpine Facilities

2003 Spring Breakup and Hydrologic Assessment

September 2003

100876-MBJ-001

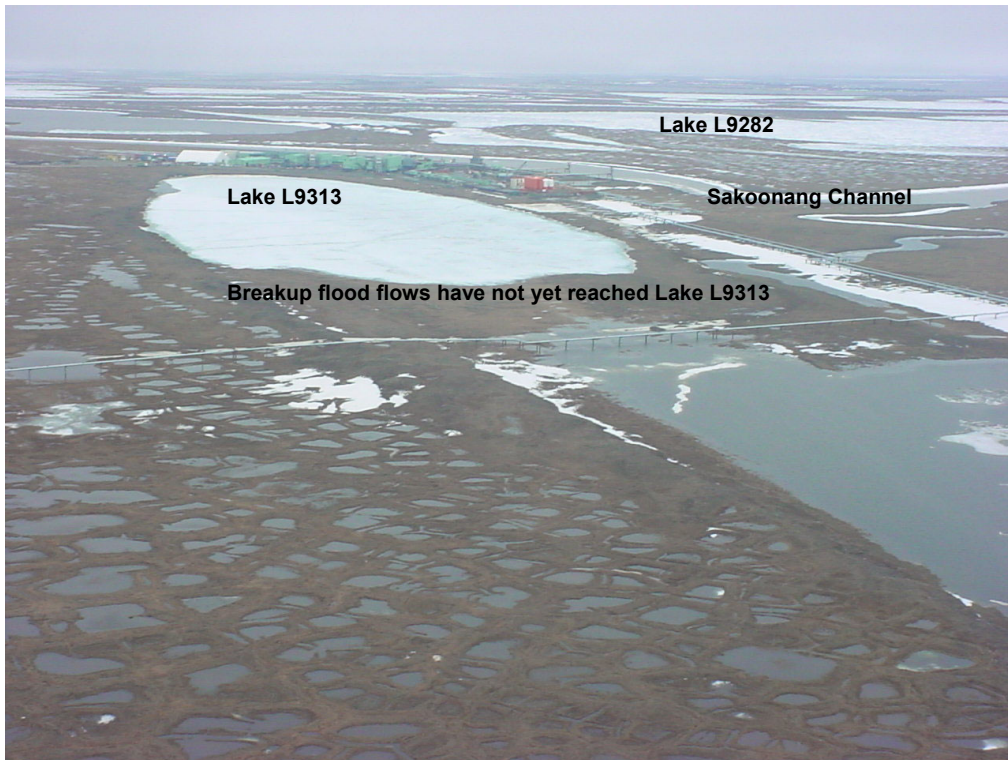
7 June 2003

Photo 3-1 Flooding conditions at Alpine approximately 24 hours prior to the peak flood stage. View looking east. Note that breakup flood flows have not yet reached Lake L9313.

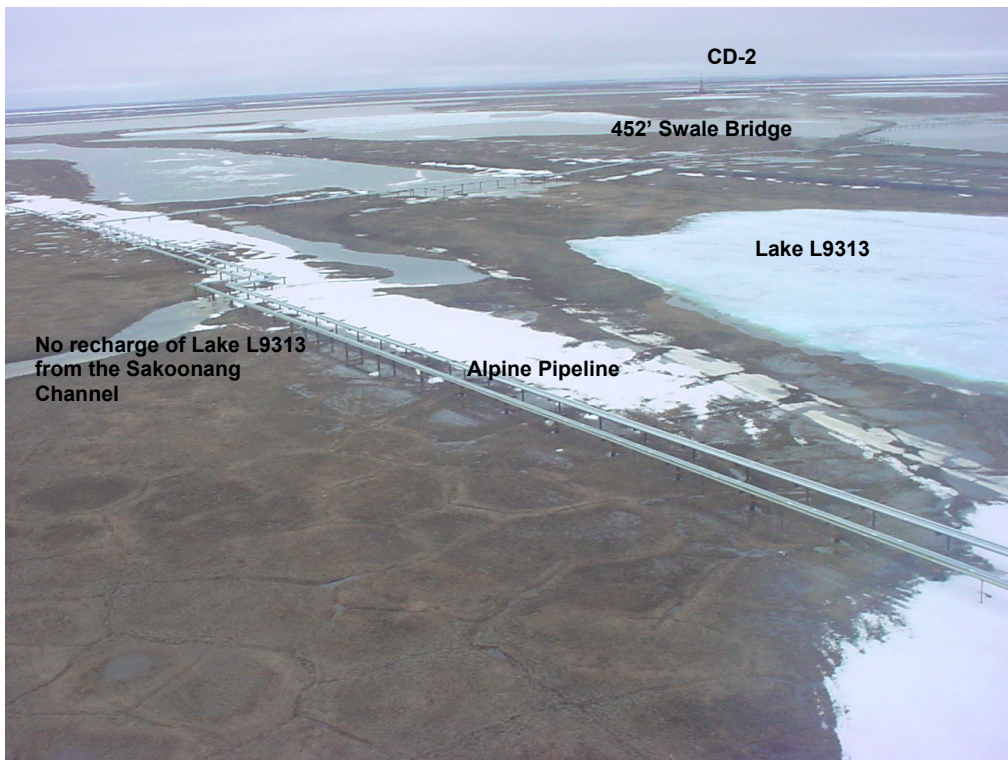
7 June 2003

Photo 3-2 Flooding conditions at Alpine approximately 24 hours prior to the peak flood stage. View looking west. Note that breakup flood flows have not yet reached Lake L9313.

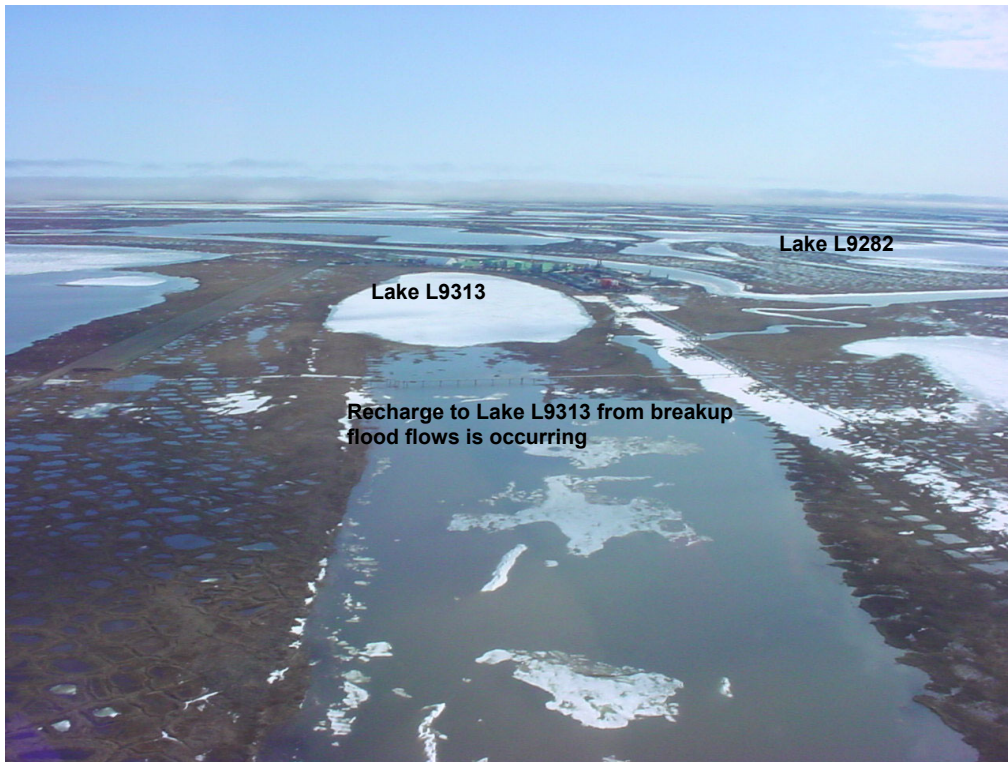
Photo 3-3 Flooding conditions at Alpine approximately 12 hours after peak flood stage. View looking northeast. Note that breakup flood flows have reached Lake L9313 and recharge is occurring.

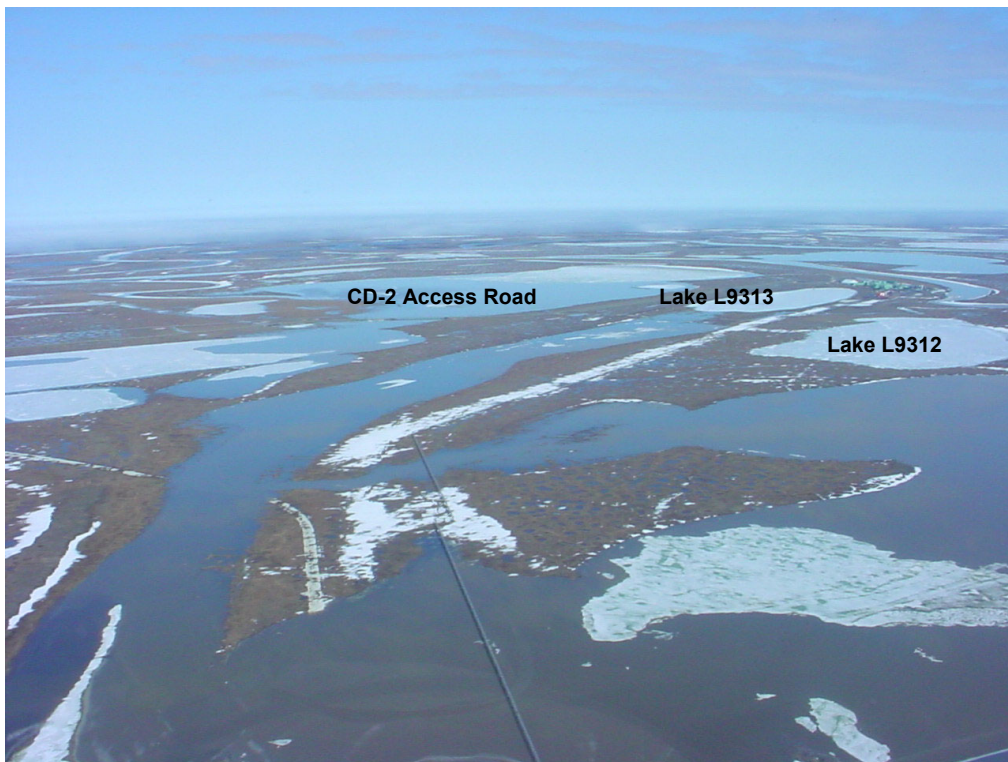
Photo 3-4 Flooding conditions at Alpine approximately 12 hours after peak flood stage. View looking north. Note that Lake L9312 is not receiving recharge from breakup flood flows.

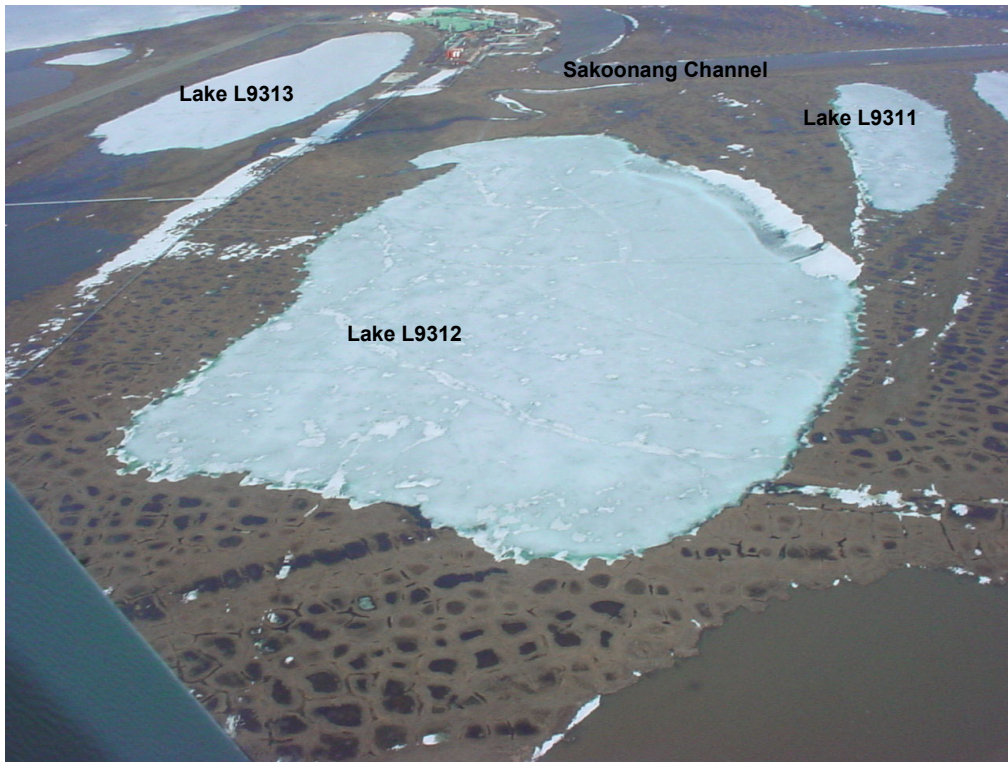
10 June 2003

Photo 3-5 Flooding conditions at Alpine approximately 24 hours after peak flood stage. Detail of Lake L9312. Note that there has been no apparent breakup flood flow recharge to the lake. Lake L9313 is still receiving breakup flood flow recharge.

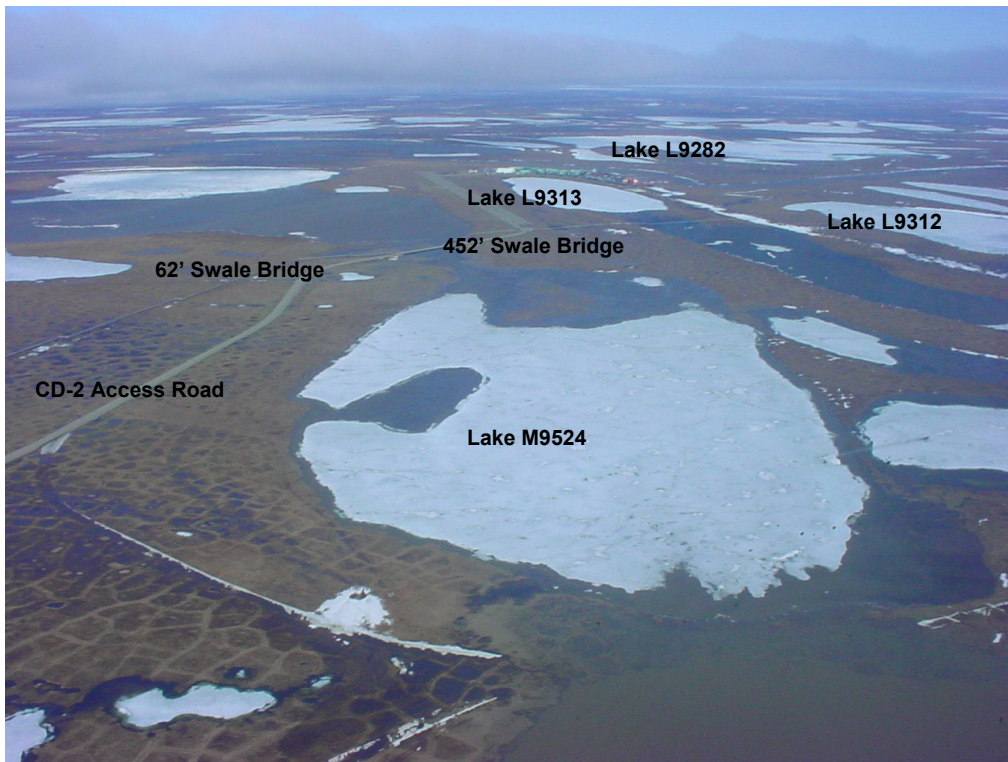
10 June 2003

Photo 3-6 Flooding conditions at Alpine approximately 24 hours after peak flood stage.

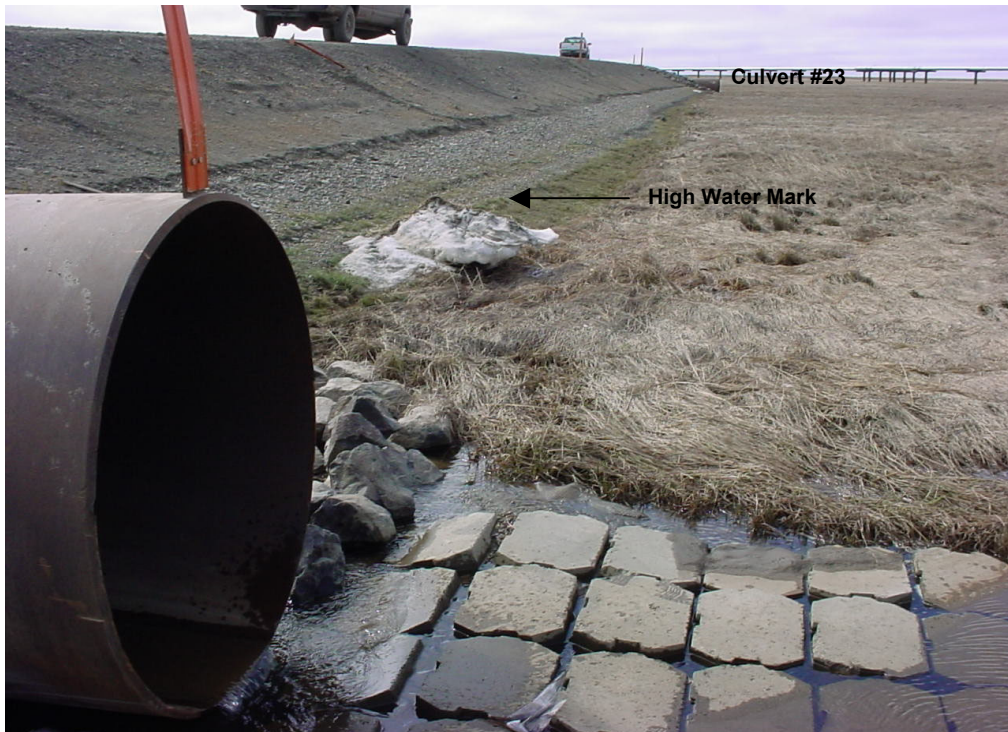
13 June 2003

In areas where inundation did occur, some minor settlement of fine-grained material was noted, however, no slumping or side slope deterioration was noted. High water marks were noted on the gravel structures. Such marks were identified where grasses and other floating debris were stranded on the gravel side slopes, or where fine-grained materials had been washed from the gravel. High water marks along the CD-2 access road are presented on Photos 5-1 through 5-3.

Photo 5-1 Looking west on the north side of the CD-2 access road from Culvert # 24.

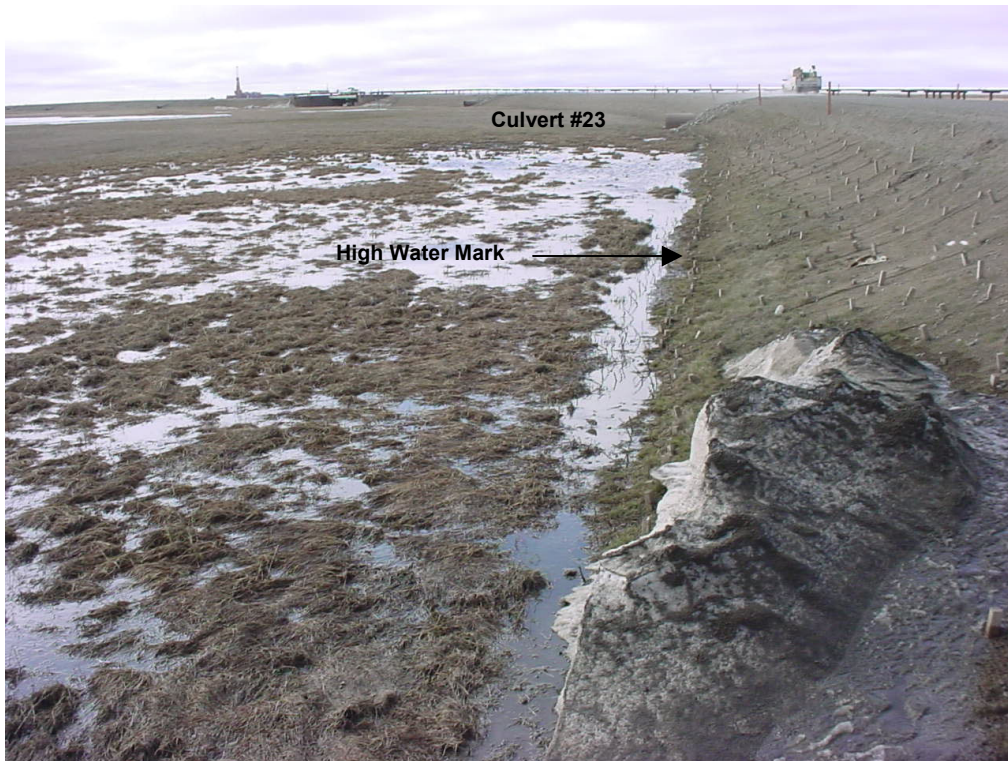
13 June 2003

Photo 5-2 Looking west on the south side of the CD-2 access road from Culvert # 24.

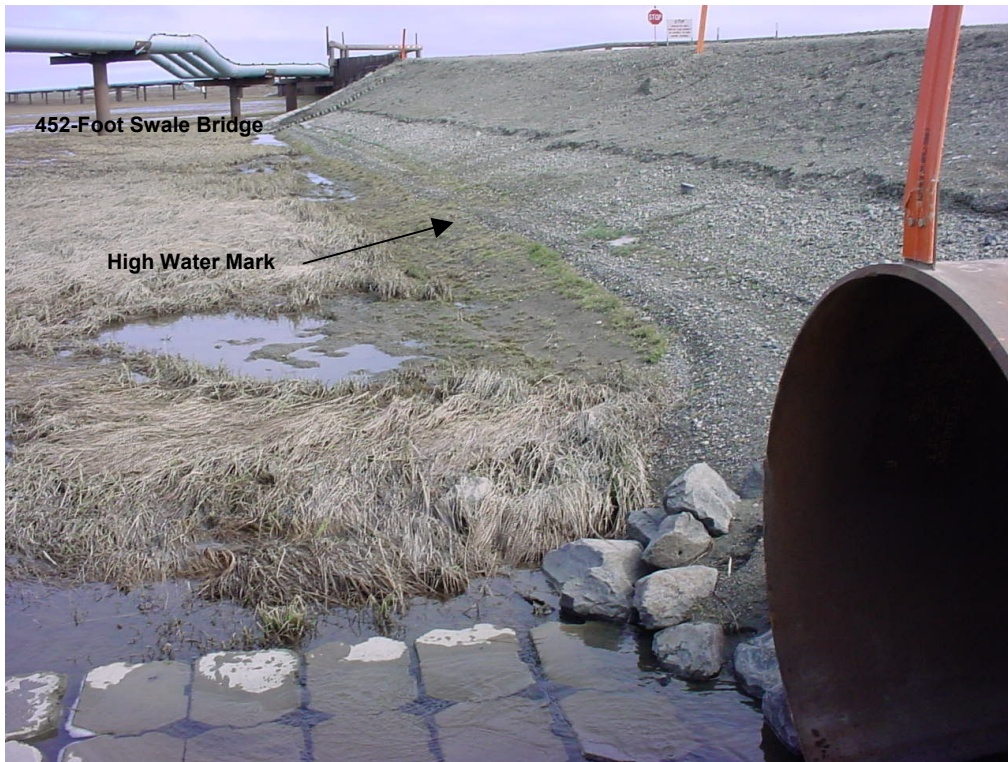
Photo 5-3 Looking east on the north side of the CD-2 access road from Culvert # 24. *13 June 2003*

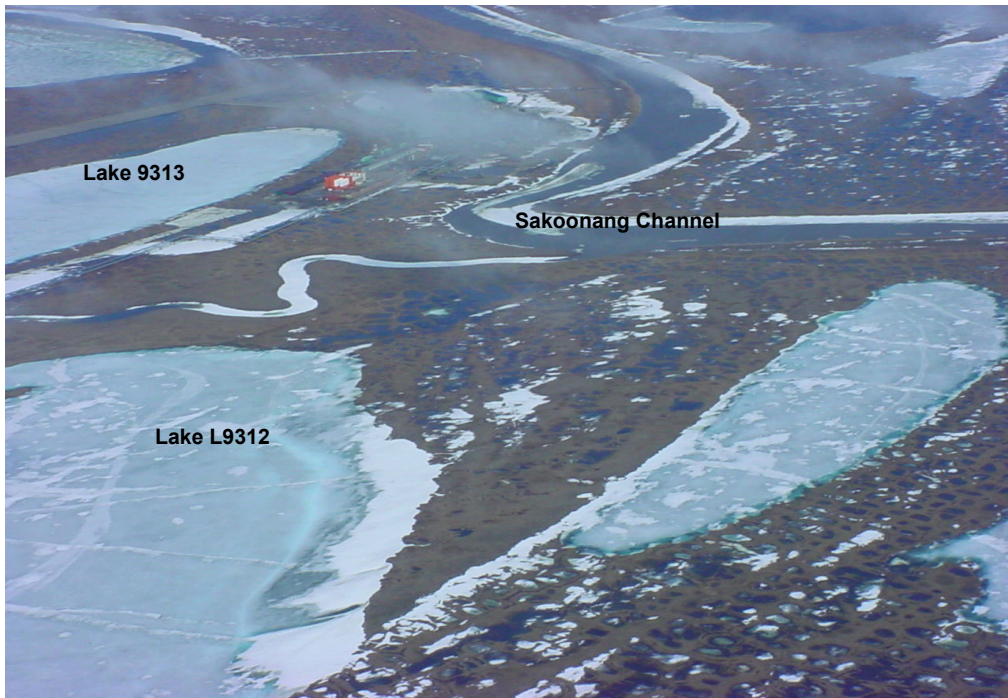
6 June 2003.

Photo 6-1 Lake L9312. View looking northeast. No breakup flood flow recharge from the Sakoonang Channel to the lake is occurring.

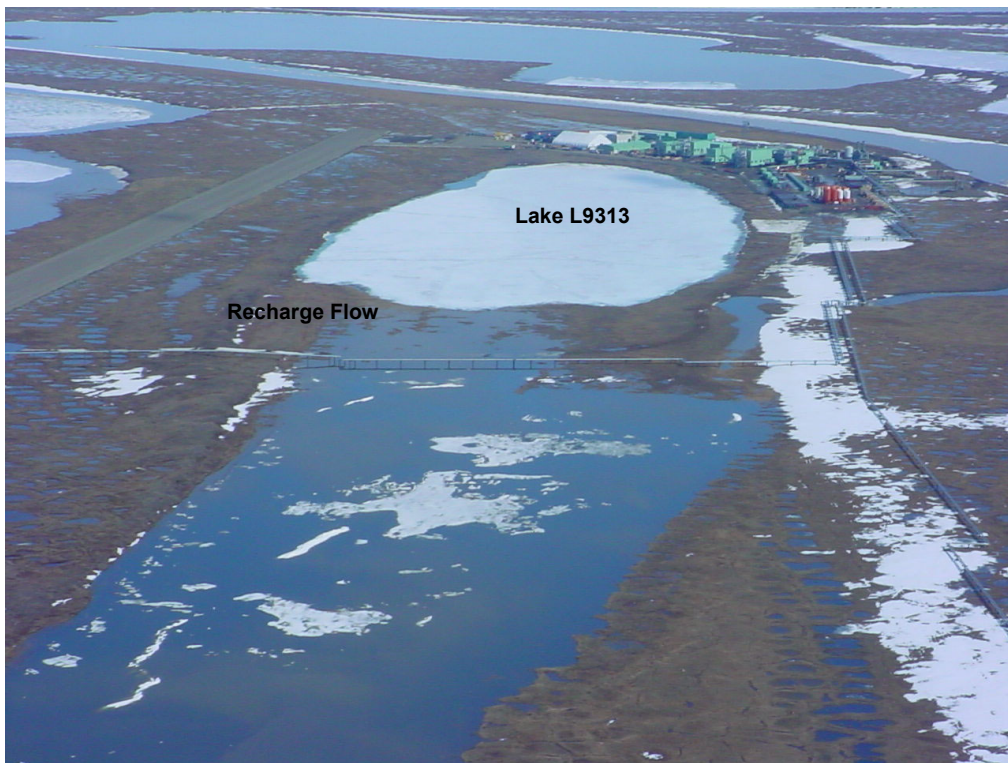
8 June 2003.

Photo 6-2 Breakup flood flow recharge to Lake L9313. View looking northeast.

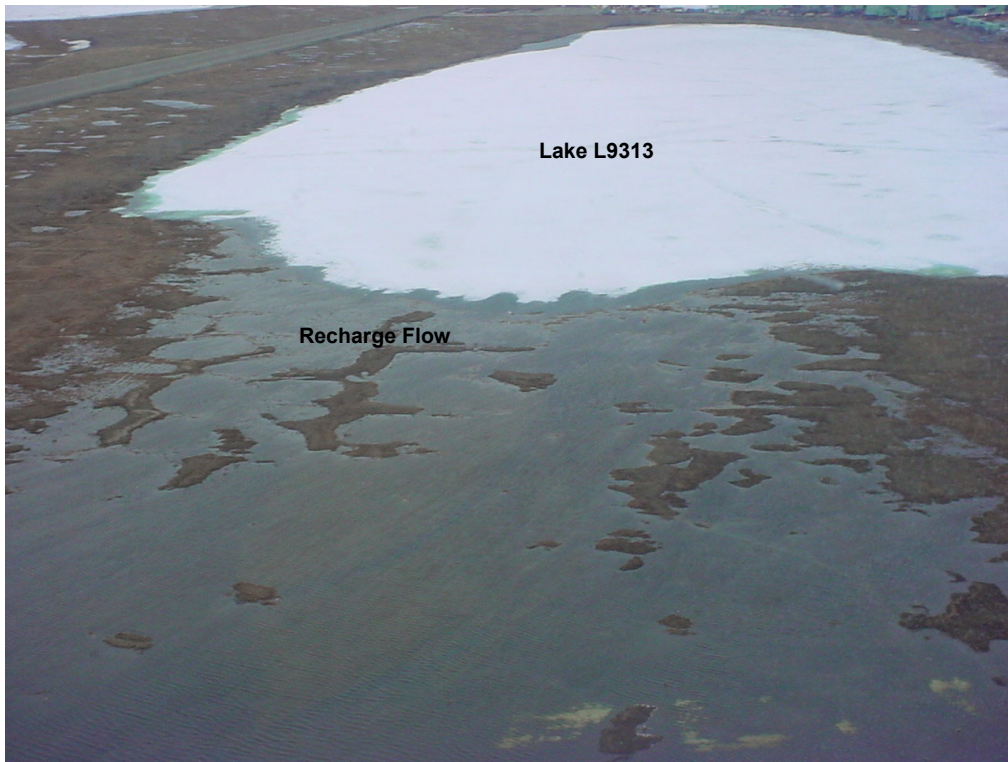
10 June 2003

Photo 6-3 Breakup flood flow recharge to Lake L9313. View looking northeast.

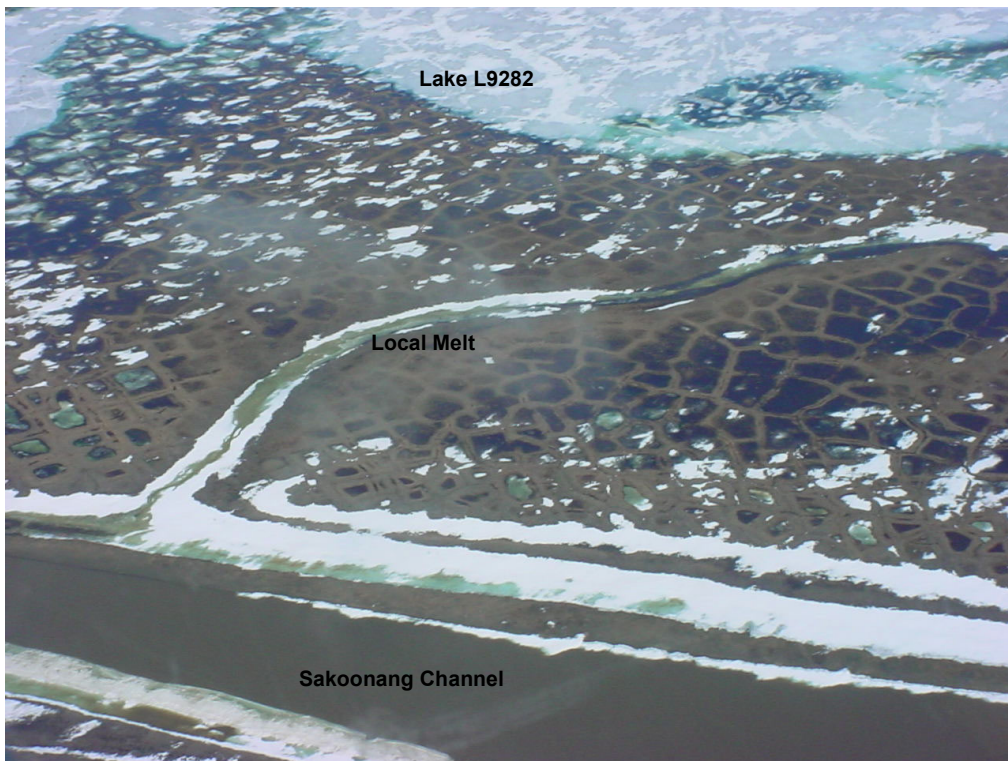
6 June 2003.

Photo 6-4 Lake L9282. View looking north. No breakup flood flow recharge from the Sagoonang Channel to the lake is occurring.

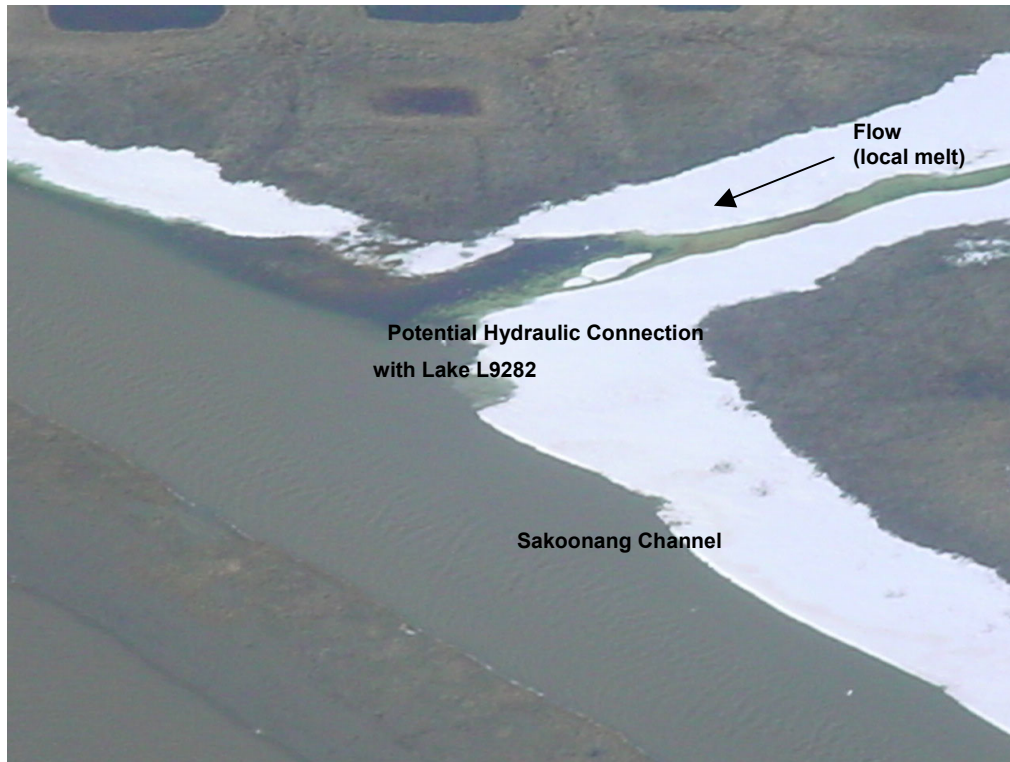
10 June 2003.

Photo 6-5 Detail of potential hydraulic connection between the Sagoonang Channel and Lake L9282. View looking north. No breakup flood flow recharge from the Sagoonang Channel to the lake is occurring.
