Alpine Pipeline River Crossing Monitoring 2003

July 2003

Re: Alpine Pipeline River Crossing Monitoring - 2003

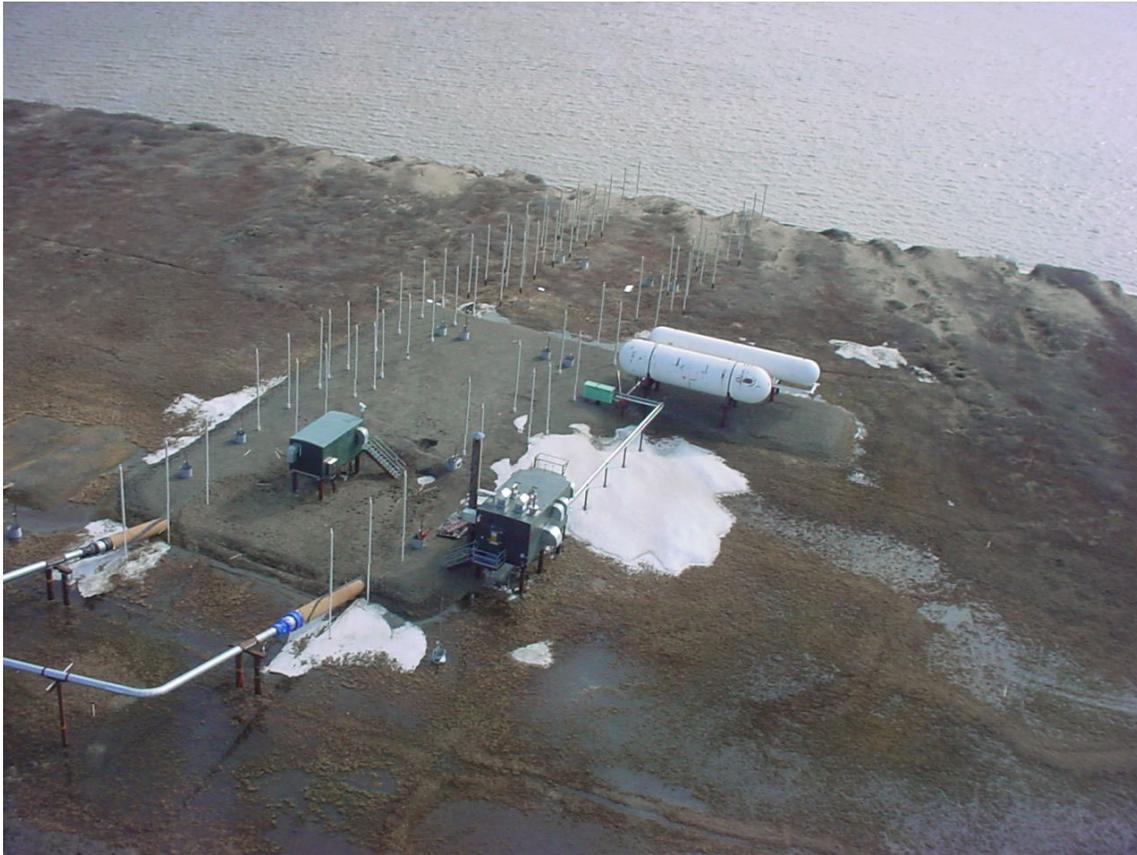
Figure 1 – Colville River HDD west bank

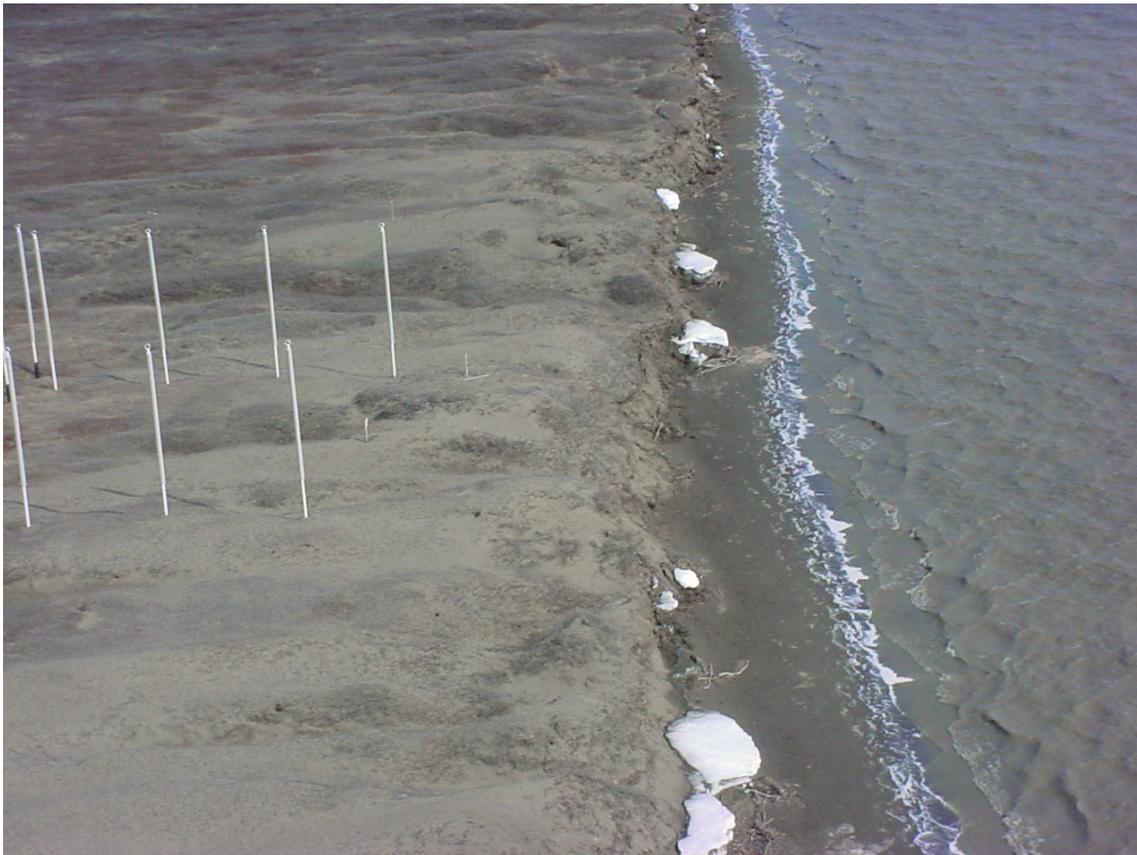
Figure 2 – Colville River HDD west bank

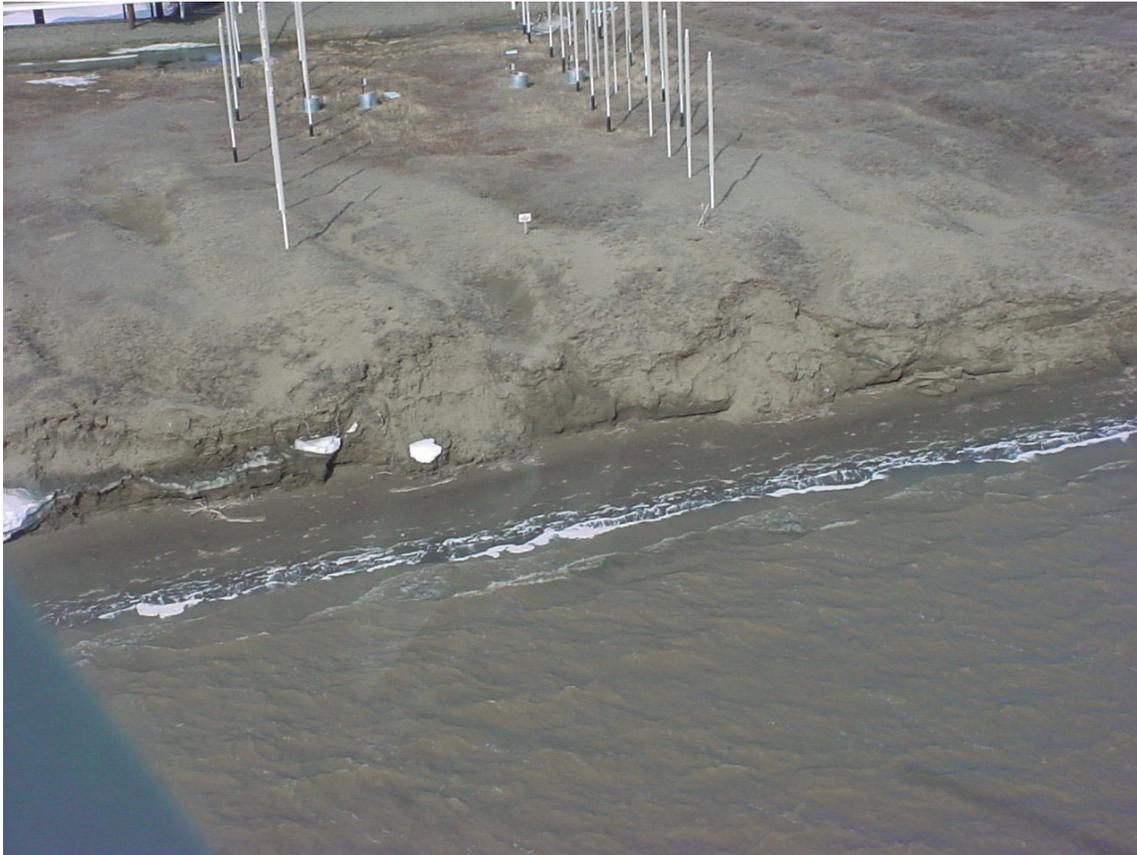
Figure 3 – Colville River HDD west bank

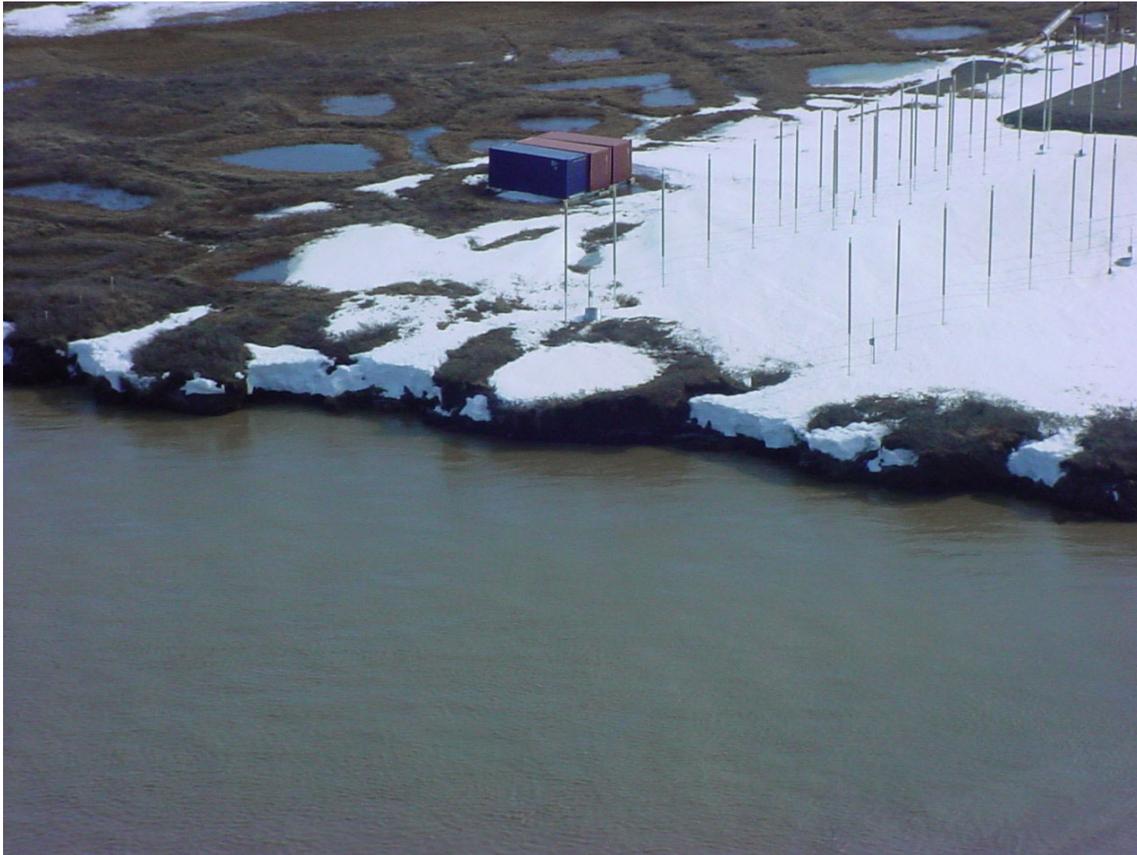
Figure 4 – Colville River HDD east bank

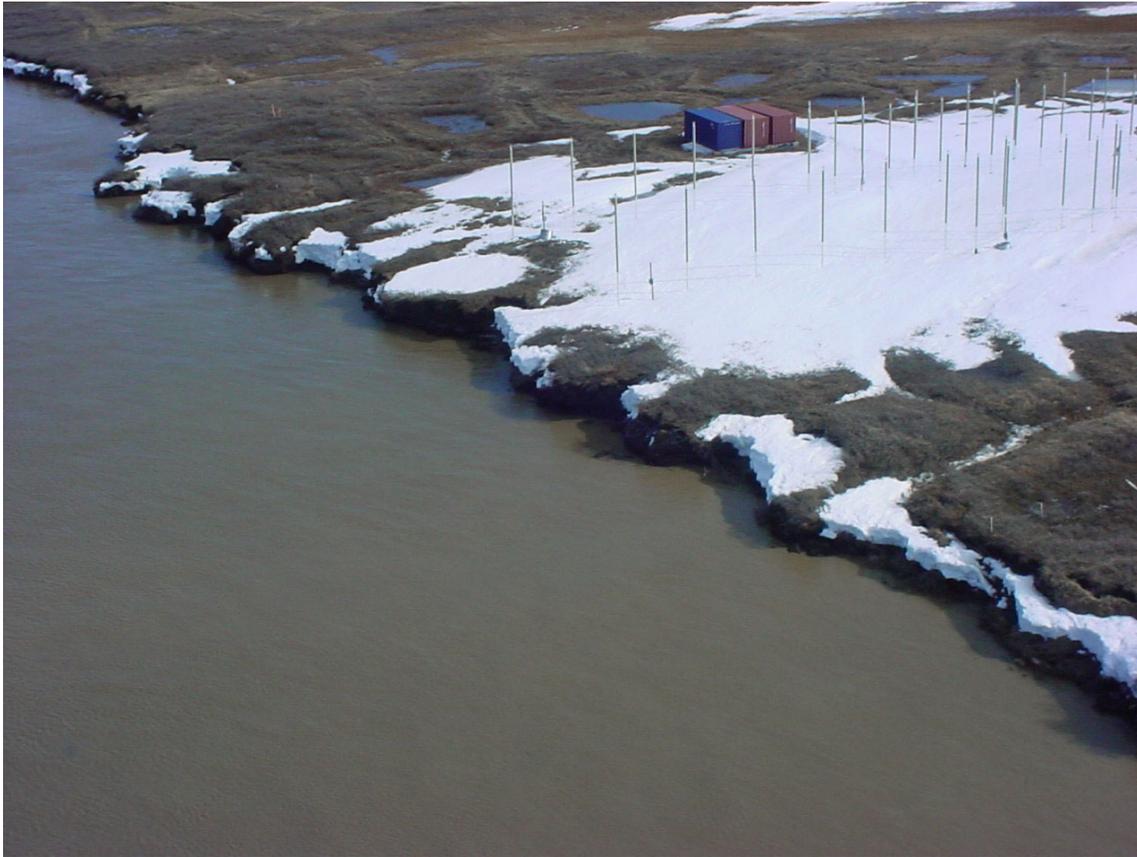
Figure 5 – Colville River HDD east bank

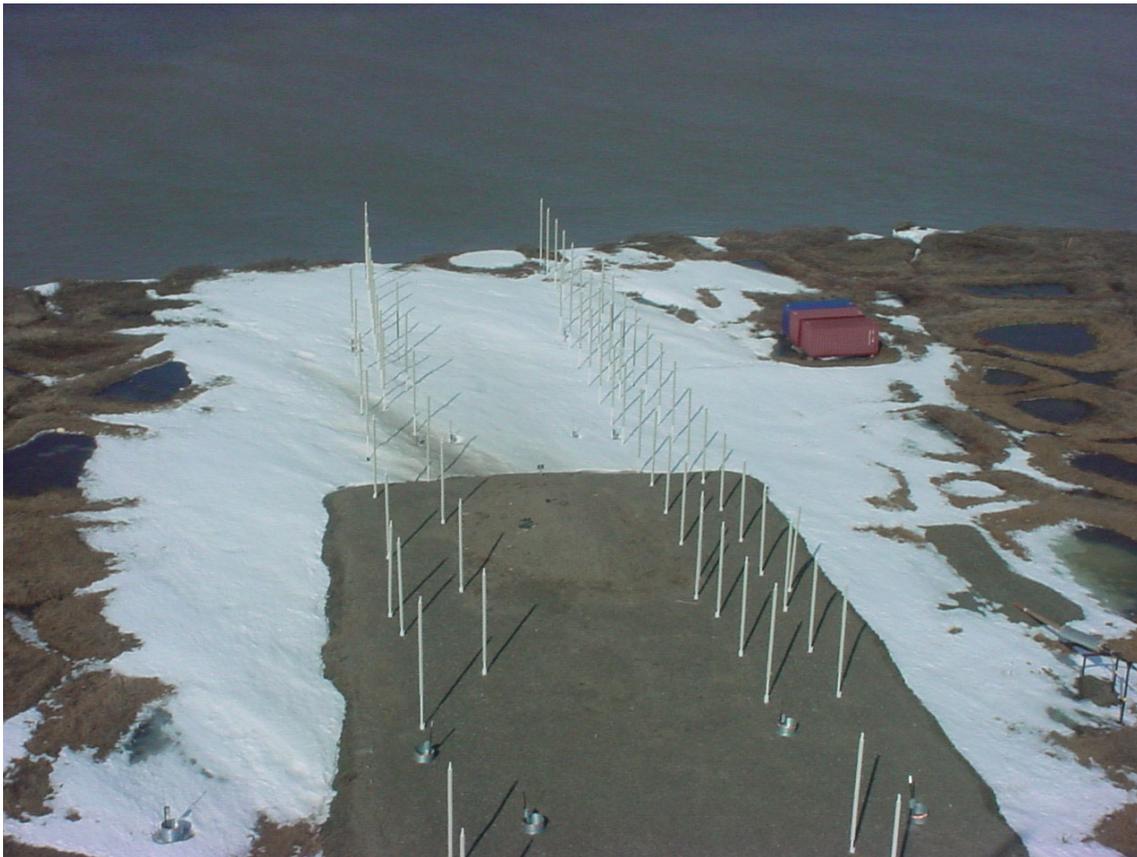
Figure 6 – Colville River HDD east bank

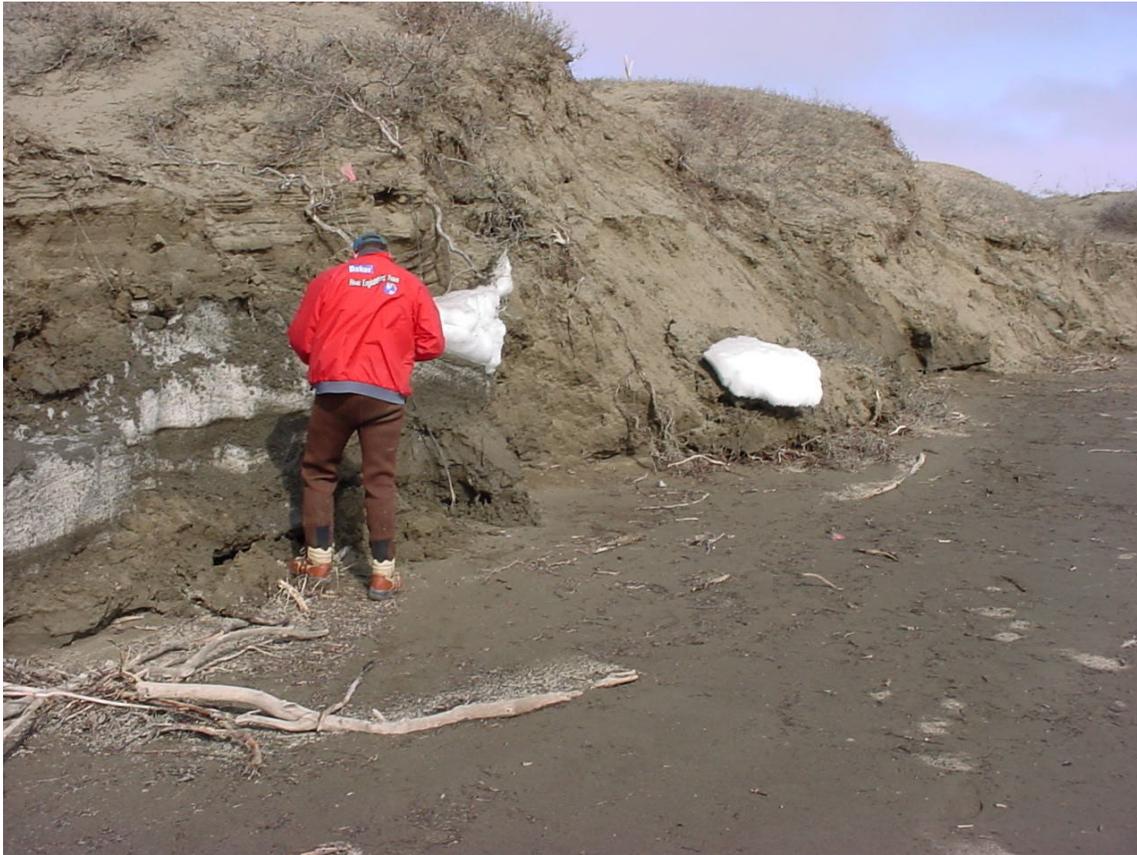
Figure 7 – Colville River Along pipeline alignment, HDD west bank

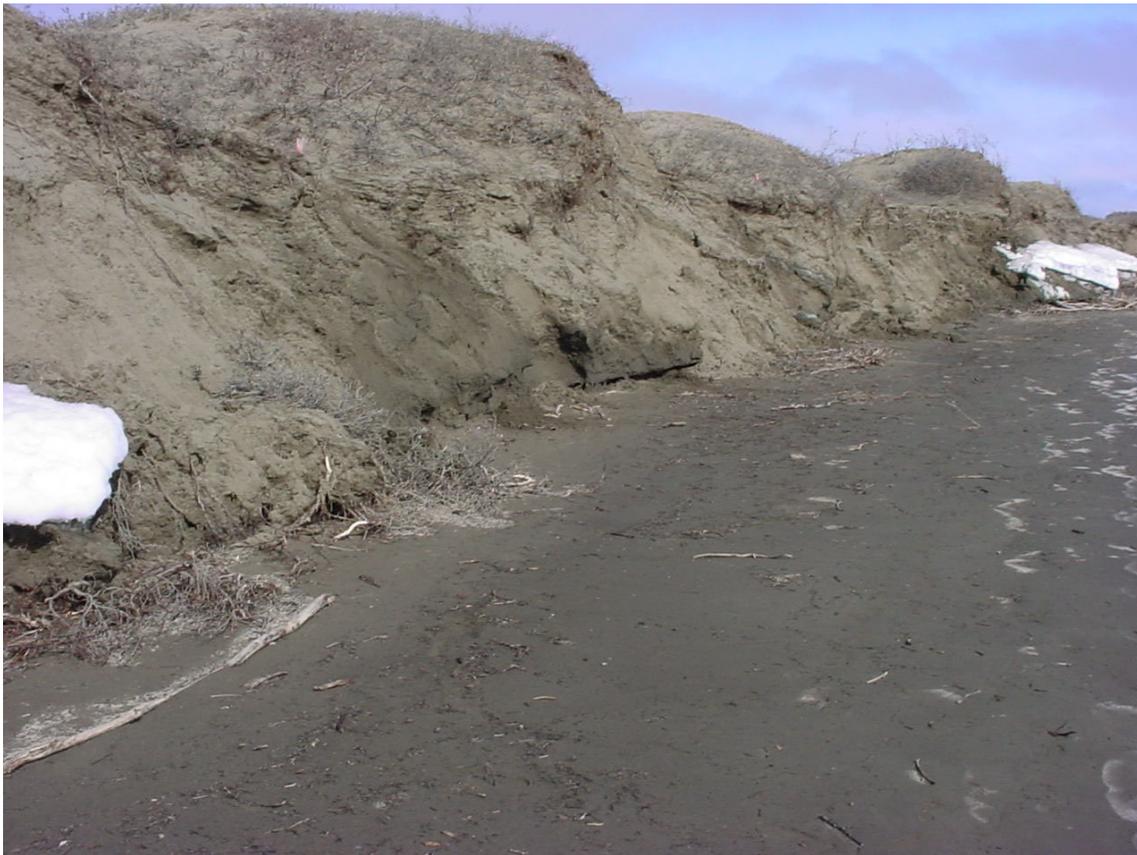
Figure 8 – Colville River HDD west bank - along pipeline alignment

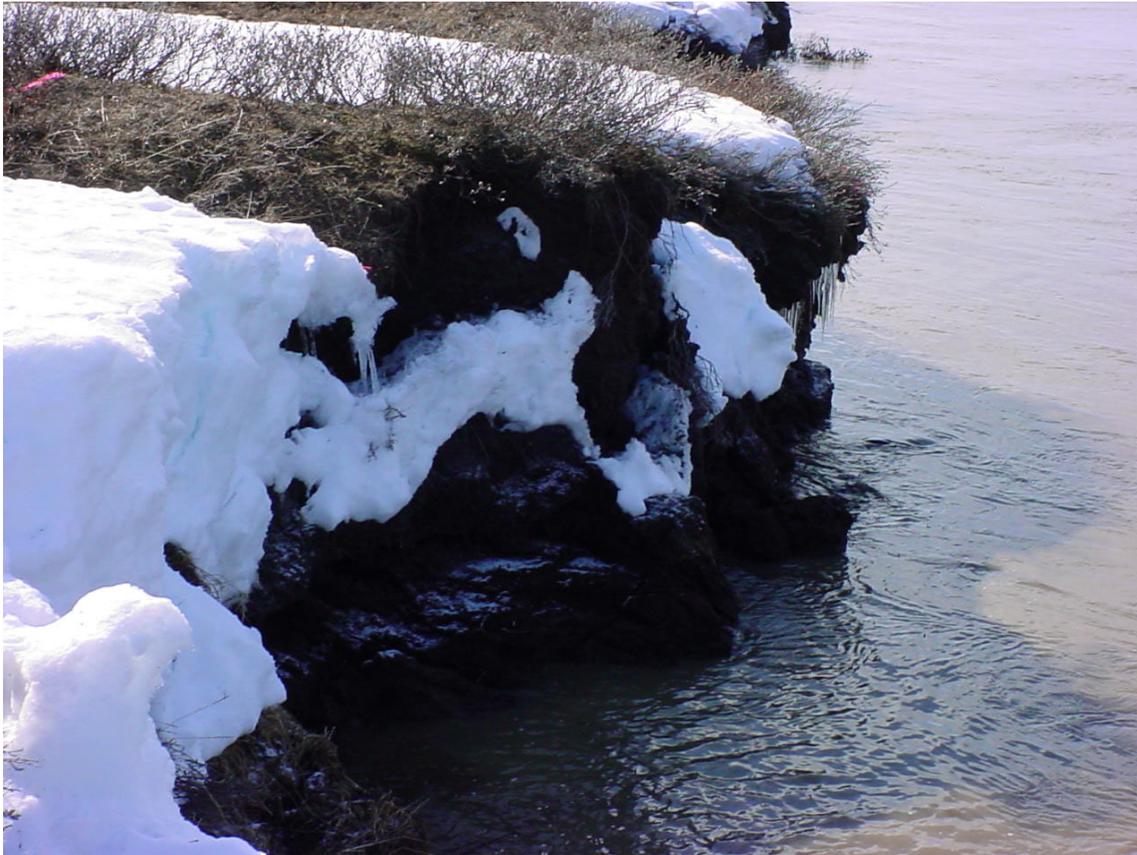
Figure 9 – Colville River HDD east bank

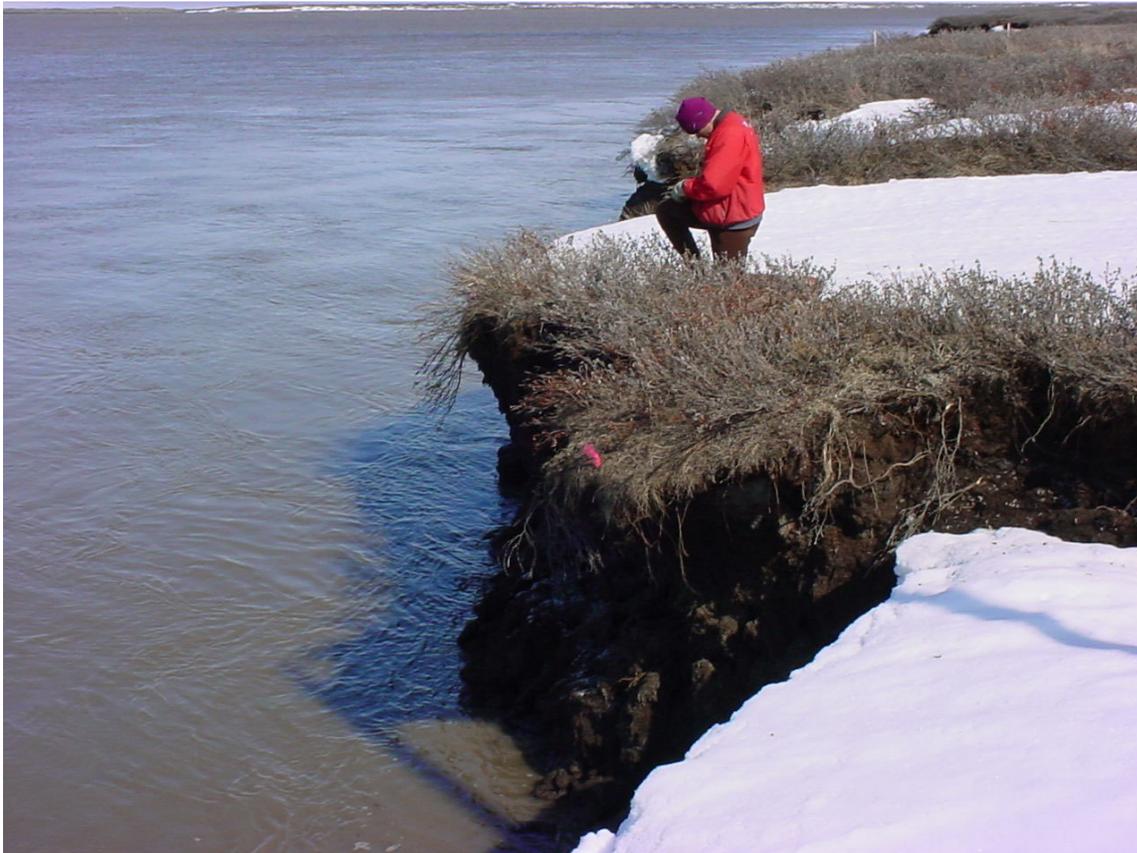
Figure 10 – Colville River HDD east bank

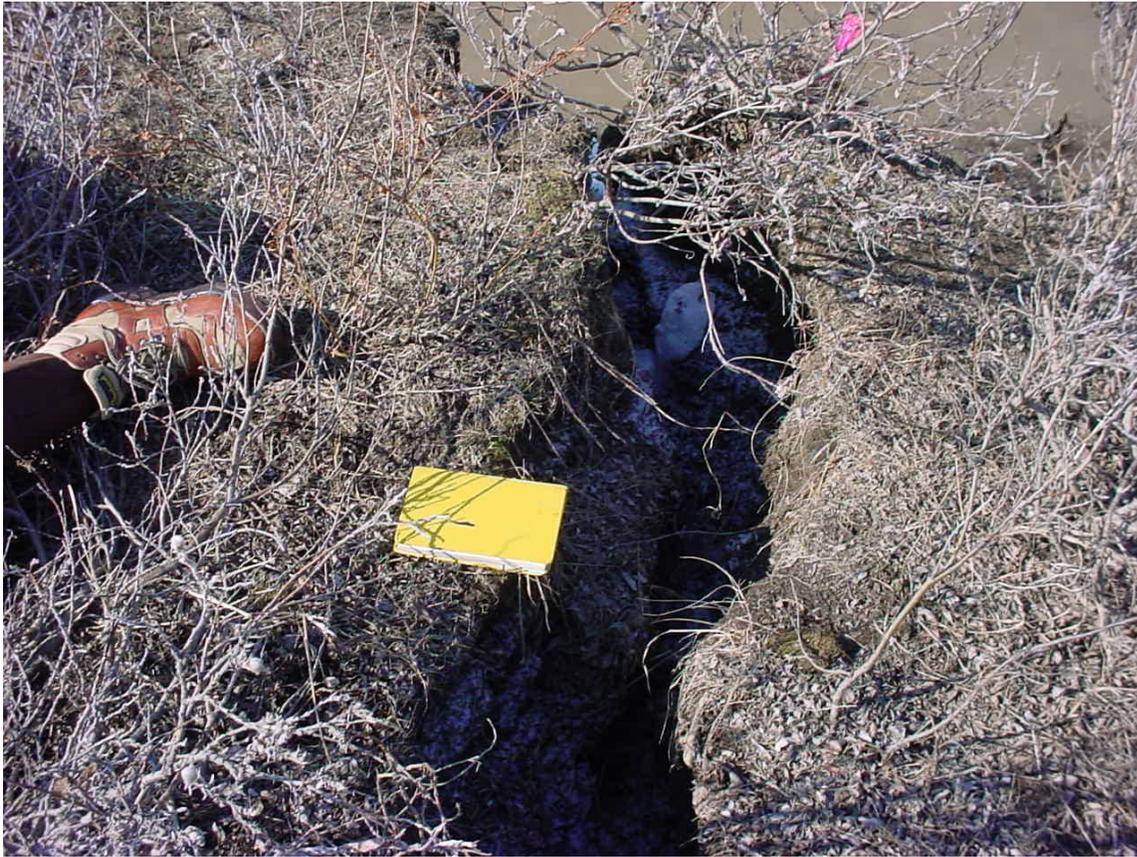
Localized slumping and sloughing of bank material was noted on both the east and west banks. On the west bank, it appeared that high water had caused minor undercutting of the bank in a number of locations, and small portions of the face had slumped. On the east bank, large cracks were noted along the top of the bank, and it appeared that larger sections of the bank (relative to the west bank) had or were in the process of slumping. Previously identified ice wedges on the east bank were not observed from the ground or the air, likely due to the snow cover. No indication of soil pressure ridge formation was observed on either bank. No indications of channel obstructions were observed.

Figure 11 – Colville River HDD east bank, cracking along the top of the bank

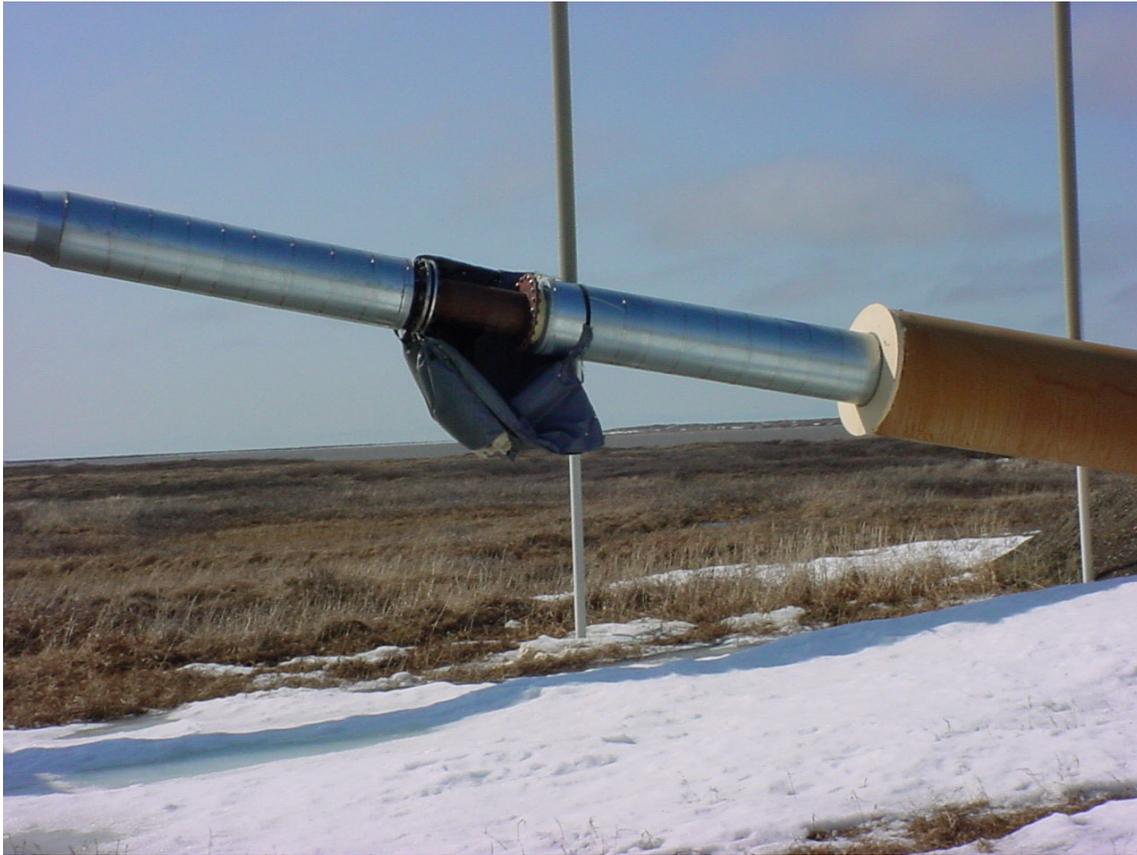
The HDD site was inspected from both the air and the ground (see attached Figures 1-12). On the day of the inspection, the west bank was free of snow while some areas of the east bank were obscured by drifts. Vertical Support Members (VSMs) and Horizontal Support Members (HSMs) on the east and west banks appeared plumb and level. No evidence of jacking or subsidence was noted. No evidence of scour was noted. Shallow standing water from localized melt was observed around many of the VSMs on the west bank. VSMs on the east bank were generally dry with no standing water. VSMs on both banks were free of debris. A loose pipeline insulation jacket was observed on the southernmost pipeline on the east bank. No pipeline leaks were found.

Figure 12 – Colville River HDD east bank, loose pipeline insulation jacket

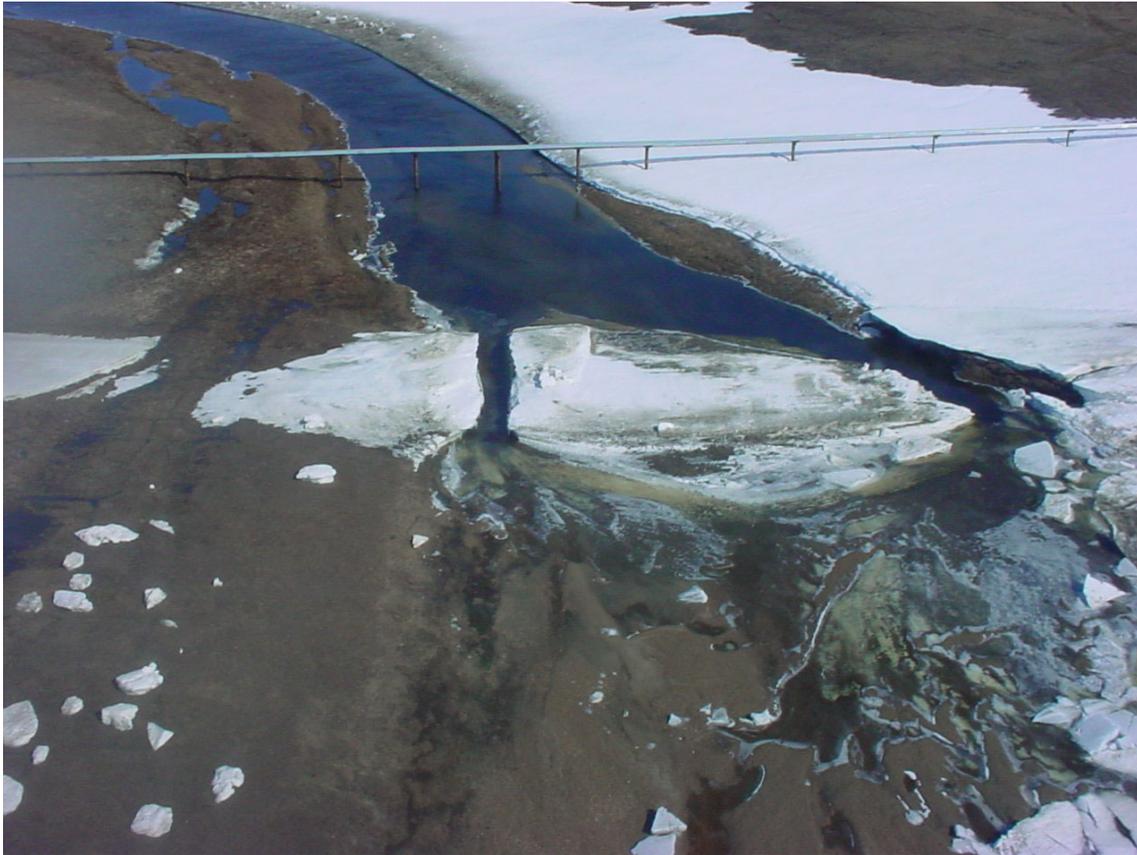
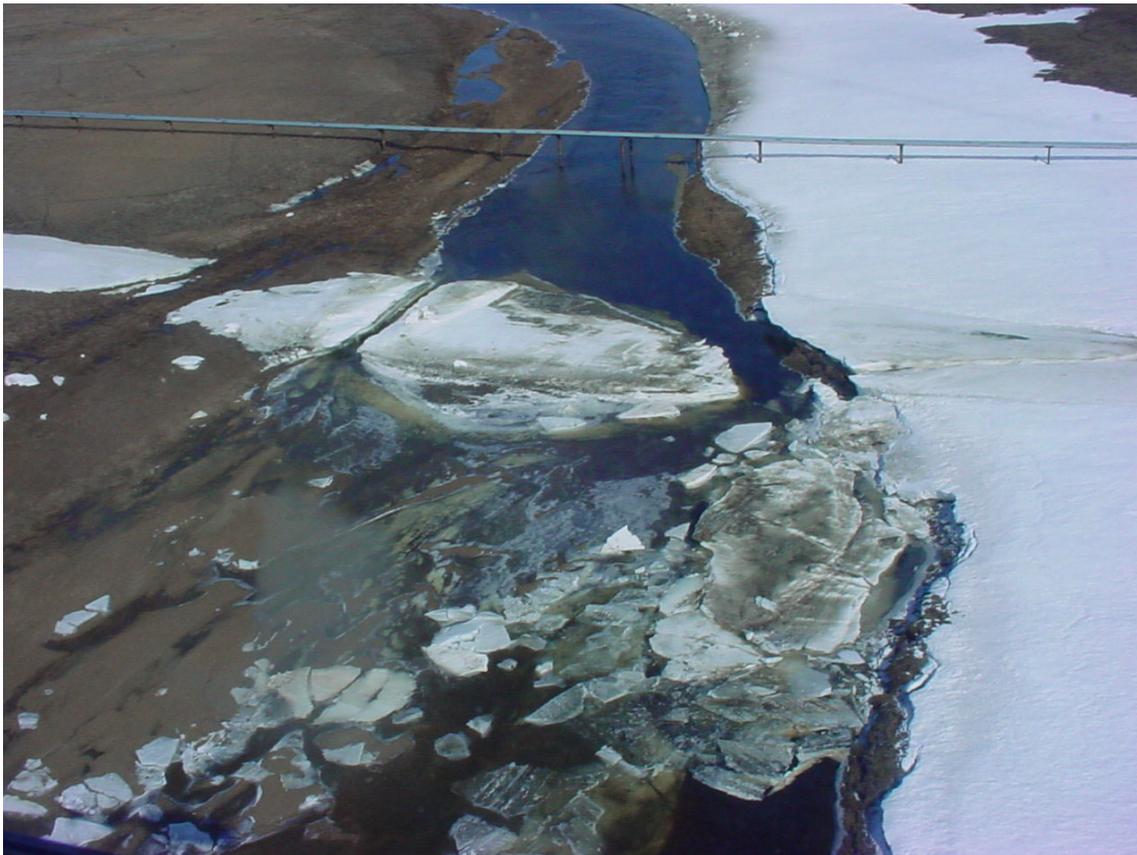
The remains of the ice bridge just upstream from the pipeline crossing were still very much in evidence. Remaining ice appeared to be groundfast and as such, posed no threat to the pipeline. Trenches that had been cut through the ice bridge to facilitate drainage had become enlarged by the floodwaters. On the east bank, relatively significant bank damage was noted in an area where floodwaters had been directed towards the bank by one of the trenches. Diminished, but still relatively large blocks of the ice bridge still covered a large portion of the channel, but the blocks were not impeding flow, as the stage was relatively

Figure 13 – Remains of the ice bridge, Kachemach River looking downstream

Figure 14 – Remains of the ice bridge, Kachemach River looking downstream

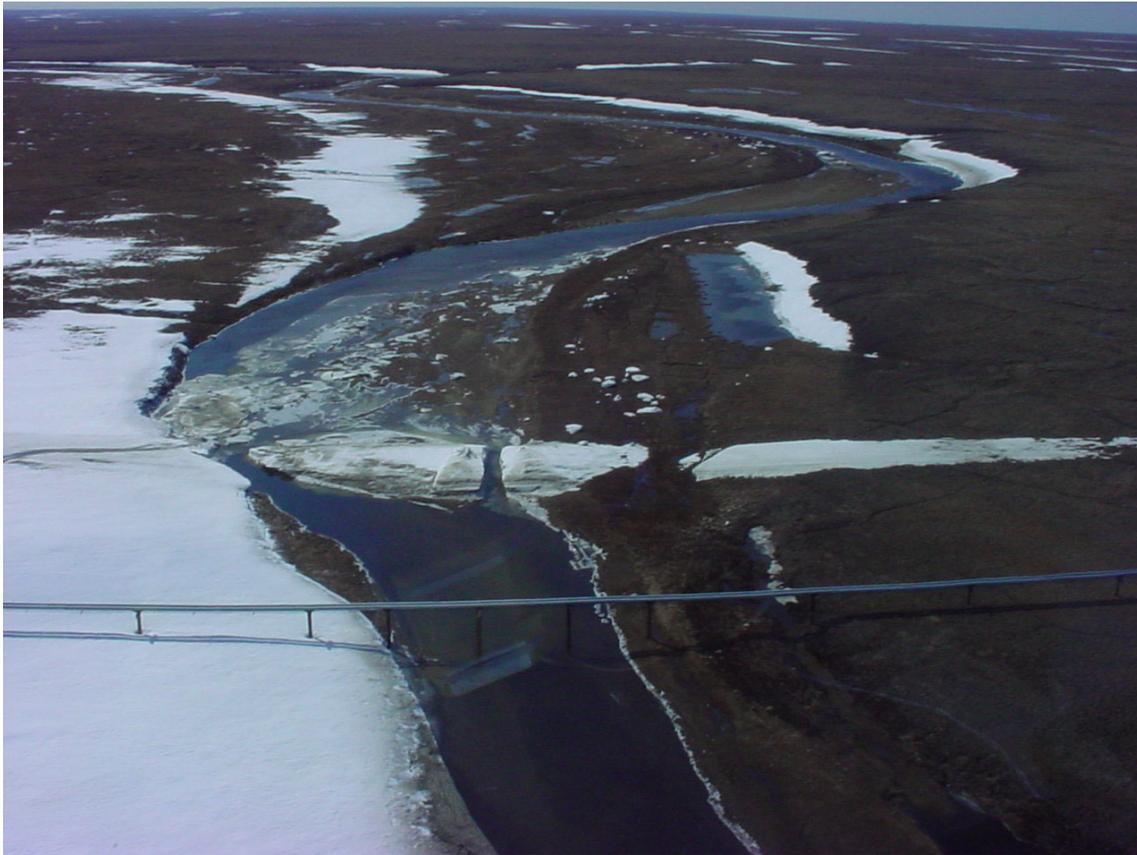
Figure 15 – Kachemach River pipeline crossing looking upstream

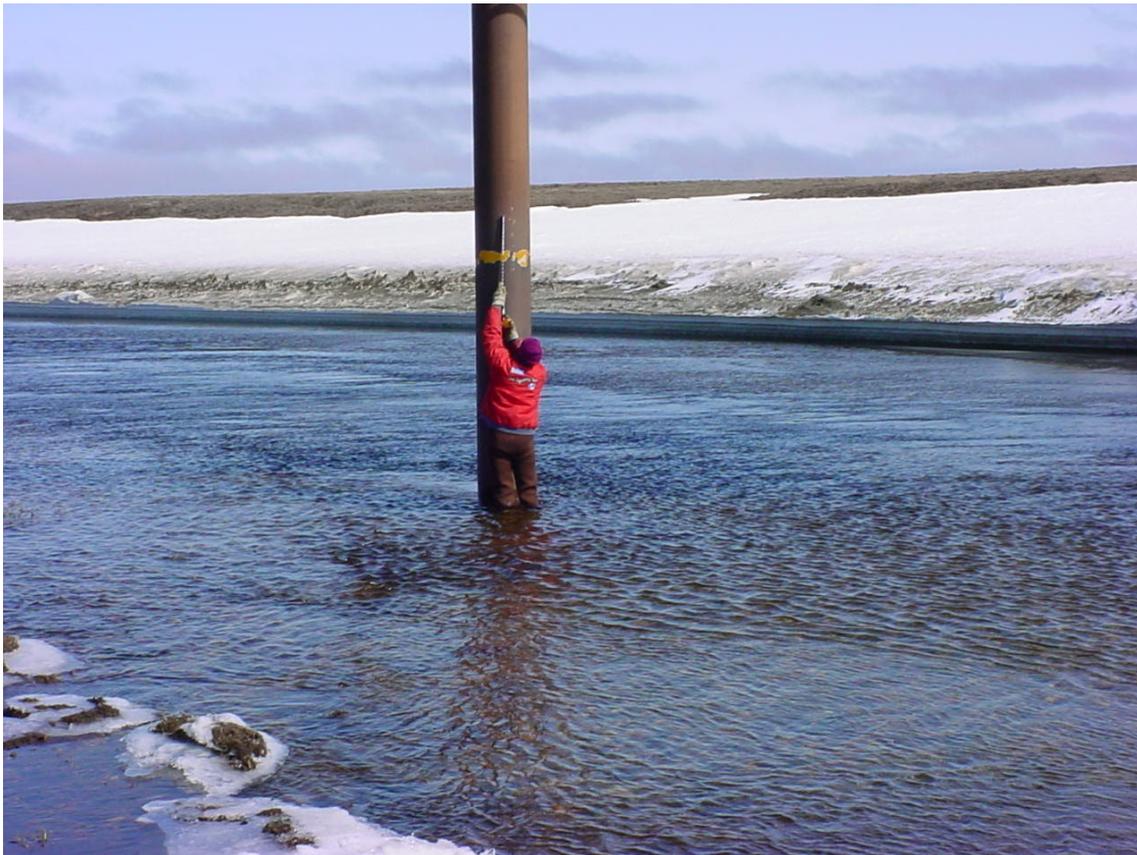
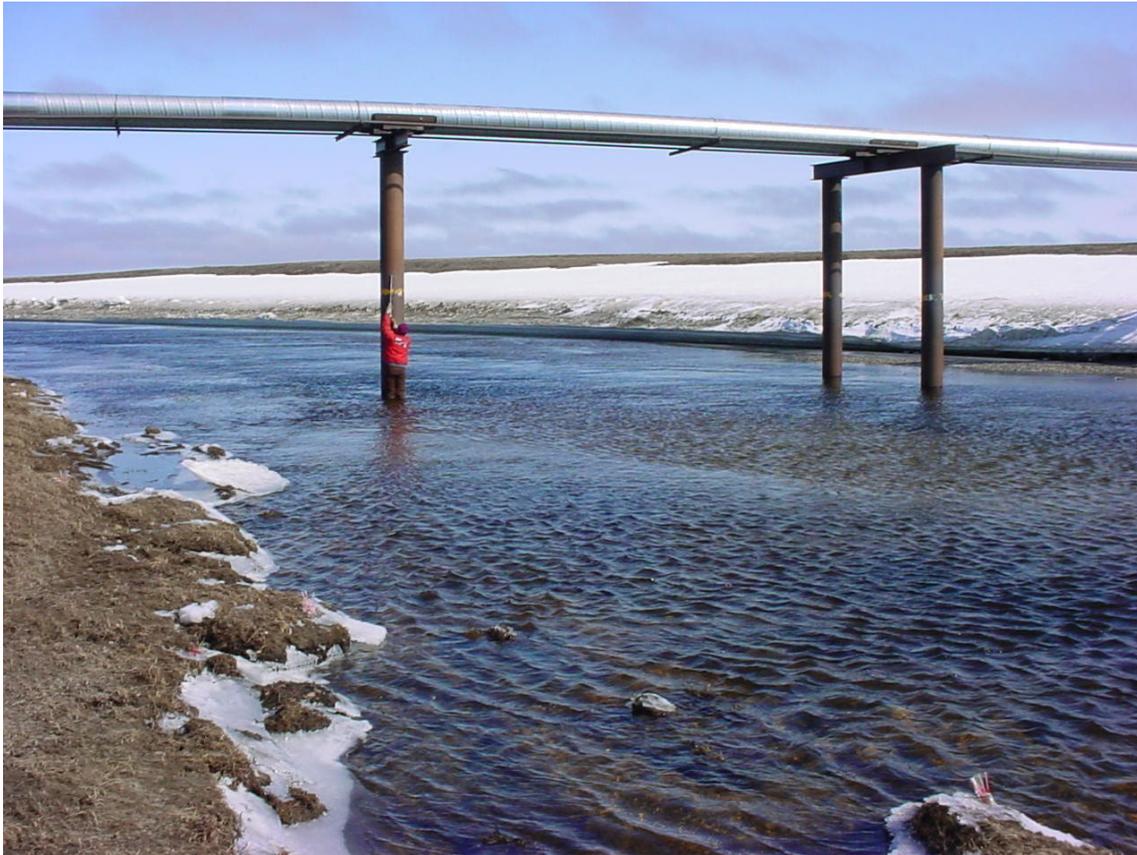
VSMs and HSMs on the east and west banks appeared plumb and level. No evidence of jacking or subsidence was noted. Three instream VSMs were examined for scour. VSM No. 1716 had no measurable scour. Scour at VSM No. 1714 was measured at 2.1 ft. (upstream side) and 1.7 ft. (downstream side). Scour was also noted around the double set VSM No. 1715, however, it was not possible to measure the scour due to the depth of water in that location. Further survey efforts would be required in order to define the magnitude and extent of scour around this VSM.

Figure 16 – High water mark on VSM 1714, Kachemach River looking downstream

Figure 17 – Approximate high water mark on VSM 1714, Kachemach River looking downstream

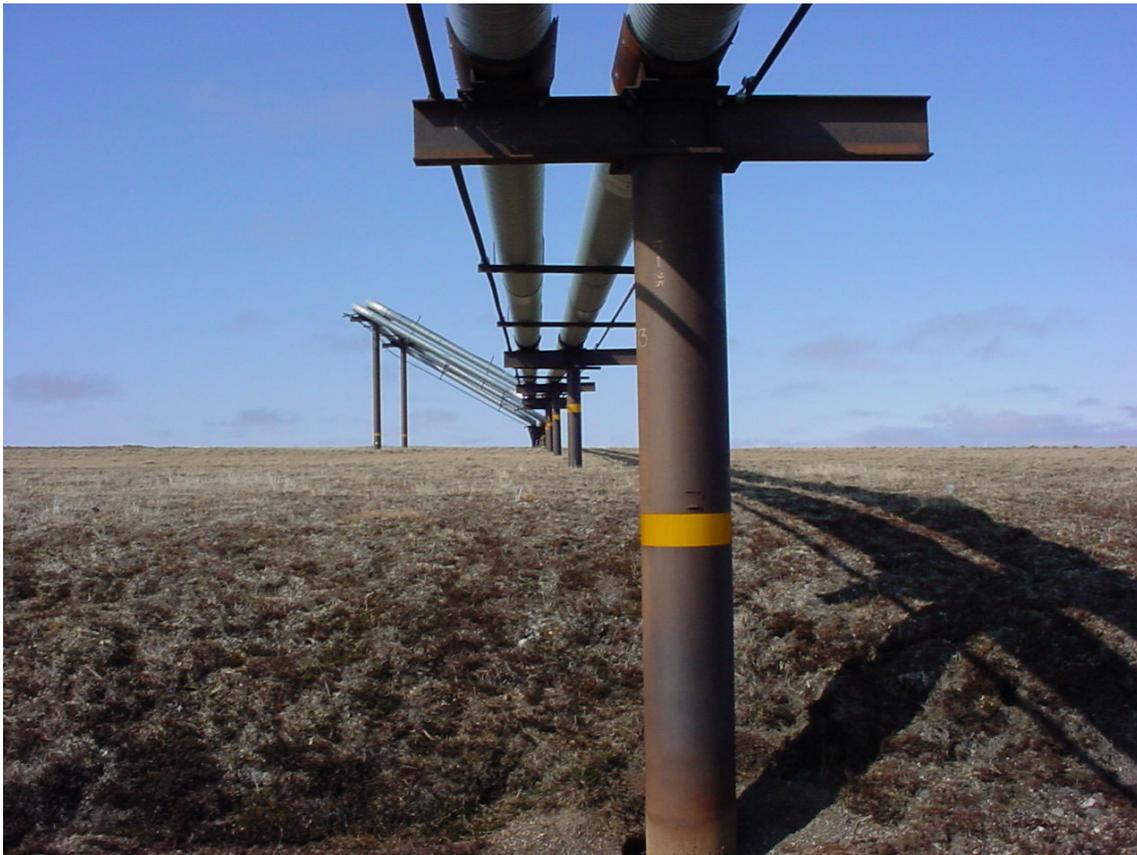
Figure 18 – VSM alignment and vertical loop, Kachemach River west bank

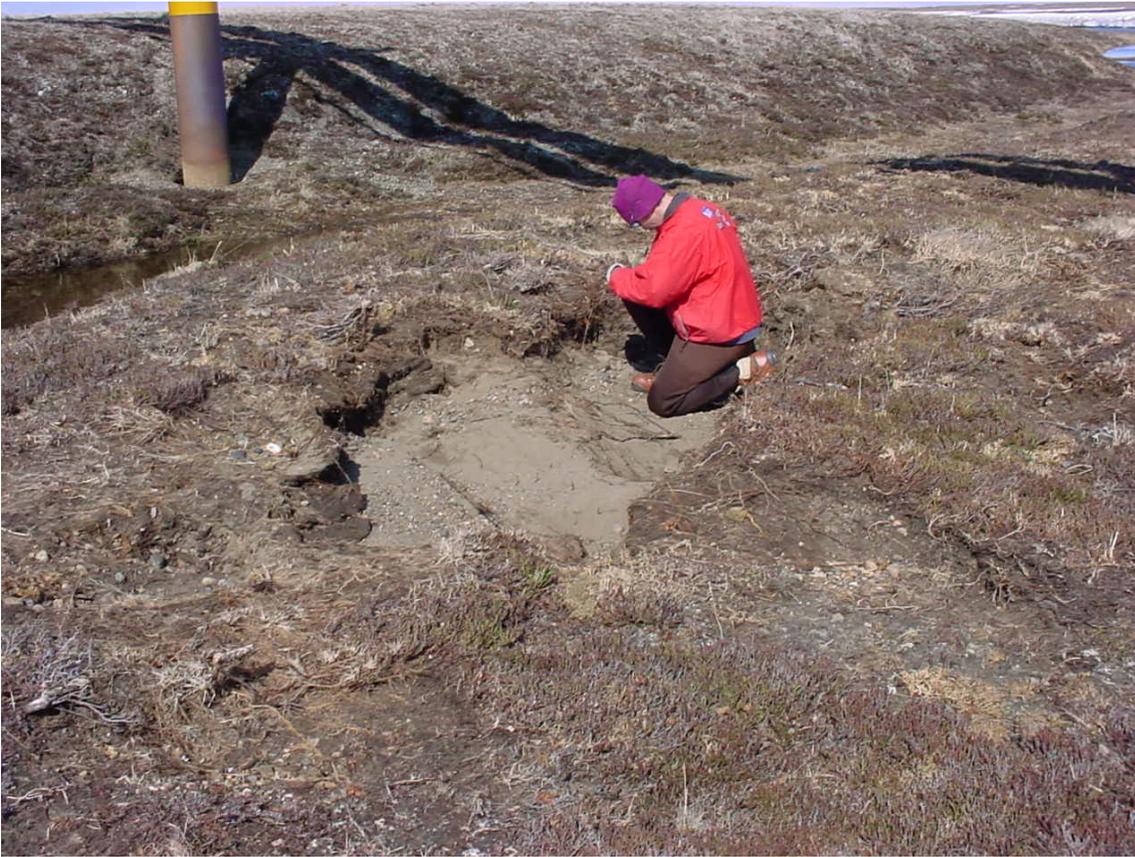
Figure 19 – Localized scour near high water mark, Kachemach River west bank

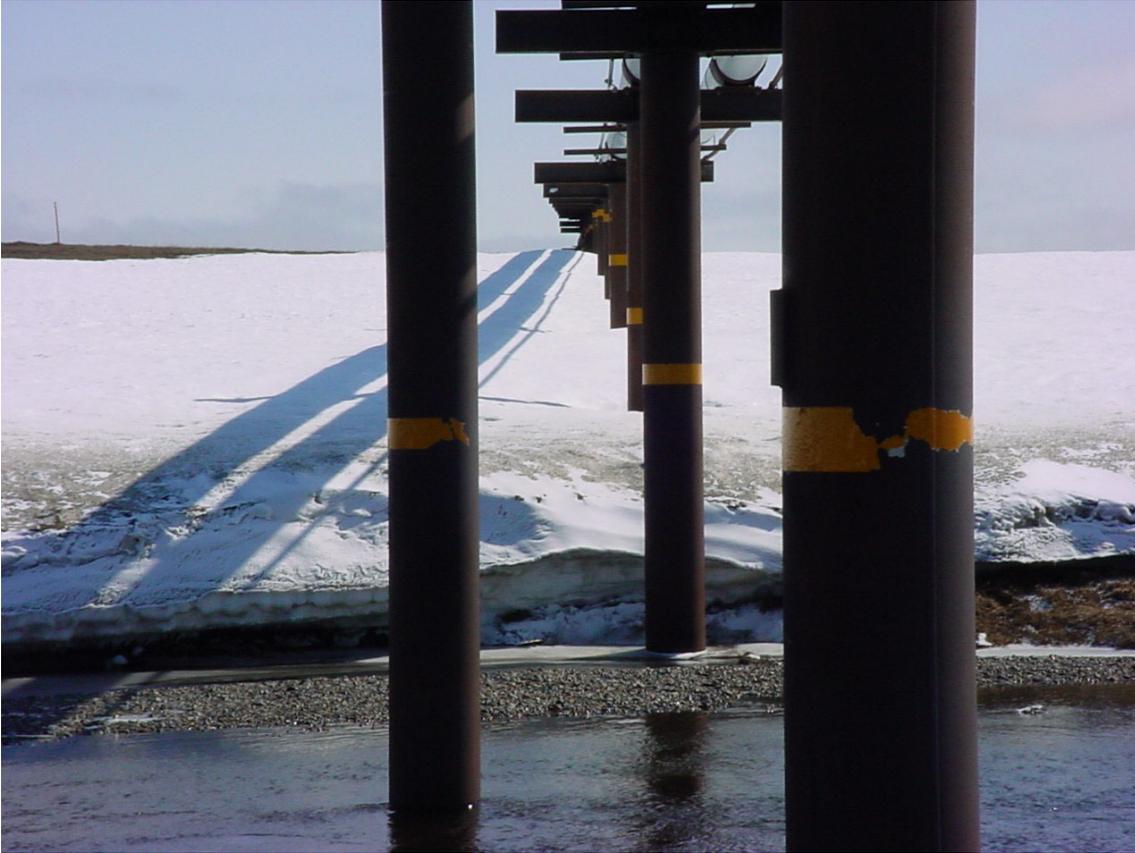
Figure 20 – VSM alignment, Kachemach River east bank

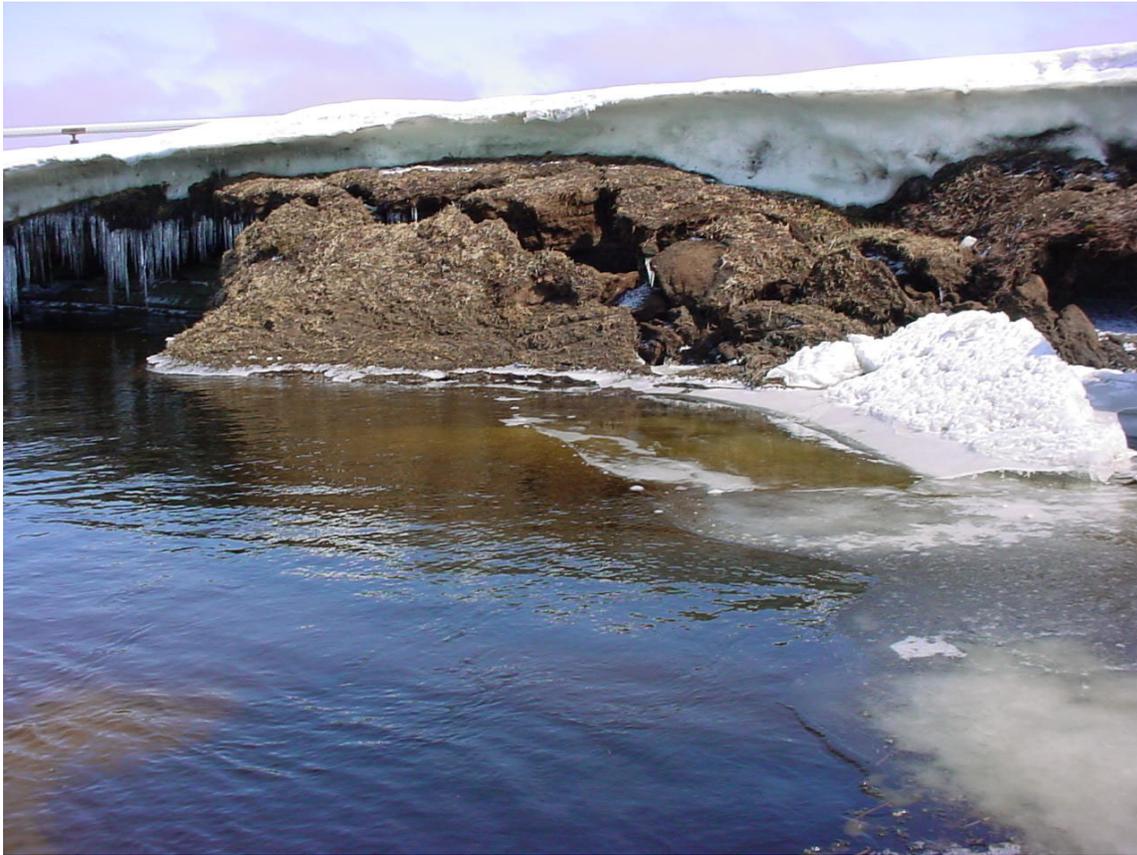
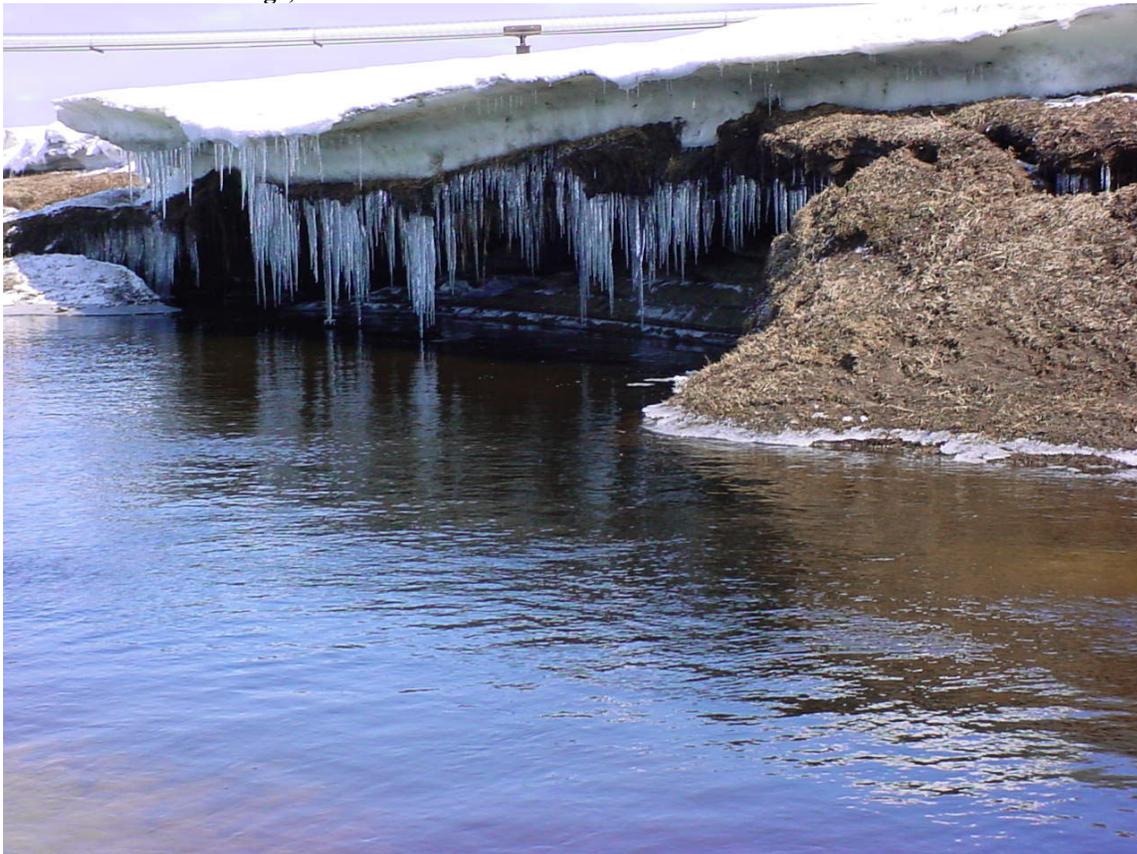
Figure 21 – Erosive damage resulting from flow directed toward the bank by a trench cut through the ice bridge, Kachemach River east bank

Figure 22 – Erosive damage resulting from flow directed toward the bank by a trench cut through the ice bridge, Kachemach River east bank
