Alpine Pipeline River Crossing Monitoring 2003

July 2003

Re: Alpine Pipeline River Crossing Monitoring - 2003

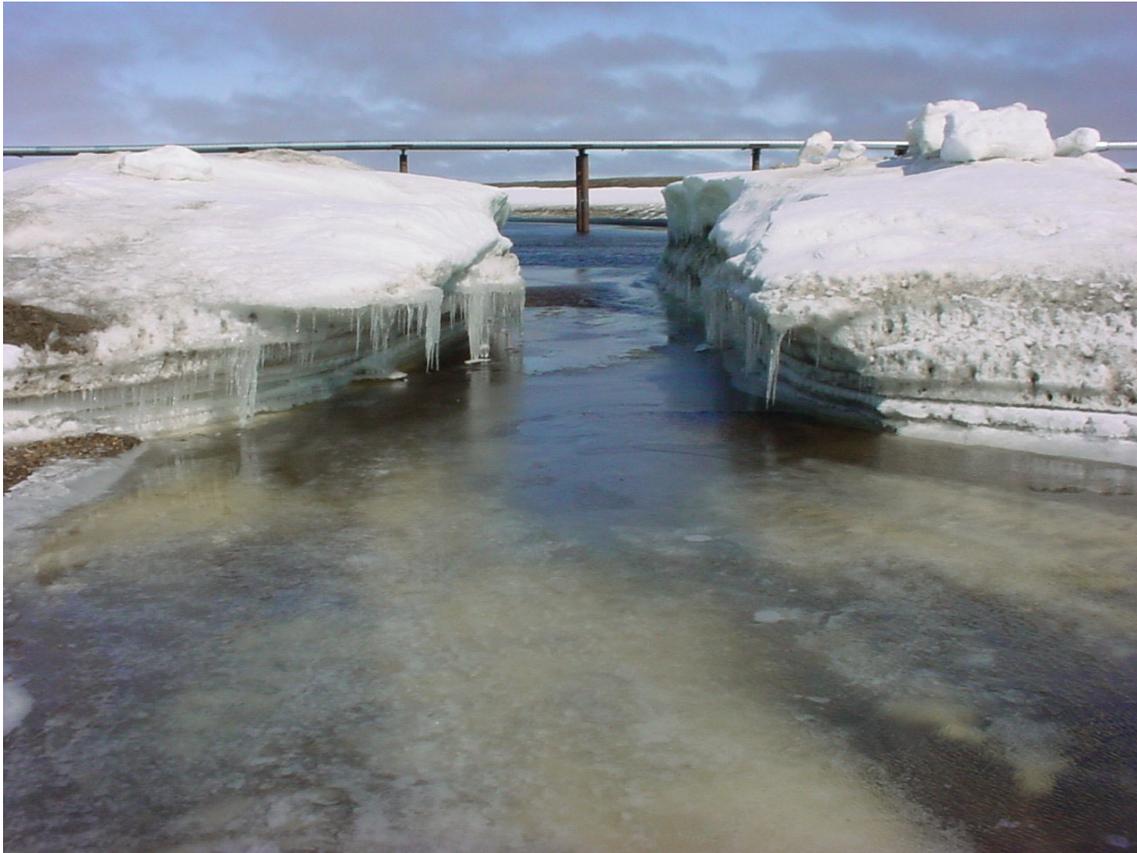
Figure 23 – A trench cut through the ice bridge and expanded by floodwaters, Kachemach River active channel

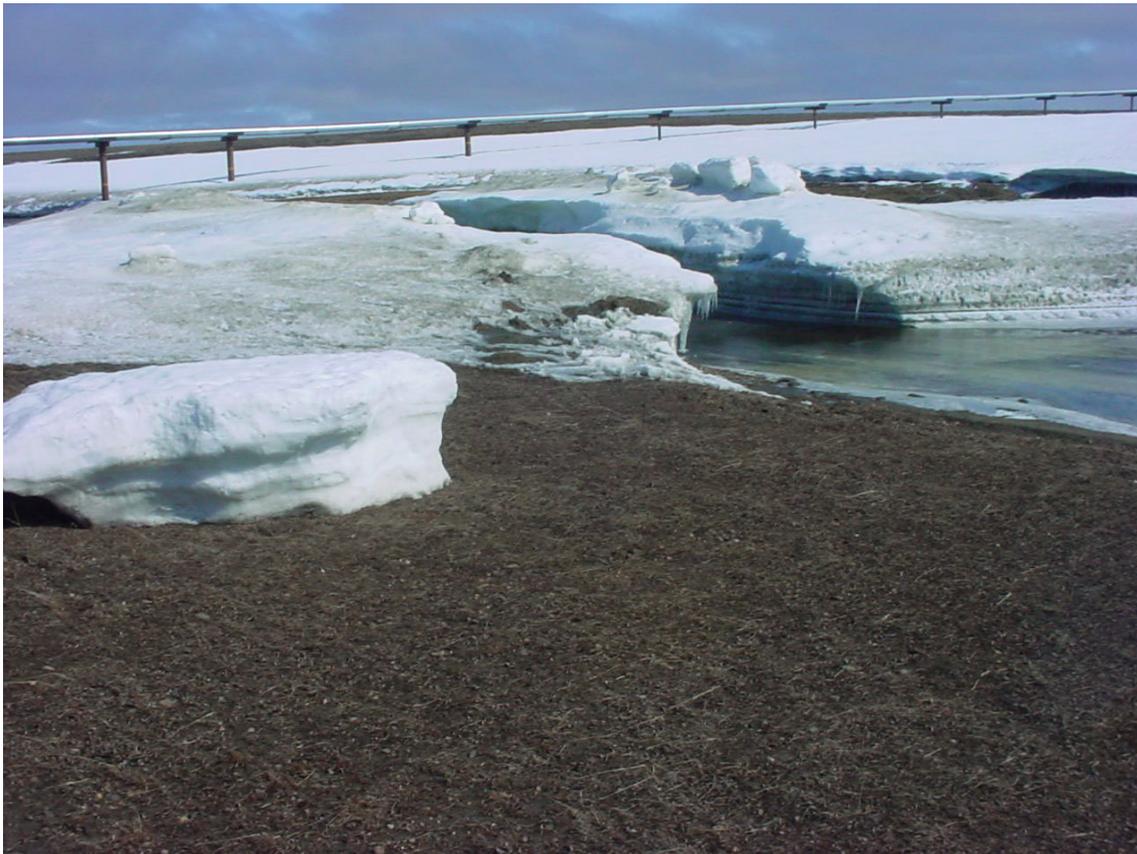
Figure 24 – Remnants of the ice bridge, Kachemach River west bank

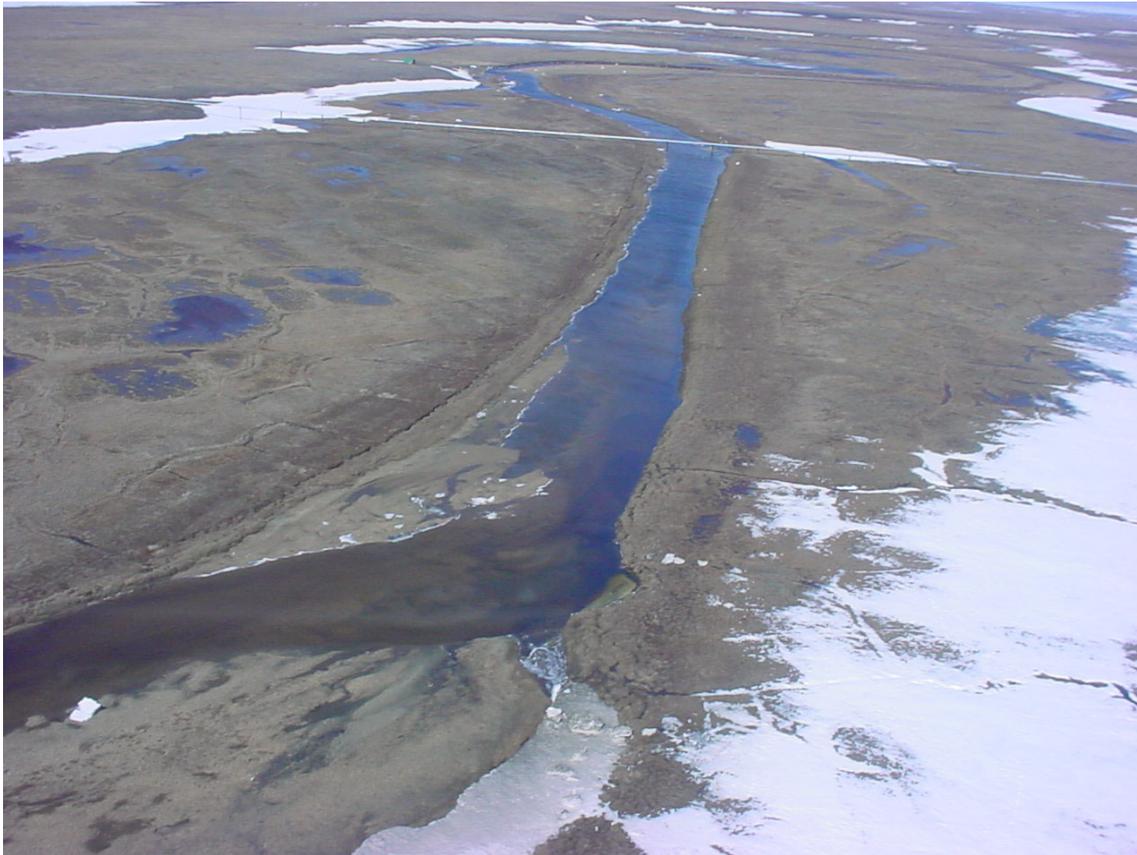
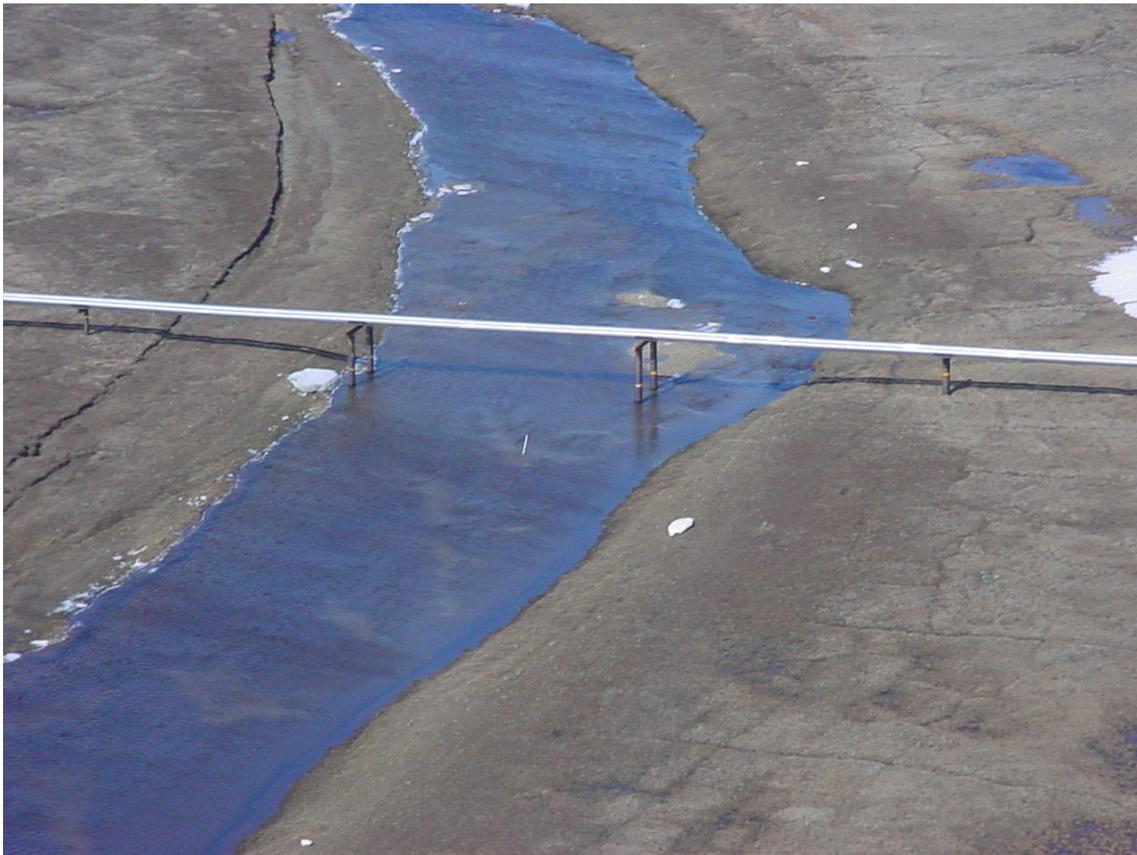
Figure 25 – Miluveach River pipeline crossing looking downstream

Figure 26 – Miluveach River pipeline crossing looking downstream

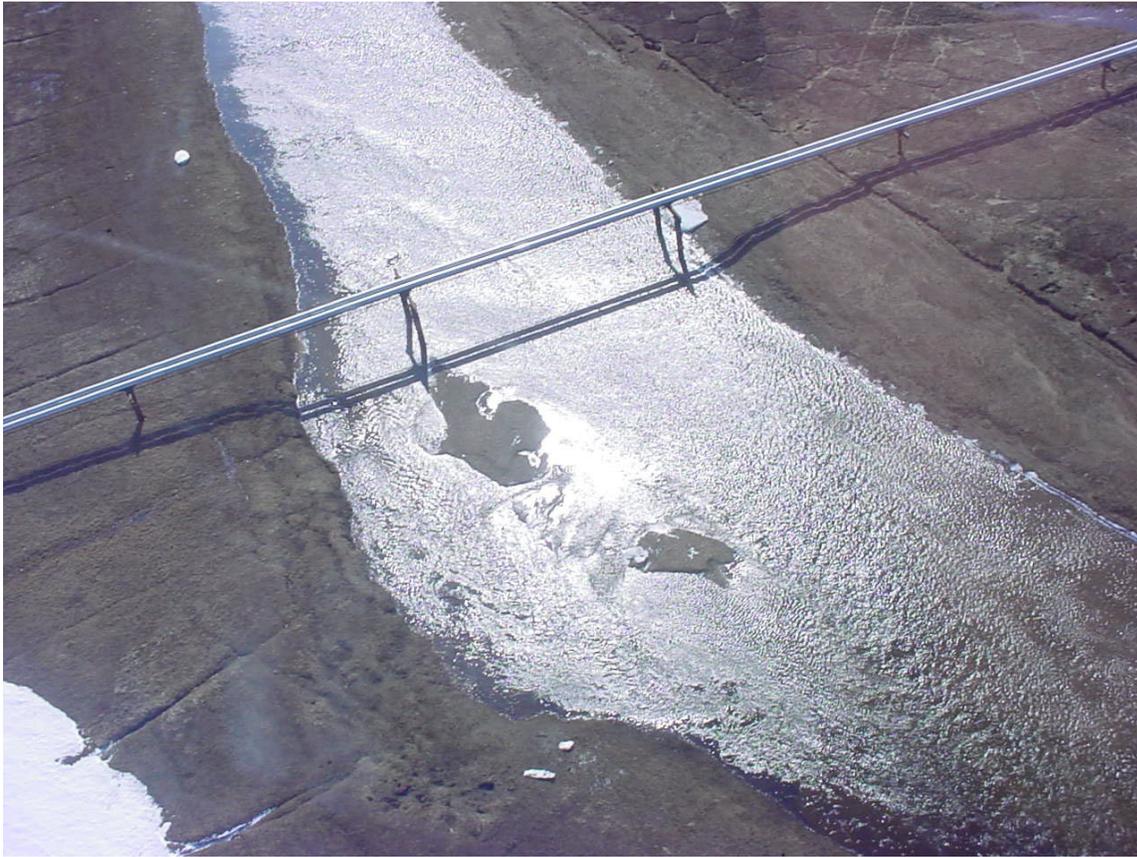
Figure 27 – Miluveach River pipeline crossing looking upstream

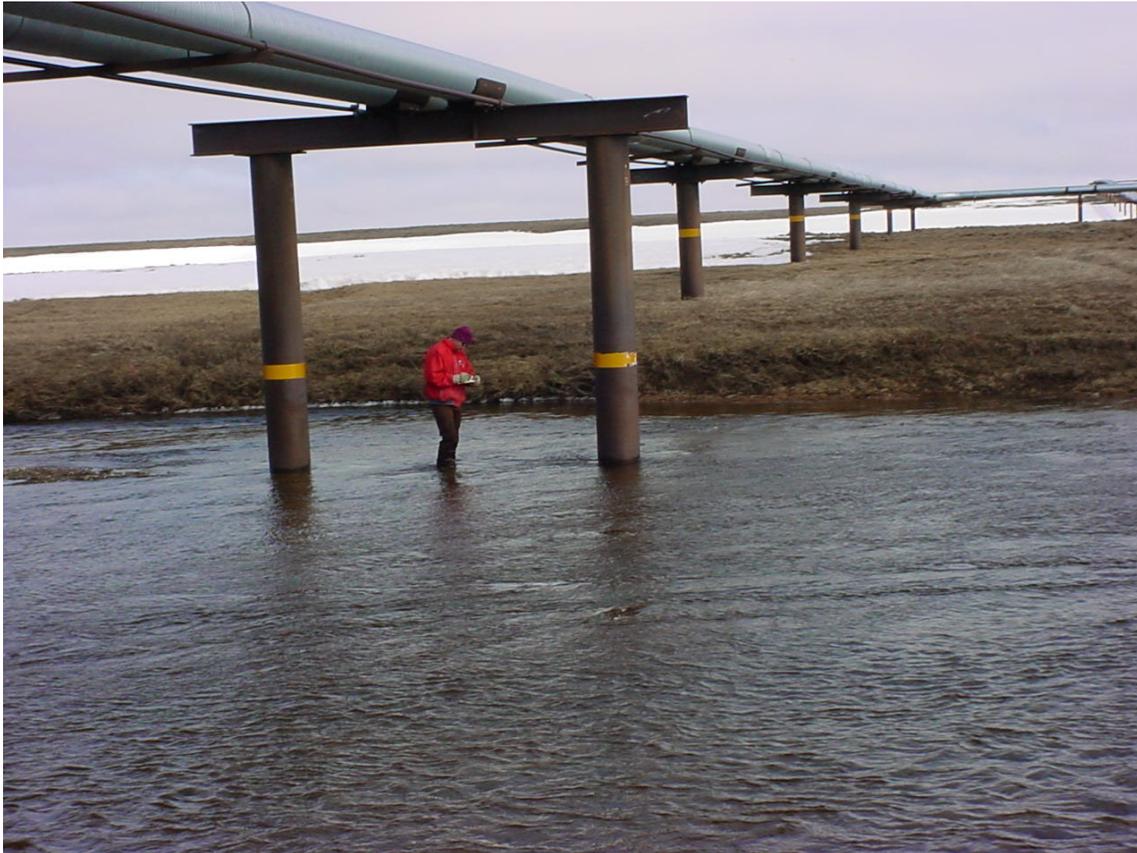
Figure 28 – Typical flow depth, Miluveach River east bank

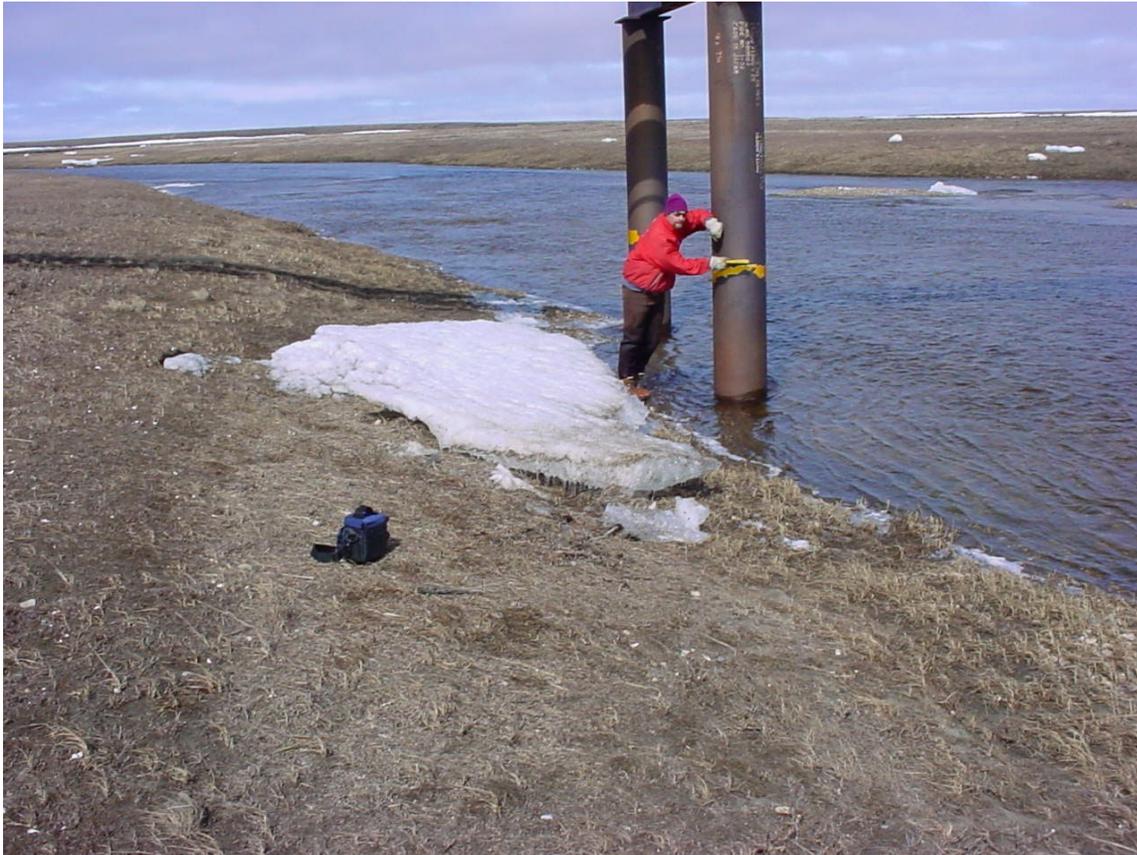
VSMs and HSMs on the east and west banks appeared plumb and level. No evidence of jacking or subsidence was noted. Two instream double set VSMs were examined for scour. Scour on instream VSMs was minimal, ranging from 1.8 to 0.3 ft. No evidence of significant scour was noted on VSMs outside the active channel. VSMs on both banks and in the active channel were free of debris. No pipeline leaks were found.

Figure 29 – Approximate high water mark on VSM 2047, Miluveach River looking downstream

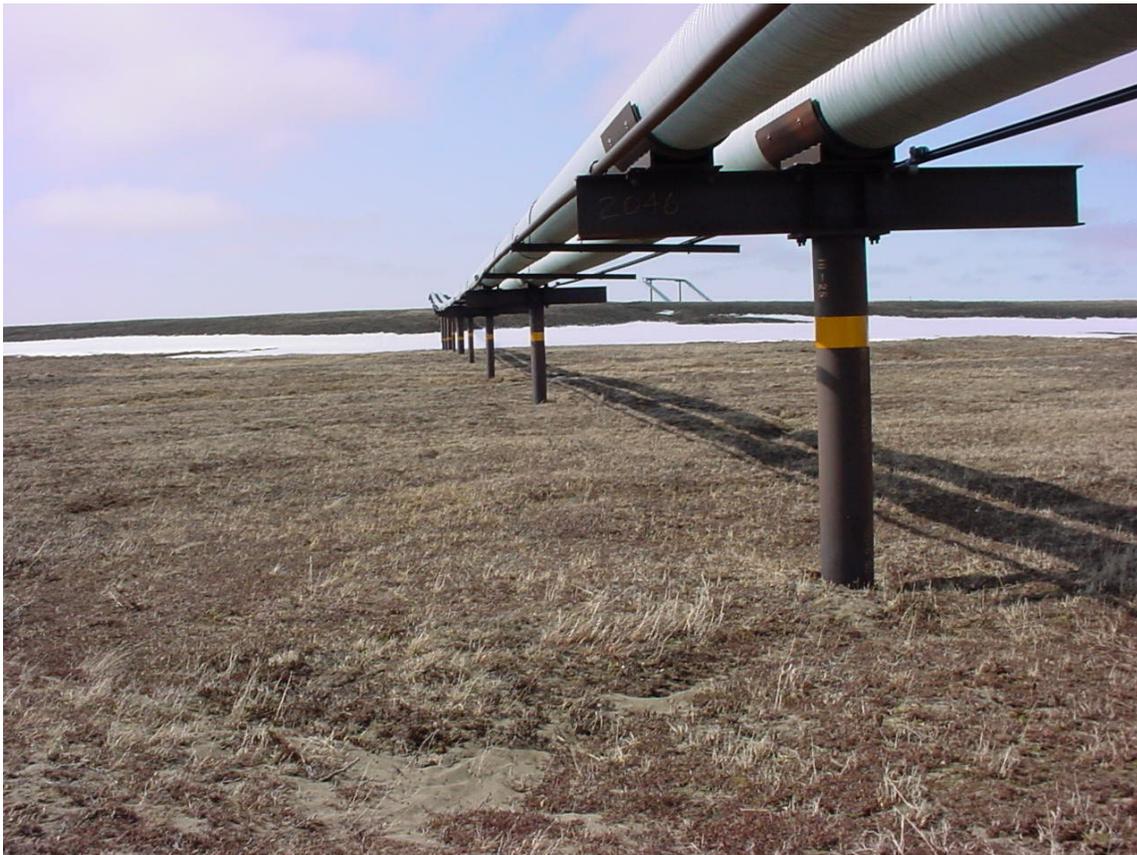
Figure 30 – VSM alignment and vertical loop, Miluveach River west bank

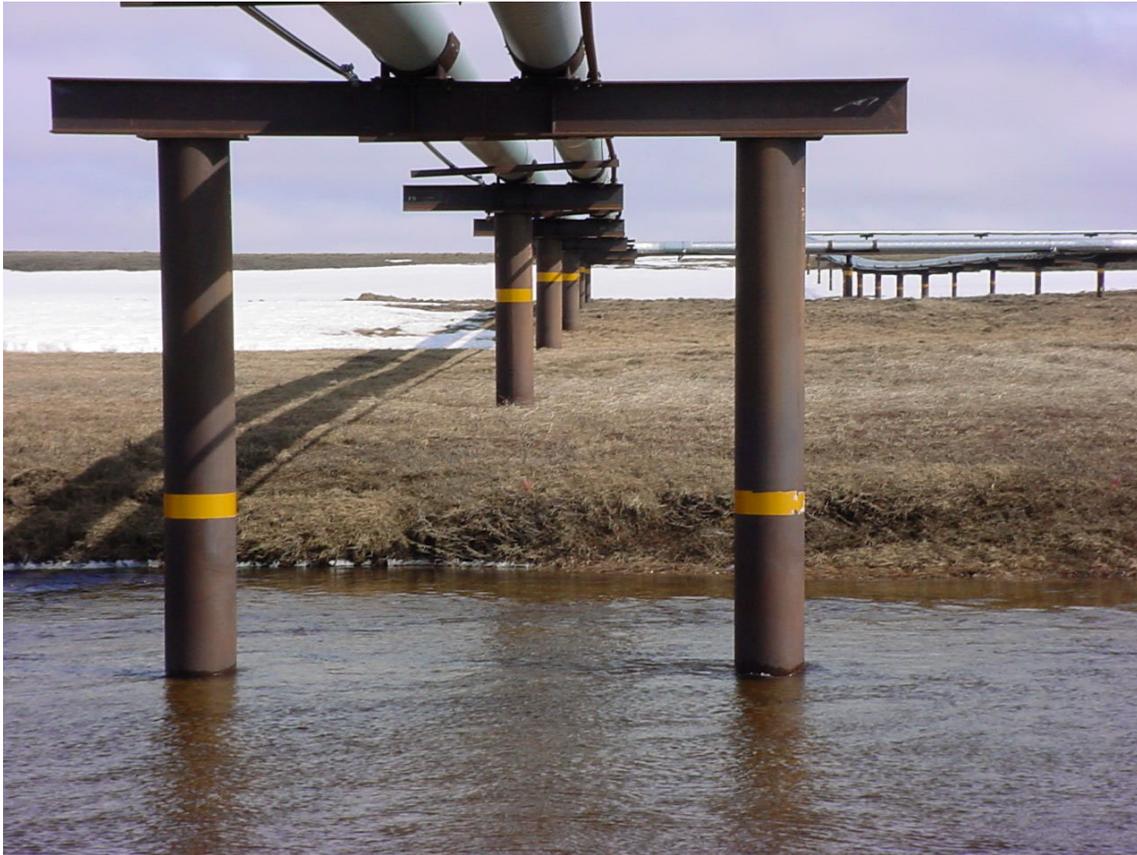
Figure 31 – VSM alignment and horizontal loop, Miluveach River east bank

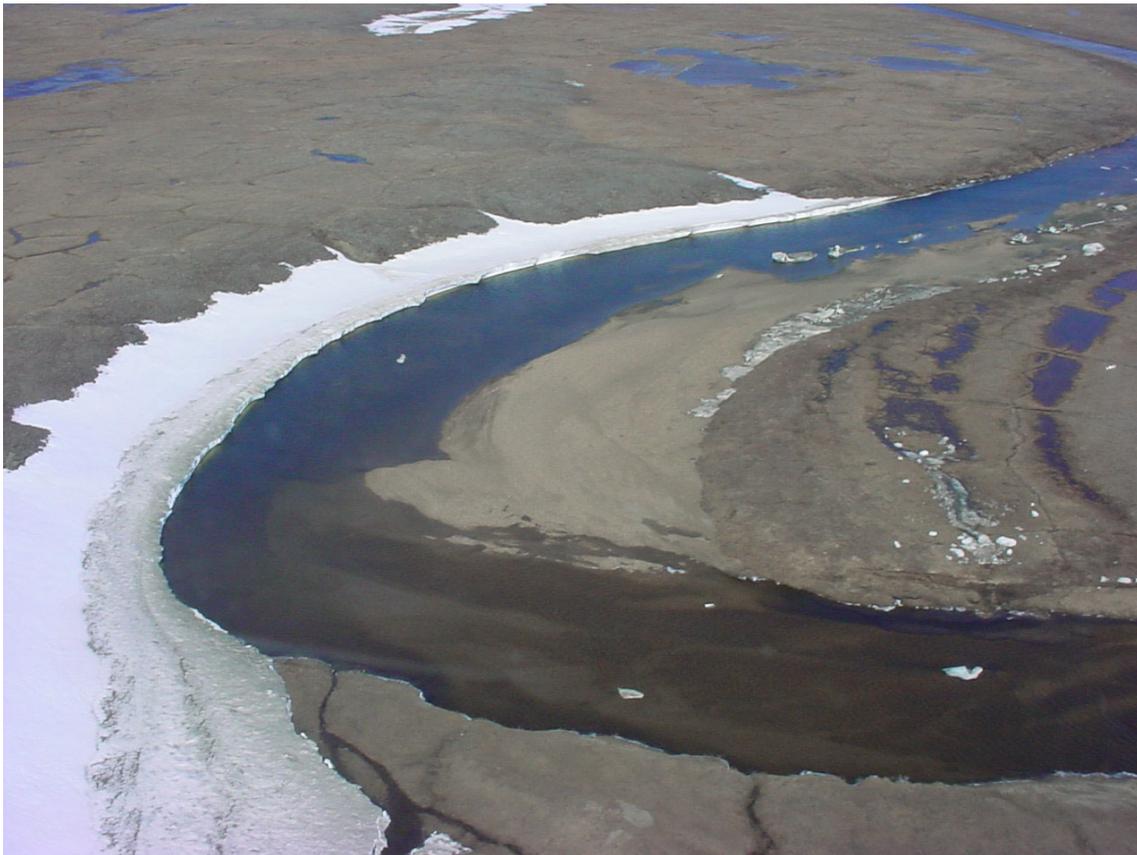
Both the east and west bank appeared to be stable; only minimal slumping was noted. No indications of channel obstructions were observed. It was not possible to make an assessment of potential bank migration in the meander bend located approximately 300 feet upstream from the pipeline crossing due to snow drifts that covered the entire outside of the bend in that area.

Figure 32 – Meander bend located approximately 100 yards upstream from the pipeline crossing, Miluveach River
