# CD-2 Gravel Road Erosion

Michael Baker, Jr., Inc.  
4601 Business Park Blvd., Suite 42  
Anchorage, Alaska 99503

October 19, 2004  
103680-MBJ-RPT-002

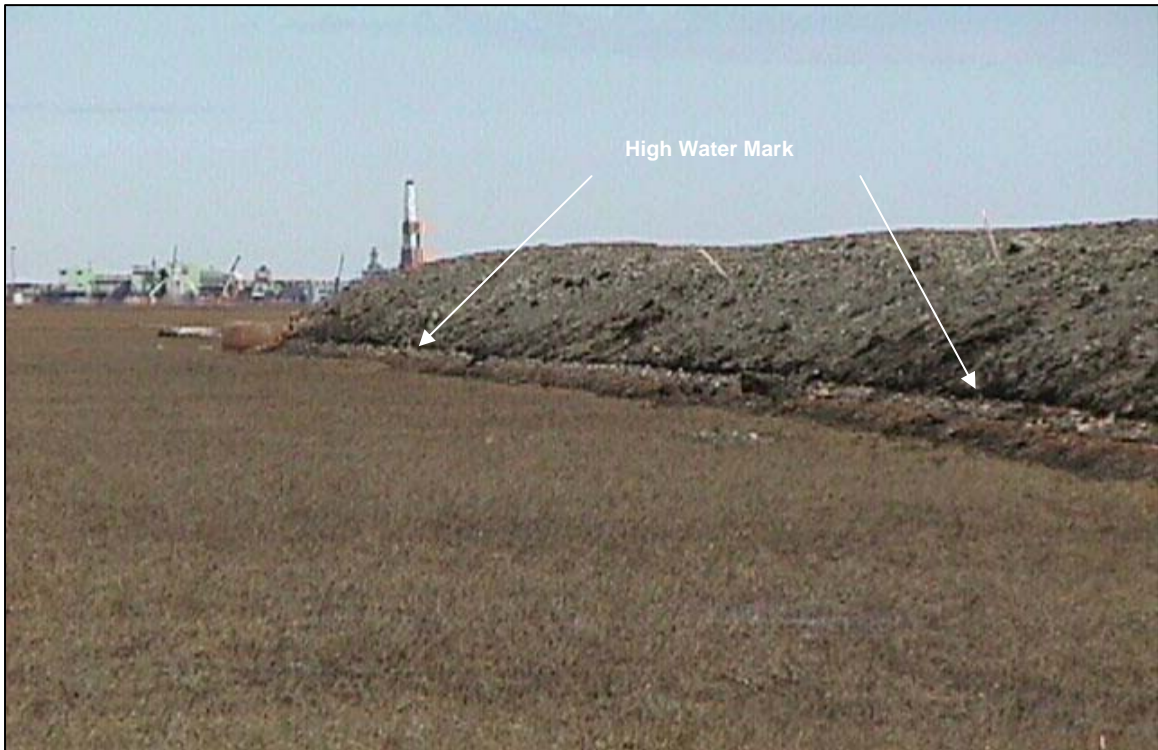
**Photo 1** Looking east along the north side of the embankment on the road to CD-2 near culvert #24. (6/15/00)

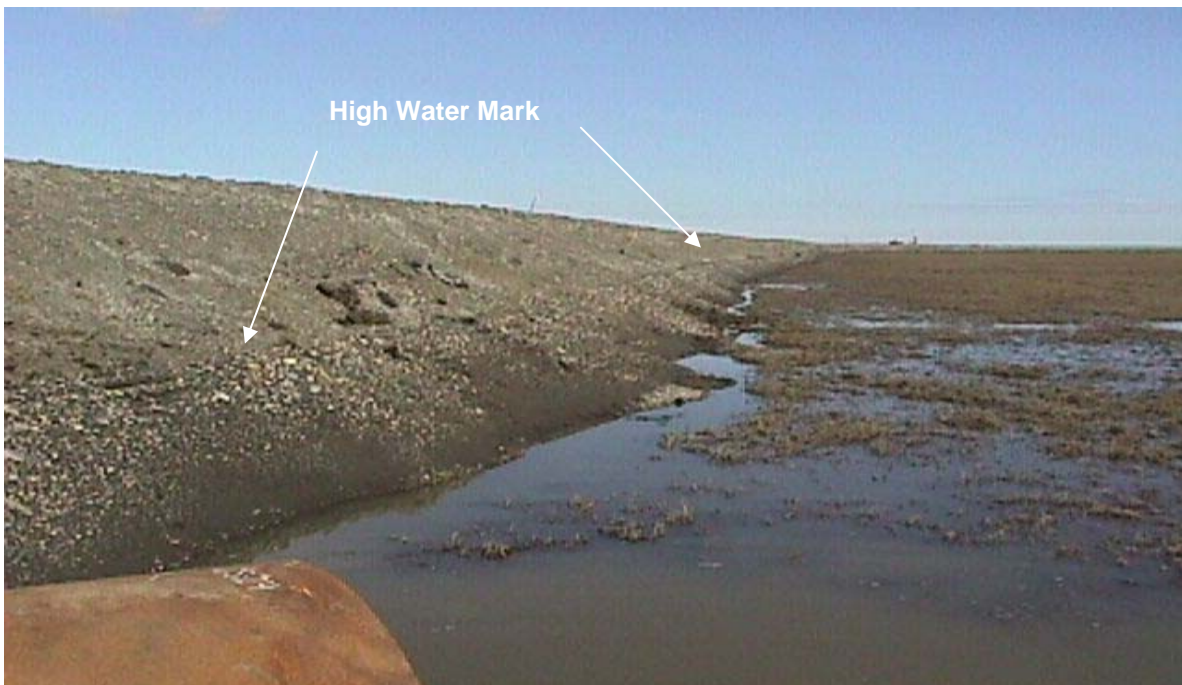
**Photo 2** Looking east along the south side of the embankment on the CD-2 access road near culvert #24. (6/15/00)

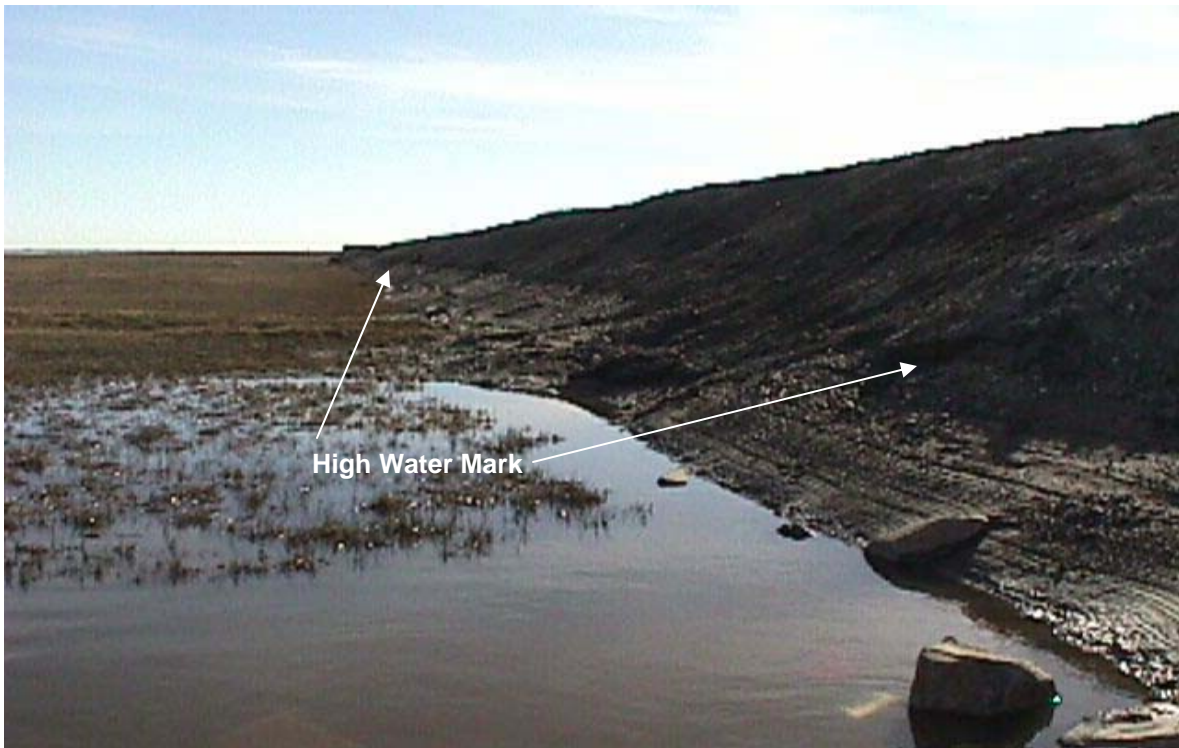
**Photo 3** Looking east along the north side of the embankment on the CD-2 access road near culvert #5. (6/18/00)

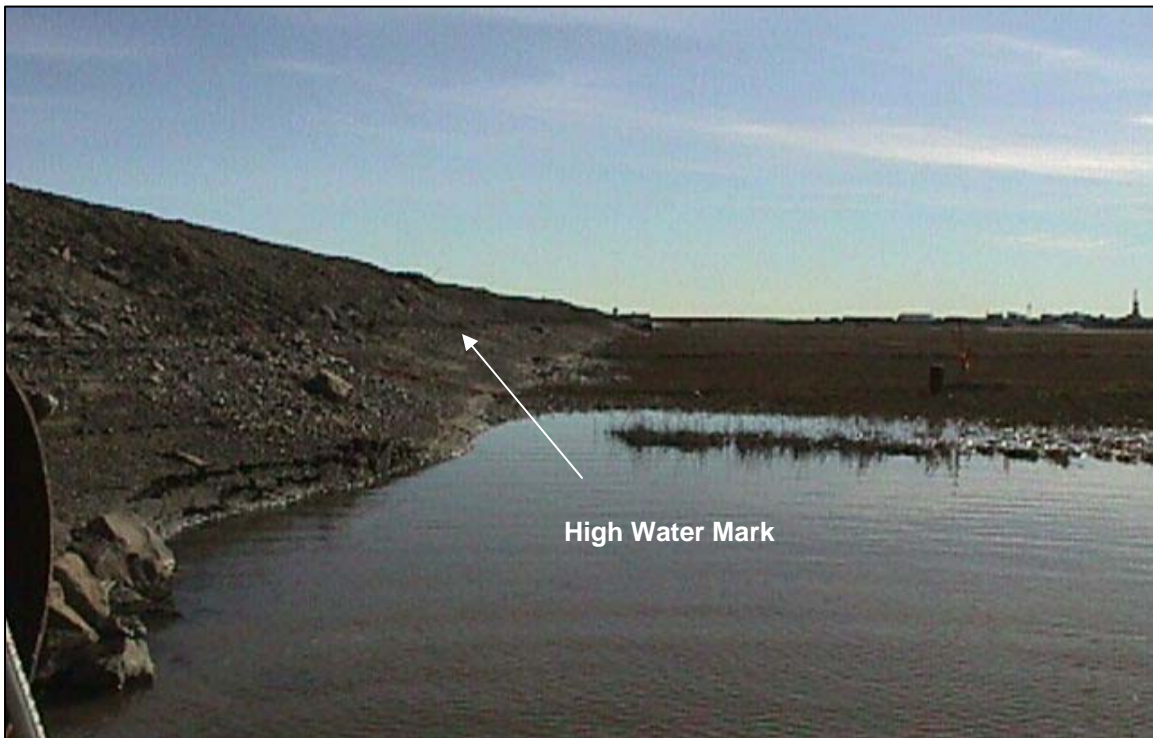
**Photo 4** Looking east along the south of the embankment on the road to CD-2 near culvert #5. (6/18/00)

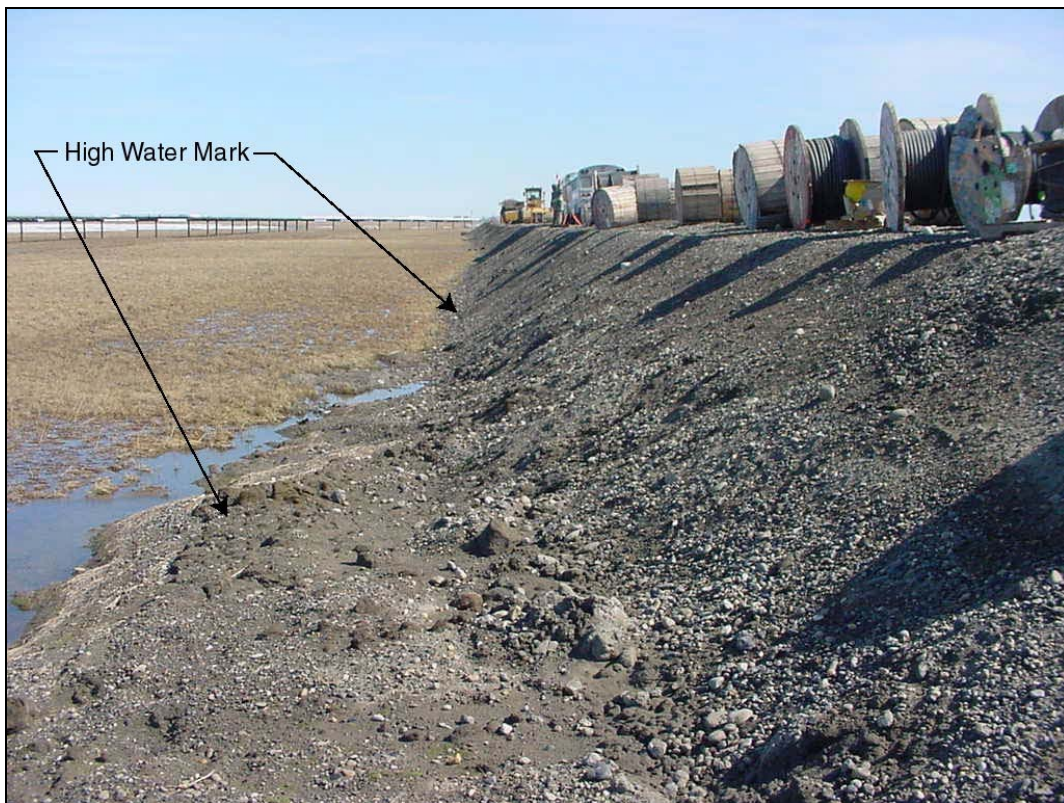
Photo 5 Facing east from Culvert #24 along the north side of the CD-2 access road. (6/16/01)

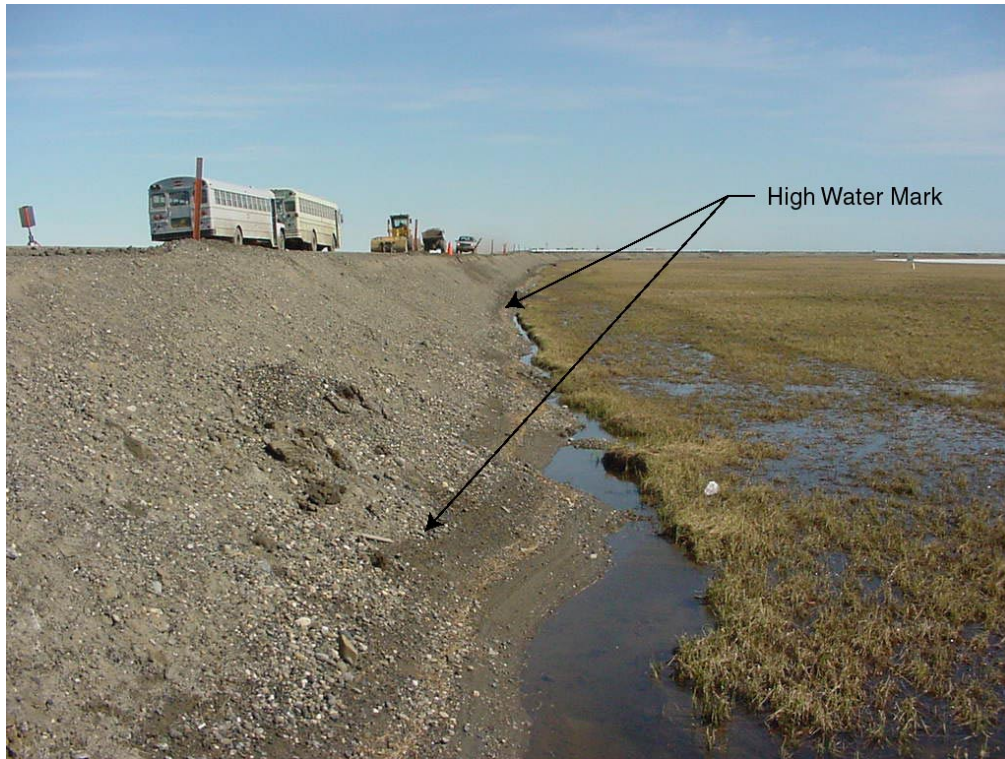
Photo 6 Facing east from Culvert #24 along the south side of the CD-2 access road. (6/16/01)

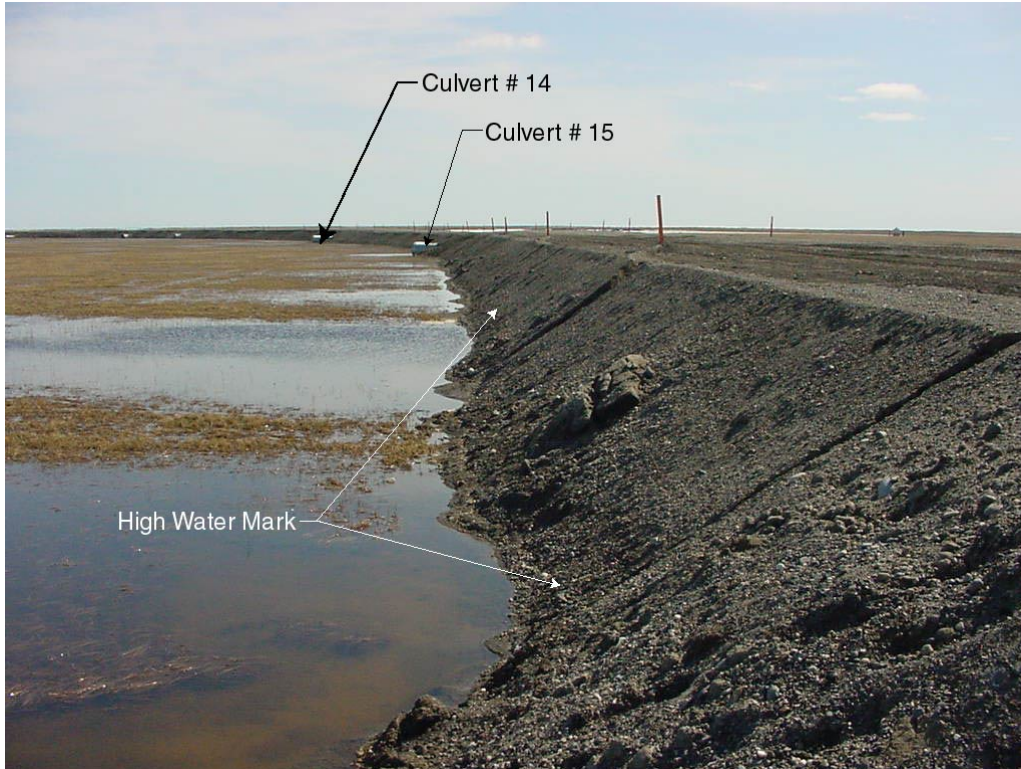
Photo 7 Facing east from Culvert #16 along the north side of the CD-2 access road. (6/16/01)

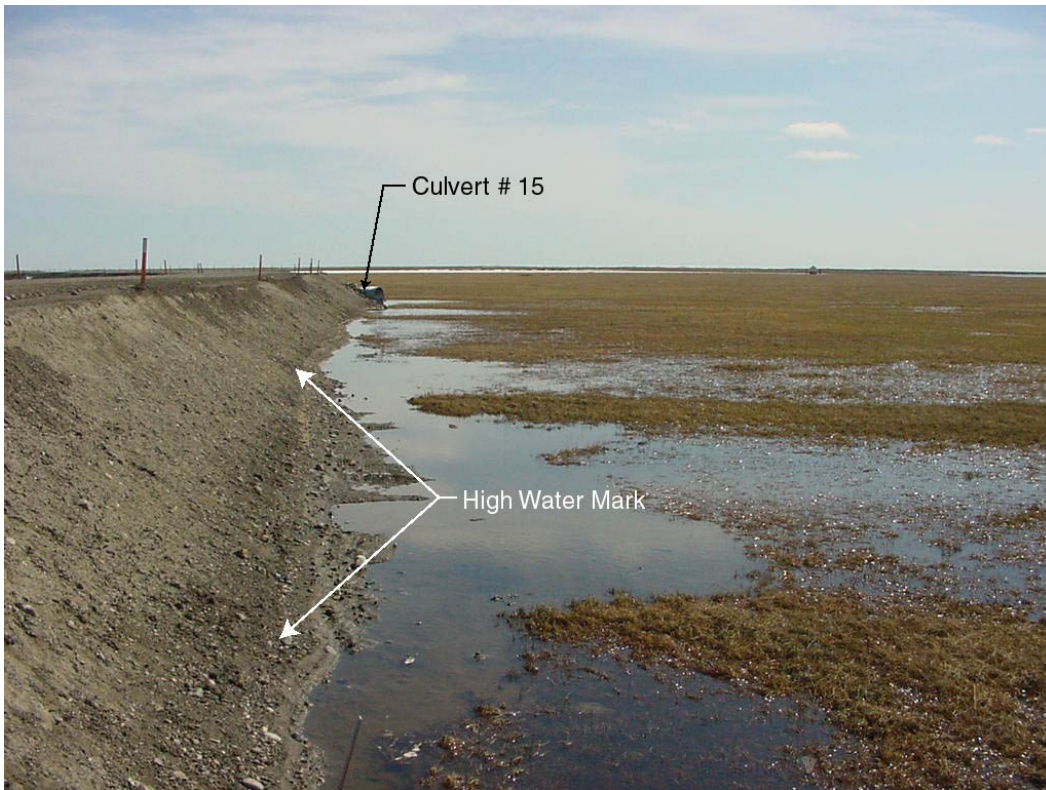
Photo 8 Facing east from Culvert #16 along the south side of the CD-2 access road. (6/15/01)

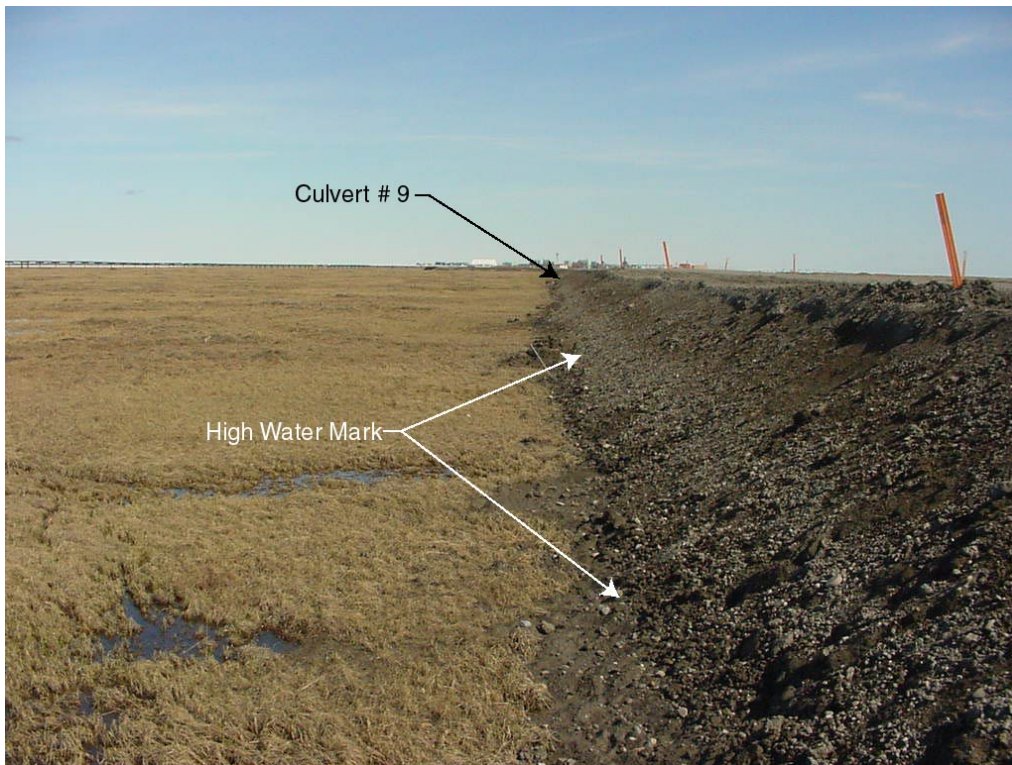
Photo 9 Facing east from Culvert #10 along the north side of the CD-2 access road. (6/15/01)

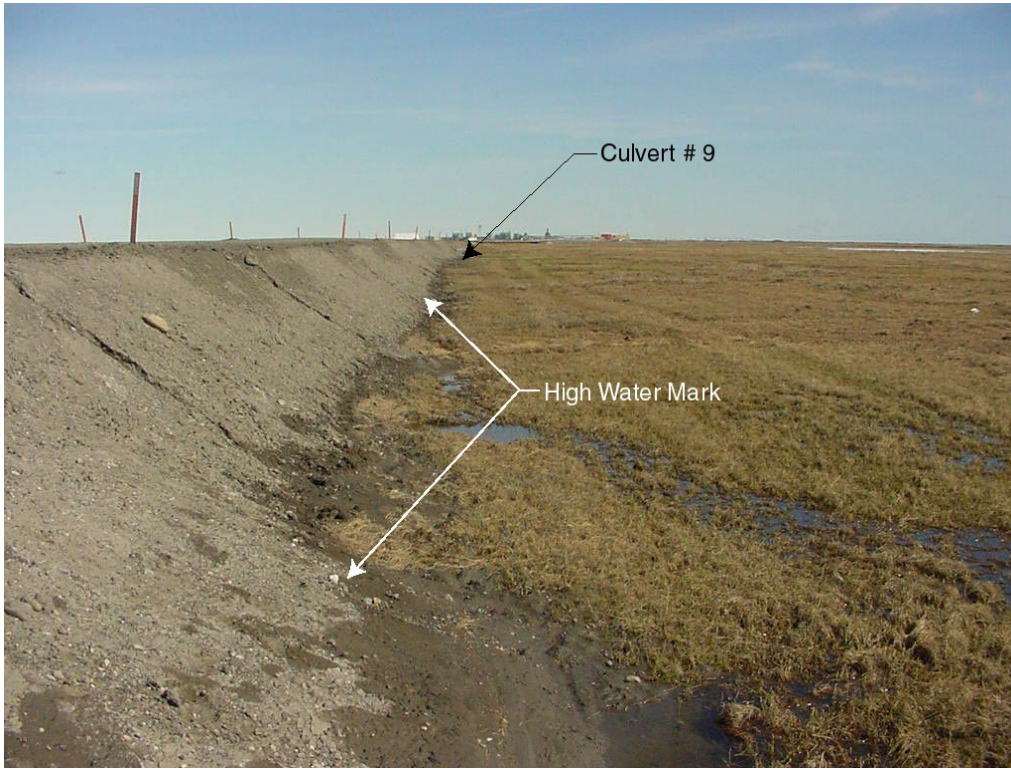
Photo 10 Facing east from Culvert #10 along the north side of the CD-2 access road. (6/15/01)

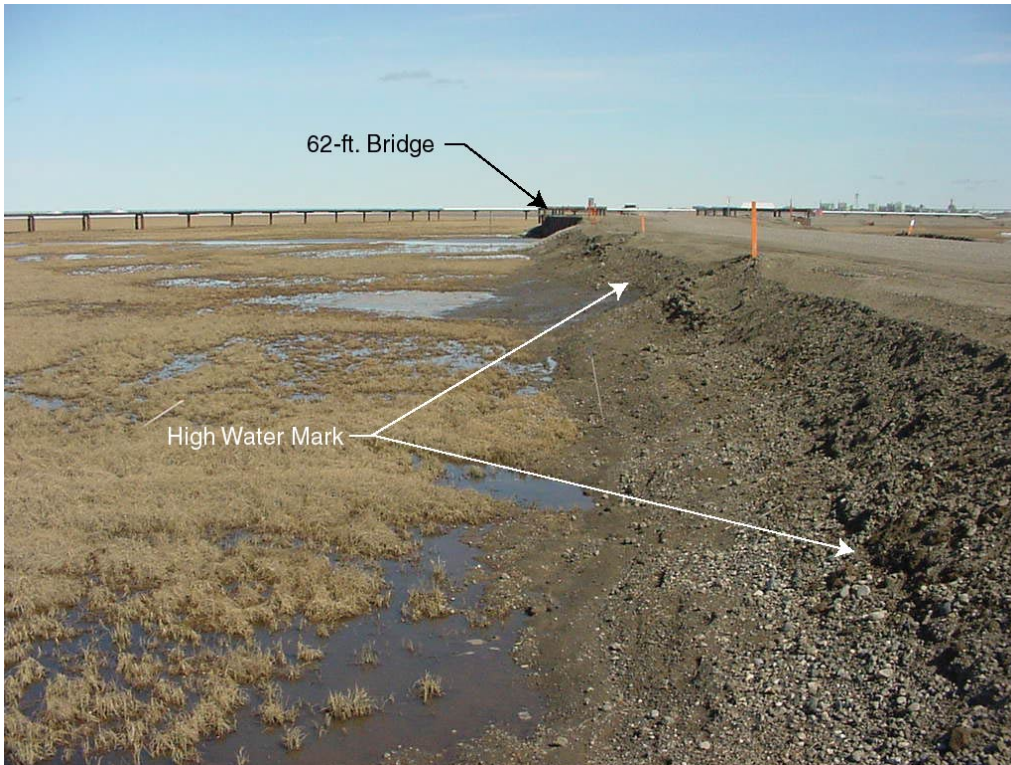
Photo 11 Facing east from Culvert #04 along the north side of the CD-2 access road. (6/15/01)

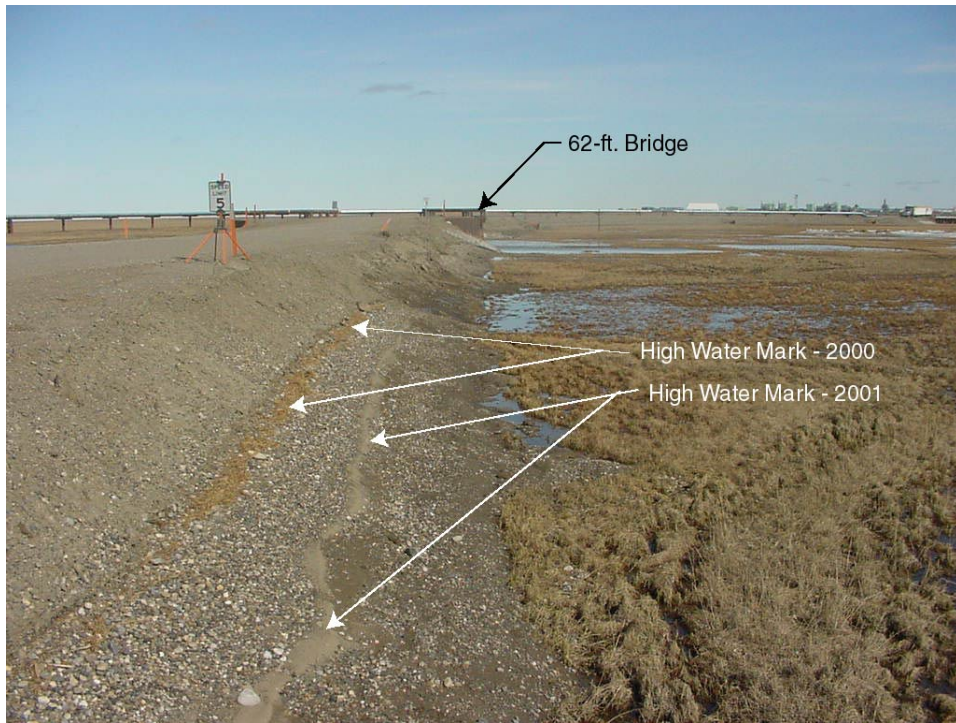
Photo 12 Facing east from Culvert #04 along the south side of the CD-2 access road. (6/15/01)

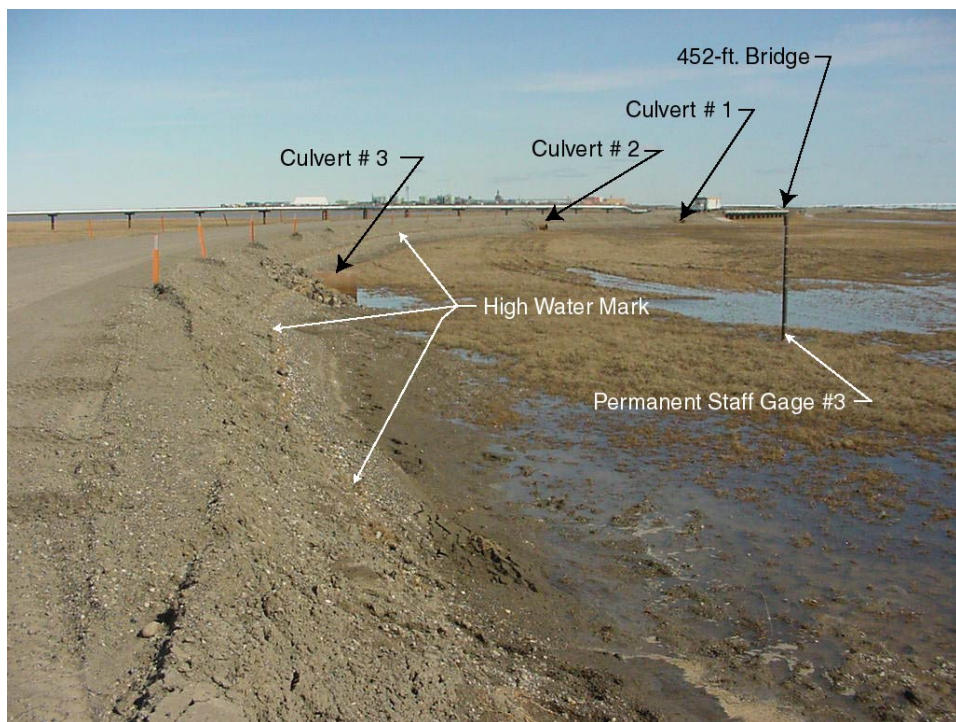
Photo 13 Facing east along the south side of the CD-2 access road from the 62-foot bridge. (6/16/01)

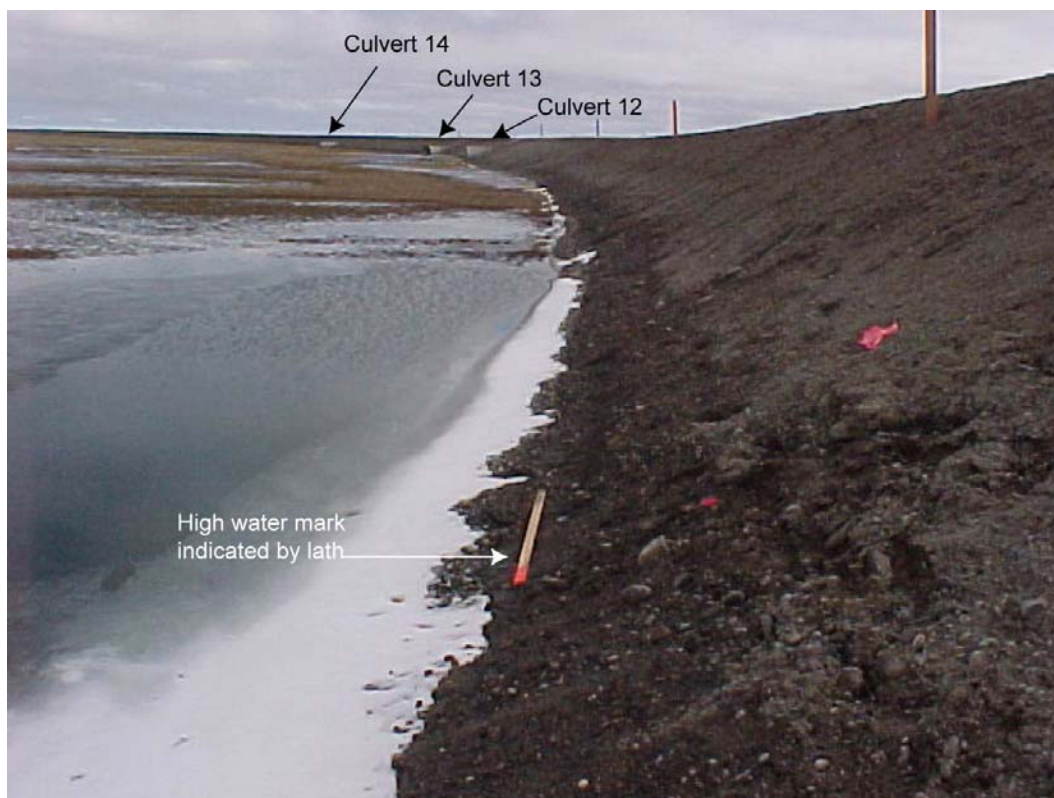
Photo 14 Facing east from Culvert #11 along the north side of the CD-2 access road. (5/31/02)

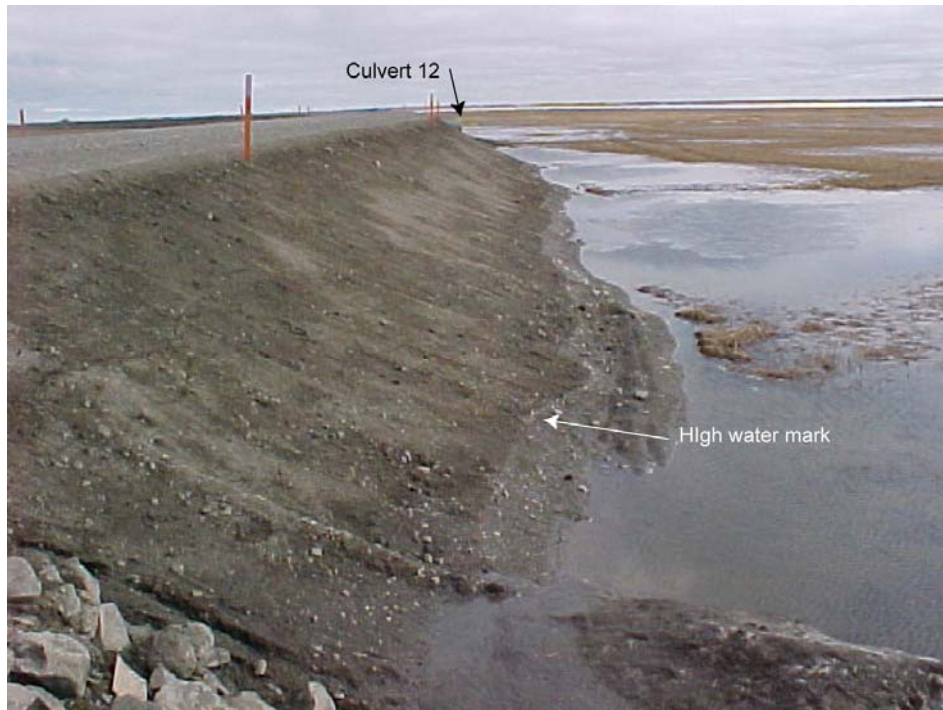
Photo 15 Facing east from culvert #11 along the south side of the CD-2 access road. (5/31/02)

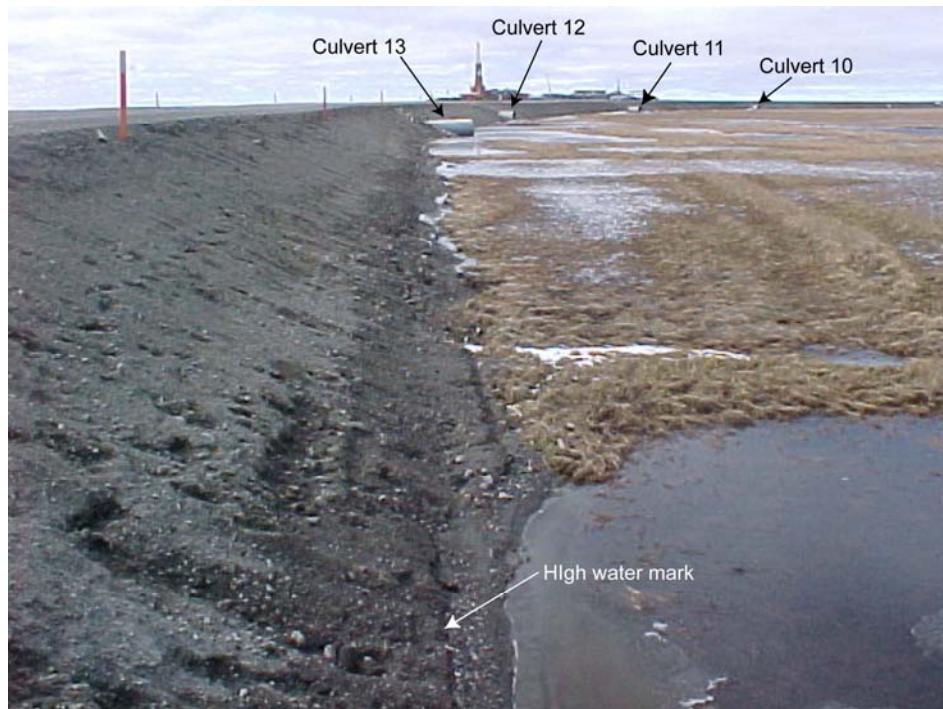
Photo 16 Facing west from culvert #14 along the north side of the CD-2 access road. (5/31/02)

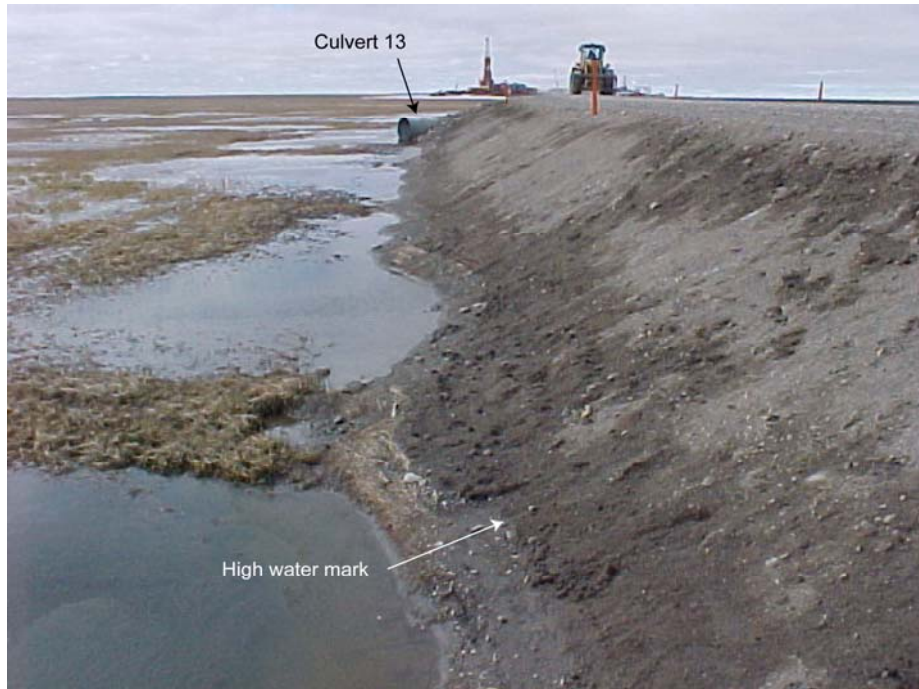
Photo 17 Facing west from culvert #14 along the south side of the CD-2 access road. (5/31/02)

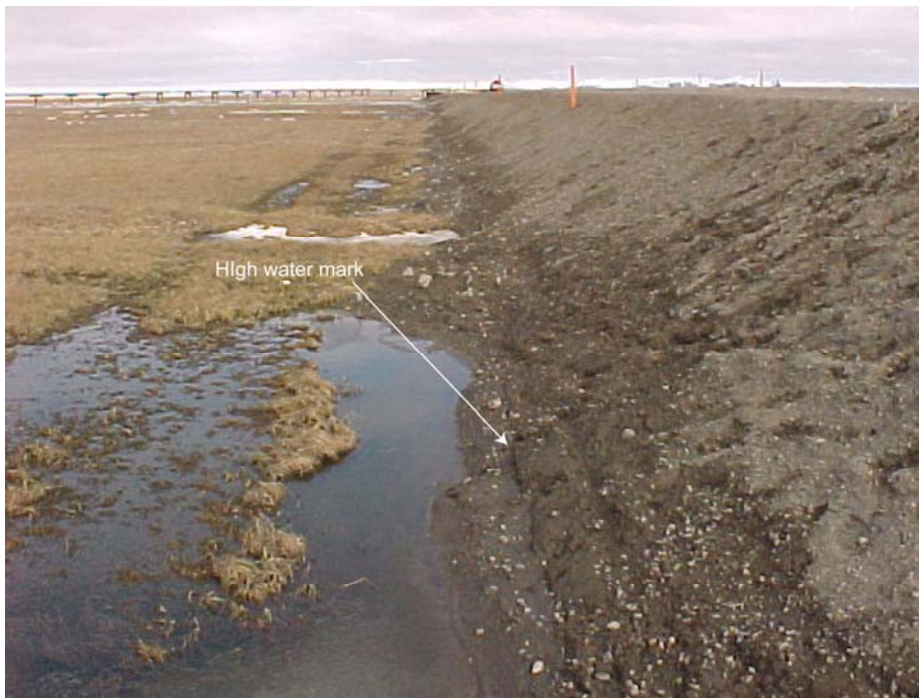
Photo 18 Facing east from culvert #20 along the north side of the CD-2 access road. (5/31/02)

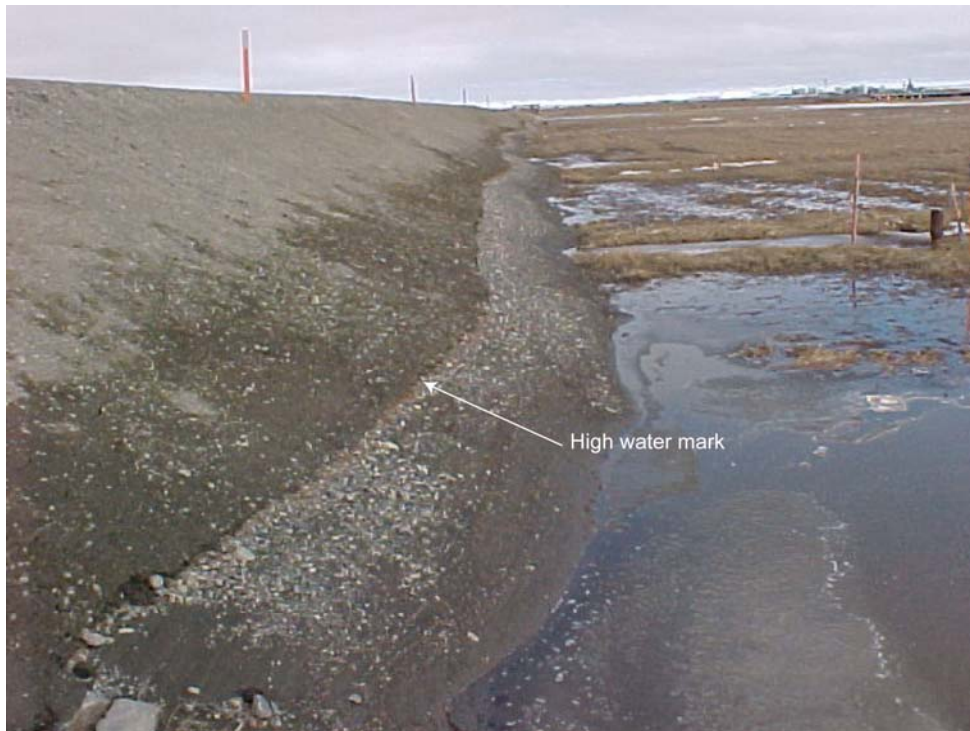
Photo 19 Facing east from culvert #20 along the south side of the CD-2 access road. (5/31/02)

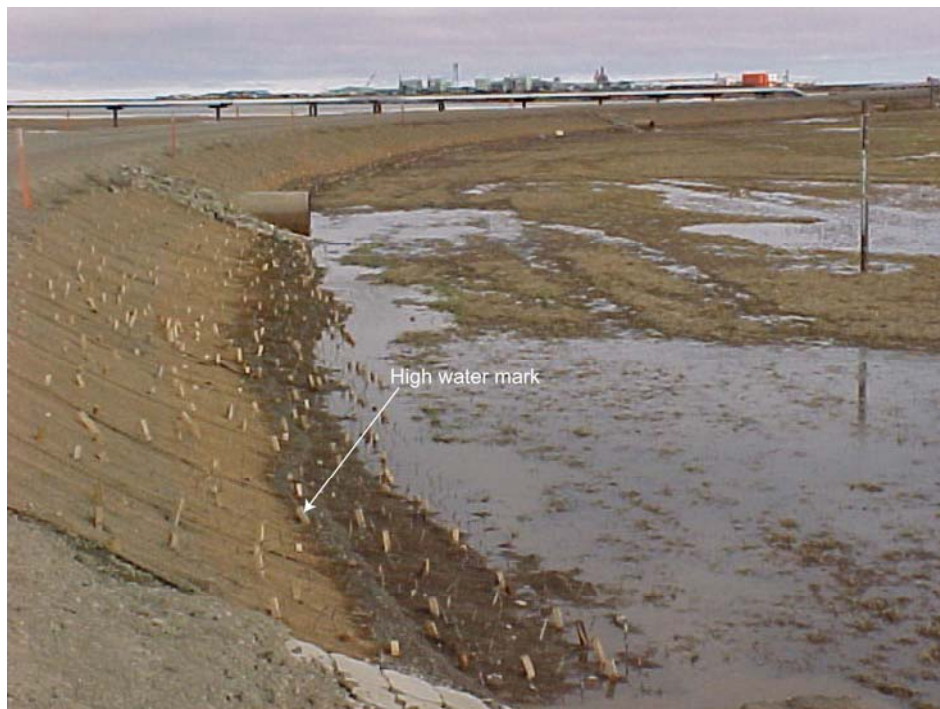
Photo 20 Facing east along the south side of the CD-2 access road from the 62-foot bridge. (5/31/02)

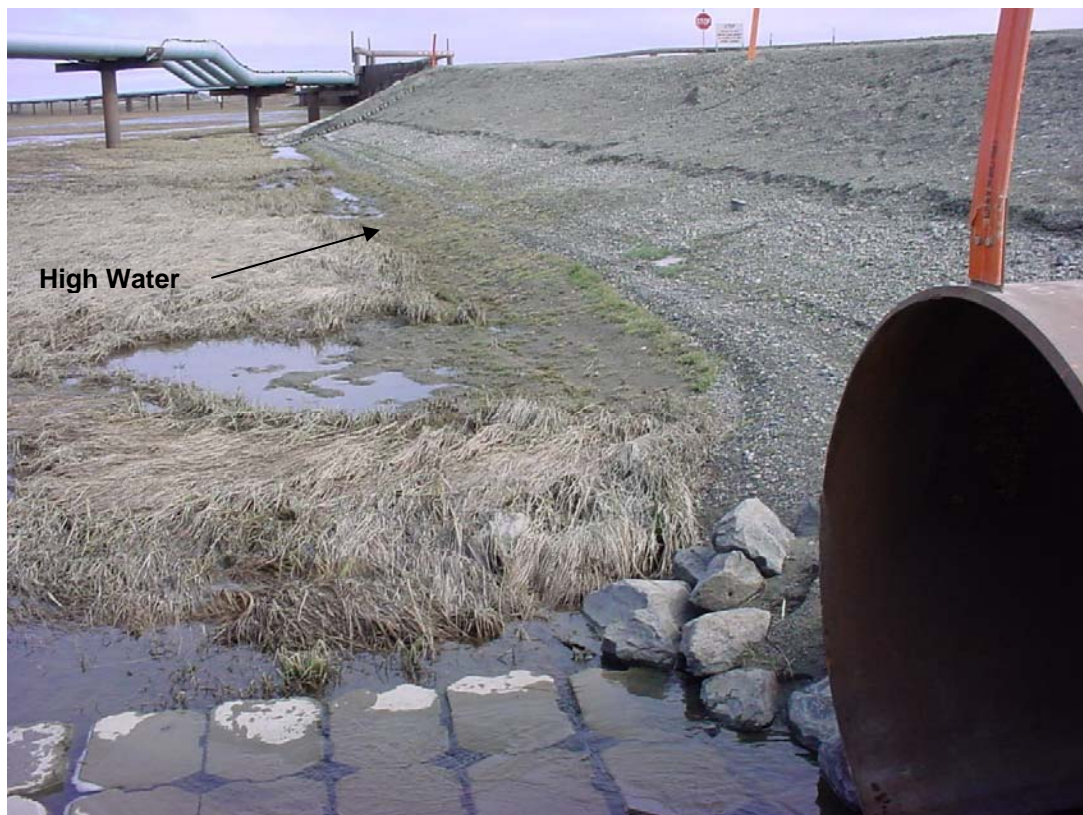
Photo 21 Looking east on the north side of the CD-2 access road from culvert #24. (6/13/03).

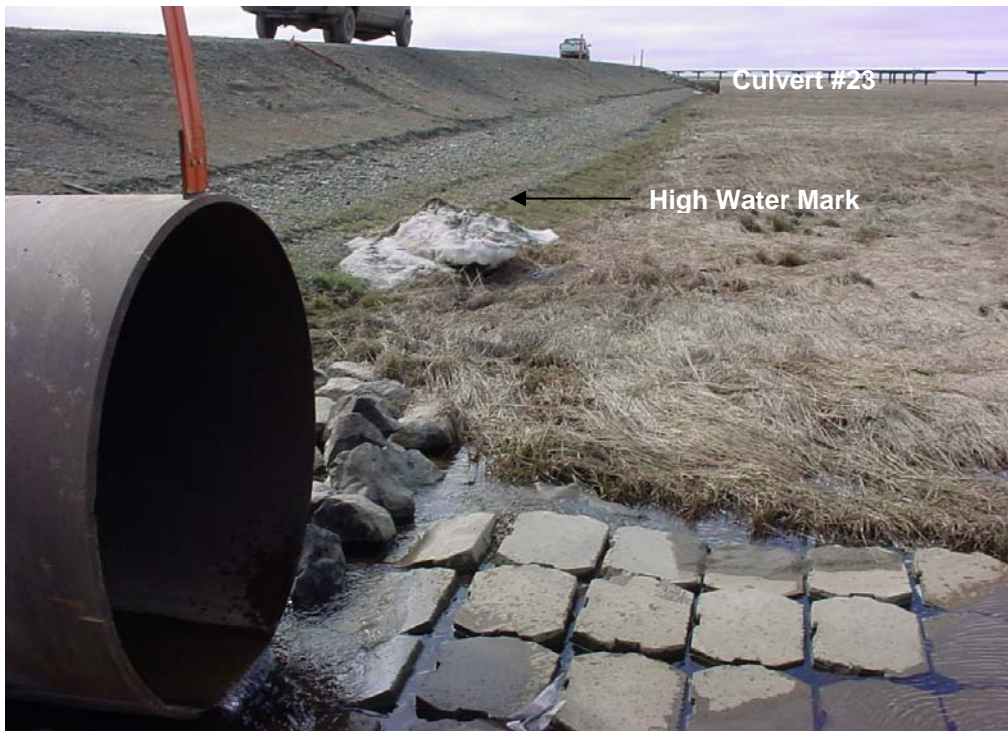
Photo 22 Looking west on the north side of the CD-2 access road from Culvert # 24. (6/13/03)

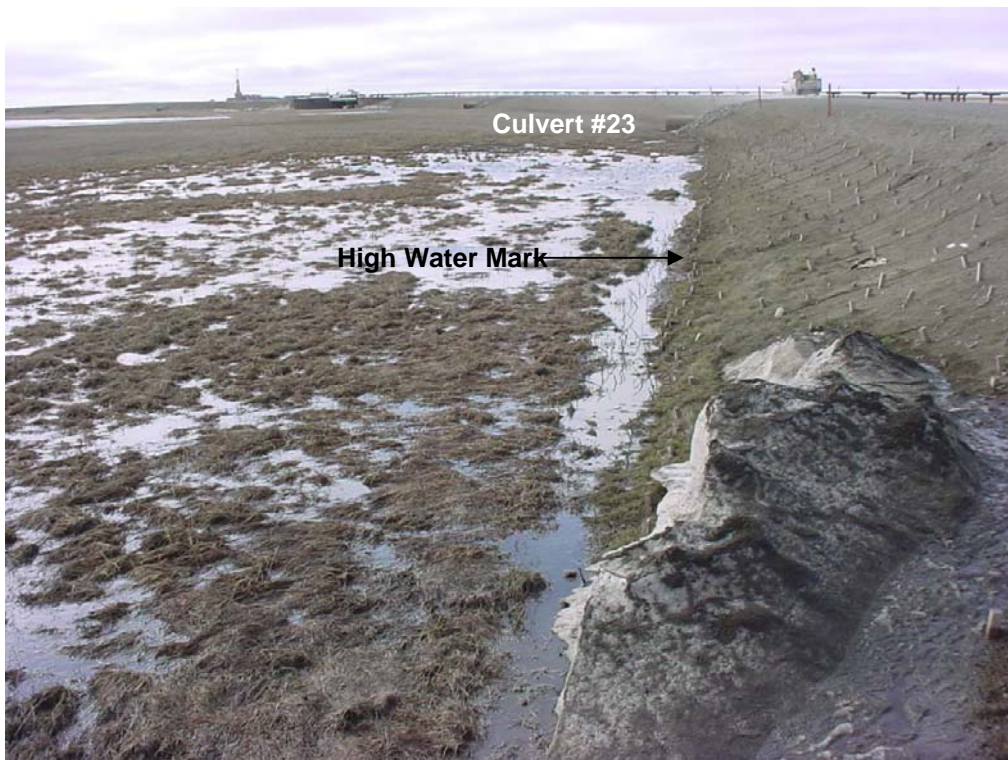
Photo 23 Looking west on the south side of the CD-2 access road from Culvert # 24. (6/13/03)

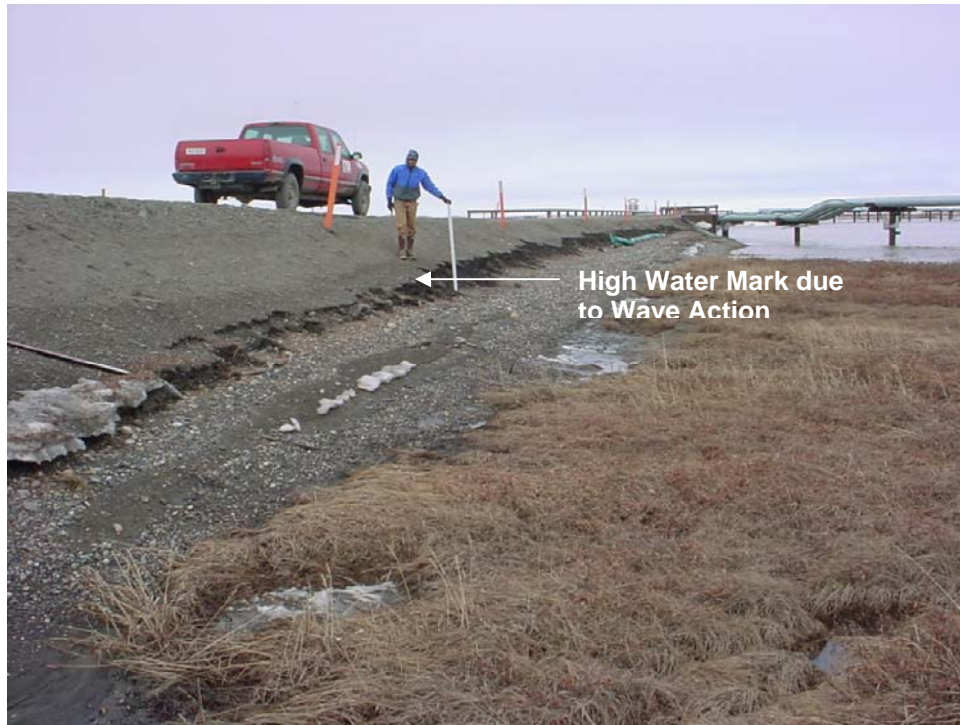
While much of the CD-2 road was protected by drifted snow and ice at the waters edge, some erosion resulted in areas that were exposed to wave action. Minor settlement of fine-grained material below the high water line was noted on a widespread basis on both sides of the road. Limited erosive damage on the north side of the road was primarily a result of wind-driven wave action caused by strong winds blowing out of the north during peak stage. However, the road performed as designed and erosion effects were minor. Alpine personnel have already addressed routine maintenance activities along the road.

Essentially the entire 10,600-foot segment of road between the CD-1 runway and the CD-2 pad was in contact with the floodwater during the 2004 breakup event. On the north side of the road, 770-feet of the road (7% of the total road length) experienced minor side slope erosion damage, while 93% of the road did not experience side slope erosion. On the south side of the road, 1720-feet of the road (16% of the total road length) experienced minor side slope erosion damage, while 84% of the road did not experience side slope erosion. All of the documented erosion along the road is classified as minor. The eroded material was generally redistributed from near the high water line to the toe of the road.

**Photo 24** Sideslope erosion of surficial gravel due to wind-driven wave impact on north side of CD-2 road between the 452-foot bridge and Culvert #25. (6/1/04)

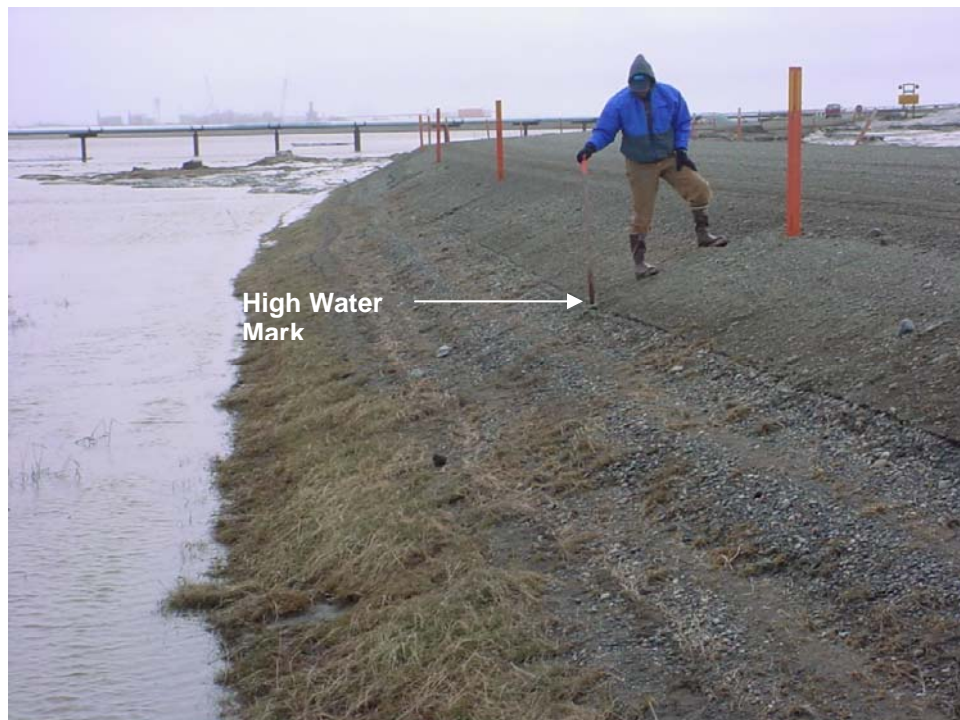
**Photo 25** High water mark on north side of CD-2 road between the 62-foot and 452-foot bridges. (6/1/04)

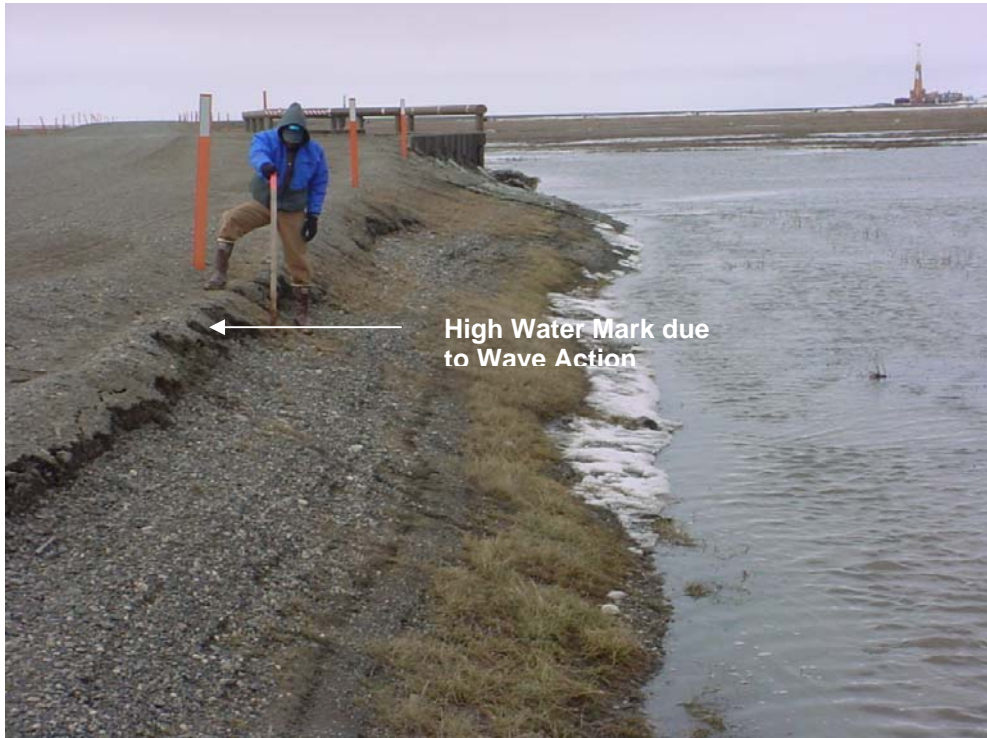
Photo 26 High water mark on north side of CD-2 road between the 62-foot bridge and Culvert #22. (6/1/04)

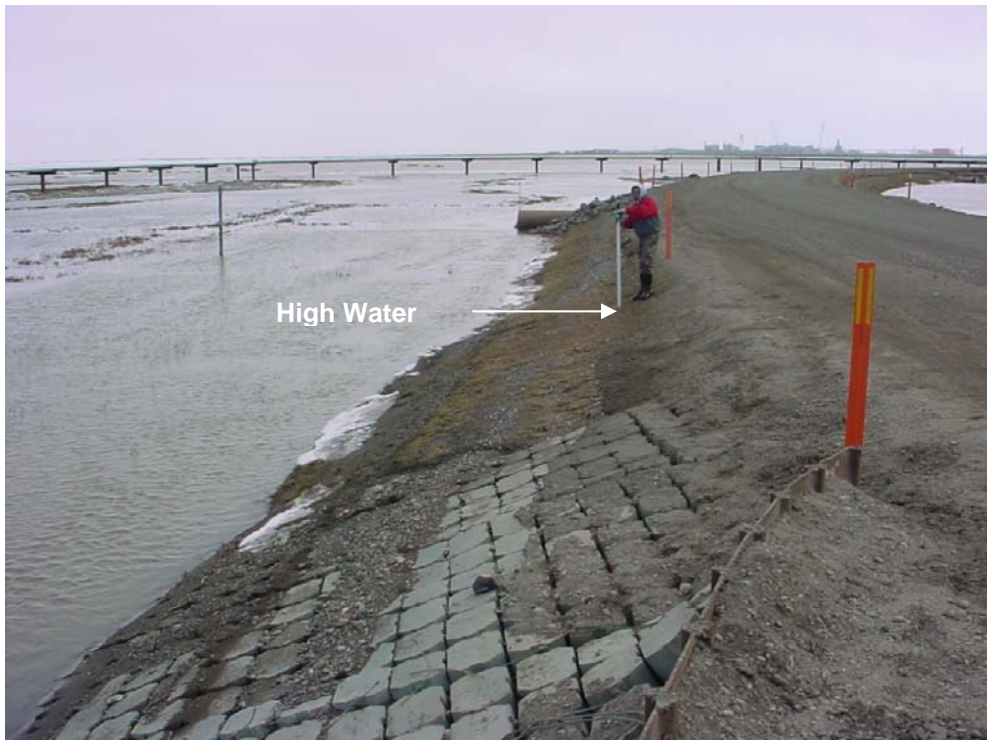
Photo 27 High water mark on north side of CD-2 road between the 62-foot bridge and Culvert #22 near Permanent Staff Gage #4. (6/1/04)

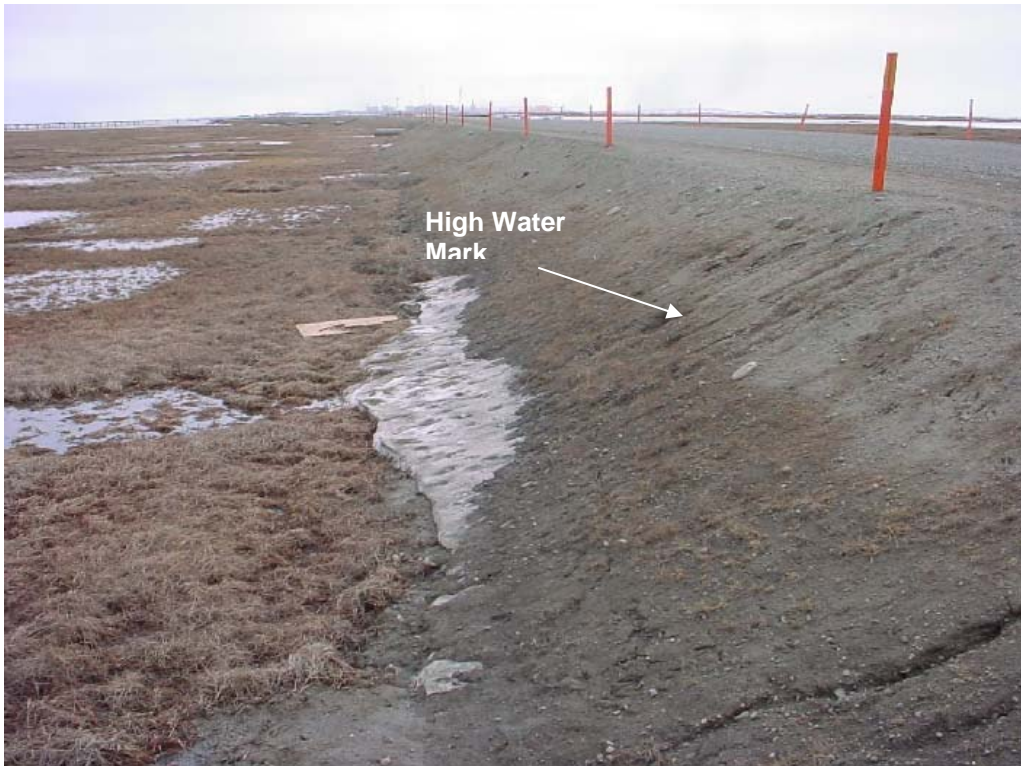
Photo 28 Looking east from culvert # 17 at the north side of the CD2 road. (6/1/04)

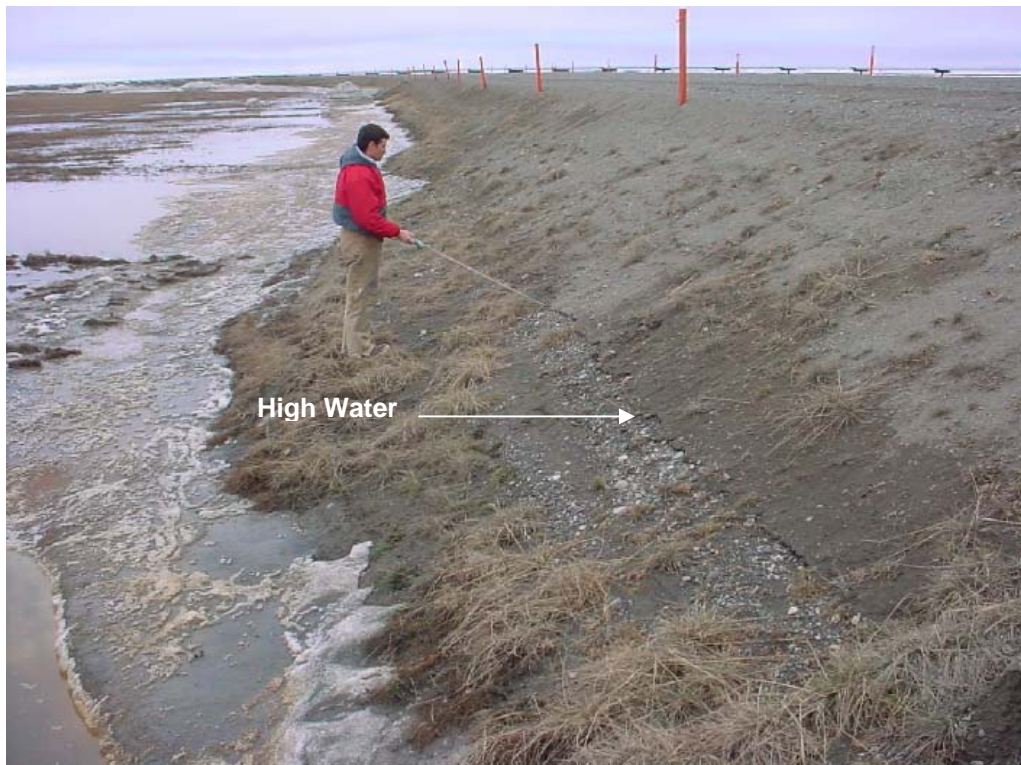
Photo 29 Looking west from culvert # 10 on south side of the CD2 road. (6/1/04)
