# CD-2 Gravel Road Erosion

Michael Baker, Jr., Inc.  
4601 Business Park Blvd., Suite 42  
Anchorage, Alaska 99503

October 19, 2004  
103680-MBJ-RPT-002

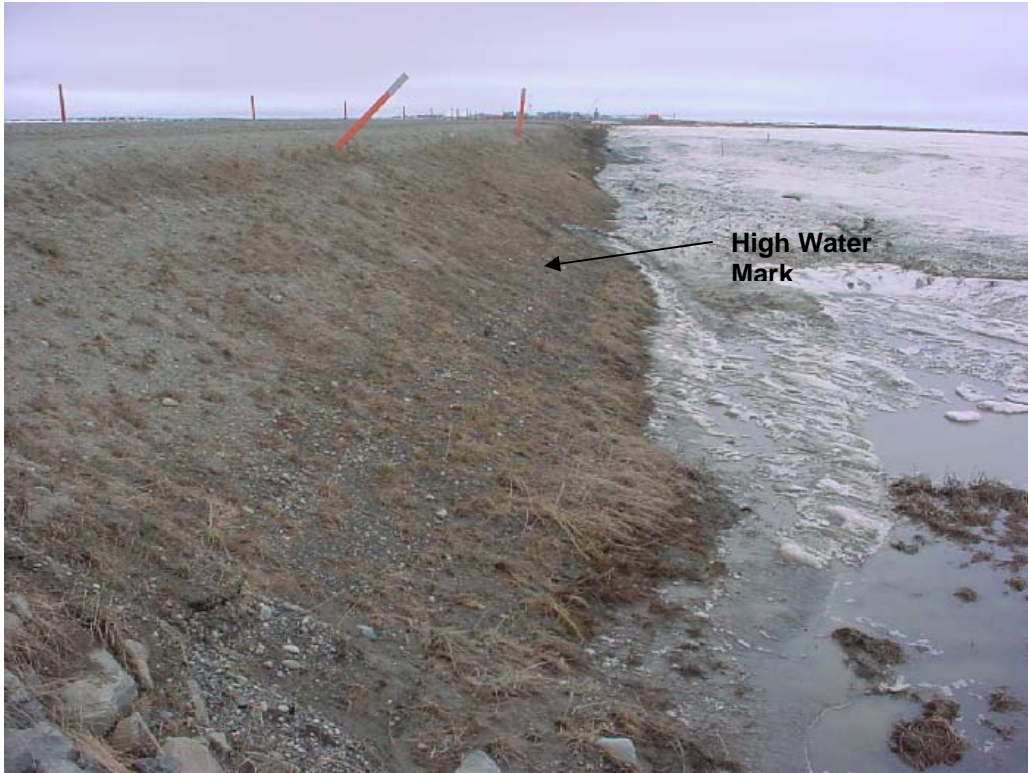
Photo 30 Looking west on south side of CD-2 road at culvert # 16 (6/1/04)
