Improved Alpine Culvert Design

Compared to Kuparuk & Prudhoe Bay Culvert Design

Michael Baker, Jr., Inc.
4601 Business Park Blvd., Suite 42
Anchorage, Alaska 99503

October 25, 2004
103680-MBJ-RPT-004

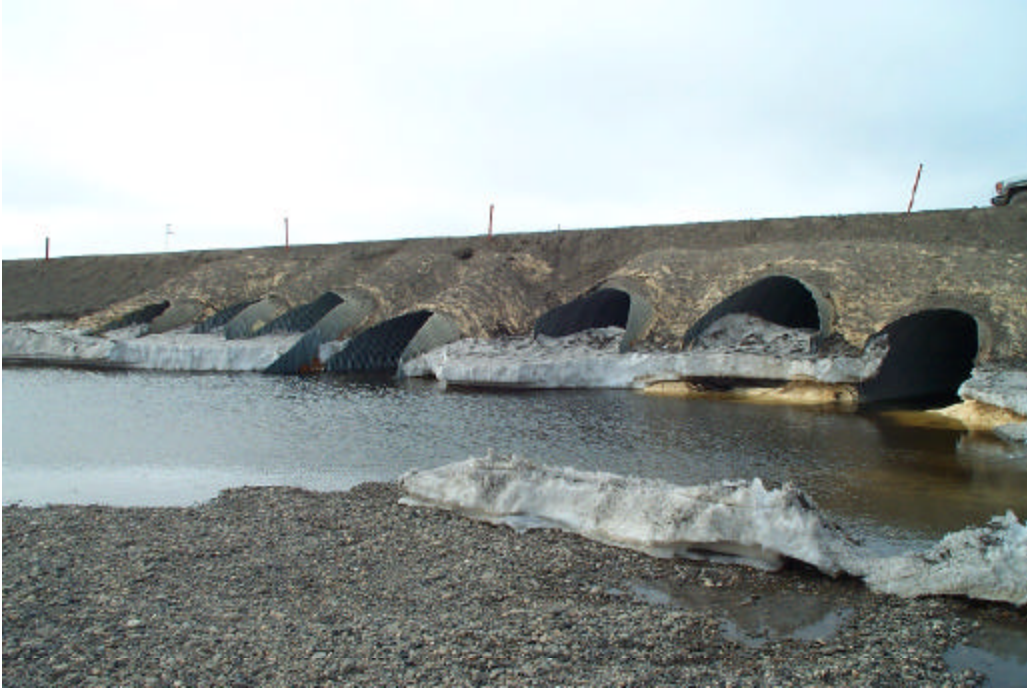
Photo 1 Culverts located in the East Creek in the Spine Road. (6/8/01)

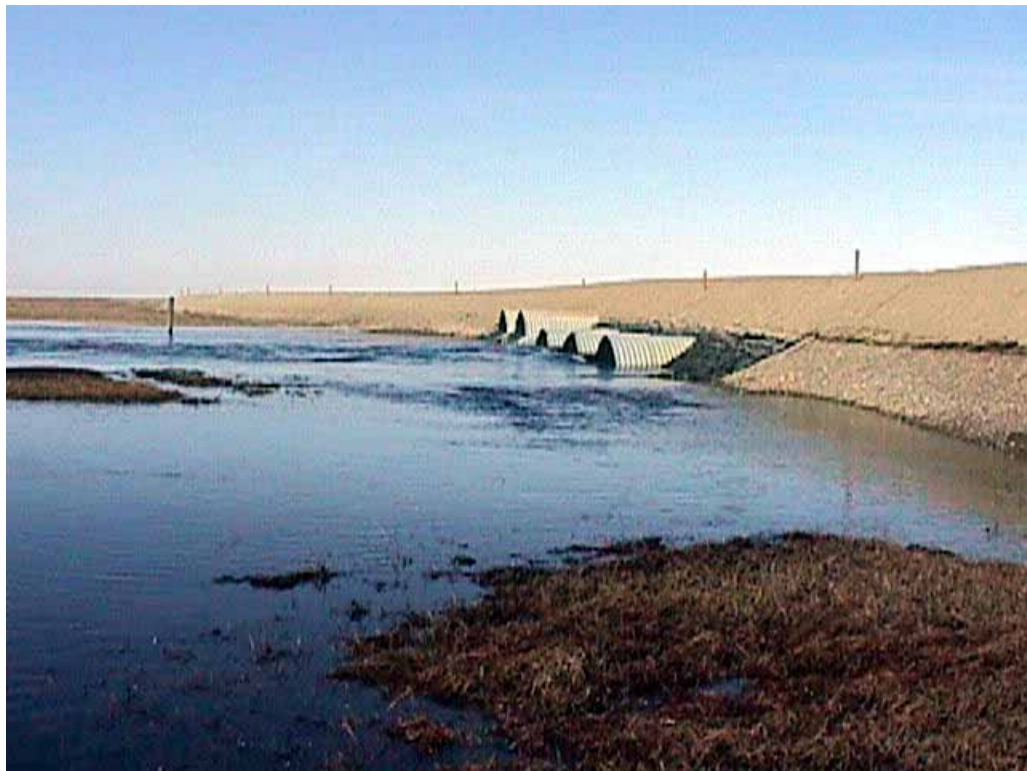
Photo 2 Culverts located in the Prudhoe Bay Unit (WOA) near W pad. (6/16/00)

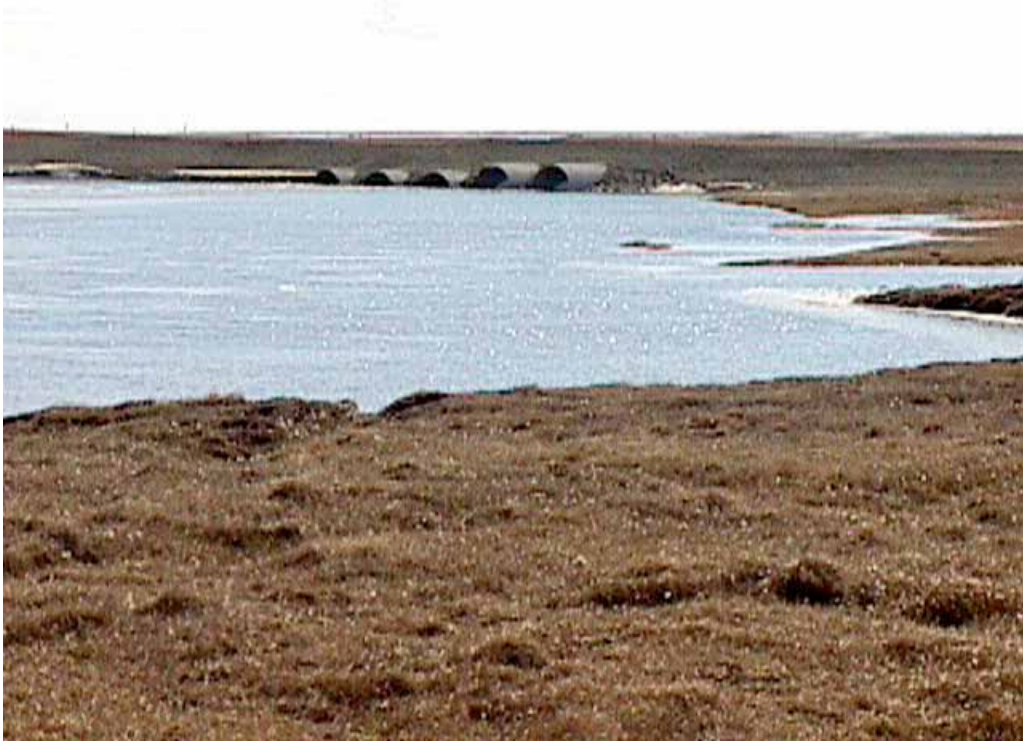
Photo 3 Culverts located in the Prudhoe Bay Unit (WOA) near W pad. (6/16/00)

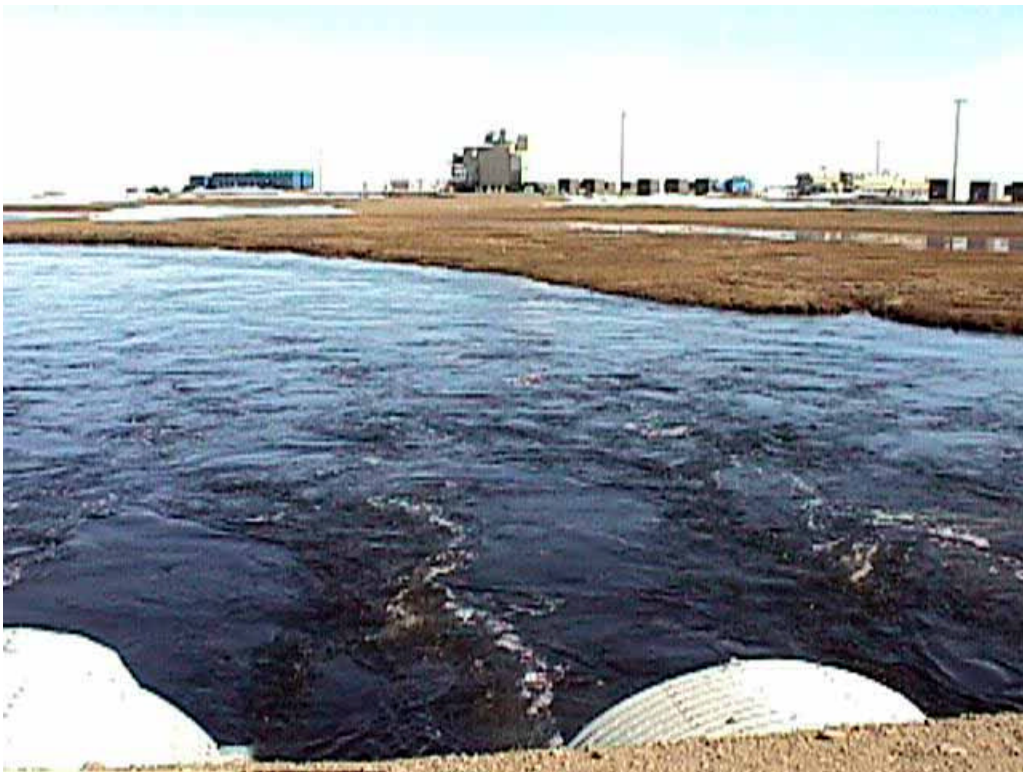
Photo 4 Downstream end of culverts located in the Prudhoe Bay Unit (WOA) near W pad. (6/16/00)

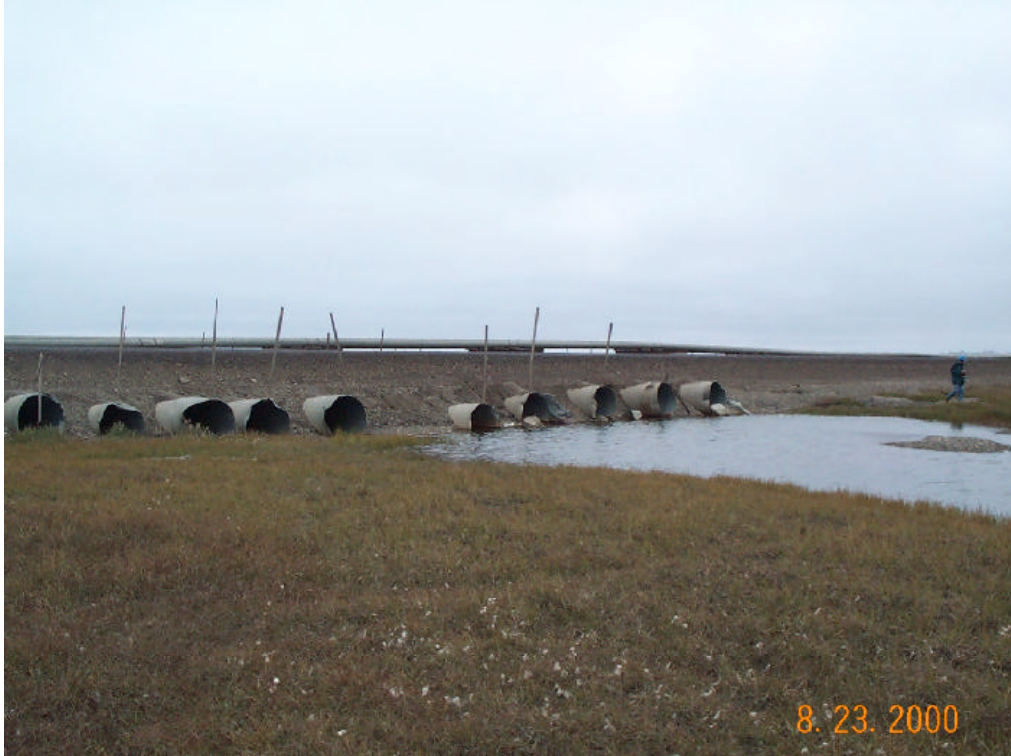
Photo 5 Culverts located in the West Fork of Central Creek in the Spine Road. (8/23/00)

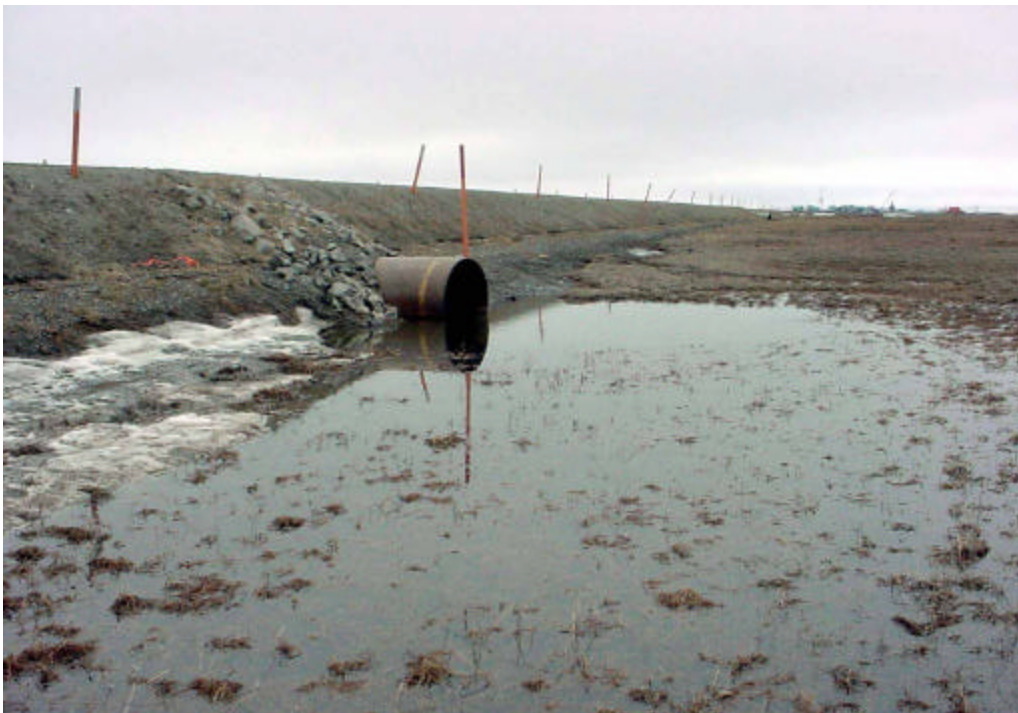
An additional significant difference is that the 48” CD-2 and proposed CD-4 culverts are steel pipe (Photo 6) rather than CMP, as is the case in much of Prudhoe Bay and Kuparuk. This provides increased strength and structural integrity reducing the potential for failure.

Photo 6 Looking east at south side of the CD-2 road near culvert #15. (6/02/04)

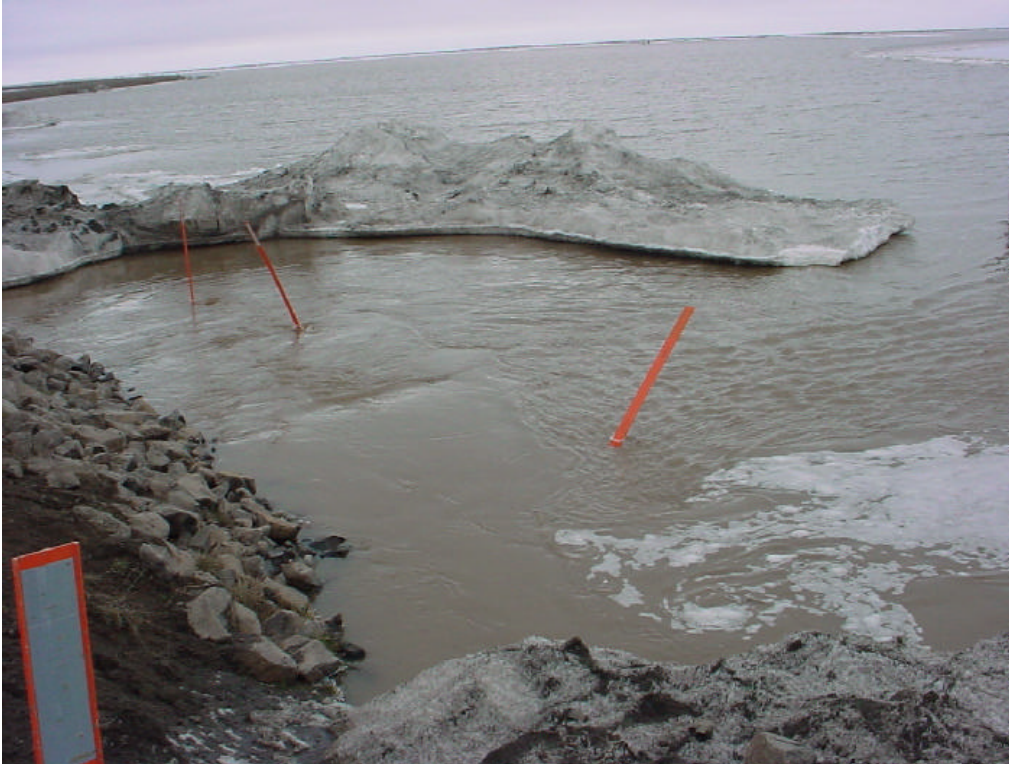
Finally, the hydraulic conditions in the Colville Delta consist of a relatively slow moving overland flood water flow caused by delta wide distribution of spring breakup (Photos 7 – 9). In Kuparuk and Prudhoe Bay, surface water flow is often concentrated in drainages with greater topographical relief than is found near Alpine. The result is higher velocities and increased hydraulic forces subjected onto these culvert systems than the Alpine culverts are subjected to.

Photo 7 Flow conditions on the south (upstream) side of the CD-2 access road for culverts 4, 5, 6, and 7. (5/28/04)

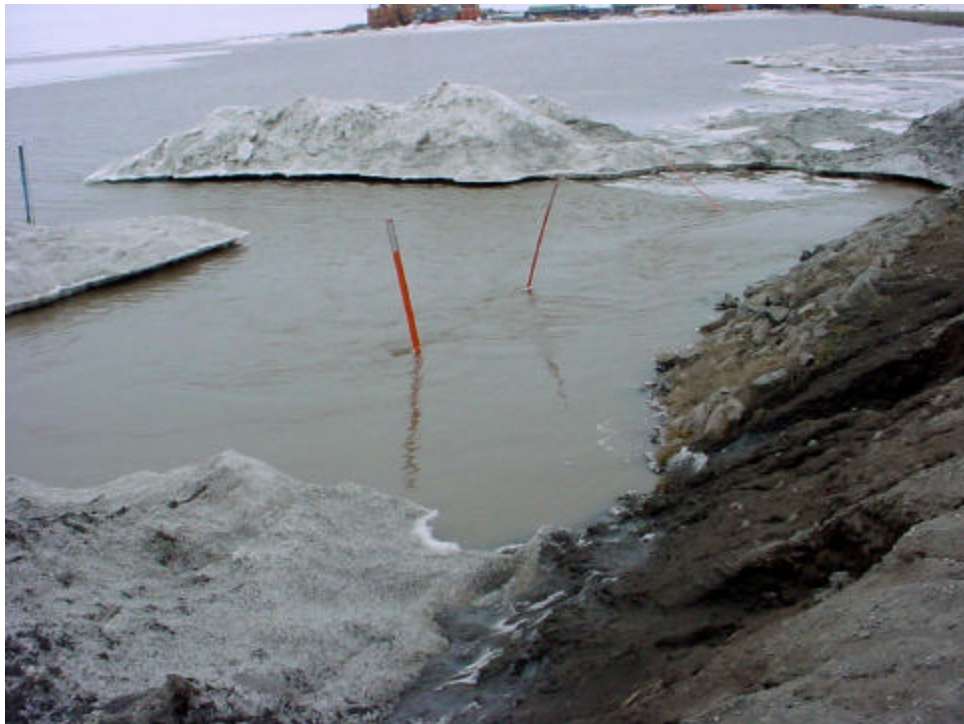
Photo 8 Looking west on south (upstream) side of road at culverts 4, 5, 6 and 7. Picture taken approximately 24 hours after peak stage was observed in the Alpine infield. (5/28/04)

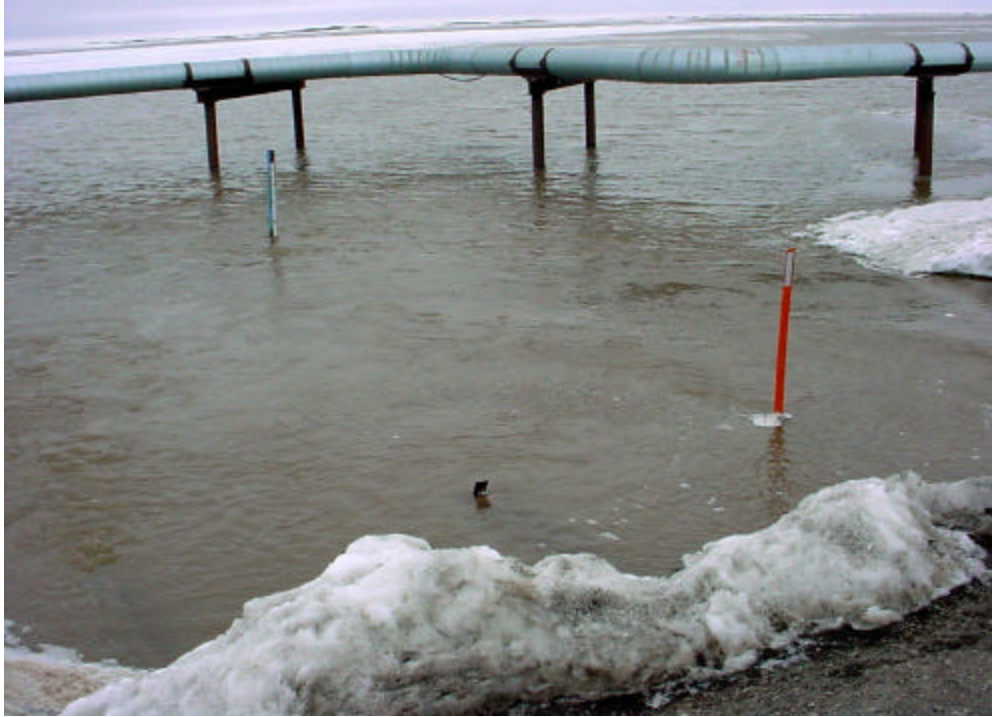
Photo 9 Looking northeast on north (downstream) side of road at culverts 4, 5, 6 and 7. Picture taken approximately 24 hours after peak stage was observed in the Alpine infield. (5/28/04)

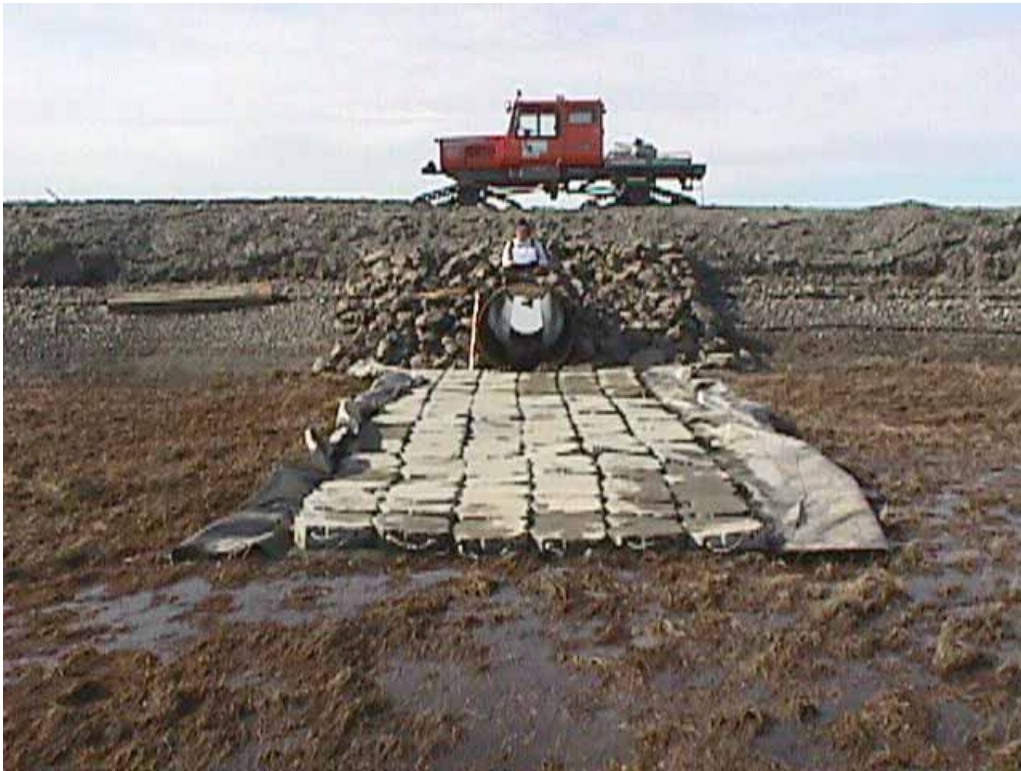
Another difference between the installations is that selected Alpine culverts downstream exits are armored with concrete mat with geotextile underlayment on the tundra (Photo 10). In addition, the Alpine culvert entrances and exits are armored with Rip Rap side slope protection (Photo 11). At Alpine, road sideslope protection includes jute mat, and revegetation (Photo 12). These erosion control systems are not typical in the Kuparuk and Prudhoe Bay area and provide further protection against wash out or failure.

Photo 10 Looking south at the north end of culvert #2. (6/18/00)

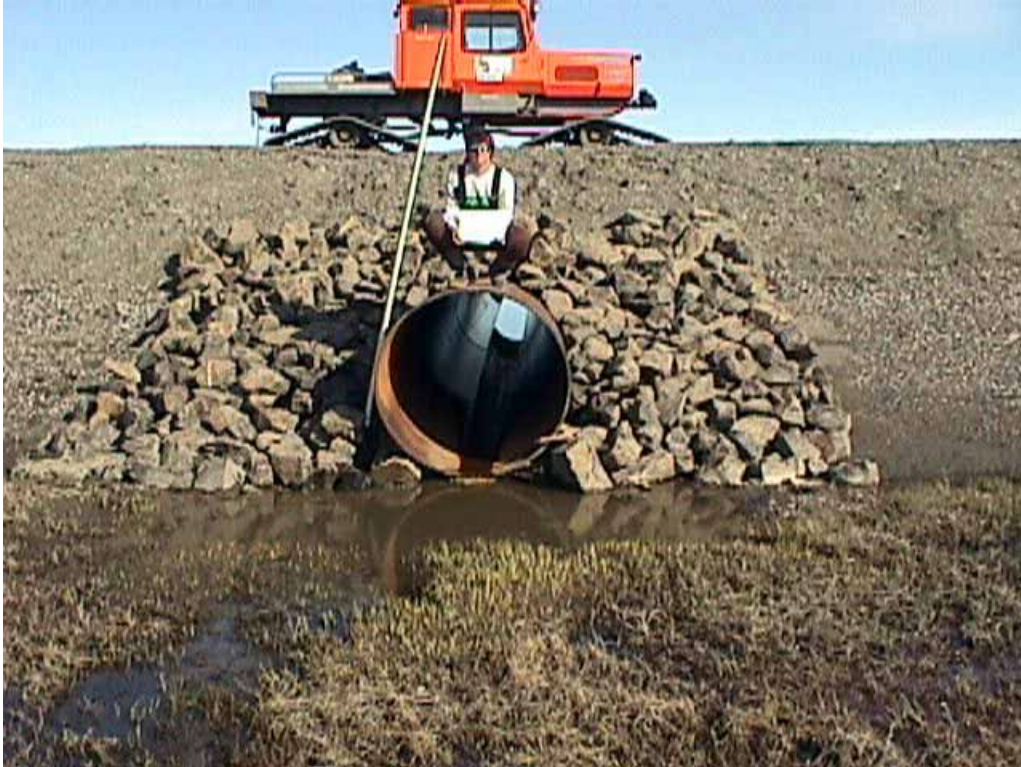
Photo 11 Looking north at the south end of culvert #4. (6/18/00)

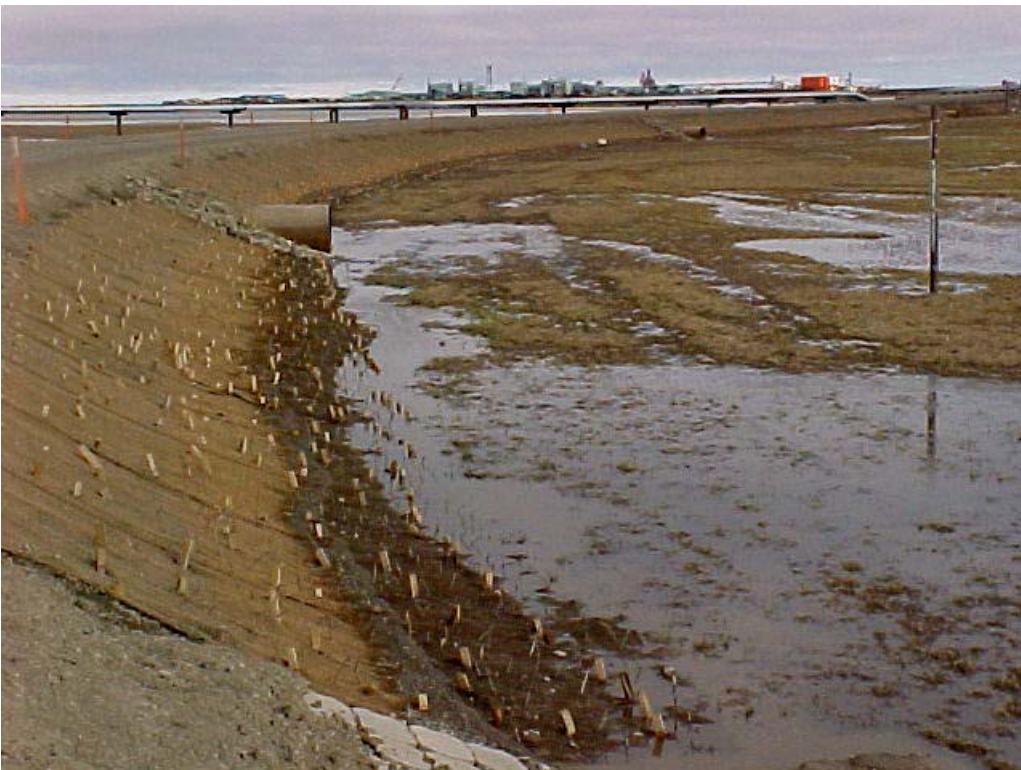
Photo 12 Facing east along the south side of the CD-2 access road from culvert #22. Looking at culverts #23 and #24. (5/31/02)
