Alpine Pipeline HDD Crossing

2007 Monitoring Report

ConocoPhillips

111620-MBJ-RPT-001

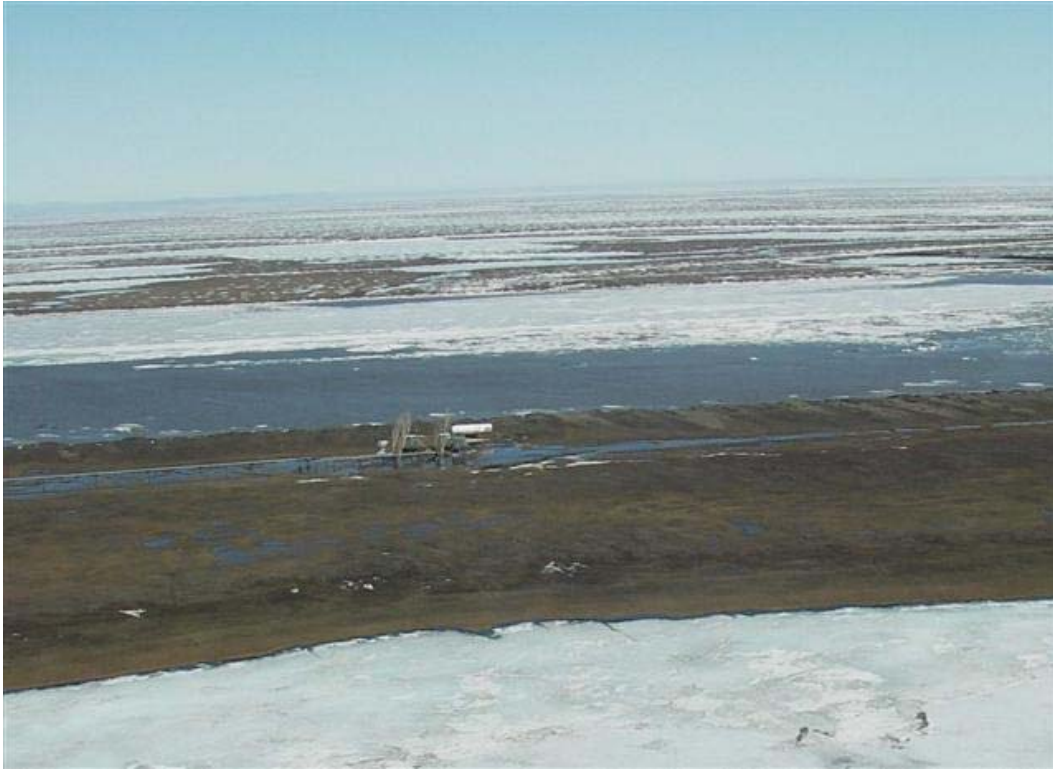
Photo A-1 HDD West, June 3, 2007. HDD West (foreground) 1 day before peak stage, looking east across Colville River.

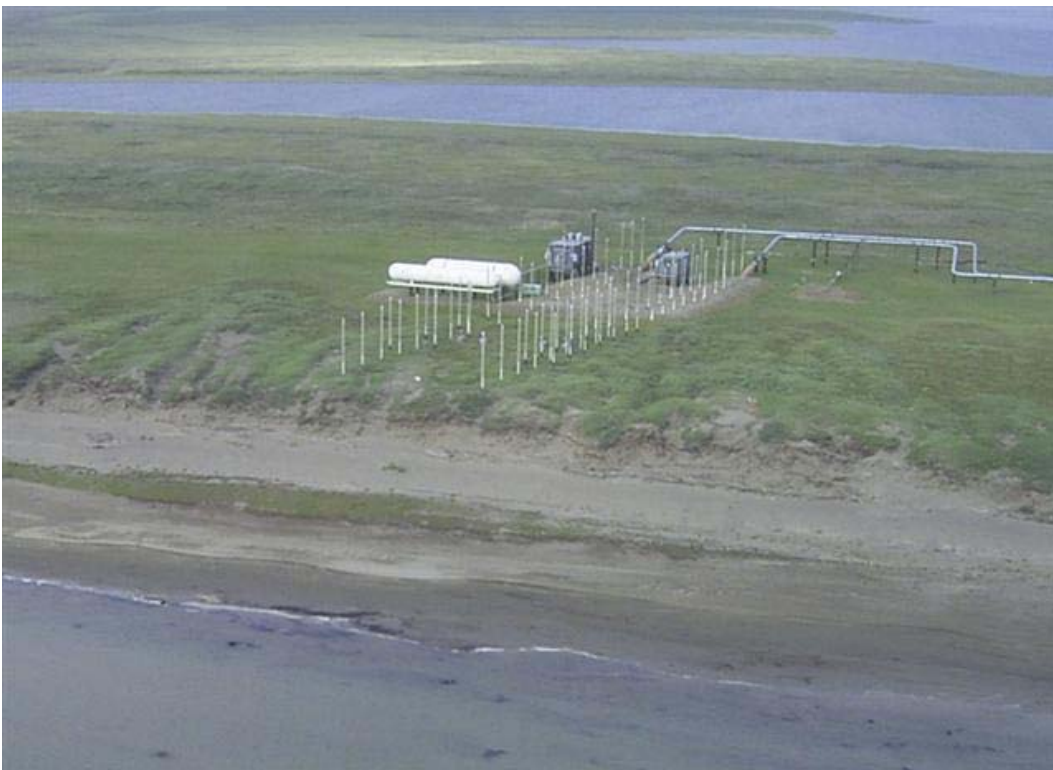
Photo A-2 HDD West, July 18, 2007. Bluff, thermosyphons, and pad at HDD West, looking west.

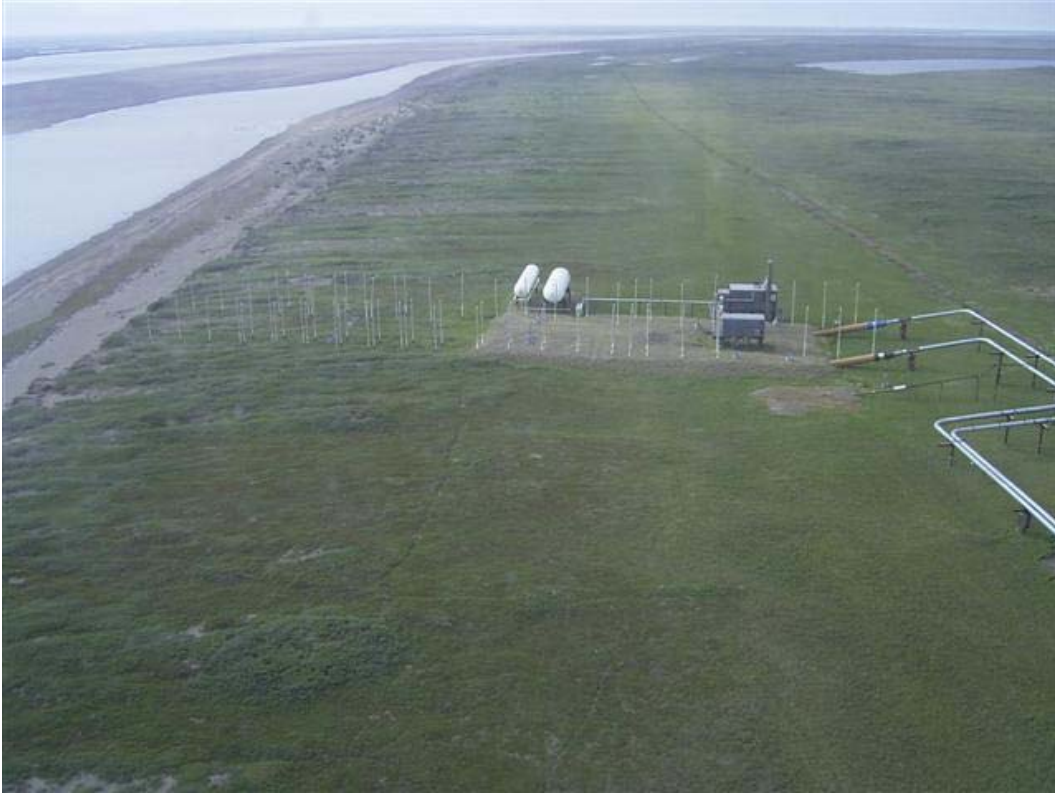
Photo A-3 HDD West, July 18, 2007. Bluff, thermosyphons, pad and pipeline at HDD West, looking south.

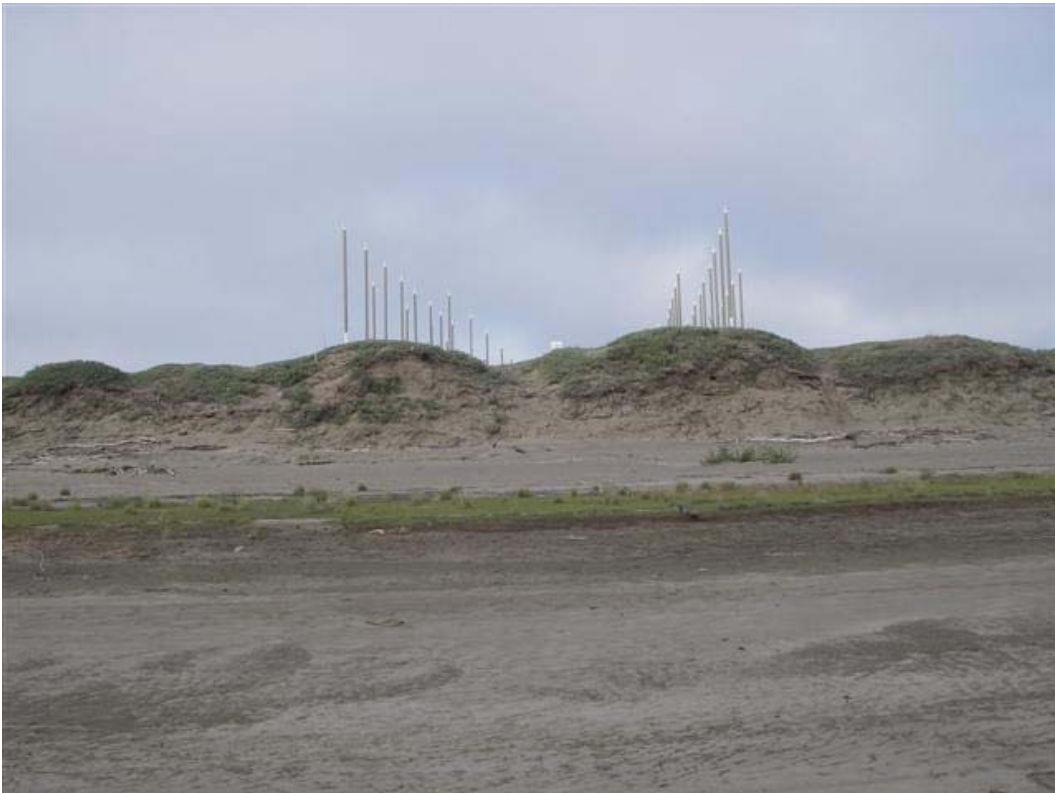
Photo A-4 HDD West, July 18, 2006. Bluff and thermosyphon at HDD West, looking west from Colville River.

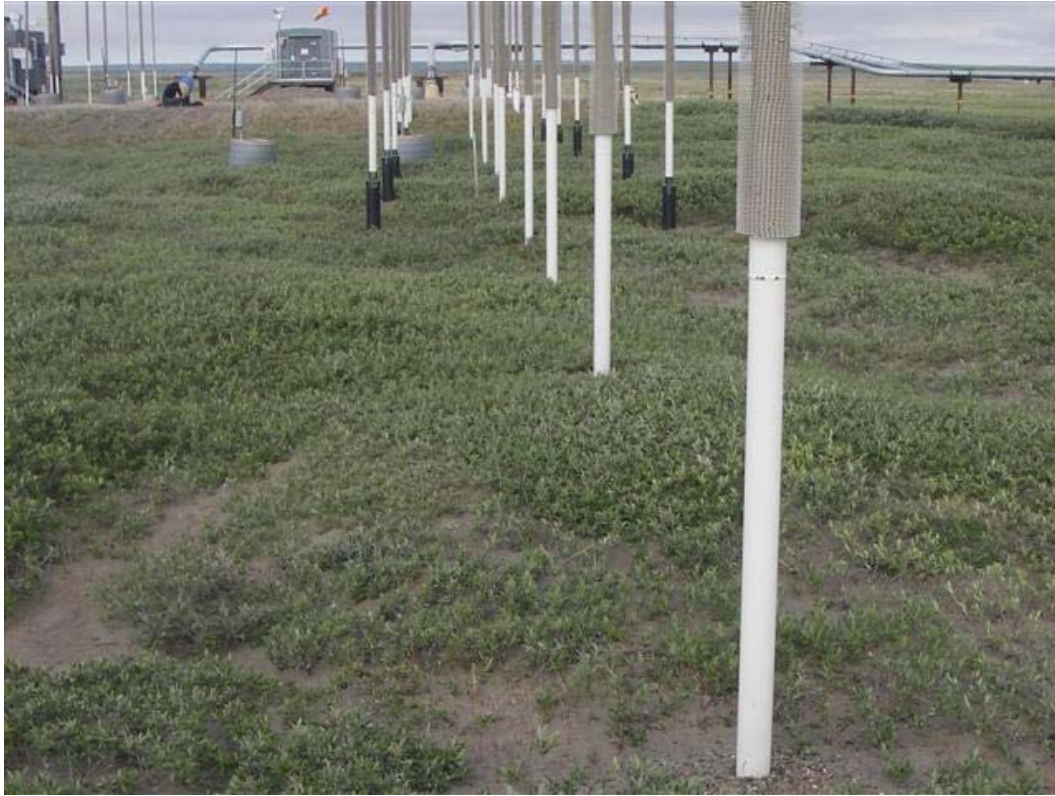
Photo A-5 HDD West, July 18, 2007. Thermosyphons, pads, and facilities at HDD West, looking west.

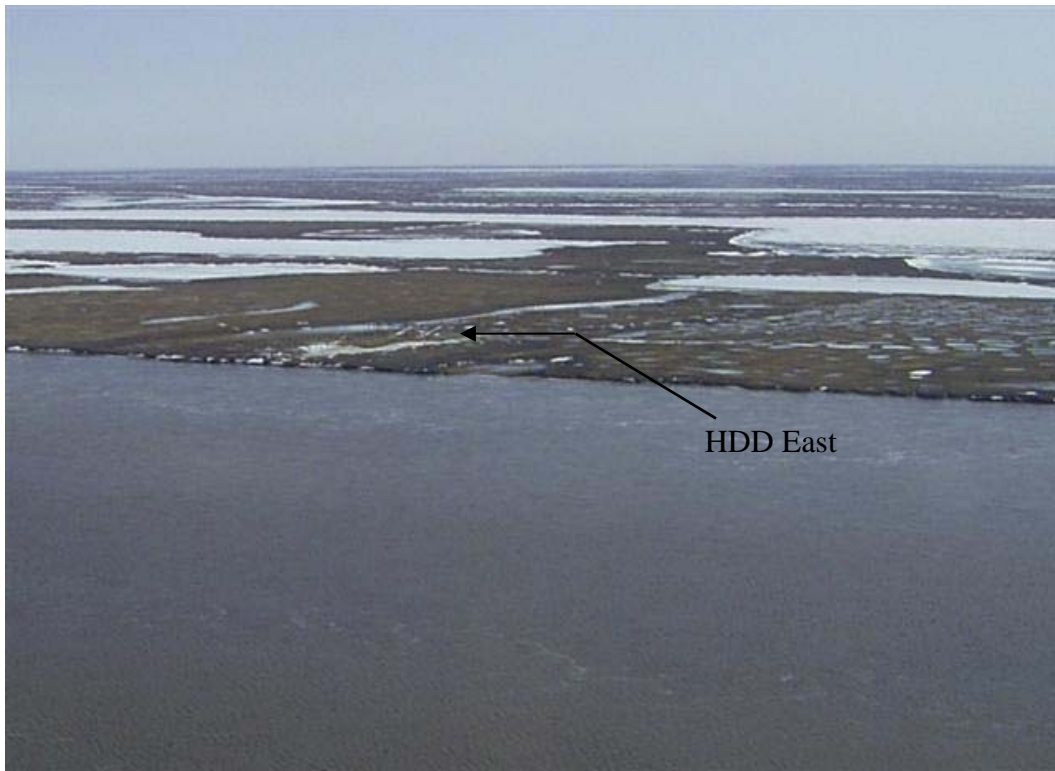
The east bank of the Colville River HDD crossing was evaluated by visual inspection, review of ground and aerial photography (**Photo A-6 through Photo A-10, Appendix A**), and field surveys. The 2007 Colville River breakup floodwaters were not observed above the river bank and there were no signs of major erosion along the east bank of the HDD crossing. Shore-fast ice upstream and downstream of the alignment (**Photo A-6, Appendix A**) was intact until June 4.

Photo A-6 HDD East, June 6, 2007. Bluff, thermosyphons, pad, and pipeline at HDD East 2 days after peak stage, looking east.

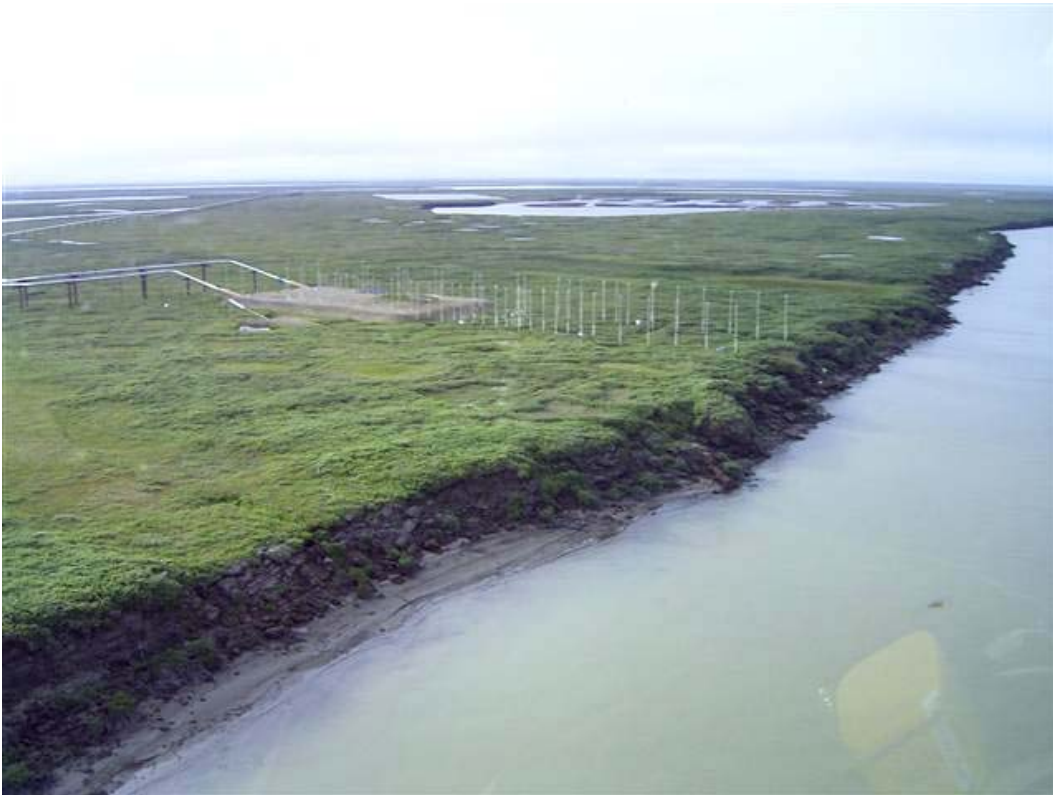
Photo A-7 HDD East, July 18, 2007. Bluff, thermosyphons, and pad at HDD East, looking southeast.

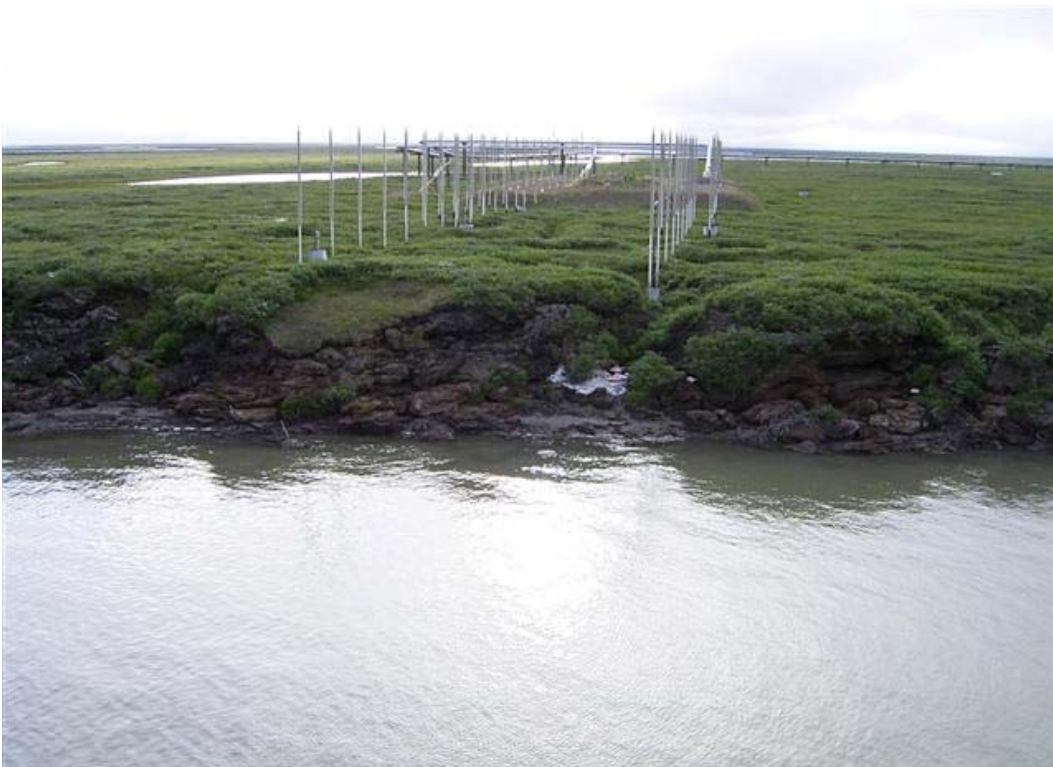
Photo A-8 HDD East, July 18, 2007. Bluff, thermosyphons, pad, and pipeline at HDD East, looking east.

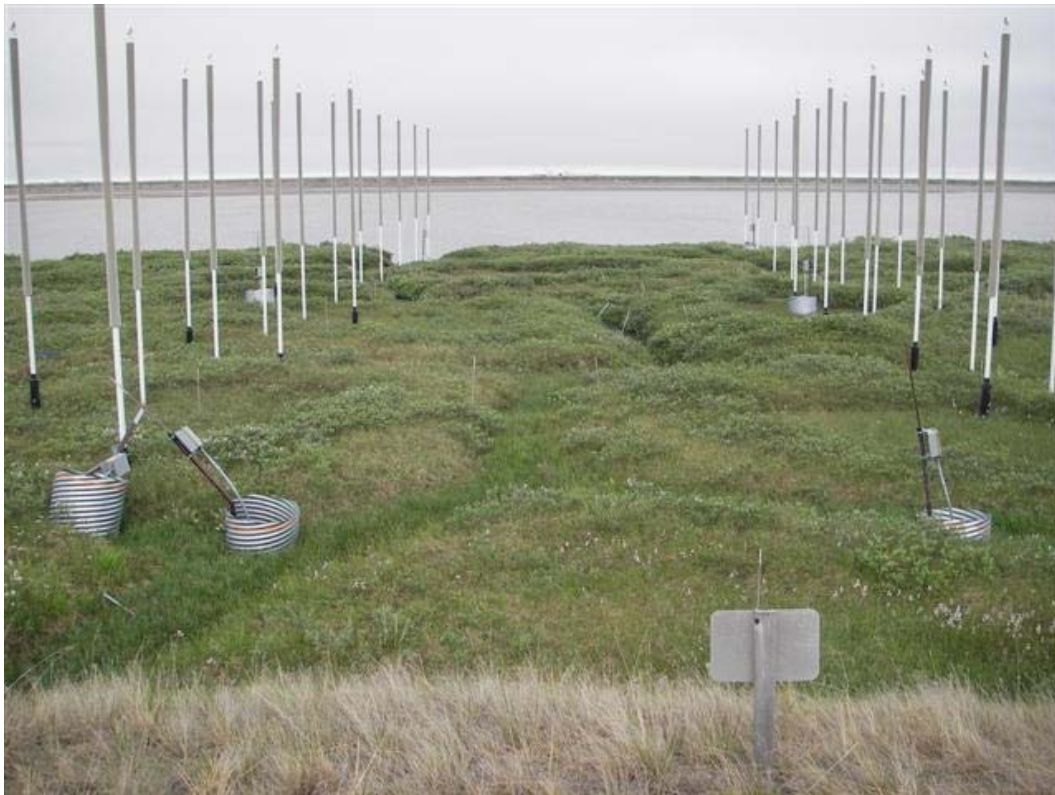
Photo A-9 HDD East, July 18, 2007. Thermosyphons and polygon trough at HDD East, looking west.

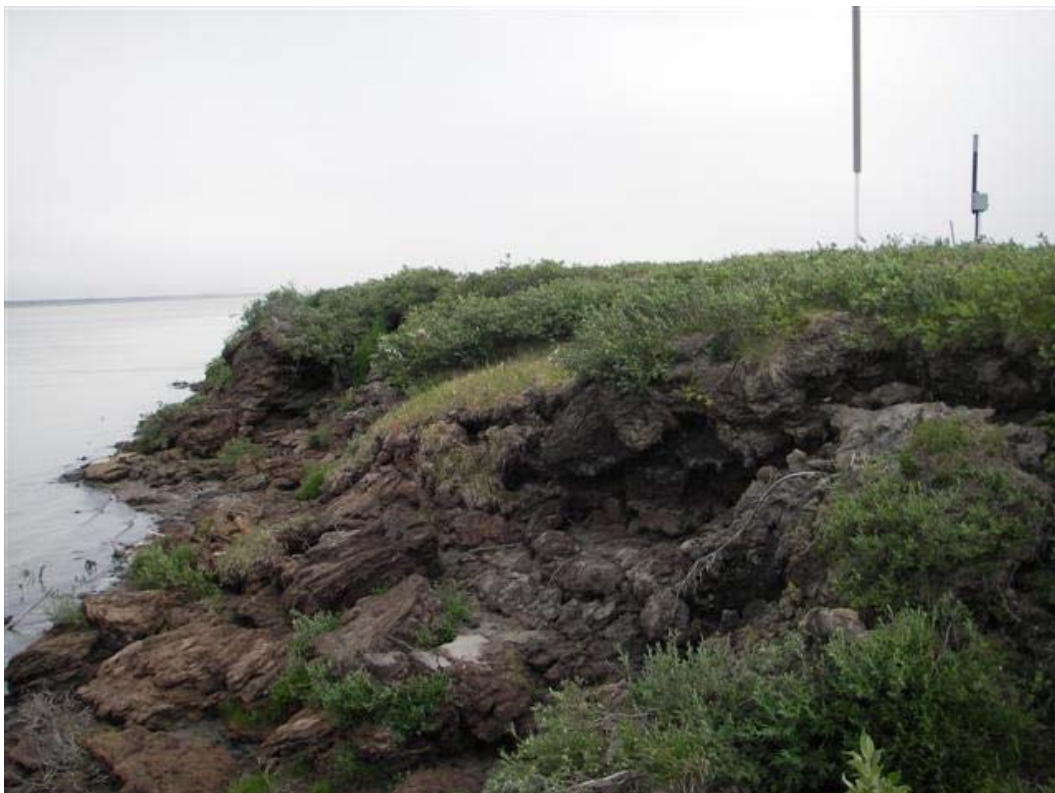
Photo A-10 HDD East, July 18, 2007. Bluff and northern thermosyphons at HDD East, looking north.

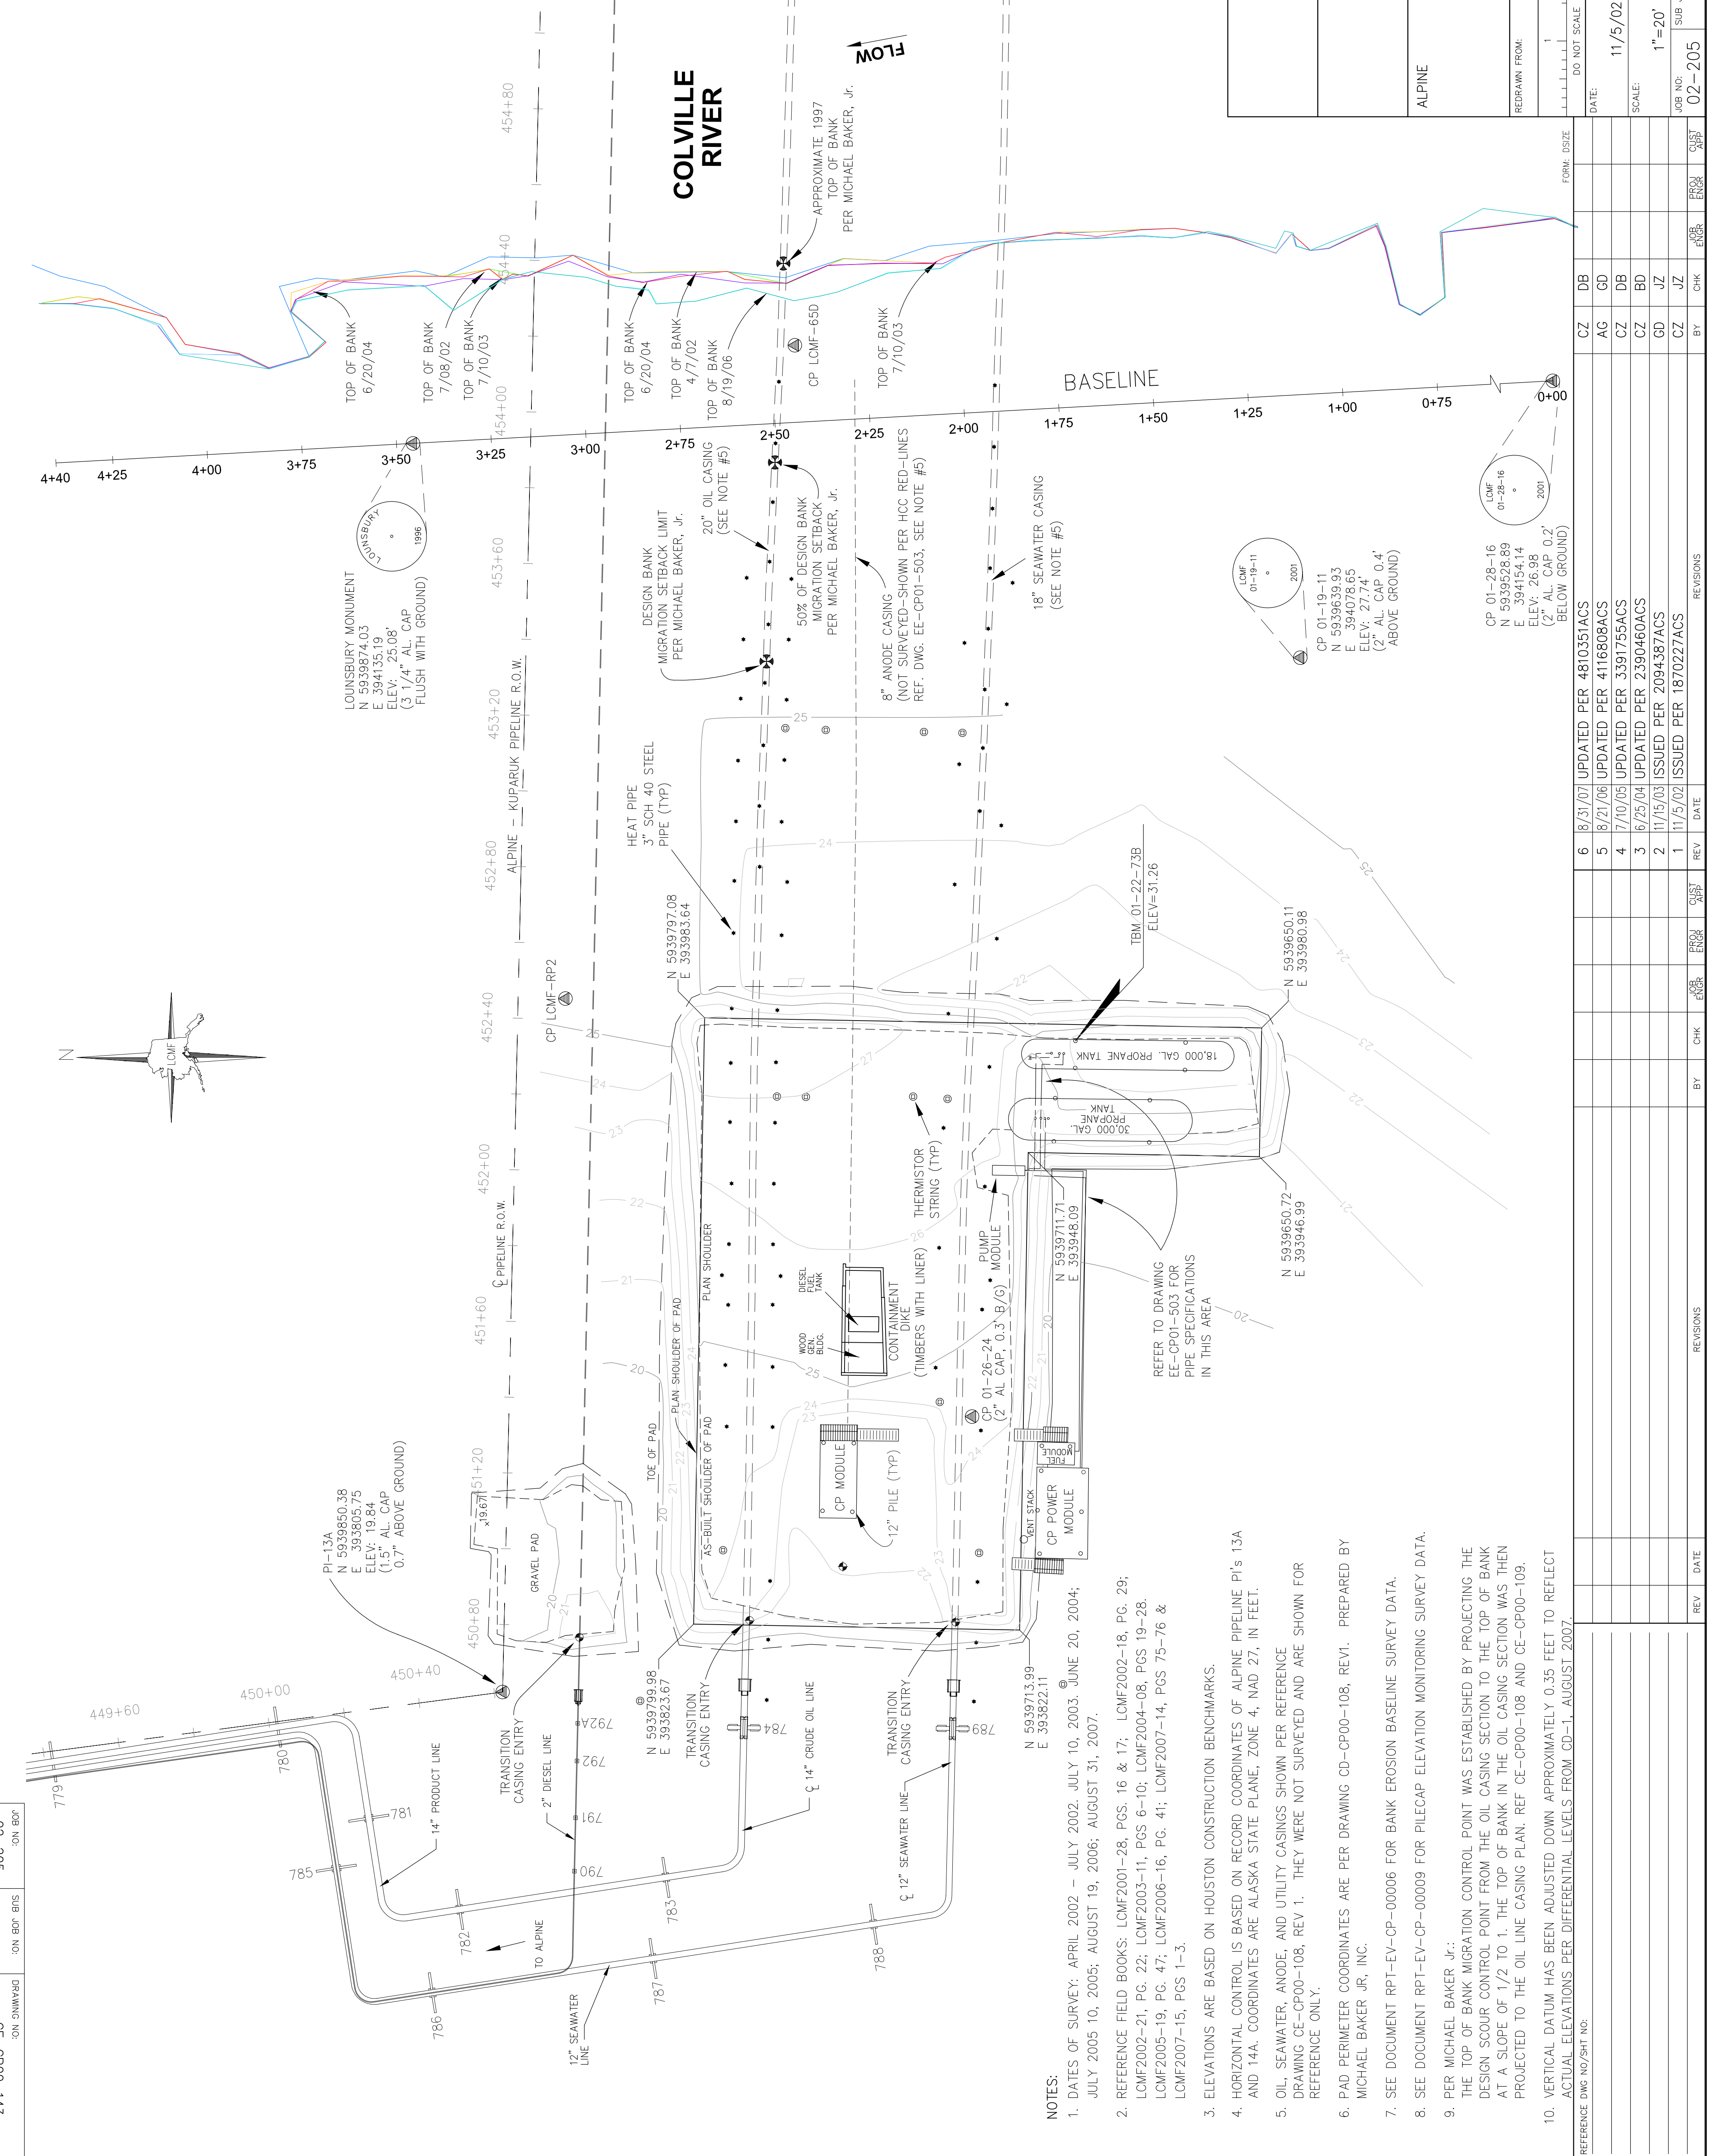
The greatest bank erosion observed between the 2006 and 2007 monitoring events was 1.0 feet, occurring approximately 150 feet downstream of the pipeline centerline.

A maximum erosion of 18.7 feet, between April 2002 and August 2007, has been measured along the top of bank at a single location 120 feet north of the NPS 14 oil pipeline centerline. This yields a maximum average rate of 3.5 feet/year over the monitoring period. The average rate of erosion along the 440-foot top of bank was measured to be 0.6 feet/year. A summary of the LCMF surveying results for the HDD West Bank crossing is presented in **Appendix B**. The measured average annual rate of bank erosion is less than the observed long-term historic average rate of 0.8 feet/year, and less than the estimated maximum erosion rate used for design of 2.3 feet/year (Baker 1997).

Approximately 9.0 feet of bank erosion at the NPS 14 oil pipeline centerline has occurred since 1997 (0.9 feet/year) based on a comparison of 2007 survey data and the 1997 scour control point (**Appendix B**). The observed bank erosion at the NPS14 oil centerline equals approximately 9% of the design setback as of 2007. The west bank erosion has not yet reached the 50% design setback; however, if either bank “migrates 50% of the design setback, erosion rates or possible mitigation measures will be evaluated” (Baker 1999).

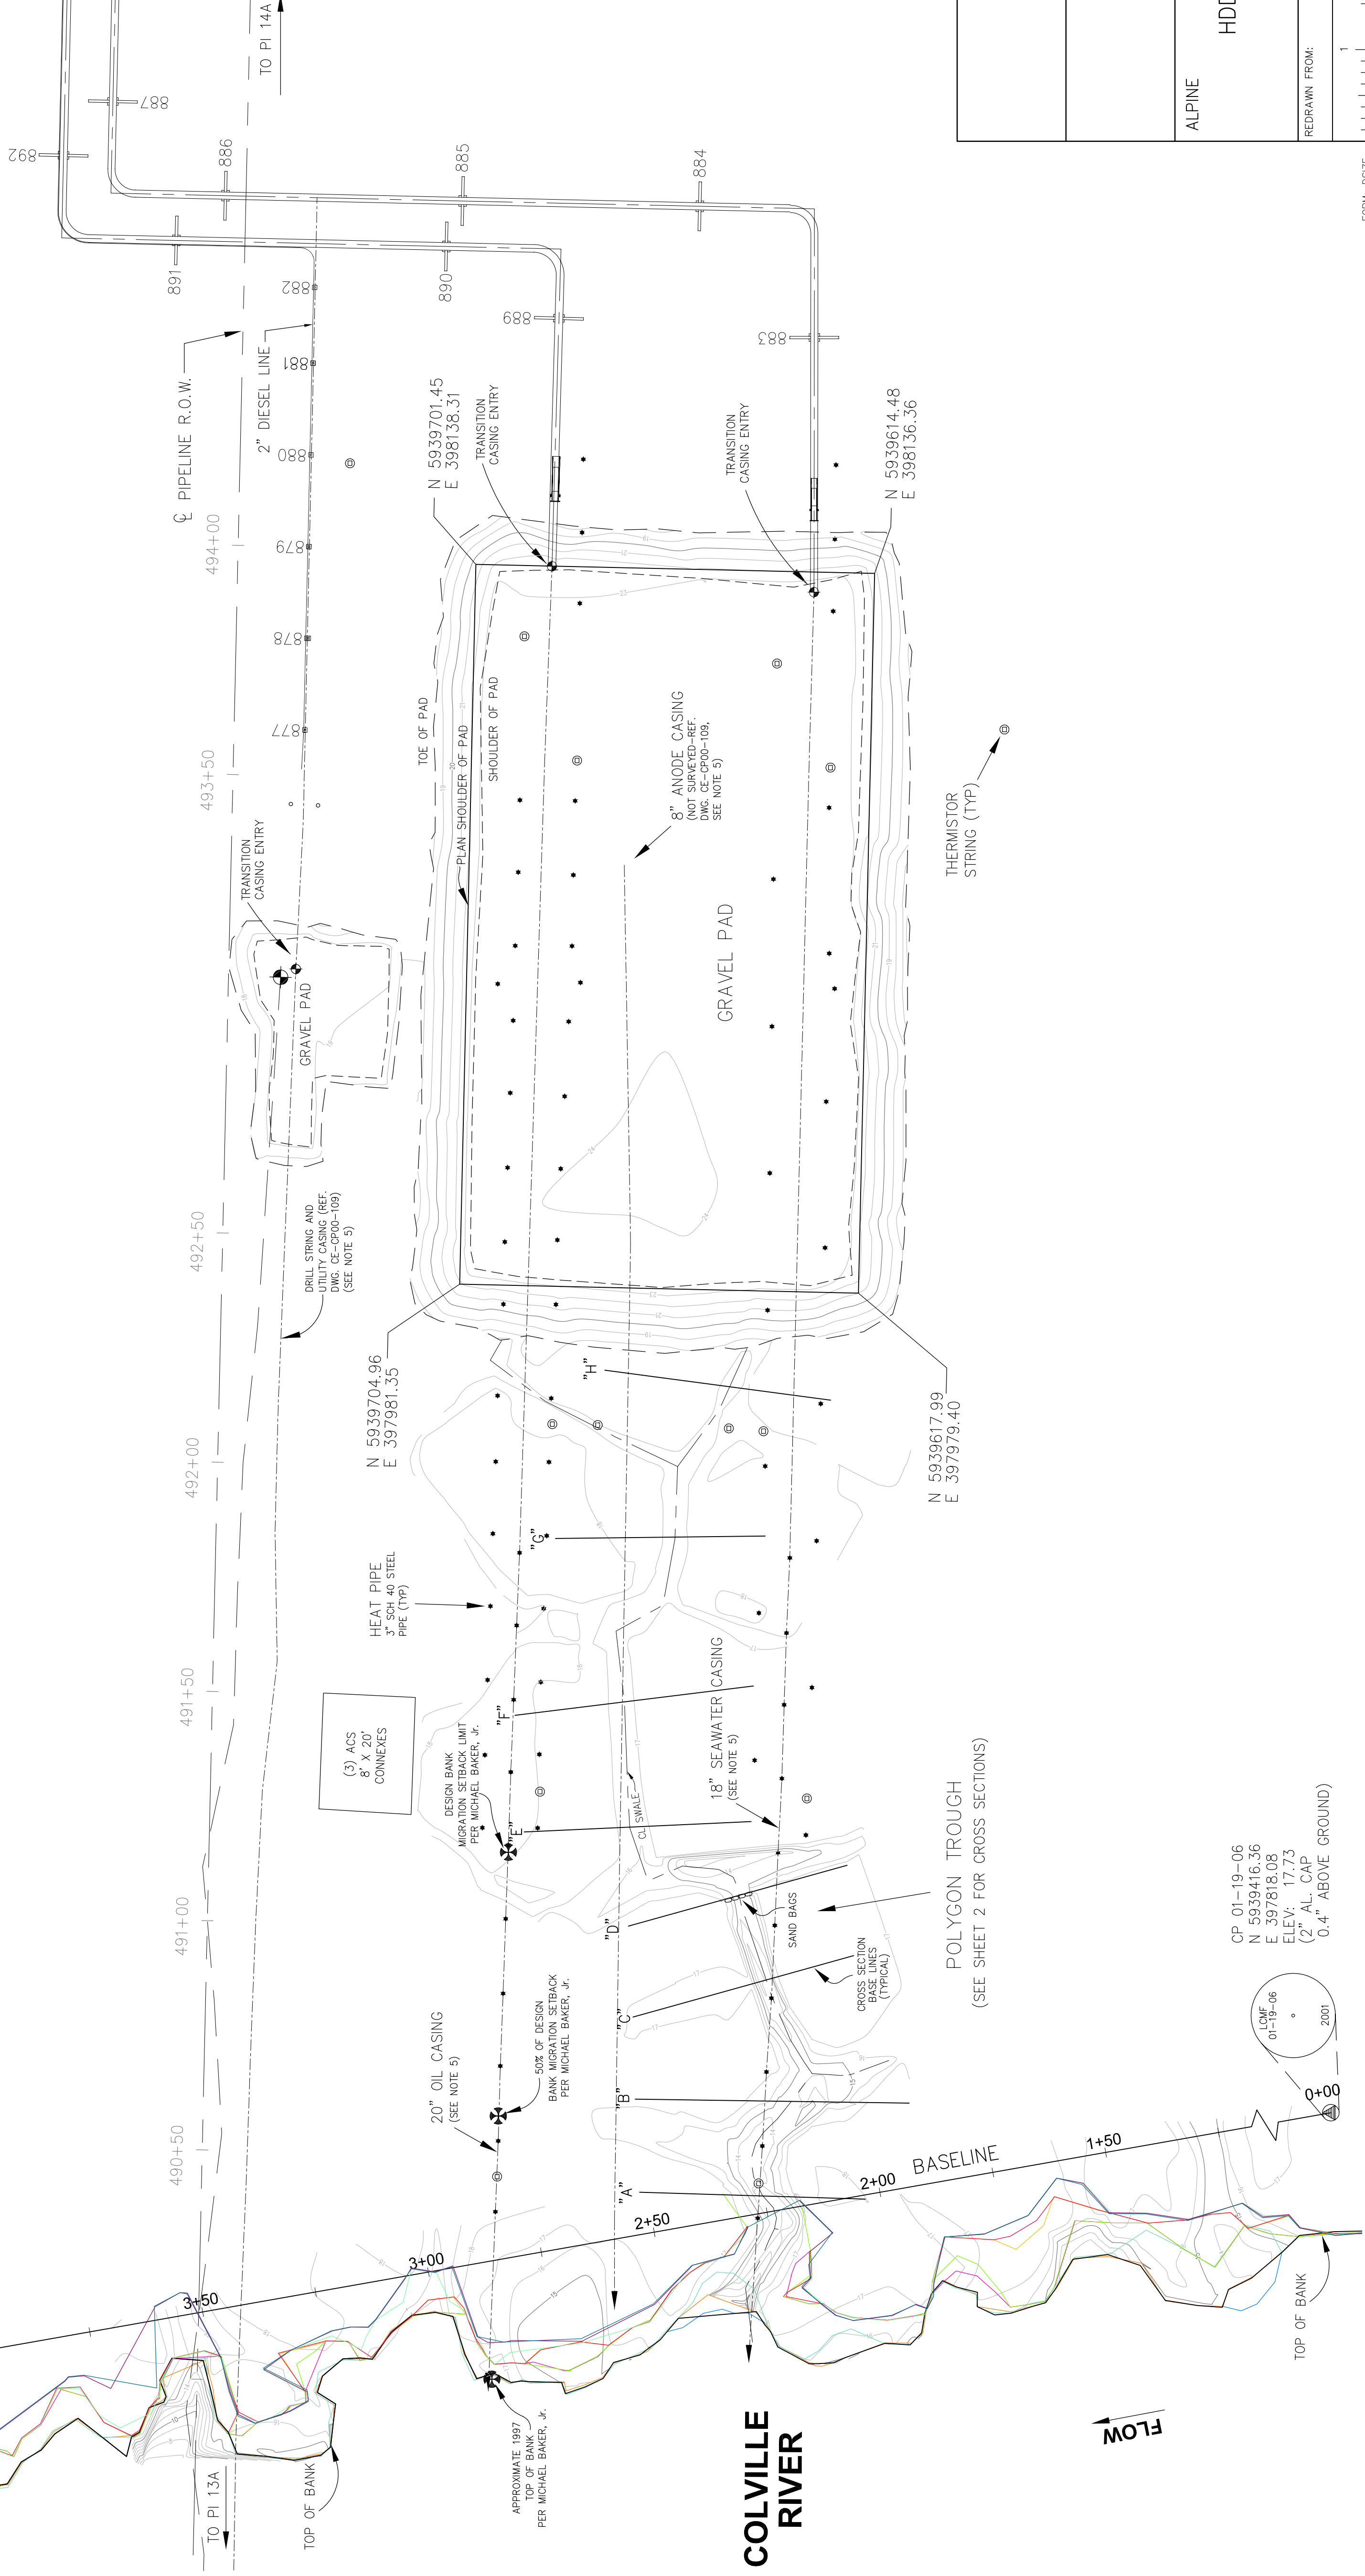
The greatest bank erosion observed between the 2006 and 2007 monitoring events was 4.2 feet over the seawater pipeline, occurring approximately 110 feet downstream of the oil pipeline centerline.

A maximum erosion of 31.0 feet, between October 2001 and August 2007, has been measured along the top of bank at a single location 110 feet south of the NPS 14 oil pipeline centerline. This yields a maximum average rate of 6.2 feet/year over the monitoring period. The average rate of erosion along the 335-foot top of bank was measured to be 2.1 feet/year. A summary of the LCMF surveying results for the HDD East Bank crossing is presented in **Appendix C**. The measured average annual rate of east bank erosion is greater than the observed long-term historical average rate of 1.5 feet/year, but less than the estimated maximum erosion rate used for design of 2.5 feet/year (Baker 1997).

Approximately 8.8 feet of bank erosion at the NPS 14 oil pipeline centerline has occurred since 1997 (0.9 feet/year) based on a comparison of 2007 survey data and the 1997 scour control point (**Appendix C**). As of 2007, the observed bank erosion equals approximately 8% of the design setback which is less than was estimated in 1997. The east bank erosion has not yet reached the 50% design setback; however, if the bank “migrates 50% of the design setback, erosion rates or possible mitigation measures will be evaluated” (Baker 1999).

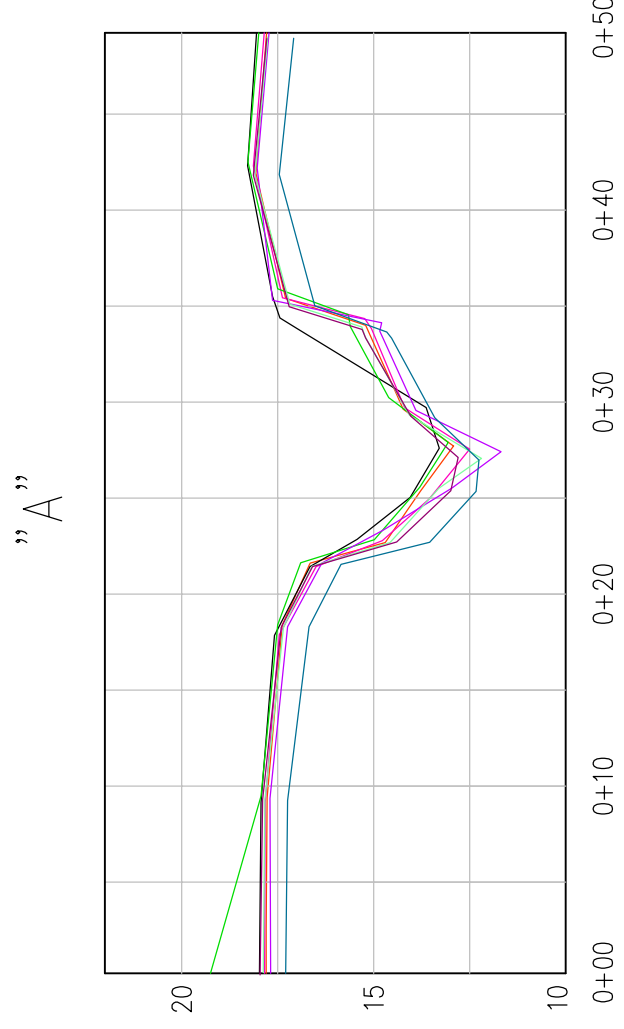
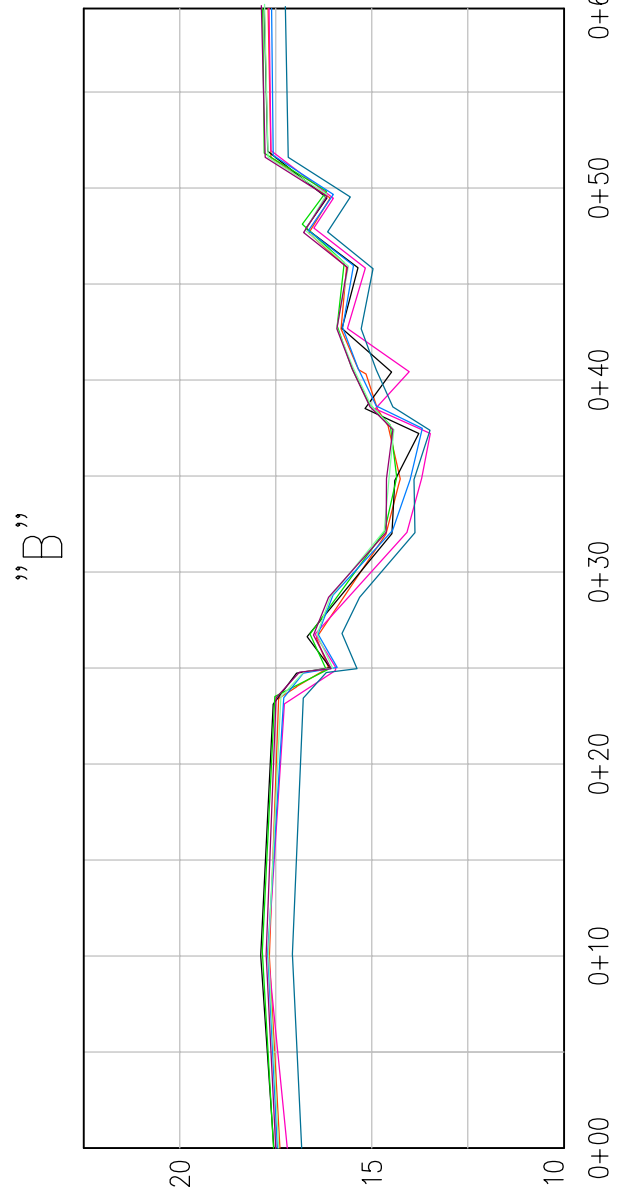
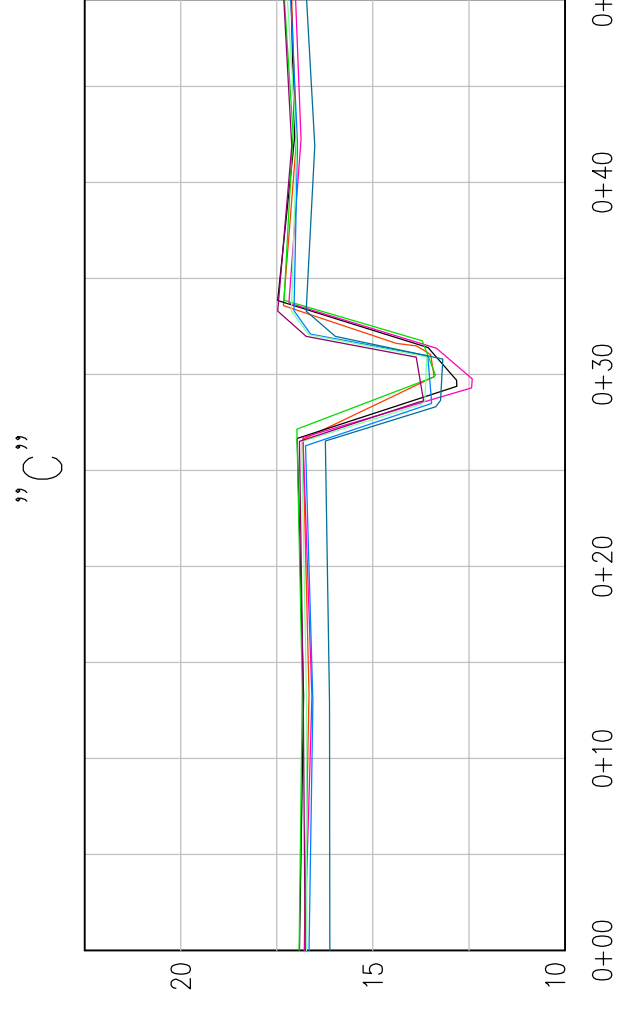
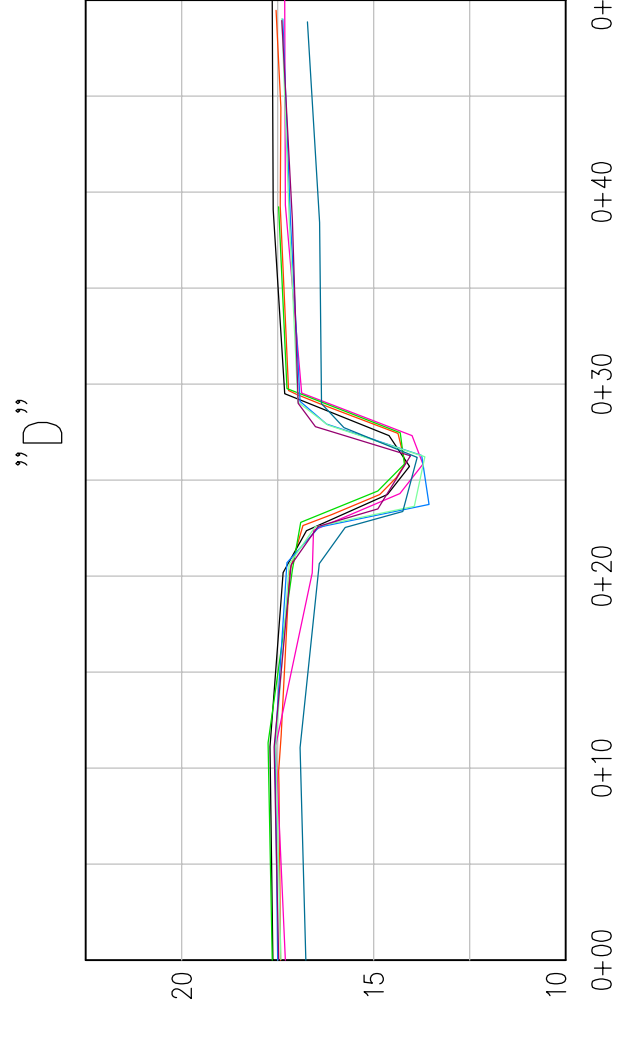
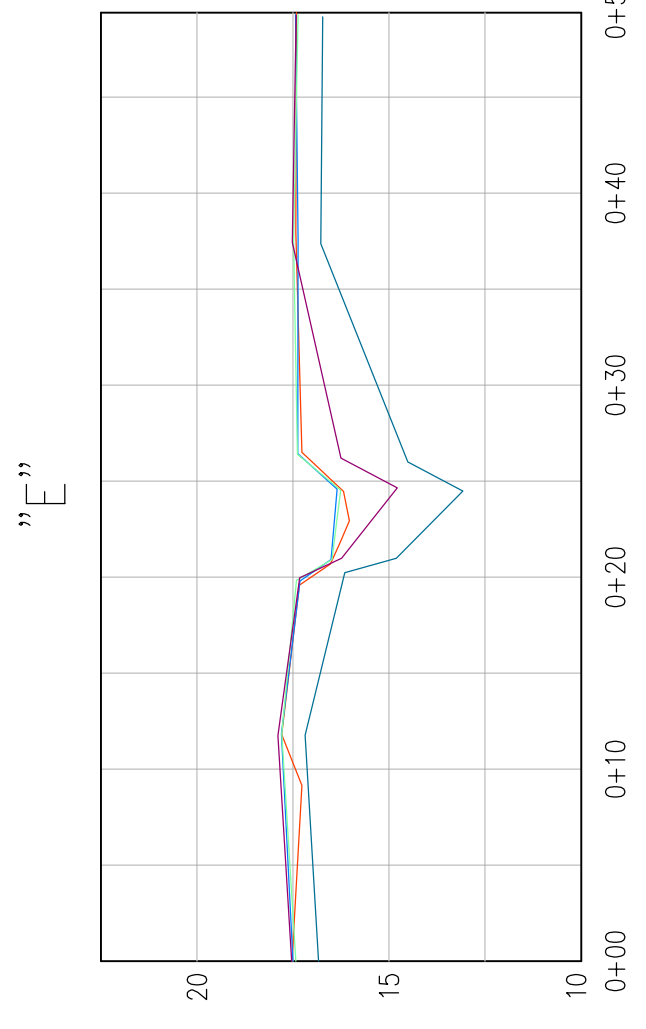
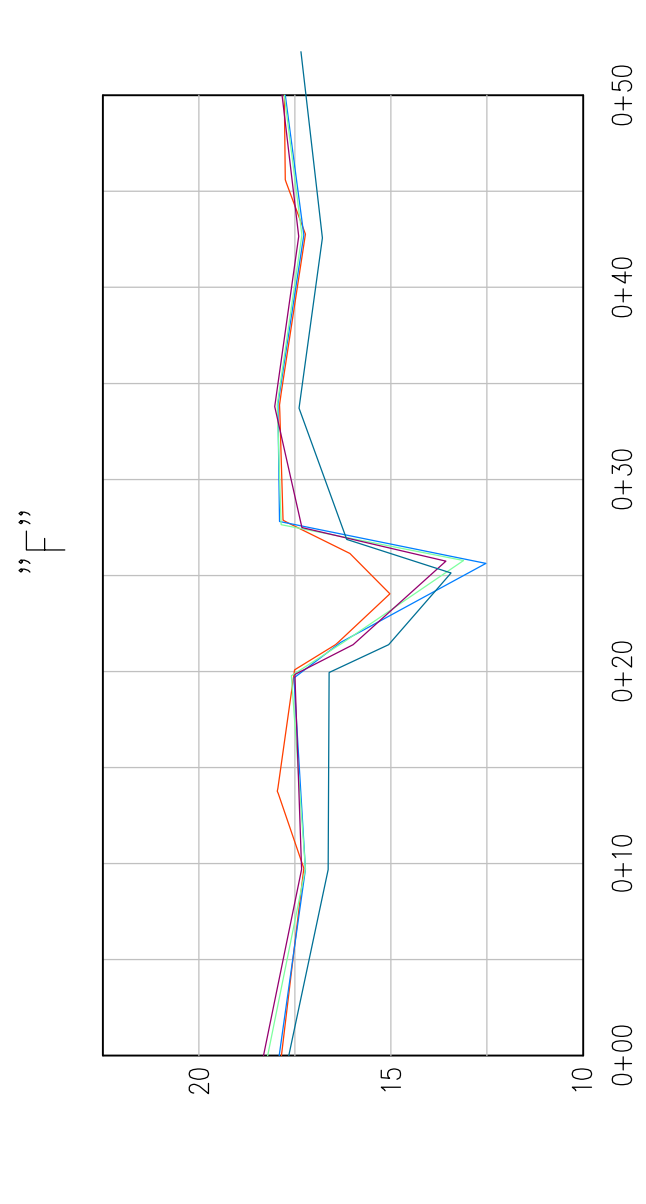
CROSS SECTIONS, POLYGON TROUGH

In addition to bank erosion surveys, subsidence monitoring has been conducted at eight cross sections of the polygon trough since 2001. The cumulative subsidence at each of the cross sections is generally less than one foot (**Appendix C**). Cross Section E has a cumulative subsidence of 1.7 feet at the polygon trough centerline, dropping 0.4 feet since 2006.
