**COLVILLE RIVER DELTA
SPRING BREAKUP
2010 HYDROLOGIC
ASSESSMENT**

Colville River Delta Spring Breakup

2010 Hydrologic Assessment

119863-MBJ-RPT-001
November 2010

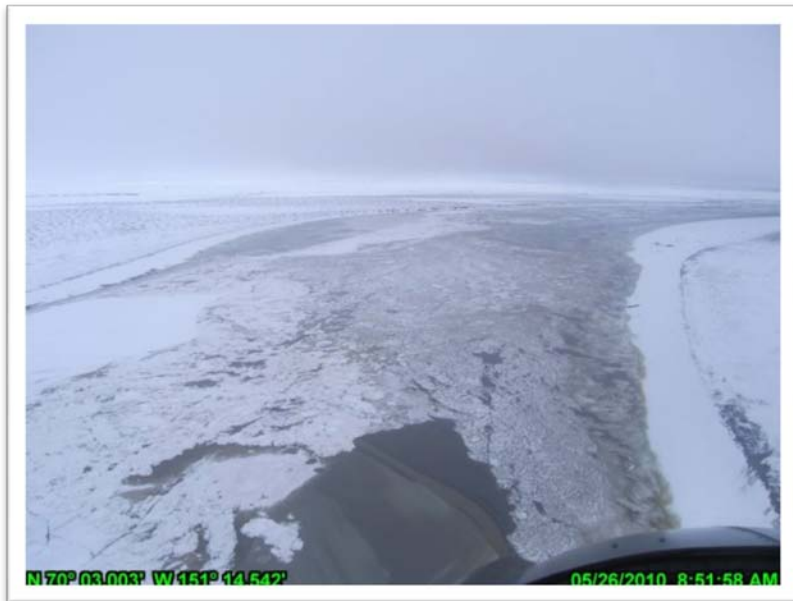
Photo 4.5: Ice floes upstream from MON1; May 26, 2010.

During reconnaissance flights on May 25 and May 26, rafted ice observed from MON1 upstream towards the Anaktuvuk confluence indicate some ice jamming had been occurring in that area since early on May 24. Photo 4.5, taken on May 26, shows an ice jam located approximately 18 miles upstream from MON1U, and approximately 46 miles downstream of the Anaktuvuk confluence. Evidence suggests this small ice jam released during the morning of May 24, as low velocity flows and discontinuous areas of open water were observed at MON1 soon after on the morning of May 26.

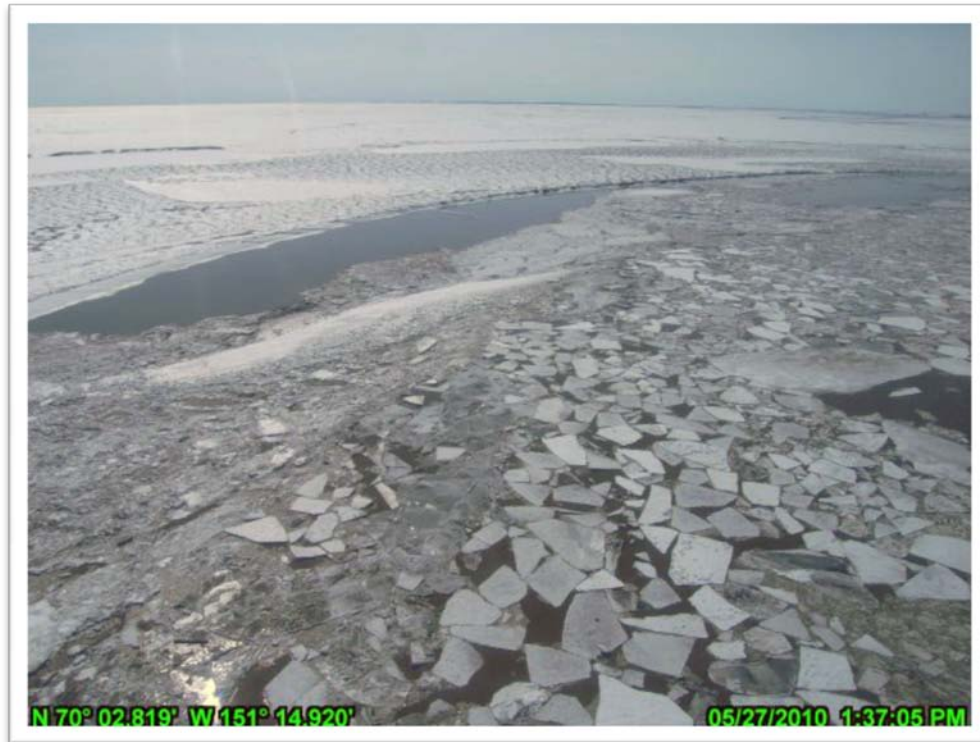
Photo 4.6: Ice floes jamming 14.6 miles upstream from MON1; May 27, 2010.

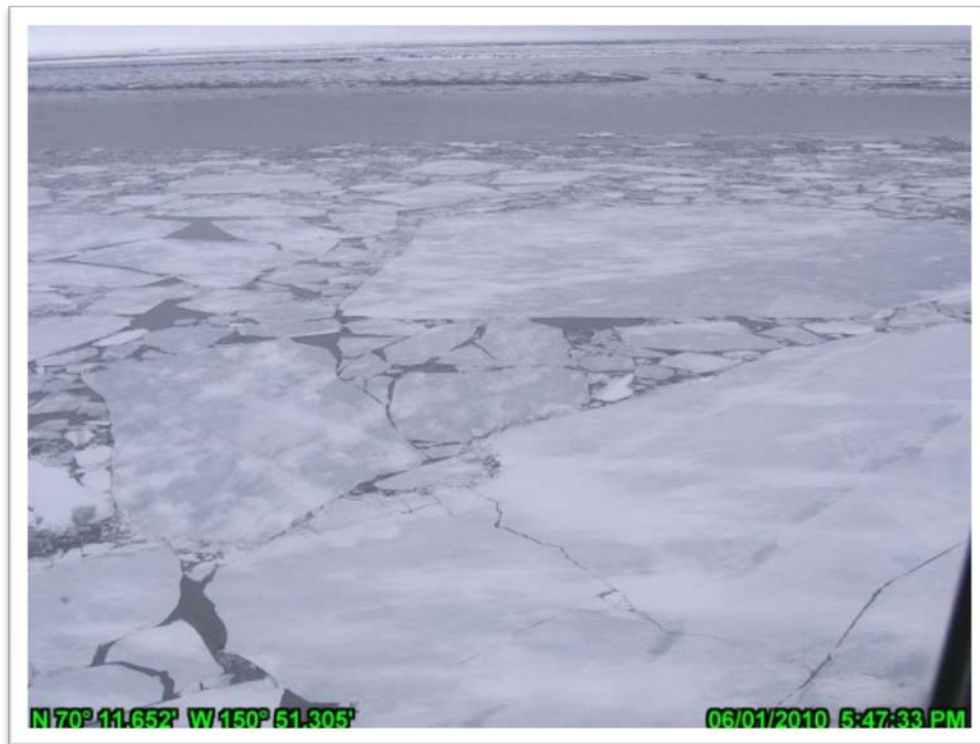
Stage rose from 12.82 to 15.01 ft BPMSL at MON1C in the 27 hours between the initial gage reading on May 30 and the May 31 reading. By May 31, ribbon ice was abundant, but not moving in the vicinity of MON1. Significant ribbon ice and ice floes were observed in the channel until past June 2, as shown in Photo 4.8.

Photo 4.8: Ice floes in the vicinity of MON1D, near peak stage; June 1, 2010.

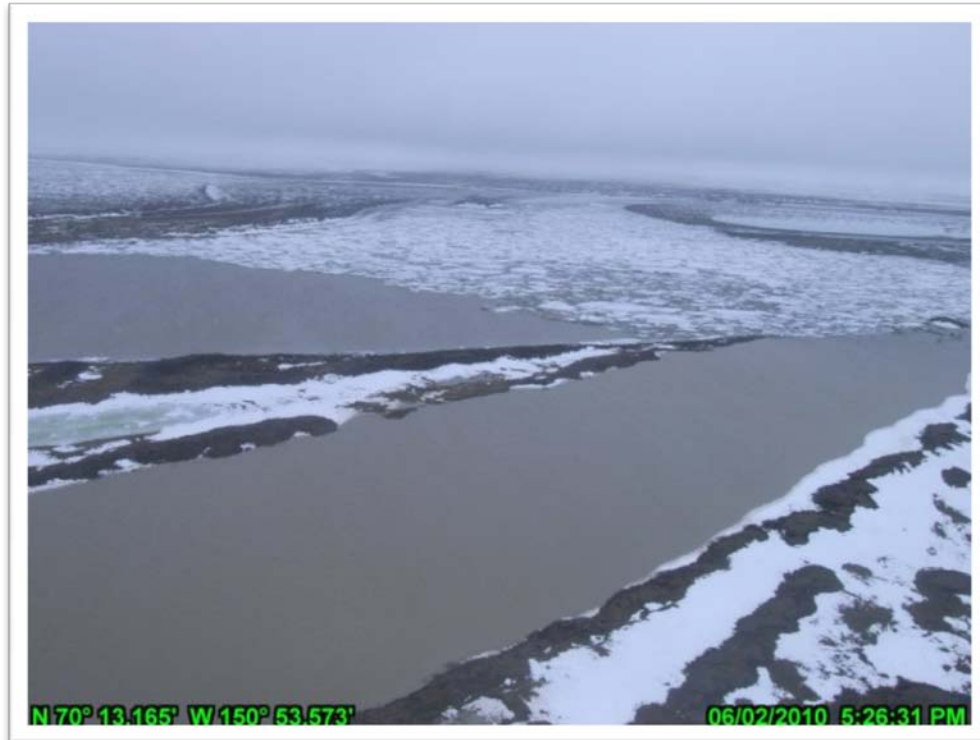
Ice activity significantly affected the breakup processes in the Nigliq Channel in 2010. Abundant ribbon ice was observed throughout the channel May 30 through June 1. On June 1, an ice jam entered the Nigliq Channel. It was observed on June 2 in the vicinity of Nuiqsut (shown in Photo 4.17) when peak stage occurred at MON MON20, MON22, and MON23. The activity of this ice jam on June 2 is likely responsible in part for the quick water level rise on the Nigliq Channel that correlated with the more dramatic rise observed in the East Channel during the same period. This ice continued jamming and releasing as it progressed slowly

Photo 4.17: Ice jam in the Nigliq Channel near Nuiqsut; June 2, 2010.

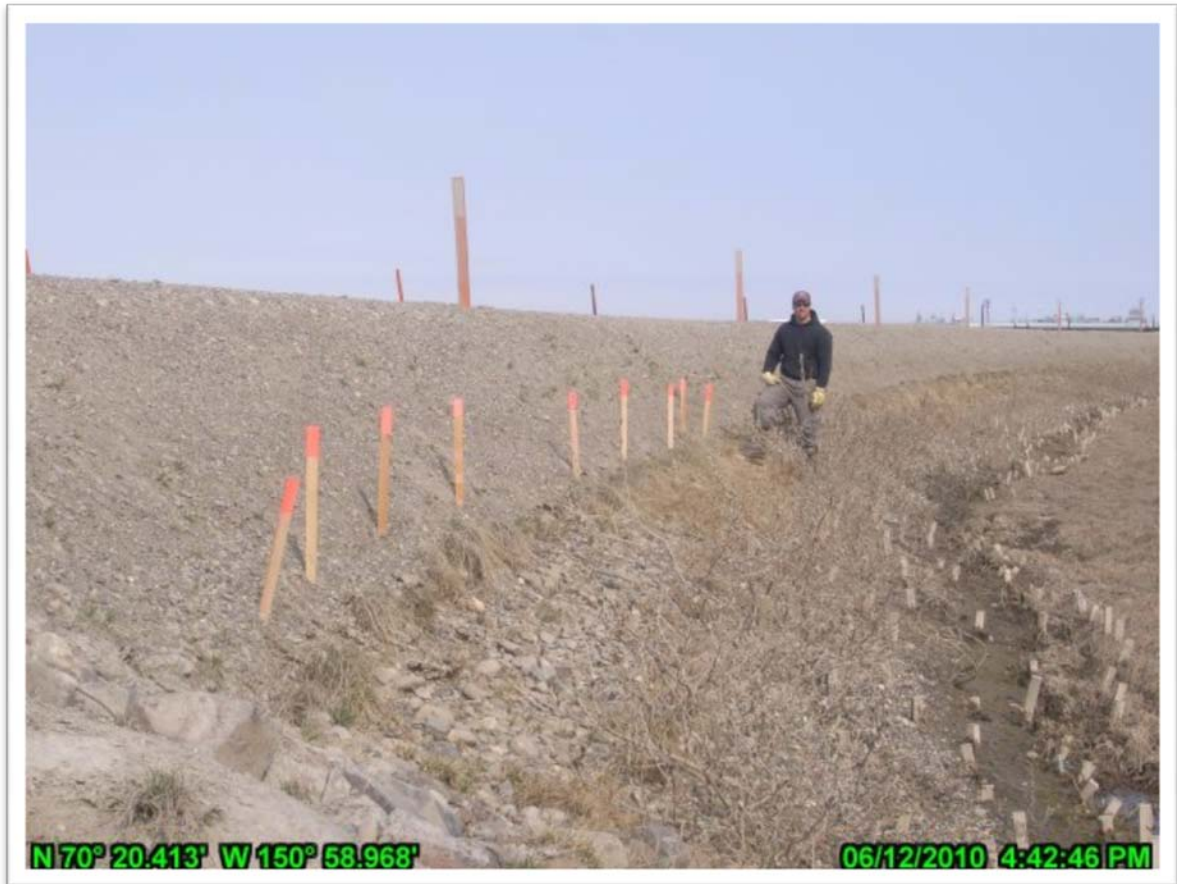
No indications of significant erosion due to breakup floodwater were observed on the Alpine gravel pads and facilities.

Photo 4.38: Fine-grained sands washed away due to floodwater erosion, CD2 road near long swale bridge; June 12, 2010.

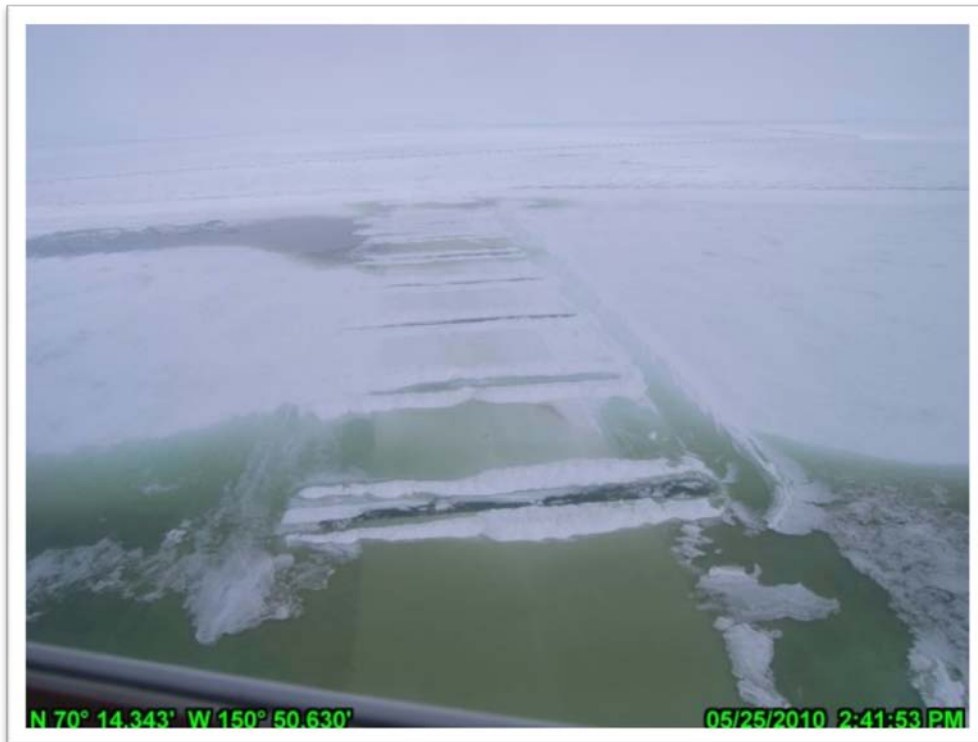
The first visual evidence of melt at the East Channel ice bridge was recorded on May 25 when water was observed in the slots cut into the ice bridge (Photo 4.45). By May 27, floodwater was beginning to flow through the area and ice floes were observed (Photo 4.46). By June 5, the East Channel ice bridge was no longer visible and was not affecting flow, with the exception of the western ramp (Photo 4.47).

Photo 4.45: Water in slots of East Channel ice bridge, looking east; May 25, 2010.

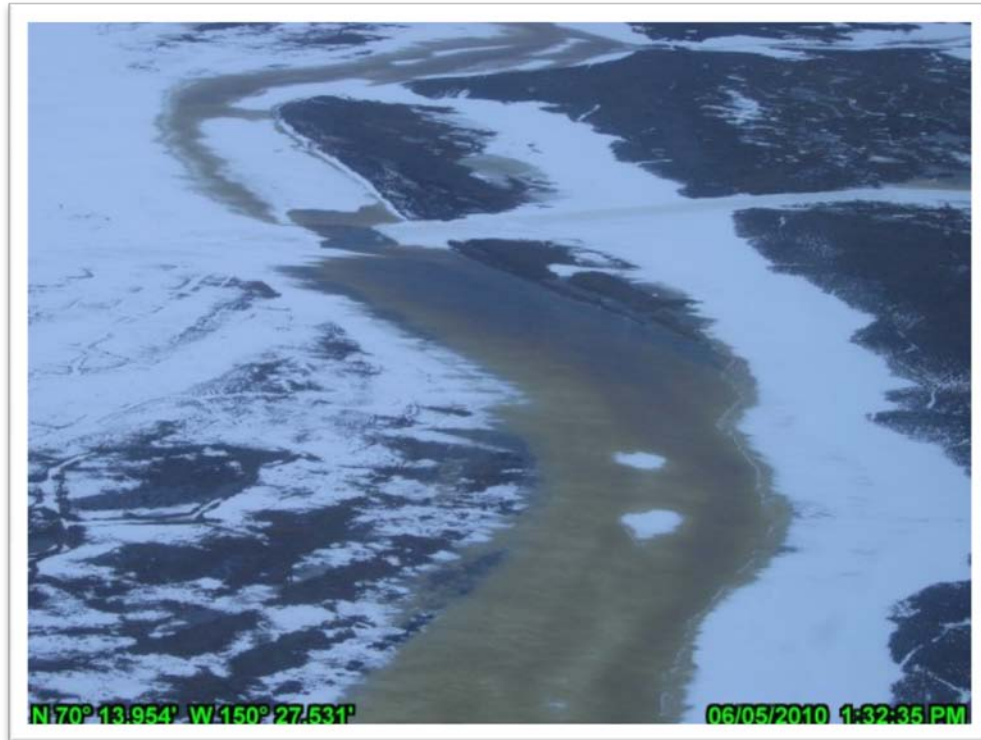
Photo 4.48: Floodwater starting to overtop Kachemach River ice bridge, looking north; June 5, 2010.

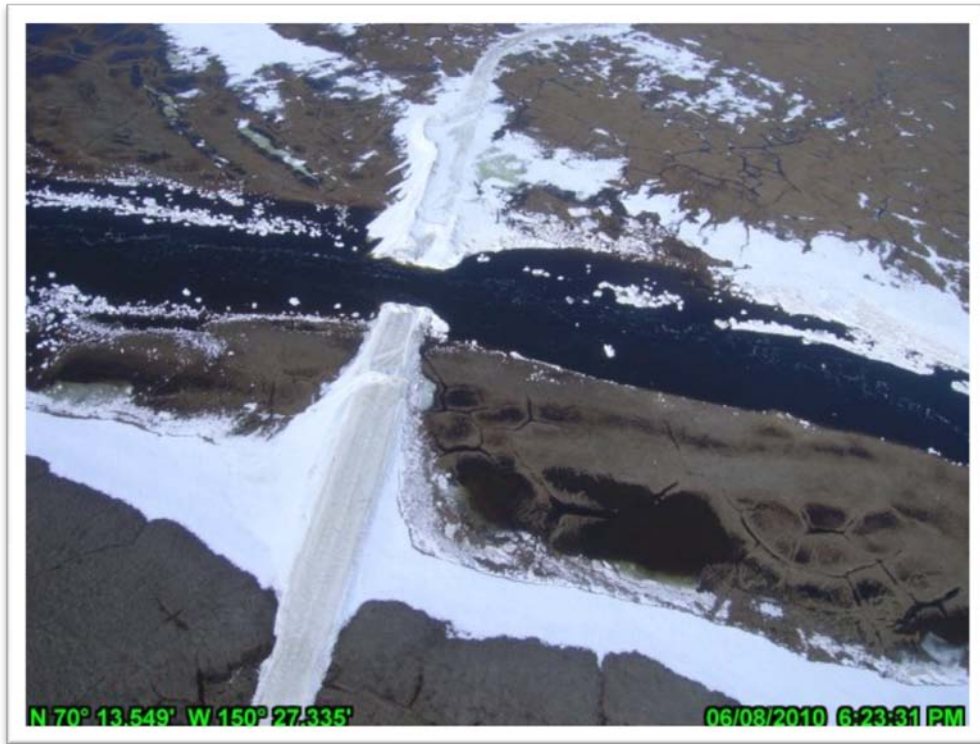
Photo 4.49: Kachemach River ice bridge breached and ice rafts observed in channel, looking east; June 8, 2010.

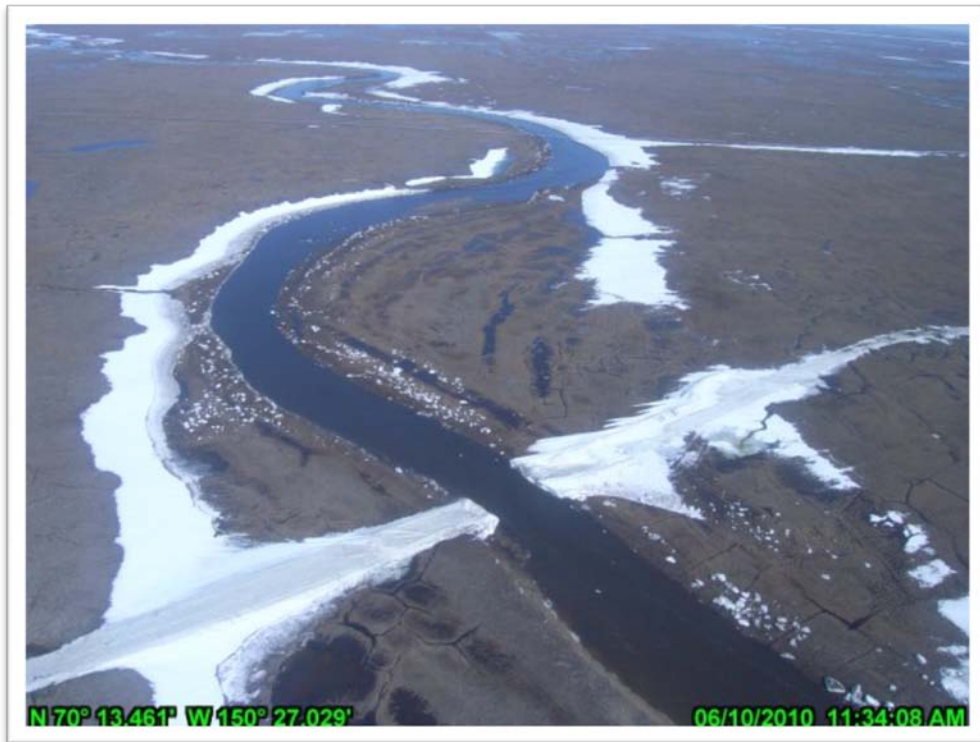
Initial aerial reconnaissance of the Kachemach River ice bridge crossing location was performed on May 13. The Kachemach River ice bridge was effectively wholly intact and no evidence of floodwater or local melt was observed. On June 5, the leading edge of floodwater had begun to overtop the Kachemach River ice bridge crossing location (Photo 4.48) and by June 8, floodwater had breached the ice bridge crossing and ice rafts were observed in the channel. An aerial reconnaissance made on June 10 revealed stranded ice on the banks of the channel indicating that peak stage had passed through the location. (Photo 4.50)

Photo 4.50: Stranded ice along the banks of the Kachemach River ice bridge location; June 10, 2010.

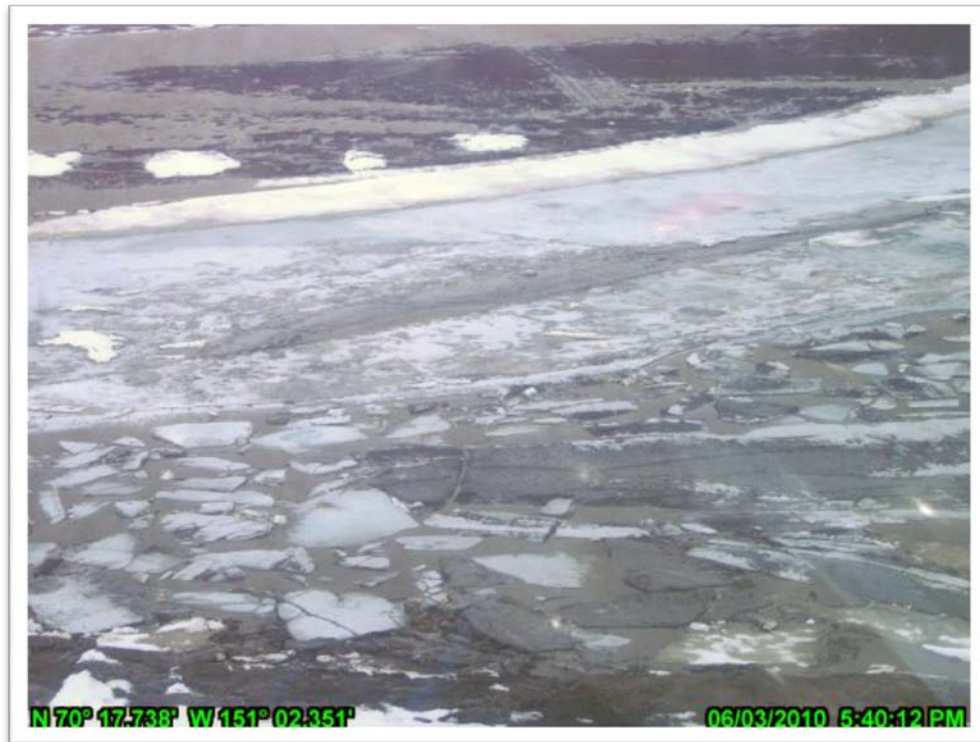
G21 is located between MON20 and MON22 on the Nigliq Channel, at the proposed CD5 crossing location. The G21 location experienced similar breakup events, including discharge, stage, and ice effects, as the other Nigliq Channel gages in the area. Photo 4.55 shows an ice jam near the CD5 road crossing on June 3.

Photo 4.55: Nigliq Channel ice jam near CD5 road crossing; June 3, 2010.

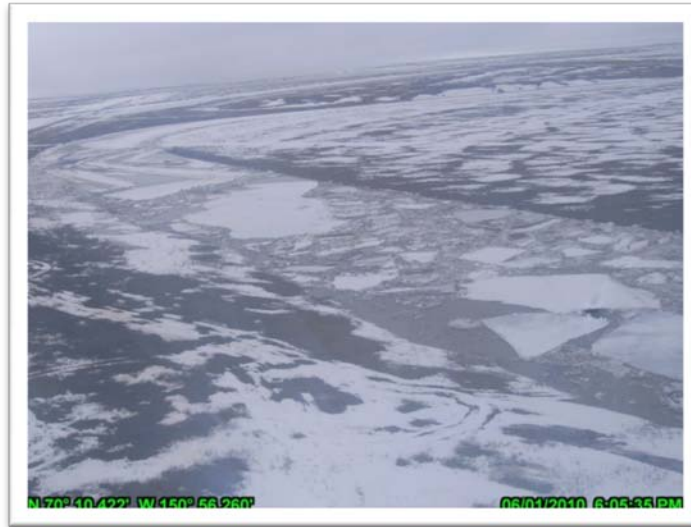
Photo 5.1: Ice jam entering the Nigliq Channel; June 1, 2010.

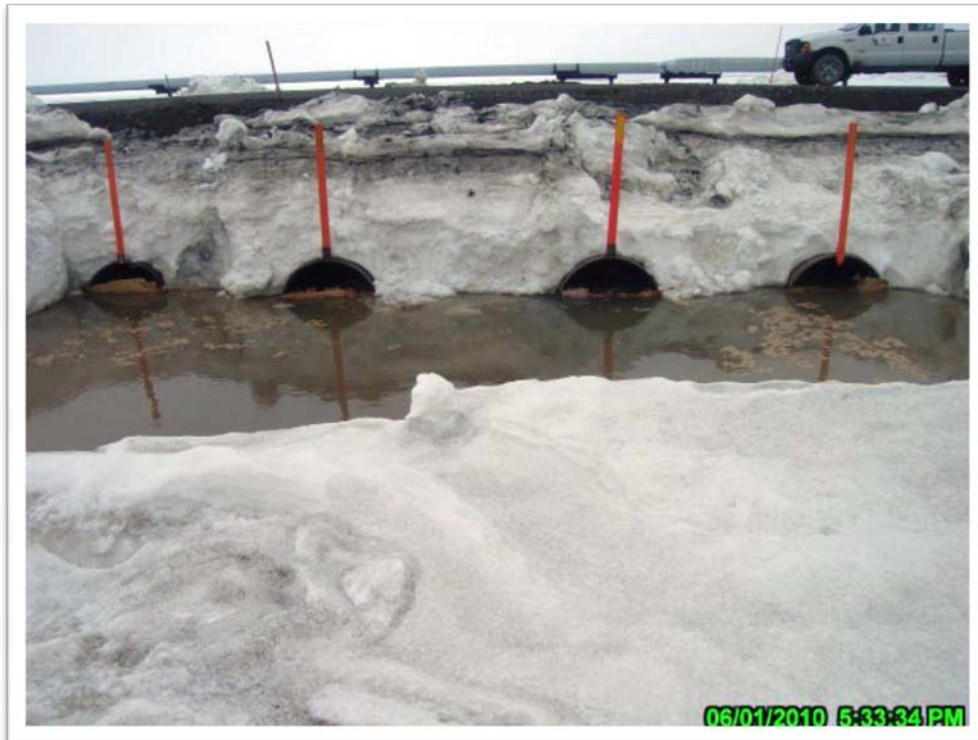
Photo 5.5: Plywood blockage of culverts CD2-7 through CD2-7 upstream along CD2 road; June 1, 2010.

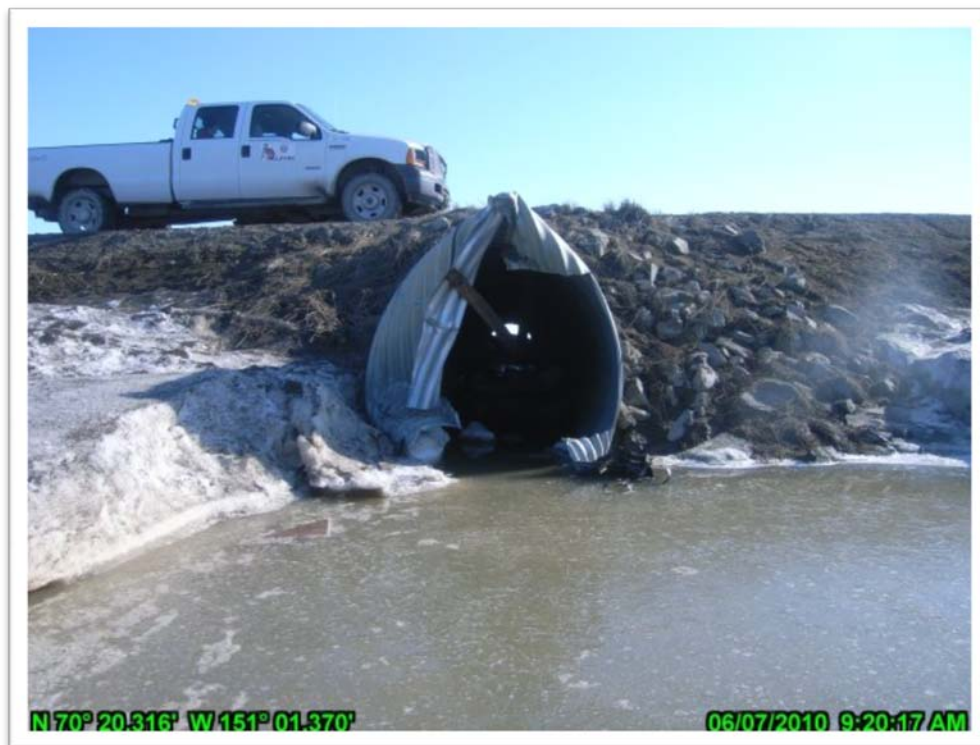
Photo 5.7: Damaged culvert CD2-9; June 7, 2010.
