Colville River Delta

ConocoPhillips
Alaska

Colville River Delta Spring Breakup 2011 Hydrologic Assessment

January 2012

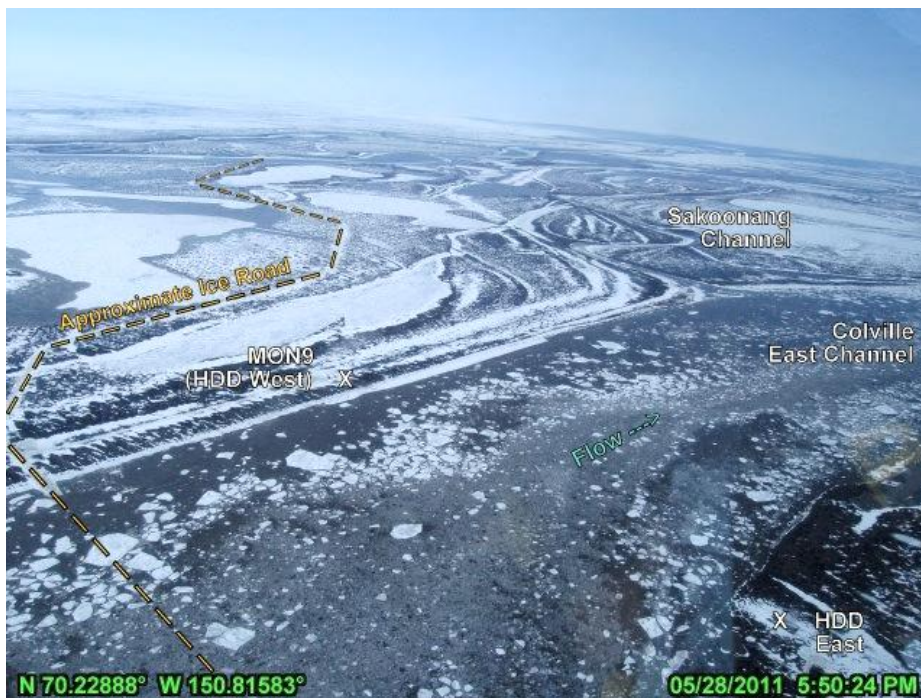
PHOTO 4.12: ICE FLOES IN THE VICINITY OF MON9 (HDD)—THE RESULT OF A MAJOR ICE JAM RELEASE UPSTREAM OF MON1, LOOKING DOWNSTREAM (NORTHWEST); MAY 28, 2011

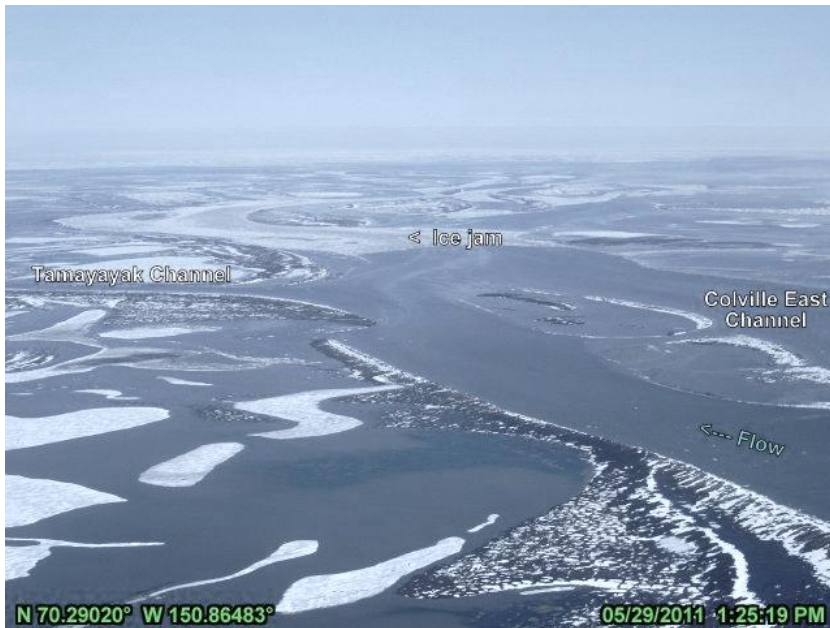
PHOTO 4.13: ICE JAM DOWNSTREAM OF THE TAMAYAYAK ENTRANCE, LOOKING DOWNSTREAM (NORTH); MAY 29, 2011

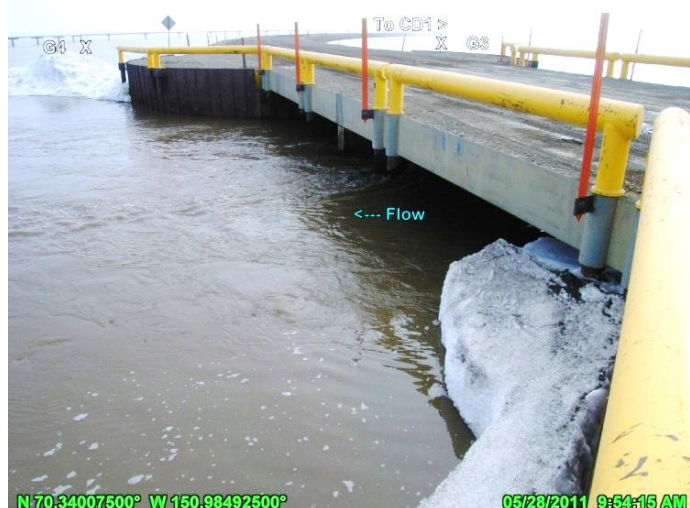
PHOTO 4.40: FLOW PASSING MOSTLY UNIMPEDED BY SNOW THROUGH THE 62-FOOT SWALE BRIDGE, DOWNSTREAM (NORTH) LOOKING WEST; MAY 28, 2011

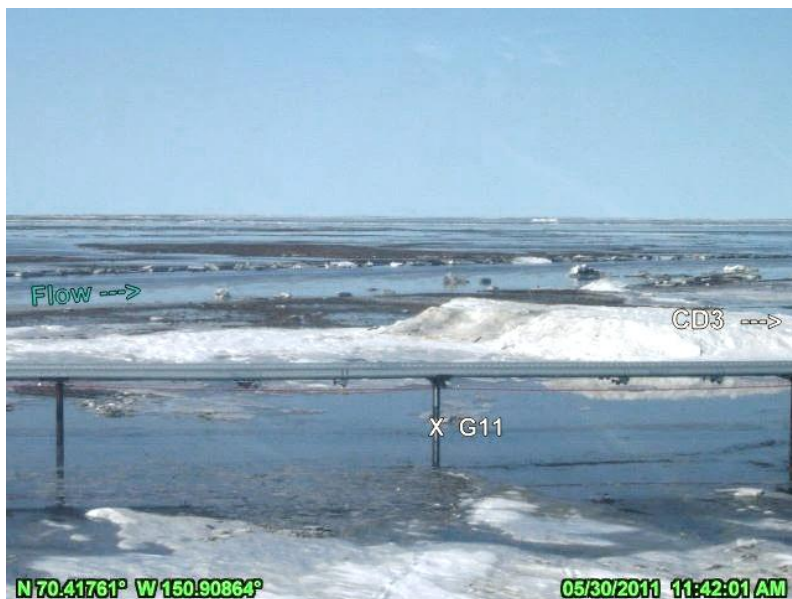
PHOTO 4.56: G11 ON THE WEST SIDE OF CD3, GROUNDED FLOES IN CHANNEL FROM OVERNIGHT ICE JAM RELEASE, LOOKING WEST; MAY 30, 2011.

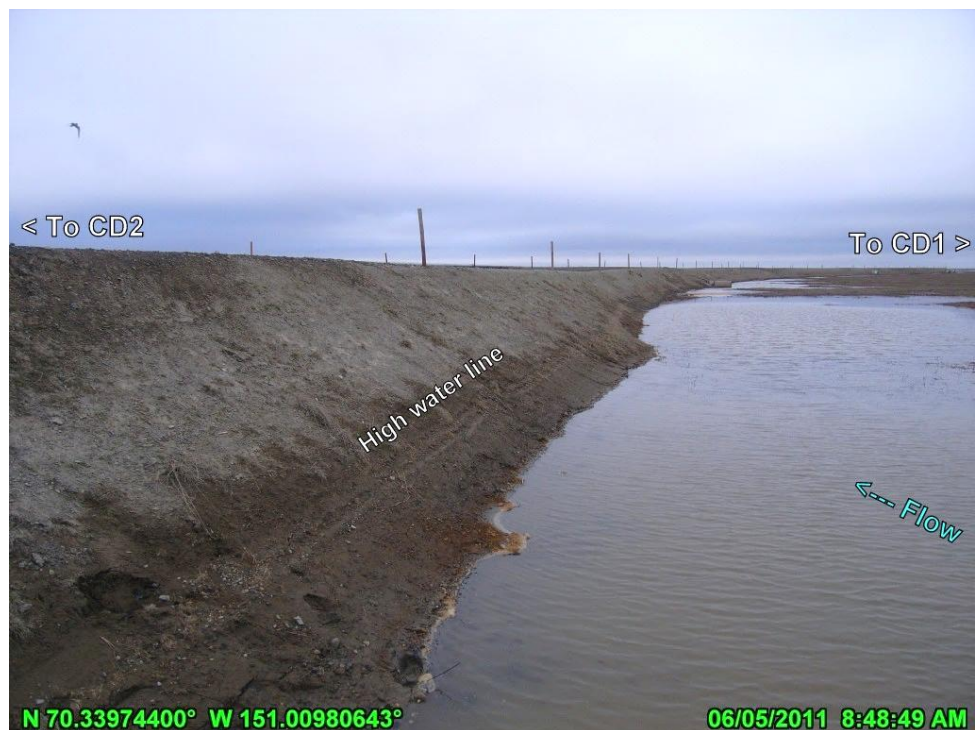
PHOTO 4.69: FINE-GRAINED MATERIAL REMOVED FROM ROAD PRISM, SOUTH SIDE OF CD2 ROAD, LOOKING EAST; JUNE 5, 2011

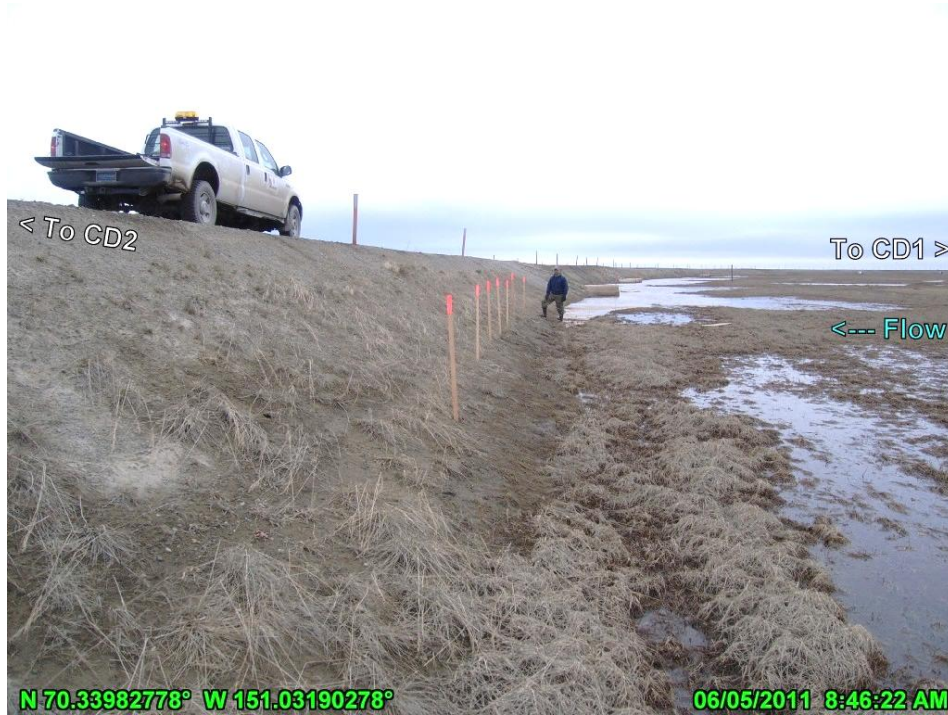
No indications of significant erosion due to breakup floodwater were observed on the Alpine gravel pads or facilities.

PHOTO 4.70: EROSION SURVEY OF CD2 ROAD PRISM POST-BREAKUP, LOOKING EAST; JUNE 5, 2011

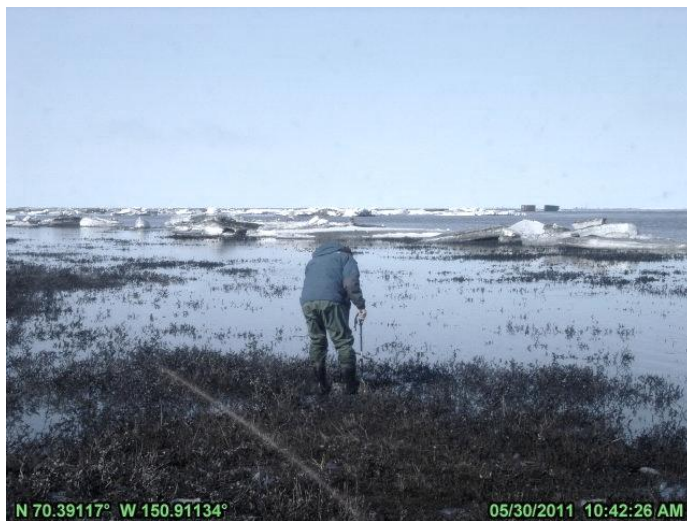
PHOTO 4.95: GROUNDED ICE IN THE VICINITY OF THE TAMAYAYAK PIPELINE CROSSING, LOOKING NORTHWEST; MAY 30, 2011

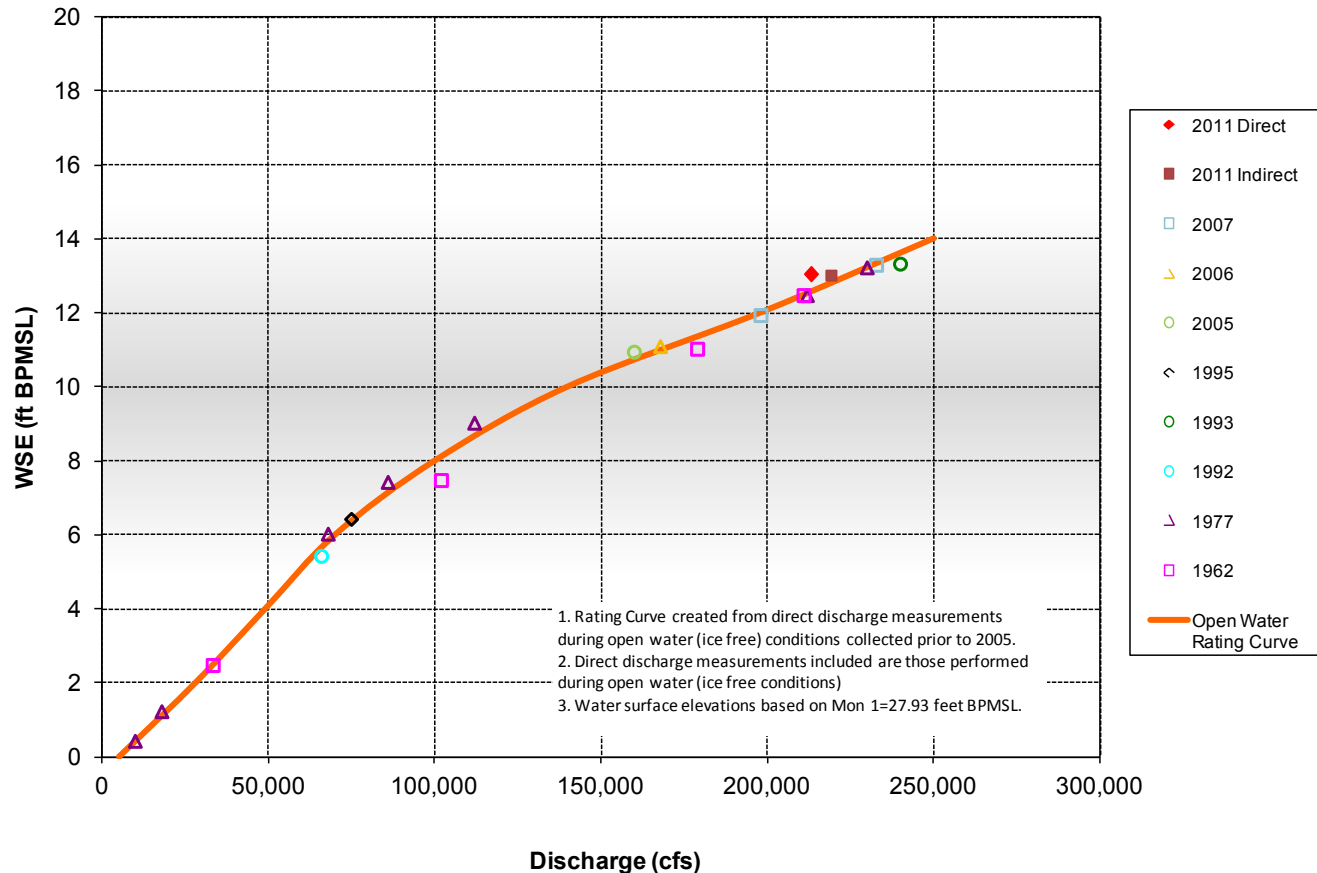
by -5 percent and -2 percent of the rating discharge, respectively. The shift is likely due to sediment deposition in the channel resulting from low flow velocities. Sediment deposition can change the bedform geometry, affecting indirect calculations and changing the relationship between stage and discharge of the rating curve. The direct discharge measurement is considered to be good based on site conditions and its relationship to the rating curve and indirect discharge estimate.

GRAPH 5.1: MON1 STAGE-DISCHARGE RATING CURVE WITH DIRECT DISCHARGE
