2013 COLVILLE RIVER DELTA SPRING BREAKUP MONITORING & HYDROLOGIC ASSESSMENT

Michael Baker, Jr., Inc.
1400 West Benson Blvd.,
Suite 200
Anchorage, Alaska 99503

135141-MBJ-RPT-001 | November 2013

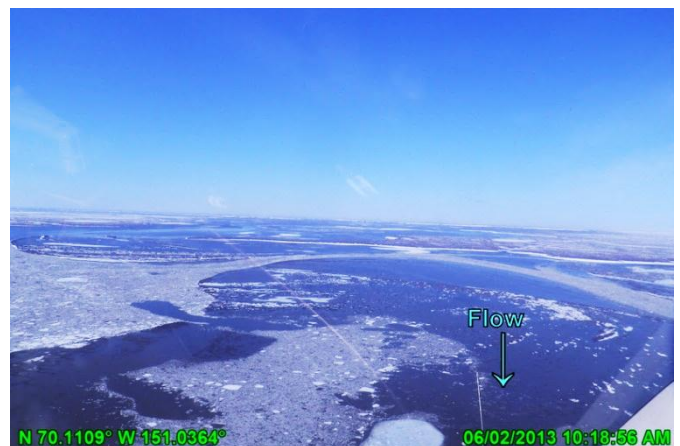
Photo 3.10: Ice jam upstream of MON1 with widespread inundation, looking south; June 2, 2013

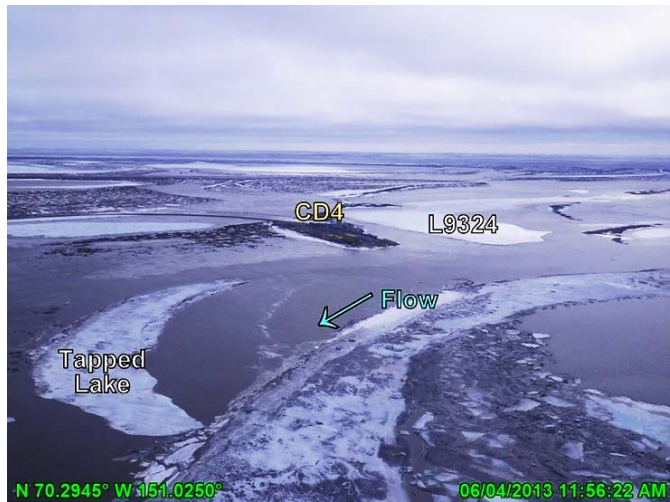
Photo 3.11: CD4 with diverted floodwater around the Nigliq Channel ice jam, looking southeast; June 4, 2013

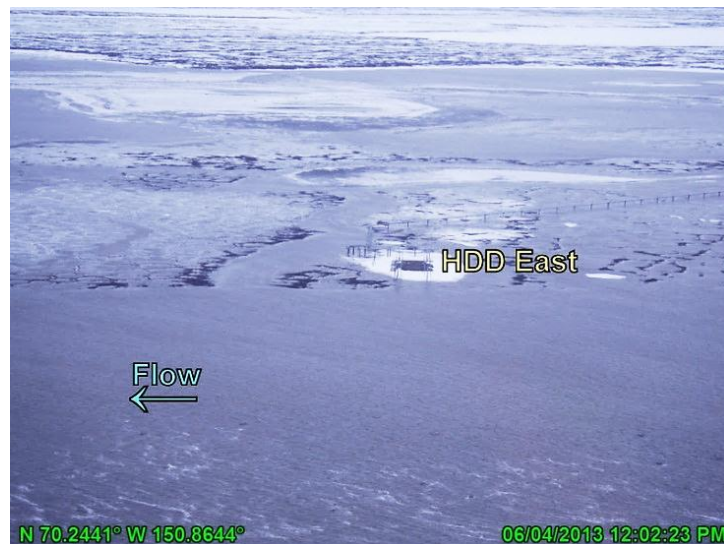
Photo 3.13: Extensive flooding near HDD East gravel pad; June 4, 2013

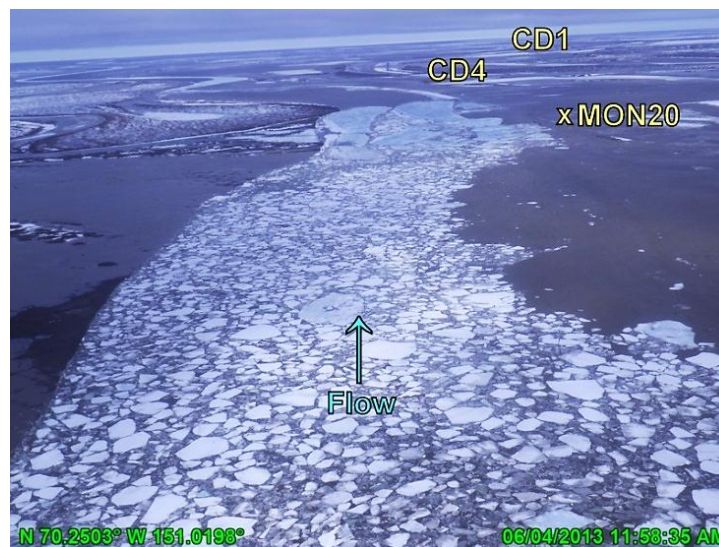
Photo 3.14: Ice jam and resulting backwater at near MON20, looking north; June 4, 2013

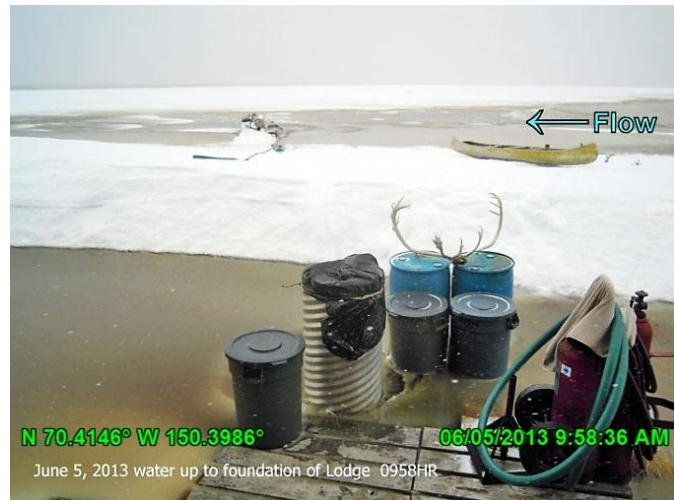
Photo 3.22: Water level up to foundation of lodge; looking west; June 5, 2013

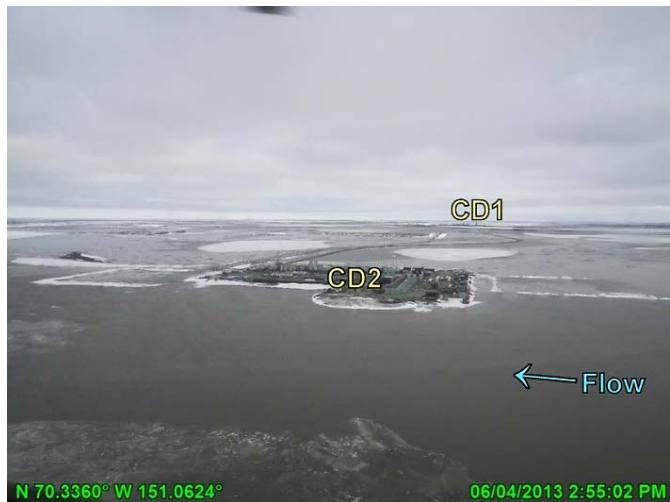
Photo 3.27: Floodwaters around CD2 road and pad near peak flood conditions, looking east; June 4, 2013

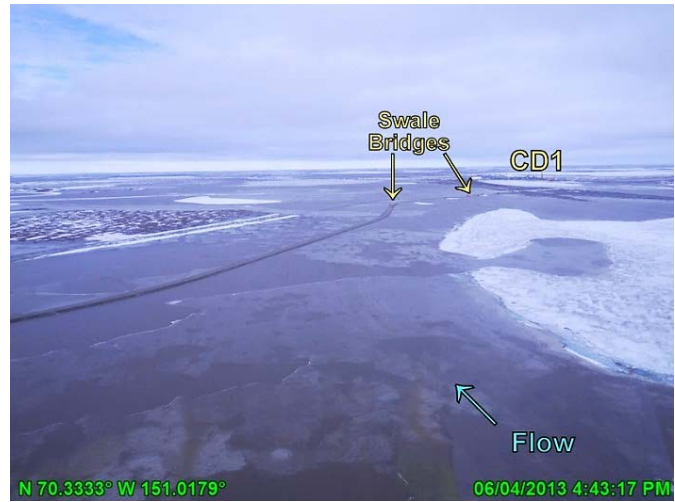
Photo 3.28: CD2 road during peak flood conditions, looking east; June 4, 2013

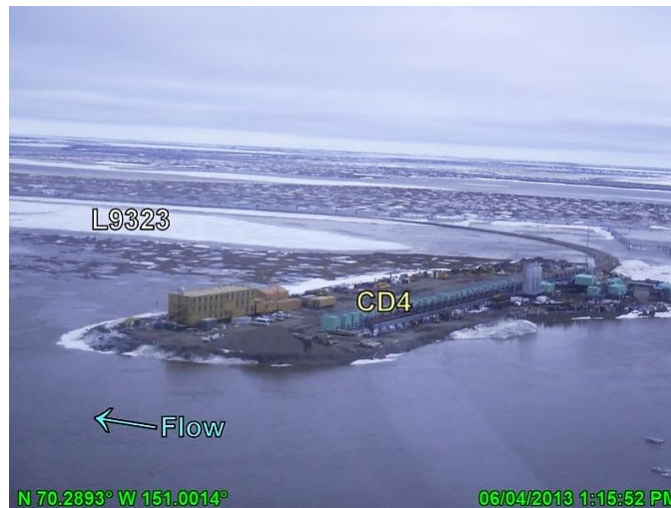
Photo 3.29: CD4 road and pad with accumulating backwater from the Nigliq Channel ice jam, looking east; June 4, 2013

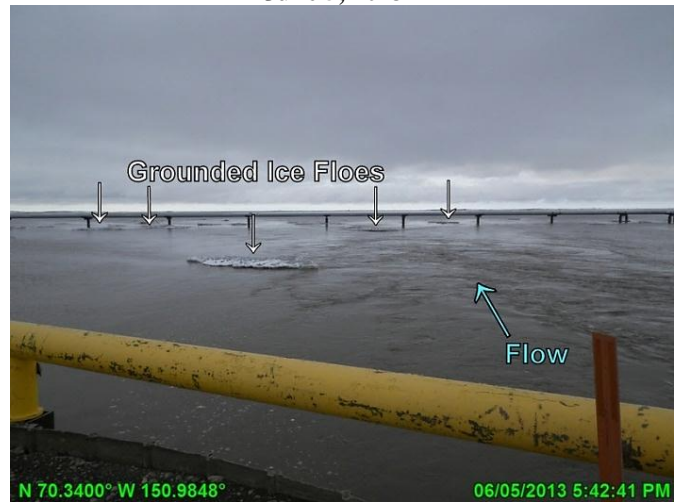
Photo 3.36: Grounded ice downstream of short swale bridge, looking north; June 5, 2013

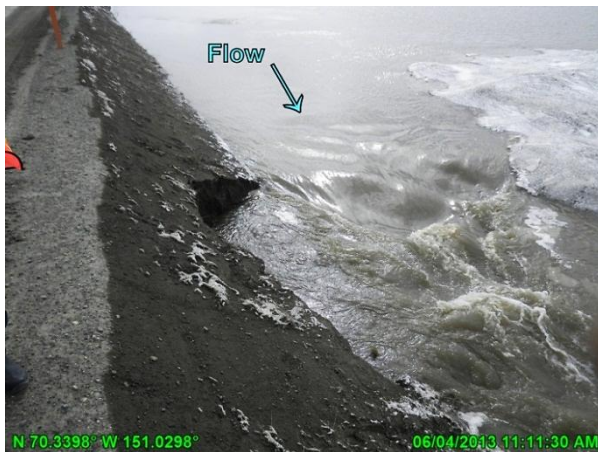
Photo 3.37: Localized erosion at the CD2 culvert battery, looking east; June 4, 2013

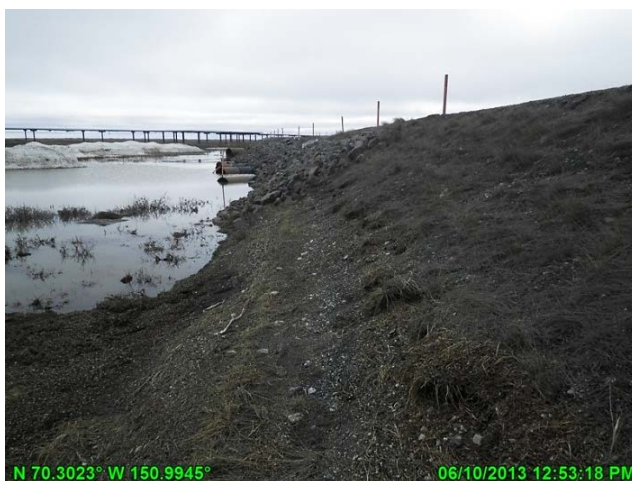
Photo 3.40: Representative conditions for CD4 culvert batteries, looking southeast; June 10, 2013

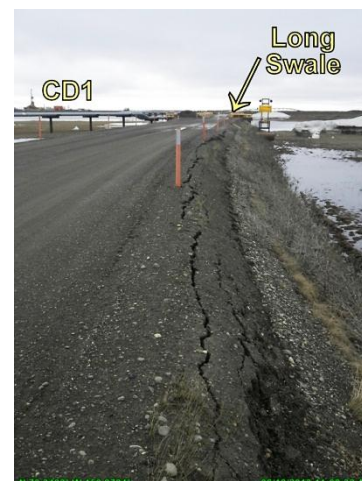
Photo 3.41: Tension cracks after flood water receded from the road prism near culvert CD2-23; June 10, 2013

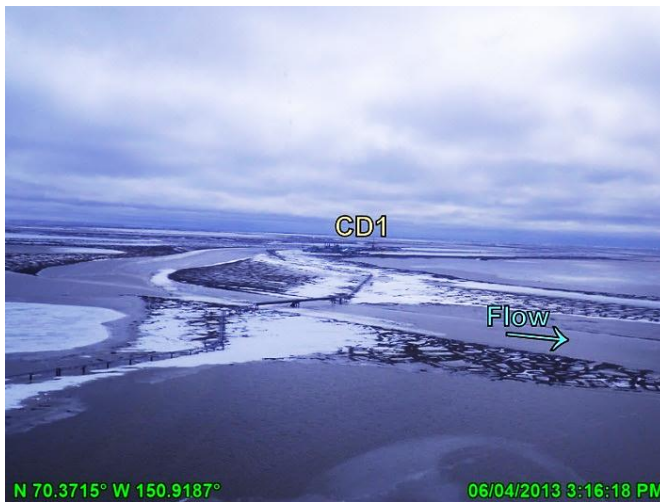
Photo 3.51: Overbank flooding at the Sakoonang Channel pipeline crossing, looking south; June 4, 2013

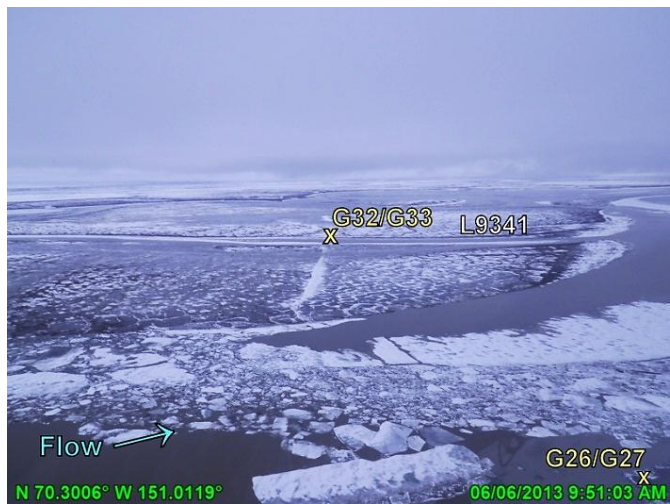
Photo 3.61: Ice jam at the proposed Nigliq Channel crossing, looking west; June 6, 2013
