2017

COLVILLE RIVER DELTA SPRING BREAKUP MONITORING & HYDROLOGICAL ASSESSMENT

Michael Baker

This report presents the observations and results from the 2017 Colville River Delta Spring Breakup Monitoring and Hydrological Assessment conducted by Michael Baker International for ConocoPhillips Alaska. In the Colville River Delta, the breakup and downstream movement of river ice typically occurs during a three-week period in May and June. The spring breakup event historically produces flooding, and rapid rise and fall of stage can occur as the result of ice jam formation and release. Annual study and reporting of spring breakup is required by U.S. Army Corps of Engineers Permits 2-960874 Special Condition #6, POA-2004-253 Special Condition #17, and POA-2005-1576 Special Conditions #1 and #17 and Alaska Department of Fish and Game Permits FH04-III-0238, FG97-III-0260, FG99-III-0051, and FG97-III-0190. The analyses provide data to support design, permitting, and operation of oilfield development.

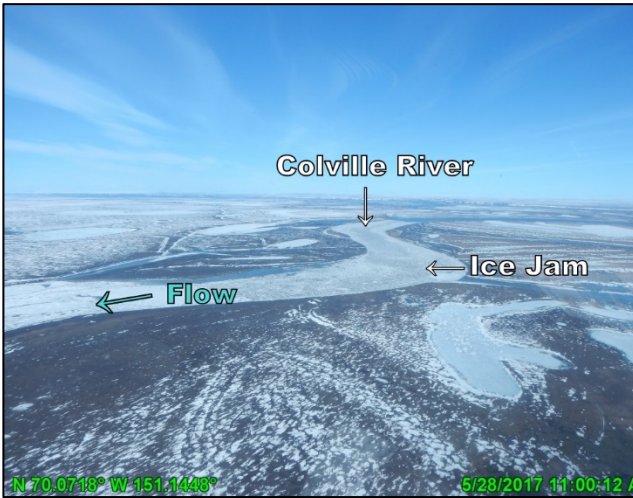
Photo 3.6: Ice jam upstream of MON1, looking south (upstream); May 28, 2017

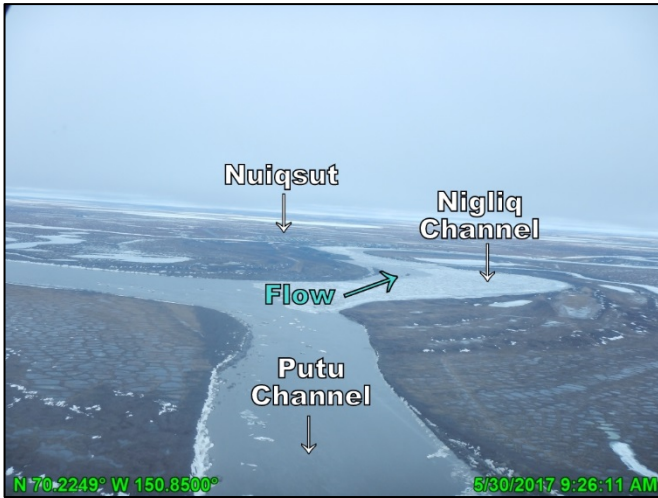
Photo 3.10: Nigliq Channel ice jam upstream of Nuiqsut, looking southwest (upstream); May 30, 2017

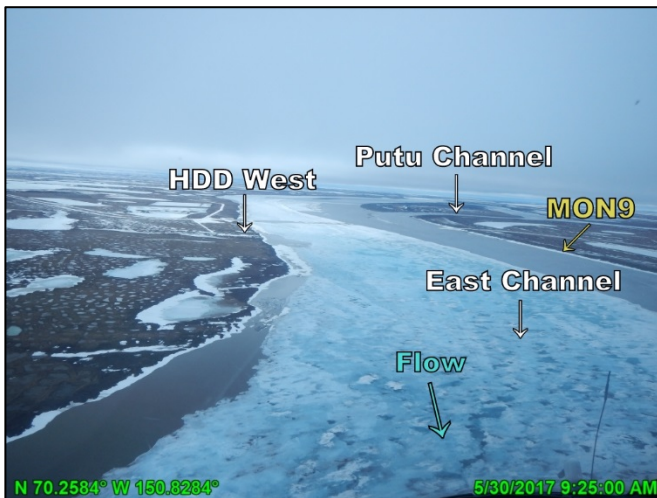
Peak stage at MON9 and MON9D were the result of backwater from the downstream ice jam at the Sagoonang Channel bifurcation. Prior to peak discharge, channel ice remained intact throughout the reach (Photo 4.3). At the time of peak discharge, the ice jam release at MON1 flushed the intact channel ice and ice floes were observed moving through the reach (Photo 4.4). After peak discharge, ice floes backed up behind the downstream intact channel ice at the Sagoonang Channel bifurcation (Photo 4.5). The estimated discharge was assigned a fair to poor quality rating (Table 2.1) due to these influences. Site specific discharge data and plan and profile drawings are provided in Appendix C.2.2.

Photo 4.3: Conditions the day prior to peak stage and peak discharge at MON9, looking southwest (upstream); May 30, 2017

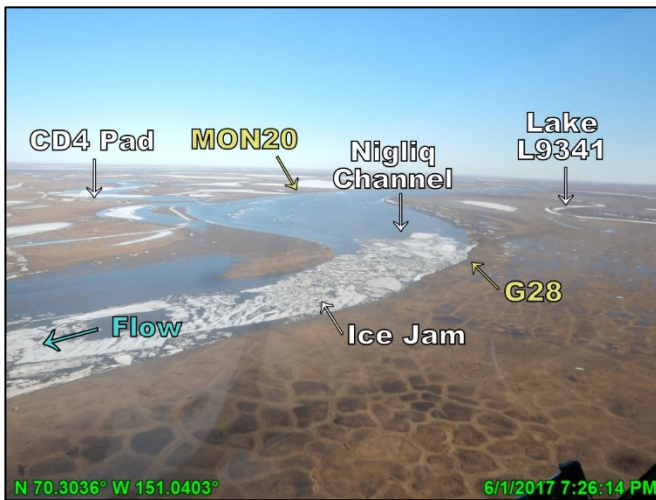
Photo 4.6: Ice jam downstream of MON20 twelve hours after peak stage, looking southeast (upstream); June 1, 2017

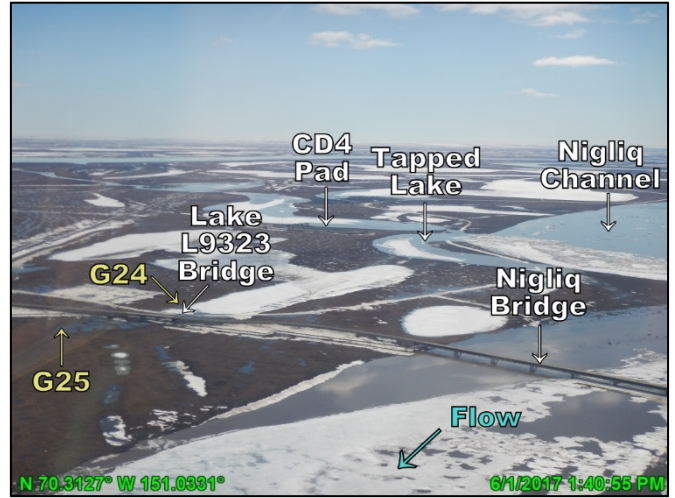
Nigliq Channel floodwaters did not hydraulically connect to Lake L9323 (Photo 4.16). Recorded water levels were the result of local melt from within the lake basin and no flow through the bridge was observed. Ice cover on the lake remained throughout the duration of monitoring. Lake L9323 Bridge stage data is provided in Graph 4.13. The graph shows stage above the PT only; gaps in data indicate stage dropped below the PT.

Photo 4.18: Lake L9323 hydraulically isolated from the Nigliq Channel, looking south; June 1, 2107

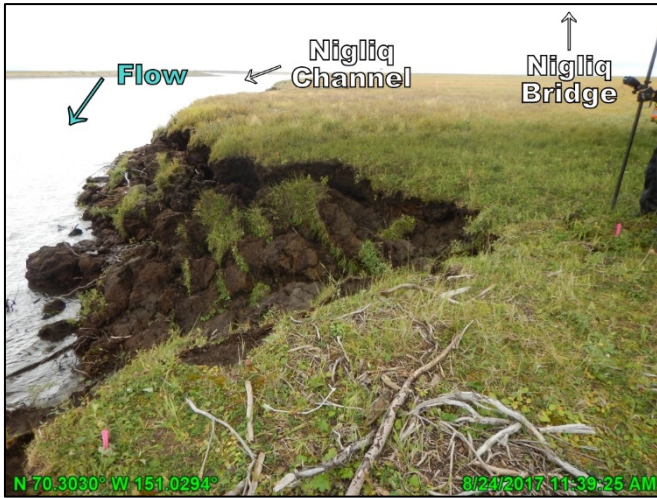
Photo 6.1: West bank of the Nigliq Channel under the Nigliq Bridge, looking south; August 24, 2017
