2017 GMT1 SPRING BREAKUP CULVERT MONITORING REPORT

Prepared for ConocoPhillips Alaska, Inc.

**Michael Baker International
3900 C Street, Suite 900
Anchorage, AK 99503**

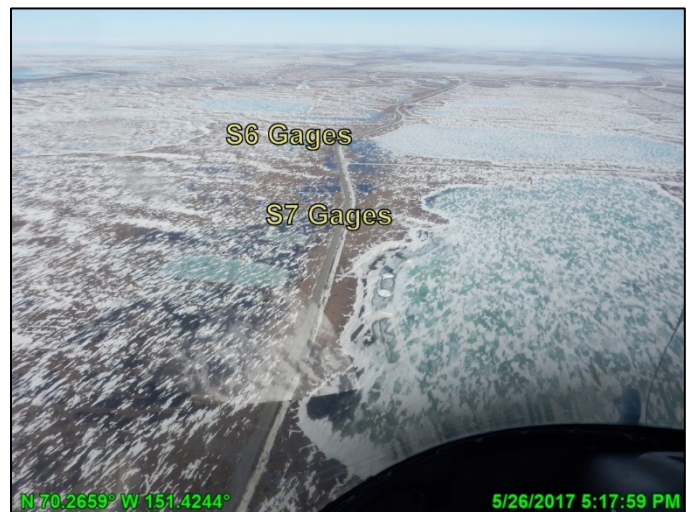
On May 17, the small drainages along the GMT1 access road were snow covered and frozen. Snow cover on the surrounding tundra was approximately 90%. By May 24, isolated, local melt was accumulating in some of the drainages. On May 26, local melt was observed accumulating at most monitoring locations and large areas of melt were becoming hydraulically connected (Photo 3.1).

Photo 3.1: Local melt accumulating along GMT1 access road, looking east; May 26, 2017

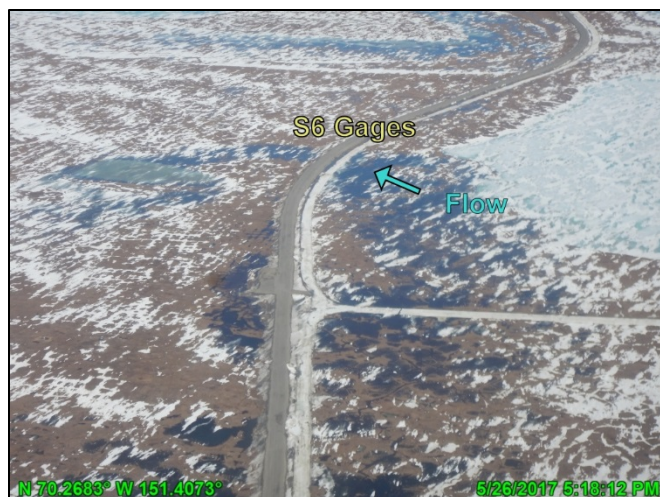
By May 28, minimal snow cover remained on the surrounding tundra and meltwater was connecting the upstream and downstream side of the road at most monitoring locations, suggesting culvert conveyance at these locations. Drifted snow and ice roads remained along the road embankment and influenced cross drainage in some locations (Photo 3.2).

Photo 3.2: Drifted snow and ice road along upstream (south) side of the GMT1 access road, looking east; May 26, 2017

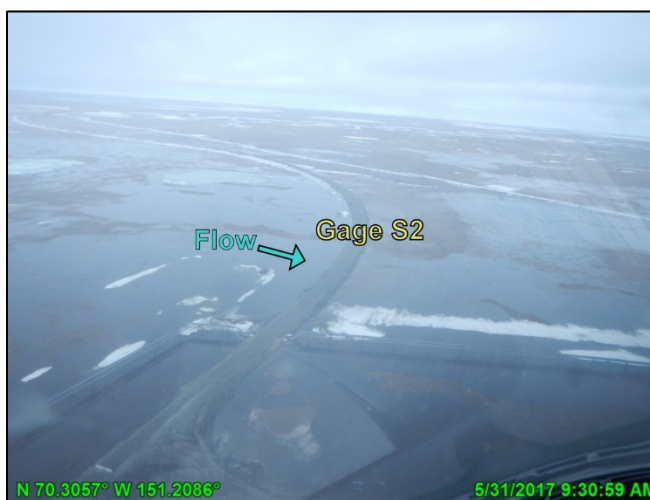
On May 26, the ice road and drifted snow on the south side of the GMT1 access road at the S2 monitoring location had mostly melted and neither were influencing drainage patterns (Photo 3.3). The ice road located north of the GMT1 pipeline north of the GMT1 access road was still intact and meltwater was accumulating between that and the GMT1 access road. PTs recorded concurrent rising water levels on the upstream and downstream side of the road, suggesting a hydraulic connection was established through the culverts.

Photo 3.3: GMT1 access road at S2 gages, looking west; May 31, 2017

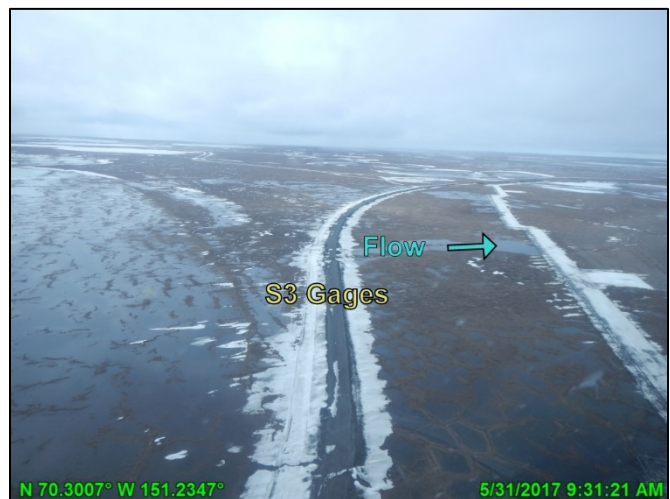
Photo 3.4: Near peak flow conditions at S3 gages, looking southwest; May 31, 2017

The ice road south of the GMT1 access road did not influence area hydraulics aside from providing some meltwater. Similar to conditions observed at the S2 monitoring location, the ice road north of the pipeline north of the GMT1 access road remained partially intact during breakup. Similarly, meltwater accumulated between the GMT1 access road and the pipeline construction ice road, influencing water levels at the S3 monitoring location. Peak stage was recorded at the downstream gage, S3-A, on May 25 at 7:30am, cresting at 20.85 feet BPMSL (Graph 3.2 and Photo 3.4). The PT installed on the upstream gage, S3-B, remained dry throughout breakup and aerial observations indicate no meltwater was on the south side of the road embankment. As a result, no hydraulic connections were established through the culverts during breakup. Ground observations on June 2 confirmed that there were no visible drainages melted through the snowpack in the vicinity of the culvert inlets and outlets.

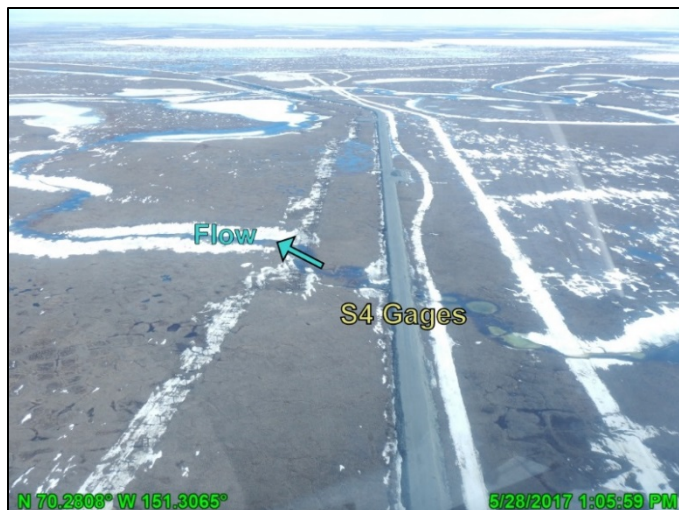
Photo 3.5: Barely Creek flowing near peak conditions, looking east; May 28, 2017

On May 26, local melt continued to accumulate and ponded water was present between the two ice roads along the south side of the GMT1 access road. Peak stage was recorded at the upstream gage, S4-C, on May 26 at 6:30pm, cresting at 16.26 feet BPMSL (Graph 3.3). This was followed by a sharp drop in stage attributed to a sudden release of ponded water melting through the ice road adjacent to the GMT1 access road. Aerial observations on May 28 confirm that streamflow in the drainage had melted a channel through the remaining ice roads and flow through the culverts was unobstructed (Photo 3.5).

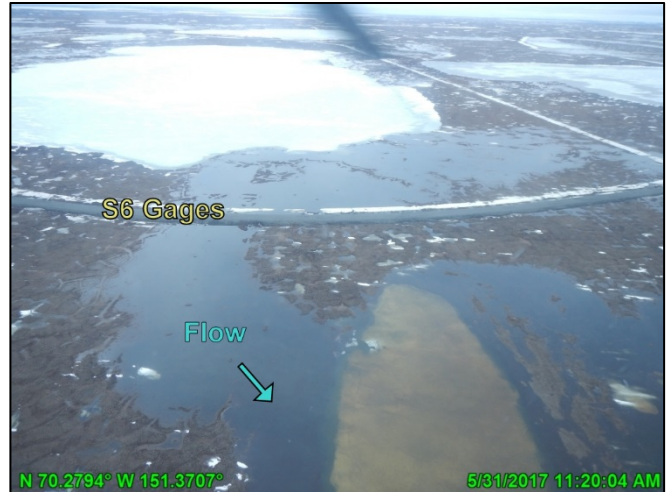
Peak stage was recorded at the downstream gage, S6-A, and the upstream gage, S6-B, on May 31 at 5:15pm and 2:30pm, respectively; cresting at 24.28 feet BPMSL and 24.47 feet BPMSL, respectively (Graph 3.4). Streamflow in the drainage had melted a path through the remaining ice road and flow through the culverts was unobstructed (Photo 3.6).

Photo 3.6: Conditions at S6 gages, looking south; May 31, 2017

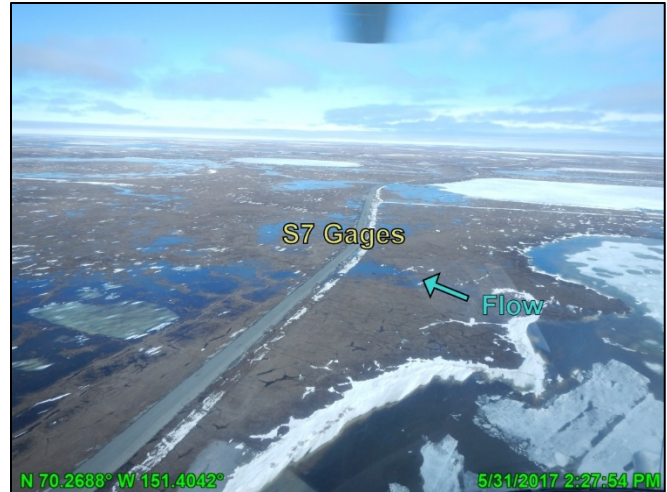
The S7 monitoring location is situated in a swale depression that drains Lake L9820 (south of the GMT1 access road) towards the north. On May 26, isolated pockets of meltwater were observed in the drainage and the ice road adjacent to the south side of the GMT1 access road remained intact. Peak stage was recorded at the upstream gage, S7-B, on May 26 at 8:15pm, cresting at 27.28 feet BPMSL (Graph 3.5). Peak stage at S7-B was likely attributed to local meltwater which ponded upstream of the ice road and did not appear to be connected to the culverts. On May 31, the drainage was dry on the north side of the road between the culverts and the downstream gage, S7-A (Photo 3.7). PT data suggests flow through the culverts began around May 31, when the downstream gage, S7-A, experienced a relatively sharp rise in water levels coinciding with rising stage measured upstream at S7-B. Peak stage was recorded at gage S7-A on May 31 at 8:15pm, cresting at 25.86 feet BPMSL (Graph 3.5). By June 1, the ice road had further deteriorated and no ponded water was present on the upstream side of the road.

Photo 3.7: GMT1 access road, looking east; May 31, 2017

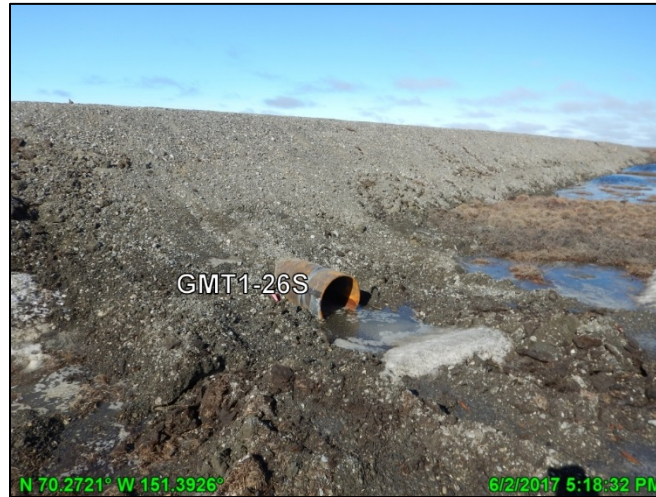
Gravel fill near the inlet and outlet of culvert GMT1-26 was identified on June 2 (Photo 3.8). It did not appear to affect spring breakup drainage.

Photo 3.8: Culvert GMT1-26, looking northeast; June 2, 2017

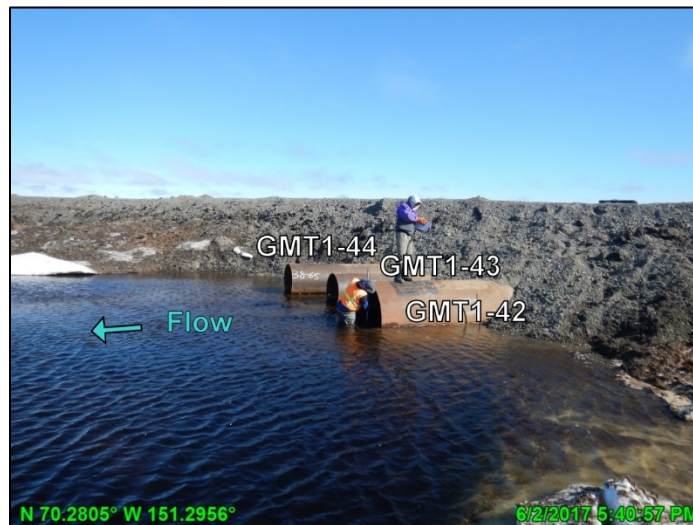
Discharge measurements were collected at culverts GMT1-25, GMT1-31 through GMT1-33, and GMT1-42 through GMT1-44 on the afternoon of June 2. The average measured velocity and total measured discharge through these culverts was 1.1 feet per second (fps) and 12.7 cubic feet per second (cfs), respectively.

Photo 3.9: Measuring discharge at GMT1-42, looking southeast; June 2, 2017

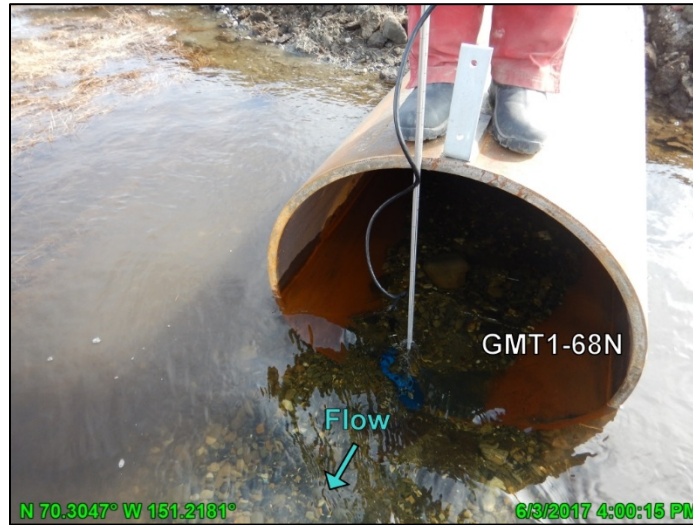
Discharge measurements were collected at GMT1-65 through GMT1-69 on the afternoon of June 3. The average velocity and total discharge through these culverts was 1.2 fps and 7.0 cfs, respectively.

Photo 3.10: Measuring discharge at GMT1-68, looking southeast; June 3, 2017
