2017

GMT1 Spring Breakup & Summer Monitoring & Hydrological Assessment

Michael Baker

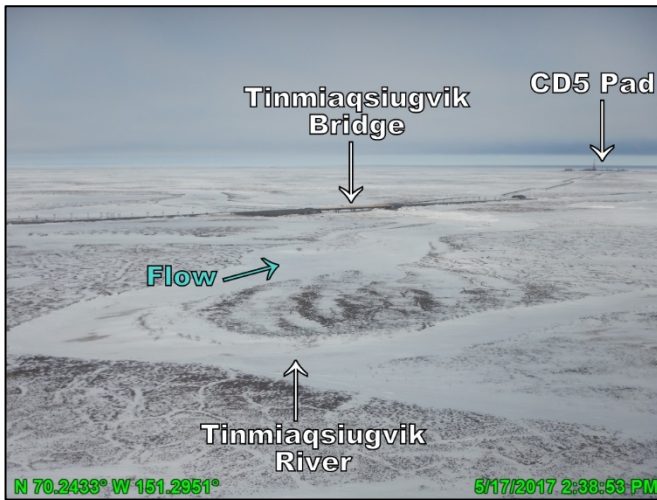
On May 17, minimal local melt was observed on top of channel ice in the Tinmiaqsiugvik River near the GMT1 access road (Photo 3.1). No water was observed moving in the drainage. All other drainages were snow covered and frozen. Snow cover along the GMT1 access road was approximately 90%. By May 23, ponded, local melt was accumulating in the slotted sections of the construction ice roads and ice pads upstream and downstream of the Tinmiaqsiugvik Bridge (Photo 3.2), but no flow was observed. On May 24, local melt was observed accumulating in some of the small drainages, on the upstream side of the Crea Bridge (Photo 3.3), and on the upstream and downstream side of the Barely Creek culvert battery. By this time, approximately 50% of the tundra along the GMT1 access road was exposed.

Photo 3.1: Local melt in the Tinmiaqsiugvik River, looking northeast (downstream); May 17, 2017

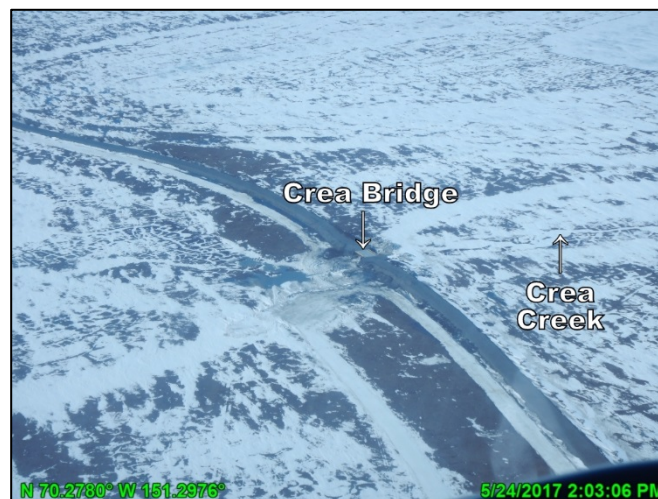
Photo 3.3: Local melt around Crea Bridge, looking west; May 24, 2017

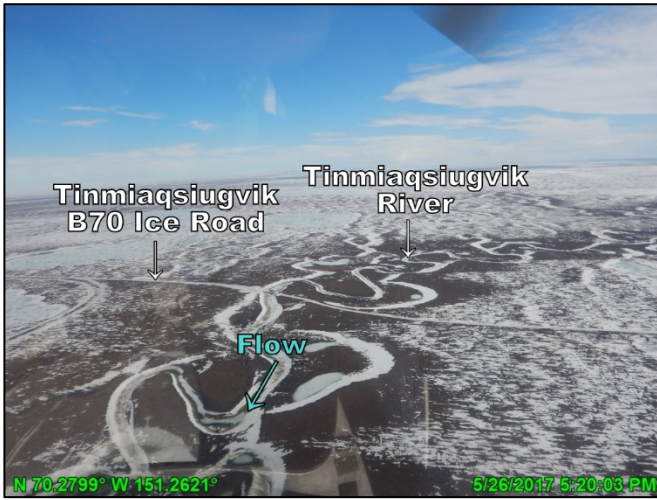
Photo 3.4: Minor flow in the Tinmiaqsiugvik River, looking south (upstream); May 26, 2017

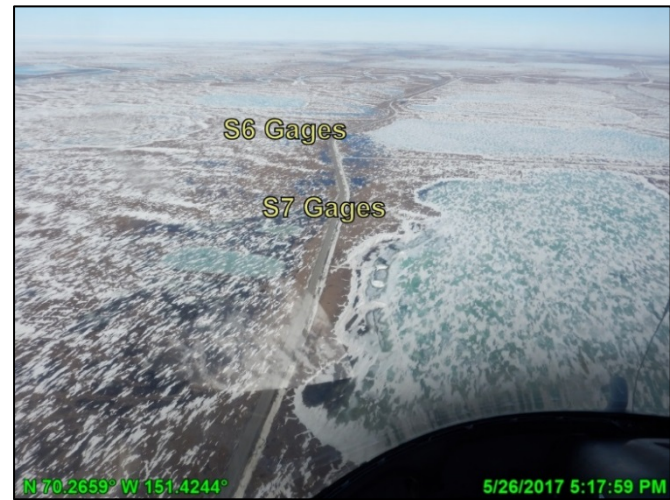
Photo 3.7: Local melt accumulating along GMT1 access road near S6 and S7 gages, looking east; May 26, 2017

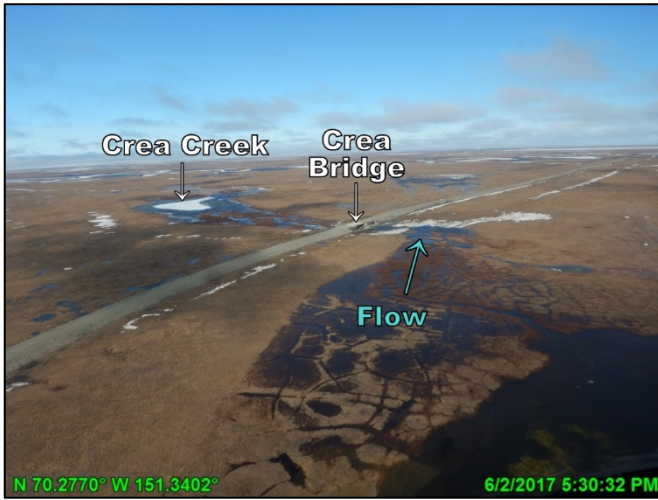
Photo 3.8: Stage receding in Crea Creek, looking northeast (downstream); June 2, 2017

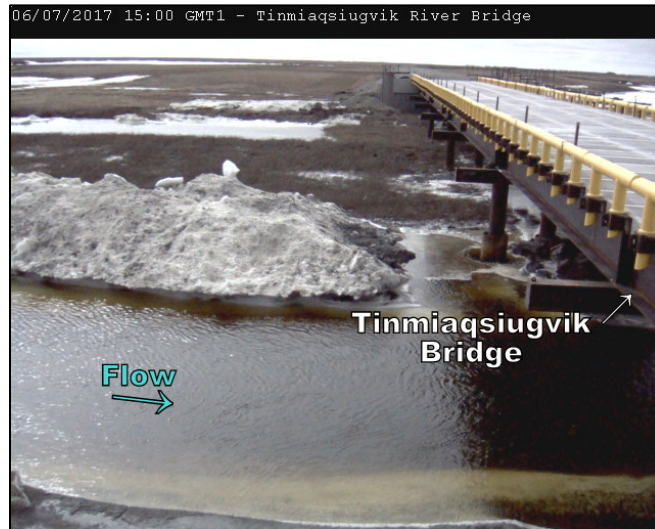
Photo 3.10: Stage receding at the Tinmiaqsiugvik Bridge, looking southwest; June 7, 2017

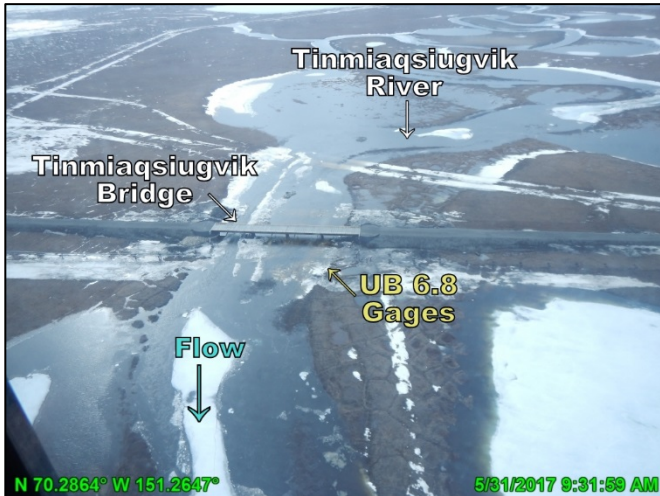
Photo 4.1: Conditions at the Tinmiaqsiugvik Bridge the day of spring peak stage and discharge, looking southeast; May 31, 2017

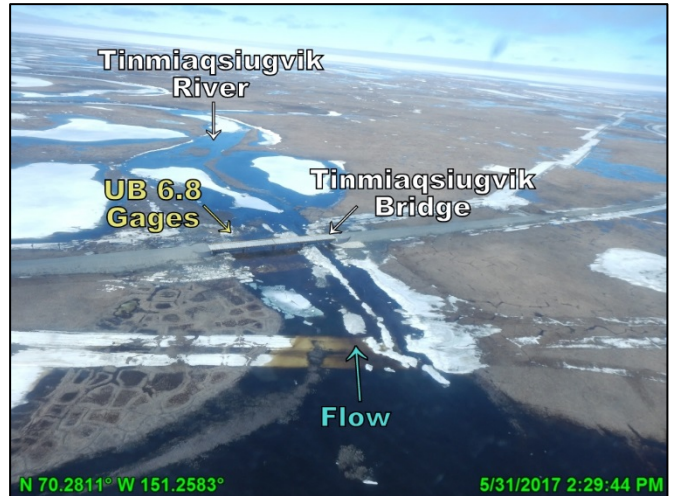
Photo 4.2: Conditions at the Tinmiaqsiugvik Bridge the day of spring peak stage and discharge, looking north; May 31, 2017

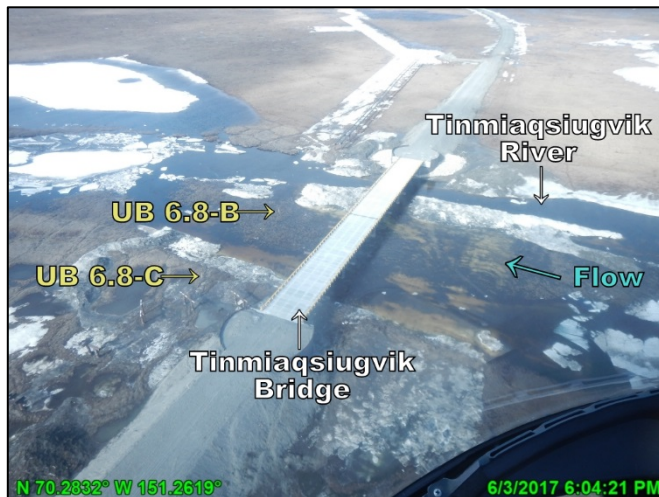
Photo 4.3: Conditions at the Tinmiaqsiugvik Bridge the day of discharge measurement, looking east; June 3, 2017

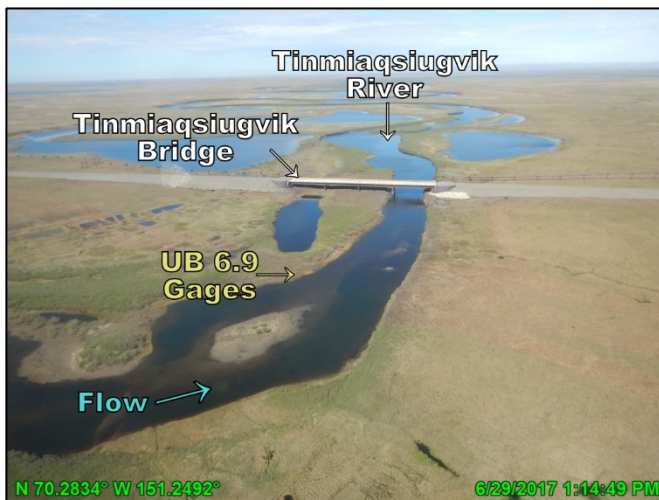
Photo 4.4: Open channel conditions at the Tinmiaqsiugvik Bridge, looking northwest (downstream); June 29, 2017

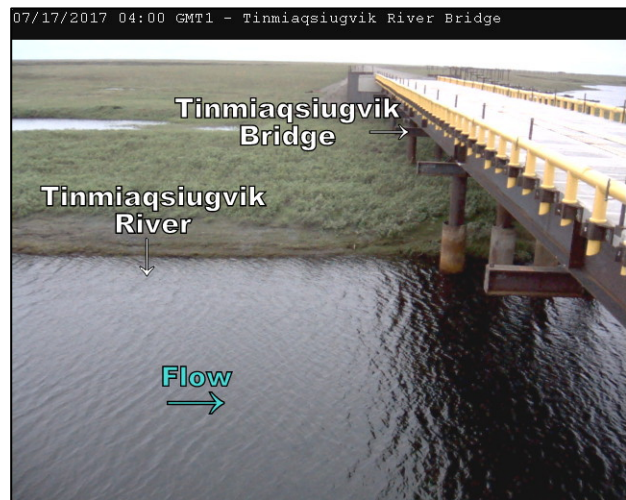
Photo 4.5: Minimum summer stage at the Tinmiaqsiugvik Bridge, looking southwest; July 17, 2017

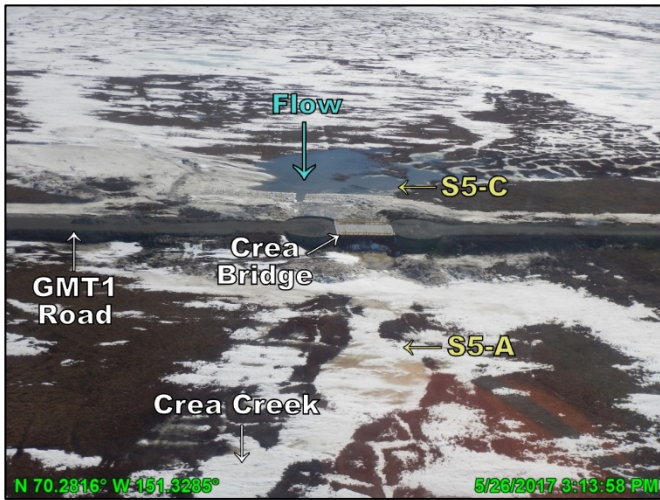
Spring breakup peak stage and discharge at the Crea Bridge were significantly influenced by ice and snow. Isolated meltwater was ponded upstream and downstream of the bridge the day prior to peak stage (Photo 4.9). Peak stage was the result of isolated meltwater which released by carving through the snow under the bridge. This caused a rapid fall of the stage hydrograph at the upstream gage, S5-C, and brief and rapid peak and fall of the stage hydrograph at the downstream gage, S5-A (Photo 4.10).

Photo 4.9: Conditions at the Crea Bridge the day before spring peak stage, looking south (upstream); May 26, 2017

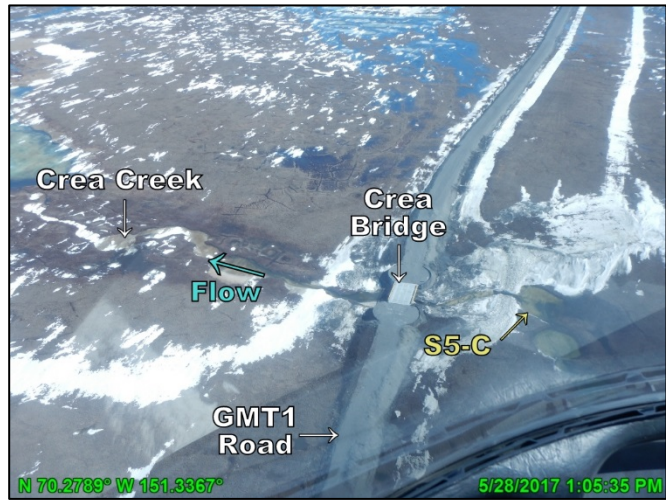
Photo 4.10: Ice and snow influence at the Crea Bridge the day after spring peak stage, looking east; May 28, 2017

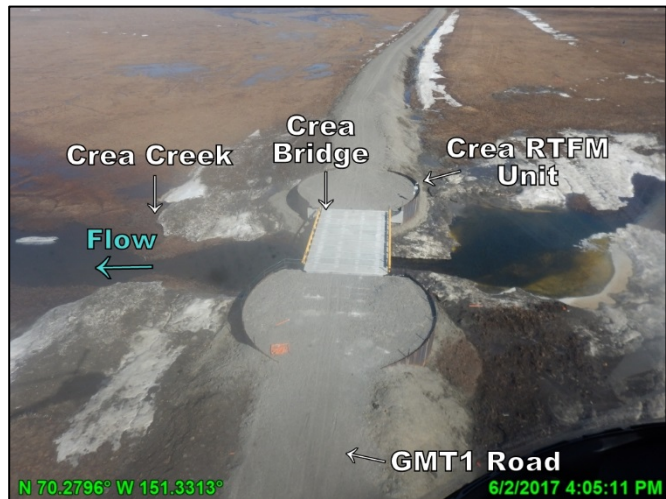
Photo 4.12: Conditions at the Crea Bridge the day of spring discharge measurement, looking east; June 2, 2017

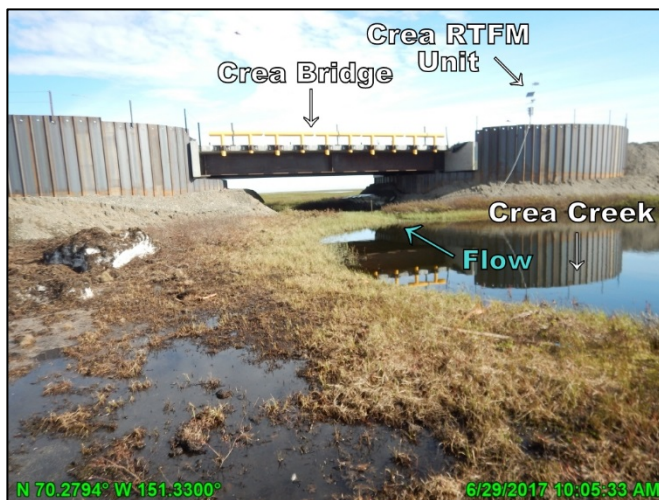
Photo 4.13: Open channel conditions at the Crea Bridge, looking northeast (downstream); June 29, 2017

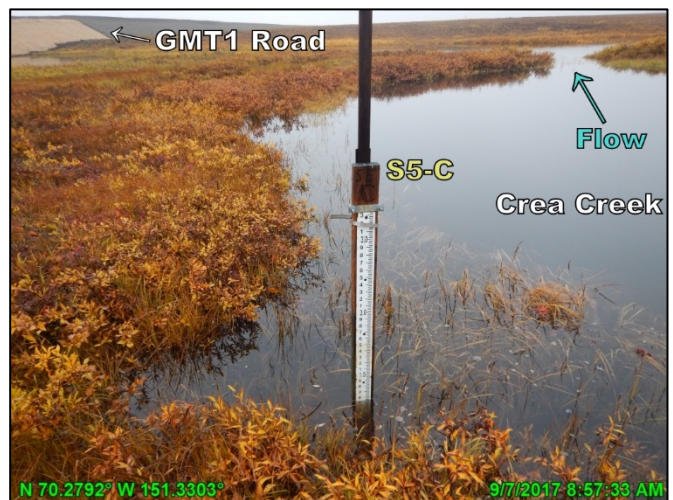
Peak discharge coincided with peak stage (Photo 4.14). It was calculated using the cross-section profiled during the direct discharge measurement, which was ice and snow-free. The estimated peak discharge was assigned a good quality rating (Table 2.2) based on those conditions.

Photo 4.14: Peak summer stage and discharge at the Crea Bridge upstream gage S5-C, looking northeast; September 7, 2017

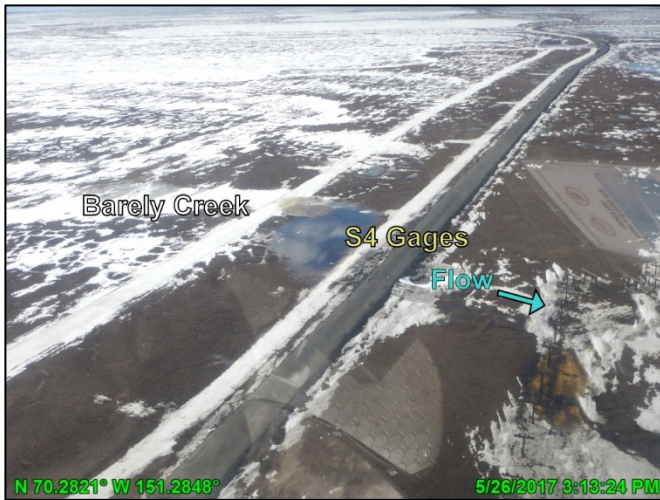
Photo 4.15: Conditions at the Barely Creek culvert battery the day of spring peak stage at gage S4-C, looking west; May 26, 2017

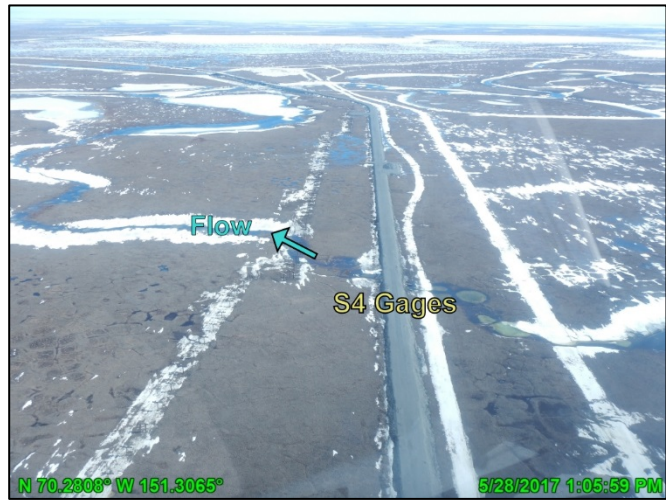
Photo 4.16: Flow through the Barely Creek culvert battery, looking east; May 28, 2017

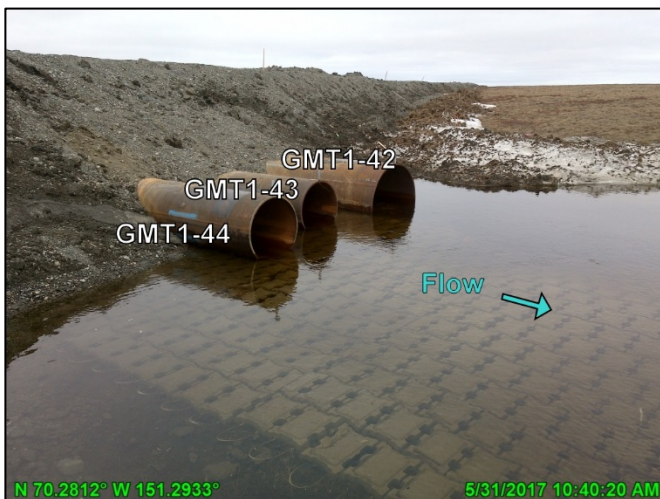
Photo 4.17: Conditions at the Barely Creek culvert battery outlet the day of spring peak discharge, looking west; May 31, 2017

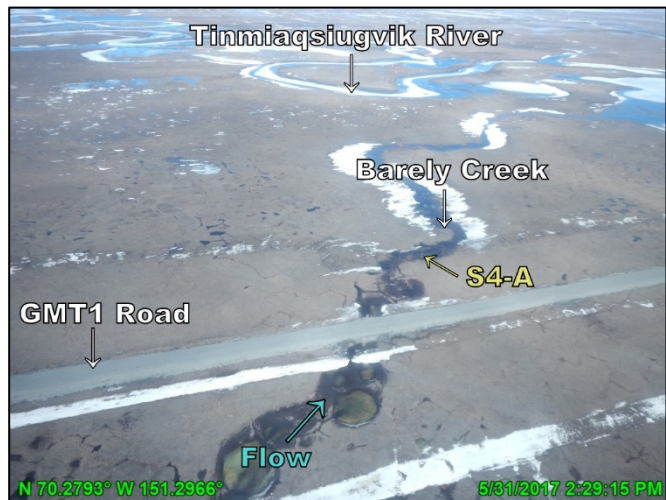
Photo 4.18: Conditions at the Barely Creek culvert battery the day of spring peak discharge, looking northeast (downstream); May 31, 2017

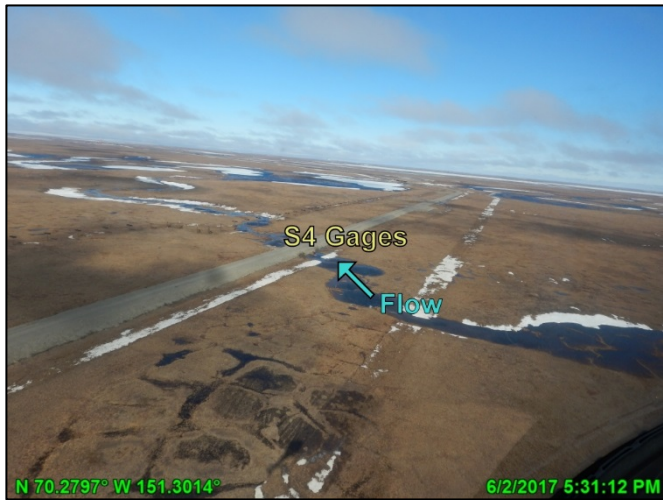
Photo 4.19: Generally open channel conditions at Barely Creek the day of spring measured discharge, looking northeast; June 2, 2017

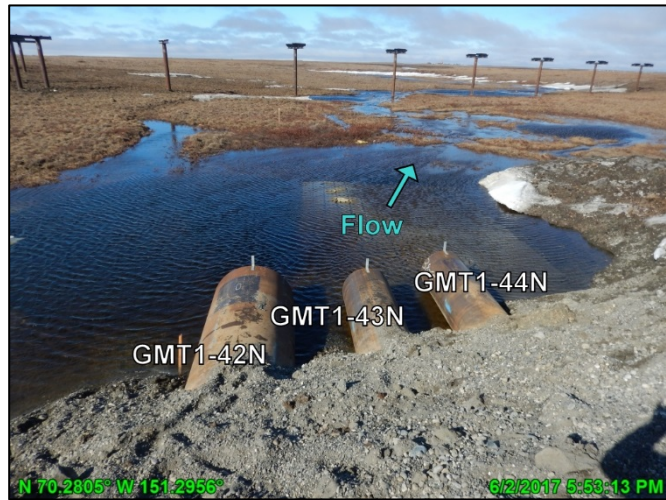
Photo 4.20: Barely Creek culvert battery the day of spring measured discharge, looking northeast (downstream); June 2, 2017

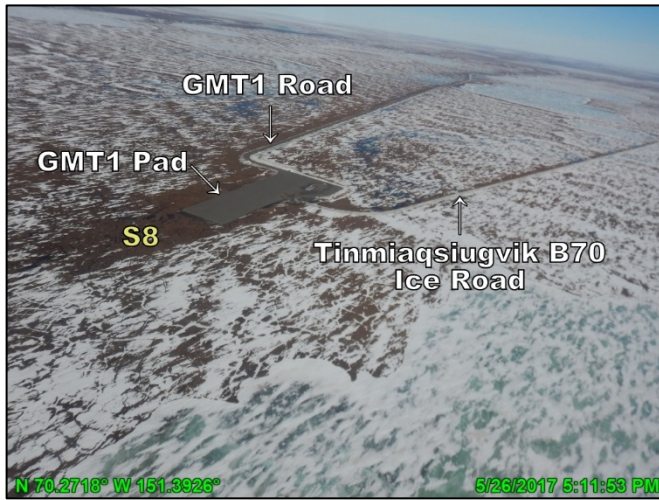
Photo 4.37: Local melt at gage S8 and GMT1 pad, looking northeast; May 26, 2017

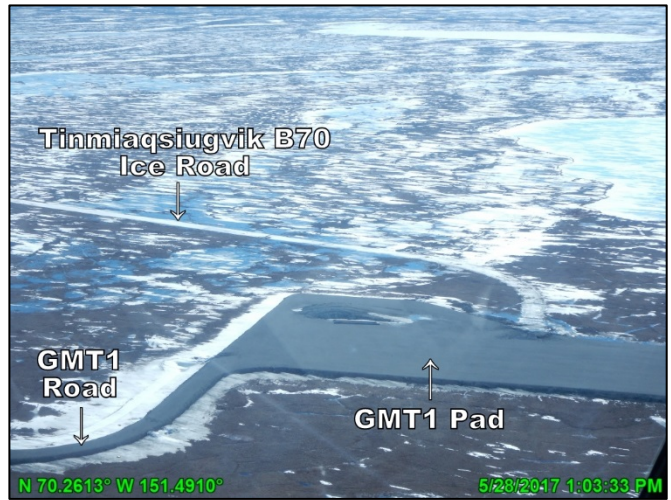
Photo 4.38: Local melt at GMT1 pad, looking south; May 28, 2017

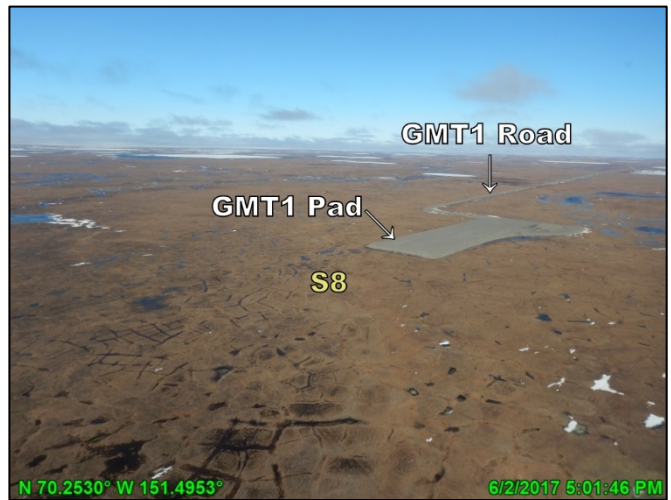
Photo 4.40: Local melt at gage S8 and GMT1 pad, looking northeast; June 2, 2017

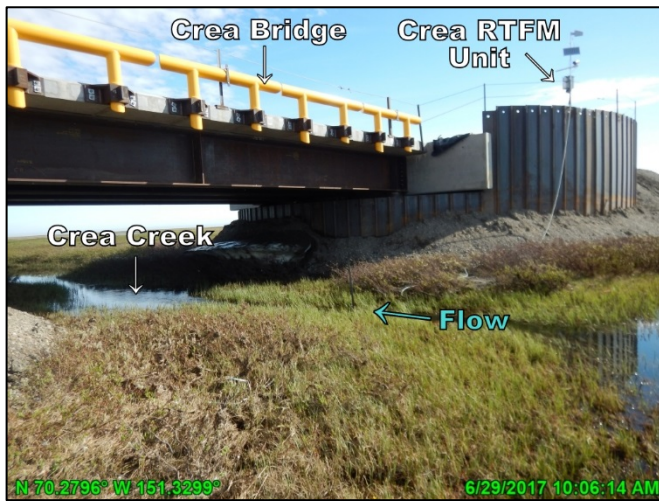
Photo 7.1: Crea Bridge right (east) abutment, looking northeast (downstream); June 29, 2017

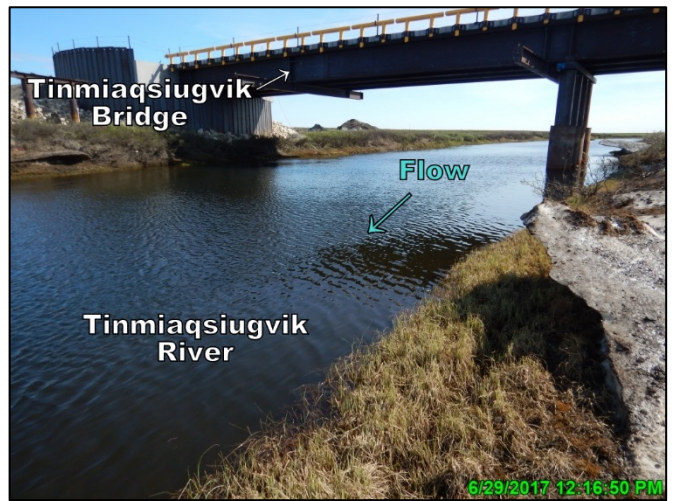
Photo 7.2: Tinmiaqsiugvik Bridge right (east) abutment and east bank, looking southeast (upstream); June 29, 2017

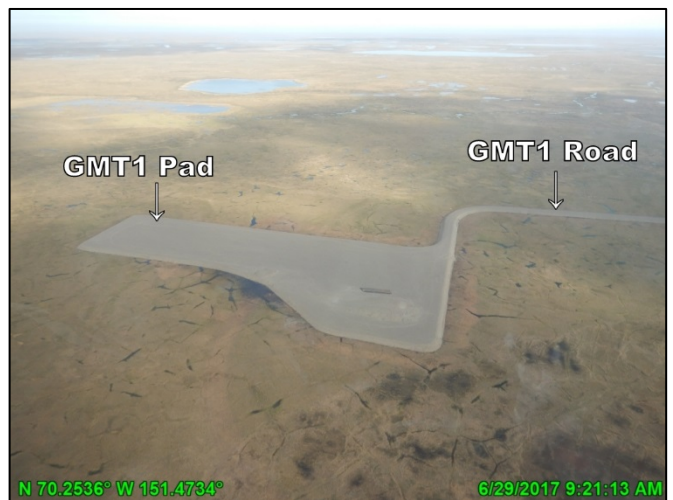
Photo 7.4: GMT1 pad, looking northwest; June 29, 2017
