2018

COLVILLE RIVER DELTA SPRING BREAKUP MONITORING & HYDROLOGICAL ASSESMENT

Michael Baker
INTERNATIONAL

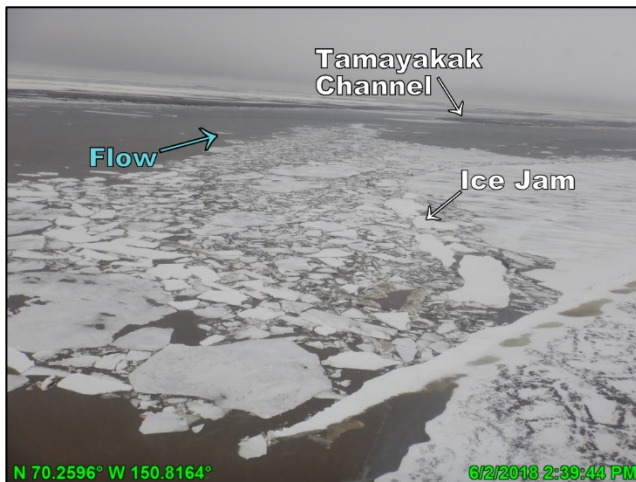
Photo 3.9: Ice jam on the East Channel downstream of MON9, near the Tamayayak tributary, looking north; June 2, 2018

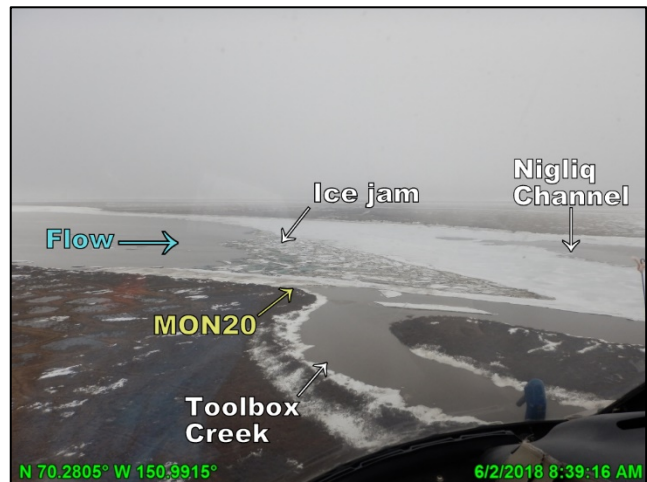
Photo 3.10: Ice jam on the Nigliq Channel near MON20, looking south; June 2, 2018

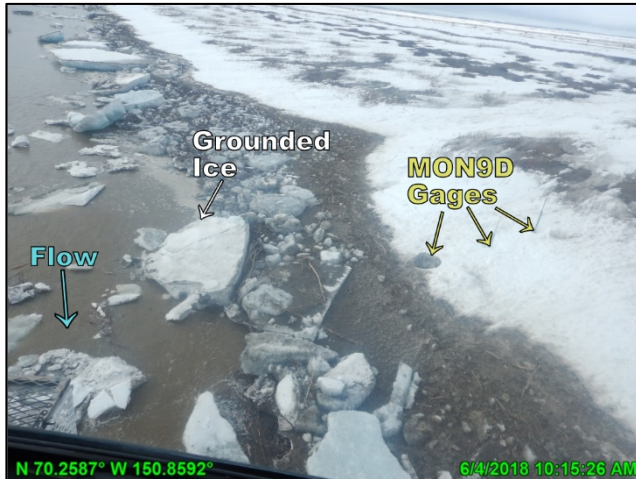
Photo 3.11: Grounded ice at MON9D following stage recession, looking south; June 4, 2018

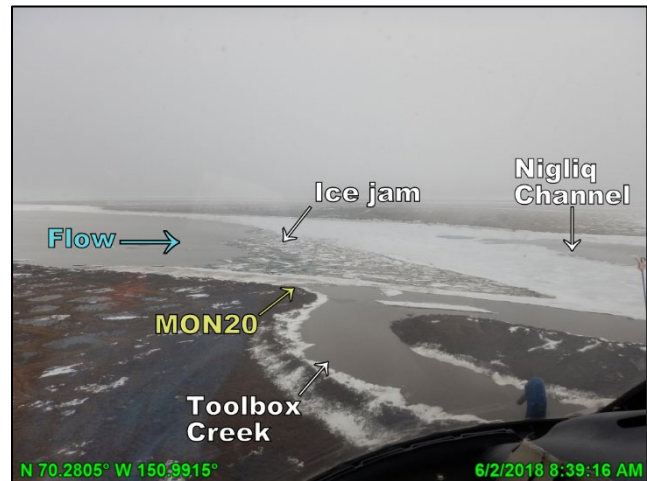
Photo 4.13: Ice jam and conditions the day prior to peak stage at MON20, looking southwest (upstream); June 2, 2018

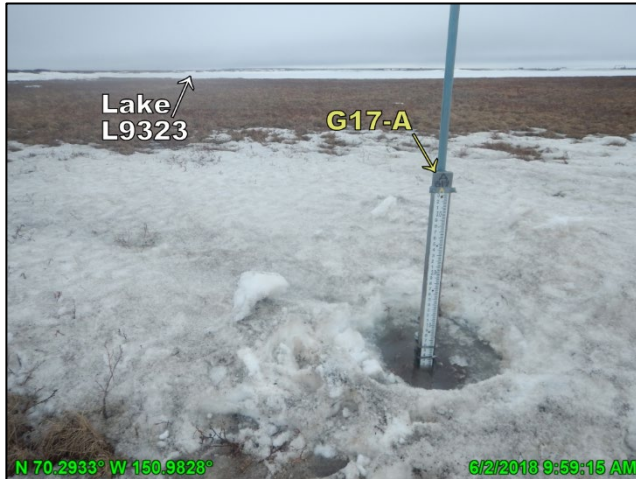
Photo 4.28: CD4 road at gage G17 showing dry conditions, looking northwest; June 2, 2018

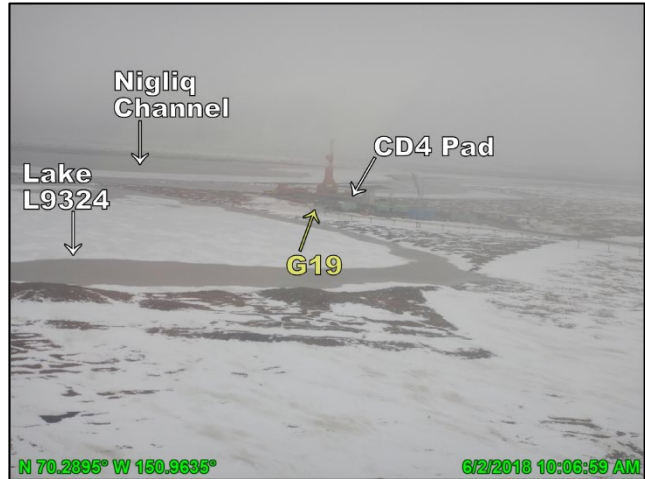
Photo 4.29: CD4 pad at gage G19 showing dry conditions, looking northwest; June 2, 2018

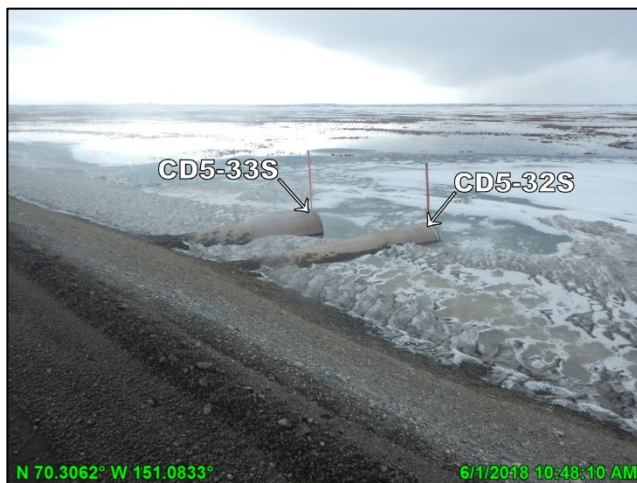
Photo 4.37: Culvert CD5-32S and CD5-33S along the CD5 road, looking southeast; June 1, 2018

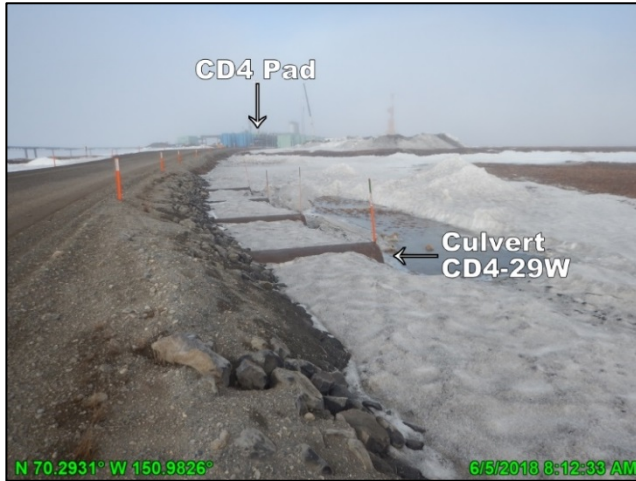
Alpine road and pads were inspected for erosion between June 4 and June 6 (Photo 5.1 through Photo 5.4). Other than minor washlines, no discernable erosion was observed during aerial and ground reconnaissance of the CD2, CD4, and CD5 roads. Floodwaters did not reach CD5 bridge abutments or the CD5 road within the CRD. A prominent washlines from 2015 spring breakup was evident along portions of the CD2, CD4, and CD5 roads. There were no signs of sloughing or undermining at drainage structures. Additional photo documentation of erosion surveys and breakup conditions along the Alpine facilities roads and pads are shown in Appendix D.

Photo 5.1: North side of CD4 road near CD4 pad, looking west; June 5, 2018
