2018 GREATER MOOSE'S TOOTH 1  
(GMT1) SPRING BREAKUP

# CULVERT MONITORING REPORT

**Michael Baker**  
INTERNATIONAL

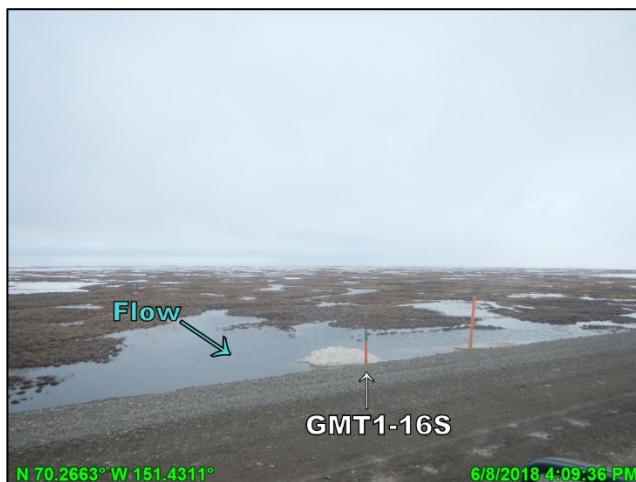
No performance issues were identified at any culverts conveying flow along the GMT1 access road. Temporary ponded water was present in drainages at several locations along the access road but was attributed to snow or culvert bladders frozen in place impeding flow and not culvert placement (Photo 1 and Photo 2).

Photo 1: Local ponding at culvert GMT1-16 on south side of GMT1 access road, looking south; June 8, 2018

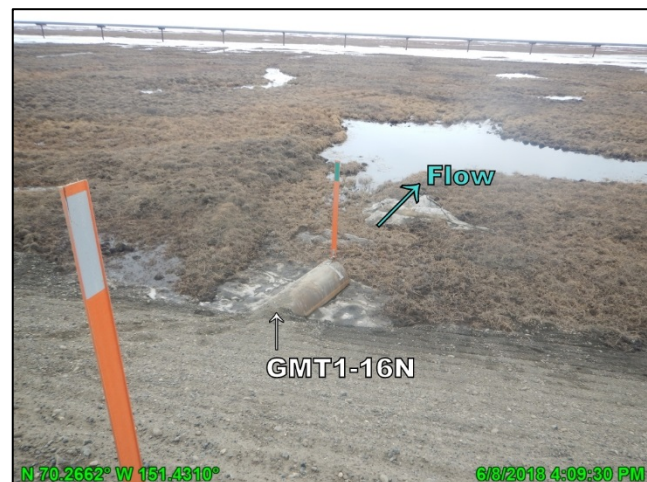
Photo 2: Culvert GMT1-16 on north side of GMT1 access road dry because a culvert bladder blocked flow, looking north; June 8, 2018

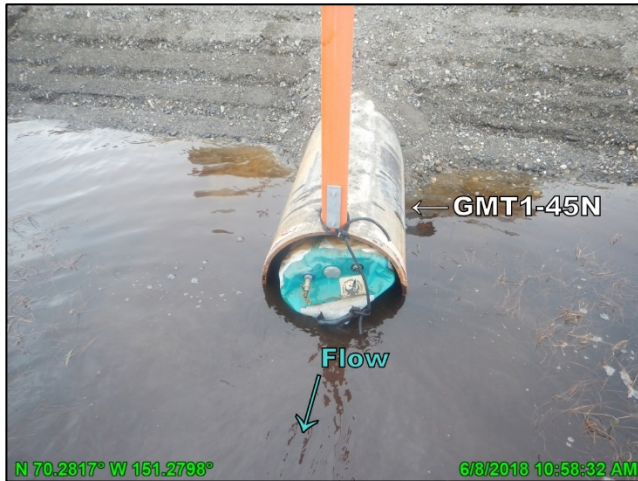
After snow was manually cleared in late April, drifting snow was observed burying the culverts. In addition, late spring snowfall events also contributed to blocked culverts. Some culvert bladders, in place to block snow from entering culverts during the winter, froze into the culverts during a freeze thaw cycle in mid May and impeded water flow (Photo 3 through Photo 5). Once conveyance paths were established through either removing culvert bladders or meltwater naturally cutting through snow/ice, the culverts all performed as designed and natural drainage patterns were maintained (Photo 6 and Photo 7). No displacement of uncompacted gravel fill attributed

Photo 3: Culvert GMT1-45 on north side of GMT1 access road with culvert bladder blockage, looking south; June 8, 2018

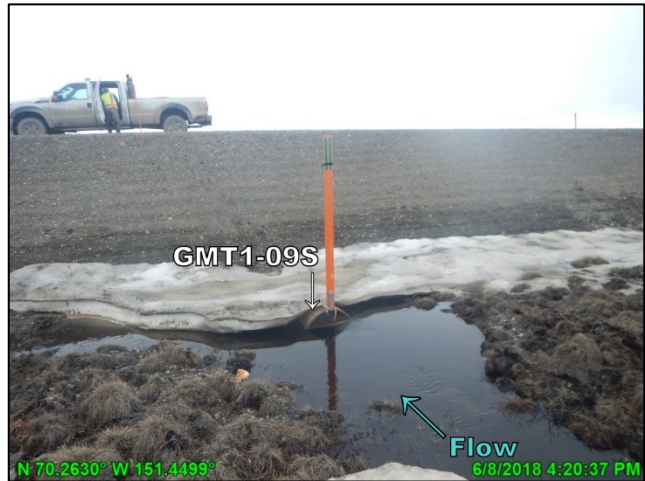
Photo 4: Culvert GMT1-09 on south side of GMT1 access road with culvert bladder blockage, looking north; June 8, 2018

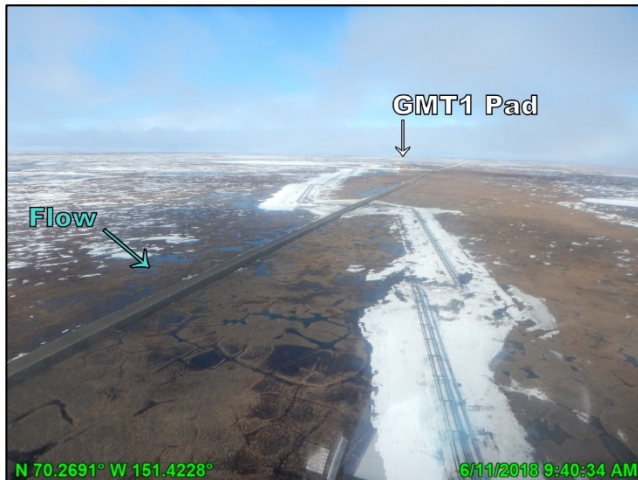
Photo 5: Ponded water on upstream side of GMT1 access road, looking west; June 11, 2018

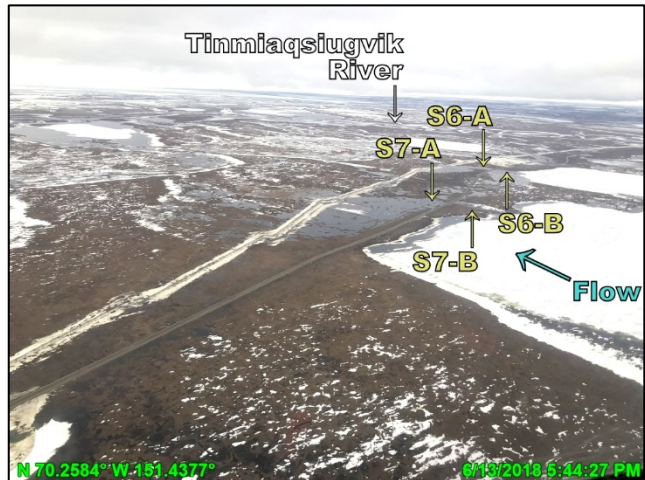
Photo 6: Water equalizing across the GMT1 access road, looking northeast; June 13, 2018

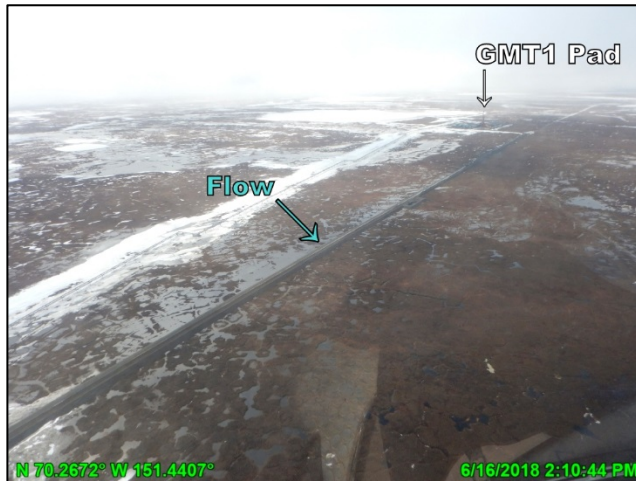
Photo 7: Water equalizing across the GMT1 access road, looking southwest; June 16, 2018

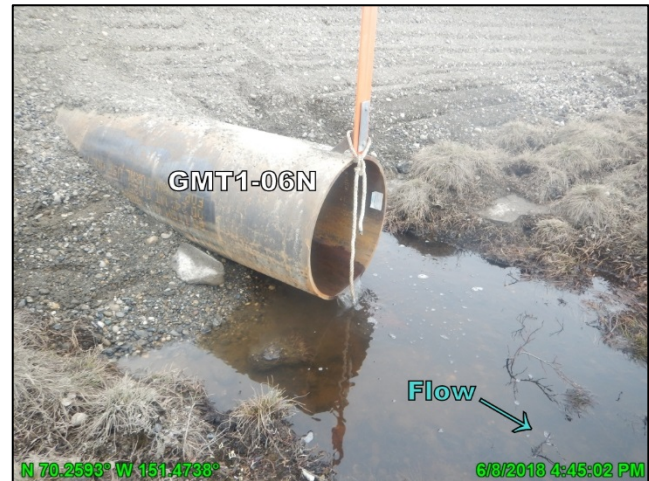
with spring breakup flooding was observed along the road embankment or around culvert inlets and outlets. There were no signs of sloughing or undermining at drainage structures and no stream channel changes were observed at access road crossings. With the exception of a culvert, GMT1-06, (Photo 8) perched on the north (DS) side of the road that may lead to the development of a scour hole at the outlet, no discernable culvert maintenance, repair, upgrade, setting adjustments, and/or replacements are recommended at this time.

Photo 8: Culvert GMT1-06 perched on the north (DS) side of the GMT1 access road; June 8, 2018

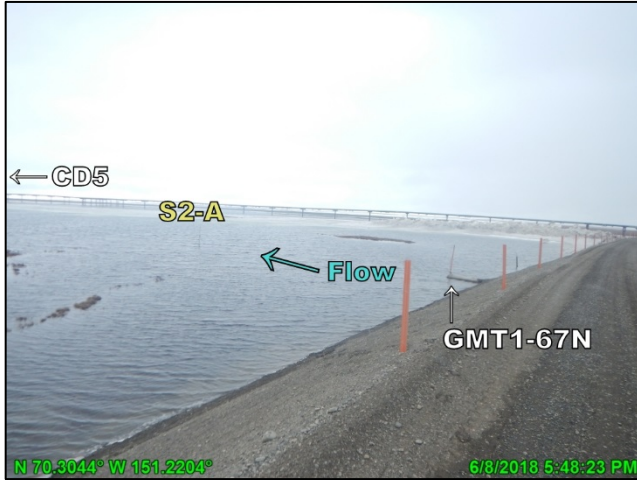
Photo F.1: Culvert GMT1-67 on north side of GMT1 access road, looking east; June 8, 2018

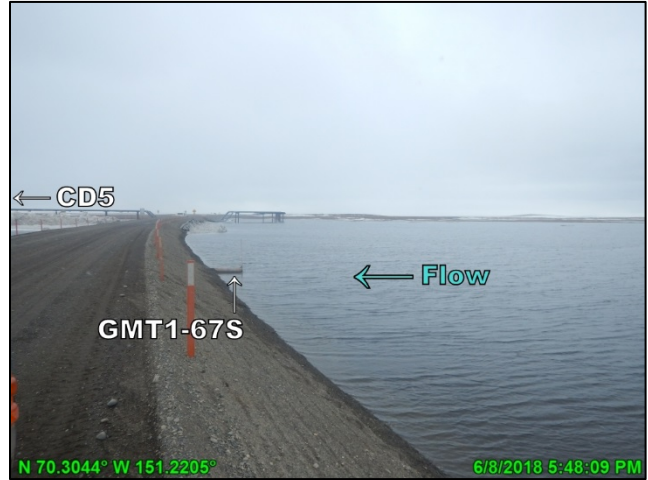
Photo F.2: Culvert GMT1-67 on south side of GMT1 access road, looking east; June 8, 2018

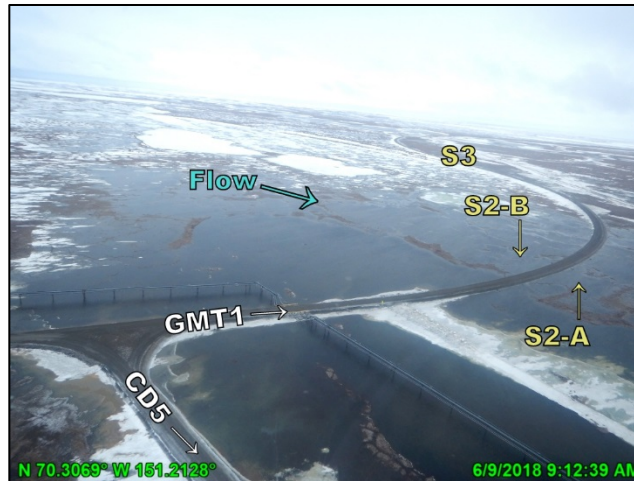
Photo F.3: GMT1 access road at CD5 intersection, looking southwest; June 9, 2018

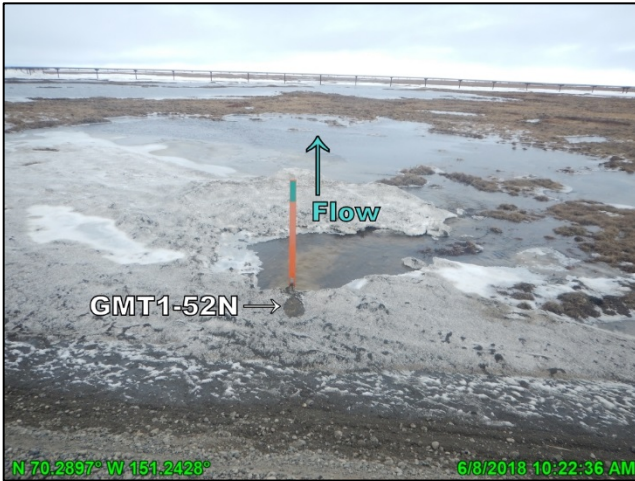
Photo F.4: Culvert GMT1-52 on north side of GMT1 access road, looking west; June 8, 2018

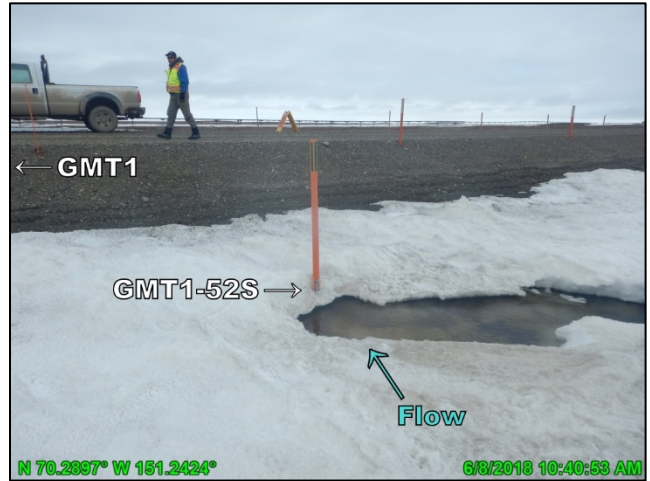
Photo F.5: Culvert GMT1-52 on south side of GMT1 access road, looking west; June 8, 2018

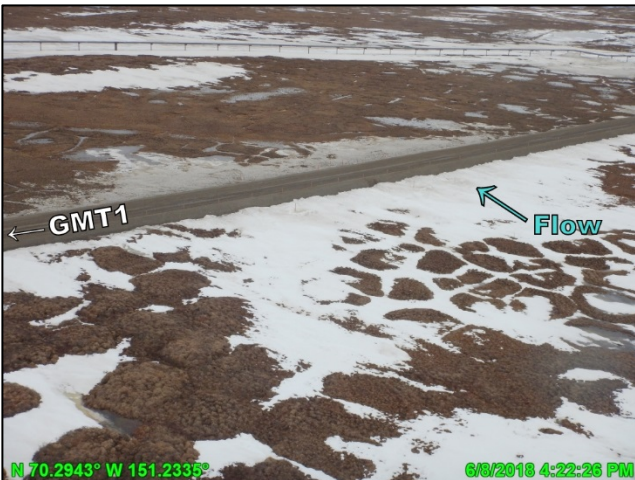
Photo F.6: Limited melt near S3 monitoring location, looking northeast; June 8, 2018

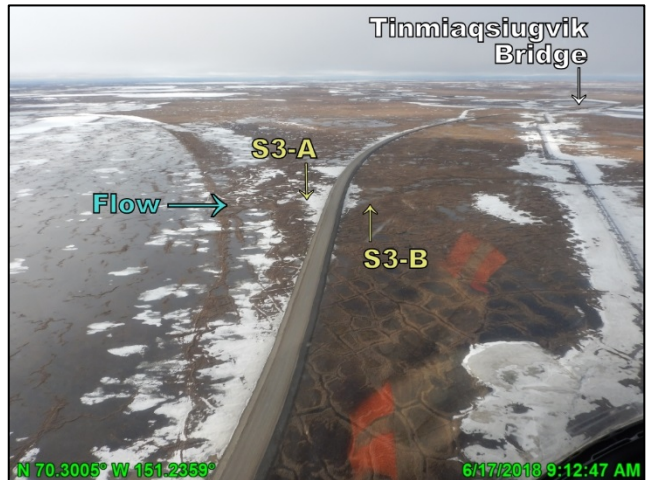
Photo F.7: Limited melt near S3 monitoring location, looking southwest; June 17, 2018

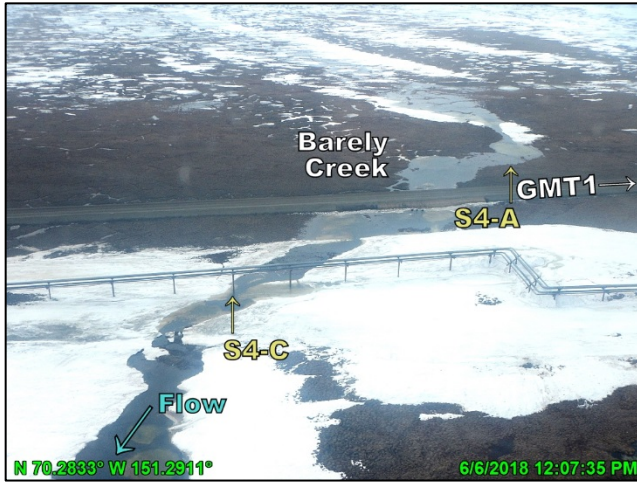
Photo F.8: Drainage at the S4 monitoring location (Barely Creek), looking southwest; June 6, 2018

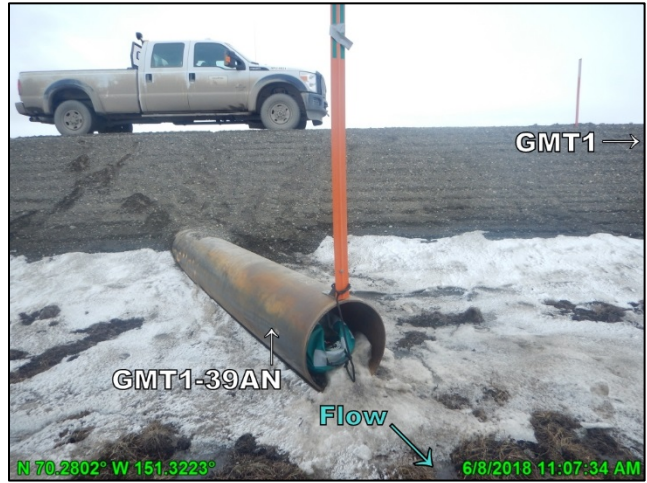
Photo F.9: Culvert GMT1-39A on north side of GMT1 access road with culvert bladder still inside, looking south; June 8, 2018

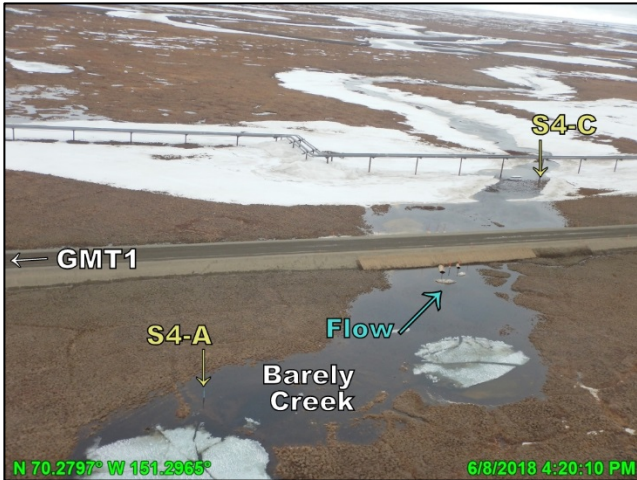
Photo F.10: Drainage at the S4 monitoring location (Barely Creek), looking northeast; June 8, 2018

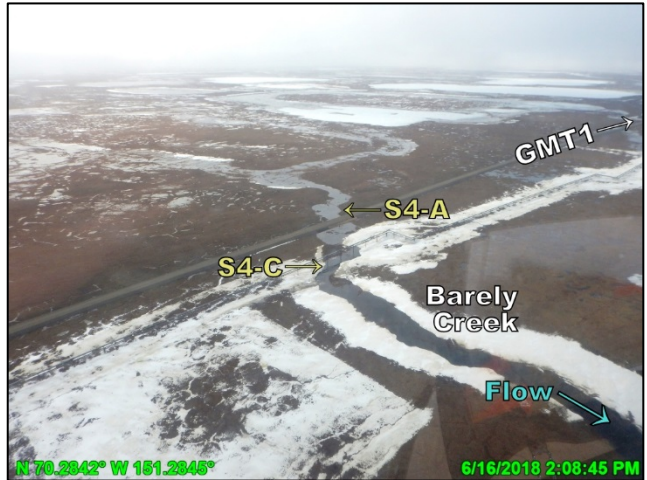
Photo F.11: Drainage at the S4 monitoring location (Barely Creek), looking southwest; June 16, 2018

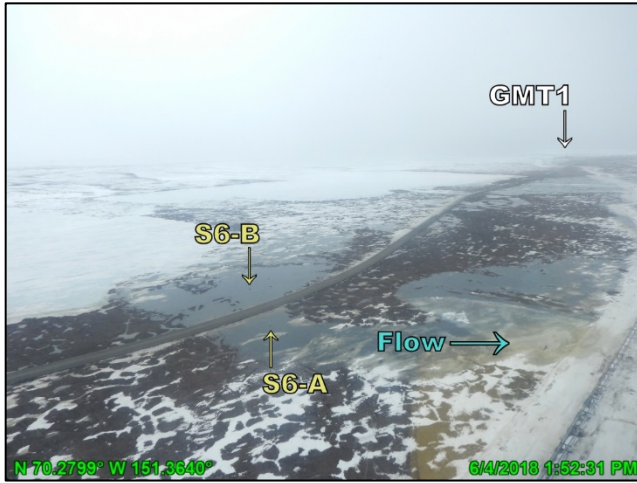
Photo F.12: Drainage equalized on both sides of the GMT1 access road near S6 monitoring location, looking southwest; June 4, 2018

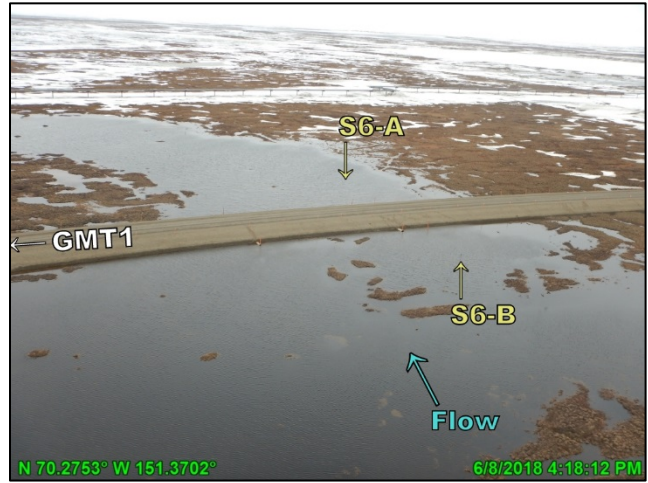
Photo F.13: Culverts GMT1-32 and GMT1-33, looking north; June 8, 2018

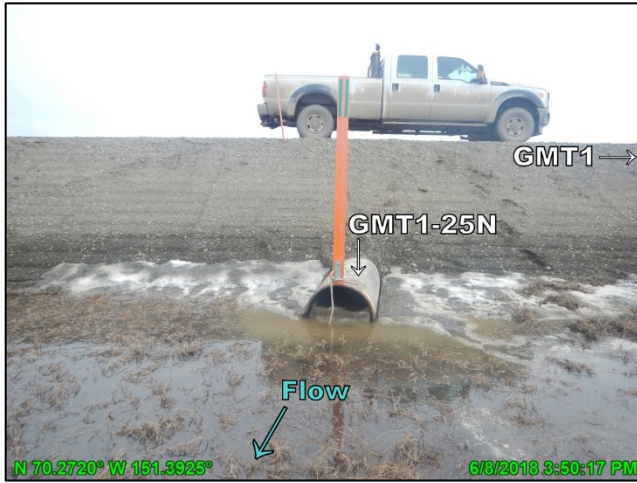
Photo F.14: Culvert GMT1-25 on north side of GMT1 access road blocked, looking south; June 8, 2018

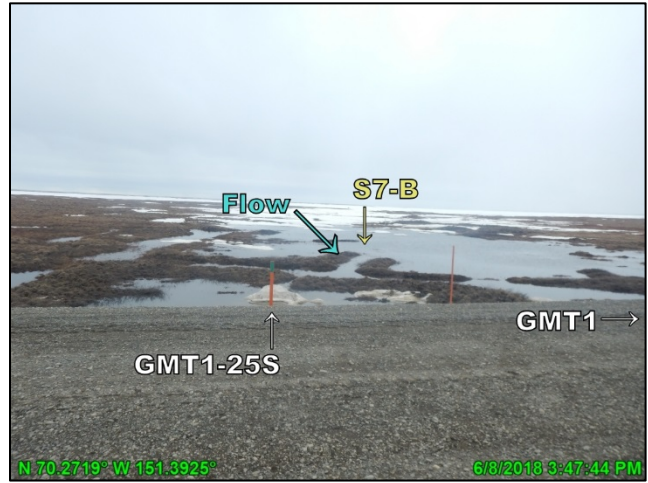
Photo F.15: Culvert GMT1-25 on south side of GMT1 access road with ponded water, looking south; June 8, 2018

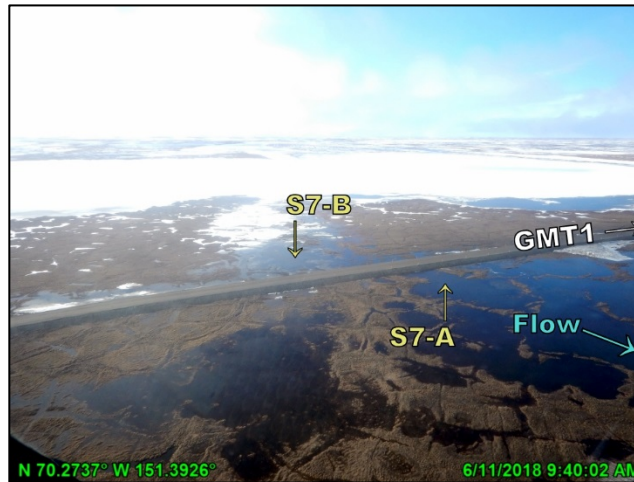
Photo F.16: Drainage equalized on both sides of the GMT1 access road near S7 monitoring location, looking southwest; June 11, 2018
