2018

GMT1 SPRING BREAKUP & SUMMER MONITORING & HYDROLOGICAL ASSESSMENT

Michael Baker

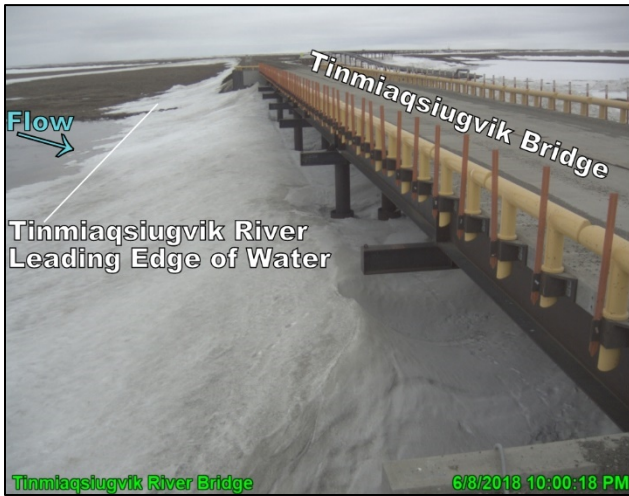
Prior to the onset of the 2018 spring breakup flooding, drifted snow was observed obstructing the Tinmiaqsiugvik Bridge opening. On the downstream side of the bridge, the construction ice pads had been excavated, leaving two large rectangular shaped basins. On June 4, local melt initially drained into and filled the excavated basins prior to the arrival of upstream floodwater. When the leading edge of floodwater reached the bridge on June 8, the drifted snow under the bridge impeded flow through the bridge opening (Photo 4.1). On June 9 peak stage was recorded. Flow was observed tunneling under the snow drift and plunging into the basin left by ice removal, evident by surface boils just downstream of the bridge. Significant backwater and overbank flooding was observed on the south (upstream) side of the GMT1 road. Snow was present both in the channel and along the banks (Photo 4.2). Aerial observations from June 11 and 14 show similar conditions to those observed on June 9, with drifted snow stretching along the length of the bridge and floodwater tunneling underneath the snowpack (Photo 4.3). On June 17, a lower stage crest was measured and flow conditions remained unchanged, though melt progression of the snow drift was apparent. By June 19, drifted snow was still present under the length of the bridge, albeit minimal, and flow was generally well-confined within the channel (Photo 4.4).

Photo 4.1: Tinmiaqsiugvik Bridge, looking west June 8, 2018

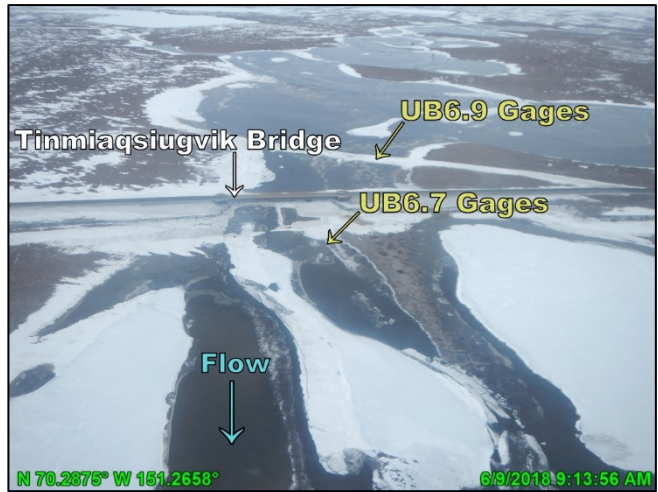
Photo 4.2: Backwater upstream of the Tinmiaqsiugvik Bridge, looking south; June 9, 2018

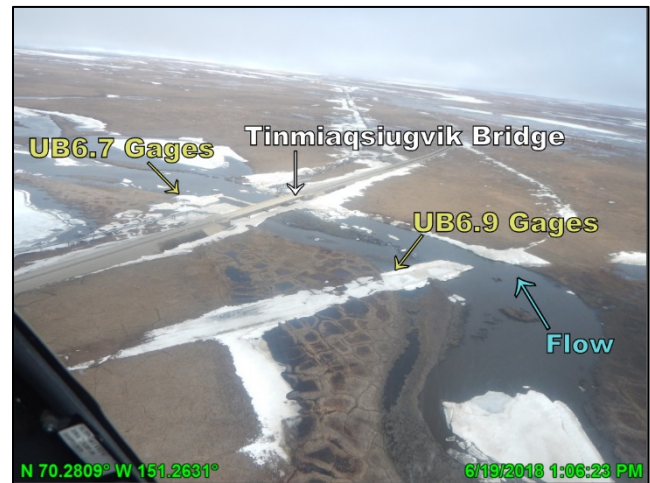
Photo 4.4: Tinmiaqsiugvik Bridge, looking northeast; June 19, 2018

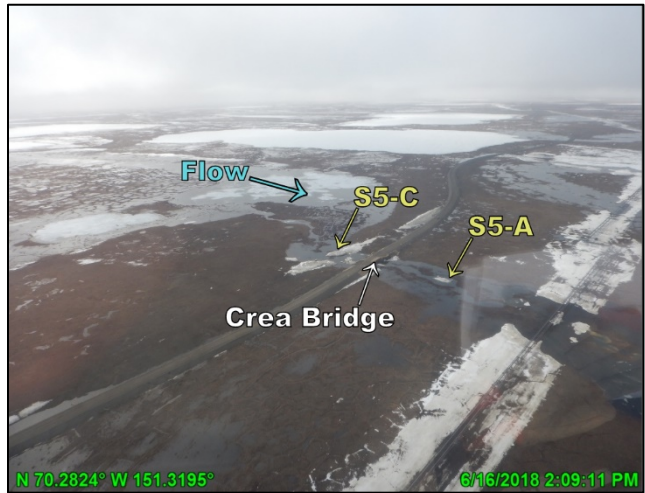
Peak discharge is estimated to have occurred as stage crested on the downstream gage on June 15 and was calculated using the open channel cross-section measured during the direct discharge measurement on June 16. The estimated peak discharge was assigned a fair to poor quality rating due to the influence of snow and ice observed during peak conditions and the direct measurement against which indirect calculations were calibrated. Indirect discharge calculated at the time of direct measurement was 4.3% less than the measured discharge.

Photo 4.10: Crea Bridge the day of the discharge measurement, looking southwest; June 16, 2018

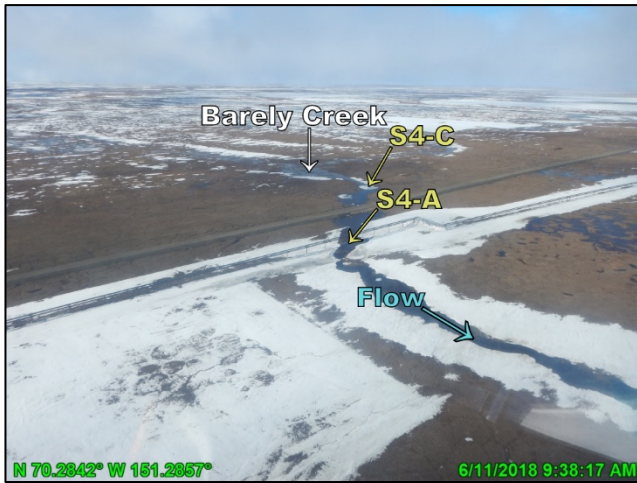
Conditions remained consistent through the next week, with a slow decline in stage observed. On June 11, snow on the surrounding tundra had decreased, but significant snow cover was still observed along the banks on the north side of the road (Photo 4.13). Meltwater had filled the Lake 9824 basin by this day. On June 18, some snow remained along the banks on the north side of the road, but the total snow cover in the drainage area was less than 10% (Photo 4.14). Bankfull conditions persisted through the end of monitoring on June 19.

Photo 4.13: Barely Creek, looking southwest (upstream); June 11, 2018

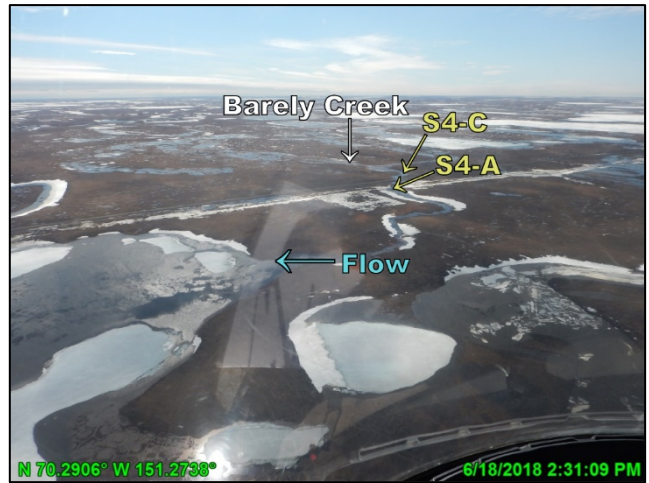
Photo 4.14: Barely Creek, looking south (upstream); June 18, 2018

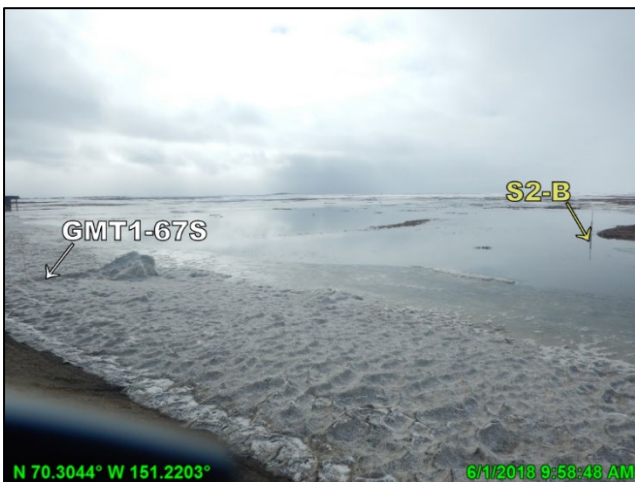
On June 1, ponded meltwater was observed at the upstream (S2-B) gage on the south side of the GMT1 access road (Photo 4.19). Snow initially blocked the culverts from conveying flow and minimal local melt was observed at the downstream (S2-A) gage on the north side of the road (Photo 4.20). Observations from the evening of June 3 show significant meltwater at both S2 gages. PT data suggests that the culvert impediment was cleared early on June 3, as similar and concurrent stage trends between gage sites indicate a hydraulic connection was established through the culverts.

Photo 4.19: S2, looking south (upstream) June 1, 2018

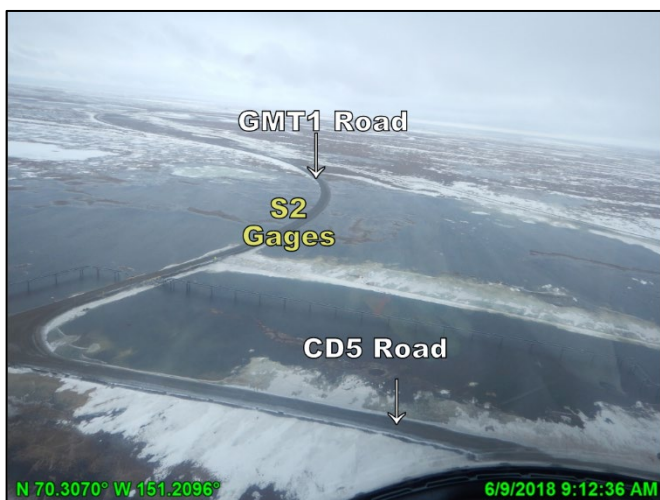
Stage increased consistently from June 4 till late June 8 and early June 9, when peak stage was recorded at the upstream and downstream gages, respectively. Observations from June 9 show hydraulically equalized conditions on each side of the road with culverts conveying flow from south to north (Photo 4.21). As upstream and downstream stage decreased after June 9, a hydraulic gradient developed and flow through the culverts increased. Meltwater was still observed at the gage sites on June 17 and minimal snow remained in the surrounding area (Photo 4.22).

Photo 4.21: Peak stage conditions at S2, looking west; June 9, 2018

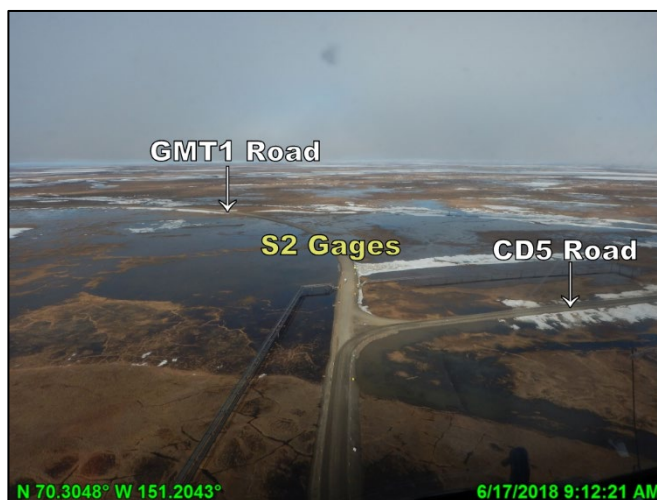
Photo 4.22: S2, looking west; June 17, 2018

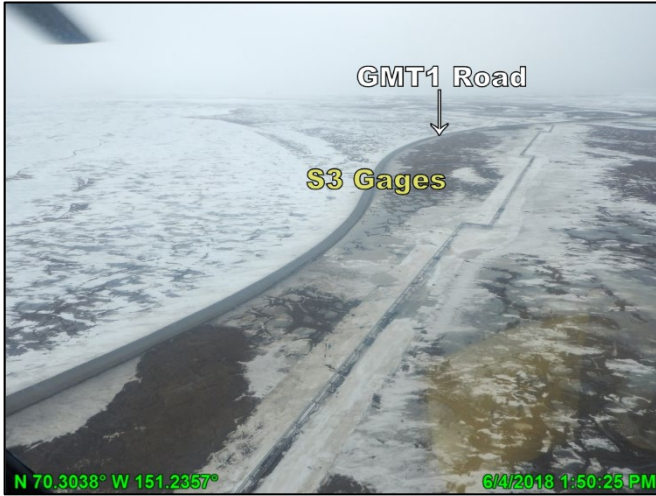
The S3 monitoring station did not see appreciable water during the 2018 monitoring period (Photo 4.23 and Photo 4.24). Initial local melt was observed on the downstream (S3-A) gage on May 14, and the upstream gage recorded a small amount of local melt on June 6 but was dry again two days later. Peak stage was recorded at the downstream gage on June 1 and was the result of local melt around the gage site.

Photo 4.23: S3, looking south; June 4, 2018

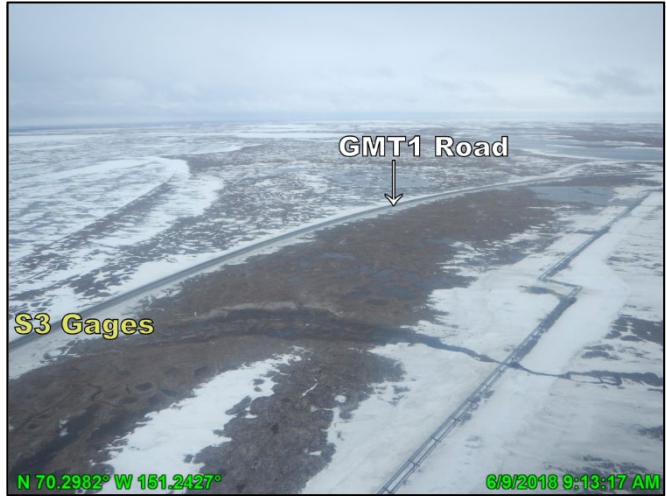
Photo 4.24: S3, looking south; June 9, 2018

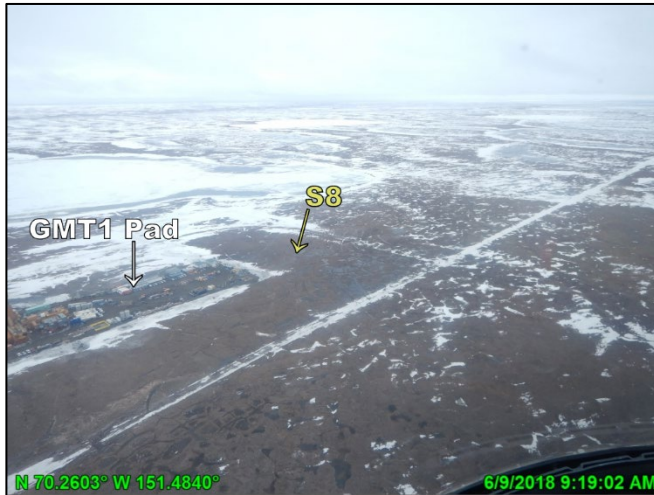
No rise in stage was observed at the G8 gage station. Surrounding meltwater was present but the gage and PT remained dry (Photo 4.31 and Photo 4.32).

Photo 4.31: S8, looking southwest; June 9, 2018

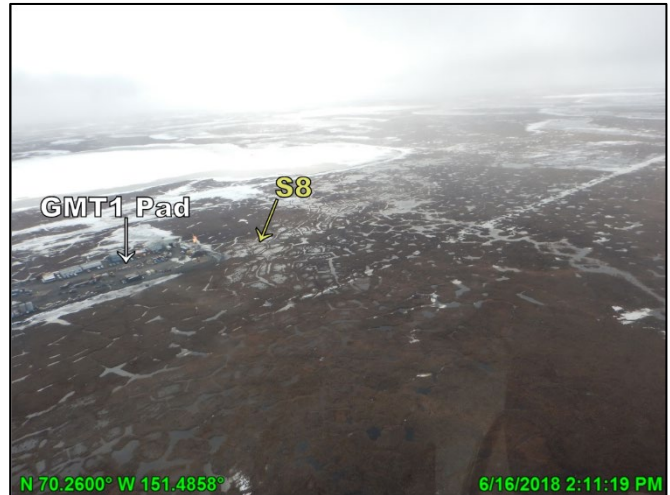
Photo 4.32: S8, looking southwest; June 16, 2018

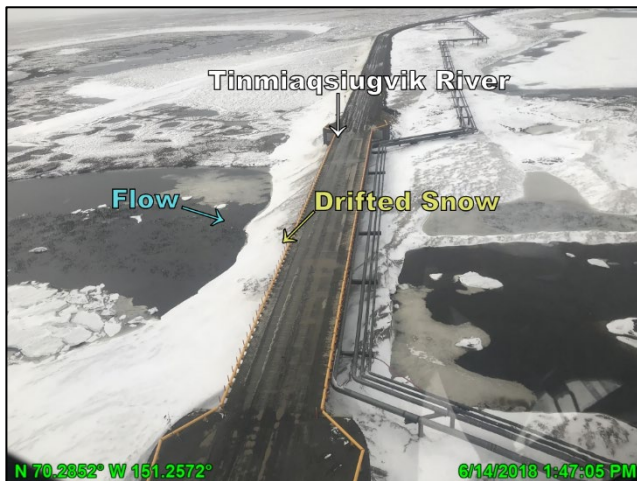
The drifted snow observed beneath the Tinmiaqsiugvik Bridge had a notable impact to water levels during spring breakup. As described in section 4.1, aerial observations suggest floodwater was backed up behind the bridge before tunneling through the drifted snow. Backwater receded once drainage through the bridge opening was established, however, the drifted snow beneath the bridge remained intact throughout breakup, concentrating flow along the east abutment (Photo 6.1 and Photo 6.2).

Photo 6.1: Drifted snow remaining intact and flow concentrated along the east abutment at the Tinmiaqsiugvik Bridge, looking west; June 14, 2018

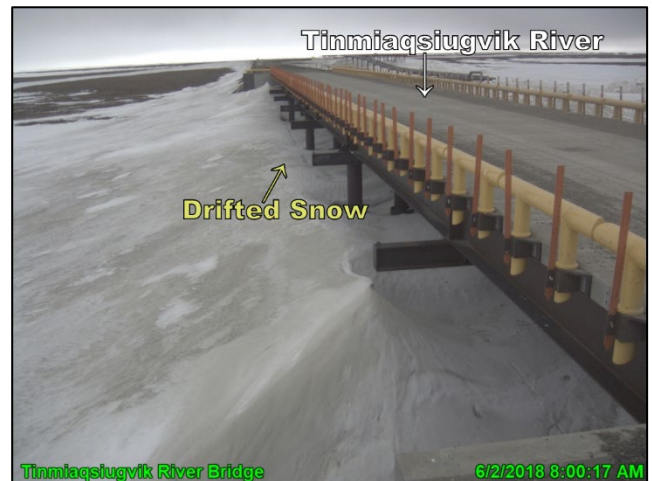
Photo 6.2: Drifted snow remaining under the Tinmiaqsiugvik Bridge, looking west; June 2, 2018

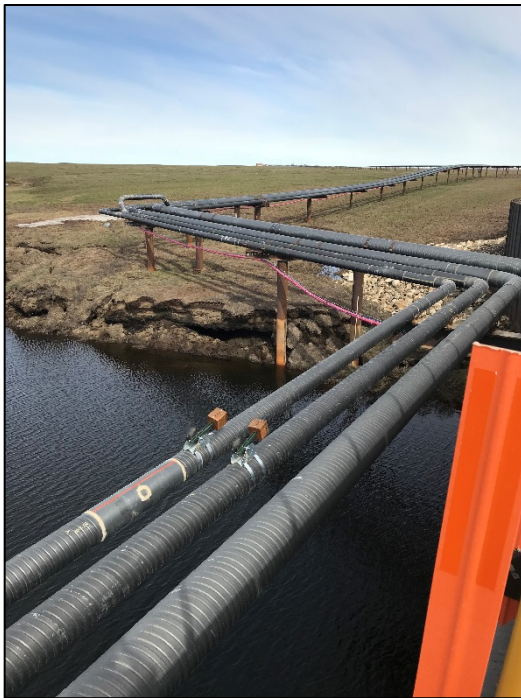
No displaced gravel fill attributed with spring breakup flooding was observed along the road embankment, around culvert inlets and outlets, or around bridge abutments. Other than at the Tinmiaqsiugvik Bridge, there were no signs of sloughing or undermining at drainage structures and no channel changes were observed at the crossings. Additional photo documentation of post-breakup conditions is provided in Appendix E.

Photo 7.1: Erosion along east bank of Tinmiaqsiugvik River, looking northeast; July 2018

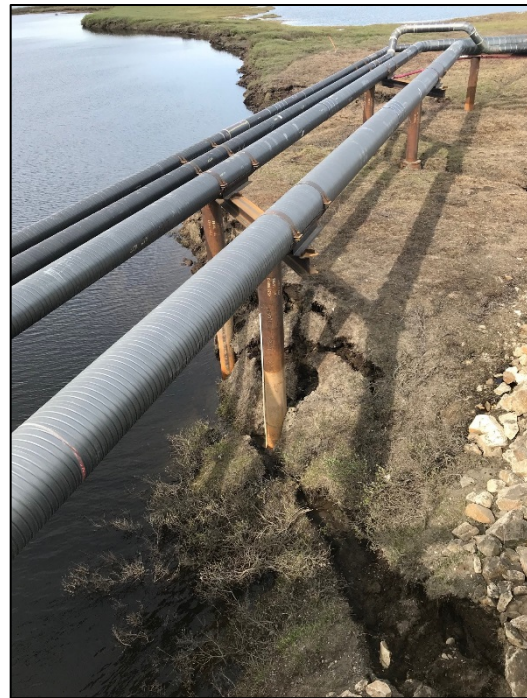
Photo 7.2: Pipeline VSM in channel, east bank Tinmiaqsiugvik Bridge, looking north (downstream); July 2018
