# CULVERT MONITORING REPORT

2019 GREATER MOOSE'S TOOTH 1 (GMT1/MT6)

SPRING BREAKUP

**ConocoPhillips**  
Alaska

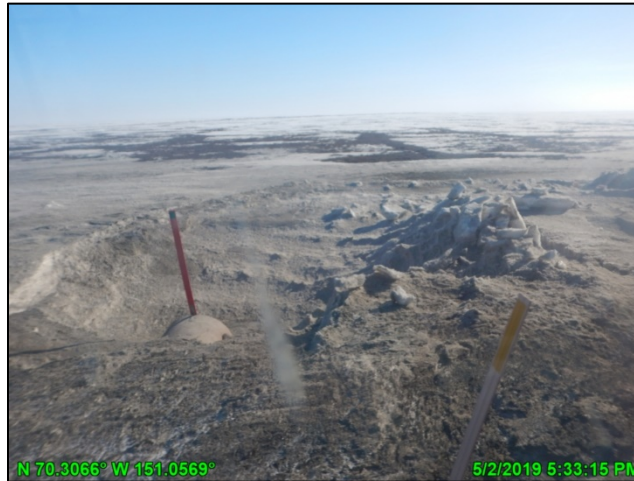
Culverts were cleared in April by mechanically removing snow, ice, and bladders from the inlets and outlets prior to spring breakup flooding. Visual inspections performed the end of April confirmed that snow had been cleared from all culvert inlets and outlets (Photo 3.1). Bladders had been removed from most culverts; however, many bladders remained frozen in place, temporarily blocking the culvert openings.

**Photo 3.1: Excavated culvert along the GMT1/MT6 access road, looking north; May 2, 2019**

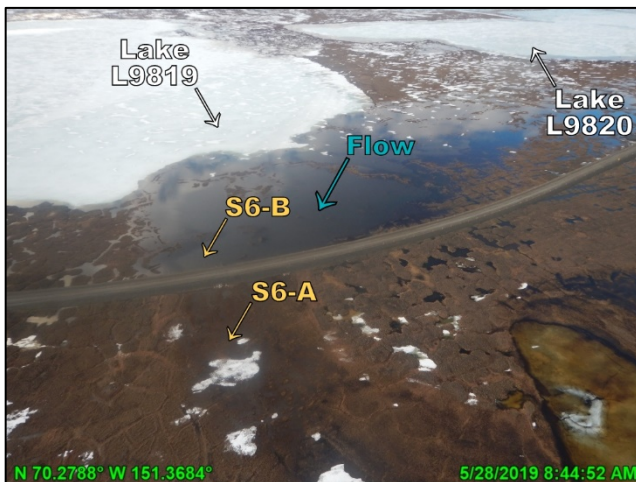
No performance issues were identified at any culverts along the GMT1/MT6 access road. Temporary ponded water was present at several locations along the access road but was attributed to snow or culvert bladders frozen in place, temporarily impeding flow, and not culvert placement (Photo 3.2 and 3.3).

Photo 3.2: Local ponding on south side of GMT1/MT6 access road at site S6, looking south; May 28, 2019

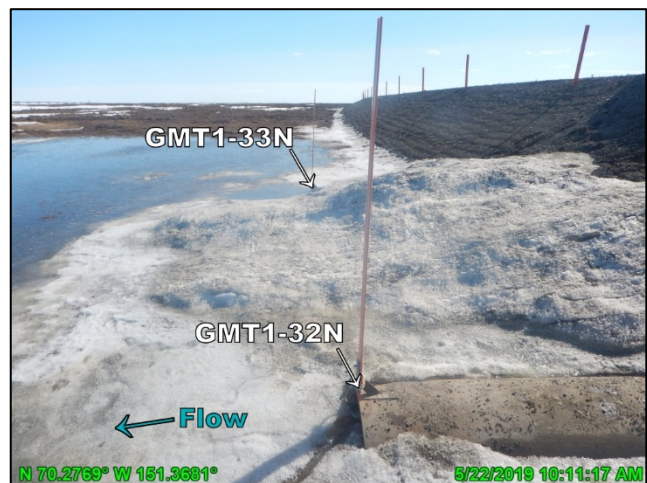
Photo 3.3: Culverts GMT1-32 and 33 impeded by ice and snow buildup, looking southwest; May 22, 2019

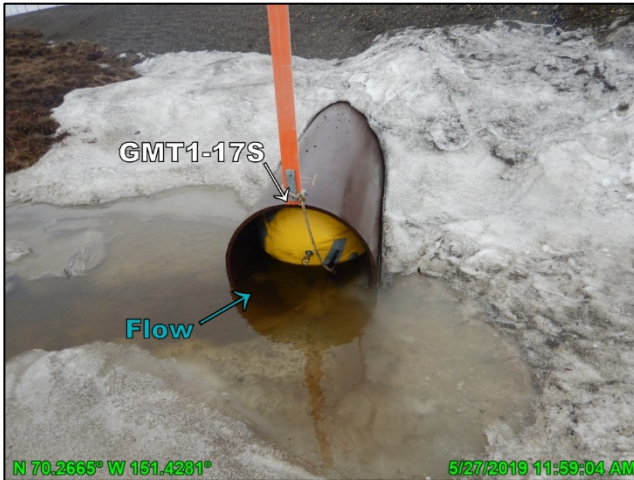
After snow was manually cleared in late April, drifted snow had accumulated at some of the culverts. Some culvert bladders remained frozen into the culverts and impeded flow (Photo 3.4). Several culverts contained ice and snow blockage which also impeded flow (Photo 3.5). Once conveyance paths were established through either removing culvert bladders or meltwater naturally cutting through snow and ice, the culverts all performed as designed and natural drainage patterns were maintained (Photo 3.6, 3.7, 3.8). Culvert GMT1-03 remains perched at the outlet, which may lead to the development of a scour hole (Photo 3.9). No displacement of uncompacted gravel fill attributed with spring breakup flooding was observed along the road embankment or around culvert inlets and outlets. No culvert maintenance, repair, upgrade, setting adjustments, and/or replacements are recommended at this time. Culvert GMT1-03 will be monitored over the coming year and plans to readjust or replace the culvert will be developed.

Photo 3.4: Culvert GMT1-17 with culvert bladder blockage, looking north; May 27, 2019

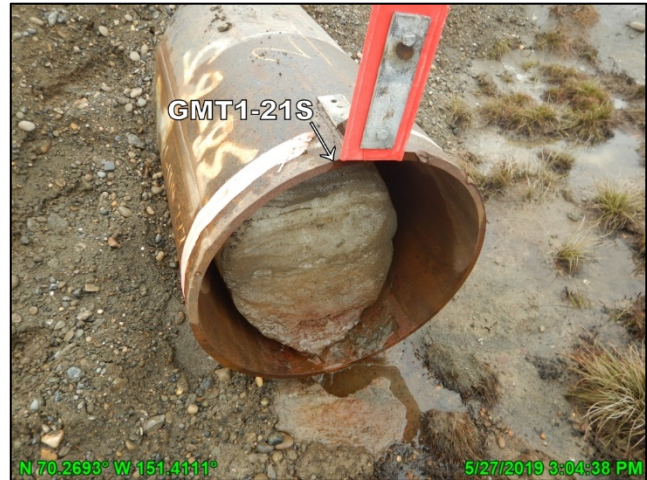
PT data indicates peak stage occurred at S7-B (US) on May 28. Meltwater at the S7-A (DS) gage did not reach the PT. With the exception of temporary blockage from drifted snow accumulation and a perched outlet at culvert GMT1-23, all culverts were observed to function as designed and natural drainage patterns in the area were maintained. Culvert GMT1-23 will be monitored over the coming year and plans to readjust or replace the culvert will be developed.

Photo 3.5: Culvert GMT1-21 with ice blockage, looking north; May 27, 2019

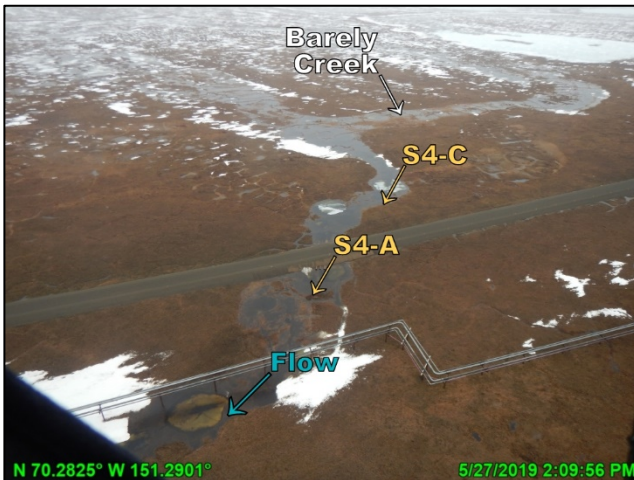
Photo 3.6: Barely Creek flowing north through GMT1/MT6 culverts, looking south; May 27, 2019

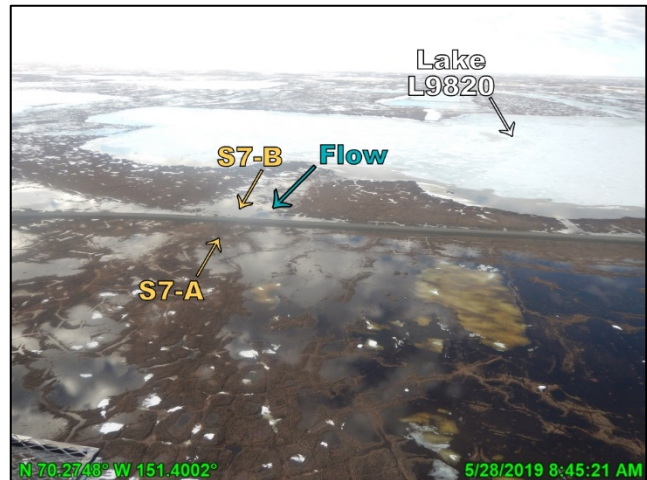
Photo 3.7: Hydraulic conditions at S7, looking south; May 28, 2019

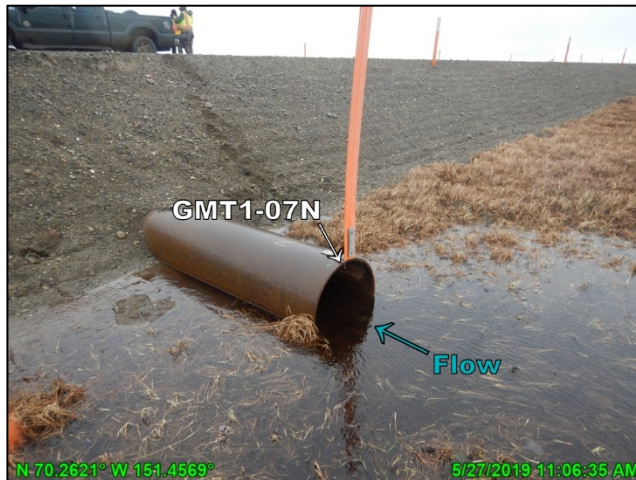
Photo 3.8: Water flowing freely through culvert GMT1-07, looking north; May 27, 2019

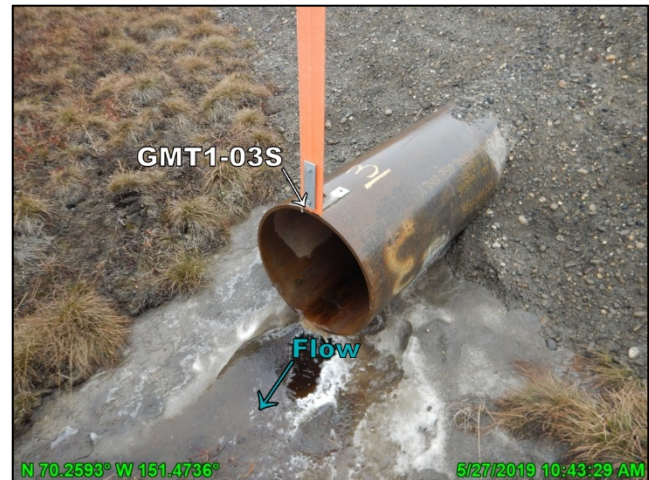
Photo 3.9: Perched culvert GMT1-03 with minimal flow, looking north; May 27, 2019

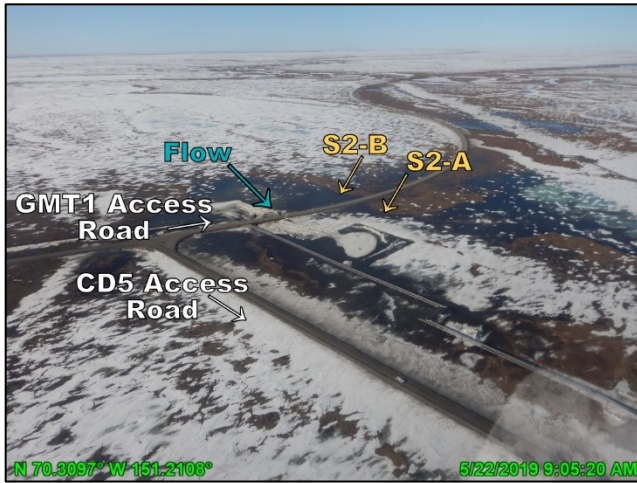
Local melt was initially observed at gage station S2 on May 17. On May 22, widespread local meltwater was observed in low lying areas on each side of the GMT1/MT6 road and aerial observations suggest hydraulic connections were established through many of the culverts (Photo F.1). By May 27, meltwater was present on

Photo F.1: Local meltwater around S2, looking southwest; May 22, 2019

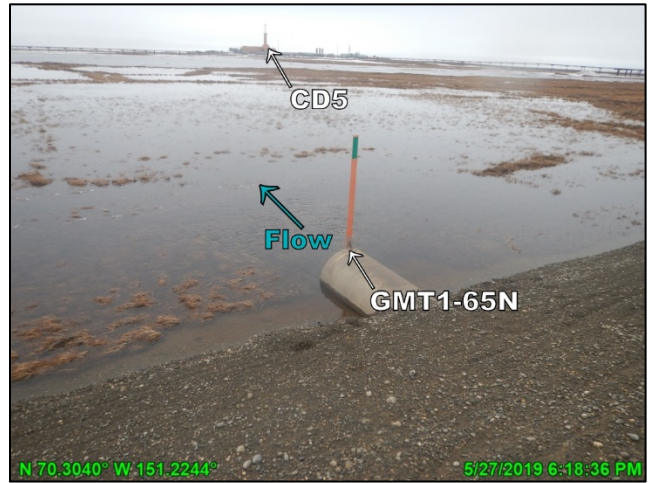
both sides of the GMT1/MT6 road and culverts GMT1-65 and GMT1-67 were conveying flow (Photo F.2). PT data indicated that meltwater stage remained elevated through June 5 at the S2-B (US) gage. Aerial observations from July 2 show equalized hydraulic conditions in the area (Photo F.3).

Photo F.2: Culvert GMT1-65 conveying flow, looking north; May 27, 2019

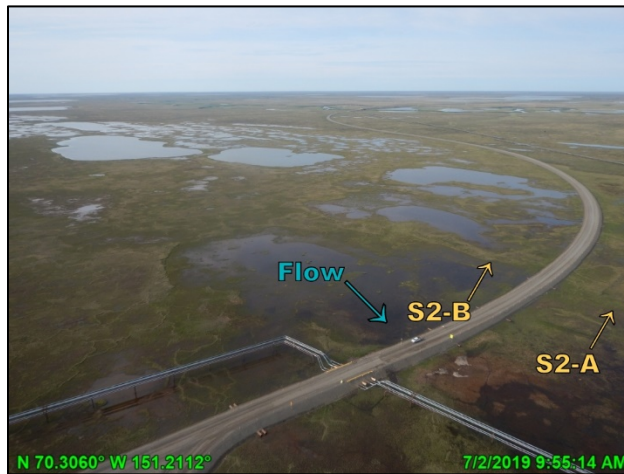
Photo F.3: Summer conditions at S2, looking west; July 2, 2019

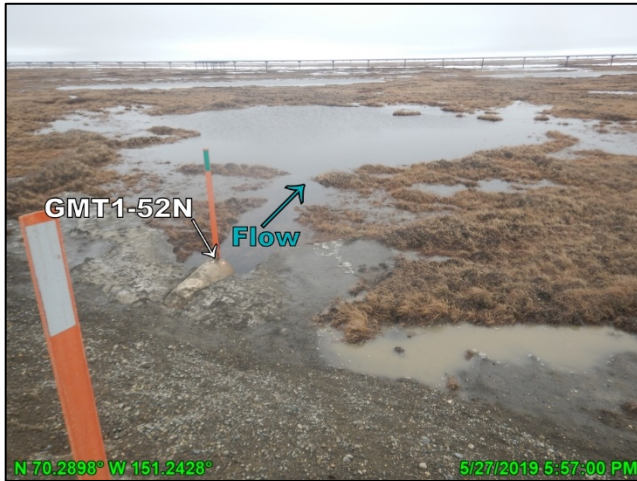
Local melt was first observed on the north (downstream) side of the GMT1/MT6 road near S3-A on May 22. On May 27, local melt was observed on both sides of the GMT1/MT6 road and GMT1-52 was conveying flow (Photo F.4). At this time, drifted snow accumulation was observed at some culvert inlets which temporarily inhibited drainage, leading to minor ponding on the south side of the road (Photo F.5). On May 29, snow cover on the surrounding tundra was minimal and local meltwater was still observed in the area (Photo F.6). Aerial observations from July 2 show equalized hydraulic conditions in the area (Photo F.7).

Photo F.4: Culvert GMT1-52, looking north; May 27, 2019

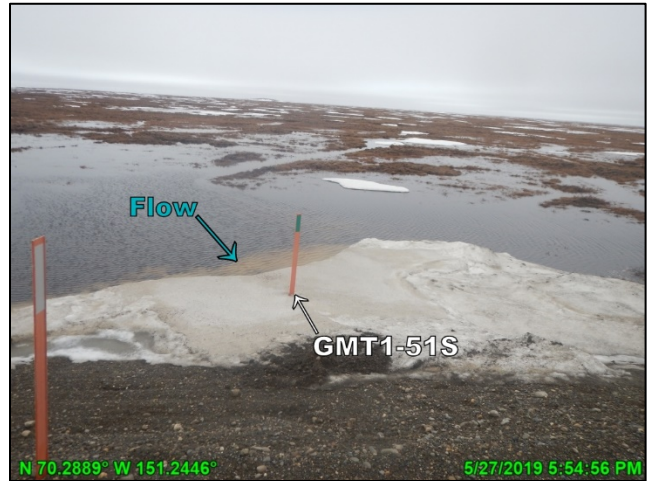
Photo F.5: Snow blockage at culvert GMT1-51, looking south; May 27, 2019

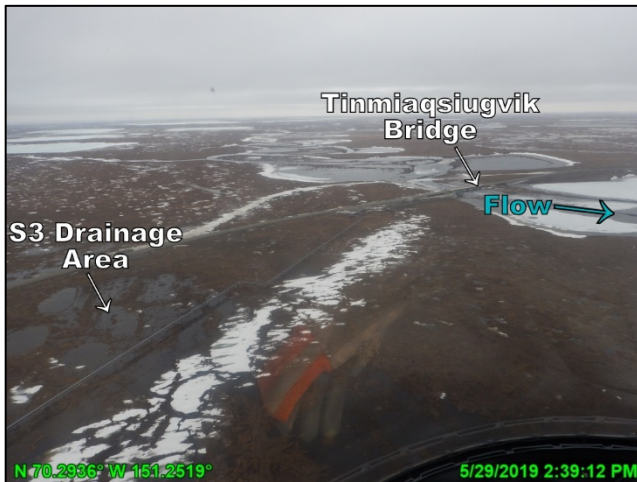
Photo F.6: S3 drainage area, looking south; May 29, 2019

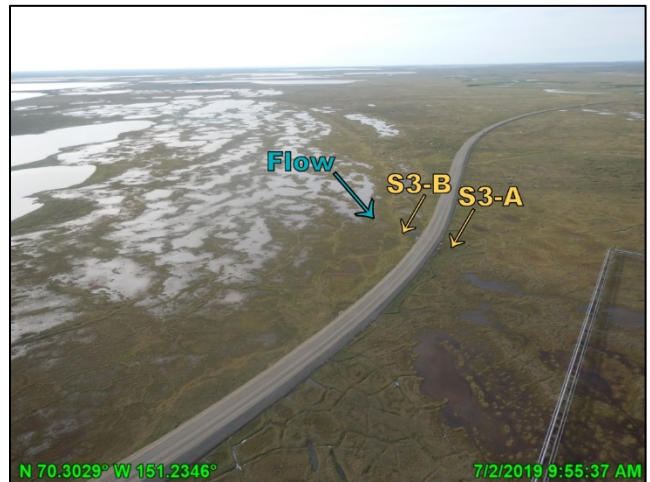
Photo F.7: Summer conditions at S3, looking south; July 2, 2019

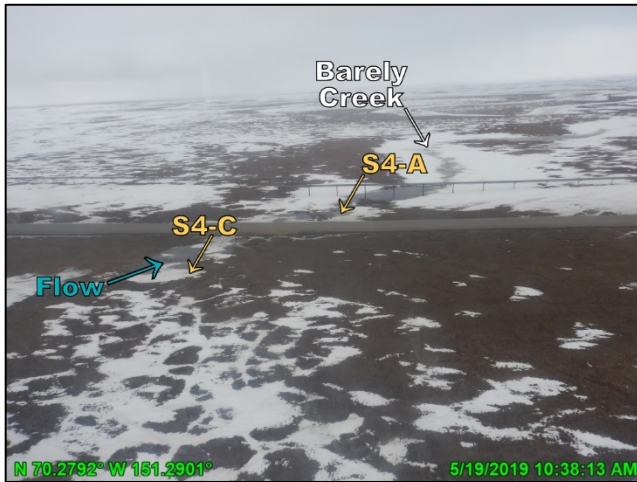
On May 19<sup>th</sup>, ponded local melt was observed in the Barely Creek drainage (Photo F.8). Snow cover on the surrounding tundra was approximately 70%. Aerial observations from May 22 show flow paths forming through drifted snowpack in the drainage on both sides of the GMT1/MT6 road, suggesting hydraulic connection had been initiated (Photo F.9). On May 27, discharge through the culverts conveying flow was measured and minor overbank flooding in the drainage was observed. (Photo F.10). Stage remained elevated through May 29 (Photo F.11). Aerial observations from July 2 show a hydraulic connection maintained through the summer in Barely Creek (Photo F.12).

Photo F.8: S4 monitoring site and Barely Creek drainage area, looking north; May 19, 2019

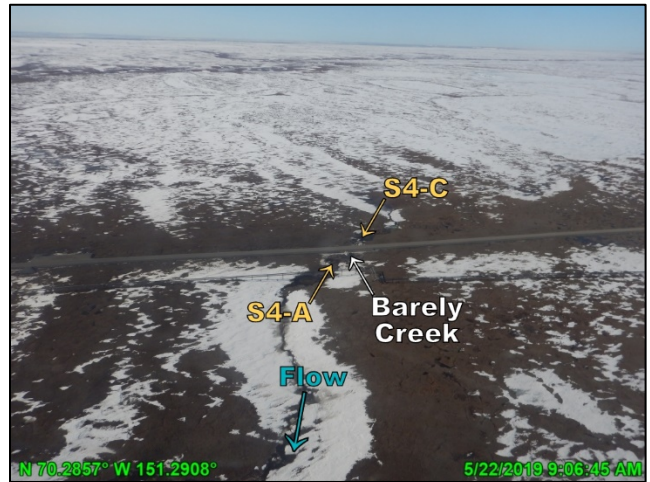
Photo F.9: Flow paths cut through the snow pack in Barely Creek, looking south; May 22, 2019

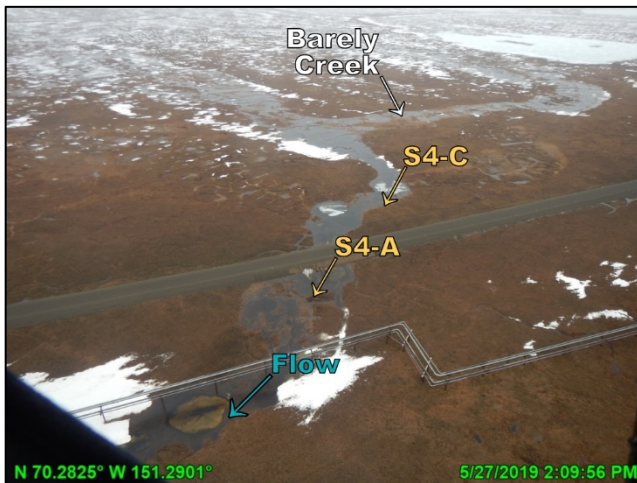
Photo F.10: Minor overbank flooding near S4; looking south; May 27, 2019

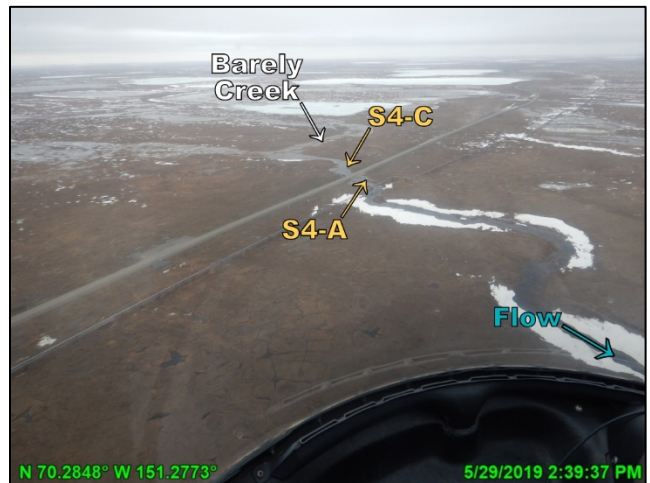
Photo F.11: Drainage conditions near S4, looking southwest; May 29, 2019

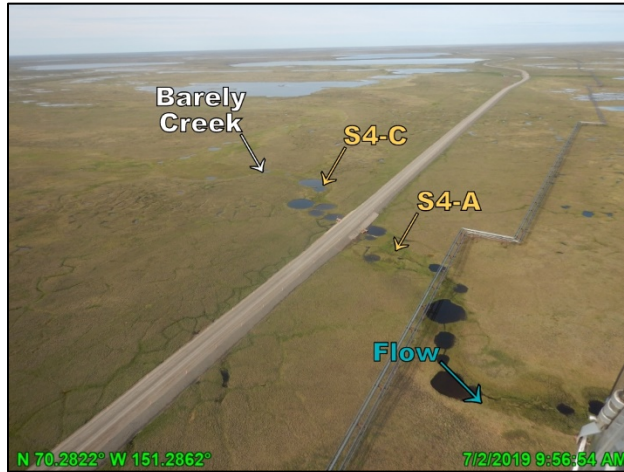
Photo F.12: Summer conditions at S4, looking southwest; July 2, 2019

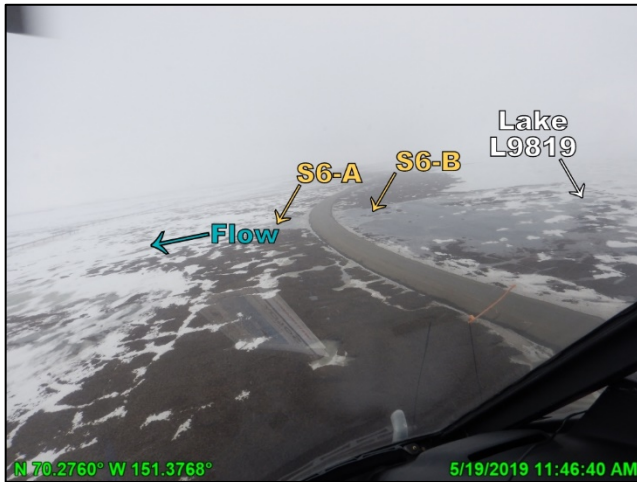
On May 19, local meltwater was accumulating near the S6 gage stations (Photo F.13). On May 22, ponded meltwater was observed on the south (upstream) side of the road and culverts situated in the drainage were blocked with snow and ice (Photo F.14). A small flow path through the snow was observed at culvert GMT1-31. On May 27, meltwater was present on both sides of the road, but continued ponding on the south (upstream) side near gage S6-B suggests partial blockage of the culverts (Photo F.15). On May 29, ponded water remained at S6-B (Photo F.16). Snow cover on the surrounding tundra was approximately 10%. PT data at S6-B (US) shows a steady drop in stage beginning on May 30, suggesting culvert blockage relief. Aerial observations from July 2 show equalized hydraulic conditions in the area (Photo F.17).

Photo F.13: Initial meltwater near S6 monitoring site, looking northeast; May 19, 2019

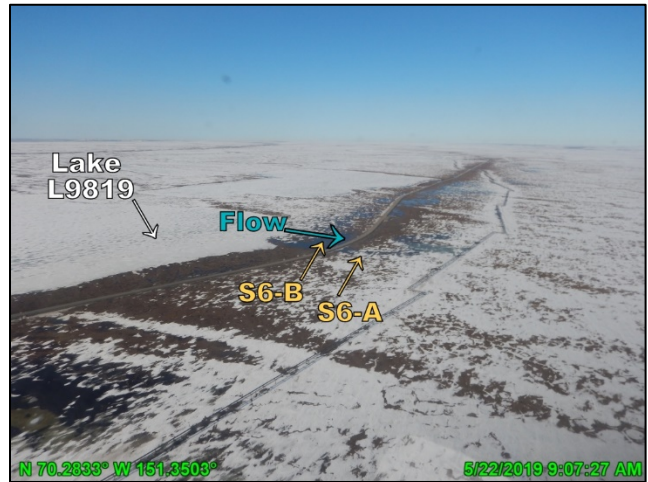
Photo F.14: S6 monitoring site and drainage area, looking southwest; May 22, 2019

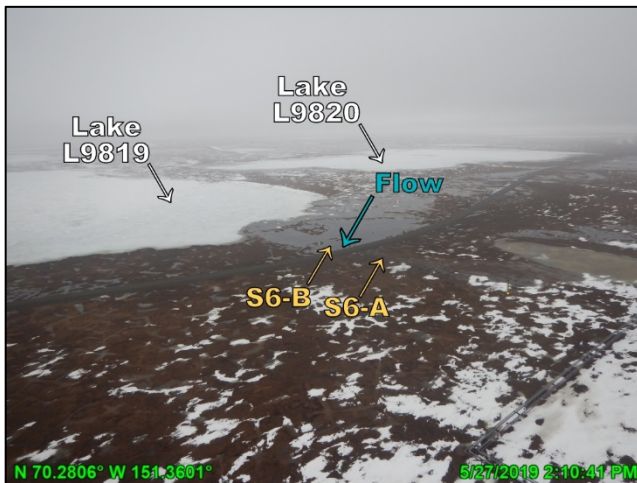
Photo F.15: Differential ponding near S6, looking southwest; May 27, 2019

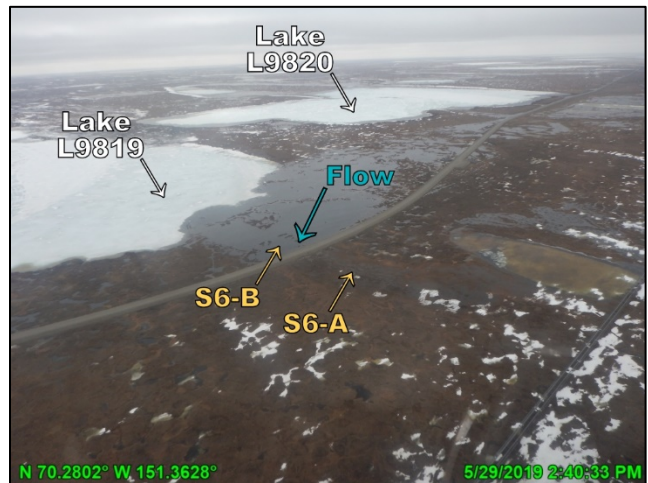
Photo F.16: Differential ponding near S6, looking southwest; May 29, 2019

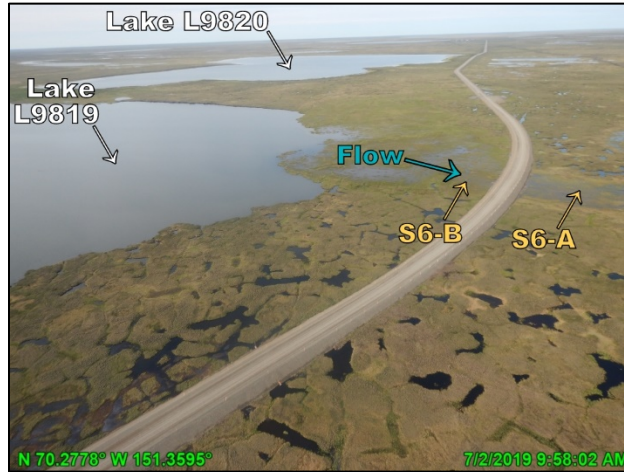
Photo F.17: Summer conditions at S6, looking west; July 2, 2019

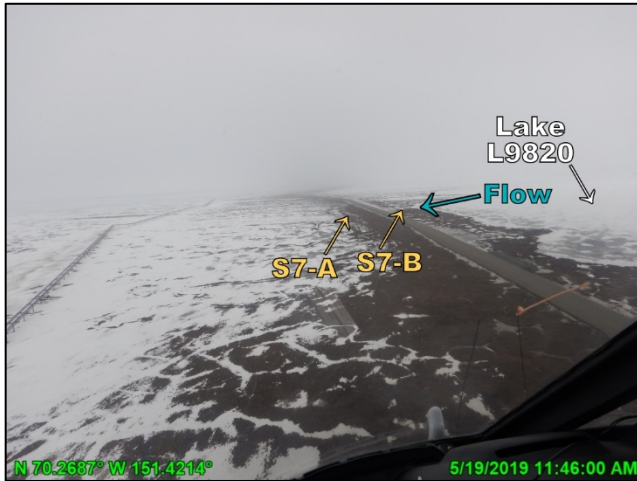
Local meltwater was first observed on May 19 (Photo F.18). On May 22, meltwater was observed on both sides of the GMT1/MT6 road near the S7 gage stations (Photo F.19). On May 27, flow was measured through culvert GMT1-27 (Photo F.20). Other culverts were partially blocked by snow and ice, leading to temporary ponding on the upstream side of the road (Photo F.21). Partially blocked culverts and accumulating ponded meltwater on the south side of the road near S7-B (upstream) forced flow through culverts situated further east. By May 29, aerial observations indicate meltwater equalization through the culverts. Snow cover on the surrounding tundra was approximately 10% (Photo F.22). Aerial observations from July 2 show equalized hydraulic conditions in the area (Photo F.23).

Photo F.18: Initial meltwater near S7 monitoring site, looking east; May 19, 2019

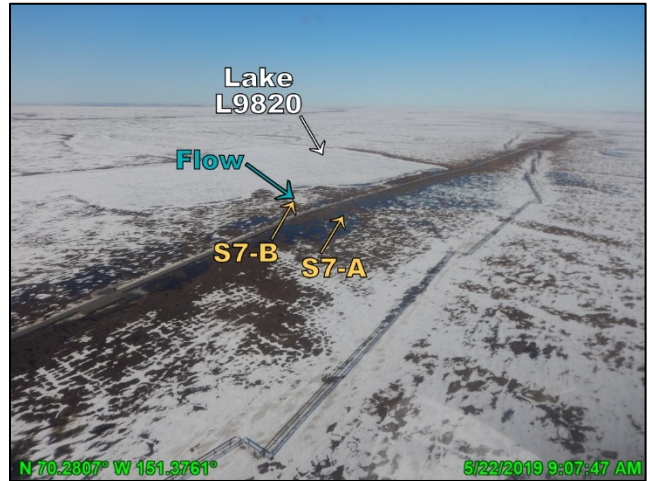
Photo F.19: Meltwater accumulation near S7, looking southwest; May 22, 2019

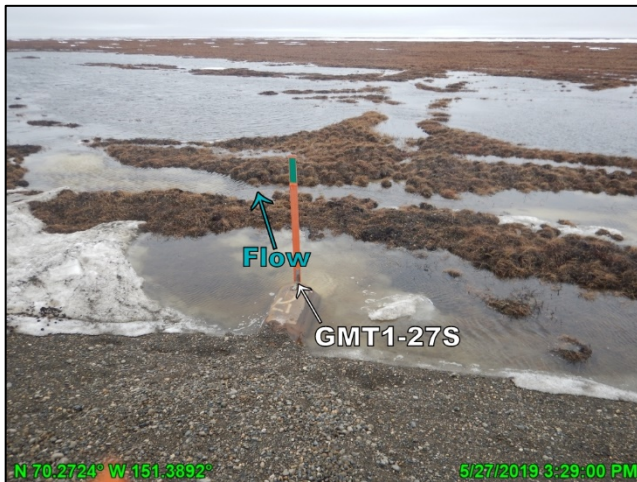
Photo F.20: Flow through GMT1-27N, looking north; May 27, 2019

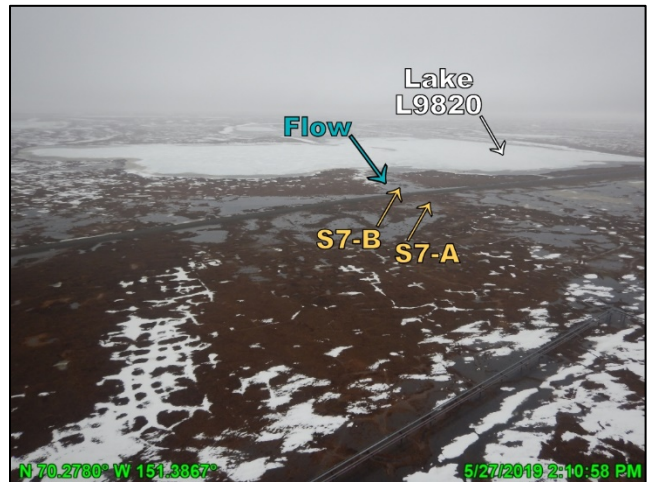
Photo F.21: S7 drainage area, looking south; May 27, 2019

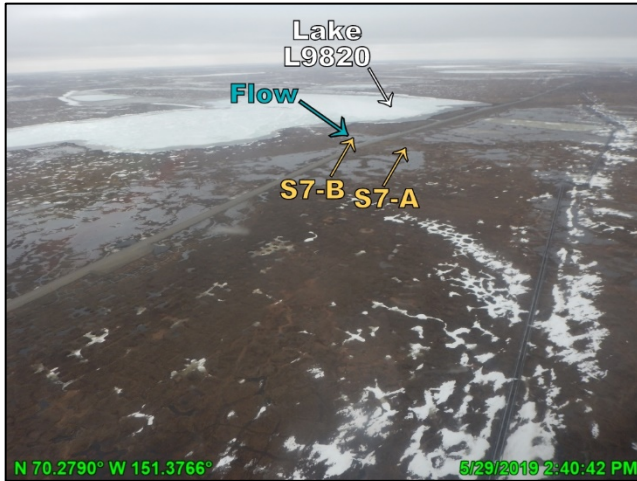
Photo F.22: S7 drainage area, looking southwest; May 29, 2019

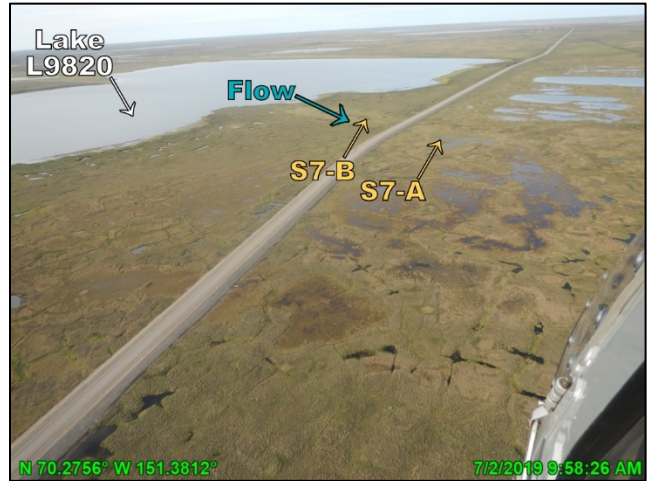
Photo F.23: Summer conditions at S7, looking southwest; July 2, 2019
