2020 Colville River Delta Spring Breakup Monitoring & Hydrological Assessment - Final

ConocoPhillips
Alaska

EXECUTIVE SUMMARY

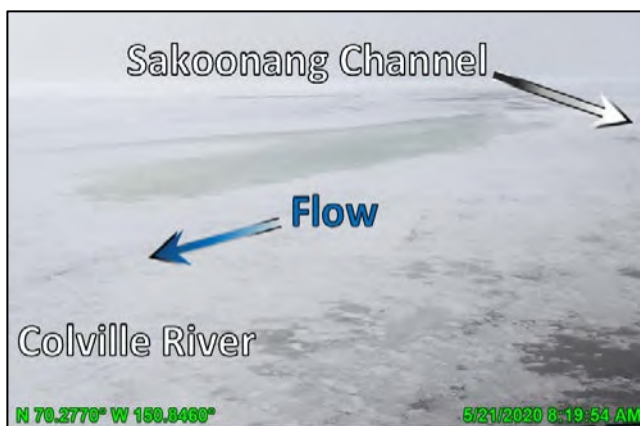
Photo 3-1: Approximate leading edge near the Sagoonang Channel bifurcation, looking south (upstream); May 21, 2020

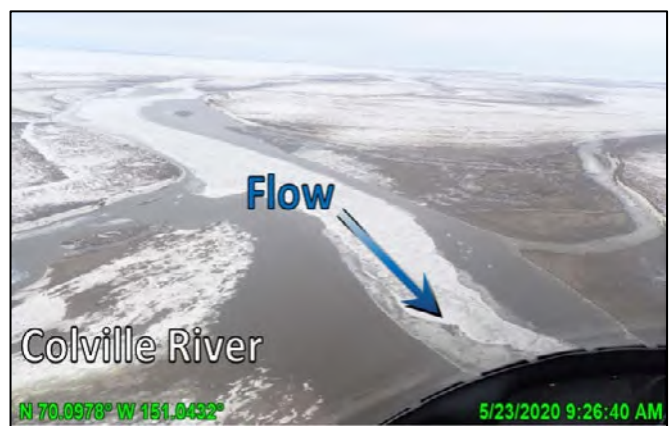
Photo 3-2: Lifted channel ice near the Horseshoe Bend upstream of MON1, looking south (upstream); May 23, 2020

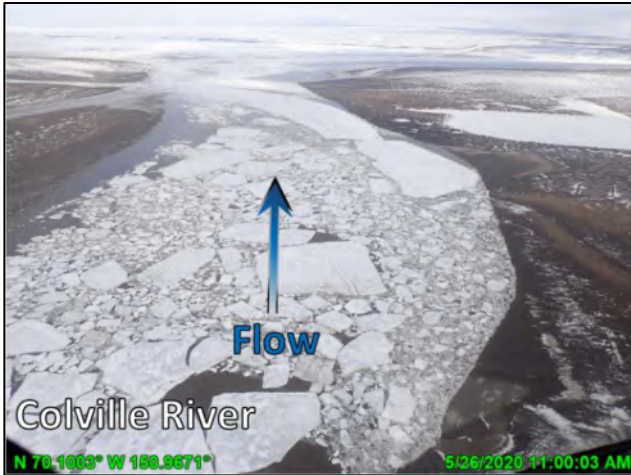
On May 26, a large ice jam approximately 10-miles long was observed beginning at the Horseshoe Bend (Photo 3-3). Upstream of this jam, stage approached bankfull and overbank flooding was present in low-lying areas (Photo 3-4). In the afternoon, stage began to recede at MON1, indicating backwater was developing behind the ice jam upstream of MON1. In the morning on May 27, this ice jam progressed into the delta and re-formed in the East Channel downstream of the HDD crossing, near the Tamayayak Channel bifurcation (Photo 3-5). Additional ice jams were observed in the Nigliq Channel upstream of Nuiqsut (Photo 3-6) and in the Sagoonang Channel near the East Channel bifurcation. Backwater rapidly accumulated behind the East Channel ice jam. Ice jams in the Nigliq and Sagoonang Channels obstructed flow into their respective channels, forcing backwater into the eastern floodplain of the CRD (Photo 3-7).

Photo 3-3: Colville River ice jam downstream extent at the Horseshoe Bend, looking north; May 26, 2020

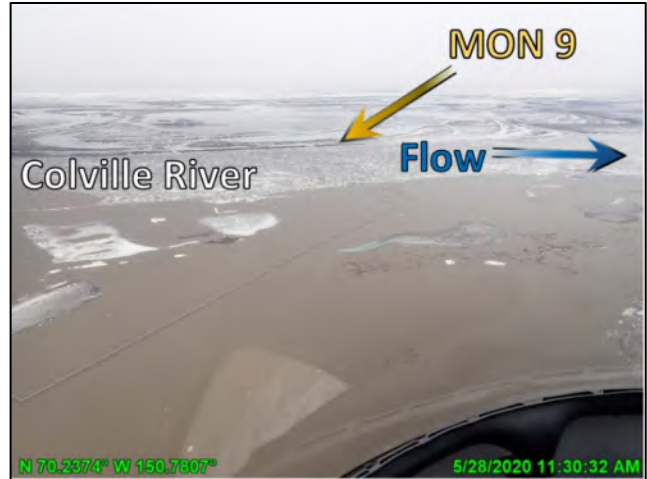
On May 28, backwater and ice continued to accumulate behind the East Channel ice jam causing further inundation of the eastern floodplain (Photo 3-8). Stage peaked at MON1 at midday on May 28. Peak stage in 2020 was the second highest stage recorded at MON1 and was only exceeded during the 2015 flood event.

Photo 3-8: Backwater near the east HDD crossing in the East Channel, looking west (downstream); May 28, 2020

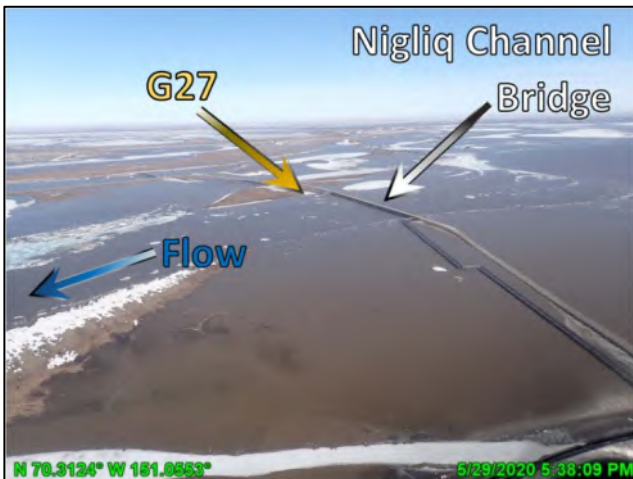
Photo 3-9: Flooding at the Nigliq Channel Bridge near peak stage, looking east (upstream); May 27, 2020

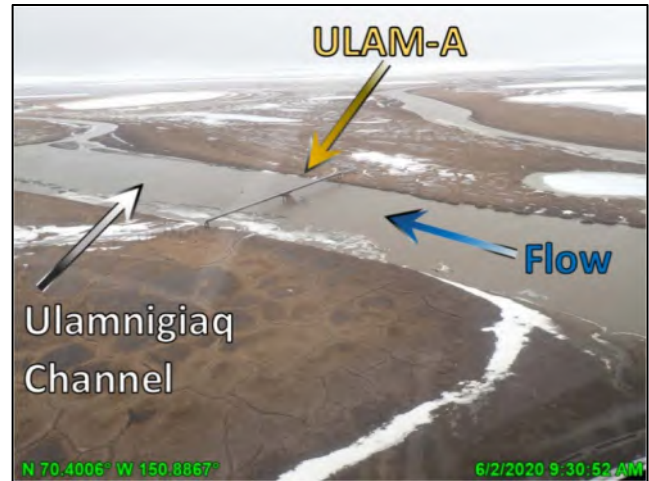
Photo 3-12: Ice-free channel near the Ulamnigiq Bridge, looking north (downstream); June 2, 2020

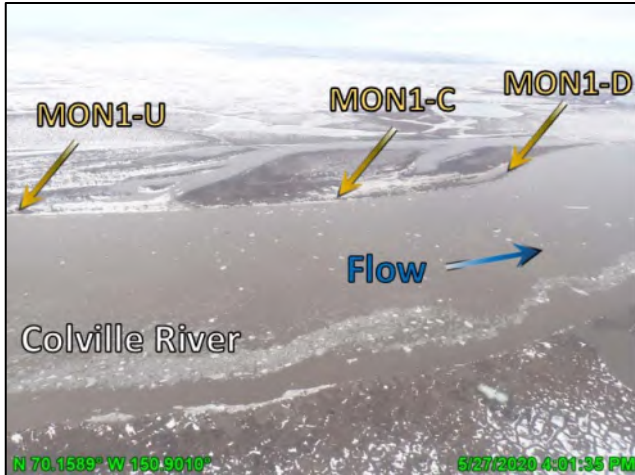
Photo 4-1: MON1 reach after channel ice flushed, looking northwest (downstream); May 27, 2020

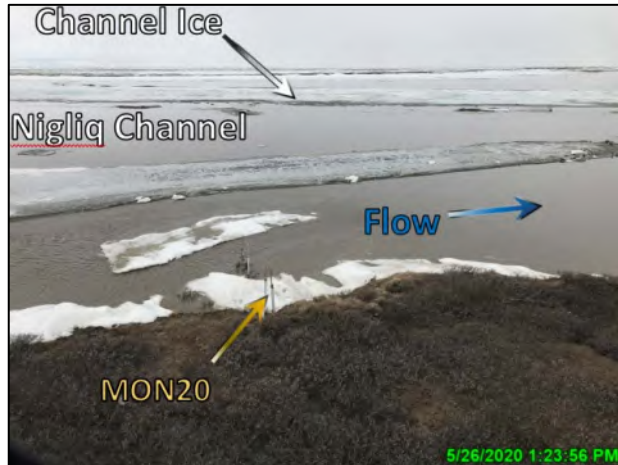
Photo 4-13: Intact channel ice near MON20, looking west; May 26, 2020

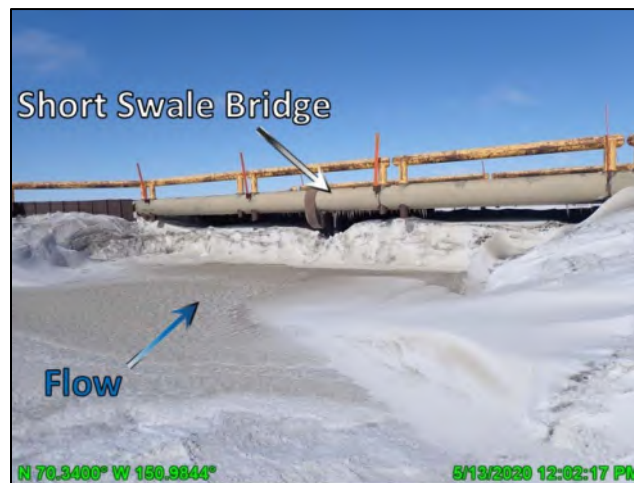
Photo 4-21: Snow cleared from the south side of the short swale bridge. Note drifted snow still present directly underneath bridge deck

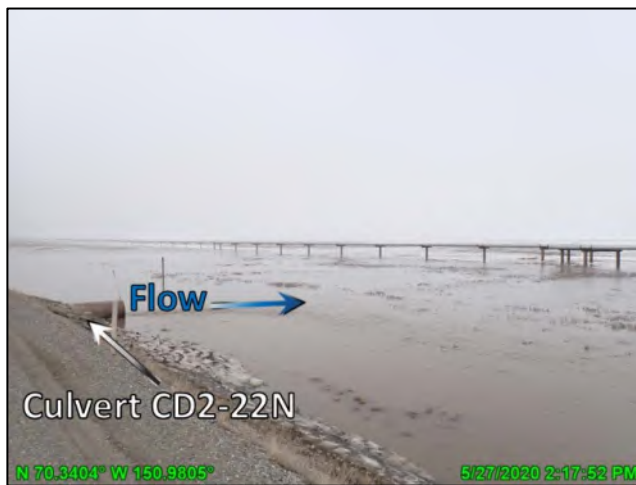
All culverts along CD2 performed as designed during this year's breakup event. Peak discharge through this drainage area occurred on May 29 during peak stage differential across the CD2 road measured at G3 and G4.

Photo 4-26: Floodwater along the CD2 road, looking northwest; May 27, 2020

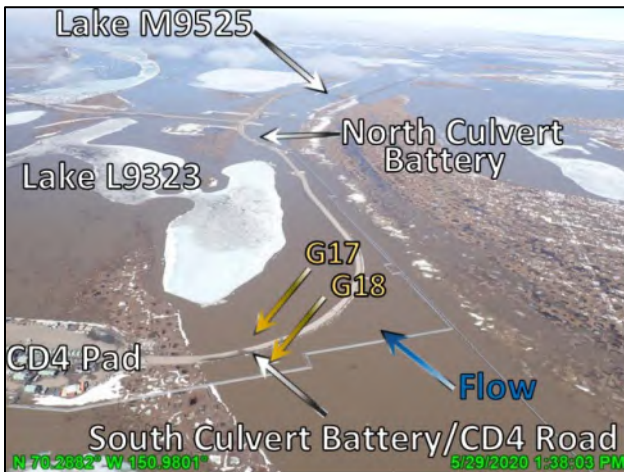
Photo 4-37: Peak conditions on CD4 road near Gage G17/G18, looking north (downstream); May 29, 2020

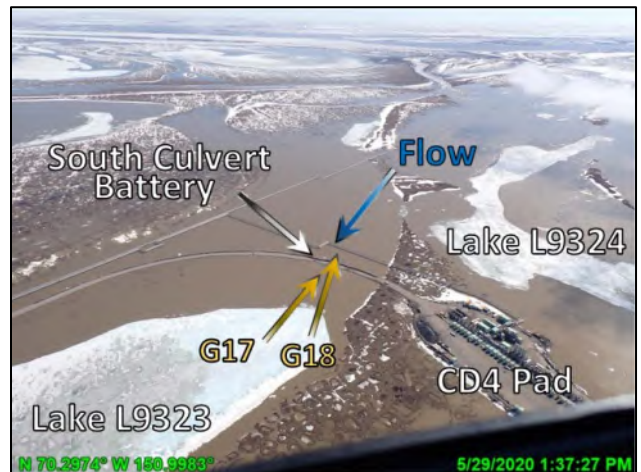
Photo 4-38: Peak conditions on CD4 road near Gage G17 & G18, looking southeast; May 29, 2020

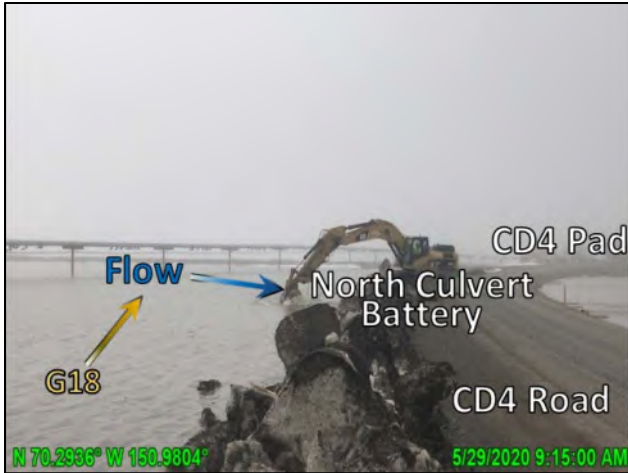
Photo 4-39: Excavator clearing ice from G17/G18 culverts battery, looking southwest; May 29, 2020

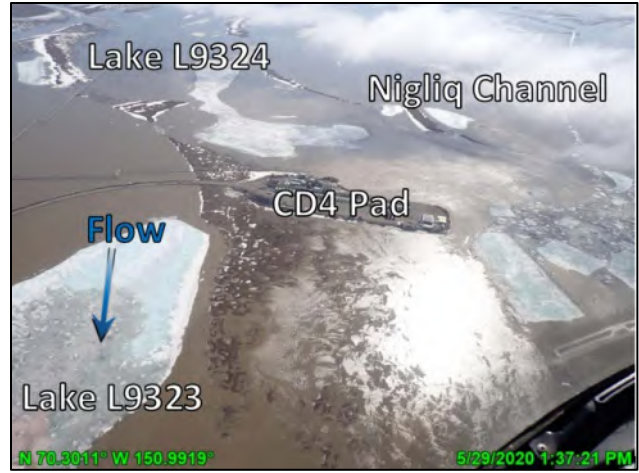
Photo 4-40: CD4 pad near peak stage conditions, looking southeast; May 29, 2020

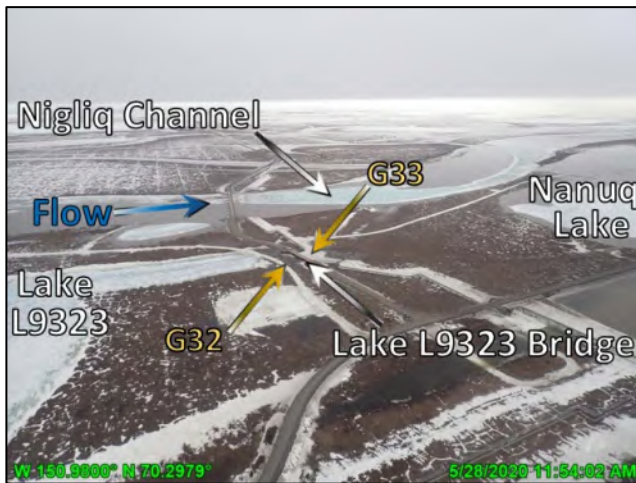
Photo 4-41: Lake L9323 bridge and vicinity prior to peak stage, looking west; May 28, 2020

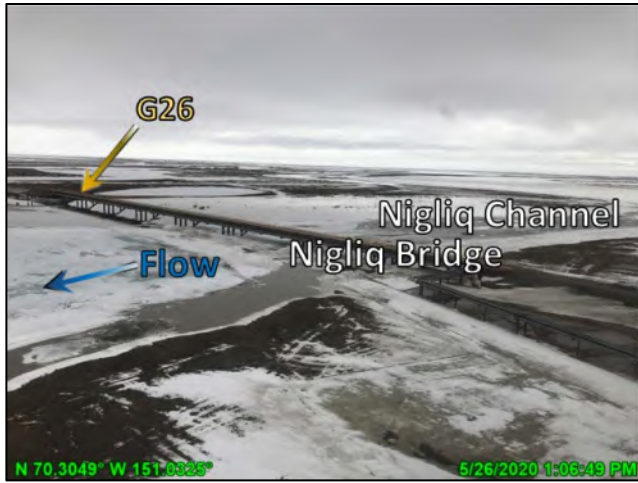
Photo 4-45: Channel ice at the Nigliq Bridge, looking southeast (upstream); May 26, 2020

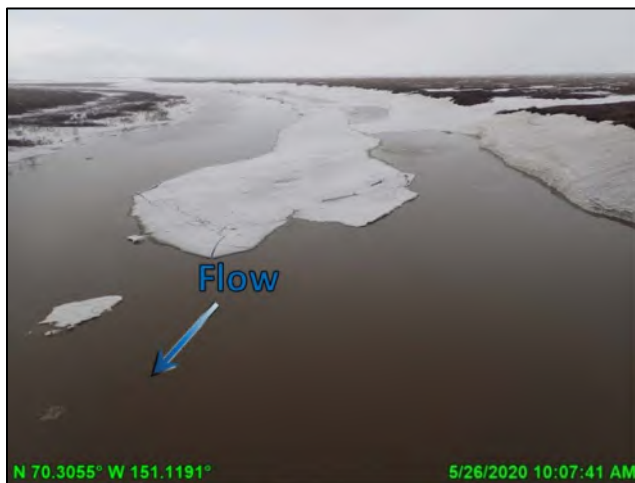
Photo 4-59: Floodwater and channel ice in the Nigliagvik Channel, looking south; May 26, 2020

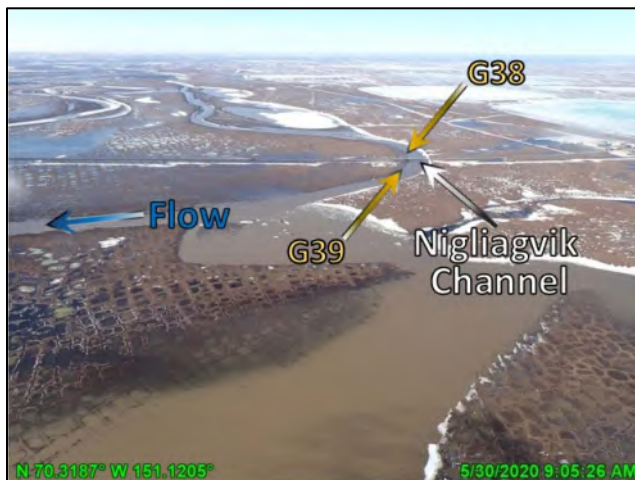
Photo 4-61: Conditions at the Nigliagvik Bridge one day after peak stage, looking southwest (upstream); May 30, 2020

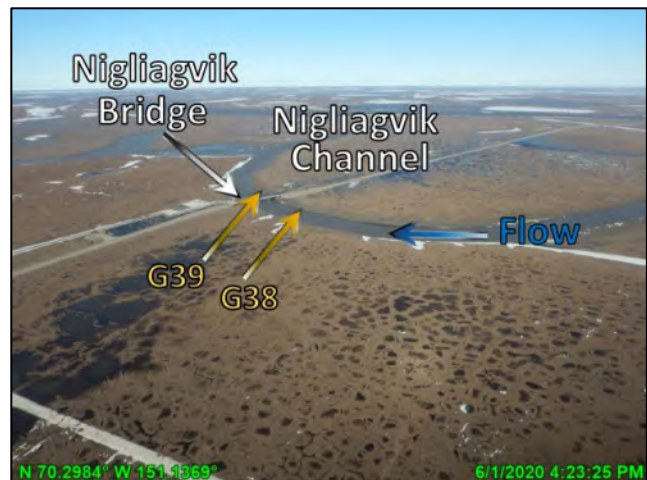
Photo 4-62: Stage below bankfull in the Nigliagvik Channel, looking northeast (downstream); June 1, 2020

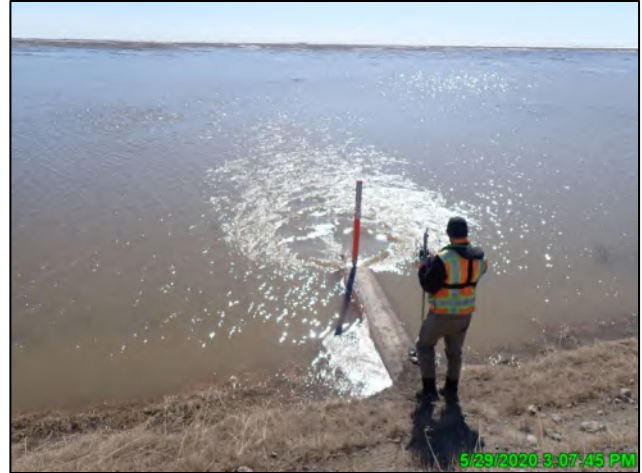
Photo 4-63: Widespread inundation west of the Nigliq channel due to overbank flooding, looking north; May 29, 2020

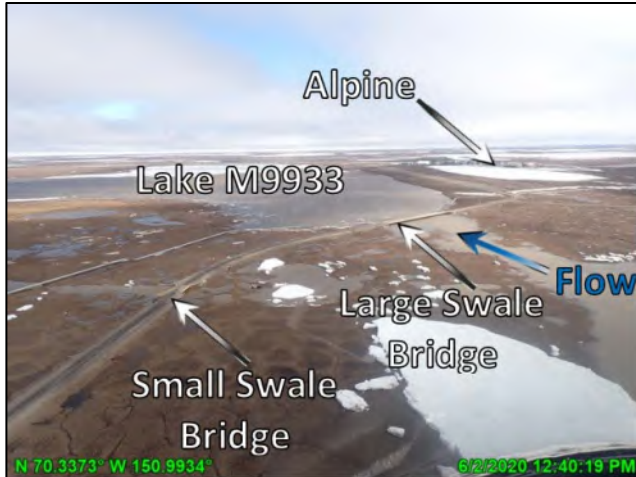
Photo 5-1: CD2 road Long and Short Swale Bridges post-breakup, looking northeast; June 2, 2020

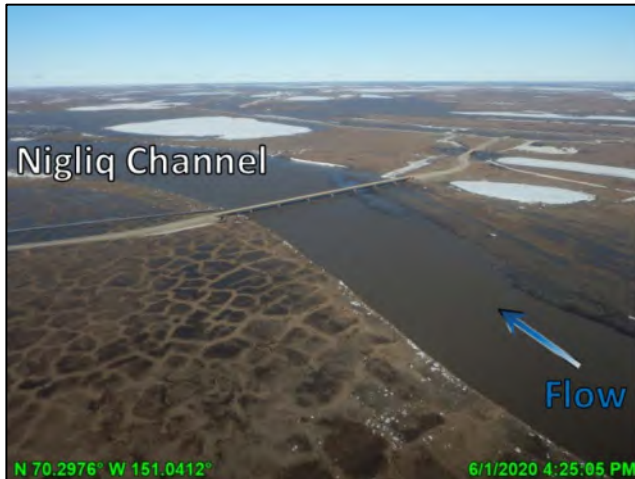
Photo 6-3: Nigliq channel post breakup showing no channel migration, looking northeast; June 1, 2020

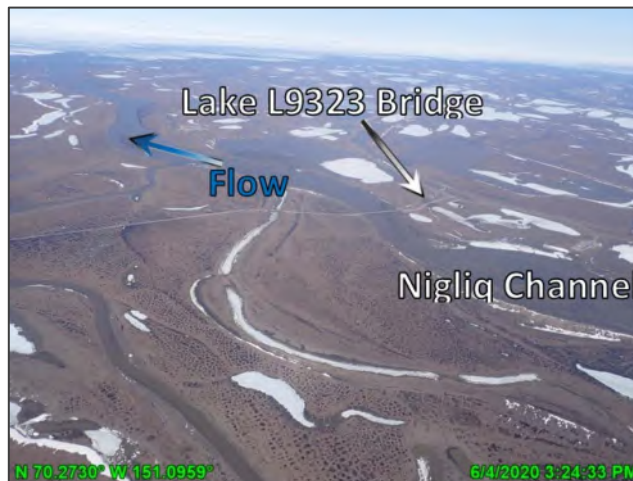
Photo D.33: Post-breakup conditions at Nigliq and Lake L9323 ice road crossings; June 4, 2020

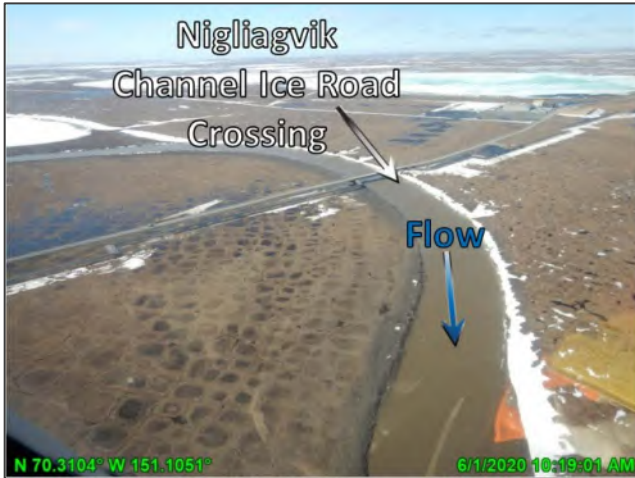
Photo D.36: Post-breakup conditions at the Nigliagvik ice road crossing, looking southwest (upstream); June 1, 2020

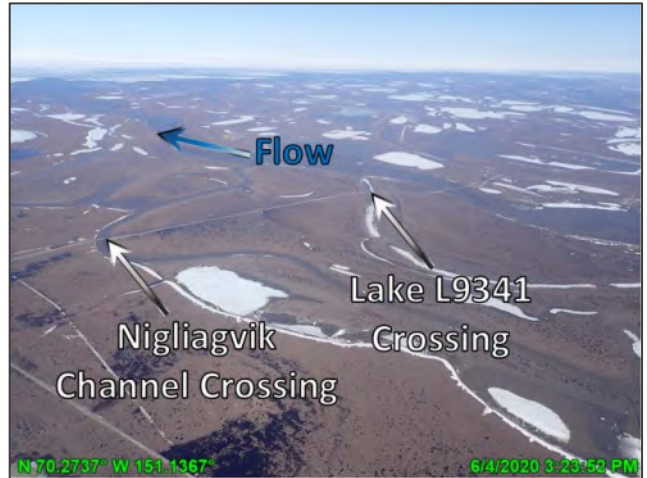
Photo D.37: Post-breakup conditions at the Nigliagvik and Lake L9341 ice road crossings, looking north (downstream); June 4, 2020

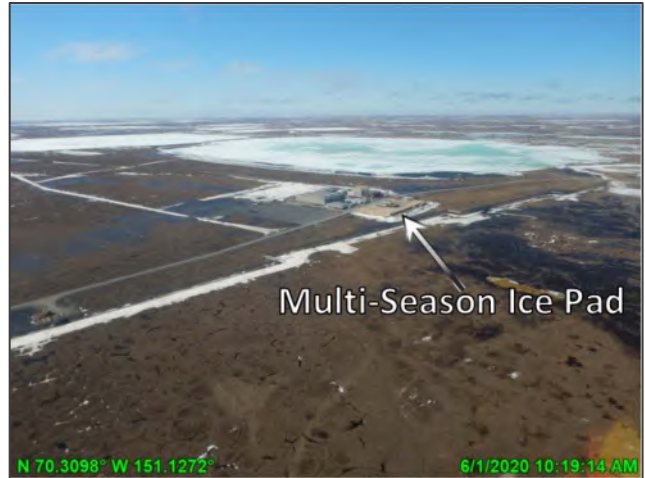
Photo D.39: Post-breakup conditions at the multi-season ice pad north of K-pad, looking west; June 1, 2020

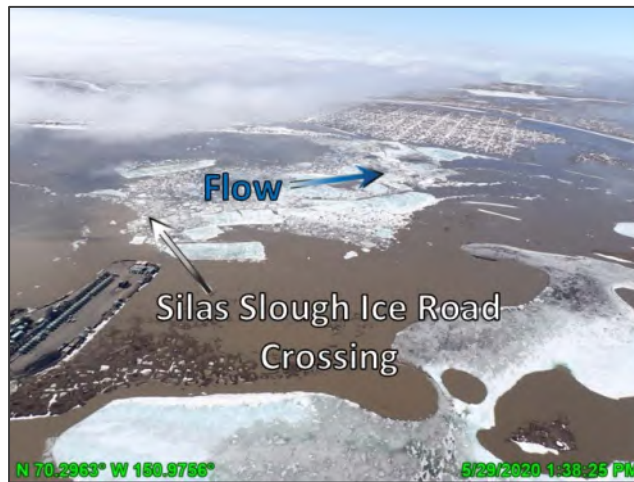
Photo D.44: Post-breakup conditions at the Silas Slough ice road crossing, looking west; May 29, 2020

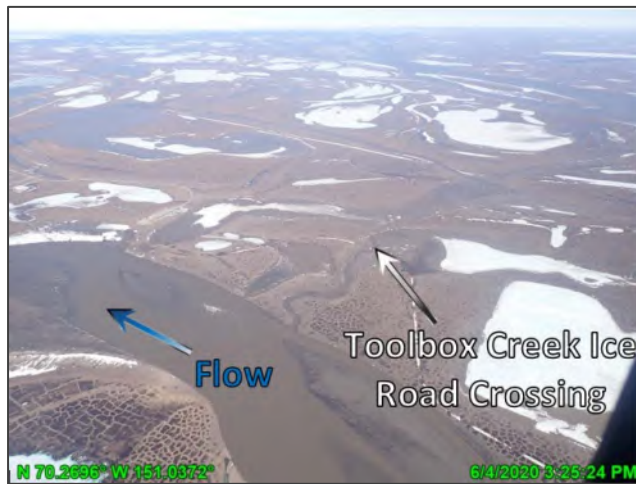
Photo D.47: Post-breakup conditions at the Toolbox Creek and Silas Slough ice road crossings, looking northeast; June 4, 2020

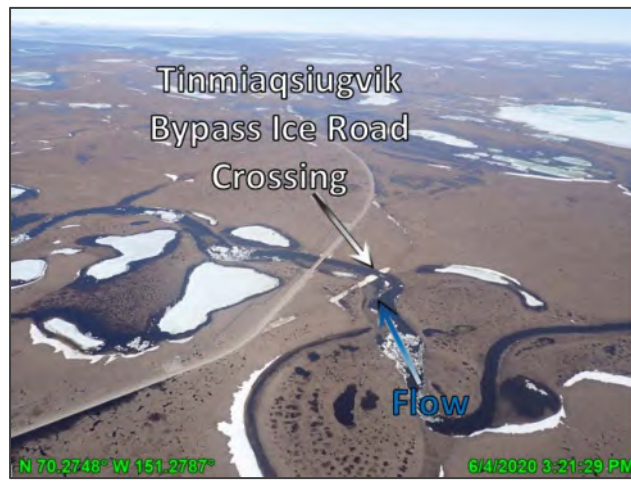
Photo D.57: Post-breakup conditions at the Tinmiaqsiugvik Bypass ice road crossing, looking northeast; May 20, 2020
