Culvert Monitoring Report

2020 Greater Moose's Tooth 2 (GMT2/MT7)

Spring Breakup

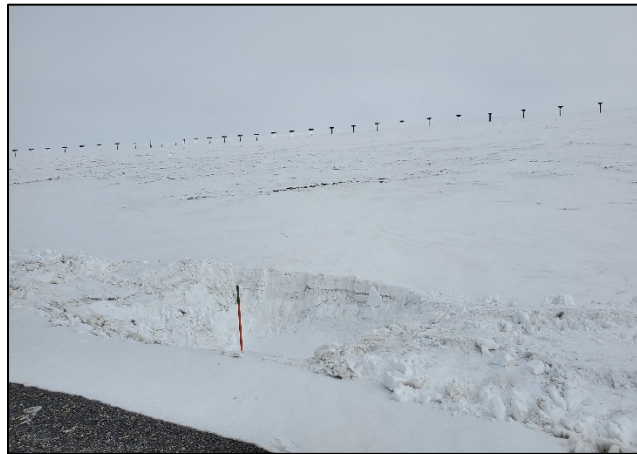
Photo 3.1: Snow cleared from a culvert on the GMT2/MT7 road, looking south; early May, 2020

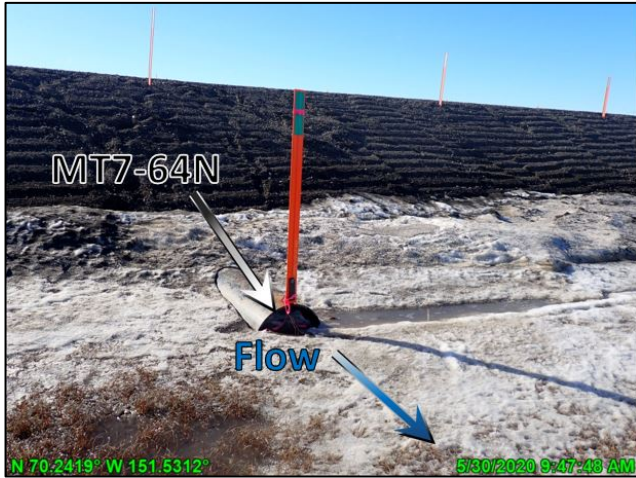
No performance issues were identified at any culverts along the GMT2/MT7 access road, besides temporary blockages from ice and drifted snow. Ponded water was present at several locations along the access road but was mainly attributed to snow and ice impeding flow and not culvert placement (Photo 3.2 and Photo 3.3).

Photo 3.2: Culvert MT7-64 outlet partially buried with snow, looking south; May 30, 2020

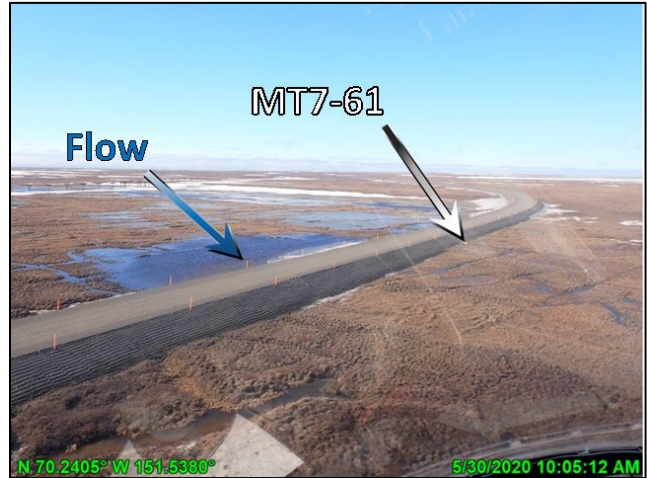
Photo 3.3: Ponding near culvert MT7-61 looking north; May 30, 2020

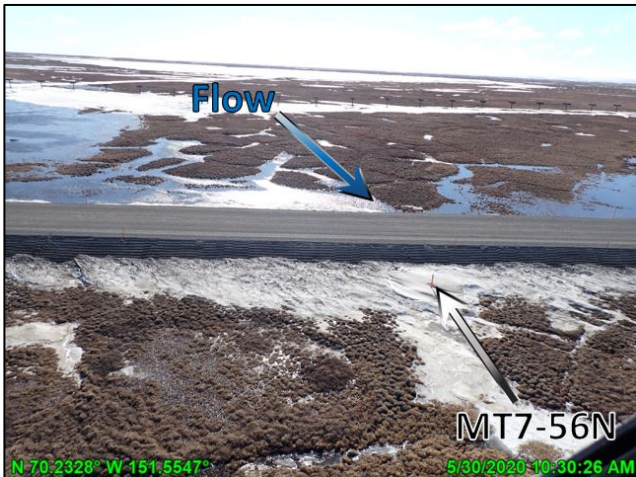
Drifted snow and along both embankments buried culvert inlets and outlets and temporarily impeded drainage in some locations (Photo 3.4 and Photo 3.5). Once conveyance paths were established by water melting through snow/ice, the culverts all performed as designed and natural drainage patterns were maintained (Photo 3.6). With the exception of the minimal sloughing observed at culvert MT7-31, no displacement of gravel fill attributed with spring breakup flooding was observed along the road embankment or around culvert inlets and outlets (Photo 3.7). Displaced gravel near MT7-31 was mechanically replaced in July after floodwaters receded (Photo 3.8). There were no signs of undermining at drainage structures. Several culverts were perched on either the north or south sides of the road which may lead to the development of scour holes (Photo 3.9). Besides these perched culverts, no culvert maintenance, repair, upgrade, setting adjustments, and/or replacements are recommended at this time.

Photo 3.4: Drifted snow blocking flow at MT7-56, looking south; May 30, 2020

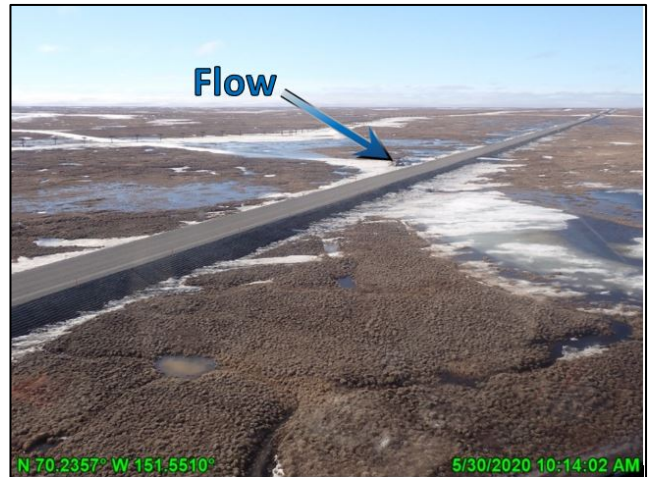
Photo 3.5: Drifted snow along GMT2/MT7 road embankments, looking southwest; May 30, 2020

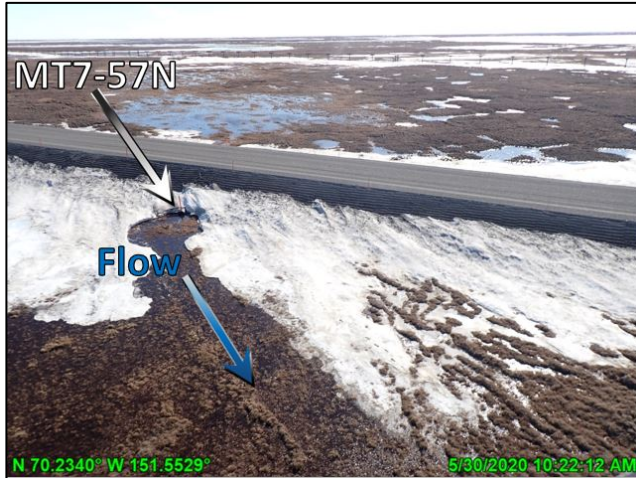
Photo 3.6: Flow through culvert MT7-57, looking south; May 30, 2020

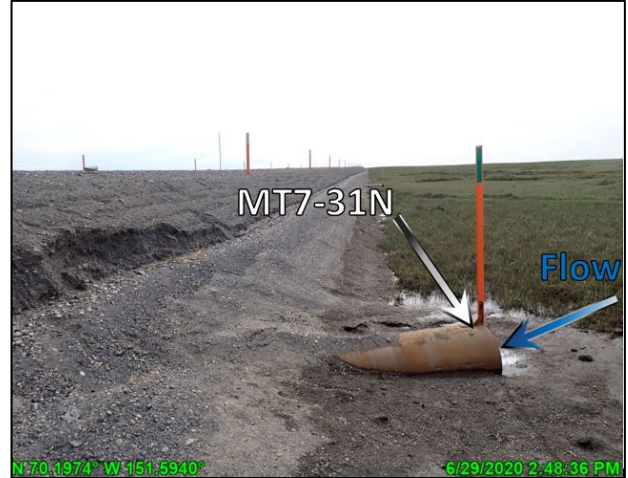
Photo 3.7: Sloughing along the north embankment near MT7-31, looking west; June 29, 2020

Equalization occurred on June 12, represented by the rapid decrease in stage at the upstream gage accompanied by the sharp increase in stage at the downstream gage which resulted in peak. CPAI crews facilitated equalization by heating the culverts to thaw ice blockages. The culvert blockages had melted out by June 29 and the S12 monitoring area was dry. Wash marks and isolated pockets of minor sloughing were observed along the north embankment. Displaced gravel from sloughing near MT7-31 was cleared after floodwaters receded.

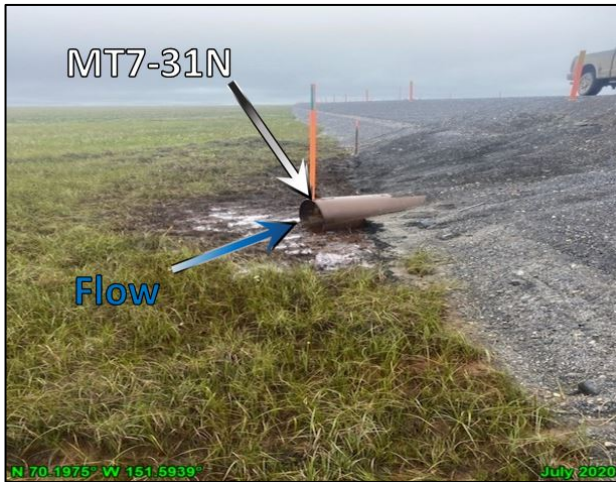
Photo 3.8: Culvert MT7-31 after displaced gravel cleared from site, looking east; July, 2020

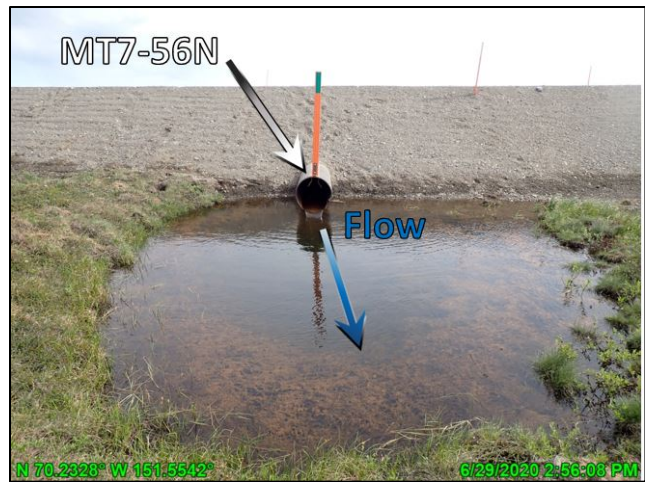
Photo 3.9: Culvert GMT2-56 perched on the north side of the GMT2/MT7 access road, looking south; June 29, 2020

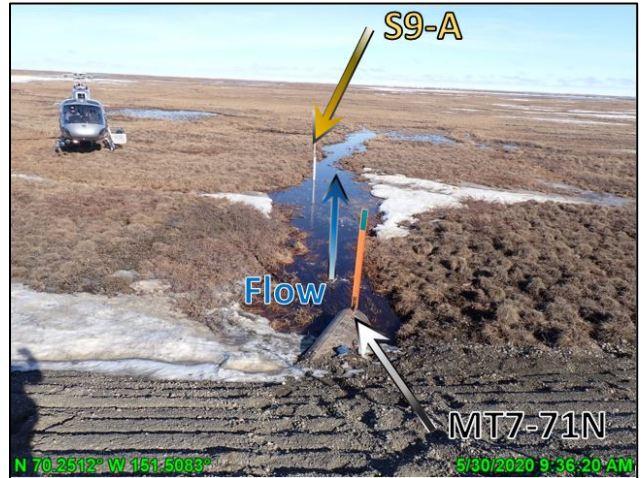
Photo F.2: Flow through culvert MT7-71, looking north; May 30, 2020

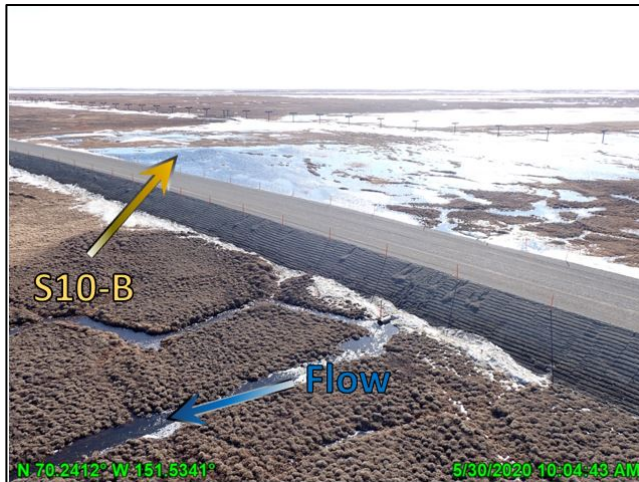
Photo F.7: Flow through culvert MT7-63, looking southeast; May 30, 2020

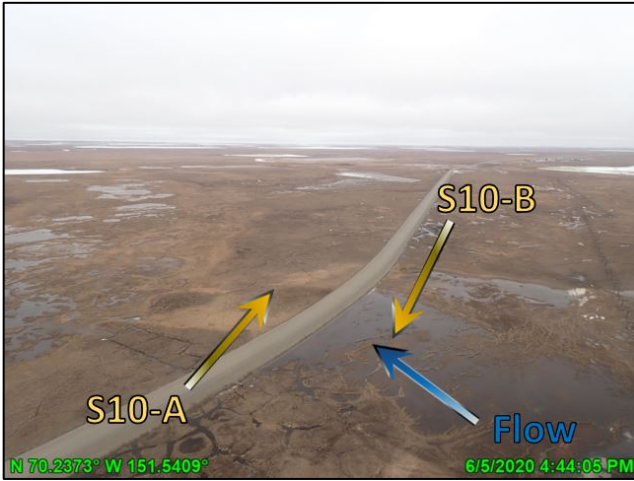
On May 31 meltwater was equalizing exclusively through culvert MT7-63. By June 5, stage had receded and impounded meltwater behind culvert MT7-64 was no longer hydraulically connected to the inlet of culvert MT7-63, leaving meltwater stagnant behind the blocked culvert MT7-64.

Photo F.9: Impounding behind blocked culvert MT7-64, looking northeast; June 5, 2020

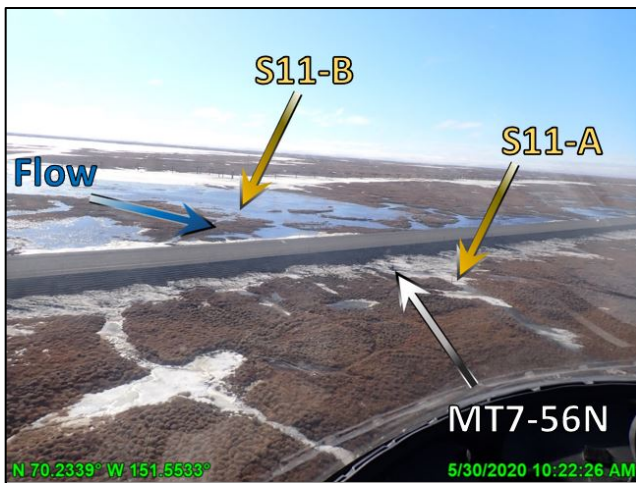
On May 30 a site visit was performed, and flow was measured through culvert MT7-57. Culvert MT7-56 was blocked with ice and snow, and impounded meltwater behind culvert MT7-56 was hydraulically connected to culvert MT7-57. On June 3, stage at the upstream gage had receded and culvert MT7-56 remained blocked. By June 29, all culvert blockages had melted out and minimal meltwater remained in the area. Minimal flow was observed through culvert MT7-56.

Photo F.13: Meltwater behind blocked culvert MT7-56, looking south; May 30, 2020

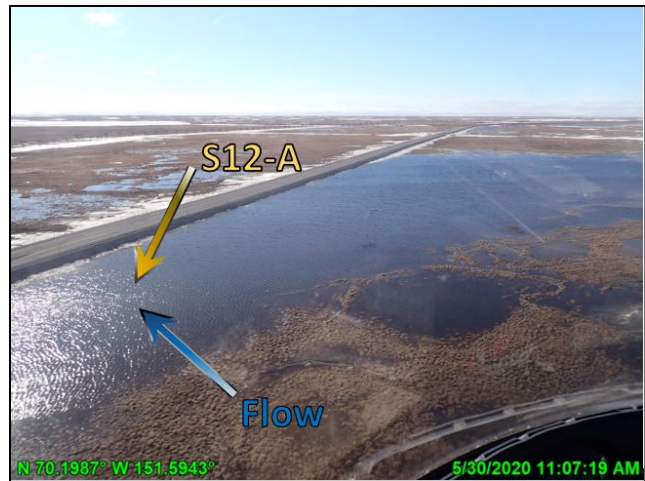
Photo F.16: Ponded water on the upstream side of the road near S12, looking southwest; May 30, 2020

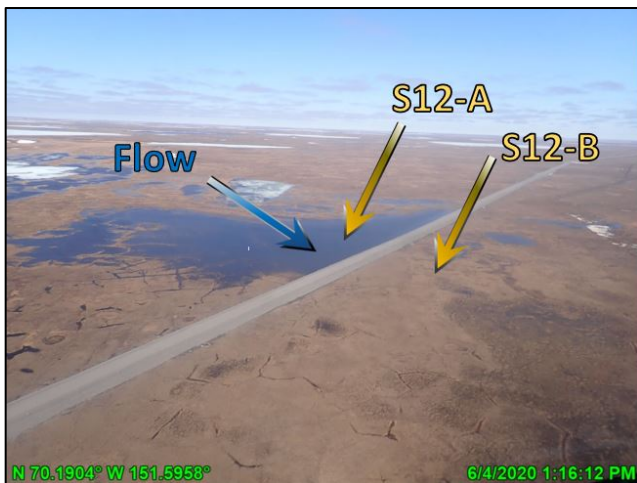
The ponding near S12 was due to ice and snow accumulation in the culverts. This was likely exaggerated by the propensity of snow to accumulate on the north/east side of roadways, driven by predominately easterly winds and winter storms. The inlets of these culverts, positioned on the north side of the road, were buried deep by snow during winter and were quickly drifted in again after snow was mechanically cleared in April. With the exception of the temporary blockages from ice and drifted snow accumulation, all culverts are presumed to be functioning as designed, and the natural drainage patterns in the area were confirmed to have been maintained. Culvert performance could be improved by the use/development of superior snow and ice clearing or thawing techniques at the culvert inlets.

Photo F.17: Ponding near S12 behind blocked culverts, looking east; June 4, 2020

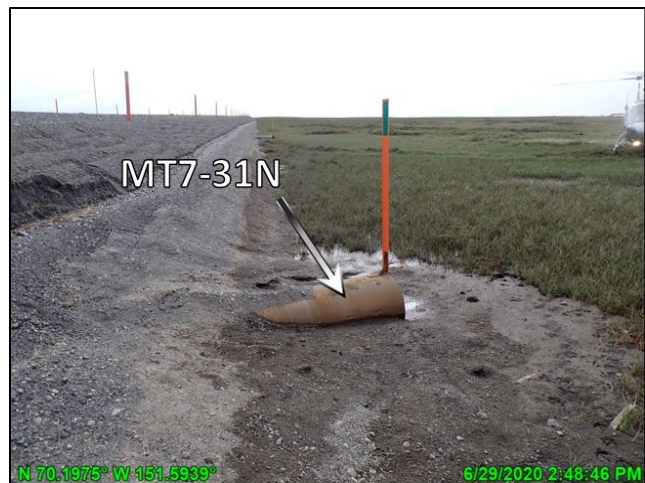
Photo F.18: Sloughed gravel near culvert MT7-31 and S12, looking west; July 2, 2020

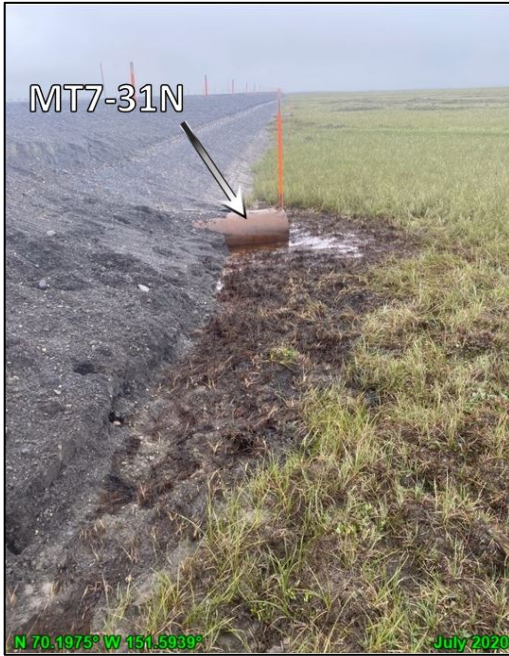
Photo F.19: Culvert MT7-31 after sloughed gravel replaced on embankment; July, 2020

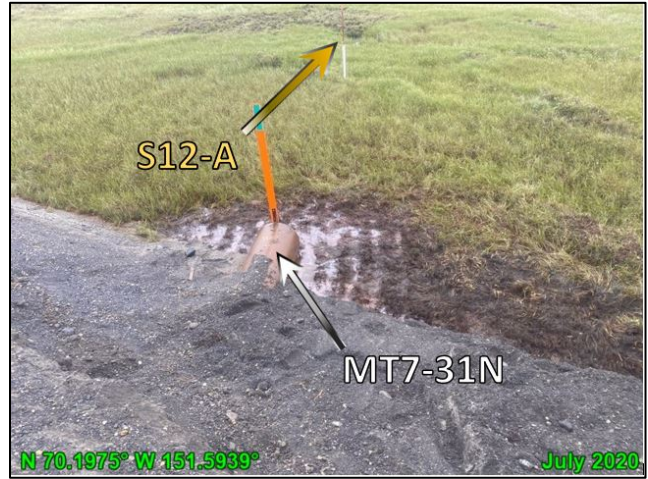
Photo F.20: Culvert MT7-31 after souhged gravel replaced on embankment; July, 2020

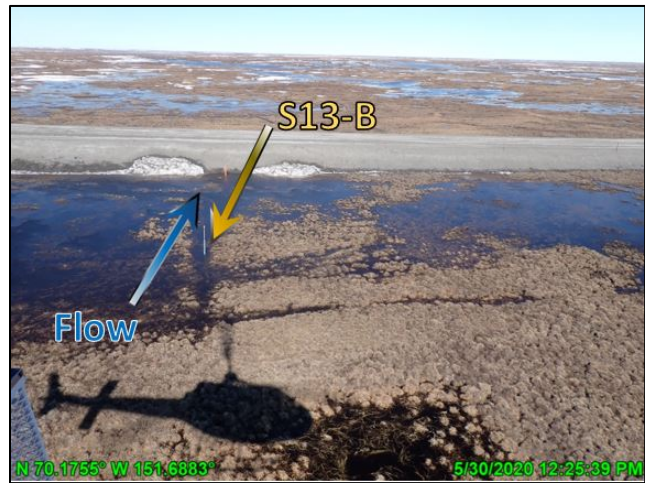
Photo F.22: Ponding near S13 along the south embankment, looking north; May 30, 2020
