# Colville River Delta

Spring Breakup Monitoring &  
Hydrological Assessment

# 2021

**Michael Baker**

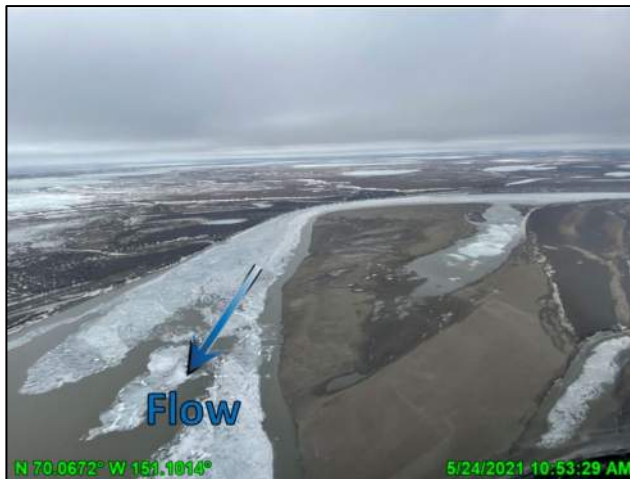
**Photo 3.1: Approximate leading edge of floodwater upstream of the Horseshoe Bend, looking south (upstream); May 24, 2021**

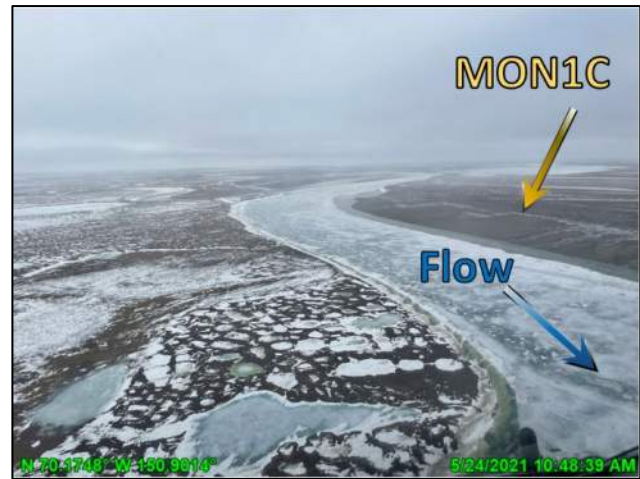
**Photo 3.2: Intact channel ice through MON1 reach with overflow and local melt along the banks, looking south (upstream); May 24, 2021**

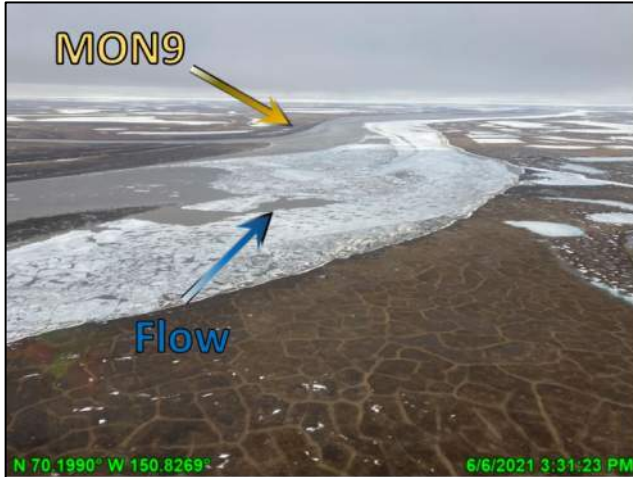
**Photo 3.7: Fragmented channel ice just upstream of HDD, looking north (downstream); June 6, 2021**

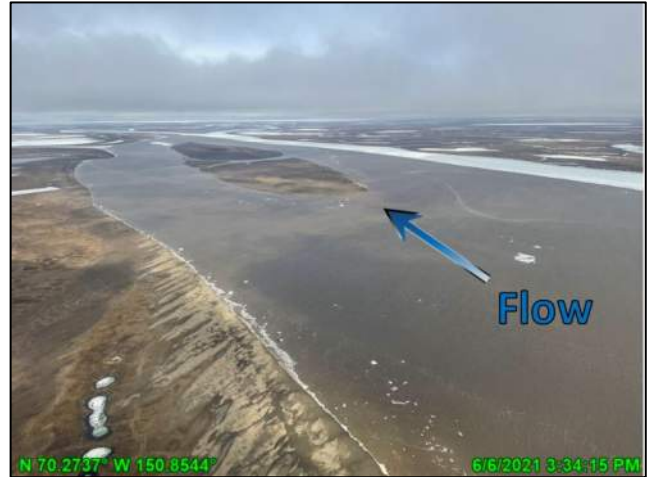
**Photo 3.8: Intact channel ice on the east side of the Colville River near the Sagoonang Channel bifurcation, with no overbank flooding, looking north (downstream); June 6, 2021**

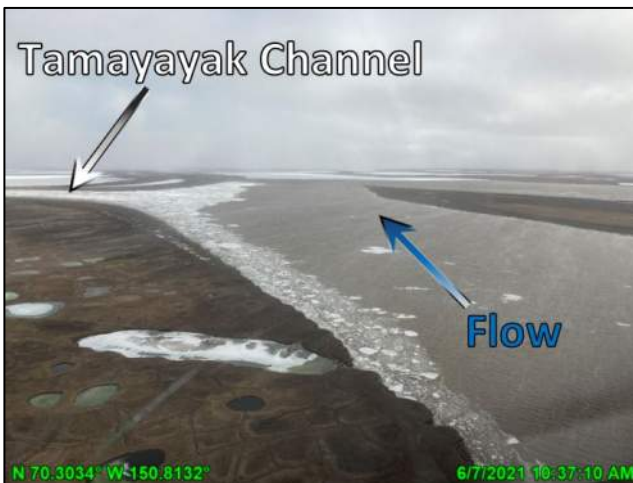
**Photo 3.9: Ice in the East Channel accumulating near the Tamayayak Channel bifurcation, looking north (downstream); June 7, 2021**

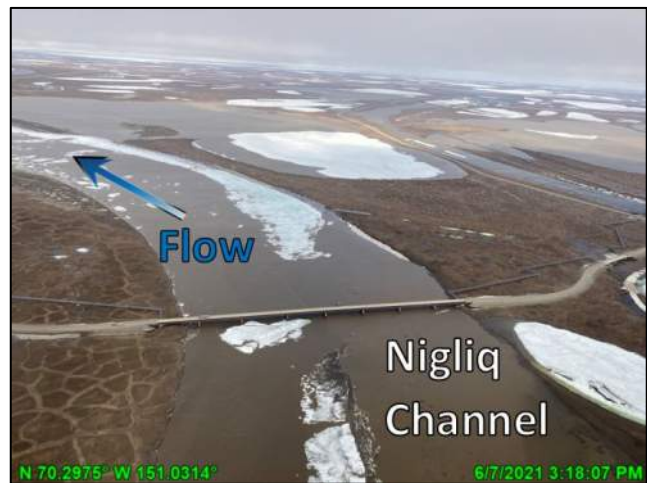
**Photo 3.10: CD5 Bridge across the Nigliq Channel near peak conditions showing no floodplain inundation or overbank flooding, looking north (downstream); June 7, 2021**

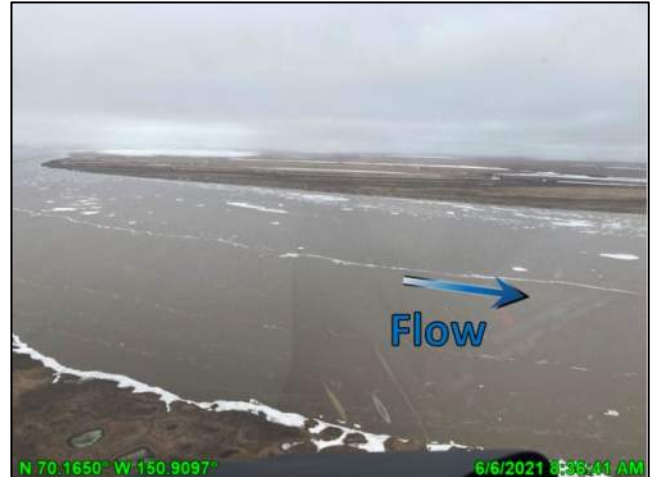
Photo 4.6: Peak conditions with periodic ice floes moving through the MON1 reach, looking southwest (upstream); June 6, 2021

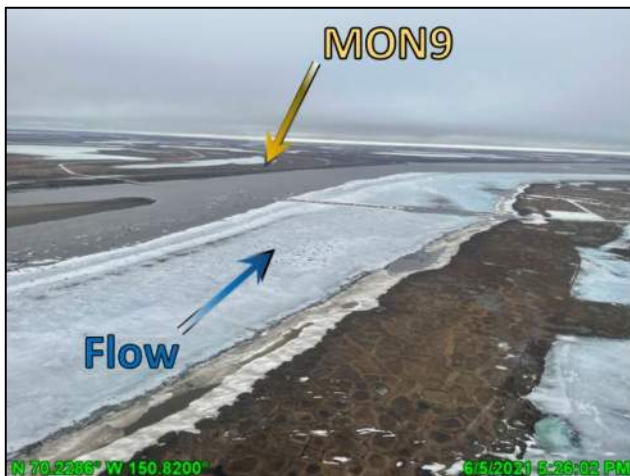
Photo 4.11: Rising stage and degrading channel ice at MON9, looking north (downstream); June 5, 2021

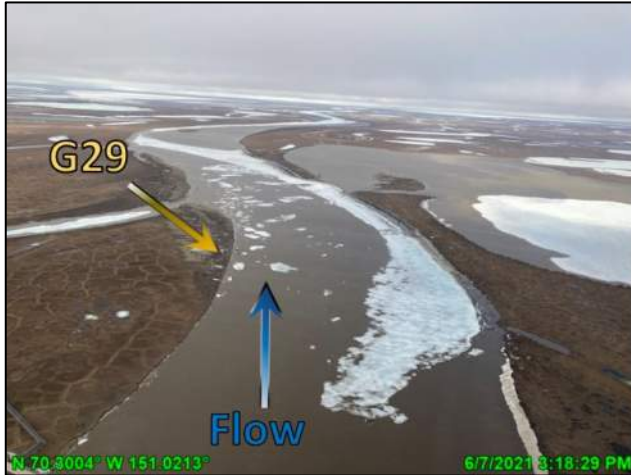
Photo 4.21: Persisting channel ice during peak conditions near MON22, looking north (downstream); June 7, 2021

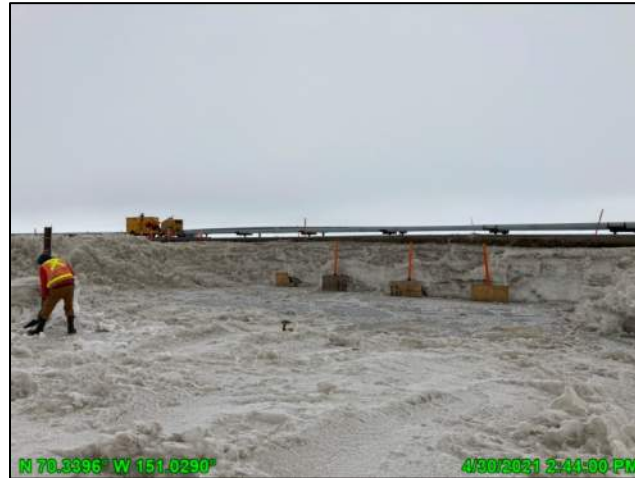
**Photo 4.25: Snow cleared from the south side of the culvert battery between G6 & G7.**

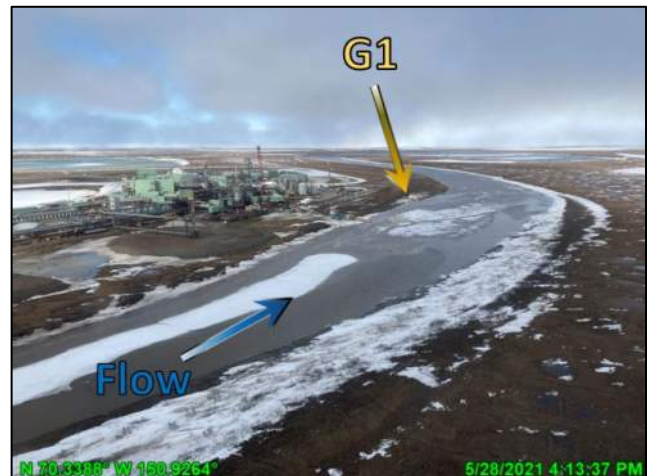
**Photo 4.26: Local melt over saturated snow in the Sakoonang Channel at G1, looking north; May 28, 2021**

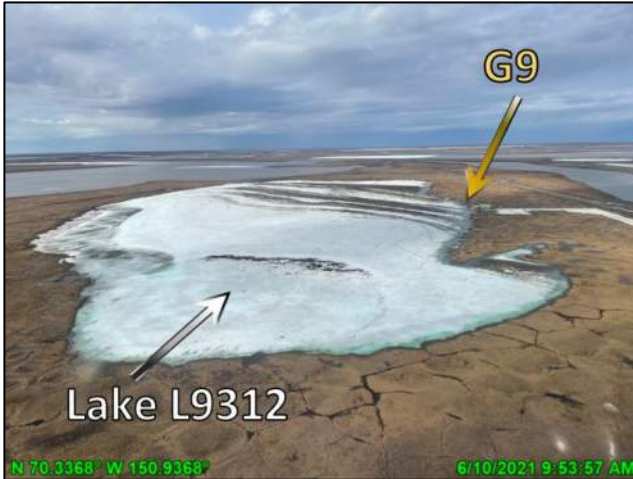
Spring breakup overbank flow did not reach Lake L9312 and as a result did not recharge during spring breakup. After breakup, Lake L9312 recharged from precipitation, but not to the bankfull elevation of 7.8 feet. Lake L9313 became hydraulically connected to Lake M9525, observed on June 7, and recharged on June 8 (Photo 4.27 and Photo 4.28). Peak stage occurred on June 8 and correlated to peak stage in the Sakoonang Channel. Stage at gage G9 (L9312) and gage G10 (L9313) is presented in Graph 4.9.

Photo 4.27: Lake L9312 after peak conditions with persisting ice, looking west; June 10, 2021

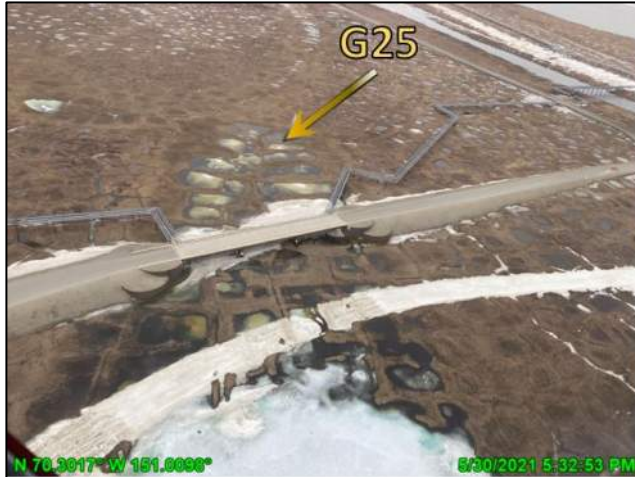
Local melt was first observed near Lake L9323 Bridge on May 30 via aerial observations (Photo 4.42). Lake L9323 did not become hydraulically connected from either the Sagoonang Channel or the Nigliq Channel (Photo 4.43 and Photo 4.44). Lake L9323 snow and ice melted throughout the monitoring period and did not reach PT elevations while drifted snow persisted underneath the bridge. A flyover on June 10 confirmed the ice remained in Lake L9323 (Photo 4.45).

Photo 4.42: Lake L9323 bridge and vicinity prior to peak stage, looking north; May 30, 2021

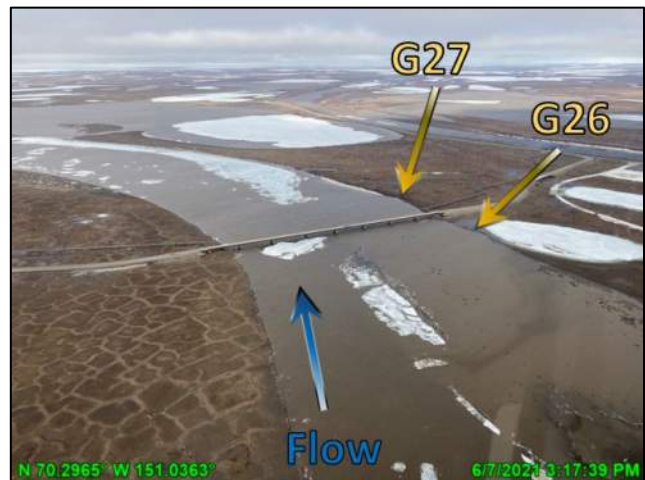
Photo 4.49: Peak conditions at the Nigliq bridge with no overbank flooding, looking northeast (downstream); June 7, 2021

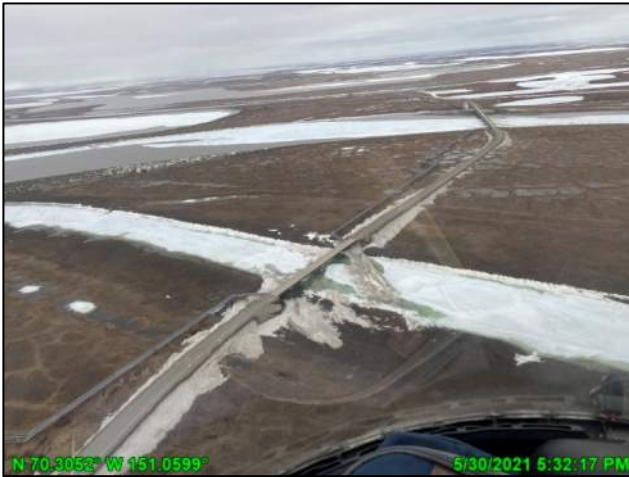
Photo 4.52: Local melt observed overtop of channel ice at Lake L9341, looking east; May 30, 2021

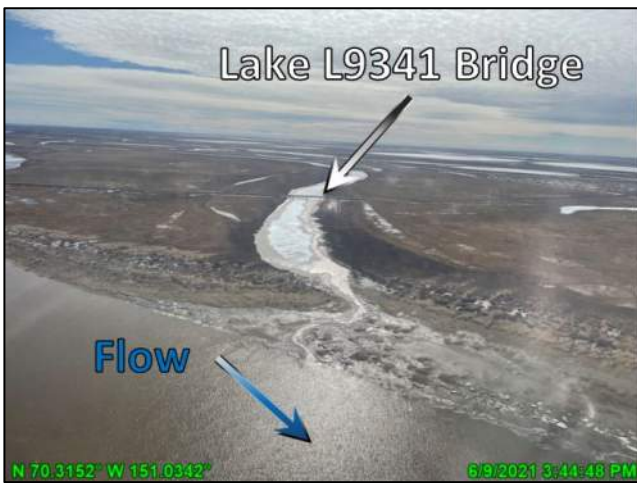
Photo 4.54: Lake L9341 with intact channel ice persisting as stage is receding, looking south (downstream); June 9, 2021

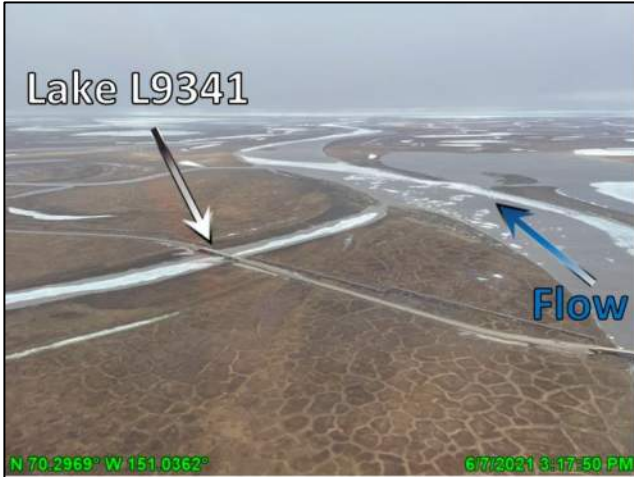
Photo 4.60: CD5 road near Lake L9341 with no overbank flooding, looking north; June 7, 2021

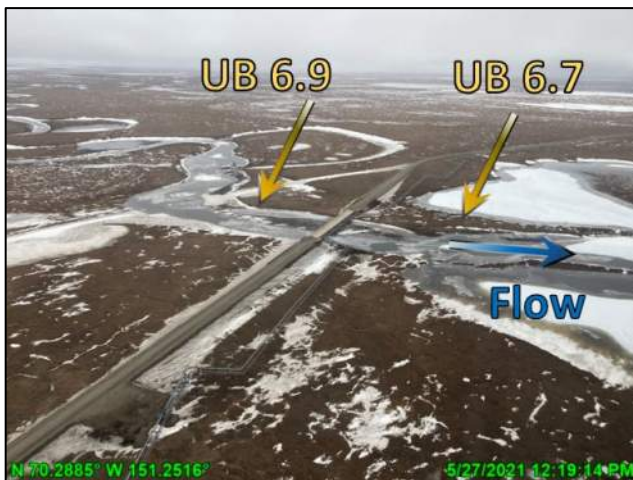
Photo 4.64: Tinmiaqsiugvik Bridge a few hours after peak stage with flow overtop saturated snow and ice, looking west; May 27, 2021

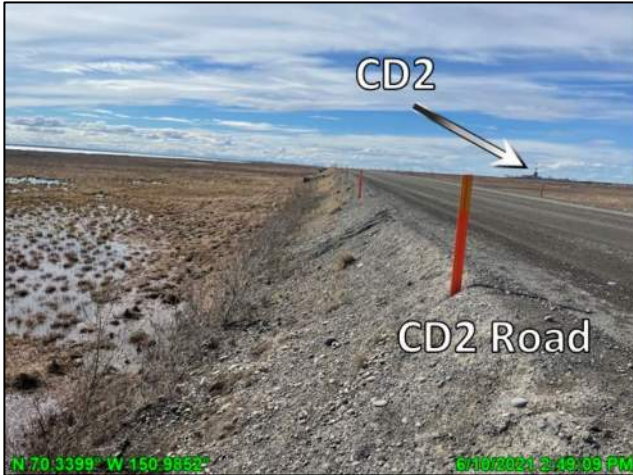
Photo 5.1: CD2 road post-breakup, looking northwest; June 10, 2021

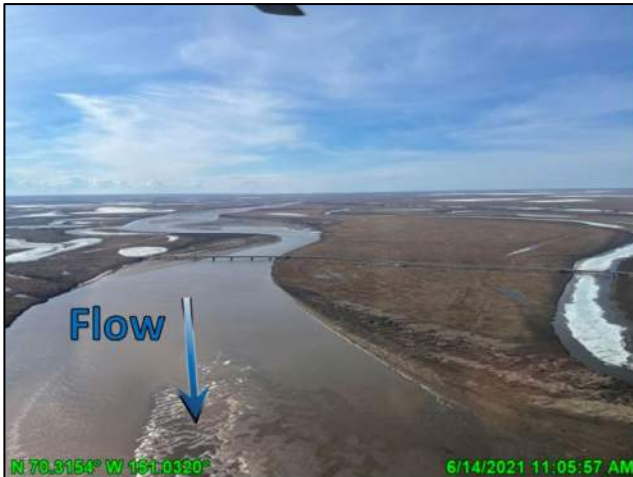
Photo 6.3: Nigliq Channel post breakup showing no channel migration, looking south; June 14, 2021
