Culvert Monitoring Report
2021 Greater Moose's Tooth 2
(GMT2/MT7)
Spring Breakup

GMT2/MT7 SPRING BREAKUP

CULVERT MONITORING REPORT

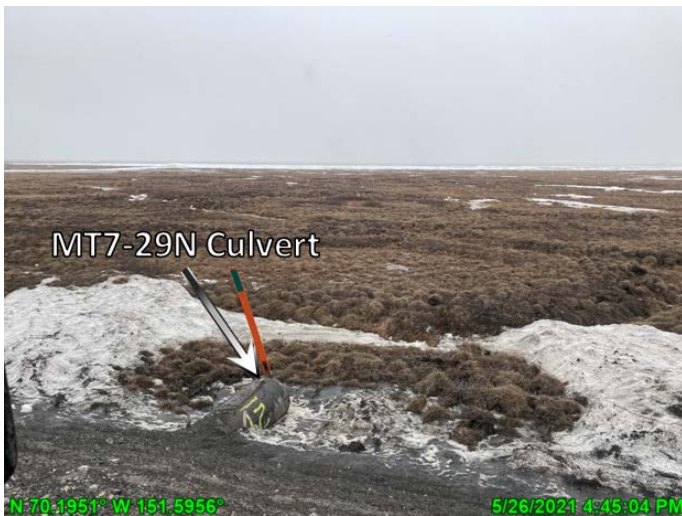
Photo 3.1: Culvert MT7-29 outlet after mechanical clearing of snow, looking north; May 26, 2021

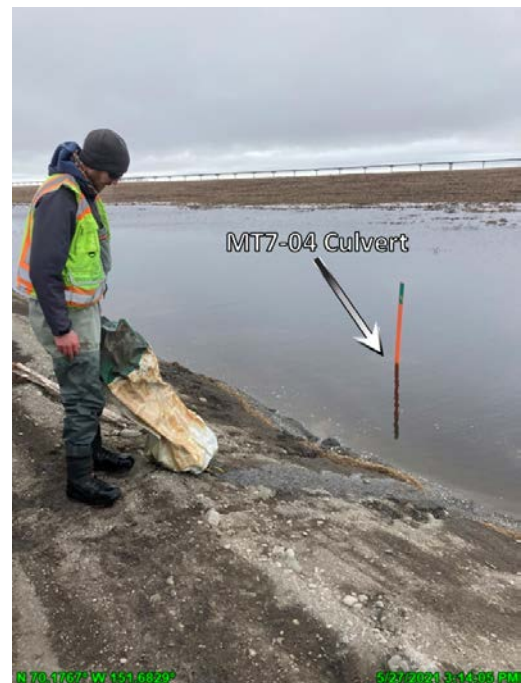
Photo 3.2: Bladder after being removed from culvert MT7-04 still blocked with ice; May 27, 2021

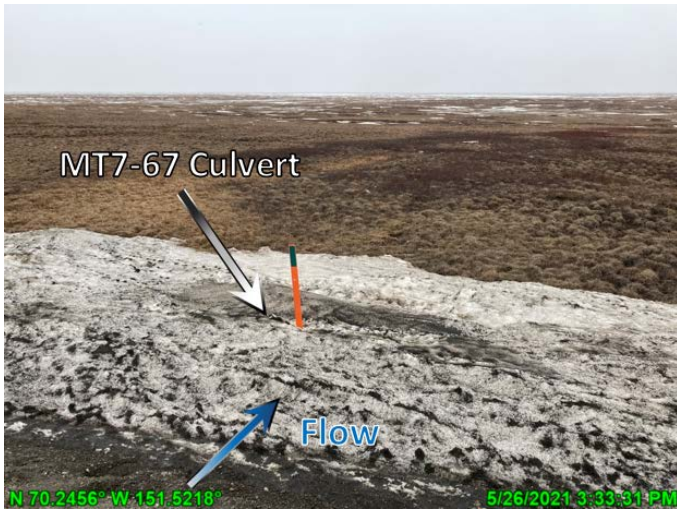
No performance issues were identified at any culverts along the GMT2/MT7 access road, besides temporary blockages from ice and drifted snow. Differential ponding was present at several locations along the access road but was mainly attributed to snow and ice impeding flow and not culvert placement (Photo 3.3 and Photo 3.4).

Photo 3.3: Culvert MT7-67 outlet partially buried with snow, looking north; May 26, 2021

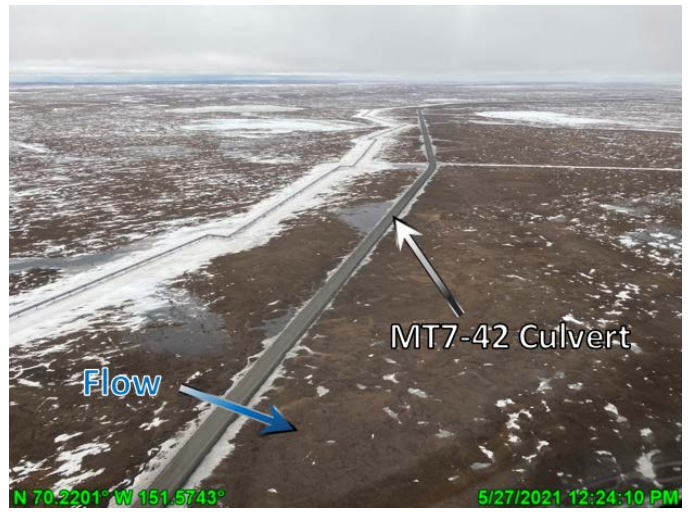
Photo 3.4: Ponding near culvert MT7-42 looking southwest; May 27, 2021

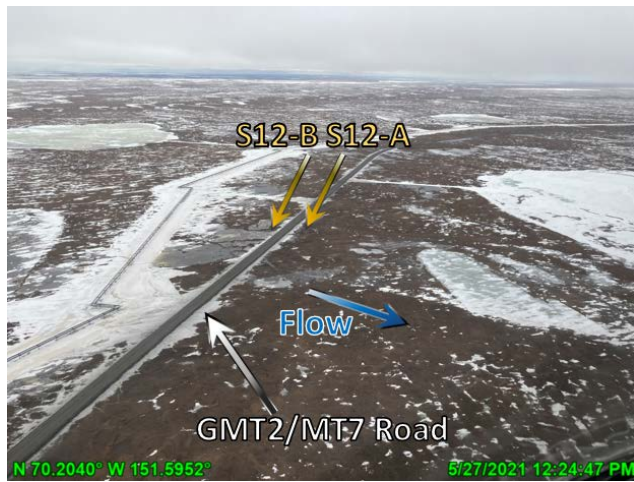
Drifted snow and ice in some culverts persisted through May (Photo 3.5 and Photo 3.6). Once conveyance paths were established by water melting through snow/ice, the culverts all performed as designed and natural drainage patterns were maintained (Photo 3.7 and Photo 3.8). No displacement of gravel fill attributed with spring breakup flooding was observed along the road embankment or around culvert inlets and outlets (Photo 3.9). There were no signs of undermining at drainage structures (Photo 3.10). Besides monitoring perched culverts that were mentioned earlier, no culvert maintenance, repair, upgrade, setting adjustments, and/or replacements are recommended at this time.

Photo 3.5: Drifted snow blocking flow near S12 gages, looking southwest; May 27, 2021

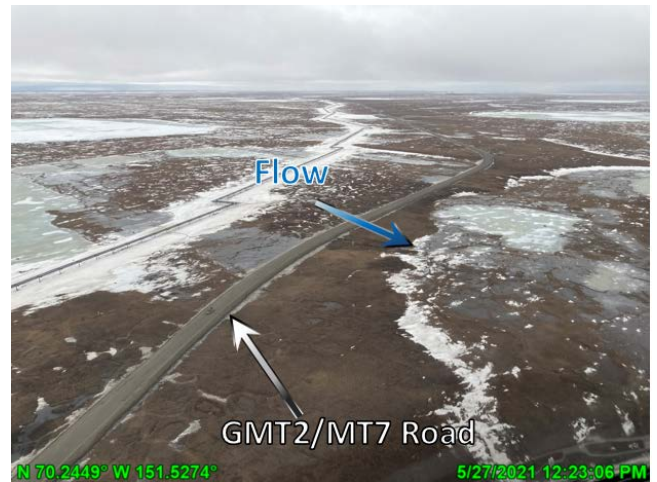
Photo 3.6: Drifted snow along GMT2/MT7 road embankments, looking southwest; May 27, 2021

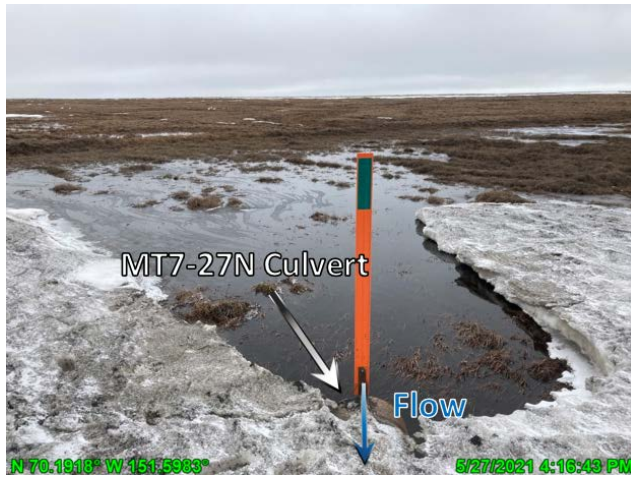
Photo 3.7: Flow through culvert MT7-27, looking north; May 27, 2021

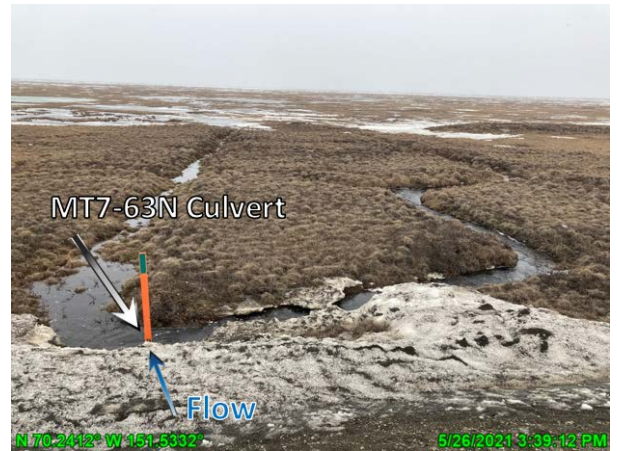
Photo 3.8: Flow through culvert MT7-63 showing natural drainage pattern cutting through snow, looking north; May 26, 2021

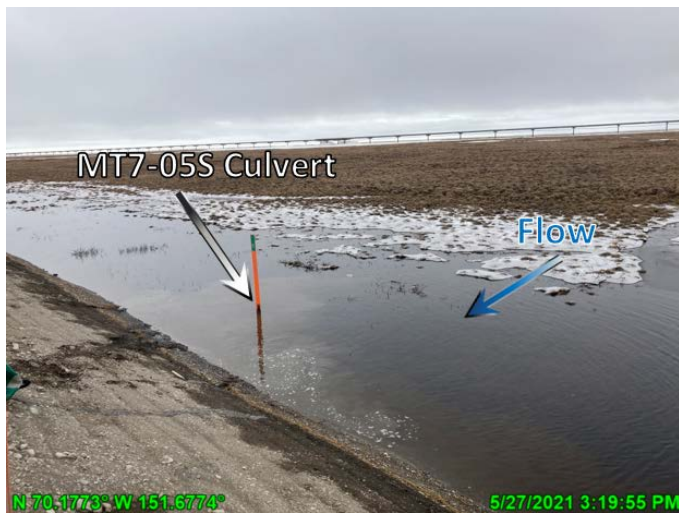
Photo 3.9: Wash line with no sloughing along the south embankment near MT7-05, looking east; May 27, 2021

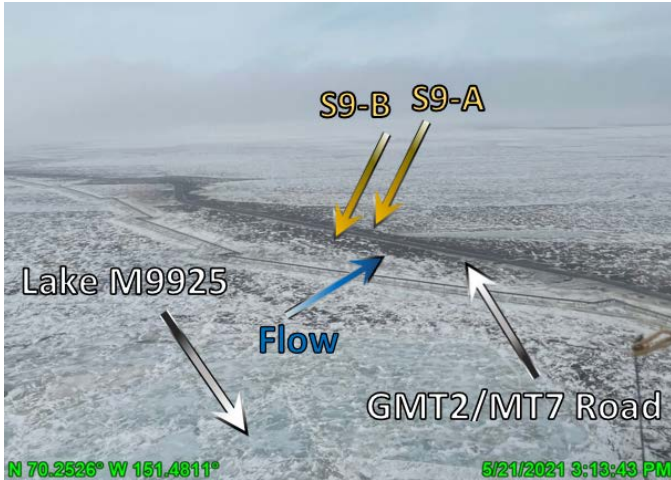
On May 21, isolated pockets of localized meltwater were observed in the drainage near the road embankments (Photo F.1). The ice road along the pipeline alignment, on the south side of the GMT2/MT7 road, remained intact. Meltwater remained impounded on the south side of the gravel road through early June. On June 5, meltwater from Lake M9925 had cut a path through the ice road and was flowing through culvert MT7-70, which is positioned on higher ground than culvert MT7-71 (Photo F.2). Meltwater remained impounded in the low-lying area behind culvert MT7-71 which was blocked by ice and snow.

Photo F.1: Local meltwater near S9, looking west; May 21, 2021

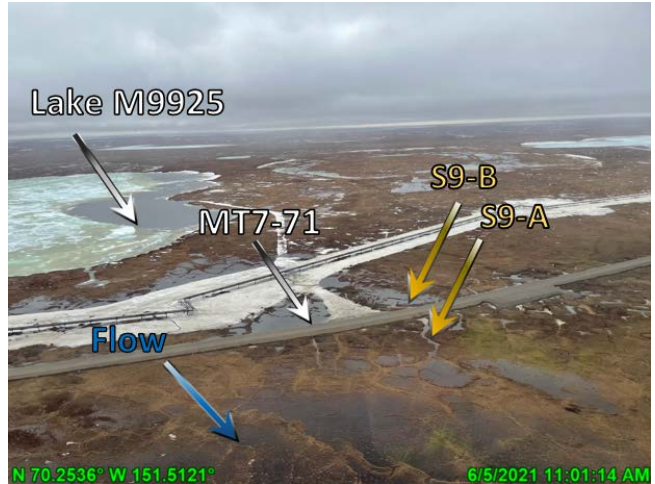
Photo F.2: Flow through culvert MT7-70, looking south (upstream); June 5, 2021

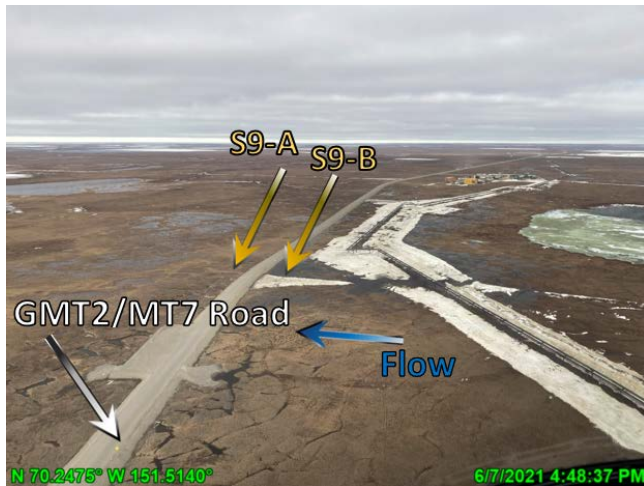
Peak stage was recorded on the upstream gage, S9-B, on June 8 (Photo F.3). Following peak, stage slowly decreased as meltwater flowed through culvert MT7-70. Aerial observations from June 10 showed impounded water remaining behind culvert MT7-71. Observations from June 26 showed the natural drainage patterns established, with minimal ponding on the upstream side of the road (Photo F.4).

Photo F.3: Near peak stage at S9-B, looking northeast; June 7, 2021

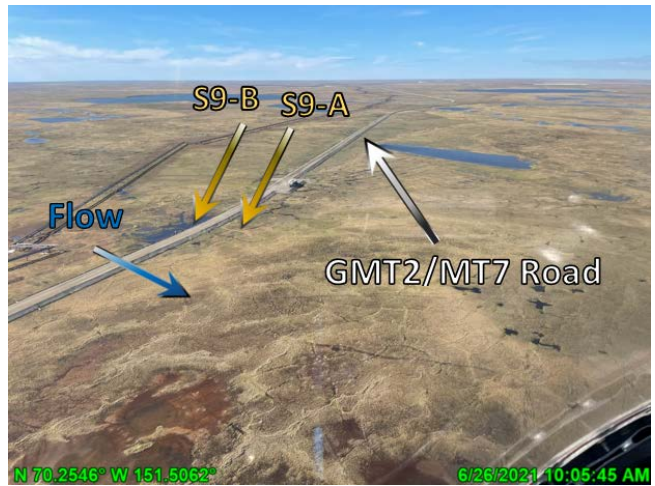
Photo F.4: Summer conditions near S9, looking northeast, June 26, 2021

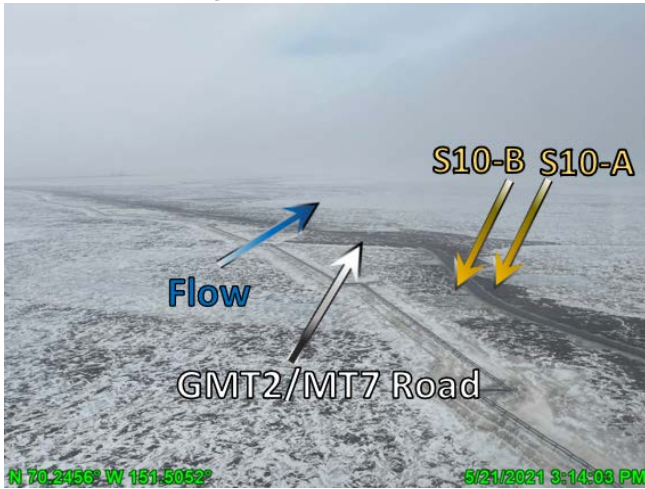
On May 21, isolated pockets of localized meltwater were observed in the drainage on the south (upstream) side of the road near the embankment (Photo F.5). The ice road along the pipeline alignment on the south side of the GMT2/MT7 road remained intact. After May 21, meltwater increased and accumulated between the ice road and the GMT2/MT7 road. On May 30, two distinct pockets of impounded meltwater were observed along the embankment between culverts MT7-59 and MT7-66 (Photo F.6). One pocket was located directly east of culvert MT7-61, and the other was between culverts MT7-63 and MT7-64 near the S10 gages. This impounded meltwater was hydraulically connected to the paleolake associated with the drainage, and multiple drainage paths had been cut through the ice road.

Photo F.5: Local melt near S10, looking west; May 21, 2021

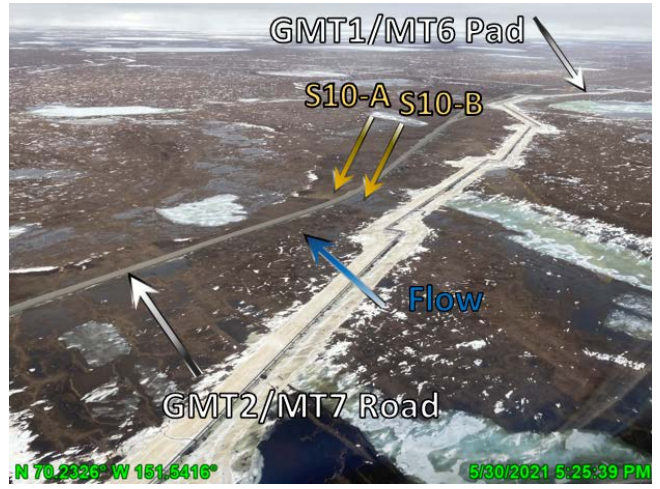
Photo F.6: Increasing meltwater on the upstream (south) side of road, looking northeast; May 30, 2021

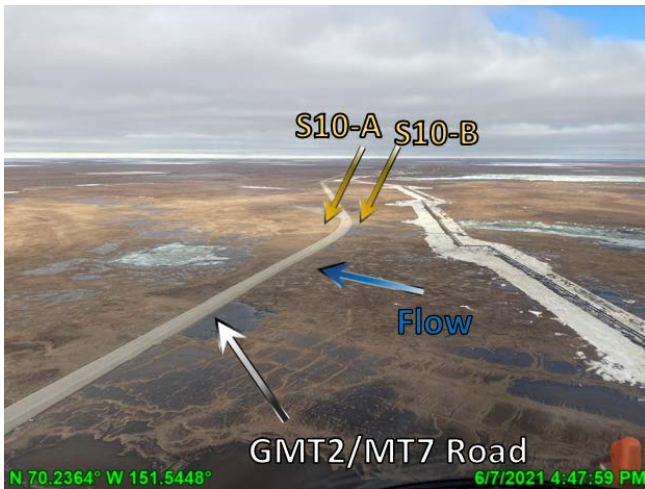
On June 7, a flow path was established through culvert MT7-63, providing relief to the area of impounded water closest to the S10 gages (Photo F.7). Observations from June 26 showed natural drainage patterns established

Photo F.7: Decreasing meltwater near S10, looking northeast; June 7, 2021

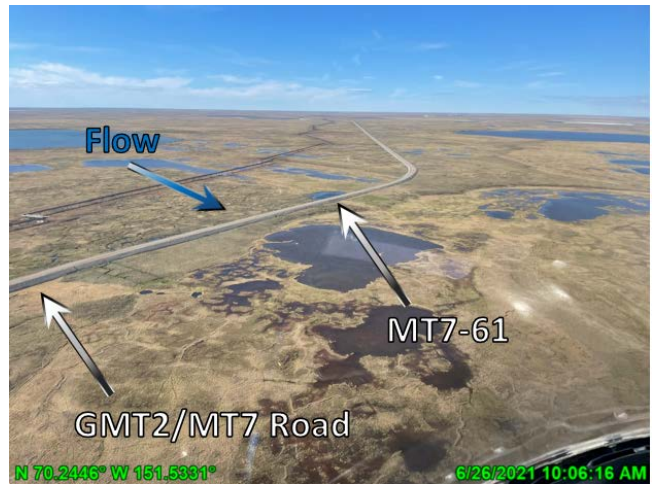
(Photo F.8). Meltwater in this study area did not reach sufficient height to measure on the site staff gages, so WSE readings and PT data were unavailable. The precise timing and magnitude of peak stage is unknown.

Photo F.8: Summer conditions near S10, looking southwest; June 26, 2021

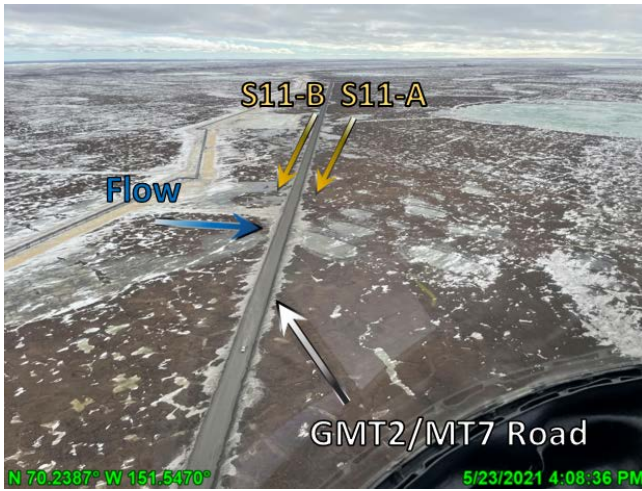
On May 23, localized meltwater was observed near the GMT2/MT7 road but had not reached the road embankment (Photo F.9). The ice road along the pipeline alignment on the south side of the GMT2/MT7 road remained intact. Meltwater reached the GMT2/MT7 road embankment on May 24 and stage peaked on the upstream gage, S11-B (Photo F.10). Following peak, stage decreased steadily as meltwater flowed through culvert MT7-57. Culvert MT7-56 was blocked with ice and snow. Stage continued to decrease, and minimal meltwater was observed along the road embankments by June 5 (Photo F.11), although some meltwater appeared to be retained behind the ice road. Observations from June 26 showed the natural drainage patterns established (Photo F.12).

Photo F.9: Local meltwater around S11, looking southwest; May 23, 2021

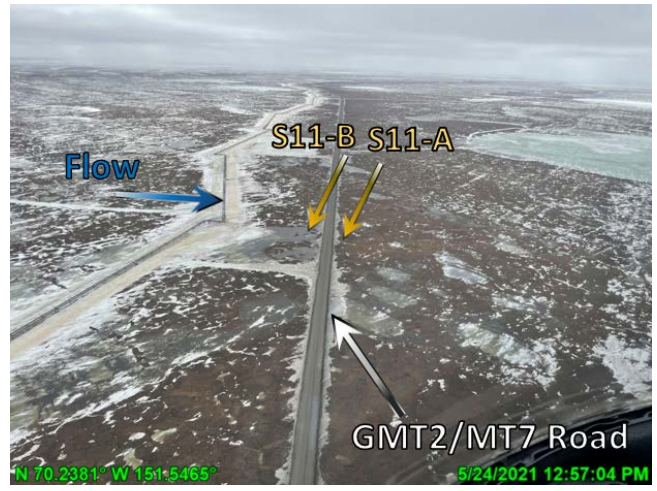
Photo F.10: Peak stage near S11, looking southwest; May 24, 2021

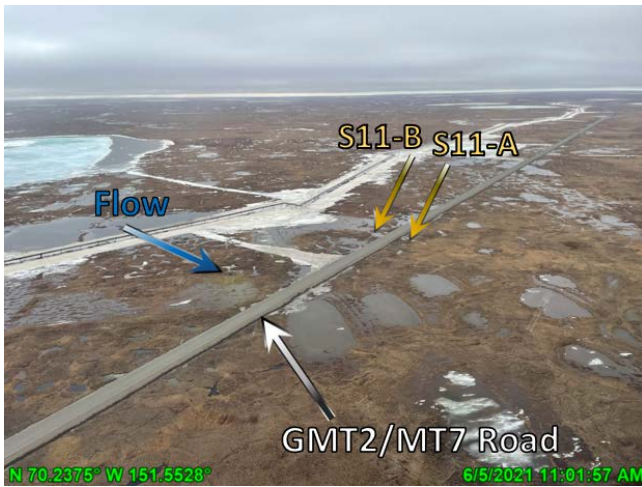
Photo F.11: Receding stage near S11, looking south; June 5, 2021

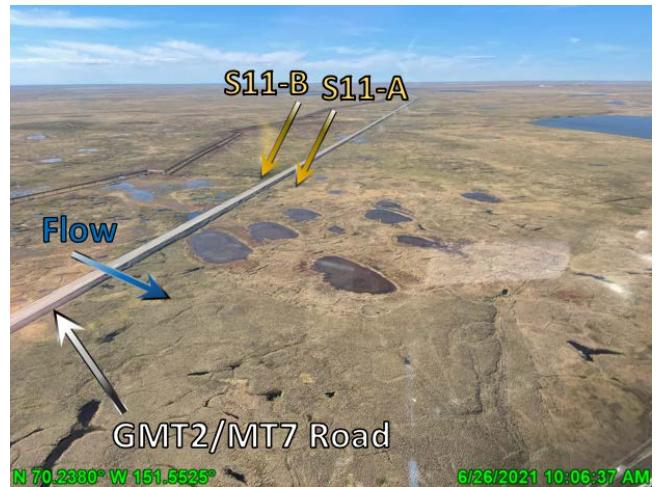
Photo F.12: Summer conditions near S11, looking southwest; June 26, 2021

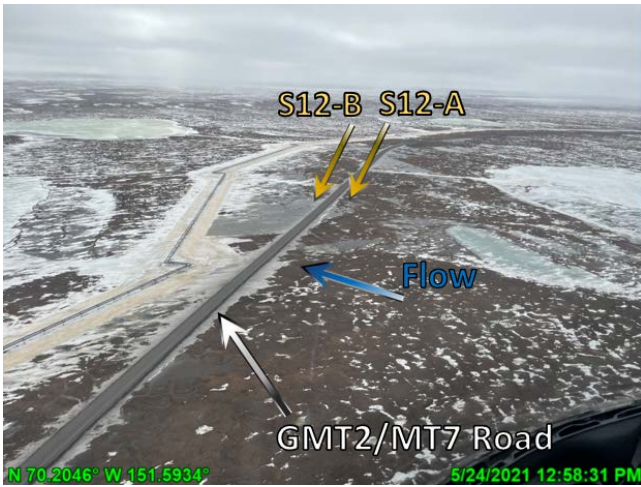
Photo F.13: Ponded water on the upstream side of the road near S12, looking south; May 24, 2021

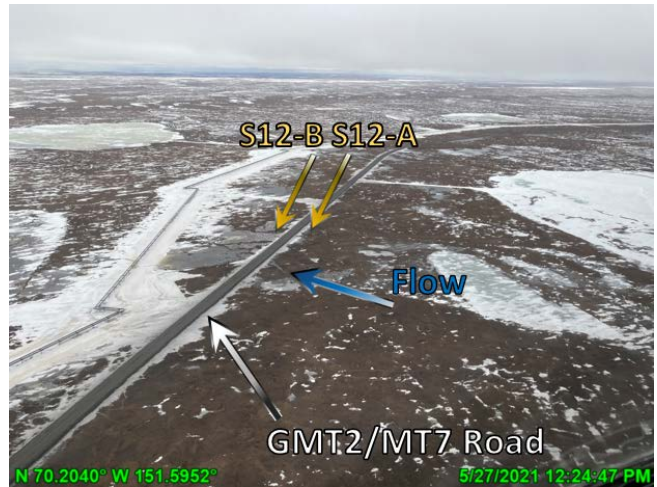
Disconnected ponding and a channel through the ice road were observed on May 27 during an overflight (Photo F.14). On June 2, minimal meltwater was observed along the road embankments (Photo F.15). Observations from June 26 showed the natural drainage patterns established (Photo F.16).

Photo F.14: Decreasing stage near S12 after peak, looking south; May 27, 2021

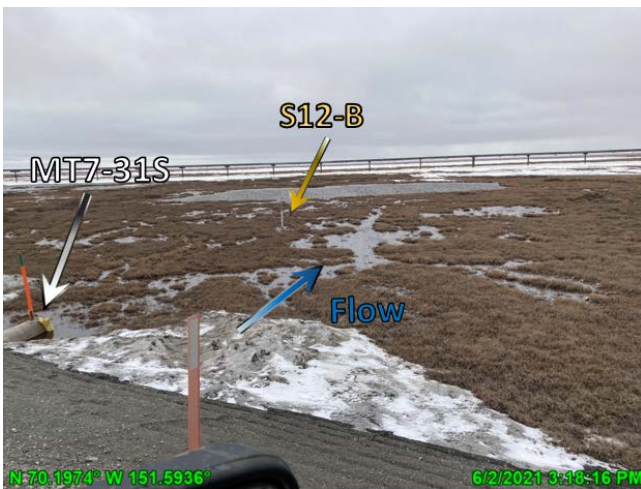
Photo F.15: Minimal ponding along road embankments at S12, looking east (downstream); June 2, 2021

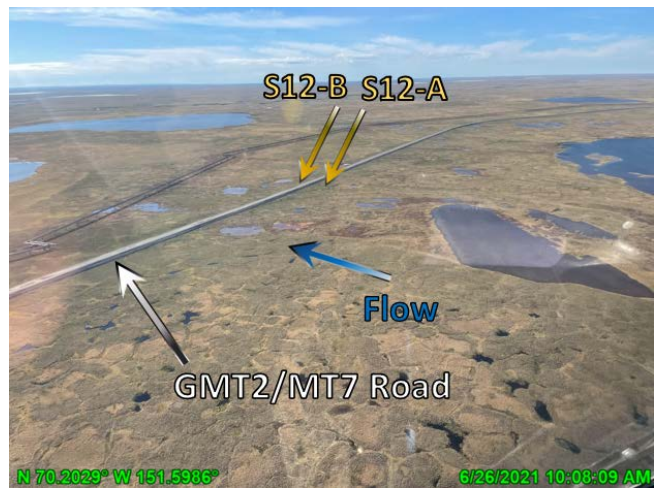
Photo F.16: Summer conditions near S12, looking south; June 26, 2021

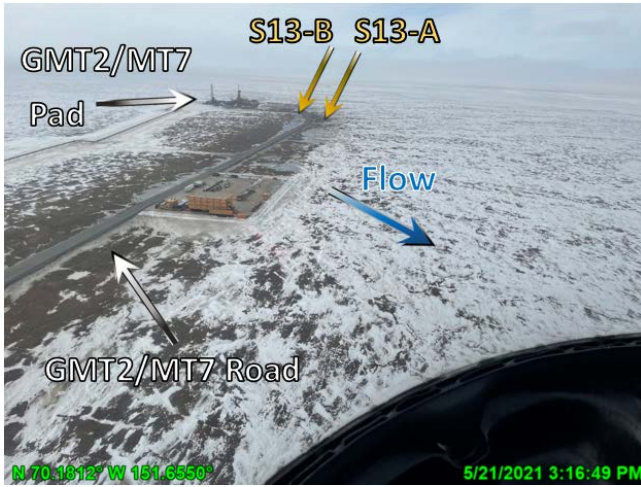
On May 21, meltwater was initially observed on the south (upstream) side of the road near S13 (Photo F.17). An observation from on May 26 revealed ponded water on the south embankment of the road, particularly near the turn onto the GMT2/MT7 pad. Peak stage was recorded in the evening of May 26. By May 27, culvert MT7-02 was conveying flow south to north (Photo F.18) and water levels were equalizing at gages S13A and S13B. Culvert bladders were pulled from culverts MT7-03 through MT7-07.

Photo F.17: Ponded meltwater on the upstream side of the road near S13, looking southwest; May 21, 2021

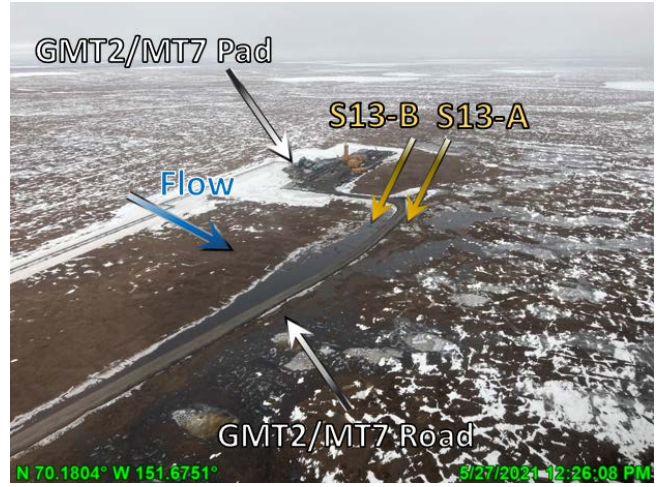
Photo F.18: Decreasing stage near S13 after peak, looking south; May 27, 2021

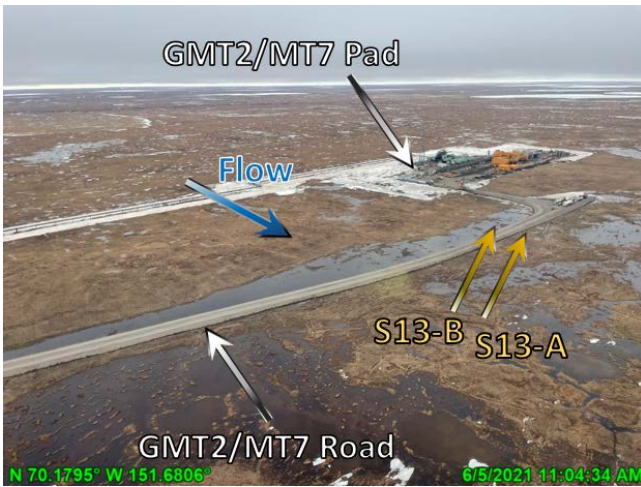
Photo F.19: ponding along road embankments at S13, looking south (upstream); June 5, 2021

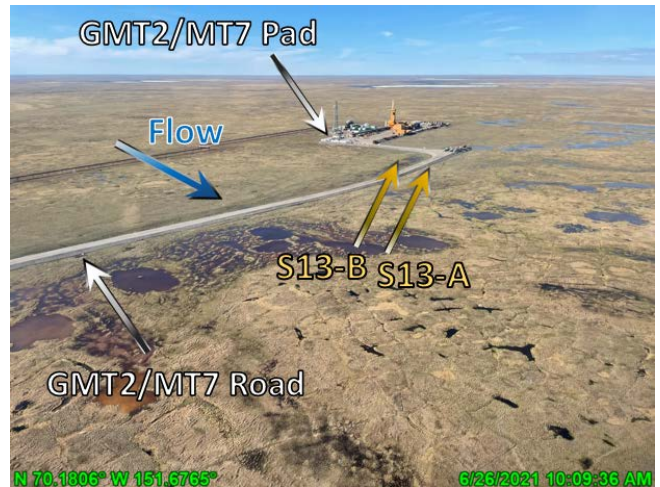
By May 29, water levels had receded, and stage fluctuated slightly throughout the rest of the monitoring period. Aerial observations on June 5 revealed meltwater remaining near the embankments on both sides of the road (Photo F.19). By June 26, observations showed the natural drainage patterns established (Photo F.20).

Photo F.20: Summer conditions near S13, looking south (upstream); June 26, 2021
