# Colville River Delta 2014 Spring Breakup Field Report

**ConocoPhillips**

Michael Baker Jr., Inc.  
3900 C Street, Suite 900  
Anchorage, AK 99503

7/16/2014

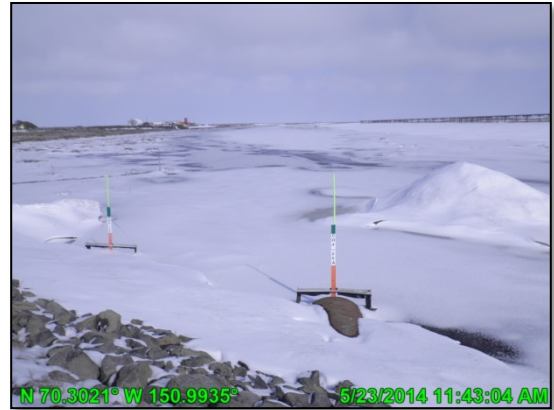
**Photo 7: CD4 Road culverts; May 23, 2014**

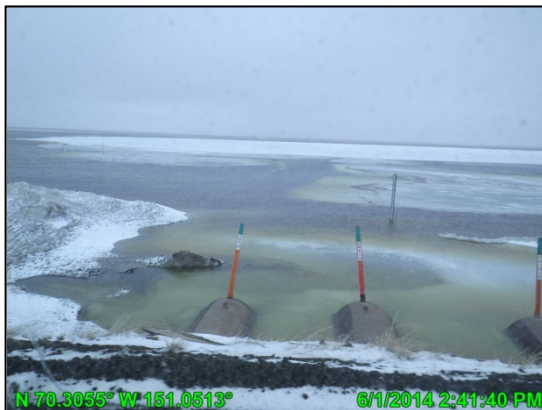
**Photo 8: CD2 Road culverts at Gage G6; June 1,  
2014**

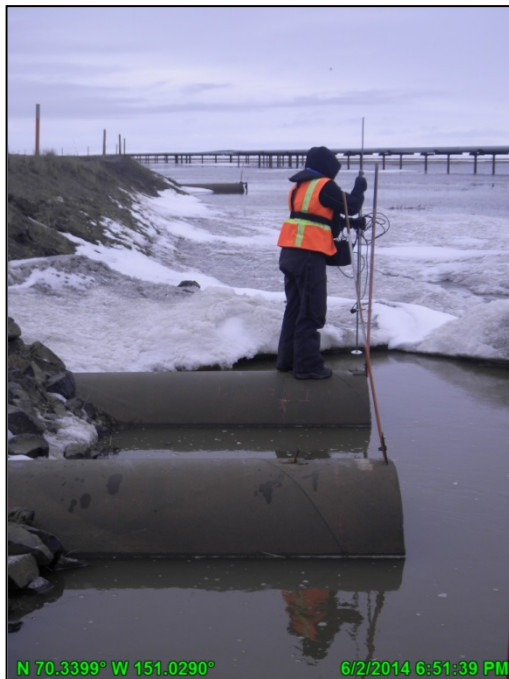
Direct discharge measurements were completed at the CD2 road culverts and swale bridges on June 2 (Photo 12). Decreasing stage and stranded ice floes along the banks at MON1 indicated water levels had crested.

**Photo 12: Discharge measurement at CD2 road culvert; June 2, 2014**

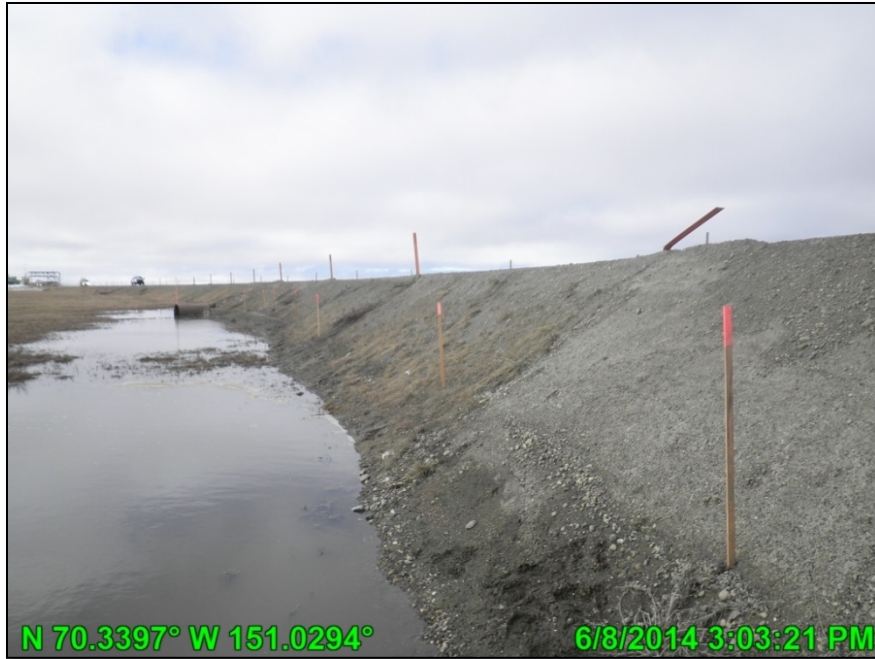
On June 8, Baker conducted a visual inspection to document erosion resulting from breakup flooding along the CD2 and CD4 roads. Other than a minor high water scarp (Photo 13) and runoff effects at delineators (Photo 14) no discernable erosion was observed on facility roads.

Photo 13: Stakes placed to illustrate minor high water scarp; June 8, 2014

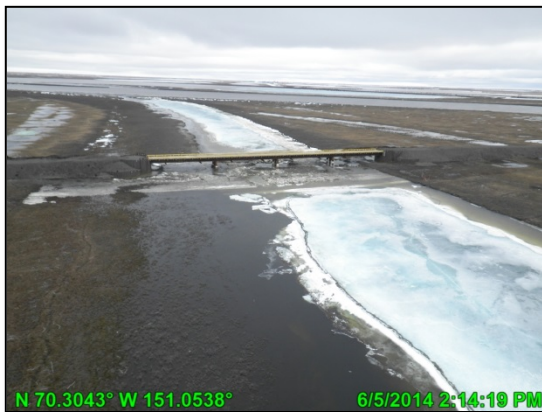
The two bridged lakes, L9341 and L9323, remained mostly frozen throughout breakup; they were ice covered on May 25 and partially open on June 5 and 6 (Photo 15 and Photo 16). Photo 17 shows the CD5 road between Lake L9341 and the Nigliagvik Channel.

Throughout the monitoring period, no flow was conveyed through the Lake L9323 bridge crossing. Lake L9341 connected to the Nigliq Channel, but flow under the bridge was not observed.

Photo 15: Lake L9341 Bridge; June 5, 2014

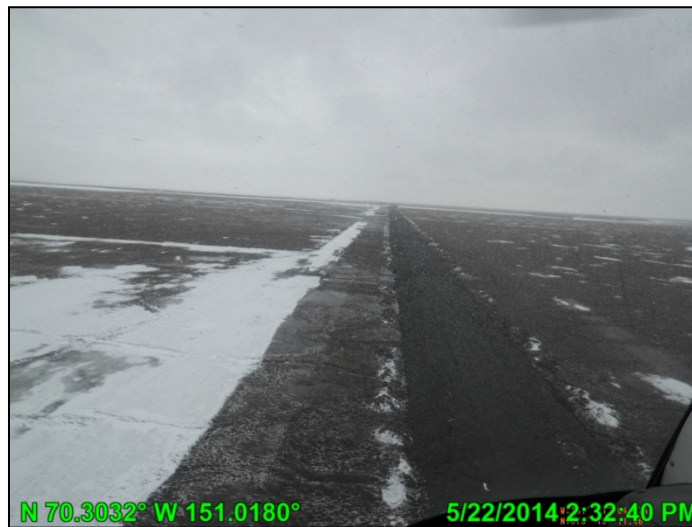
Photo 17: CD5 Road between Lake L9341 and Nigliagvik Channel; May 22, 2014

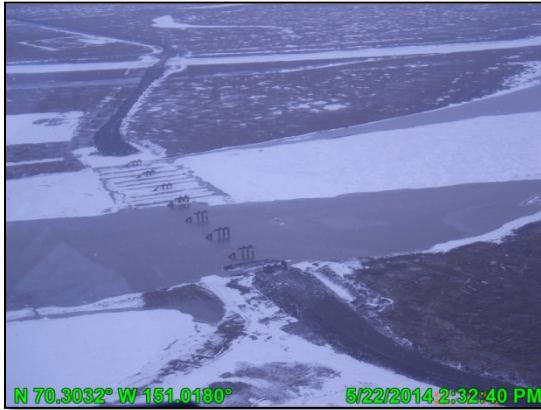
Intact channel ice was present at the Nigliq Channel crossing on May 22 and 31 (Photo 18 and Photo 19), and open water conditions were observed by June 3 (Photo 20 and Photo 21). No flow was observed through the CD5 road culverts; some areas had ponded water. No water was observed around the multi-season ice pad or other CD5 pads throughout the monitoring period (Photo 22). A direct discharge measurement was collected downstream of the Nigliq Channel crossing on June 5.

**Photo 18: CD5 Road and Nigliq Channel crossing;  
May 22, 2014**

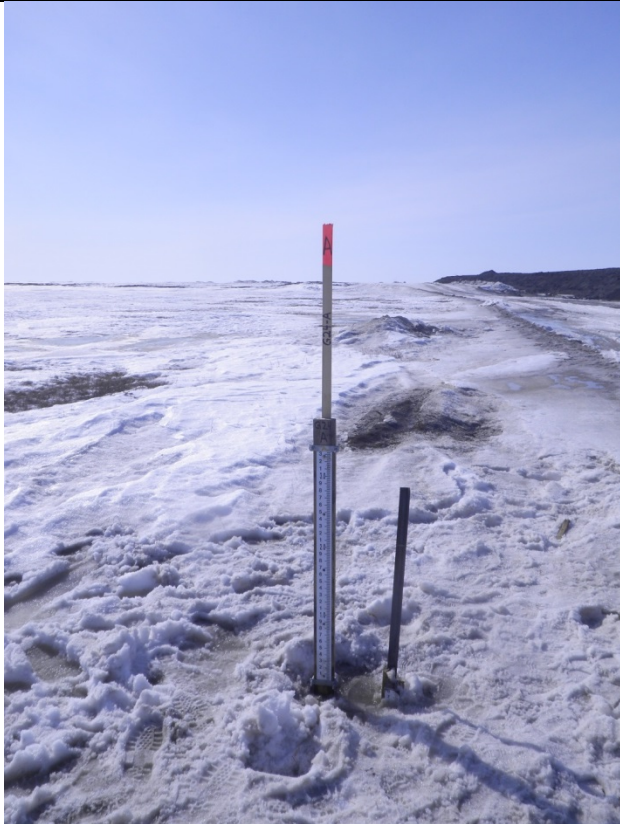
Photo 2: Hazardous exposed steel at MON9D marked; May 2, 2014

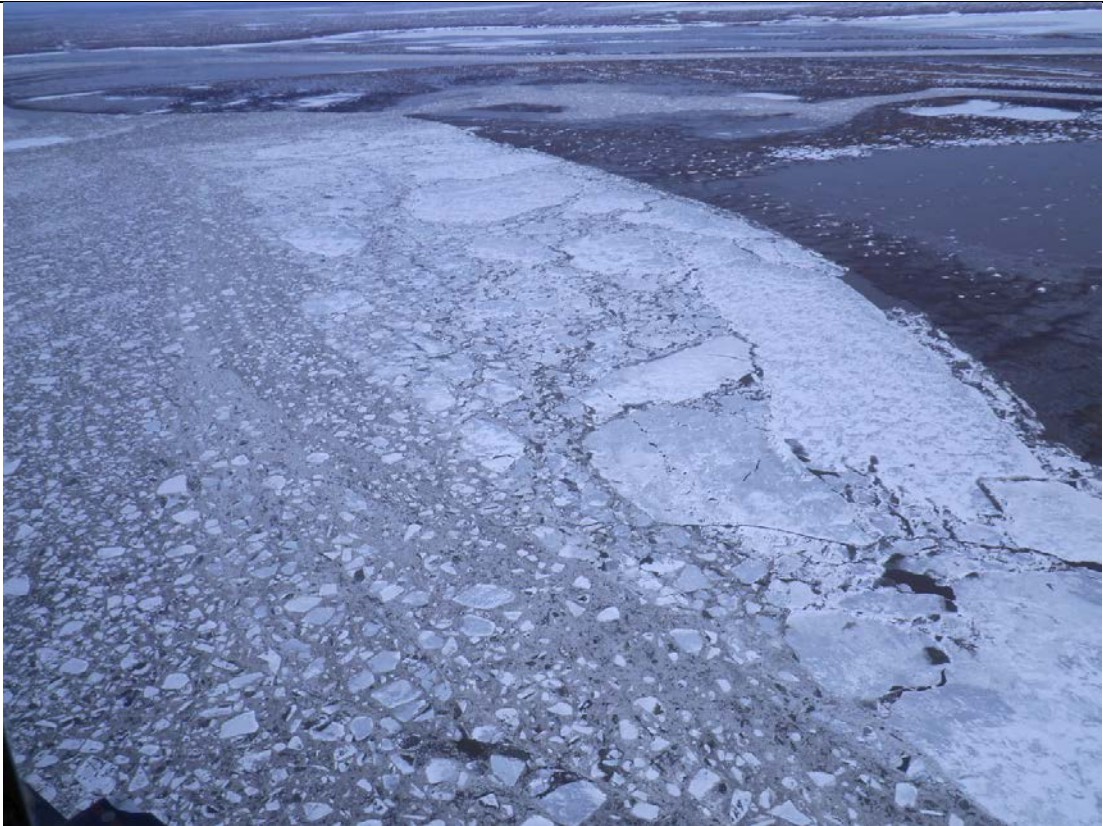
Photo 2: Ice jam upstream of MON1; May 20, 2014

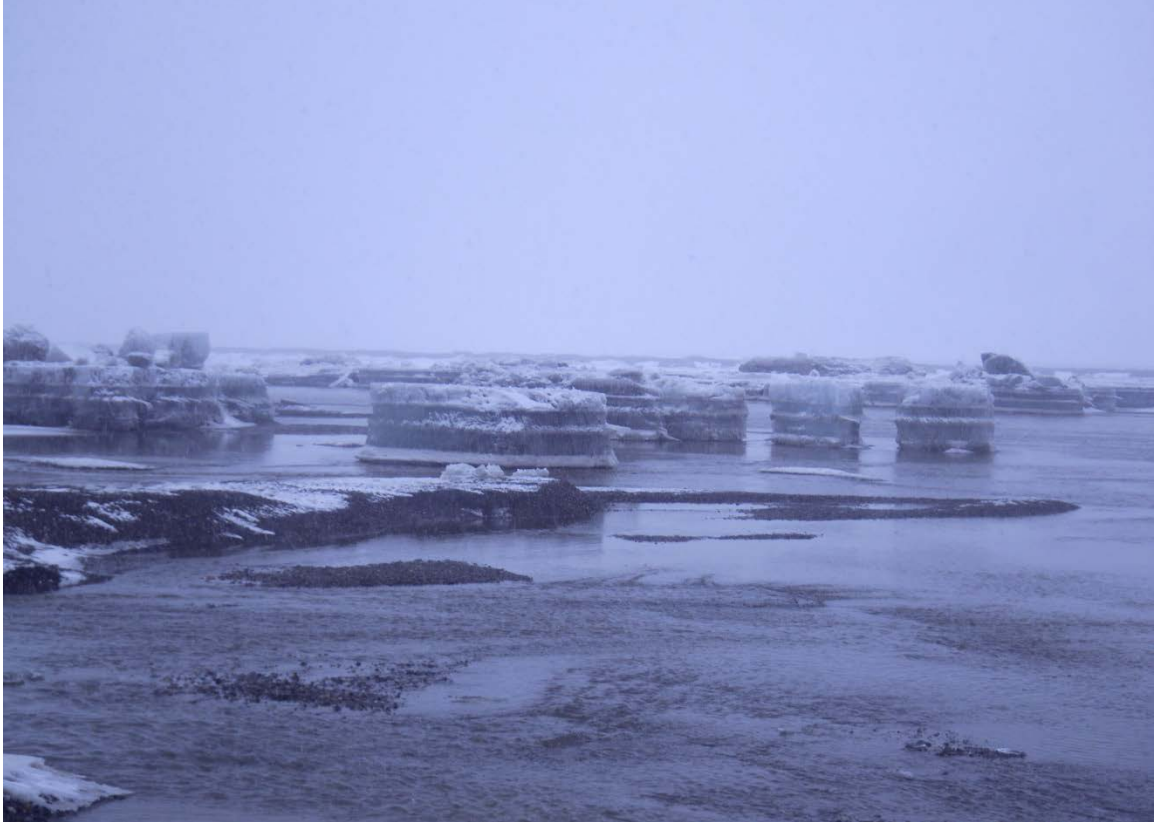
**Photo 1: Stranded and rafted ice on shoals within ice jam upstream of MON1; May 22, 2014**

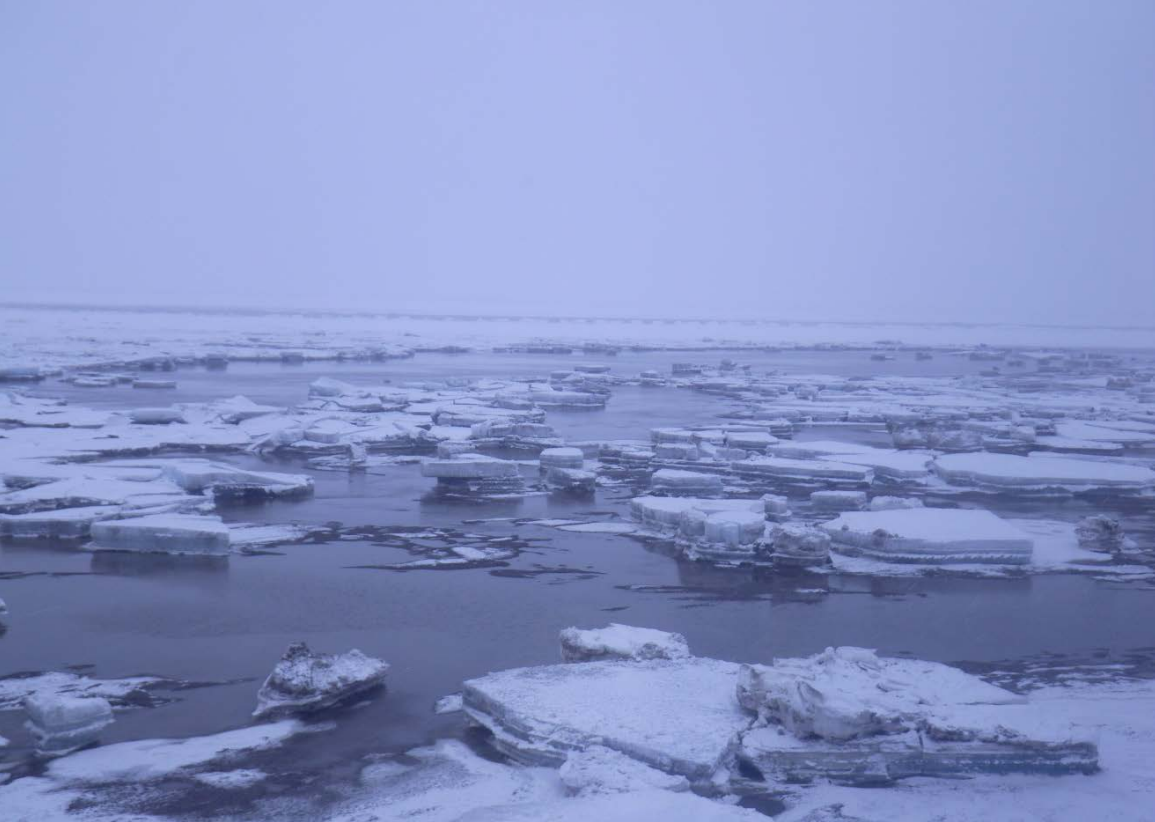
**Photo 2: Stranded ice on shoals within ice jam upstream of MON1; May 22, 2014**

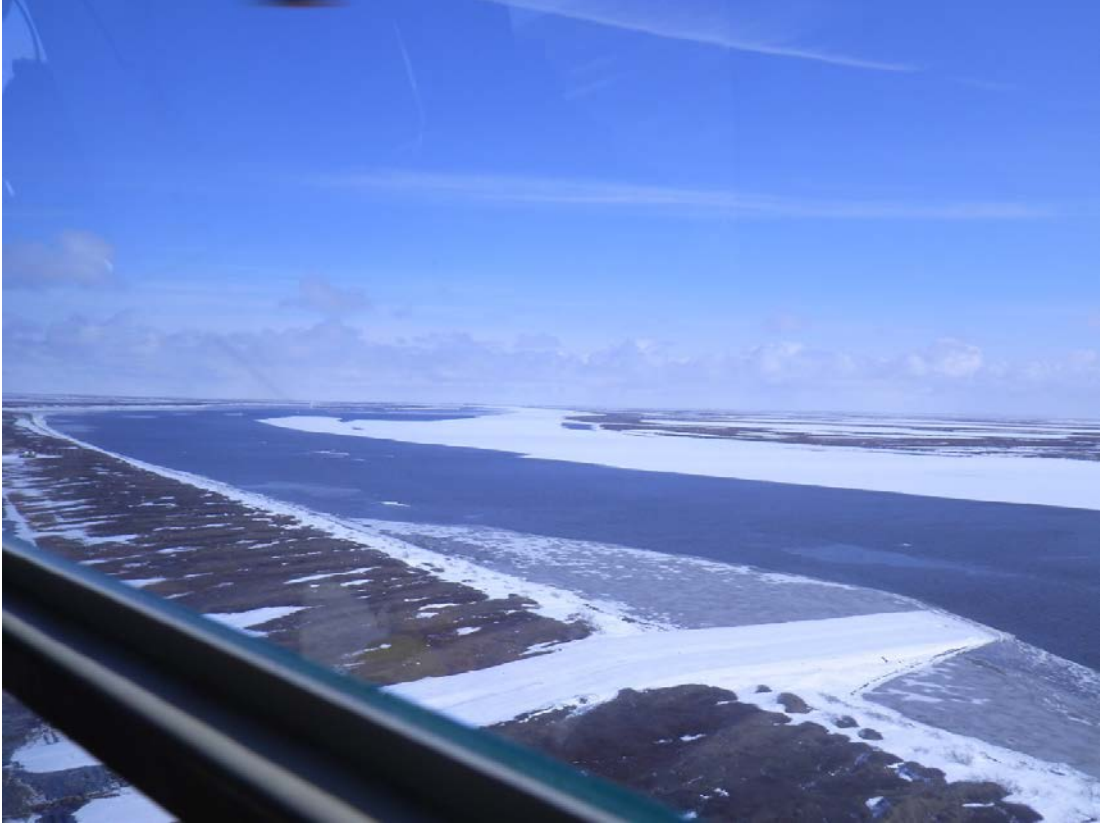
Photo 1: Remnants of the Colville River Ice Bridge ramp adjacent to MON9; May 24, 2014

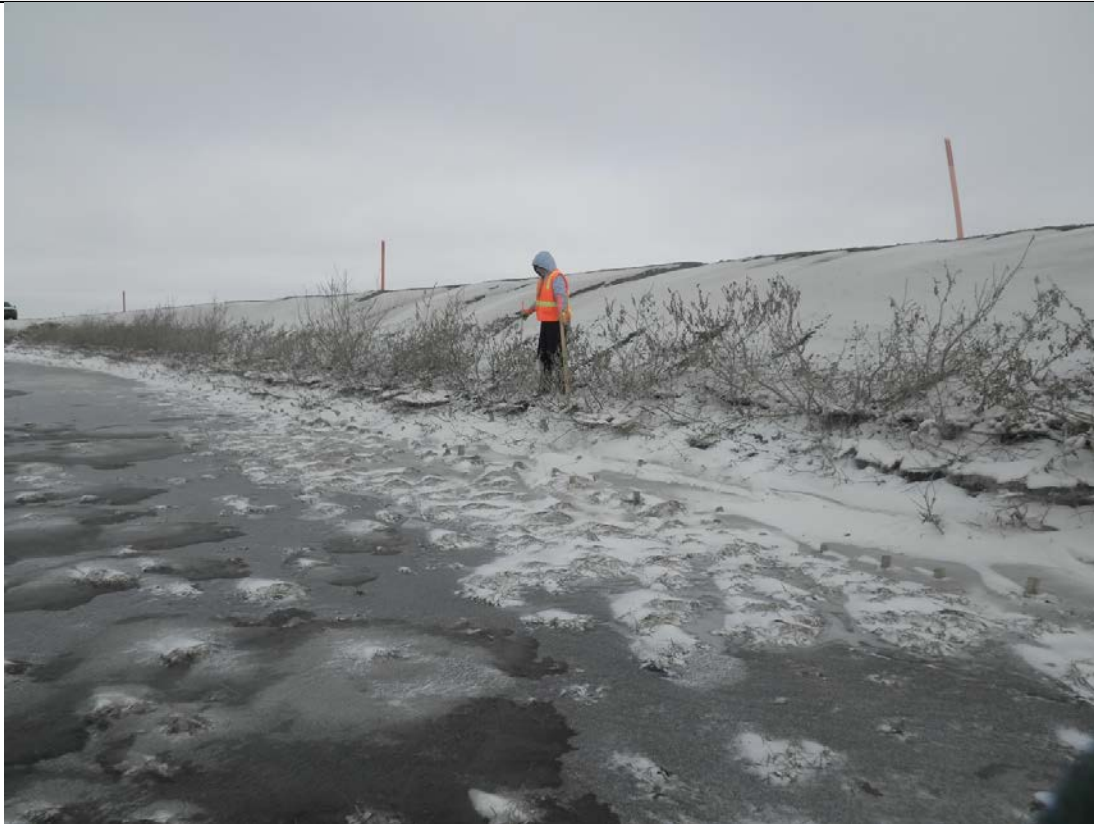
Photo 1: Erosion Survey on the CD2 Road; May 25, 2014

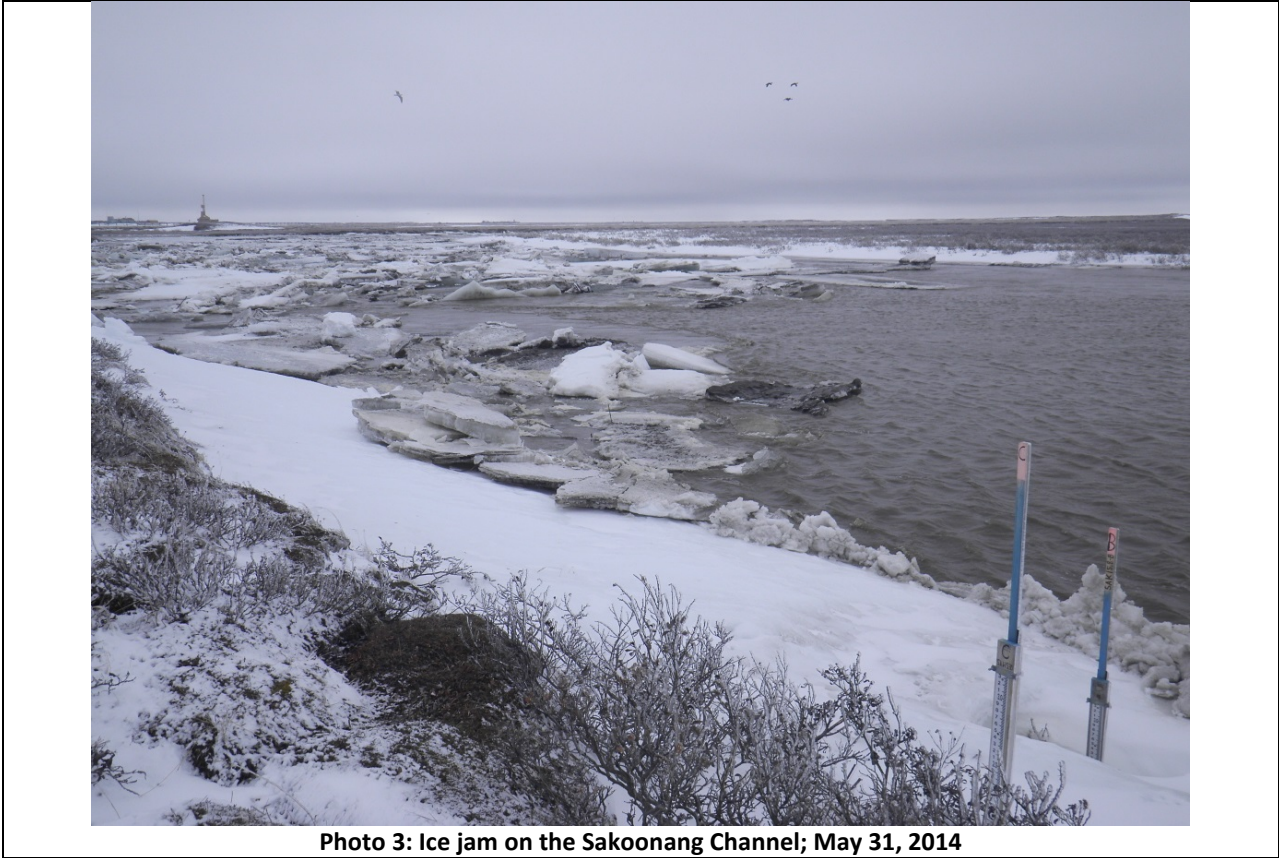
Photo 3: Ice jam on the Sakoonang Channel; May 31, 2014

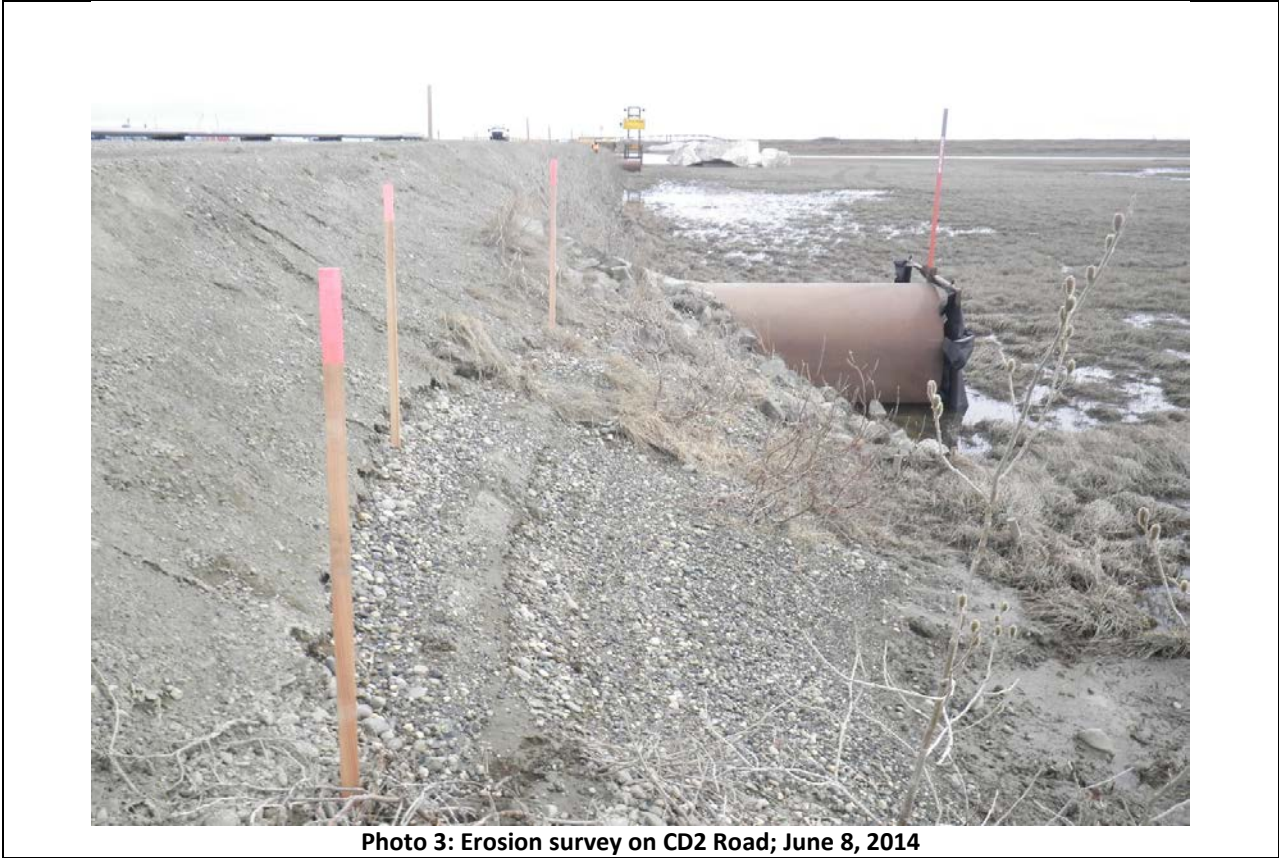
Photo 3: Erosion survey on CD2 Road; June 8, 2014
