Colville River Delta 2015 Spring Breakup Field Report

ConocoPhillips

Michael Baker
INTERNATIONAL

7/14/2015

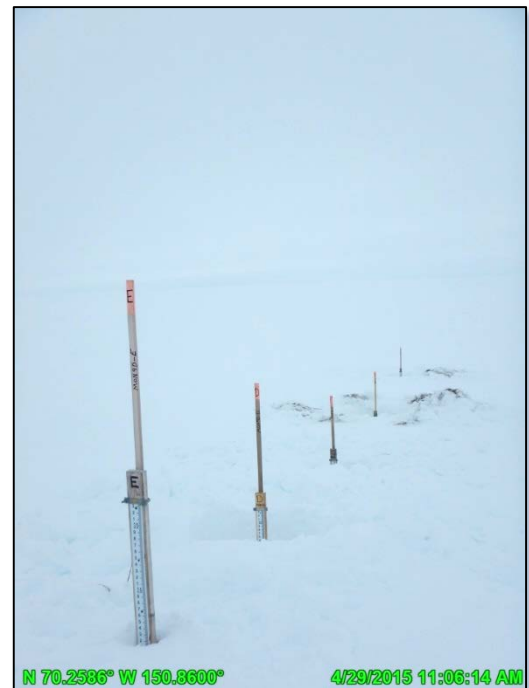
Photo 2.1: Gage set MON9D showing staff gage elevation overlap from the “A” gage nearest the channel to the “E” gage at the top of the bank; April 29, 2015

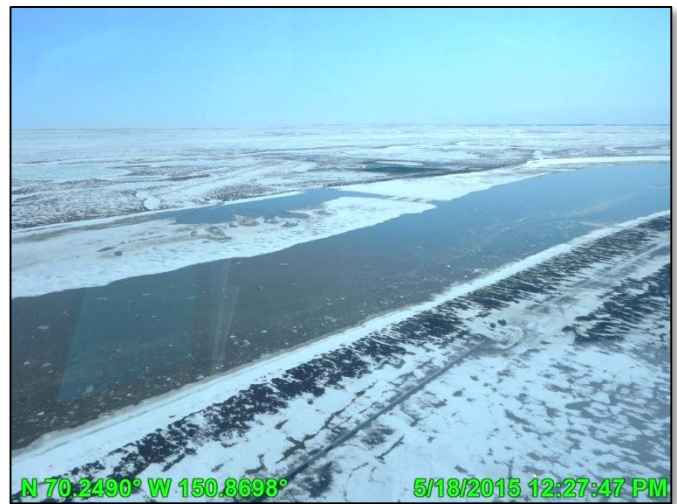
On May 12, the leading edge of floodwater was located in the Anaktuvuk River, approximately 100 river miles (RM) upstream from the MON1 gages on the Colville River. On May 15, the leading edge of floodwater was observed in the Colville River, on the Umiat webcam, approximately 80 RM upstream of MON1. Initial low velocity breakup flow moved through the Nigliq Channel and East Channel on May 18 (Photo 3.1).

Photo 3.1: Initial floodwater in the East Channel at HDD and the Colville ice bridge crossing, looking southeast; May 18, 2015

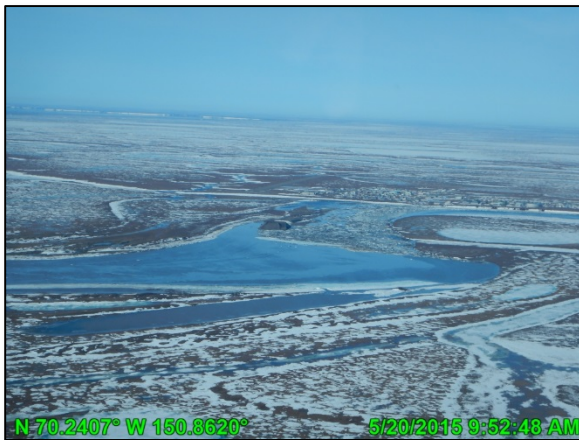
On May 19, a large ice jam formed in the Colville River between Ocean Point and the Itkillik River confluence (approximately 5 RM upstream from MON1) and a smaller ice jam formed in the Nigliq Channel near Nuiqsut. Flow was observed in the Sagoonang Channel near CD1. Flow from the Nigliq Channel entered Nanuq Lake and moved toward the large swale bridge on the CD2 road via Lake M9524.

The ice jam upstream of MON1 was still in place on May 20 and causing inundation of low lying areas. Minimal ice floes were observed upstream of the jam and the channel was mostly free of intact ice. The ice jam in the Nigliq Channel near Nuiqsut remained in place. This ice jam was diverting flow outside the main channel near the village (Photo 3.2). WSEs continued to rise throughout the delta and flow was observed at both swale bridges along the CD2 road.

Photo 3.2: Ice jam in the Nigliq Channel near the village of Nuiqsut, looking west; May 20, 2015

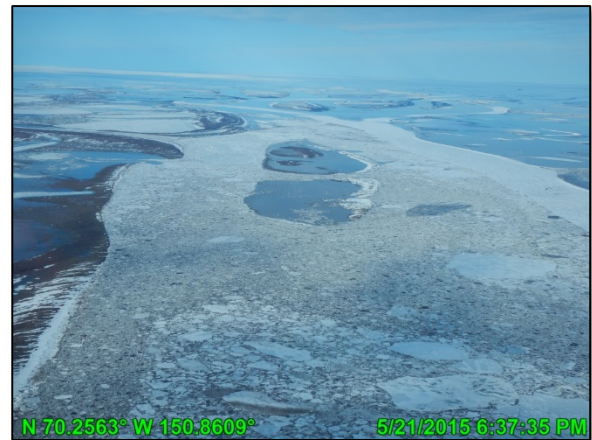
On May 21, the ice jam upstream of MON1 released and a new ice jam formed in the East Channel at the Tamayayak bifurcation (Photo 3.3). Backwater from the East Channel ice jam inundated low lying areas and was diverted into the Nigliq Channel.

Photo 3.3: Ice jam in the East Channel extending from the Tamayayak bifurcation upstream to HDD, looking north; May 21, 2015

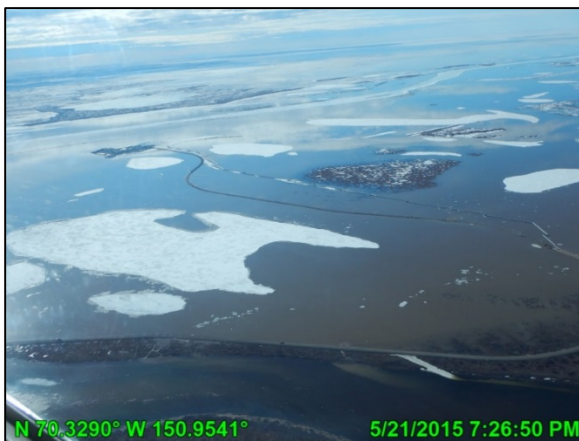
overland through the lake basins between the Nigliq and Sakoonang channels. Extensive flooding occurred around the CD2 and CD4 roads and pads (Photo 3.4). At 7:00 PM, a high water mark was observed at MON1, indicating water levels were receding at the head of the delta.

Photo 3.4: Extent of inundation near peak flooding around the CD2 road and pad, looking northwest; May 21, 2015

High WSEs occurred around the CD2 and CD4 facilities as a result of concurrent ice jamming in the East Channel and the Nigliq Channel that forced floodwater overland and through the lake basins south of CD4 facilities. On the evening of May 21, floodwater overtopped the CD4 road at the south end of Lake L9323. Additionally, extensive overbank flooding was observed along the Alpine Pipeline from CD4 to the HDD crossing and at the HDD East pad. Overbank flooding was not as extensive at CD1 pad, CD3 pad, and the Sakoonang, Tamayayak, and Ulamnigiak pipeline crossings. The CD5 road bridges and culverts conveyed the large volume of flow that was forced into the Nigliq Channel. With exception of the CD4 road, no major erosion or scour was observed at the bridges, pads, or roads. Observed minor impacts around roads and facilities included:

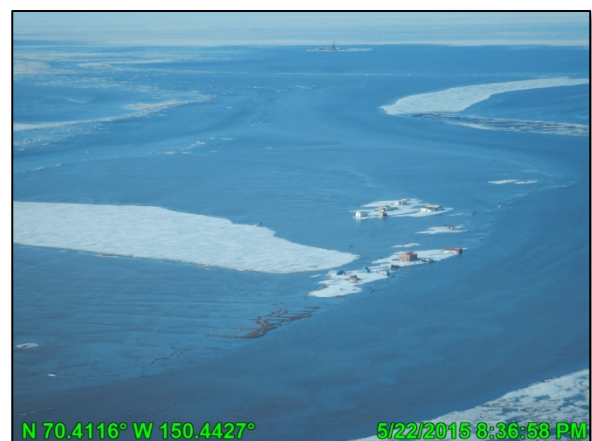
On May 22, discharge was measured in the Nigliq Channel just upstream of the CD5 road crossing. In addition, scour depth measurements were collected at the base of the Nigliq Bridge piers. Discharge through the CD2 road Long Swale Bridge was also measured on May 22. In the lower delta, Helmerick's Island was mostly inundated (Photo 3.5).

Photo 3.5: Lower delta showing Helmerick's Island mostly submerged, looking north; May 22, 2015

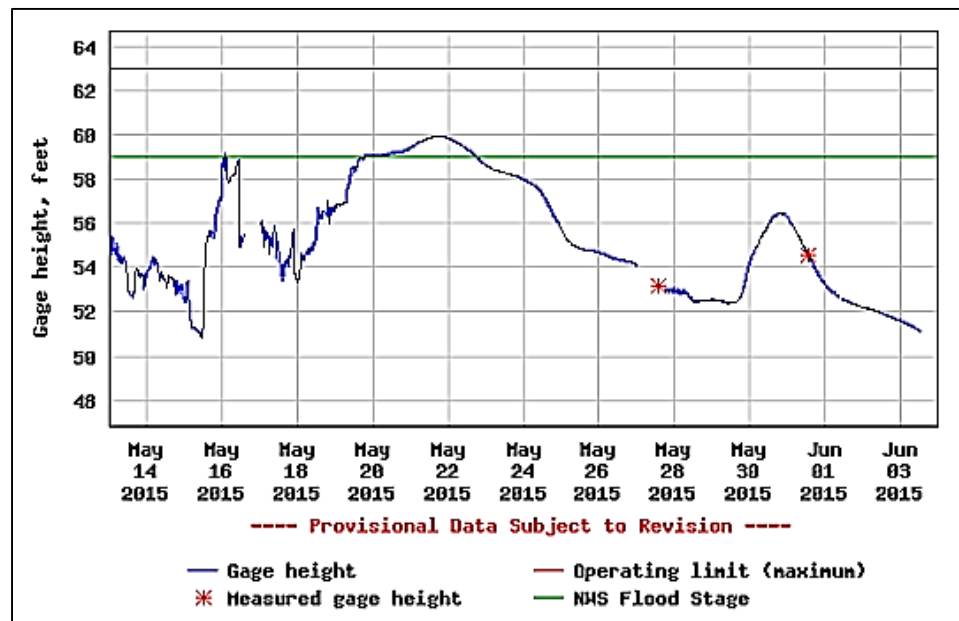
Above average temperatures in the Brooks Range and the North Slope initiated spring breakup flooding in mid-May. The 2015 CRD spring breakup was a short duration, high magnitude event occurring earlier than average. The hydrograph recorded at the USGS gage at Umiat peaked at 59.9 feet on May 21; 59 feet is considered minimum flood stage at the Umiat gage (Figure 3.1). The confluences of the Chandler and Anaktuvuk rivers are downstream of Umiat and their contributions are not accounted for in the Umiat gage data.

Figure 3.1: Colville River gage height at Umiat (USGS 2015)

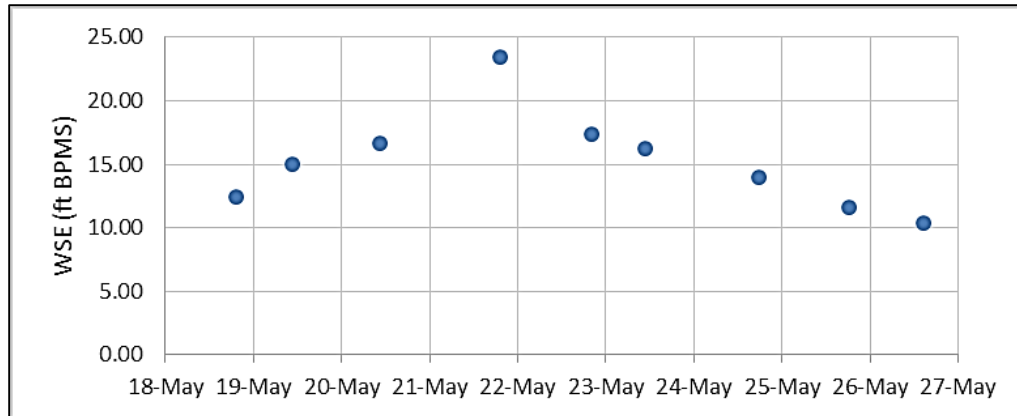
Stage in the Colville River at the head of the delta, upstream of the Nigliq Channel bifurcation, increased rapidly on May 21 as a result of concurrent ice jams in the East Channel and Nigliq Channel. Based on preliminary staff gage observations, stage at MON1 peaked at 23.5 feet BPMSL on the evening of May 21 (Figure 3.2).

Figure 3.2: Preliminary WSEs at MON1 based on staff gage readings
