# 2014

# Colville River Delta Spring Breakup

## Monitoring and Hydrological Assessment

Michael Baker Jr., Inc.  
3900 C Street, Suite 900  
Anchorage, Alaska 99503  
907-273-1600  
November 2014

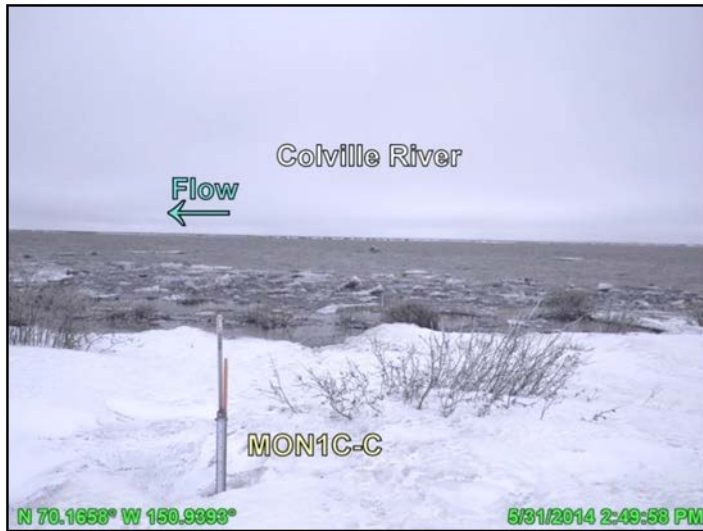
Photo 3.6: MON1C Peak stage, looking east;  
May 31, 2014

Peak stage was observed on May 31 – June 1, and the high water period continued for about 24 hours (Photo 3.6). Peak stage was almost one foot higher than the first crest.

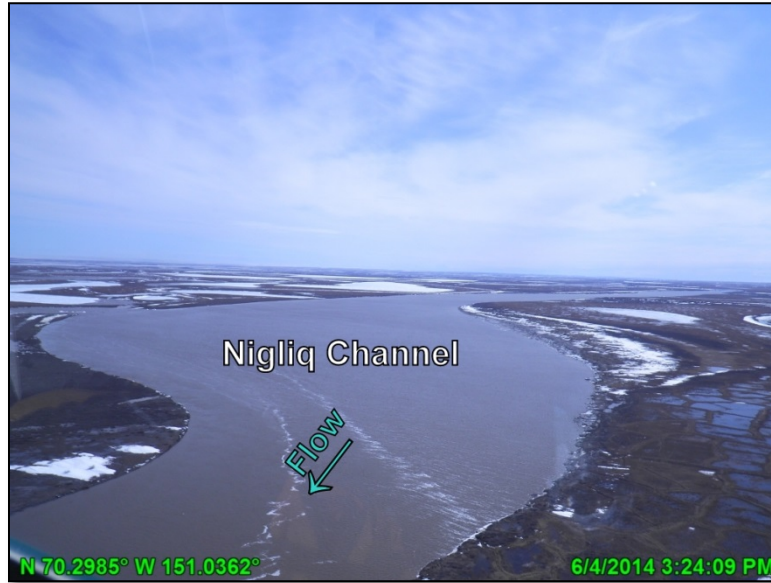
On June 4, the Nigliq Channel was mostly free of ice with some stranded ice along the banks and a few grounded ice floes. Water levels continued to decrease (Photo 3.8). A discharge measurement was collected on June 5 at the Nigliq Channel crossing location, and a few ice floes were observed within the channel.

**Photo 3.8: Nigliq Channel upstream of the bridge crossing, looking south; June 4, 2014**

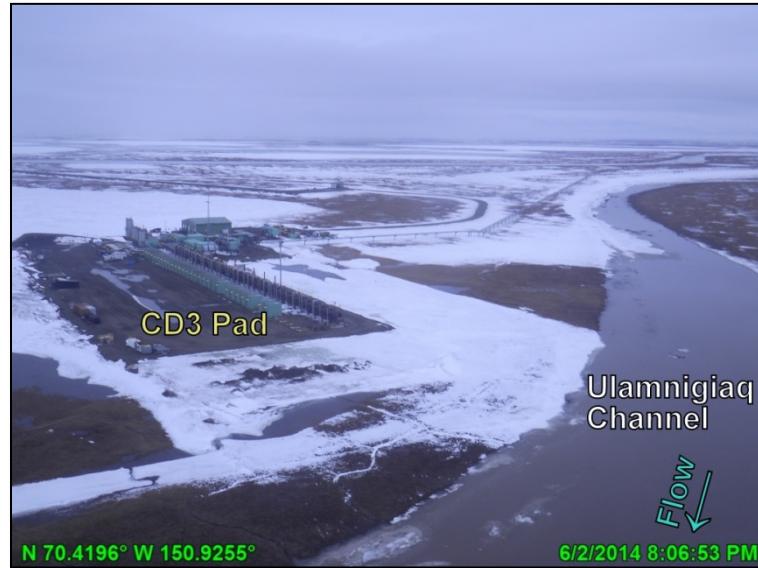
The CD3 Pad and airstrip remained above flood level for the duration of the 2014 breakup flood event. No floodwater or local melt was observed at gage G11, and the PT did not record water (Photo 3.12).

Photo 3.12: CD3 during peak stage, looking southeast; June 2, 2014

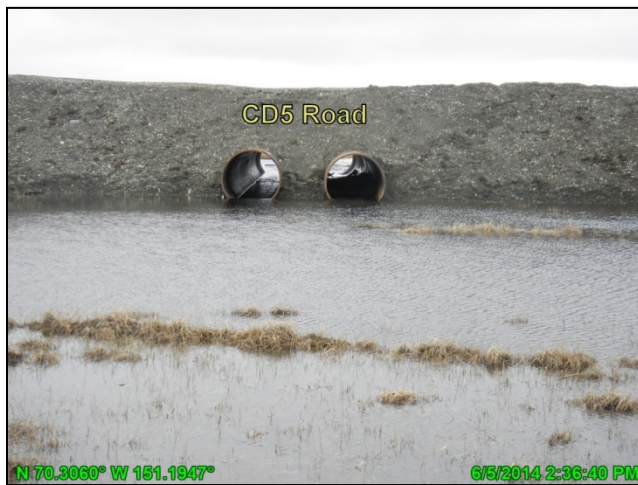
Photo 5.1: CD5 Road culverts adjacent to Gage S1, ponded local melt water with no observed flow, looking north; June 5, 2014

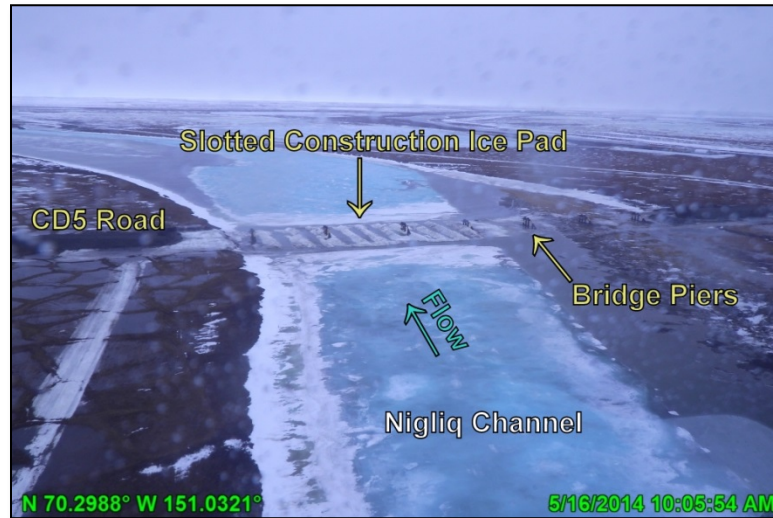
The data suggests the lowering of the Nigliq Channel bed in response to a change in local flow dynamics near the bridge. The floating construction ice pad, situated in the channel and around the piers (Photo 6.1), caused vertical channel contraction, accelerating flow through the constriction below the ice. Flow vectors were likely directed toward the channel bed at the abrupt change in ice thickness associated with the upstream edge of the floating ice pad situated near transect 10. This is similar to the flow hydraulics at the upstream terminus of an ice or debris jam where the plunging flows can result in large depressions in the channel bed parallel to the constricting edge. In general, as the distance from the upstream terminus causing plunging flow increases, the flow vectors realign with the stream bed, reducing the erosive forces further downstream (Baker 2013b). The observed change in channel bathymetry is considered a response to short term impacts from the bridge construction pad and not attributed to the presence of CD5 infrastructure.

Photo 6.1: Nigliq Channel Bridge pilings at slotted construction ice pad, looking north; May 16, 2014

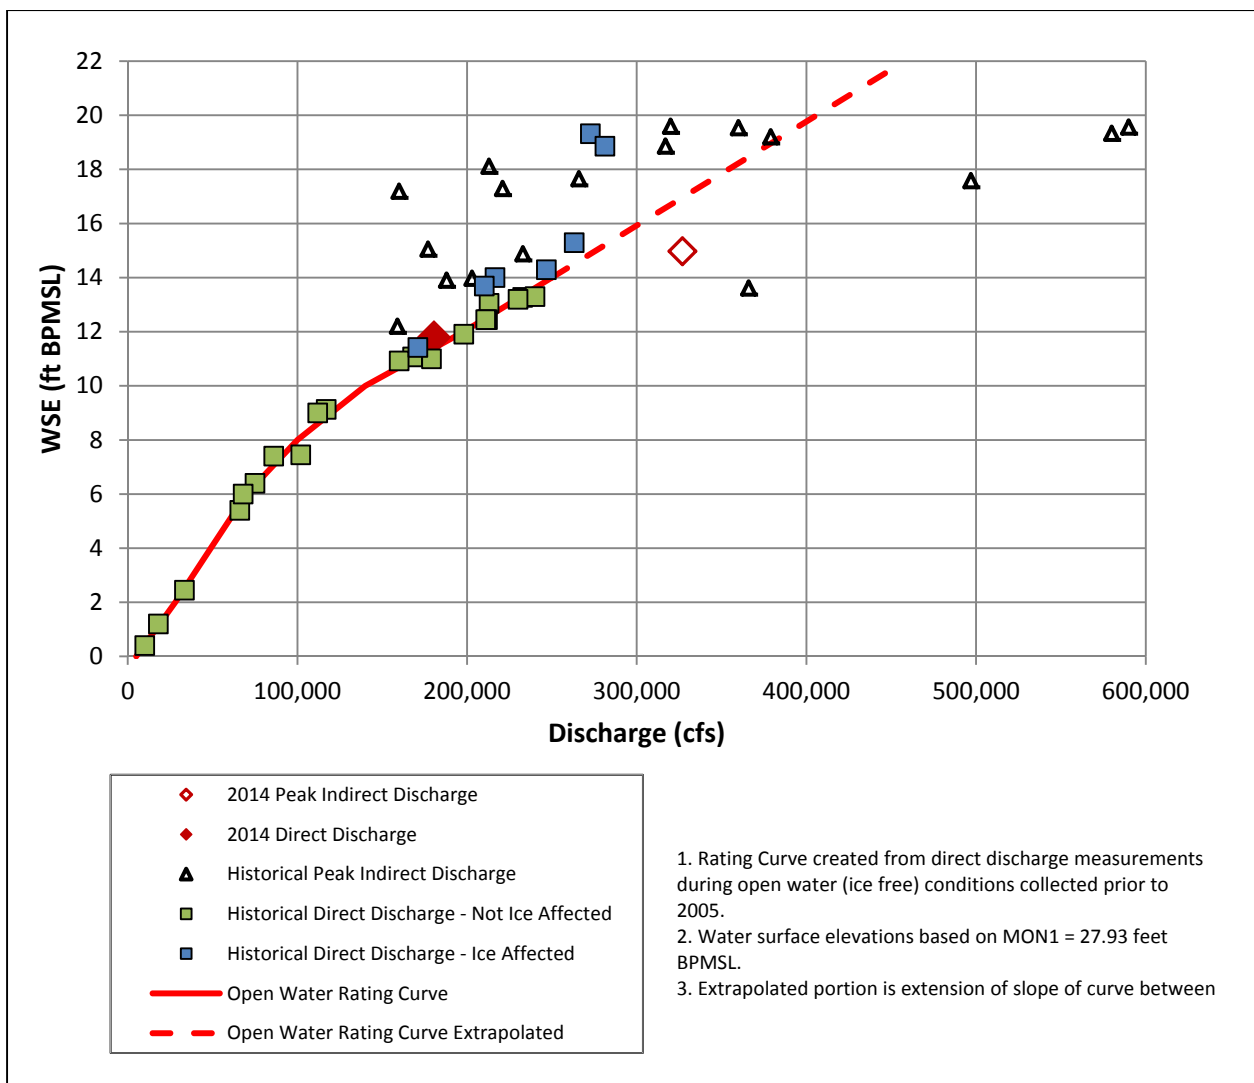
The 2014 peak discharge of 327,000 cfs at 14.97 feet BPMSL falls to the right of the rating curve and is typical of values resulting from an ice jam release. Conversely, values to the left of the rating curve tend to be the result of downstream ice jam backwater effects.

**Graph 8.5: MON1 Stage-Discharge Rating Curve with Peak Discharge Values**

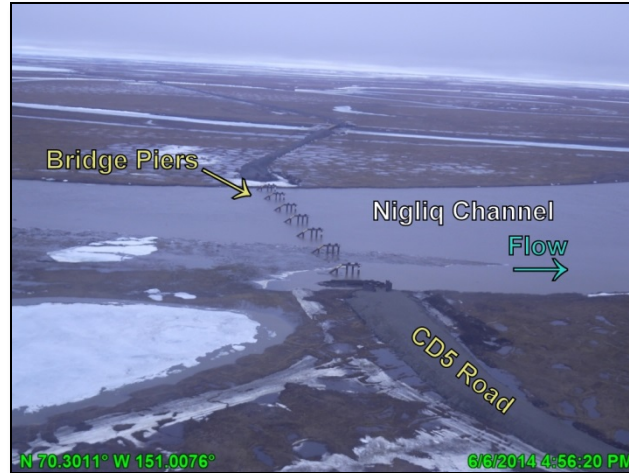
Photo C.3: CD5 Road between Nigliq Channel and CD5 pad, local melt water with no flow observed through culverts or around road prism, looking west; June 6, 2014

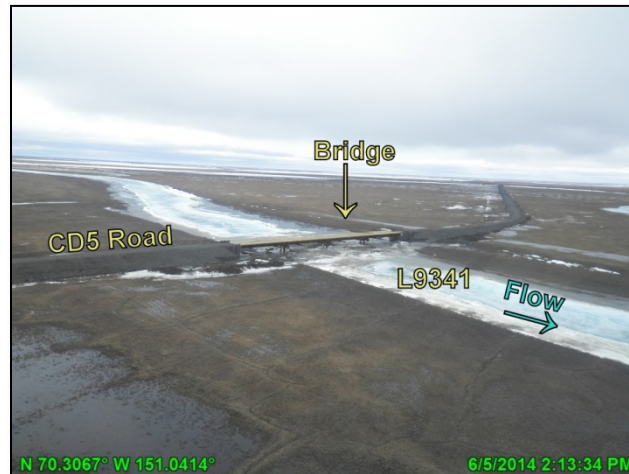
Photo C.4: CD5 Road between Lake L9341 and Nigliagvik Channel, local melt water with no flow through culverts or around road prism, looking west; June 5, 2014

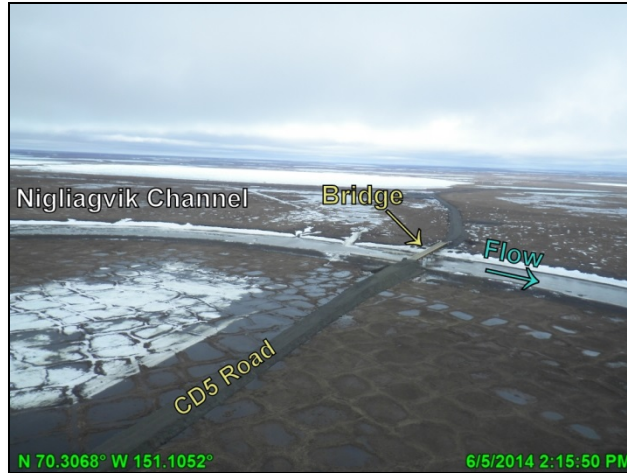
Photo C.5: CD5 Road between Nigliagvik Channel and CD5 Pad, local melt water with no observed flow around road prism looking west; June 5, 2014

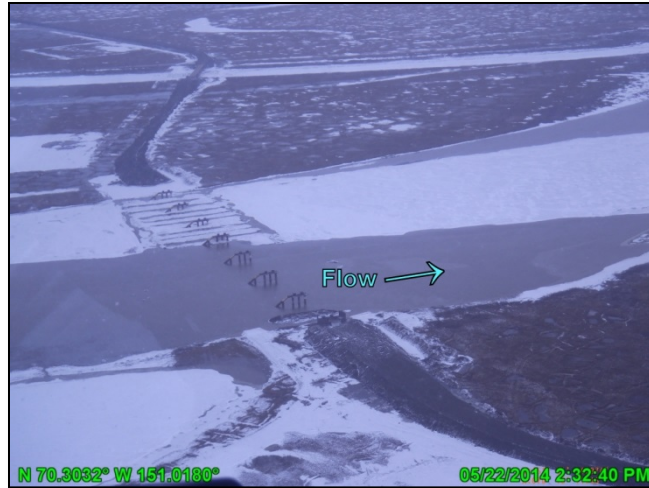
Photo C.25: Degradation of construction ice pad at Nigliq Channel Bridge crossing, looking west;

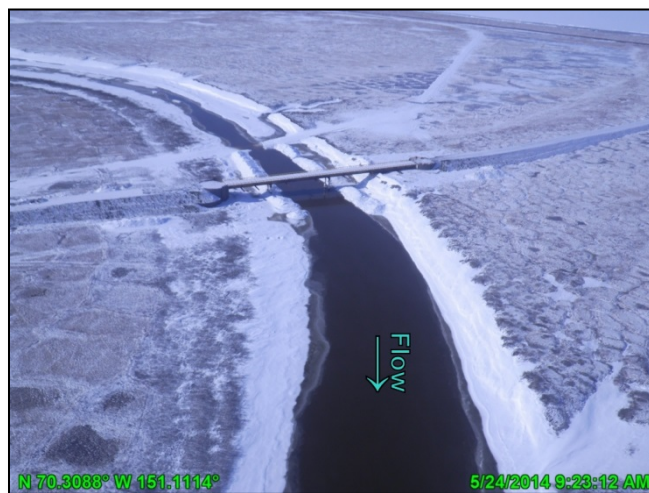
Photo C.27: Degradation of Nigliagvik Channel Bridge construction ice pad, looking south; May 24, 2014
