2015 COLVILLE RIVER DELTA SPRING BREAKUP MONITORING AND HYDROLOGICAL ASSESSMENT

148414-MBJ-RPT-001 | November 2015

EXECUTIVE SUMMARY

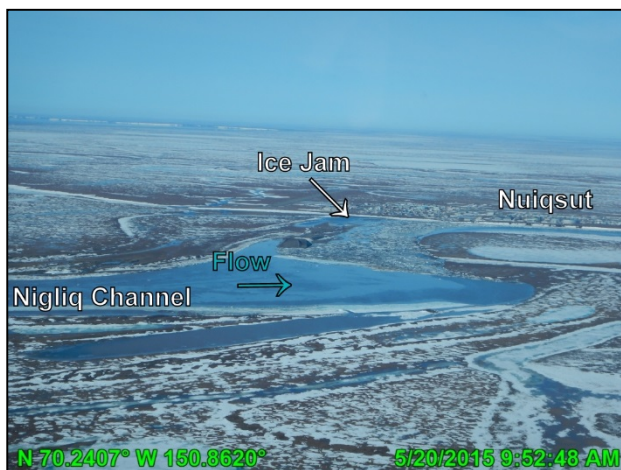
Photo 3.3: Ice jam in the Nigliq Channel near the village of Nuiqsut, looking west; May 20, 2015

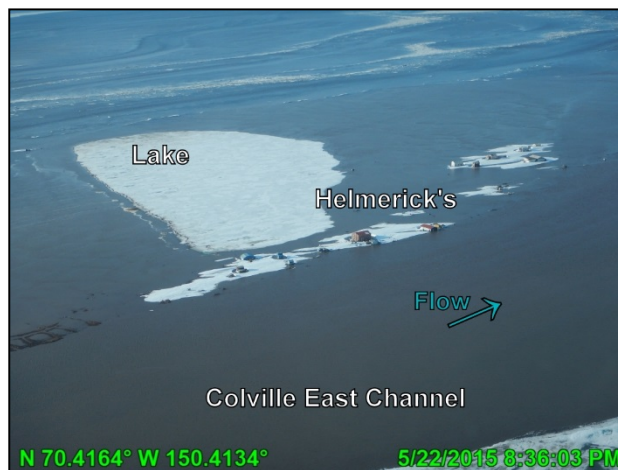
In the morning on May 22, the East Channel ice jam at the Tamayayak Channel bifurcation released resulting in a sudden drop in stage at upstream gage locations. Water levels around Alpine facilities peaked and quickly receded with the sudden backwater relief. In the lower delta, Helmerick's Island was mostly inundated (Photo 3.6).

Photo 3.6: Lower delta showing Helmerick's Island mostly submerged, looking north; May 22, 2015

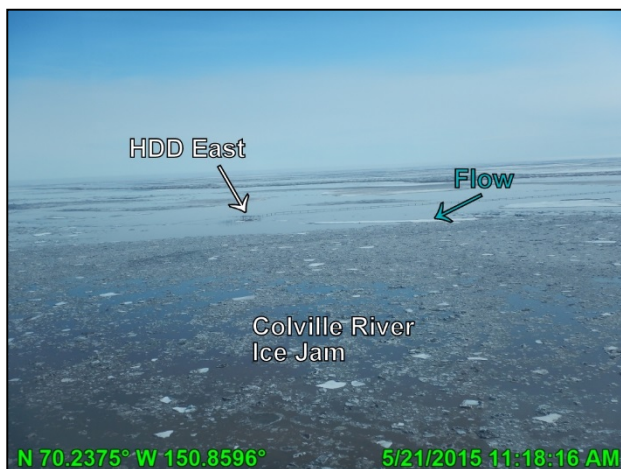
Photo 3.8: Ice floes and overbank flooding at MON9, looking east at Alpine Pipeline HDD east; May 21, 2015

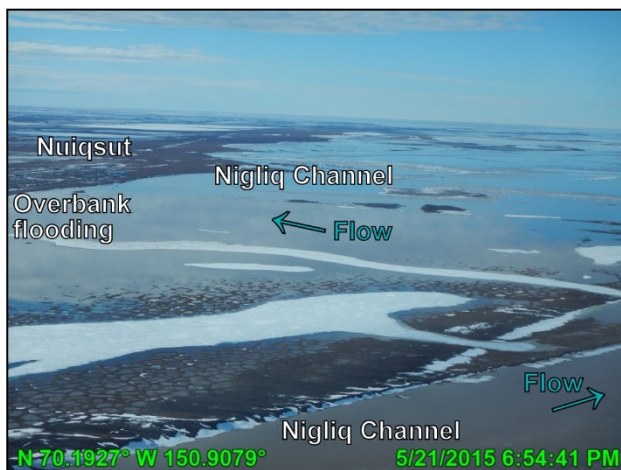
On May 21, water levels steadily increased as backwater in the East Channel was diverted into the Nigliq Channel (Photo 3.10 and Photo 3.11). PT data from MON20 shows that stage increased 7.13 feet in 24 hours reaching a peak WSE of 17.58 feet BPMSL (Table 3.3). The peak stage at MON20 was pronounced and WSE declined at nearly the same rate it had risen, dropping 6.38 feet in 24 hours (Graph 3.4). The peak WSEs at the downstream monuments occurred on May 22 and were less pronounced as floodwater spread through the lower delta.

Photo 3.10: Overbank flooding in the Nigliq Channel prior to peak stage, looking northwest at the ice road to Nuiqsut; May 21, 2015

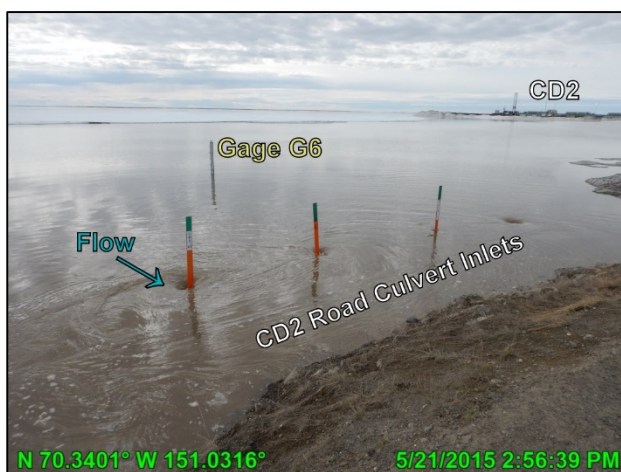
Photo 3.13: CD2 road culvert battery inlets inundated prior to peak WSE, looking west; May 21, 2015

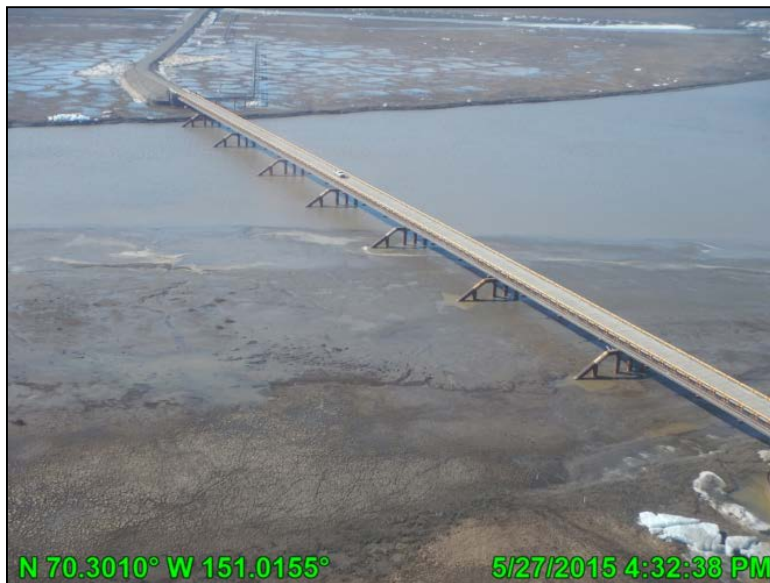
Photo 6.1: Nigliq Bridge Piers Post-Breakup; May 27, 2015

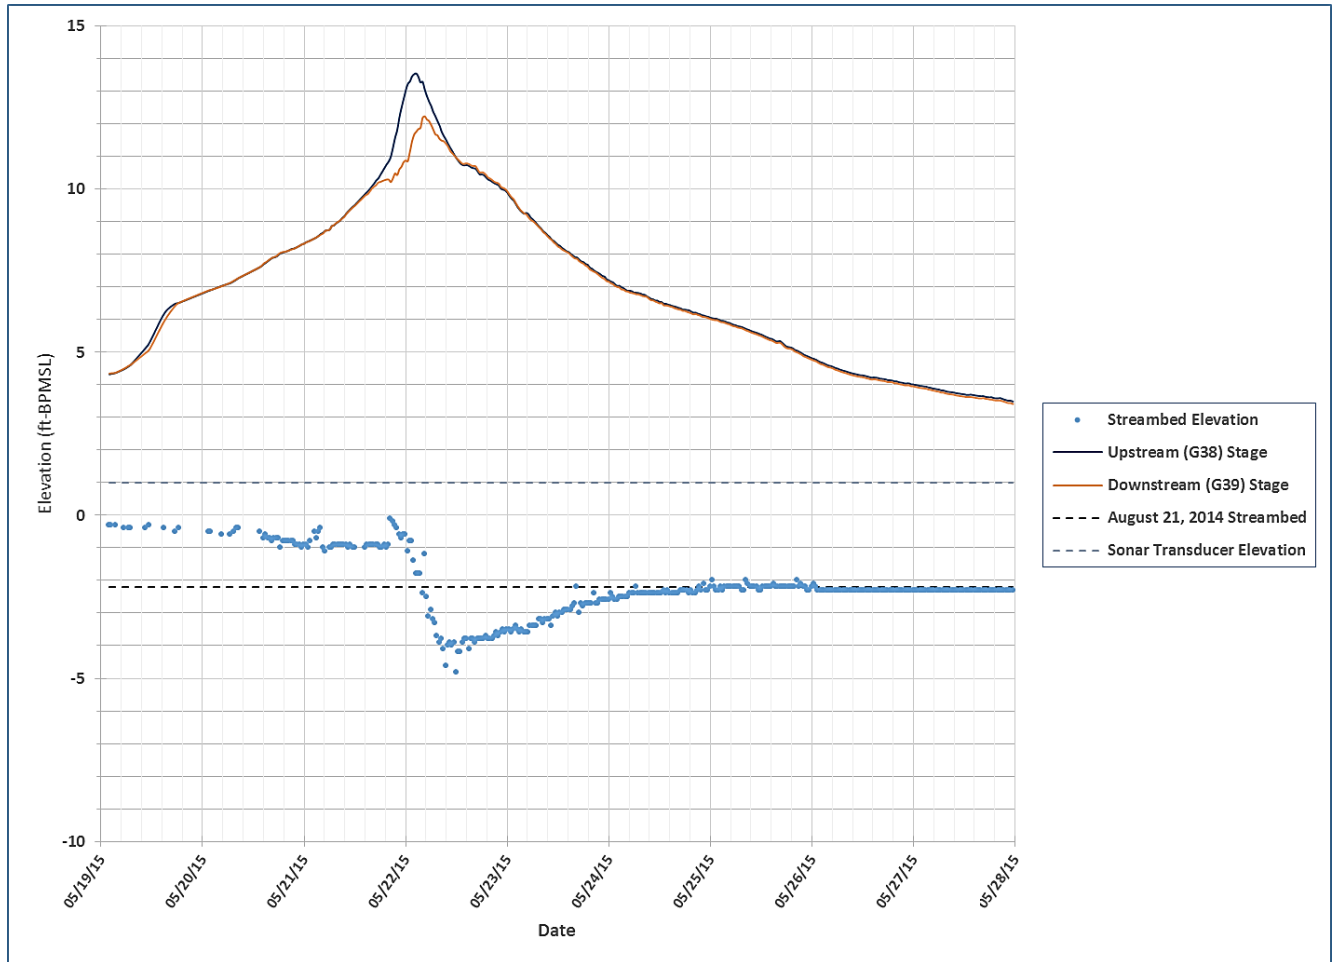
Graph 6.1: 2015 Spring Breakup Nigliagvik Bridge Pier 3 Scour

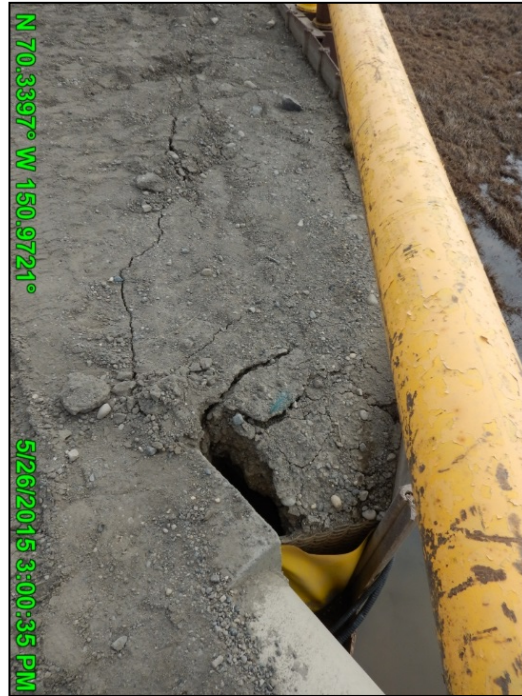
Photo C.12: Cracks in the Long Swale Bridge abutment fill, southeast abutment; May 26, 2015

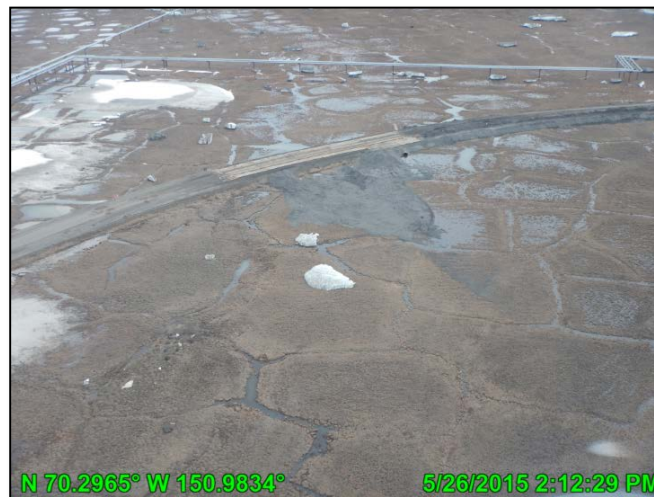
On May 21, floodwater overtopped and breached the CD4 road between the CD4 pad and the CD5 road intersection. No other roads or pads were overtopped or breached. The horizontal directional drilled Colville River crossing site and other pipeline crossing were not adversely affected.

Photo C.13: Aerial view of the CD4 road washout showing the material deposit following initial clean up and road repair, looking southeast; May 26, 2015

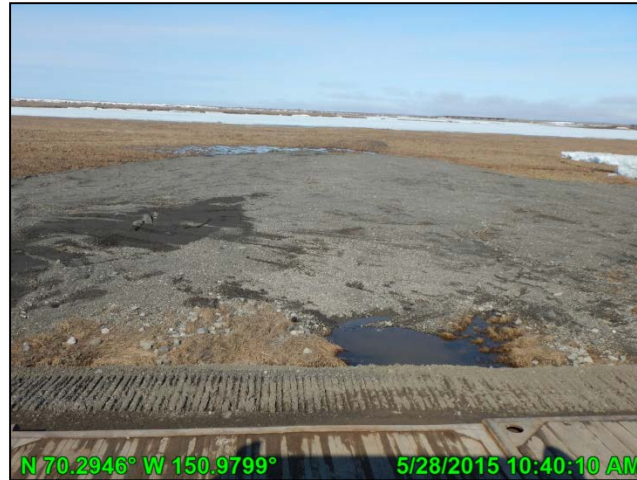
Photo C.14: Ground view of the CD4 road breach outwash following initial clean up and road repair, looking northwest; May 26, 2015

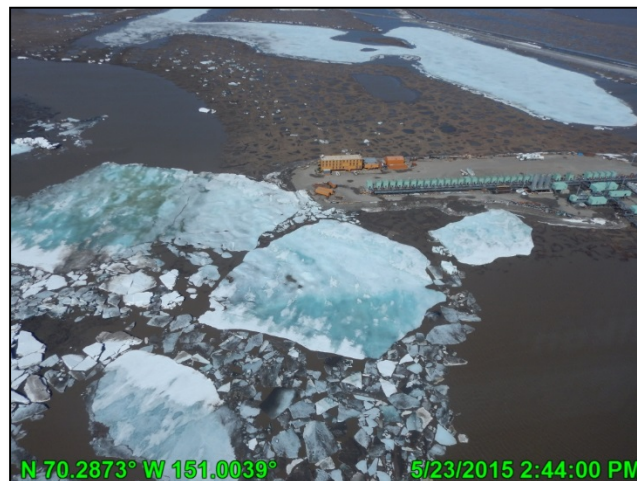
Photo C.15: Ice floe grounded on the CD4 pad, looking north; May 23, 2015

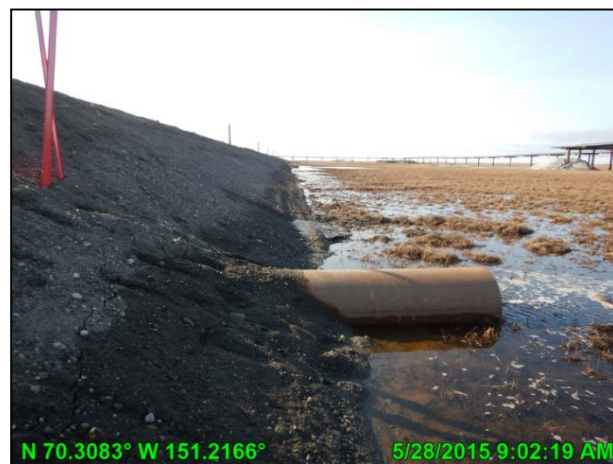
Photo C.19: CD5 road showing water saturated embankment and cracking, looking south on the west side of the road at culvert CD5-02; May 28, 2015

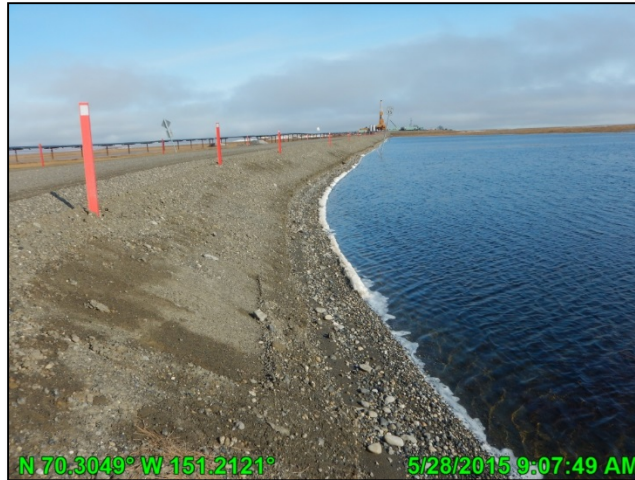
Photo C.20: CD5 road near the CD5 pad showing wash line on the east side of the road, looking north at Lake MB0301 toward CD5 pad; May 28, 2015

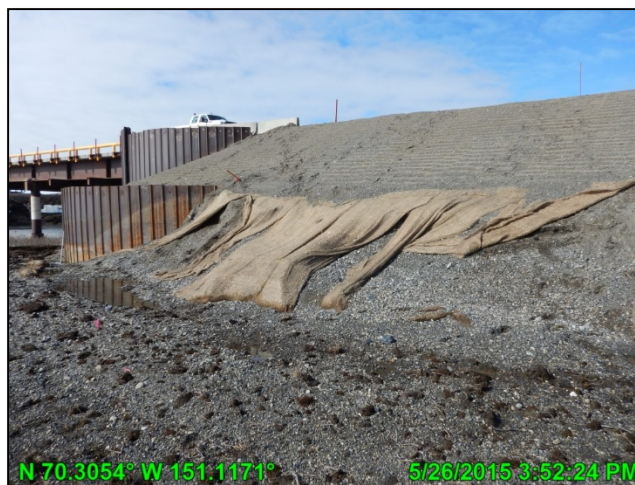
Photo C.22: Nigliagvik Bridge east abutment showing scour line and damaged erosion control material, looking west; May 28, 2015

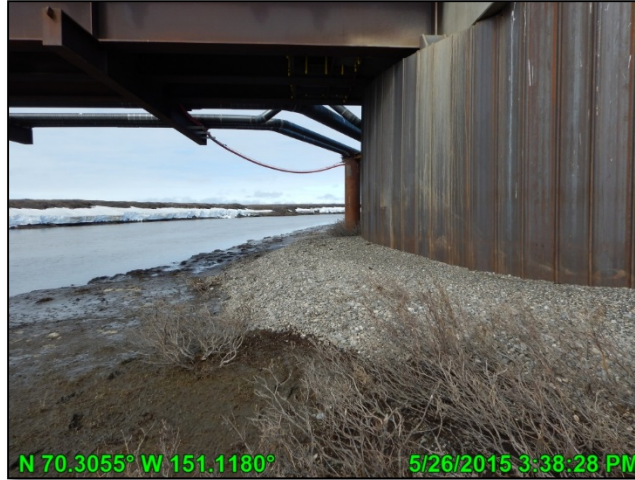
Photo C.23: Deposition of fill material at the Nigliagvik Bridge east abutment, looking west; May 28, 2015
