2016 COLVILLE RIVER DELTA

SPRING BREAKUP MONITORING & HYDROLOGICAL ASSESSMENT

MICHAEL BAKER INTERNATIONAL

ConocoPhillips
Alaska

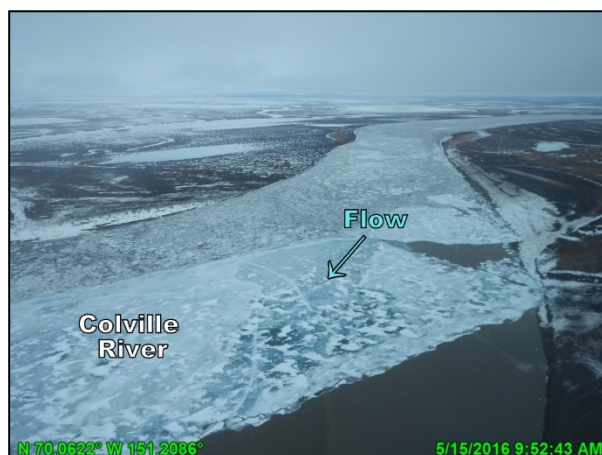
Photo 3.2: Downstream extent of the Colville River ice jam at Ocean Point, looking southwest; May 15, 2016

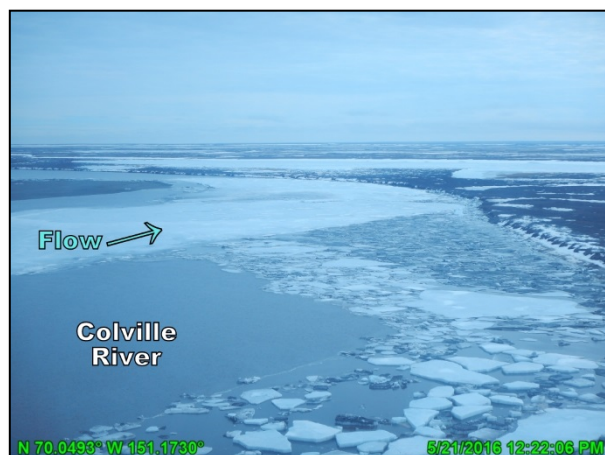
Photo 3.3: Intact channel ice holding back ice floes on the Colville River upstream of MON1, looking northeast; May 21, 2016

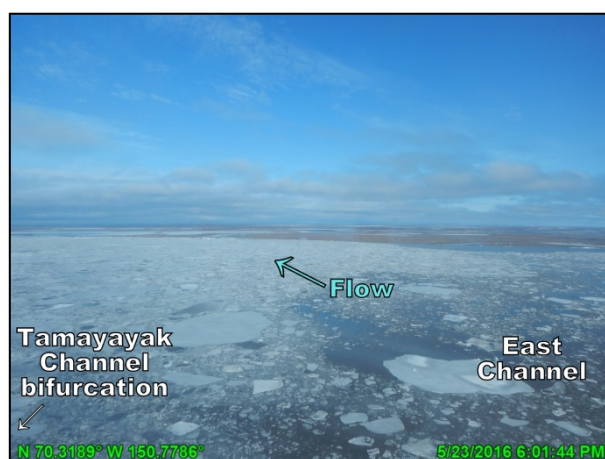
Photo 3.5: Ice jam at the Tamayayak Channel bifurcation, looking northeast; May 23, 2016

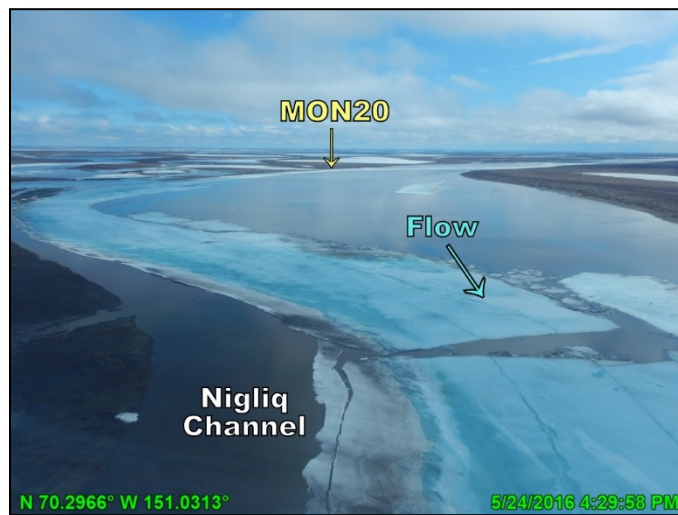
Photo 3.12: Deteriorating channel ice downstream of MON20, looking southeast; May 24, 2016

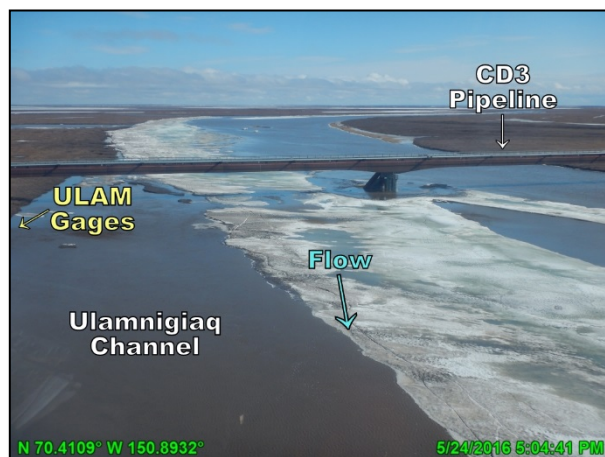
Photo 3.18: Deteriorating channel ice at the ULAM CD3 pipeline crossing, looking southwest; May 24, 2016

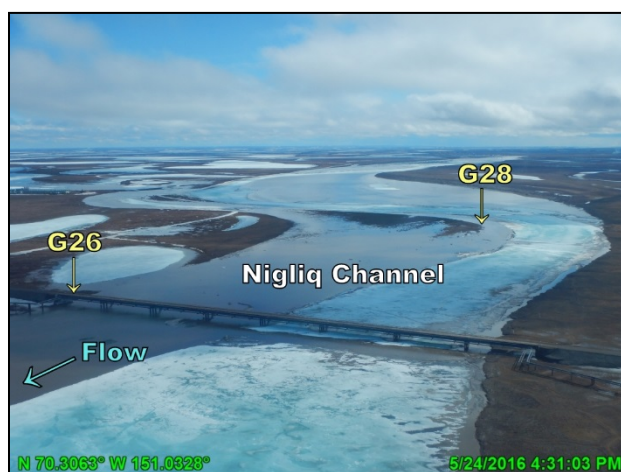
Prior to peak stage on the Nigliq Channel, channel ice was progressively deteriorating. By May 24, longitudinal and transverse cracks in conjunction with local ponding and shrinking ice cover were observed at the Nigliq Bridge (Photo 3.23). On the morning of May 25, the intact channel ice broke up releasing the upstream ice jam and resulting backwater. Peak stage was observed at 9:00am, cresting at gages G28, G26, G27, and G29 at 9.16 feet BPMSL, 9.05 feet BPMSL, 9.06 feet BPMSL, and 8.86 feet BPMSL, respectively (Table 3.12 and Graph 3.16).

Photo 3.23: Deteriorating intact channel ice at the Nigliq Bridge, looking southeast; May 24, 2016

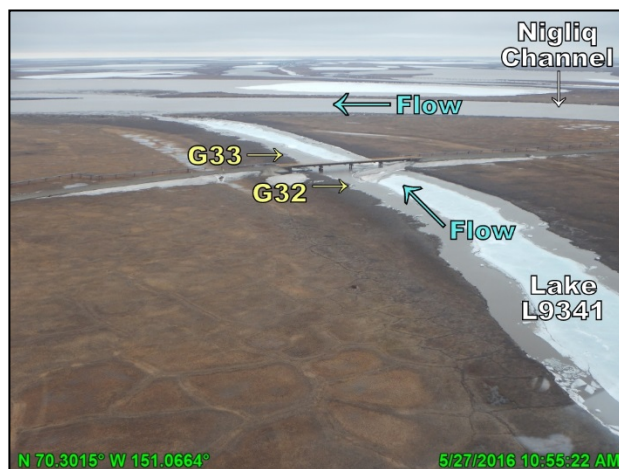
Photo 3.27: Deteriorating intact ice and snow drift at Lake L9341 Bridge, looking northeast; May 27, 2016

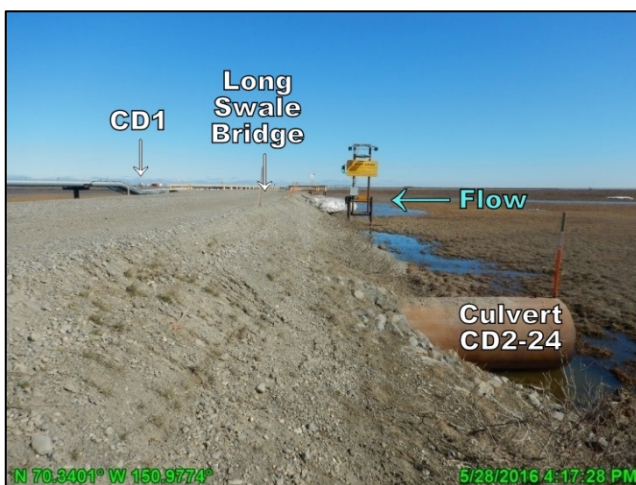
Alpine gravel pads and access roads were inspected for erosion on May 28 and May 29. Other than washlines, no discernable erosion was observed during aerial and ground reconnaissance of the CD2 (Photo 5.1), CD4 (Photo 5.2), and CD5 (Photo 5.3) roads. Floodwaters did not reach the CD5 bridge abutments or road within the CRD. A prominent washline from 2015 spring breakup was evident along portions of the CD2, CD4, and CD5 roads. There were no signs of sloughing or undermining at drainage structures. Additional photo documentation of erosion surveys and breakup conditions along the Alpine facilities roads and pads are shown in Appendix C.1.

Photo 5.1: CD2 road at culvert CD2-24, looking east; May 28, 2016

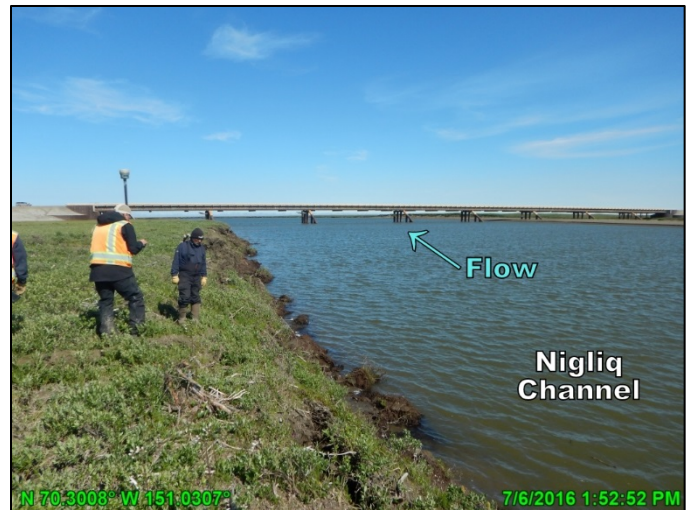
The greatest bank erosion observed between 2013 and 2016 along the west bank was 26.6 feet occurring at station 0+00, approximately 1,200 feet upstream (south) of the Nigliq Bridge. The average rate of erosion at station 0+00 is 8.9 feet per year (ft/yr). The average rate of change for all stations between 2013 and 2016 is approximately 5.4 ft/yr (erosion). This value averages both erosion and deposition. Survey data is presented in Appendix G.1.

Photo 6.4: West bank upstream of the Nigliq Bridge, looking north; July 6, 2016

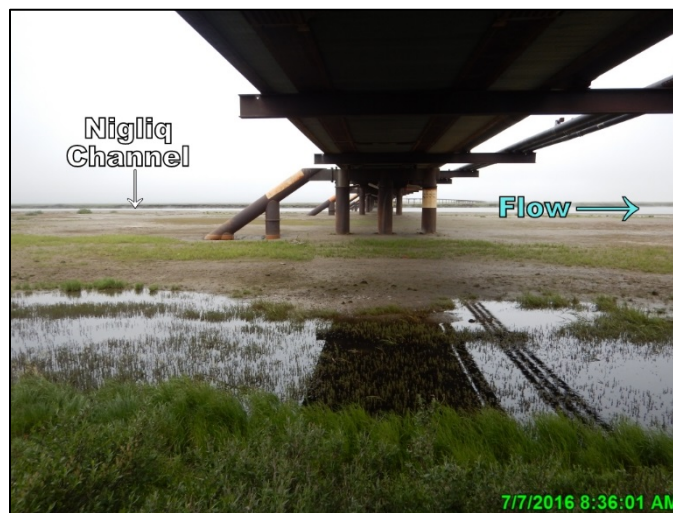
The greatest bank erosion observed between 2013 and 2016 along the east bank was 0.2 feet occurring at station 10+00, approximately 400 feet upstream (south) of the Nigliq Bridge. The average rate of erosion at station 10+00 is 0.05 ft/yr. The average rate of change for all stations between 2013 and 2016 is approximately -0.46 ft/yr (deposition). This value averages both erosion and deposition. Survey data is presented in Appendix G.1.

Photo 6.5: East bank at Nigliq Bridge, looking west; July 7, 2016

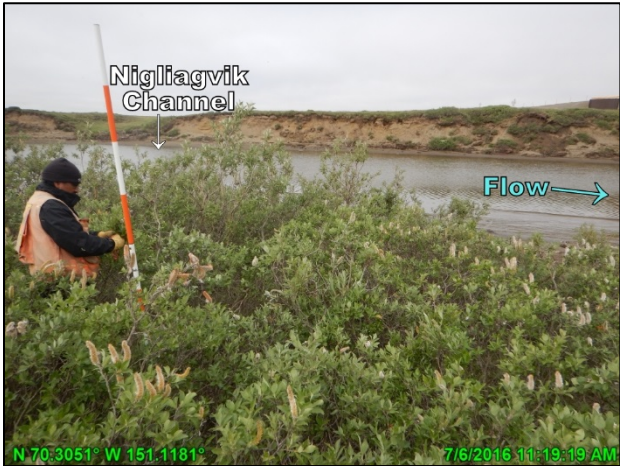
The greatest bank erosion observed between 2013 and 2016 along the east bank was 7.3 feet occurring at station 4+00, approximately 100 feet upstream (south) of the Nigliagvik Bridge (Photo 6.8). The average rate of erosion at station 4+00 is 2.4 ft/yr. The average rate of change for all stations between 2013 and 2016 is approximately 0.8 ft/yr (erosion). This value averages both erosion and deposition. Survey data is presented in Appendix G.2.

Photo 6.8: East bank upstream of the Nigliagvik Bridge, looking west; July 6, 2016
