2019 GMT1 /MT6 Spring Breakup & Summer Monitoring & Hydrological Assessment

Prepared for:

ConocoPhillips
Alaska

MSA Contract No. 296937

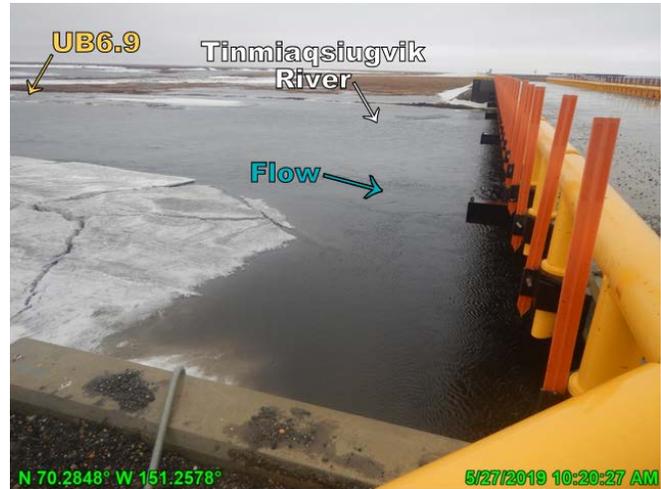
Photo 4.2: Backwater upstream of the Tinmiaqsiugvik Bridge, looking south; May 27, 2019

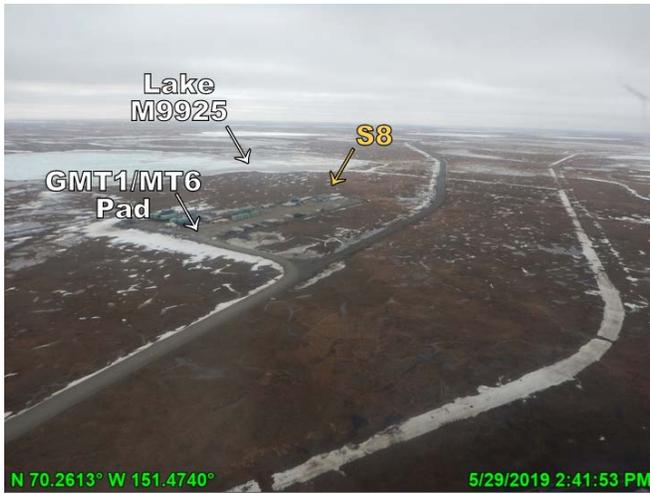
No rise in stage was observed at the G8 gage station. Surrounding meltwater was present but the gage and PT remained dry (Photo 4.20 and Photo 4.21).

Photo 4.20: S8 drainage area, looking northeast; May 29, 2019

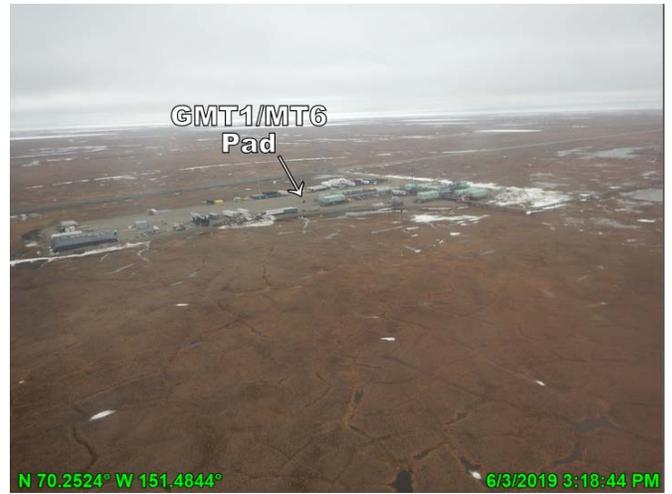
Photo 4.21: S8 drainage area, looking north; June 3, 2019

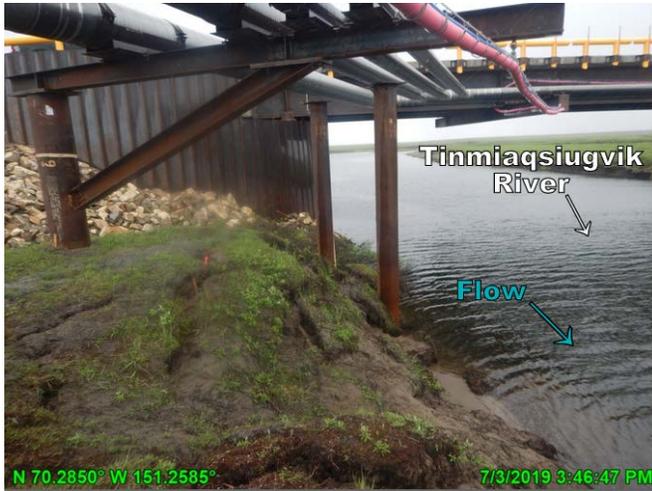
Post-breakup conditions were assessed to evaluate erosion and scour at the Tinmiaqsiugvik Bridge and Crea Bridge abutments, Barely Creek culvert inlets and outlets, and along the banks upstream and downstream of all GMT1/MT6 access road crossings. In addition, the access road and pad were inspected for erosion and any displaced gravel fill onto the tundra. At the Tinmiaqsiugvik Bridge, bank erosion was first observed at the east abutment and along the east bank immediately downstream of the bridge in 2018. During the 2018-19 winter, the two VSMs most threatened by the bank erosion were abandoned and replaced with a single VSM with a cantilevered horizontal support. The 2019 observations show continued erosion along the bank at the abandoned VSMs (Photo 7.1 and Photo 7.2). Similar to 2018, thermo-erosional niching and subsequent riverbank block failure continue to occur. This is caused when moving water undercuts an ice-rich bank through thermal and mechanical processes forming a “niche.” At a point the niche is deep enough that the overhanging block collapses and further erodes at the toe of the bank. A gully, also downstream of the Tinmiaqsiugvik Bridge on the east bank, has deepened since 2018. The gully, that now encompasses both VSMs of the support downstream (pipeline flow direction) of the new VSM, appears to be a thermokarst feature with exposed ice wedges (Photo 7.3 and Photo 7.4). The gully is approximately 4 feet deep at the VSMs.

Photo 7.1: Erosion along east bank of Tinmiaqsiugvik River, looking south (upstream); July 3, 2019

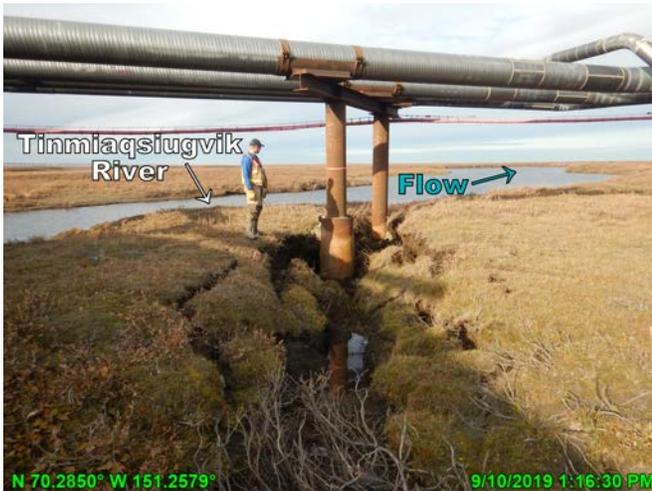
Photo 7.3: Thermokarst gully on east bank, downstream of the Tinmiaqsiugvik Bridge, looking north; September 10, 2019

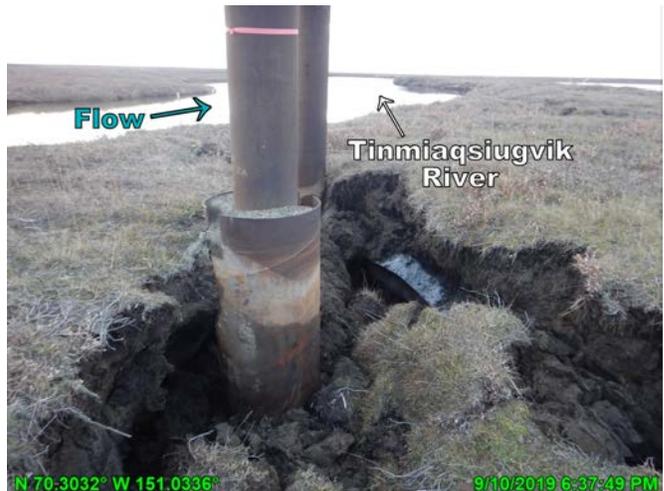
Photo 7.4: Exposed ice wedge in thermokarst gully on east bank, downstream of the Tinmiaqsiugvik Bridge, looking north; September 10, 2019

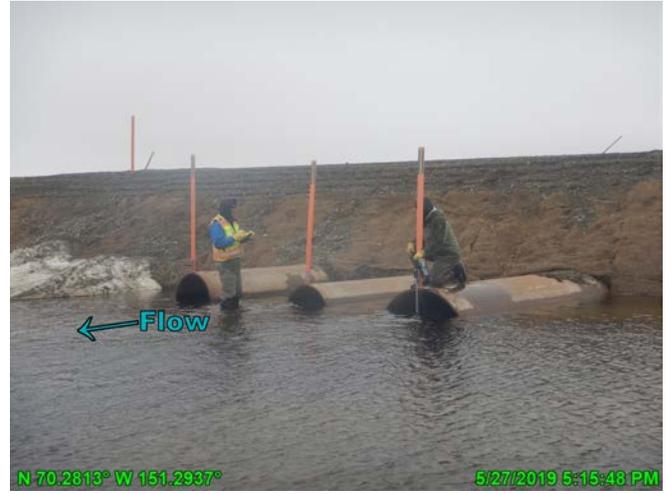
No displaced gravel fill attributed with spring breakup flooding was observed along the road embankment, around culvert inlets and outlets, or around bridge abutments (Photo 7.5 through Photo 7.19). Other than at the Tinmiaqsiugvik Bridge, there were no signs of sloughing or undermining at drainage structures and no channel changes were observed at the crossings. Additional photo documentation of post-breakup conditions is provided in Appendix E.

Photo 7.18: Barely Creek culverts outlets, looking south (upstream); May 27, 2019

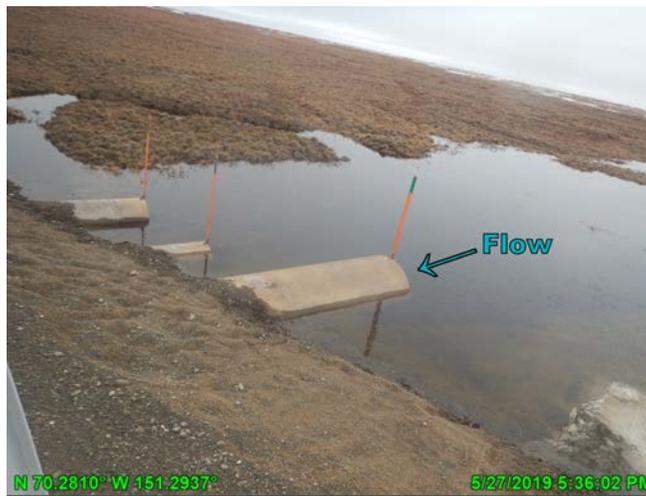
Photo 7.19: Barely Creek culverts inlets, looking southeast (upstream); May 27, 2019
