CULVERT MONITORING REPORT

2019 GREATER MOOSE'S TOOTH 2 (GMT2/MT7)

SPRING BREAKUP

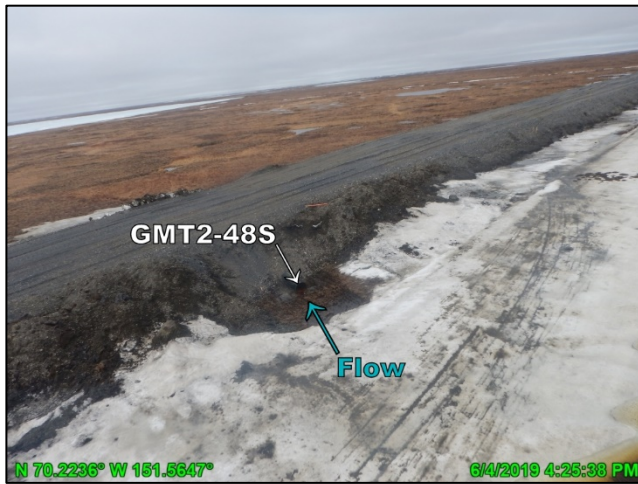
No performance issues were identified at any culverts along the GMT2/MT7 access road. Temporary ponded water was present in drainages at several locations along the access road but was attributed to the ice road, snow or culvert caps frozen in place impeding flow and not culvert placement (Photo 3.1 and Photo 3.2).

Photo 3.1: Culvert GMT2-48 and adjacent ice road, looking north; June 4, 2019

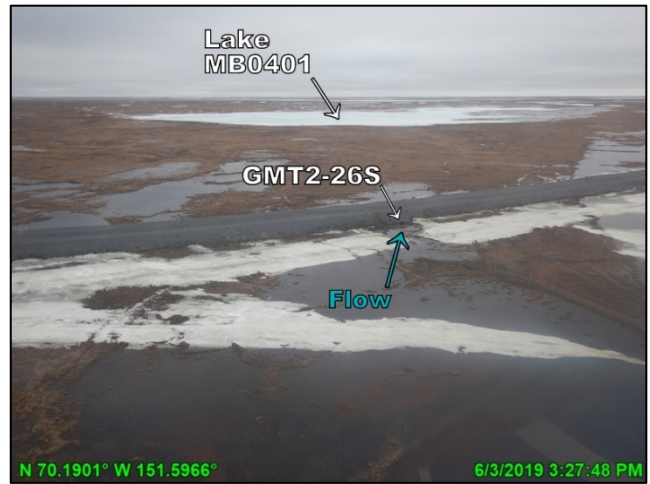
Photo 3.2: Local ponding at culvert GMT2-26 looking north; June 3, 2019

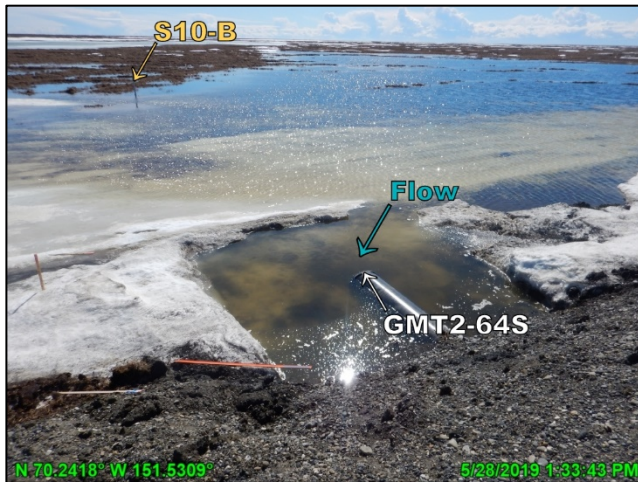
Some culvert caps left in place were blocking flow (Photo 3.3). In addition, drifted snow and the adjacent ice road also impeded drainage in some locations (Photo 3.4 and Photo 3.5). Once conveyance paths were established by either removing culvert caps or meltwater naturally cutting through snow/ice, the culverts all performed as designed and natural drainage patterns were maintained (Photo 3.6 and Photo 3.7). With exception of the minimal sloughing observed at culvert GMT2-31, no displacement of uncompacted gravel fill attributed with spring breakup flooding was observed along the road embankment or around culvert inlets and outlets. There were no signs of undermining at drainage structures. Several culverts were perched on either the north or south sides of the road which may lead to the development of scour holes (Photo 3.8). Besides these perched culverts, no culvert maintenance, repair, upgrade, setting adjustments, and/or replacements are recommended at this time.

Photo 3.3: Culvert GMT2-64S blocked by a culvert cap, looking south; May 28, 2019

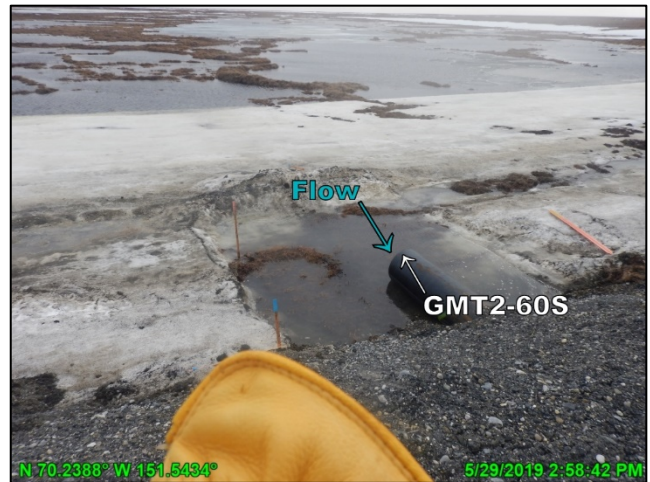
Photo 3.4: Culvert GMT2-60 and adjacent ice road, looking south; May 29, 2019

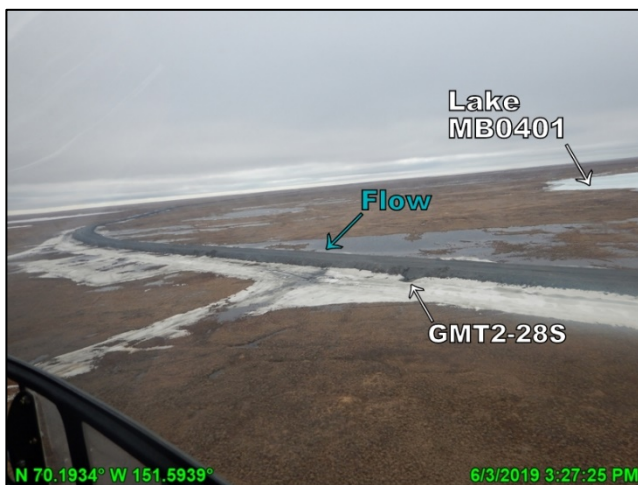
Photo 3.5: Ponded water on the north side of GMT2/MT7 access road near culvert GMT2-28, looking west; June 3, 2019

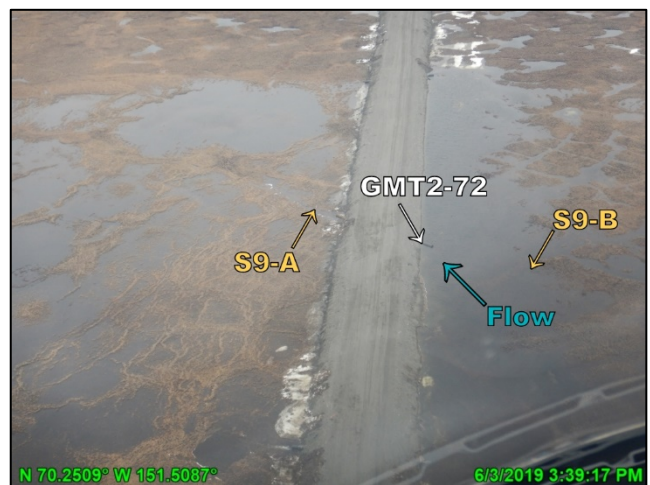
Photo 3.6: Meltwater on both sides of the GMT2/MT7 access road near S9 monitoring location, looking northeast; June 3, 2019

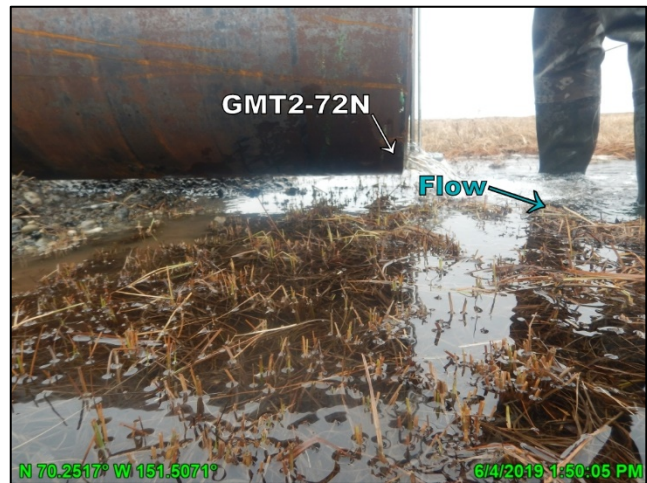
Photo 3.8: Culvert GMT2-72 perched on the north (DS) side of the GMT2/MT7 access road, looking southwest; June 4, 2019

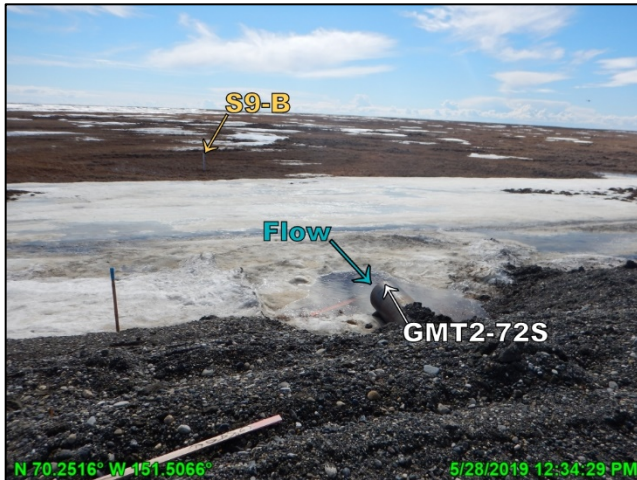
Local melt was first observed on May 27 as ponded water started accumulating on both sides of the road. Visual observations on May 28 showed minimal meltwater at gage station S9 (Photo F.1). Any meltwater from Lake M9925 traveled through a low-lying area to the west of S9 and passed through culvert GMT2-70 and 71. On May 28, flow was measured at various culverts to the east, but meltwater through these culverts was disconnected from Lake M9925.

Photo F.1: Minimal meltwater at S9, looking south; May 28, 2019

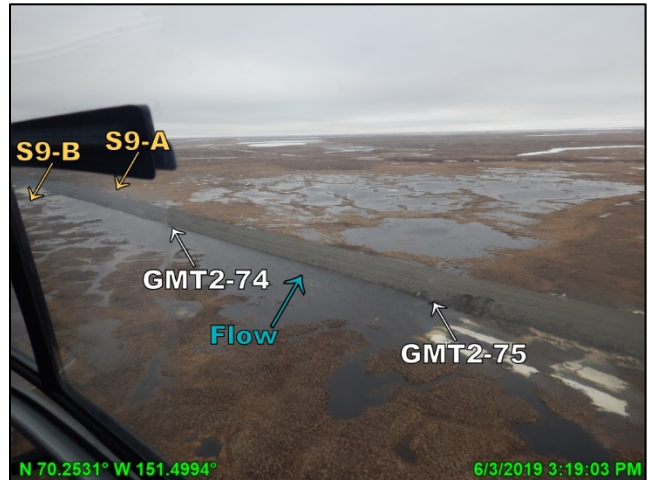
On June 3, aerial observations revealed differential ponding around the S9 gage area. Meltwater had reached the embankment on the south (upstream) side of the alignment and ponding was observed extending from culvert GMT2-72 to GMT2-75 (Photo F.2). The ice road had deteriorated and was submerged under ponded water and likely impacted the drainage in this area. By June 4, water was observed flowing through the S9 culverts, although a small area of differential ponding was still observed around GMT2-72 and GMT2-73.

Photo F.2: Differential ponding near GMT2-75, looking west; June 3, 2019

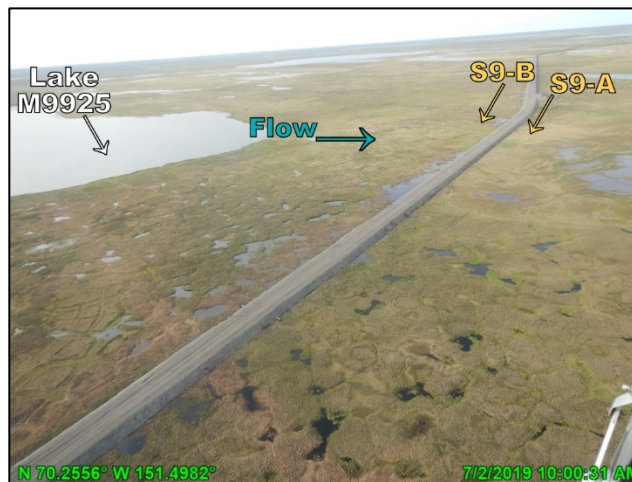
On July 2, field crews returned to S9 to further inspect the area of ponding around culvert GMT2-72 and GMT2-73. The appearance of differential ponding was still observed (Photo F.3). Historical aerial imagery reveals that the road alignment bisects a poorly defined natural drainage and, absent the road, the northernmost extent of meltwater ponding may not extend beyond the northernmost extent of the road footprint. Therefore, it is uncertain whether moving existing culverts or installing an additional culvert would improve drainage or decrease the appearance of differential ponding in the area.

Photo F.3: Summer conditions near S9, looking southwest; July 2, 2019

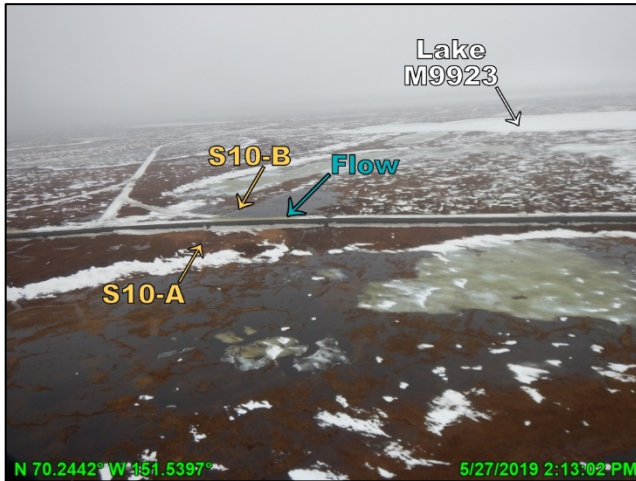
Local melt was first observed in the S10 monitoring location on May 27 as meltwater pooled in low areas of the associated paleolake on both sides of the road. Differential ponding was observed at culvert GMT2-64, with larger quantities of meltwater on the south (upstream) side of the alignment (Photo F.4). On May 28, field crews walked the alignment and discovered the culvert installation cap was still in place on the inlet of culvert GMT2-64. Once this cap was removed, rapid flow through the culvert was observed as the area hydraulically equalized. By May 29, meltwater had cut flow paths through the ice road at most culvert locations. Flow was confirmed through culvert GMT2-61, GMT2-65 and GMT2-67. At GMT2-61, ponded water and differential pooling was observed on the south side of the road, but flow through GMT2-61 suggests the ponding was due to a partially blocked culvert (Photo F.5).

Photo F.4: Meltwater accumulation near S10, looking south; May 27, 2019

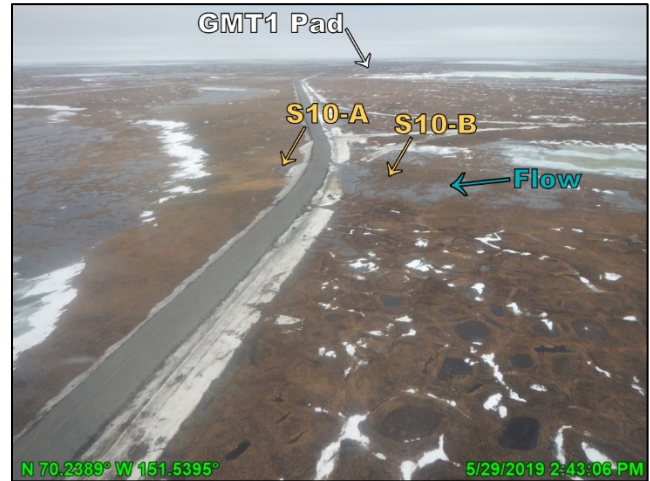
Photo F.5: Differential ponding near GMT2-61, looking northeast; May 29, 2019

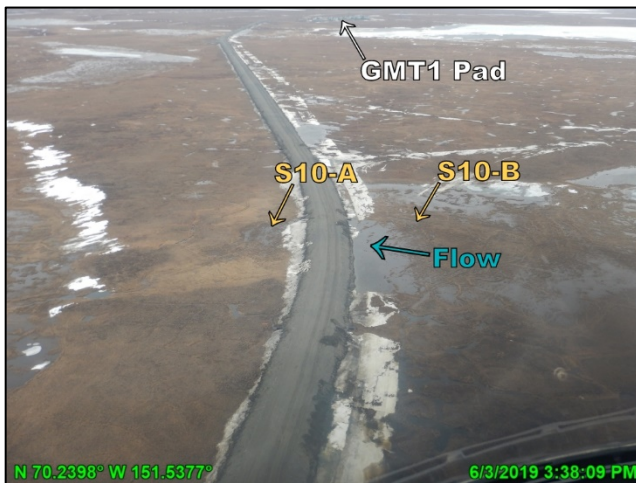
On June 3, aerial observations revealed hydraulically equalized conditions at most locations. Areas of minor ponding were still observed at GMT2-61 (Photo F.6). On June 4, discharge was measured through culverts that were conveying flow, although stage had receded relative to the May 29 measurement. Aerial observations from

Photo F.6: Areas of ponding near GMT1-61, looking northeast; June 3, 2019

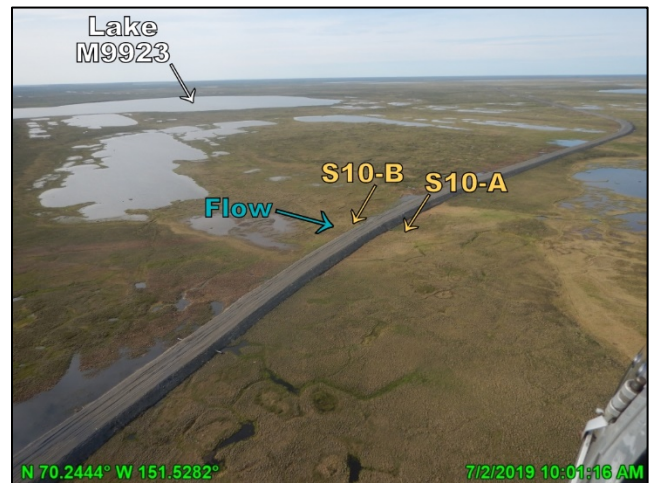
July 2 show equalized hydraulic conditions in the area and any ponded water at GMT2-61 had dissipated (Photo F.7).

Photo F.7: Summer conditions near S10, looking south, July 2, 2019

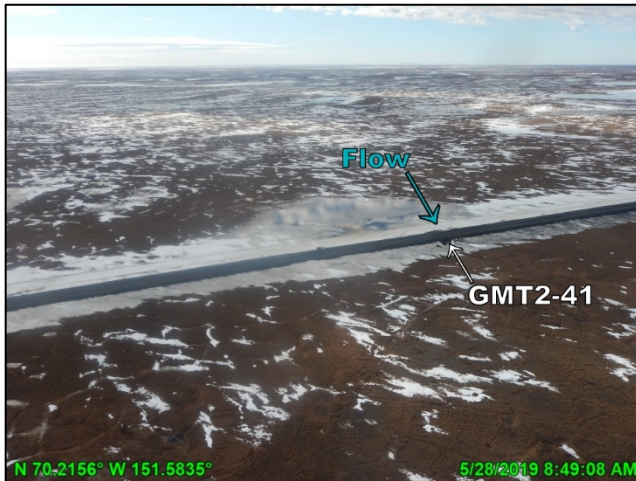
GMT2-41 on May 28 (Photo F.8). Differential ponding was also observed around S11 at culvert GMT2-56 (Photo F.9). On May 29, field crews landed at GMT2-56 to inspect conditions at the site. The south (inlet) end was mostly submerged and appeared to be blocked (Photo F.10), and the north (outlet) end of GMT2-56 was dry (Photo F.11). In addition, the ice road was blocking drainage, leading to large quantities of meltwater accumulating in the associated paleolake to the south.

Photo F.8: Differential ponding near GMT2-41, looking south; May 28, 2019

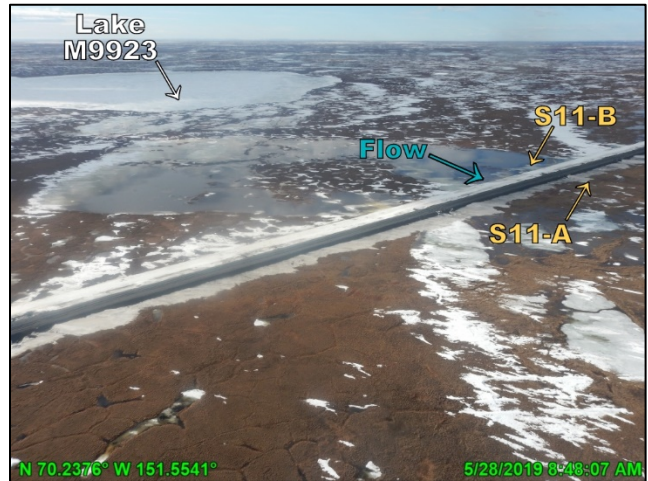
Photo F.9: Differential ponding near S11, looking south; May 28, 2019

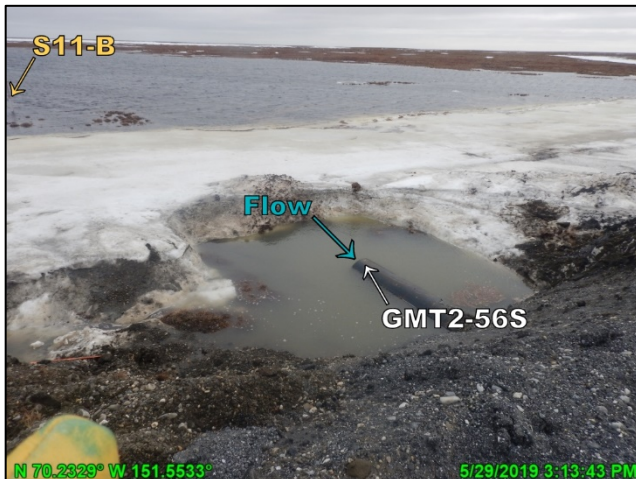
Photo F.10: Blocked culvert GMT2-56 inlet with meltwater ponding, looking south; May 29, 2019

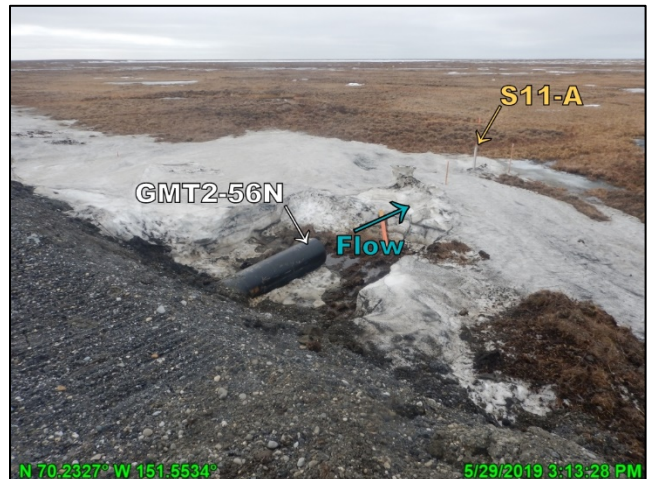
Photo F.11: Dry conditions at GMT2-56 outlet, looking north; May 29, 2019

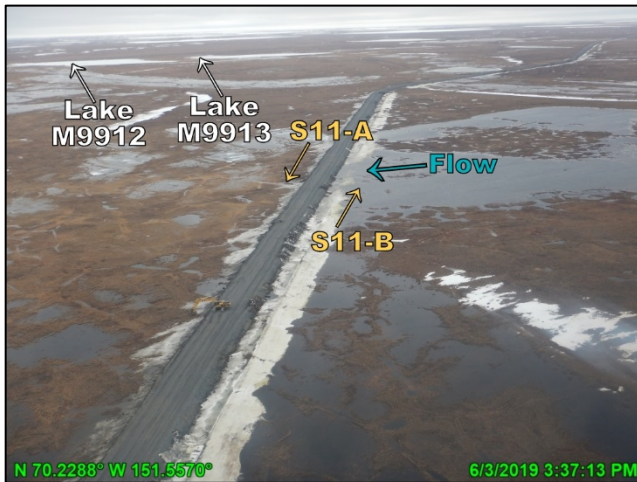
Aerial observations from June 3 revealed little change. Differential ponding was still observed near S11 at culvert GMT2-56 (Photo F.12) and further west at culvert GMT2-41 (Photo F.13). The ice road and ice blockage in culverts were likely the main cause for poor drainage in the area. On June 4, increased meltwater conveyance through the culverts suggested culvert relief from blockage. Culvert GMT2-56 was observed to be conveying flow, and aerial observations revealed the partial restoration of natural drainage patterns as compared with the previous day (Photo F.14). Ponding on the south side of the alignment around GMT2-41 was still present, although flow through the culvert was observed and measured. The deteriorating ice road had allowed pooled meltwater to reach the toe of the embankment at the GMT2-41 inlet (Photo F.15).

Photo F.12: Differential ponding near S11, looking north; June 3, 2019

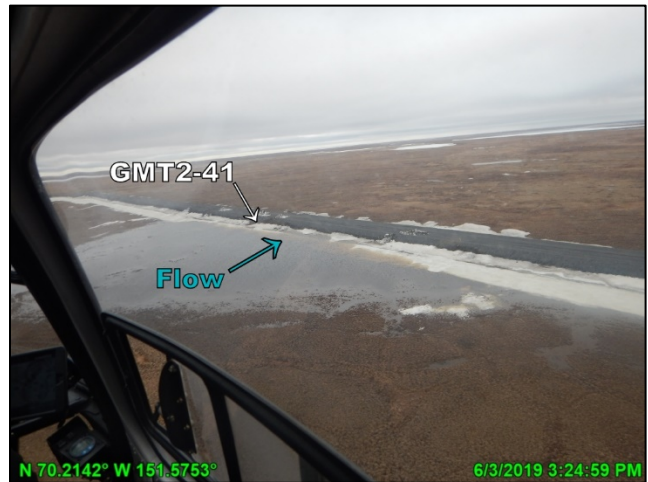
Photo F.13: Differential ponding near culvert GMT2-41, looking west; June 3, 2019

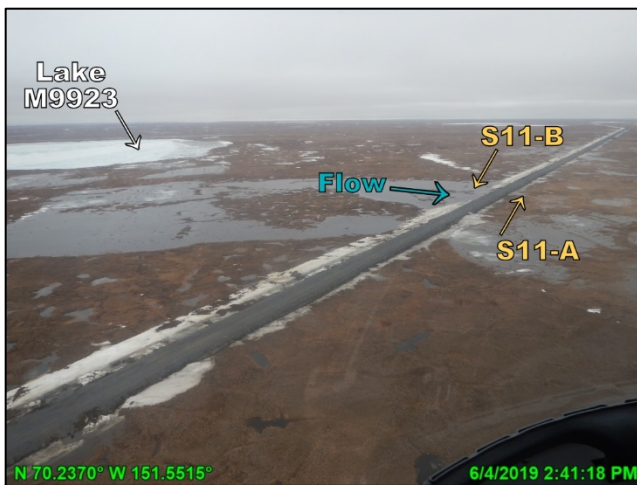
Photo F.14: Restoration of natural drainage pattern near S11, looking south; June 4, 2019

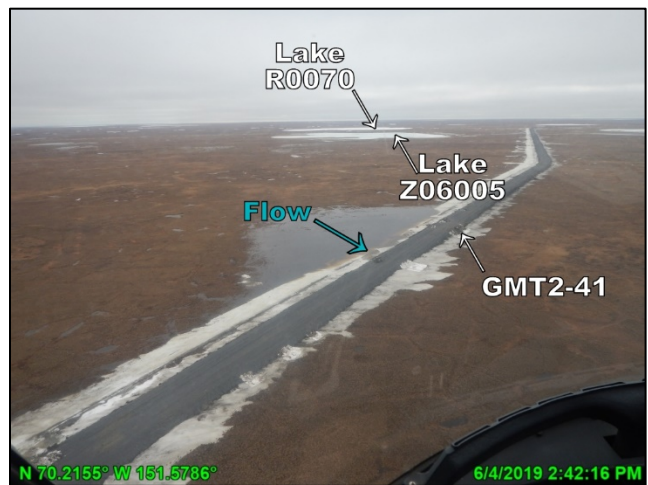
Photo F.15: Continued differential ponding near GMT2-41, looking south; June 4, 2019

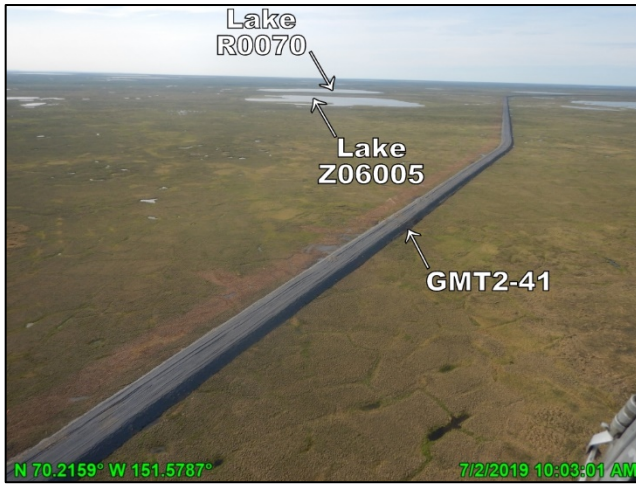
On July 2, field crews returned to S11 to further inspect the area of ponding around culverts GMT2-56 and GMT2-41. The area around GMT2-41 appeared hydraulically equalized and mostly dry (Photo F.16). The appearance of differential ponding around culvert GMT2-56 was still observed based on aerial photography (Photo F.17). Similar to S9, historical aerial imagery reveals that the road alignment bisects a poorly defined natural drainage and, absent the road, the northernmost extent of meltwater ponding may not extend beyond the northernmost extent of the road footprint. Therefore, it is uncertain whether moving existing culverts or installing an additional culvert would improve drainage or decrease the appearance of differential ponding in the area.

Photo F.16: Equalized summer conditions near GMT2-41, looking south; July 2, 2019

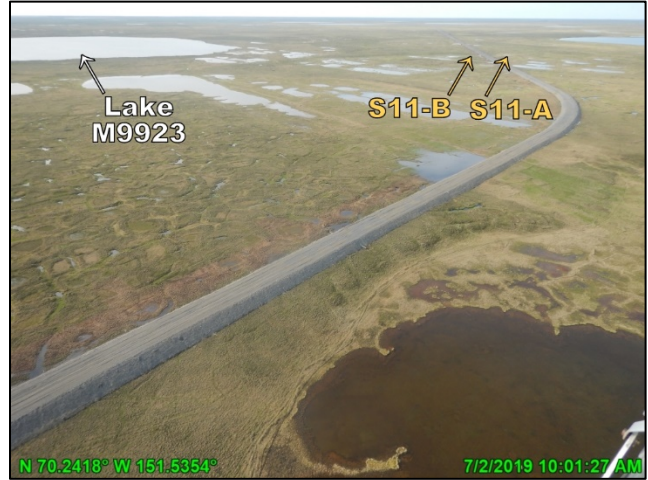
Photo F.17: Summer conditions near S11, looking south; July 2, 2019

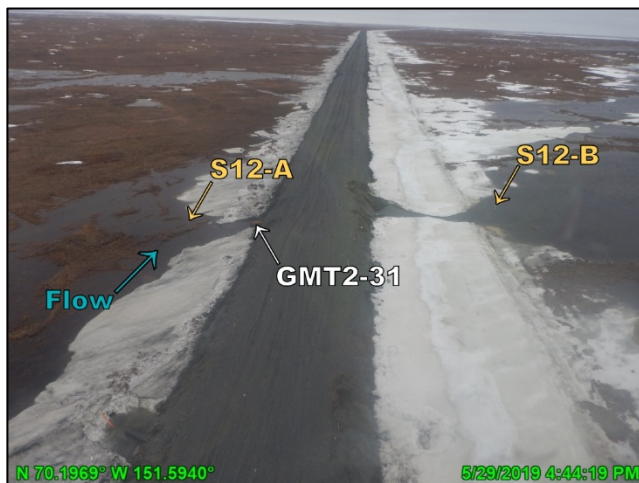
Photo F.20: Minor sloughing near culvert GMT2-31, looking west; May 29, 2019

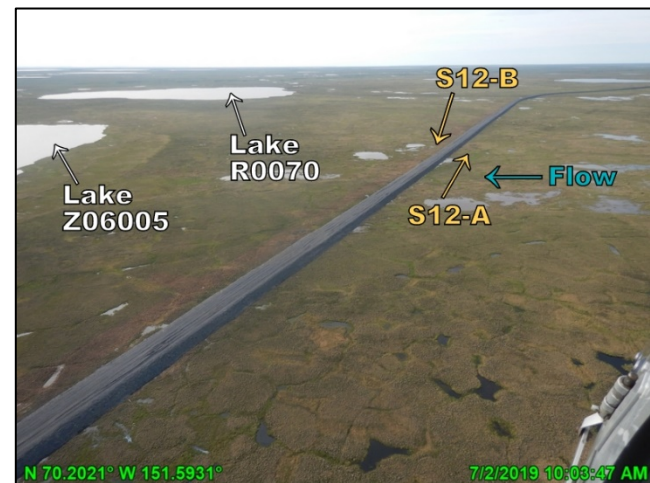
Local meltwater was first observed at S12 on May 27. In general, the ice road was impeding meltwater from reaching the south (inlet) end of the culverts, however, photographic documentation suggests some meltwater draining from Lake Z06005 had cut a path through the ice road and was flowing through culvert GMT2-31 (Photo F.18). Aerial observations also indicate natural drainage patterns were maintained through an ice road intersection constructed around culvert GMT2-28 (Photo F.19). By May 28, flow paths through the ice road were observed at most culverts. An overflight performed on June 3 confirmed hydraulically equalized conditions across the area, however, at S12, meltwater from a small lake on the south (upstream) side of the alignment was reaching and sloughing the embankment around GMT2-31 (Photo F.20). Aerial observations from July 2 show equalized hydraulic conditions in the area (Photo F.21).

Photo F.21: Summer conditions near S12; July 2, 2019

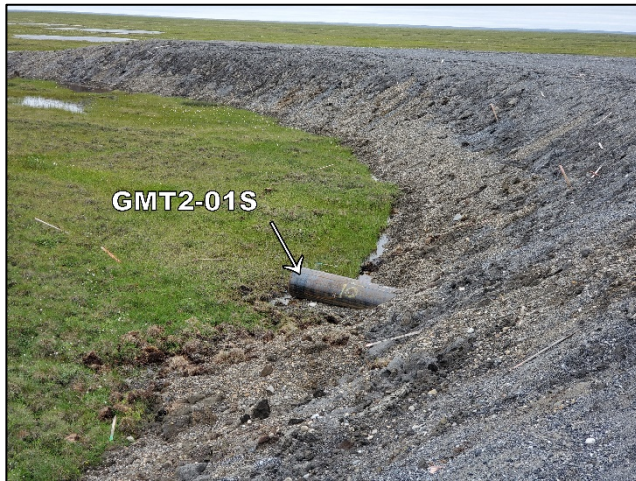
The S13 monitoring location is situated in small, poorly defined network of polygon troughs near the GMT2/MT7 pad location. Culverts GMT2-01 through GMT2-04 are located in this series of polygons while culverts GMT2-05 through GMT2-20 are located on higher ground to the west. An ice road adjacent to the south embankment of the GMT2/MT7 road affected hydraulic performance in the area. In July 2019, a 4-foot extension was added to culvert GMT2-001 because the road was wider than originally designed at this location (Photo F.22).

Photo F.22: Extension on culvert GMT2-01, looking west; July 2019

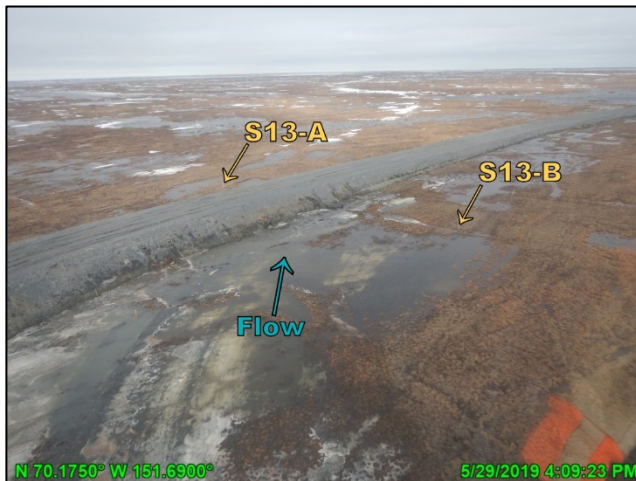
Photo F.24: Ponding near S13, looking north; May 29, 2019
