Project Note

Subject: **CD5 Bank Erosion, Channel Bathymetry, and Bridge Bathymetry Monitoring**

From: Jeff Baker and Garrett Yager 2/21/2014

2013 Colville River Delta Spring Breakup Monitoring and Hydrologic Assessment (A component of the CD5 Adaptive Management Strategy) 135141

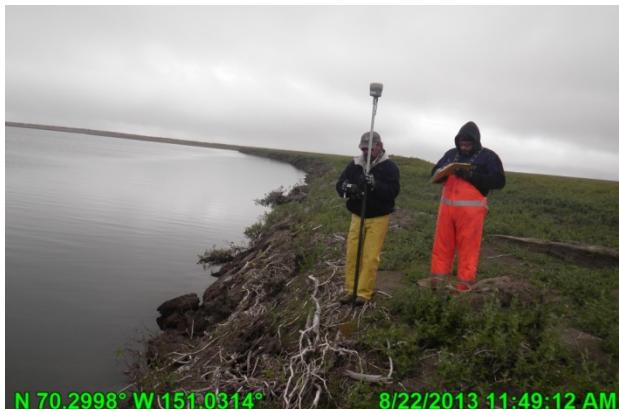
Top of bank composition downstream of the CD5 bridge crossing is patterned, wet sedge meadow tundra. Banks are characterized by active sloughing with prominent tension cracks. No exposed ice lenses or ice wedges were evident during the time of survey. No large block collapse or thermo-erosional niches were present. Sloughing bank faces were steep and moderately vegetated with scattered drift wood (Photo 6.1). Sloughing bank faces extended to the water line, lacking any exposed beach at the toe of the bank. Edge of bank survey points were positioned at the perimeter of the intact vegetation above the first major tension crack (Photo 6.2).

Photo 6.1: Sloughing of the Nigliq Channel west bank with scattered drift wood upstream of the proposed CD5 bridge crossing, looking south; August 22, 2013

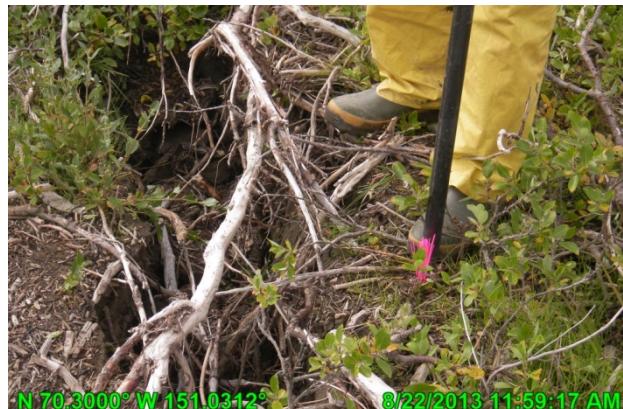
Photo 6.2: Edge of bank survey point established above the first major tension crack upstream of the proposed CD5 bridge crossing on the west bank of the Nigliq Channel; August 22, 2013

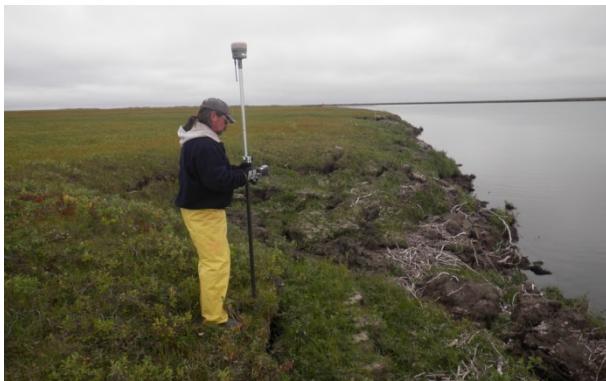
Bank indentations, formed by ground subsidence likely attributed to melting of underlying ice-wedges, give the bank a scalloped appearance near the proposed CD5 bridge crossing. At these locations, the edge of bank was established above the subsided ground (Photo 6.3).

Photo 6.3: Ground subsidence and defined edge of the Nigliq Channel west bank near the proposed CD5 bridge crossing; looking north; August 22, 2013

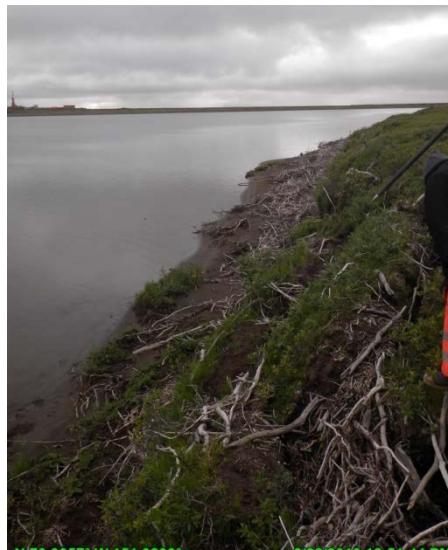
Downstream of the proposed CD5 bridge crossing, the grade of the sloughing bank was moderate. A beach was observed at the toe as the bank transitioned from a cut bank to a depository bank (Photo 6.4). Tension cracks were evident and similar to the upstream delineation; survey points were established above the first major crack.

Photo 6.4: Nigliq Channel west bank with beach at toe, downstream of the proposed CD5 bridge crossing; looking southeast; August 22, 2013

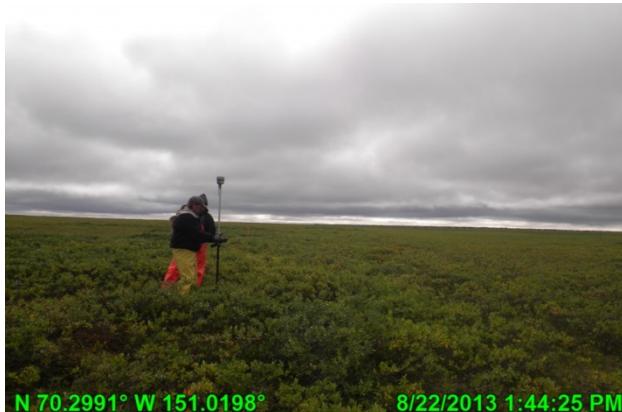
The east bank of the Nigliq Channel upstream of the proposed CD5 bridge crossing is defined as an extensive depository point bar. The point bar is composed of barren ground near the channel and transitions to partially vegetated grasses and dense low willows further from the channel. A gradual break in grade defines the bank from the point bar terrain. The edge of bank survey points were established at the top of the grade break (Photo 6.5).

Photo 6.5: Edge of Nigliq Channel east bank defined as top of grade break on point bar, upstream of the CD5 bridge crossing, looking southwest; August 22, 2013

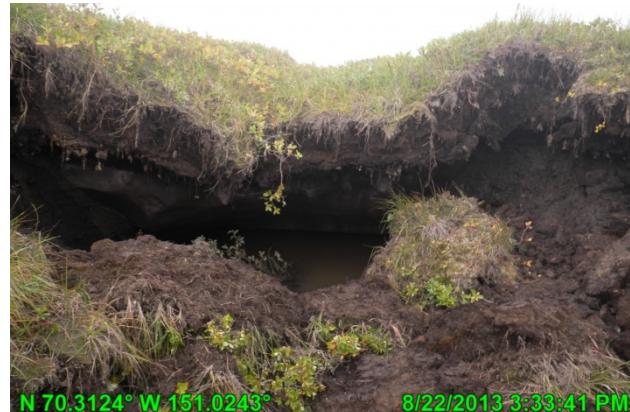
Additional visual inspections of the east bank, downstream of the proposed CD5 bridge crossing, were conducted from a boat. Active sloughing, similar to the west bank, was observed. Beyond the downstream extent of the detailed bank delineation limits, thermo-erosional niches (Photo 6.6) and ensuing block collapse (Photo 6.7) were prevalent along the bank.

Photo 6.6: Exposed ice wedge and resulting thermo-erosional niche, west bank of the Nigliq Channel downstream of the proposed CD5 bridge crossing; August 22, 2013

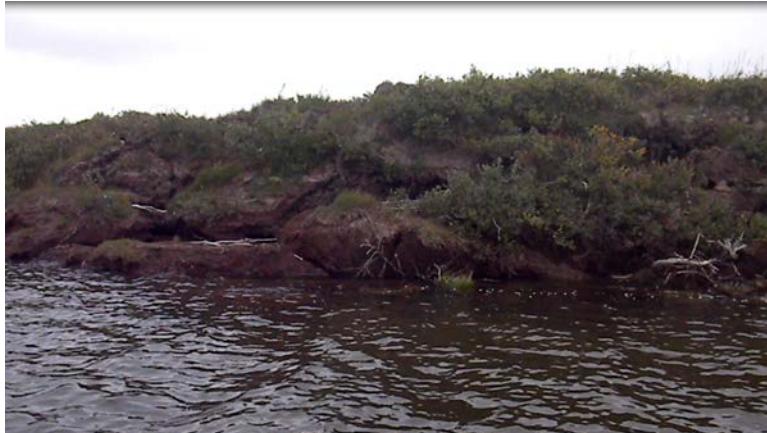
Photo 6.7: Block collapse resulting from thermo-erosional niche, west bank of the Nigliq Channel downstream of the proposed CD5 bridge crossing; August 22, 2013

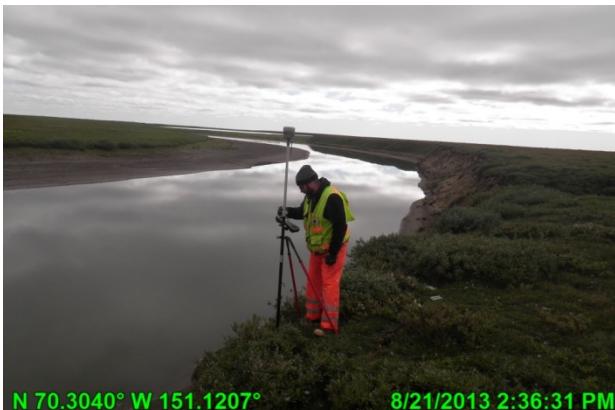
The west bank of the Nigliagvik, upstream of the proposed CD5 bridge crossing, is characterized by steep, sandy bluffs with an overhanging mat of moist sedge-shrub tundra (Photo 6.8). Minor tension cracks were observed in the overhanging tundra mat. Survey points were established where the vegetative mat is anchored to the bluff (Photo 6.9).

Photo 6.8: Sandy bluffs and overhanging tundra mat on the east bank Nigliagvik, upstream of the proposed CD5 bridge crossing; looking south; August 21, 2013

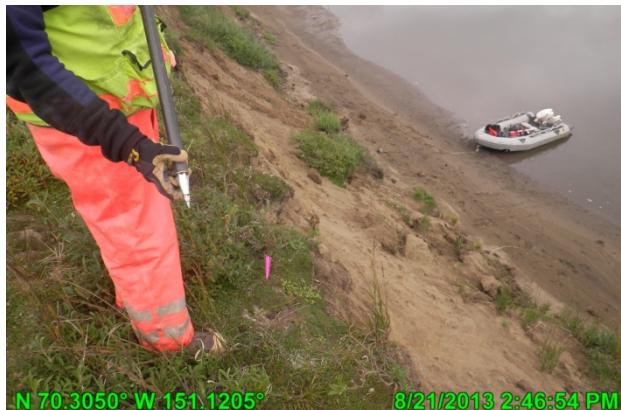
Photo 6.9: Survey point established at anchored edge of the vegetative mat on the Nigliagvik west bluff, upstream of the proposed CD5 bridge crossing; August 21, 2013

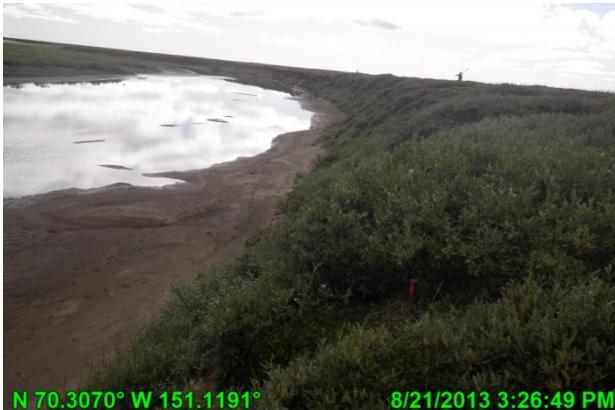
Downstream of the proposed CD5 bridge crossing, the gradient of the west bluff becomes moderate. Vegetation is established on the bluff face (Photo 6.10). Survey points were collected at the break in grade defining the top of the bank. Bank indentations, formed by ground subsidence likely attributed to melting of underlying ice-wedges, were encountered downstream of the proposed CD5 bridge crossing. At these locations, the edge of bank was delineated above the subsiding ground (Photo 6.11).

Photo 6.10: Established vegetation on the bluff face of the west bank Nigliagvik, downstream of the proposed CD5 bridge crossing; looking south; August 21, 2013

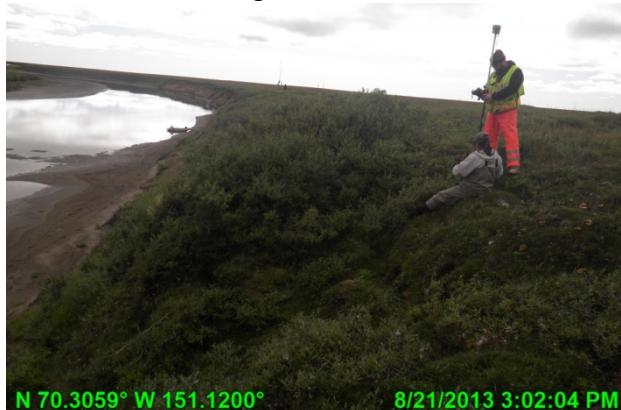
Photo 6.11: Nigliagvik west bank indentation downstream of the proposed CD5 bridge crossing; looking south; August 21, 2013

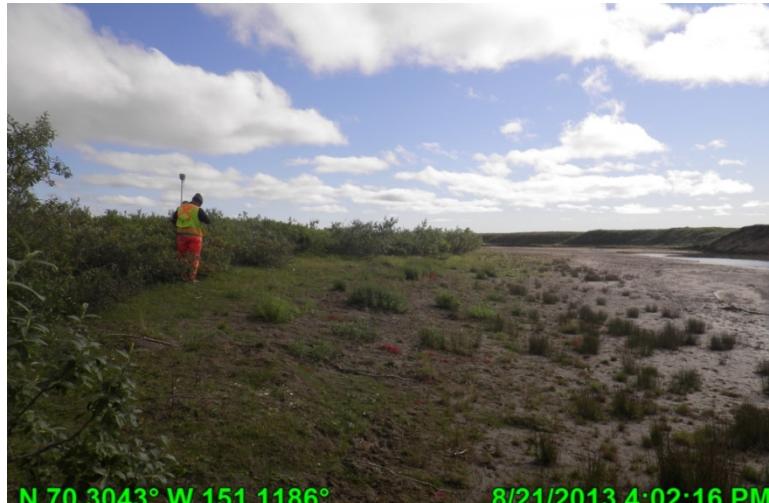
The east bank of the Nigliagvik is a narrow, muddy depository bank with barren terrain near the channel transitioning to sparsely vegetated mudflats and moist low willow shrub. A break in grade defining the top of bank was not identified. The edge of bank was determined to be at the distinct change in vegetation from sparse grass to dense willows (Photo 6.12). The east bank profile of the Nigliagvik was relatively uniform upstream and downstream of the proposed CD5 bridge crossing. Nigliagvik Bank Surveys are located in Attachment D.

Photo 6.12: East edge of Nigliagvik bank defined where willows are rooted, upstream of the proposed CD5 bridge crossing; looking northeast; August 21, 2013

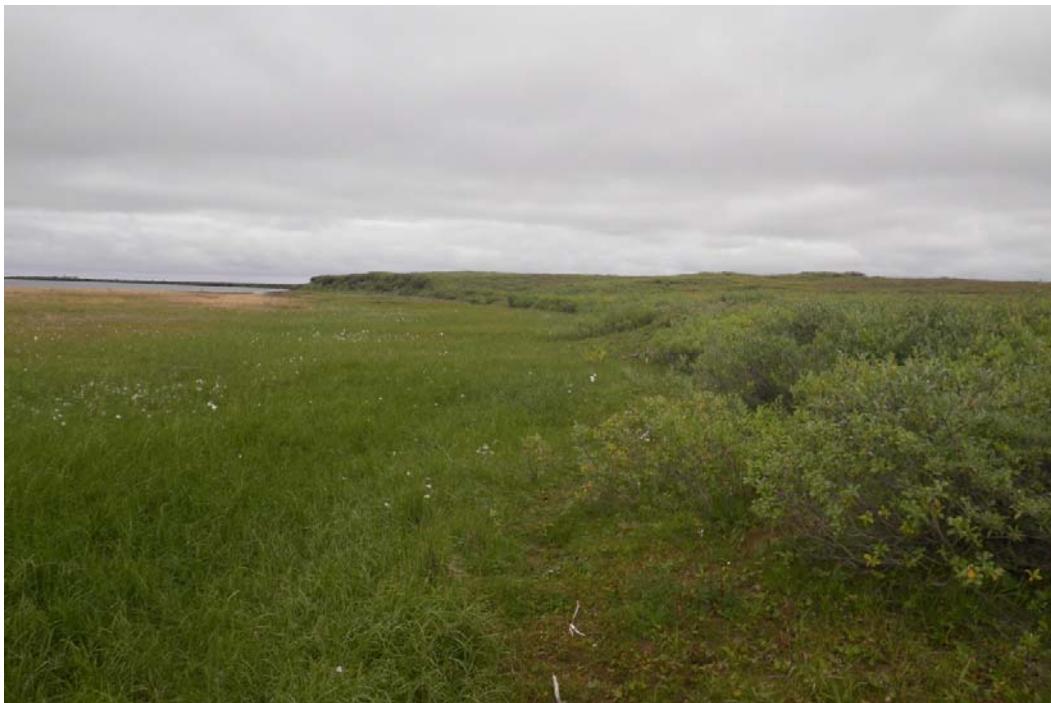
**Photo 2: The east bank of the Nigliq Channel downstream of the
proposed CD5 crossing; August 22, 2013**
