Colville River Delta Spring Breakup 2013 Field Report

ConocoPhillips
Alaska

Michael Baker, Jr., Inc.
1400 West Benson Blvd., Suite 200
Anchorage, Alaska 99503

July 18, 2013
Project Number: 135141

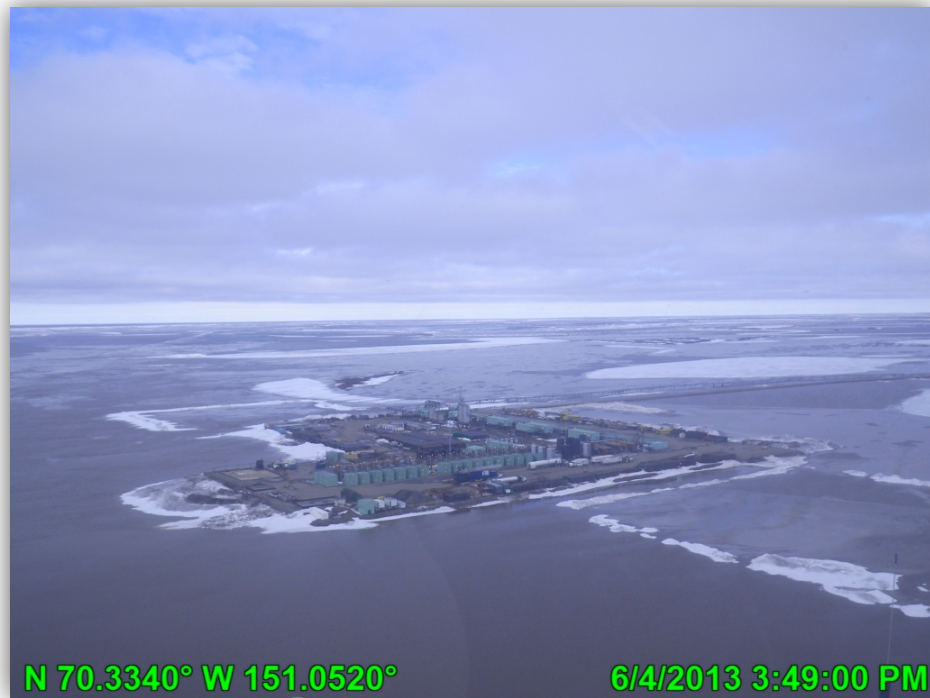
On June 2, an ice jam was observed approximately 7 miles upstream of MON1. The ice jam was estimated to have released around June 3 and reformed one mile south of CD4 in the Nigliq Channel and in the East Channel near the Tamayayak bifurcation. Peak stage at MON1 is expected to have occurred on June 3, which is later than the historical average. By June 4, water levels had increased significantly in the delta and around facilities. Diverted flood water around the Nigliq Channel ice jam inundated the floodplain south of the CD2 road at which point all CD2 culverts were conveying flow (Photo 7 and Photo 8). Backwater from the East Channel ice jam flooded the Sakoonang Channel and contributed to flood water south of the CD4 pad, initiating flow through the CD4 culvert batteries into Lake M9525. The swale bridges and all culverts appeared to function properly through the duration of the flood. Alpine drinking water lakes L9313 and L9312 were observed recharging from Lake M9252 and the Sakoonang Channel respectively.

Photo 6: CD2 surrounded by overbank flow from the Nigliq Channel ice jam; June 4, 2013

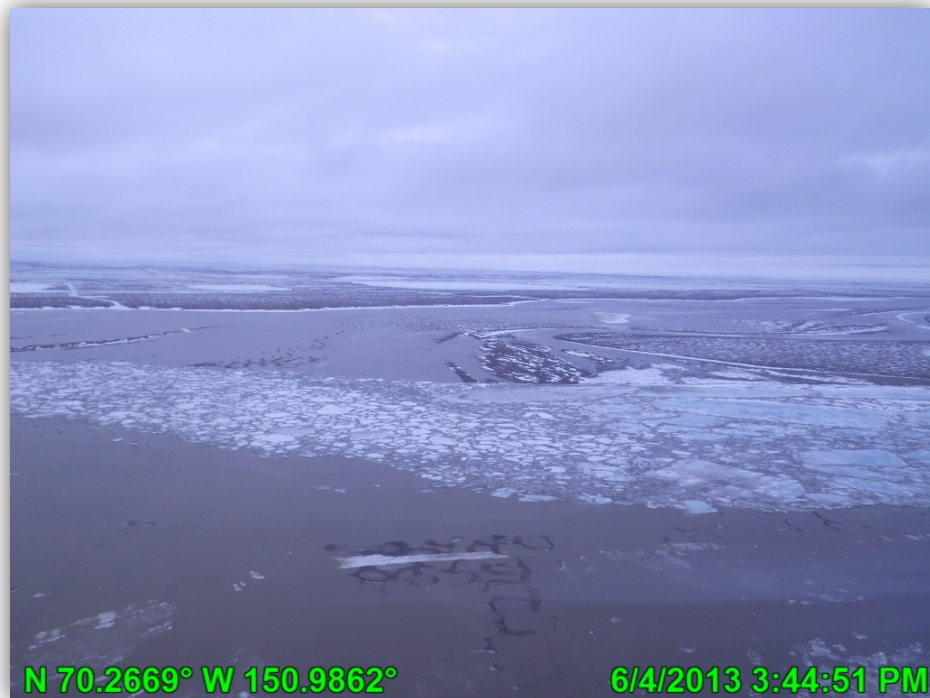
Photo 7: Nigliq channel ice jam upstream of CD4; June 4, 2013

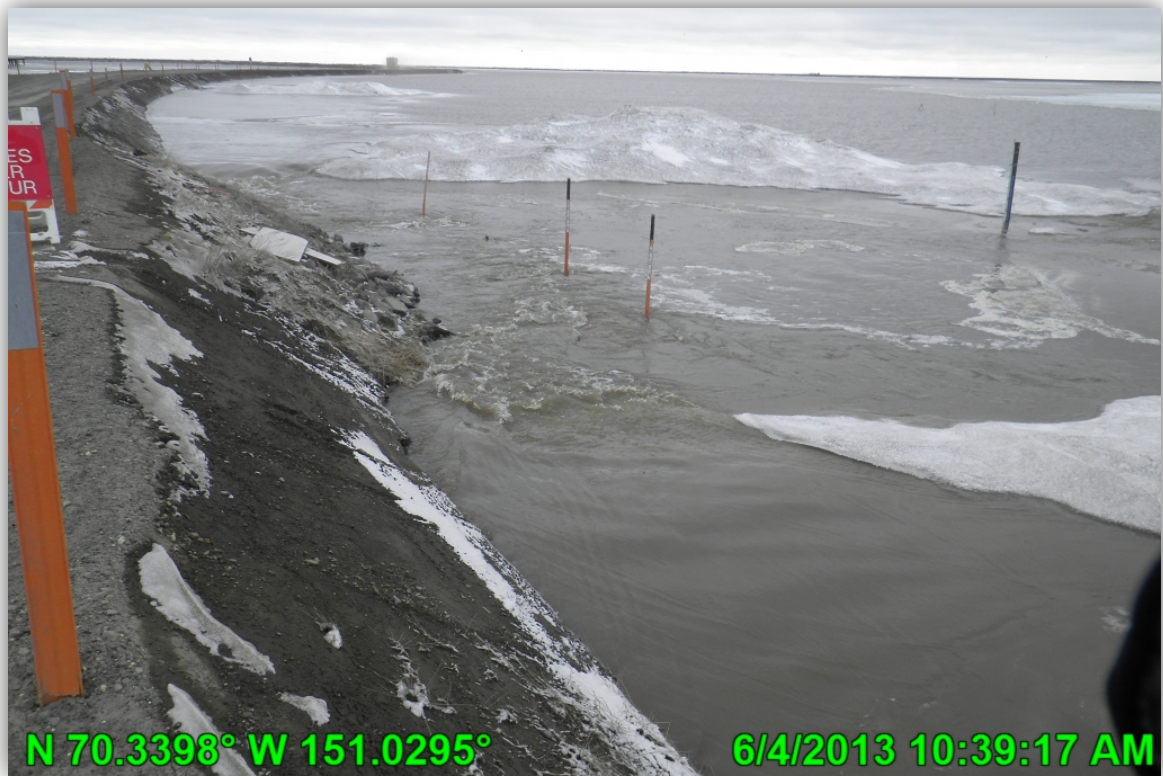
By the afternoon of June 4, flood water had peaked near the CD2 facilities (Photo 9). By June 5, flood water had peaked near the CD4 facilities. Water levels began to quickly recede around facilities once the ice jam in the Nigliq Channel released and moved downstream. By June 8th, water level gages around facilities were dry.

Photo 8: CD2 culvert batteries submerged due to peak flood waters; June 4, 2013

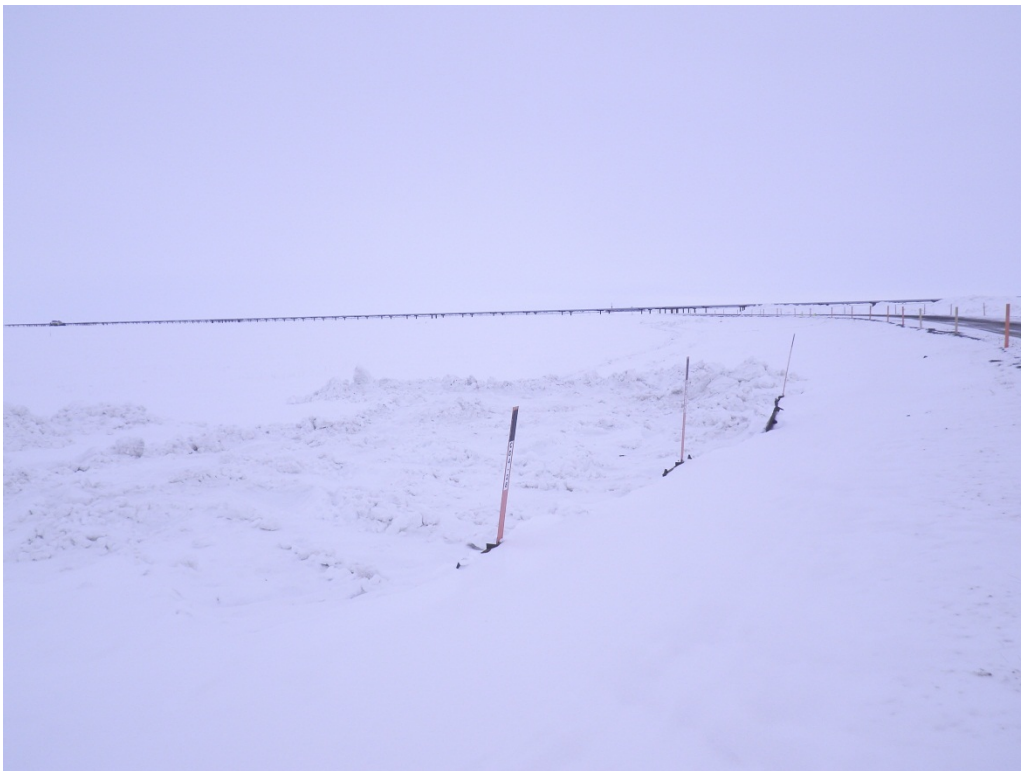
Photo 2: Evidence of snow removal at CD4 culverts; May 13, 2013

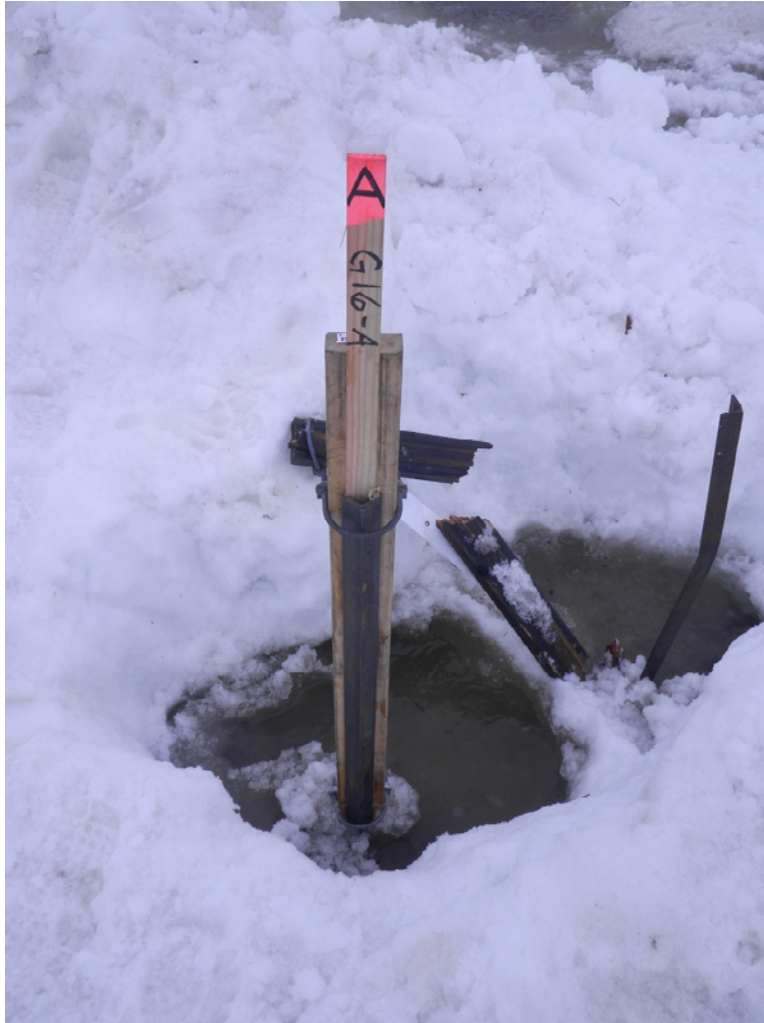
Photo 1: Newly installed Gage 16-A located next to the old gage which was damaged by culvert snow clearing activities; May 28, 2013

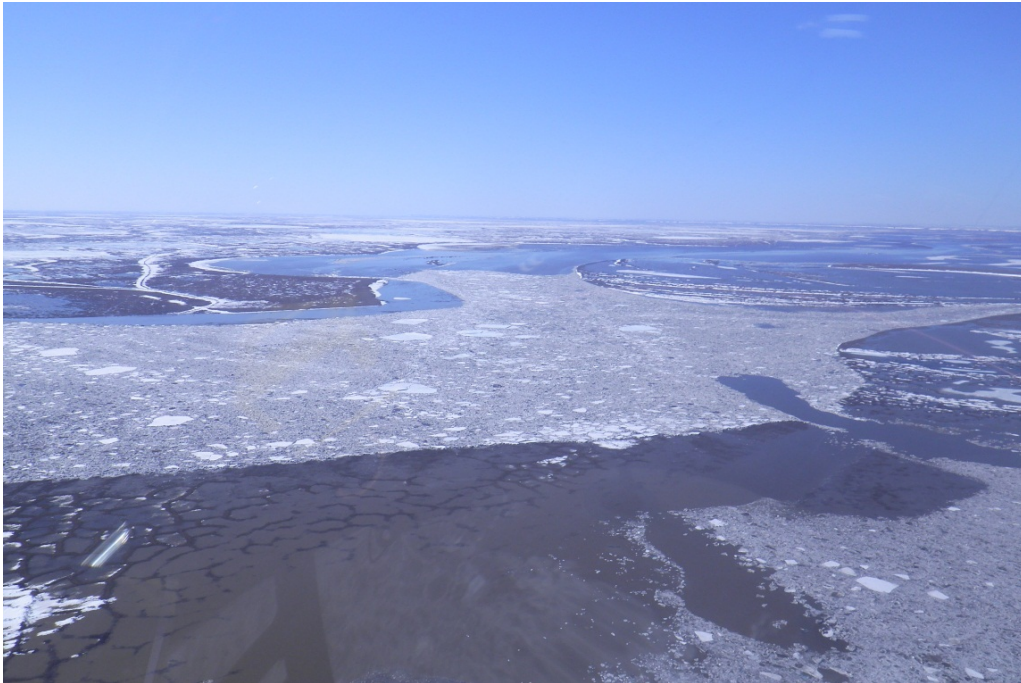
Photo 1: Ice jam and backwater flooding located 7 river miles upstream of MON1, looking south; June 2, 2013

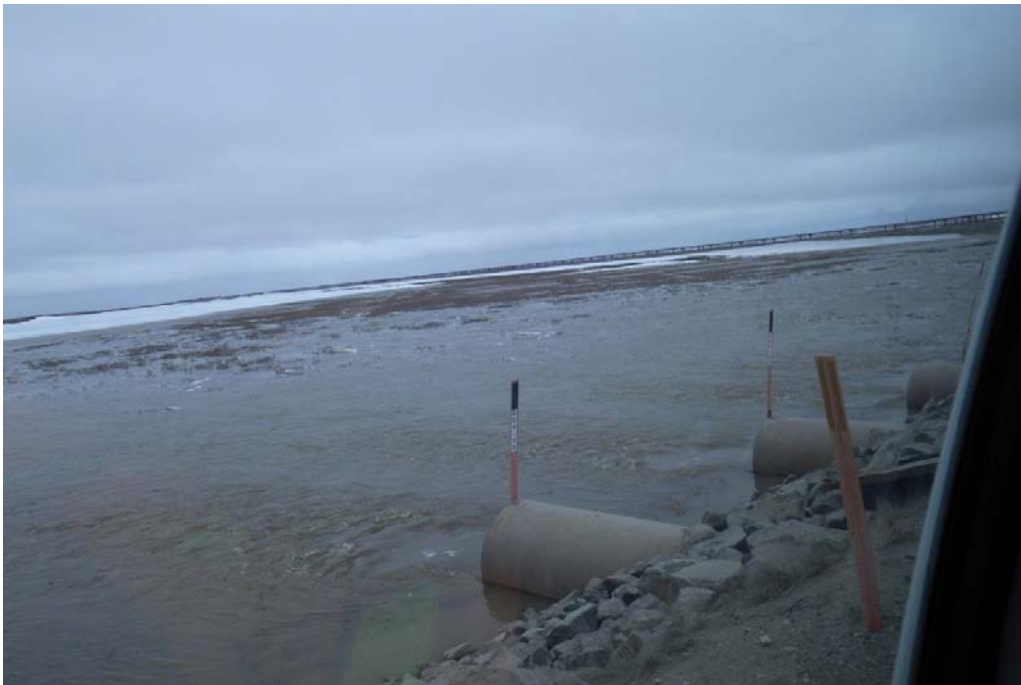
Photo 2: North CD4 culvert battery conveying flow from Lake L9324 to Lake L9323, looking north; June 3, 2013

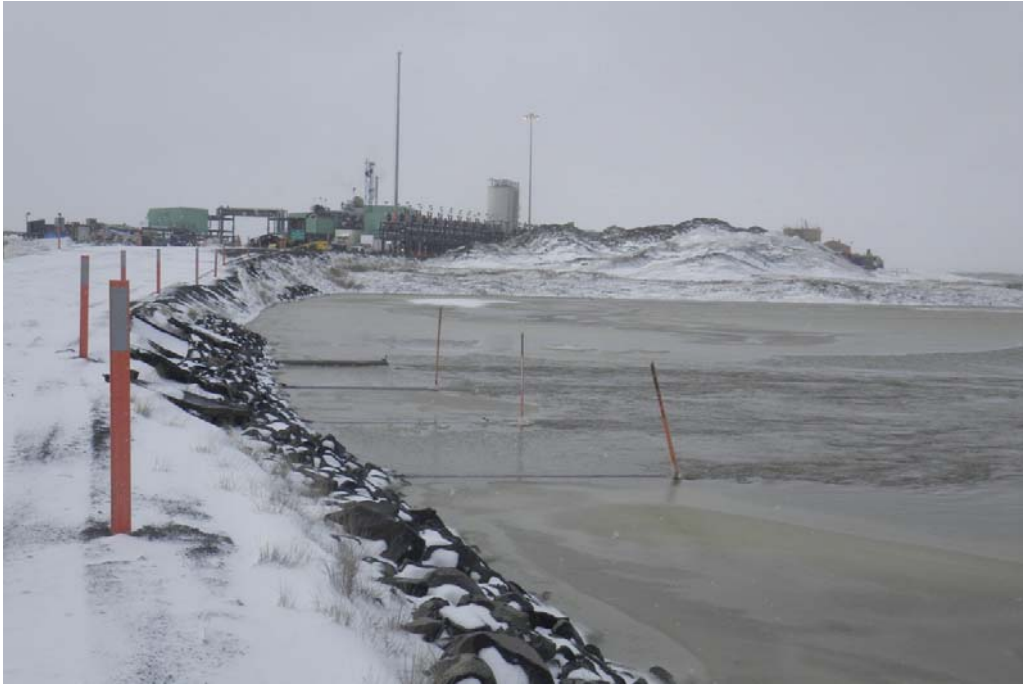
Photo 1: South CD4 culvert battery outlets looking west; June 5, 2013

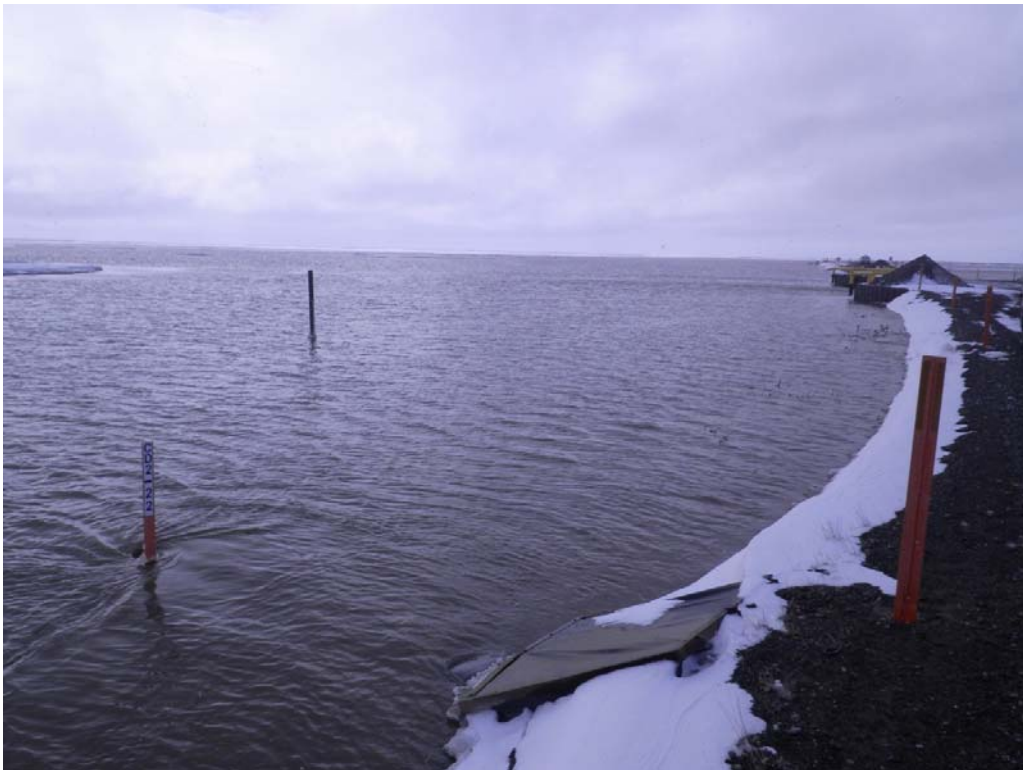
Photo 2: CD2 culverts between swale bridges, looking west; June 5, 2013

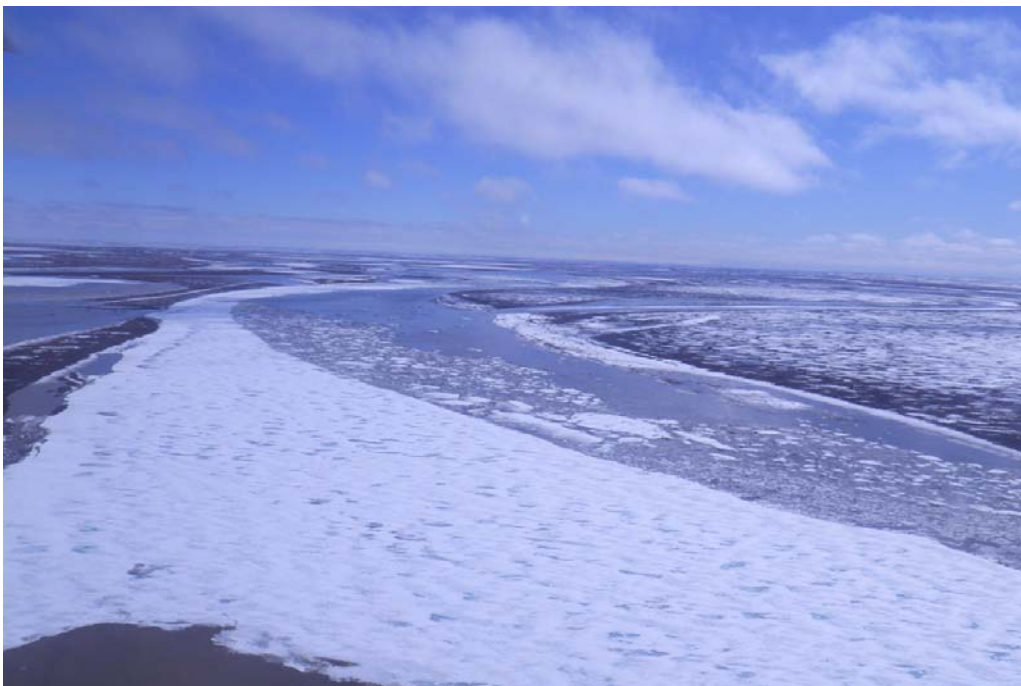
Photo 2: The Nigliq Channel ice jam adjacent to CD2, looking south; June 6, 2013

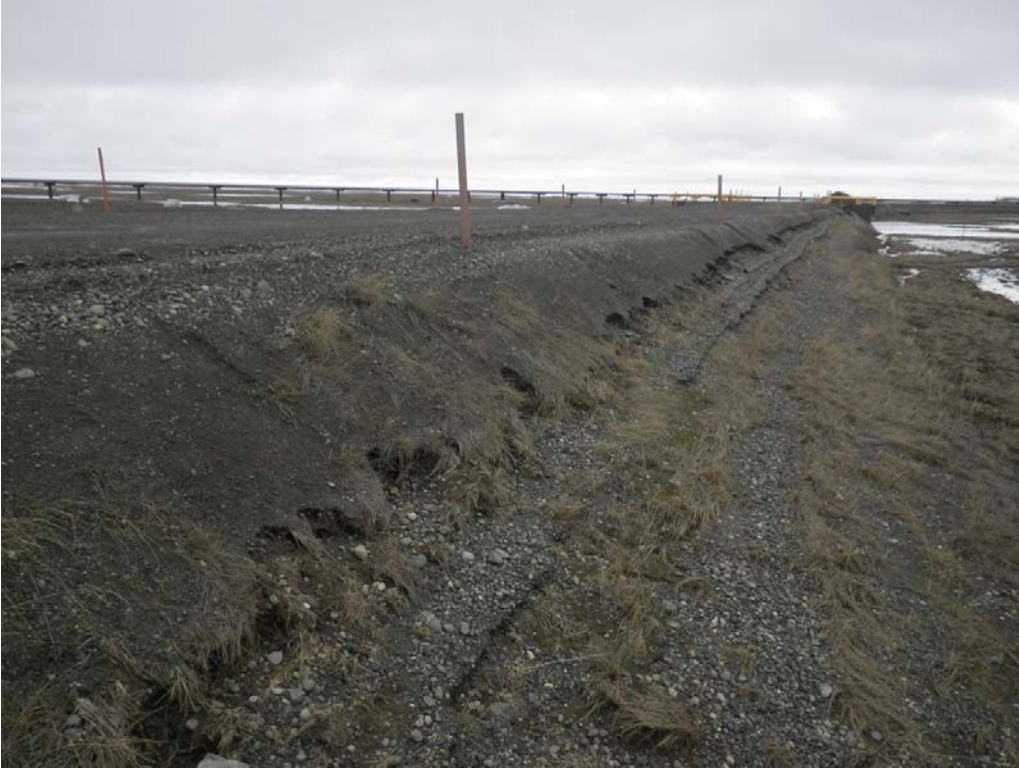
Photo 2: A small eroded scarp in the CD2 road prism west of the small swale bridge, looking east; June 10, 2013
