# CD-North Development Project

## 2001 Spring Breakup and Hydrologic Assessment

**October 2001**  
25008-MBJ-RPT-002

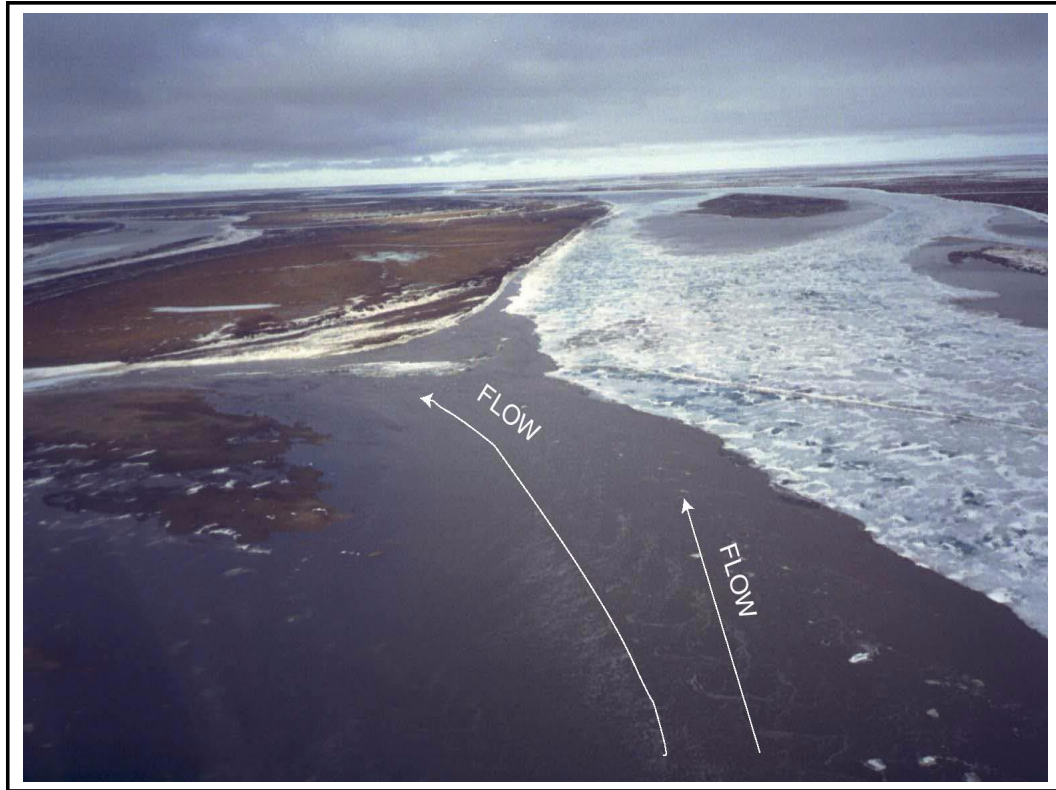
**Photo 2-1. Looking North at the Divergence of the East Channel and Nigliq Channel, 5 June 2001. Note flow entering Nigliq on left.**

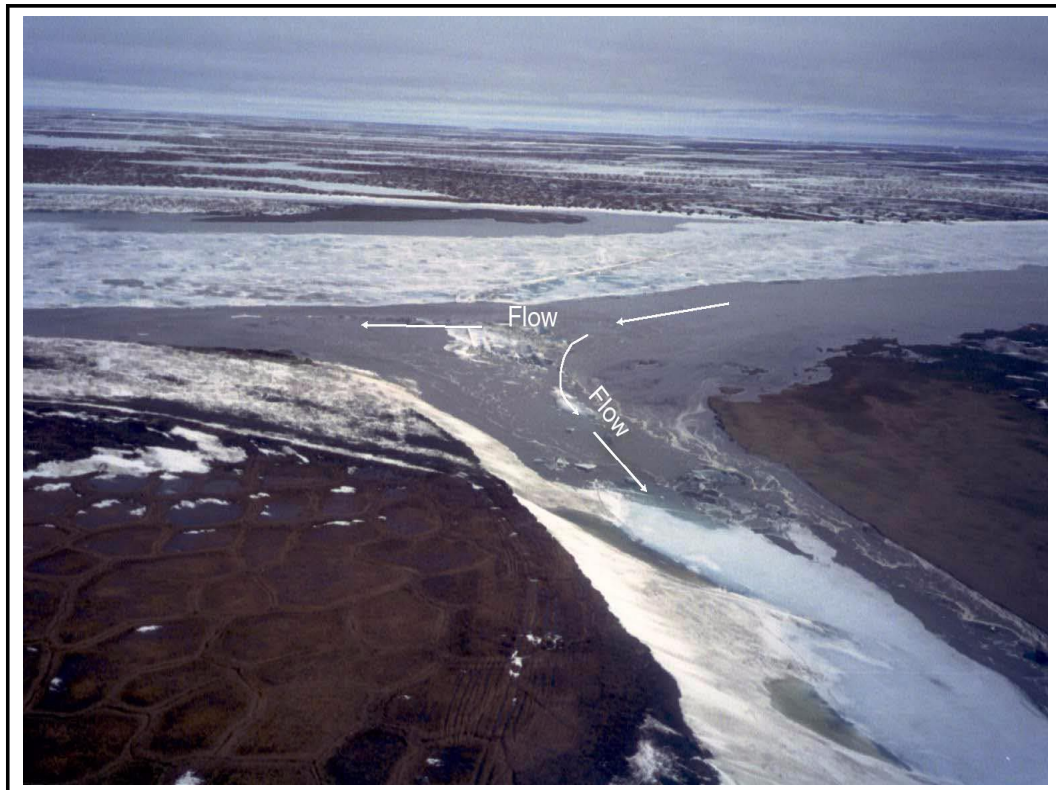
**Photo 2-2. Looking East at the Divergence of the East Channel and Putu Channel, 5 June 2001. Note flow entering Putu Channel.**

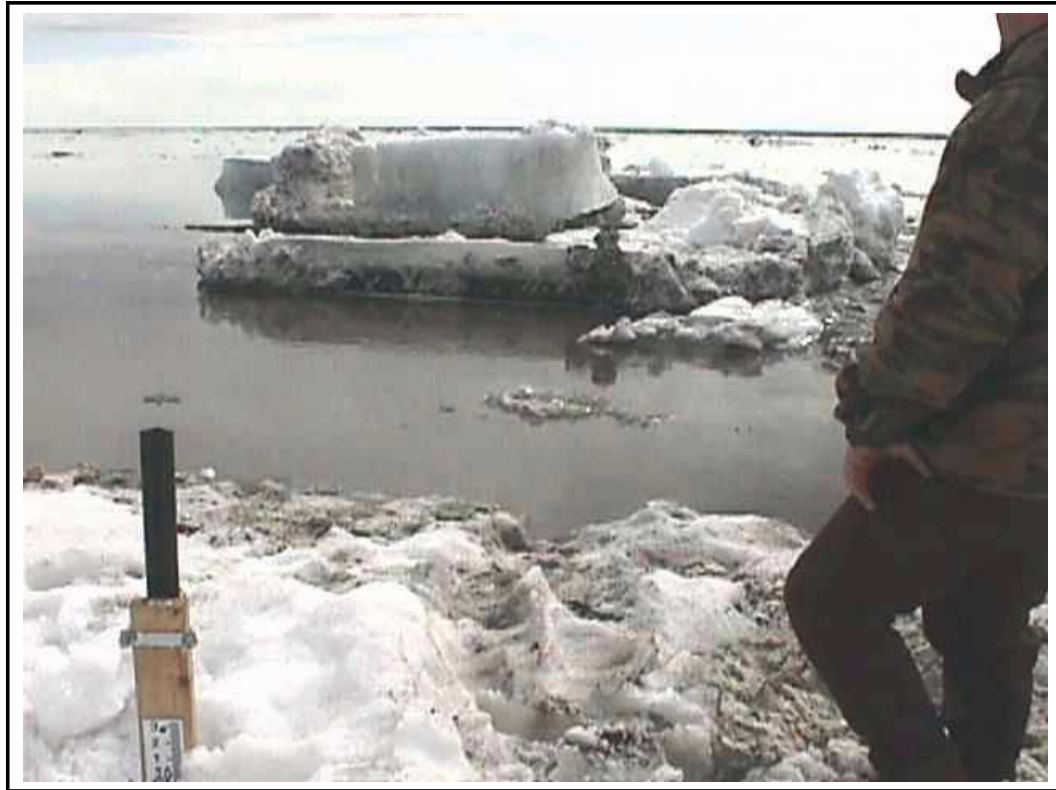
**Photo 2-7. Temporary Benchmark 01U, 10 June 2001. Looking east at conditions in the Colville River at Temporary Benchmark 01U approximately 3 - 4 hours after the peak water surface elevation occurred.**

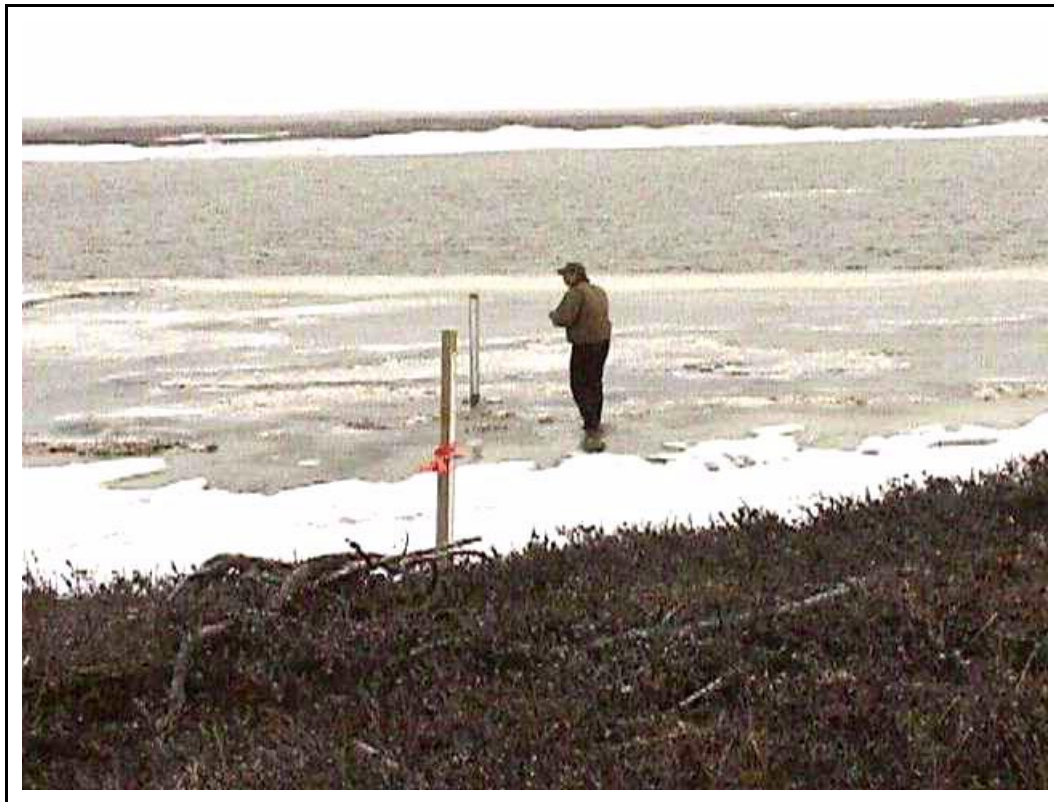
Based on normal depth calculations, it was estimated that at the time the peak water surface elevation occurred, discharge on the Sakoonang Channel at the proposed pipeline crossing was approximately 14,500 cubic feet per second (cfs) with an average velocity of 3.8 feet per second (ft/sec). Water surface elevations and observations for the Sakoonang Channel are summarized in Table 3-2. Photos 3-1 and 3-2 show the Sakoonang Channel on 7 and 9 June, respectively.

**Photo 3-1. Sakoonang Channel, 7 June 2001. Looking north across the channel from the downstream gages.**

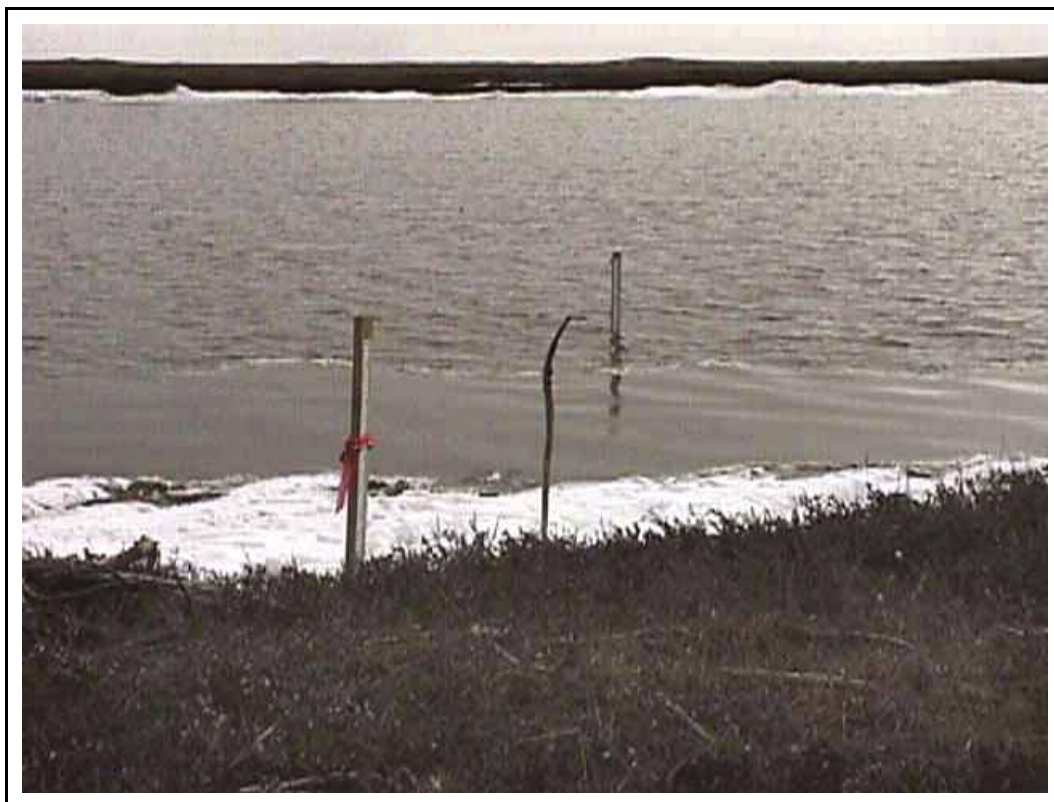
**Photo 3-2. Sakoonang Channel, 9 June 2001. Looking north across the channel from the downstream gages.**

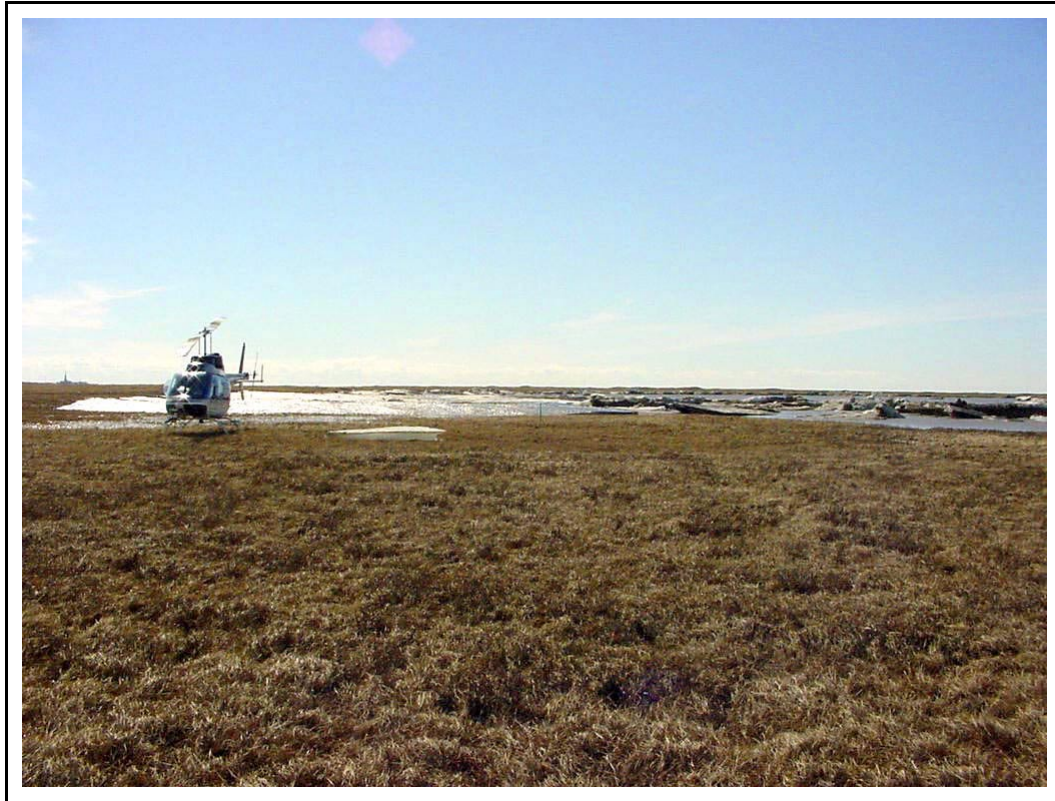
In the Tamayagiaq Channel, flowing water was first observed on 7 June. Water surface elevations peaked at 9.13 feet and 8.60 feet at the upstream and downstream monitoring sites, respectively. In the vicinity of the proposed pipeline crossing the peak water surface elevation was estimated to be 9.1 feet. Peak water surface elevations occurred on the morning on 11 June and no intact channel ice or snow was visible; however, ice floes up to 30 feet across and 4 feet thick were observed. Based on normal depth calculations, it was estimated that at the time the peak water surface elevation occurred, peak discharge on the Tamayagiaq Channel at the proposed pipeline crossing was approximately 21,500 cfs with an average velocity of 3.2 ft/sec. Water surface elevation and observations for the Tamayagiaq Channel are summarized in Table 3-3. Photos 3-3, 3-4, and 3-5 show the Tamayagiaq Channel on 6 and 11 June, respectively.

**Photo 3-5. Tamayagiaq Channel, 11 June 2001. Looking southwest from the downstream gages. Note the grounded ice chunks behind helicopter.**

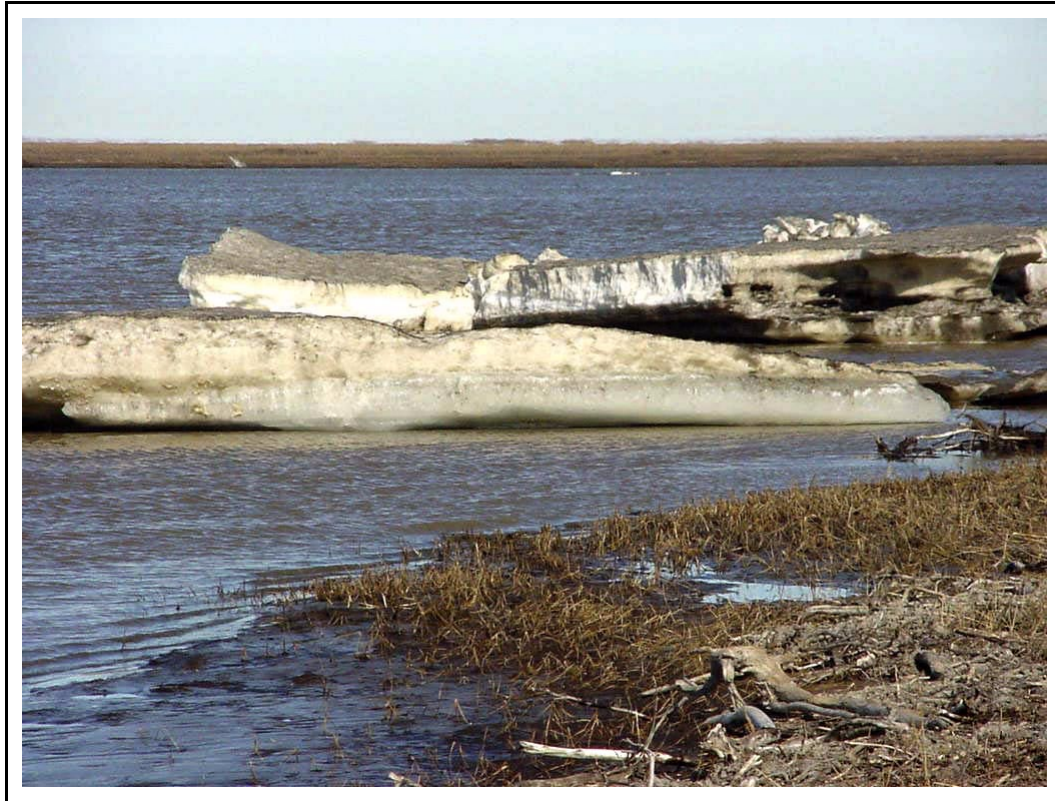
Based on normal depth calculations it was estimated that at the time the peak water surface elevation occurred, peak discharge on the Ulamnigiaq Channel at the proposed pipeline crossing was approximately 14,200 cfs with an average velocity of 3.2 ft/sec. Water surface elevation and observations for the Ulamnigiaq Channel are summarized in Table 3-4. Photos 3-6 and 3-7 show conditions at the Ulamnigiaq Channel on 6 and 11 June, respectively.

**Photo 3-7. Ulamnigiaq Channel, 11 June 2001. Looking east across the channel from the upstream gages.**

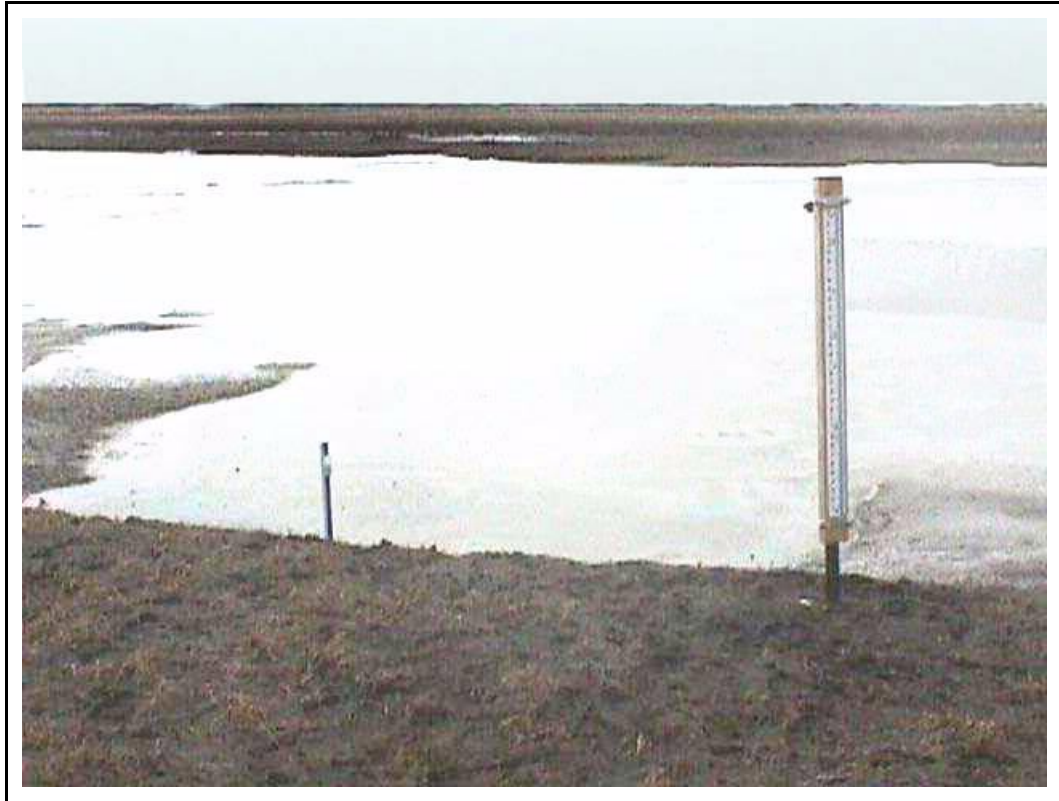
Based on normal depth calculations, it was estimated that at the time the peak water surface elevation occurred, peak discharge on the West Ulamnigiq Channel at the proposed pipeline crossing was approximately 12,200 cfs with an average velocity of 2.82 ft/sec. Water surface elevations and observations for the West Ulamnigiq Channel are summarized in Table 3-5. Photos 3-8 and 3-9 shows snow conditions in the West Ulamnigiq Channel on 7 and 9 June, respectively.

**Photo 3-9. West Ulamnigialq Channel, 9 June 2001. Looking west across the channel from the upstream cross section.**

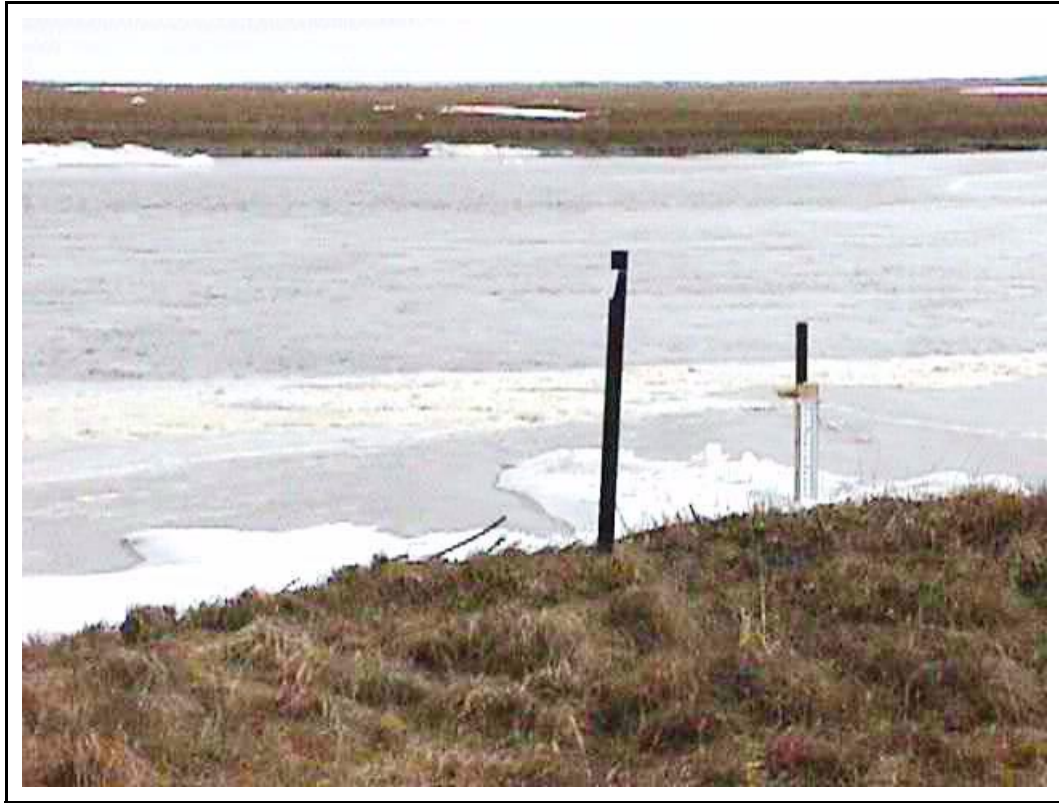
the water surface elevation in the West Ulamnigiq Channel (adjacent and to the west of the proposed pad location) peaked at 7.57 feet. In the East Ulamnigiq Channel (adjacent and to the east of the proposed pad location) the water surface elevation peaked at 7.43 feet. Channel and snow conditions in the East Ulamnigiq Channel were similar to the conditions observed in the West Ulamnigiq Channel. Photos 3-10 and 3-11 show conditions in the East Ulamnigiq Channel on 7 and 9 June, respectively.

**Photo 3-11. East Ulamngiaq Channel, 9 June 2001. Looking east across the channel from the gages.**
