CD-South Development Project

2001 Spring Breakup and Hydrologic Assessment

Michael Baker Jr., Inc.
Anchorage, Alaska 99503
907-273-1600

September 2001
25008-MBJ-RPT-001
Revised November 2001

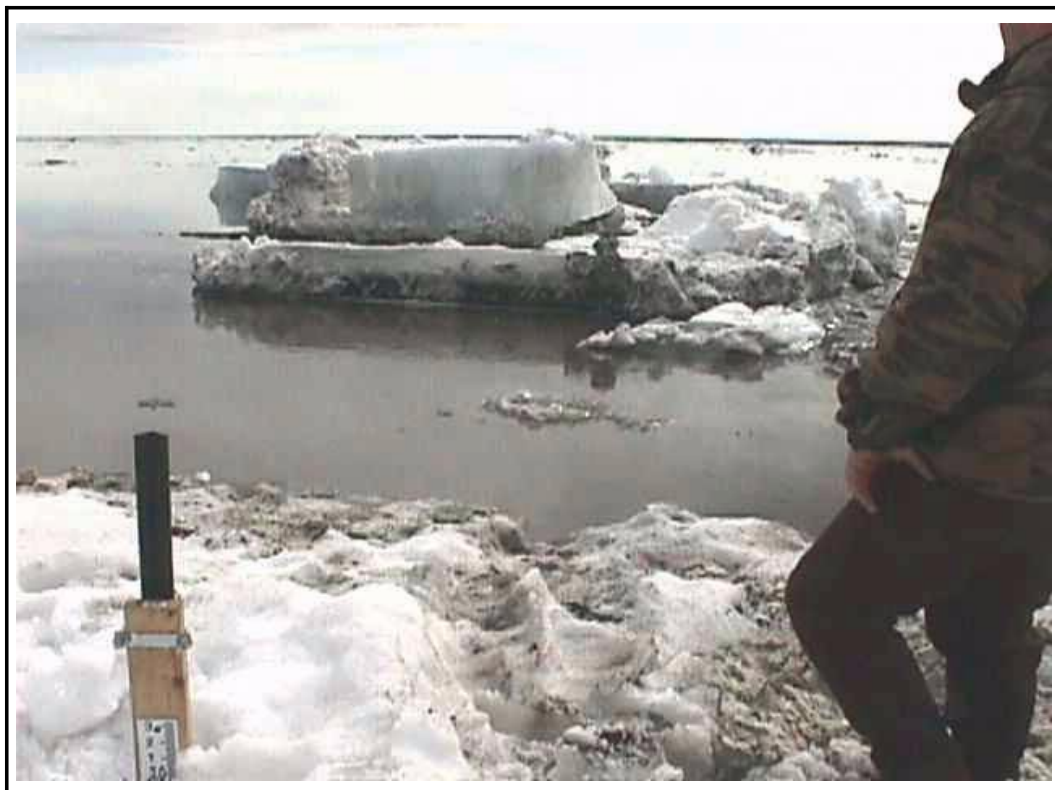
The peak water surface elevation at Monument 01 occurred on the morning of 10 June, at an elevation of 17.37 feet (Photo 2-7). Discharge at the time of the peak water surface elevation was estimated to have been 208,000 cubic feet per second (cfs). At the time of the peak water surface elevation, the low water channel ice on both the East and Nigliq Channels was mostly intact (however floating). In addition, the Sakoonang and other channels in the lower portions of the delta were blocked with snow, or contained intact low water channel ice.

Photo 2-7. Temporary Benchmark 01U, 10 June 2001. Looking east at conditions in the Colville River at Temporary Benchmark 01U approximately 3-4 hours after the peak water surface elevation occurred.

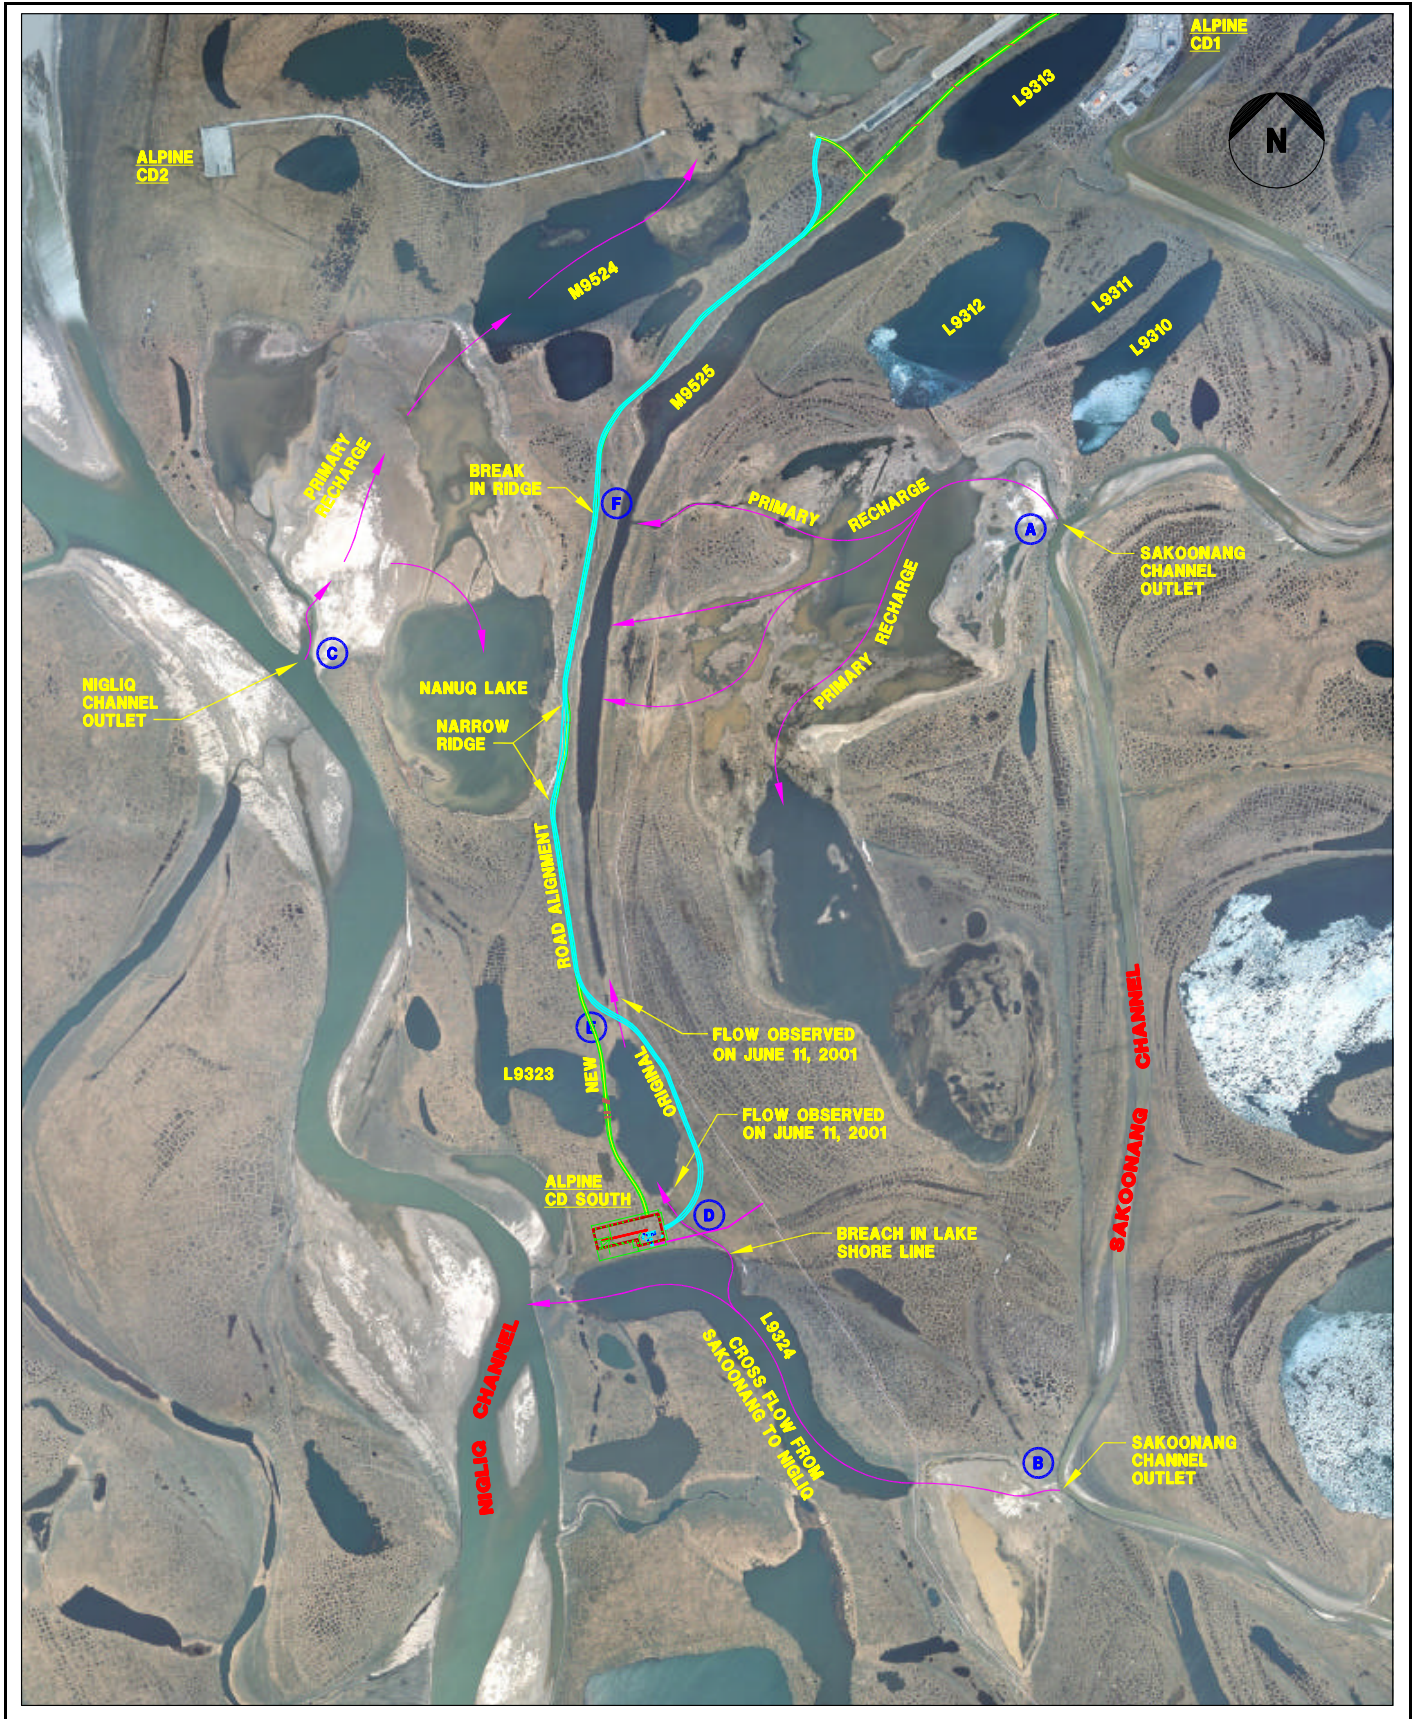
Figure 3-2. CD-South Road Alignment Breakup Flooding 2001

Cross-flow was observed at two locations along the original alignment. On 11 June during aerial reconnaissance, flow across the alignment was observed south of Lake L93-23 in the paleochannel that connects Lake L93-24 to Lake L93-23 (Figure 3-2, Location D and Photos 3-8, 3-9, and 3-10). A breach in the shoreline of Lake L93-24 was allowing water to flow from the lake into the paleochannel. The width of flow was visually estimated to be between 50 and 100 feet wide. Flow was confined to the base of the ridge, which forms the left bank of the paleochannel, and by 12 June had decreased such that, from the air, it no longer appeared to be continuous. During the 18 June alignment investigation, wet tundra and bent grass, as well as a high water mark on the surface ice of Lake L93-23, confirmed that flow in this area had occurred. The width of the flow was estimated at 150 feet based on visual observations of the ground conditions. Silty water on the edge of Lake L93-23 verified that this flow was caused by inundation of water from the Sakoonang Channel.

On 11 June, flow across the original alignment was observed north of Lake L93-23 in the paleochannel that connects Lake L93-23 and Lake M95-25 (Figure 3-2, Location E). The width of flow was visually estimated at 100-200 feet. During the 18 June alignment investigation, flow through the grass was observed at this location; however, depths were very shallow and flow velocity was barely discernible. No cross-flow was observed east of Lake L93-23.

A prominent break in the ridge was noted during both field reconnaissance trips. The approximate location of the break is 2,000 feet north of Nanuq Lake at coordinates N70°19'24.1", W150°59'34.8" (Figure 3-2, Location F and Photo 3-12). The break was estimated to be approximately 145 feet wide, and there was no indication of flow through this break this year.

The area east of the proposed alignment was recharged by two breaches in the Sakoonang Channel. The first breach was located east of Lake M95-25 where the Sakoonang Channel begins a "U" shaped bend (Figure 3-2, location A and Photo 3-7) and appeared to be the primary recharge mechanism to those areas east of the proposed alignment. The second breach was located east of the southernmost portion of Lake L93-24 (Figure 3-2, Location B) at the 90° channel bend. Recharge contributions from this breach were negligible compared to the contributions observed from the breach east of Lake M95-25.

The area west of the proposed alignment was recharged by a breach in the Nigliq Channel. The breach was located west of Nanuq Lake (Figure 3-2, Location C) and was the primary mechanism for recharge to those areas west of the proposed alignment.

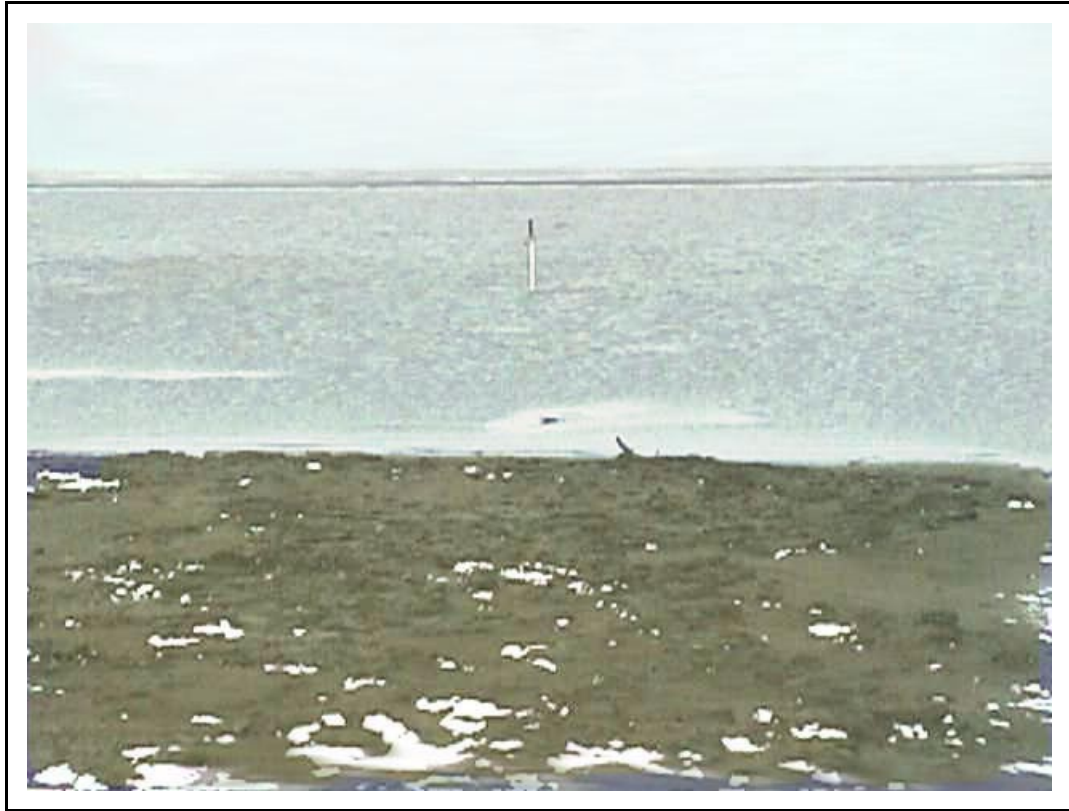
Photo 3-7. Monument 28, 7 June 2001. Looking west across Nigliq Channel.

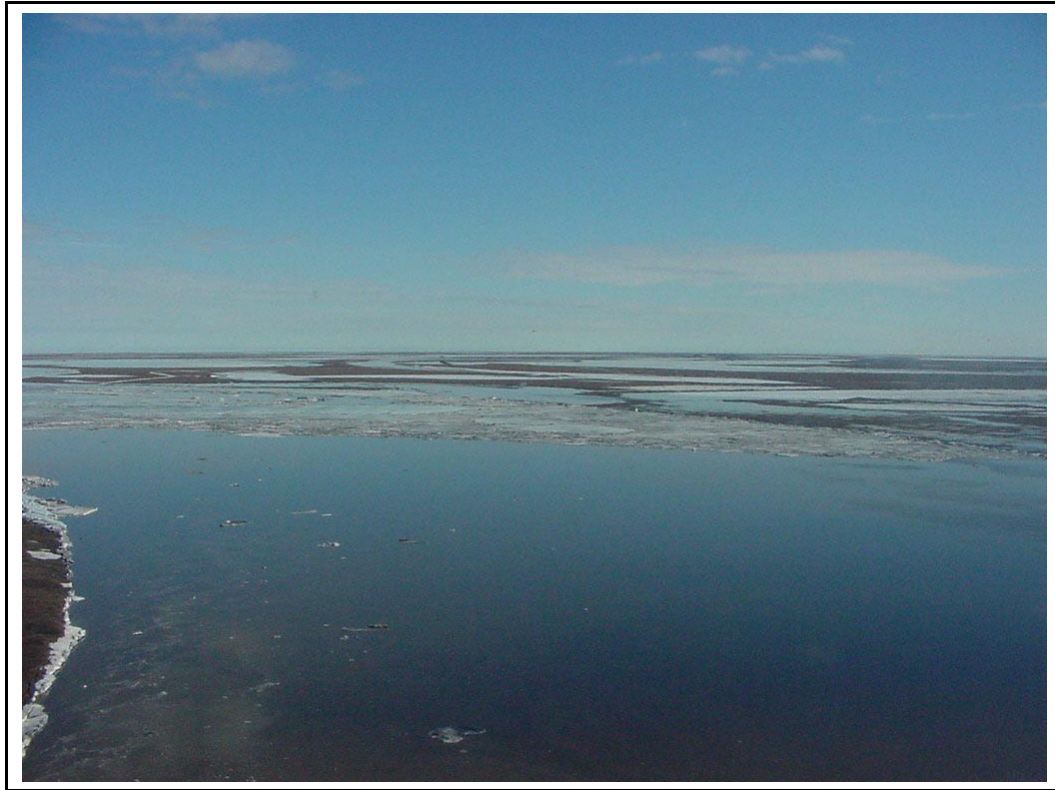
Channel ice in the Nigliq channel adjacent to the proposed CD-South facility remained intact until 8 June. On 9 June, ice chunks began moving through open water areas near the CD-South pad site, and by 10 June, channel ice in this section of river had broken into large floes. On the morning of 11 June, channel ice upstream of TBM 20N had cleared; however, an ice jam had formed adjacent to the proposed pad location, at the bend in the channel just below TBM 20N. The location of this ice jam is one of the areas identified by traditional knowledge (Phillips Alaska, Inc., and Anadarko Petroleum Corp., 2001) as being prone to annual grounded ice jamming. The observed ice jam, however, appeared to be a surface ice jam rather than a grounded ice jam and did not appear to cause significant backwater, blockage, or diversion of flow. Intact channel ice remained downstream of the ice jam, suggesting that the presence of the jam might have slowed the clearing of ice downstream from the proposed facility location.

Photo 3-9. Ice Jam on Nigliq Channel, 11 June 2001. Looking north at the west of the proposed CD-South facility.

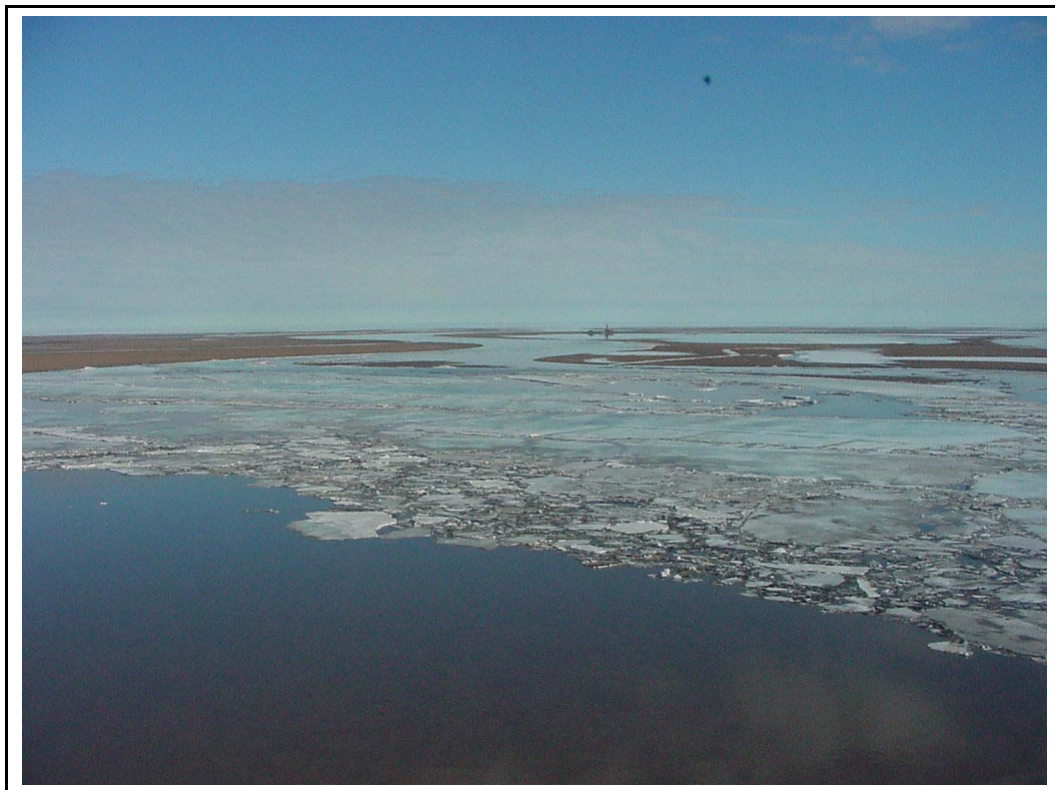
Photo 3-10. Ice Jam on Nigliq Channel, 11 June 2001. Looking northwest just west of the proposed CD-South facility.

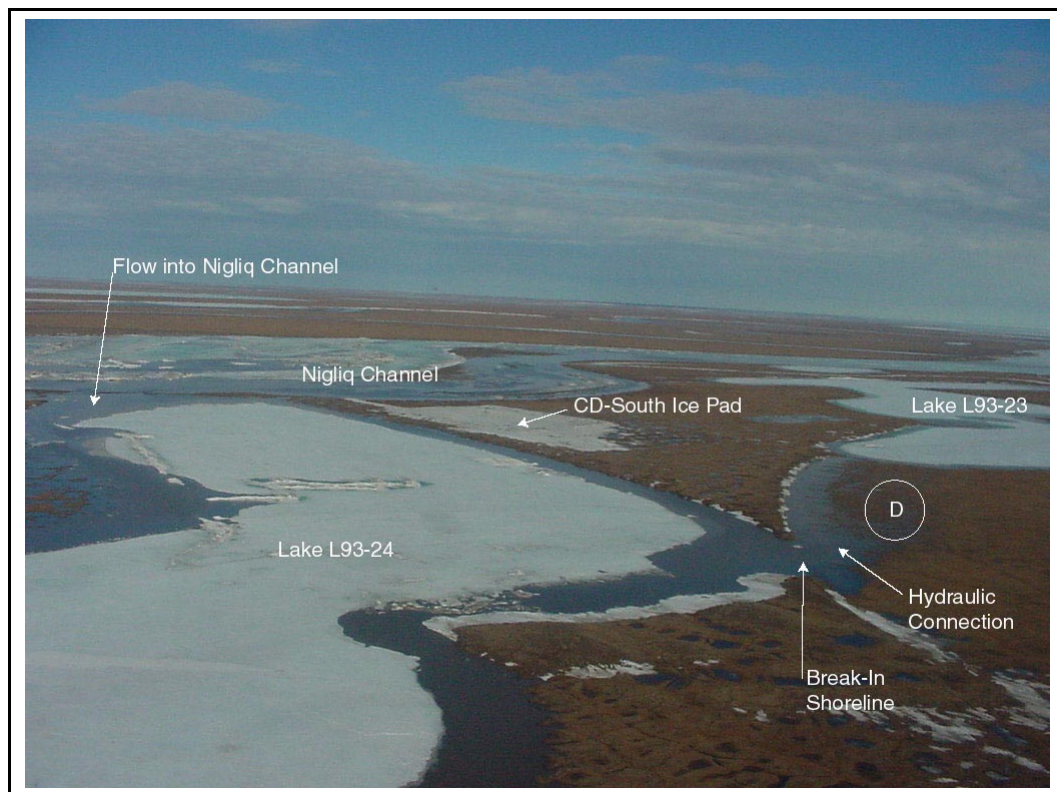
Photo 3-12. Looking West towards CD-South Pad Location, 11 June 2001.

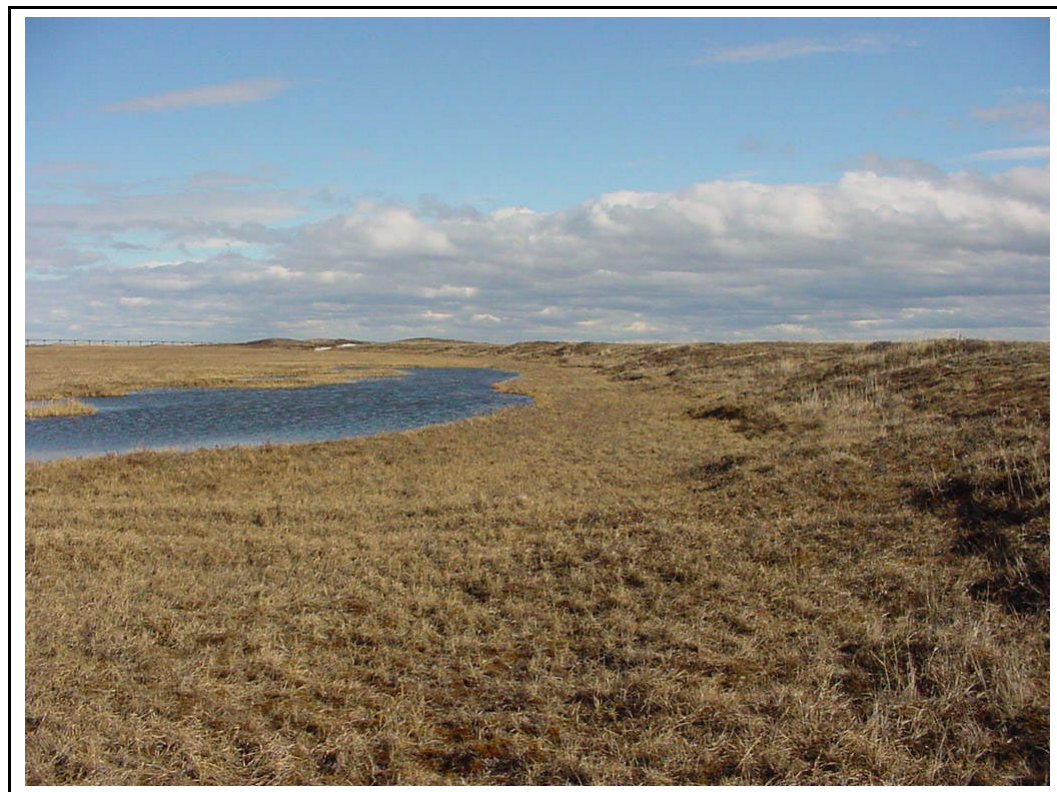
Photo 3-14. Looking South from the South End of Lake L93-23, 18 June 2001. Looking at the paleochannel that connects Lakes L93-23 and L93-24.

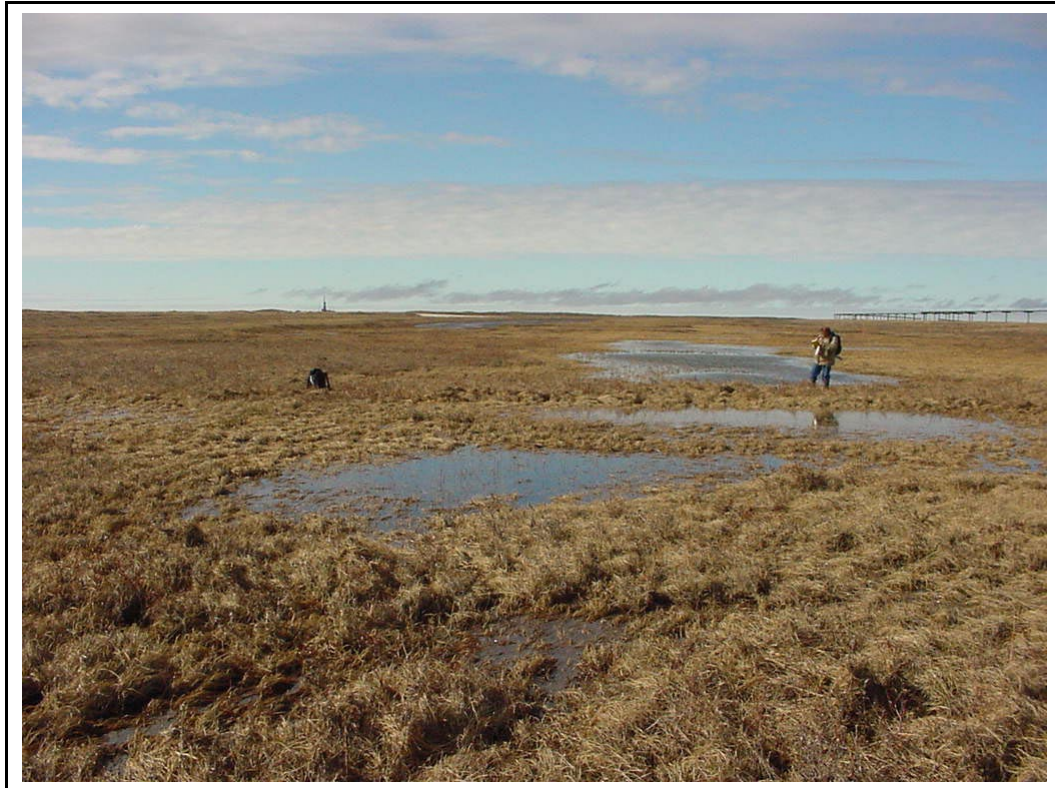
Photo 3-15. Looking North from the North End of Lake L93-23, 18 June 2001. Standing in the paleochannel that connects Lakes L93-23 and M95-25.

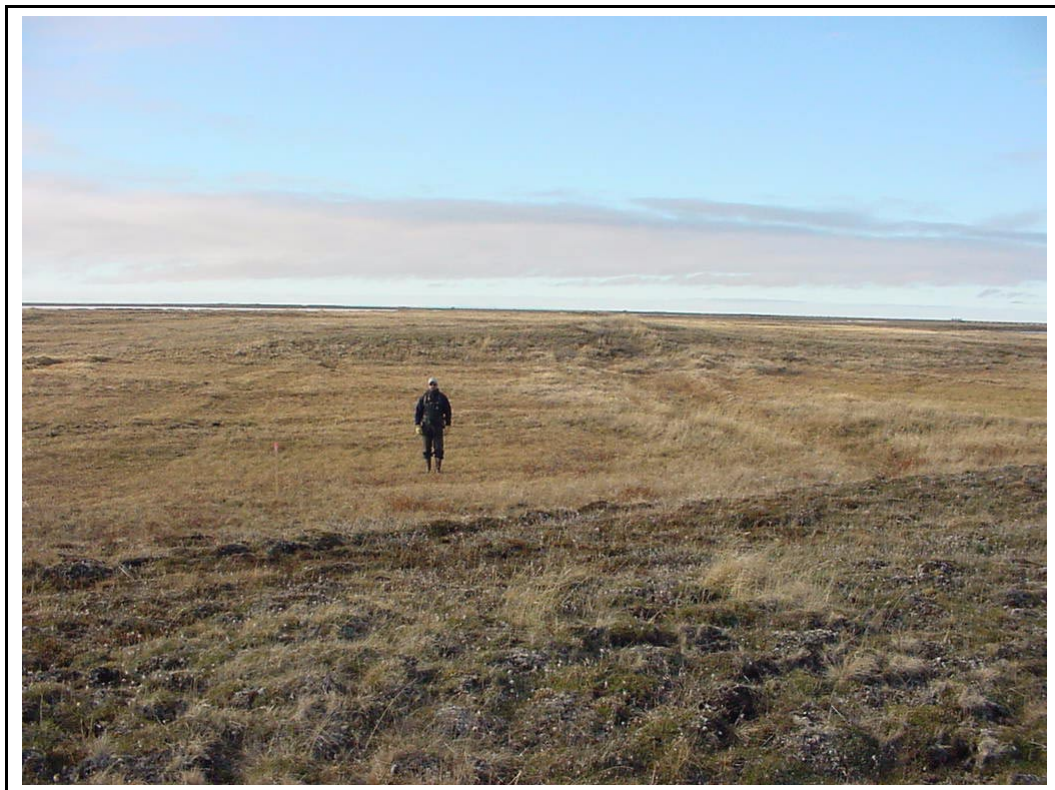
Photo 3-16. Looking North at the Prominent Break in the Ridge. Ridge is located approximately 2,000 feet north of Nanuq Lake.
