CD-South Development Project

**2002 Spring Breakup and Hydrologic
Assessment**

November 2002

25436-MBJ-DOC-002

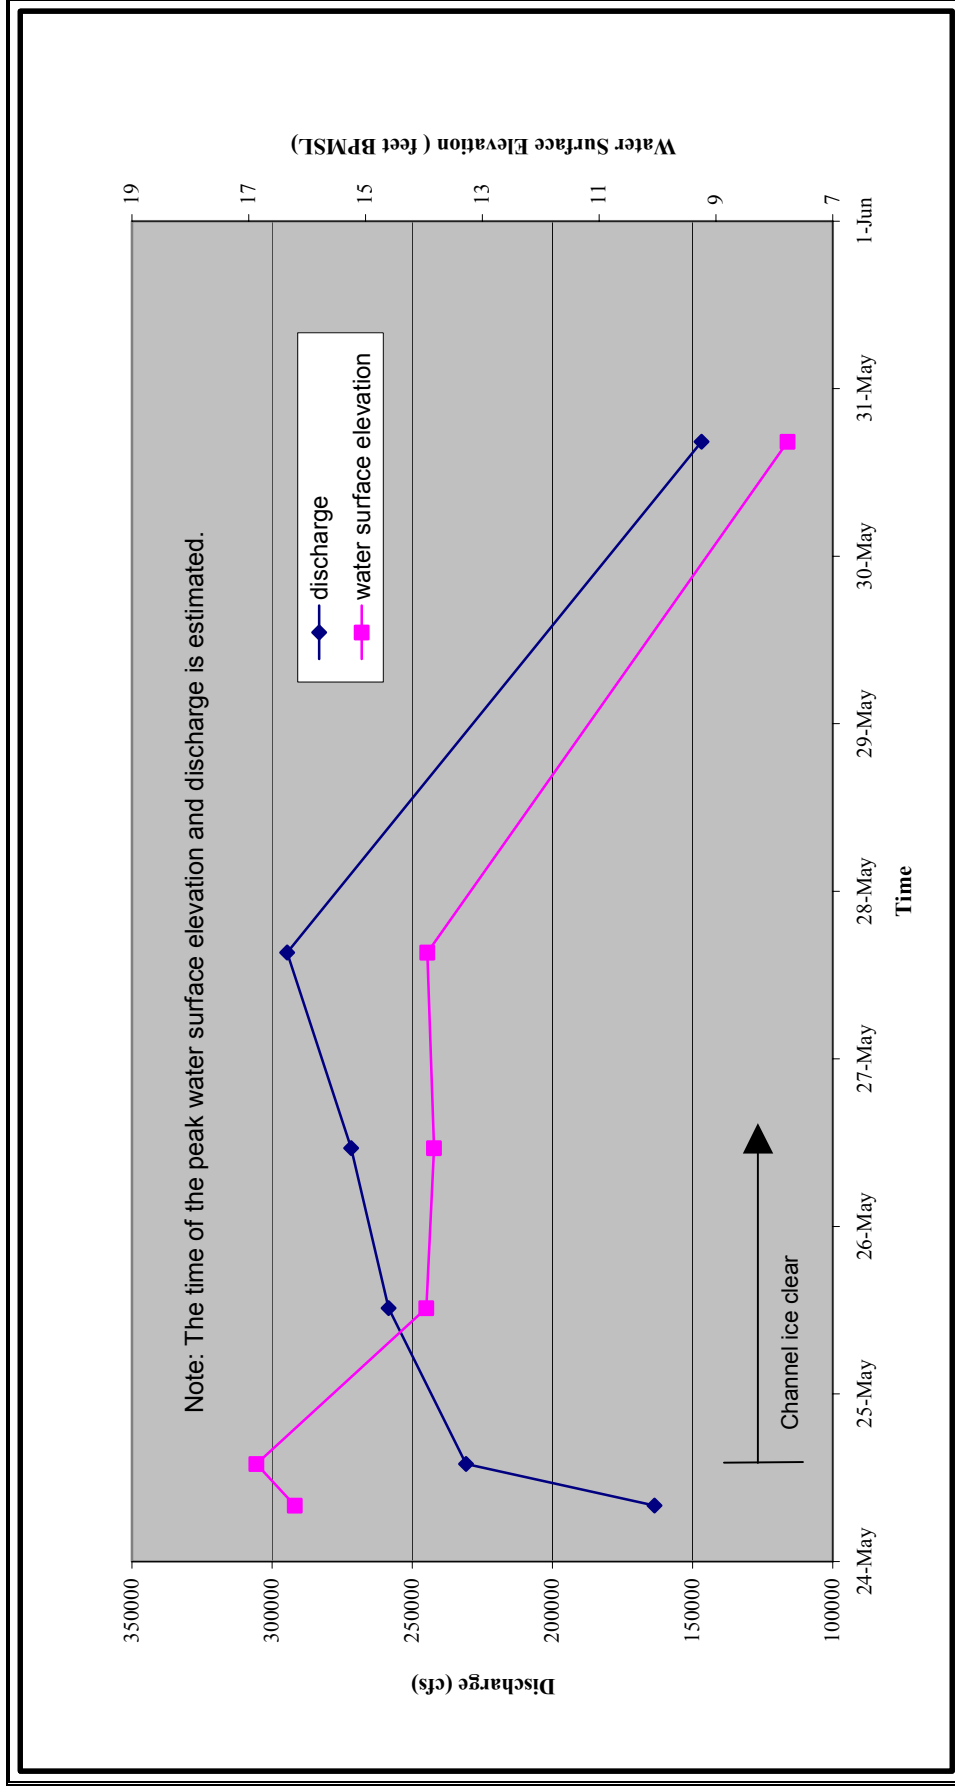
Figure 2-2 Discharge and Water Surface elevation vs. Time at Monument 01

The estimated peak discharge in 2002 is the same as that estimated for 2001. and observations at Monument 01 and other areas of the Delta suggest that the discharges were very similar. Thus, the estimated peak discharge is considered a reasonable approximation based on the available data. A hydrograph of water surface elevation and discharge vs. time is presented on Figure 2-2.

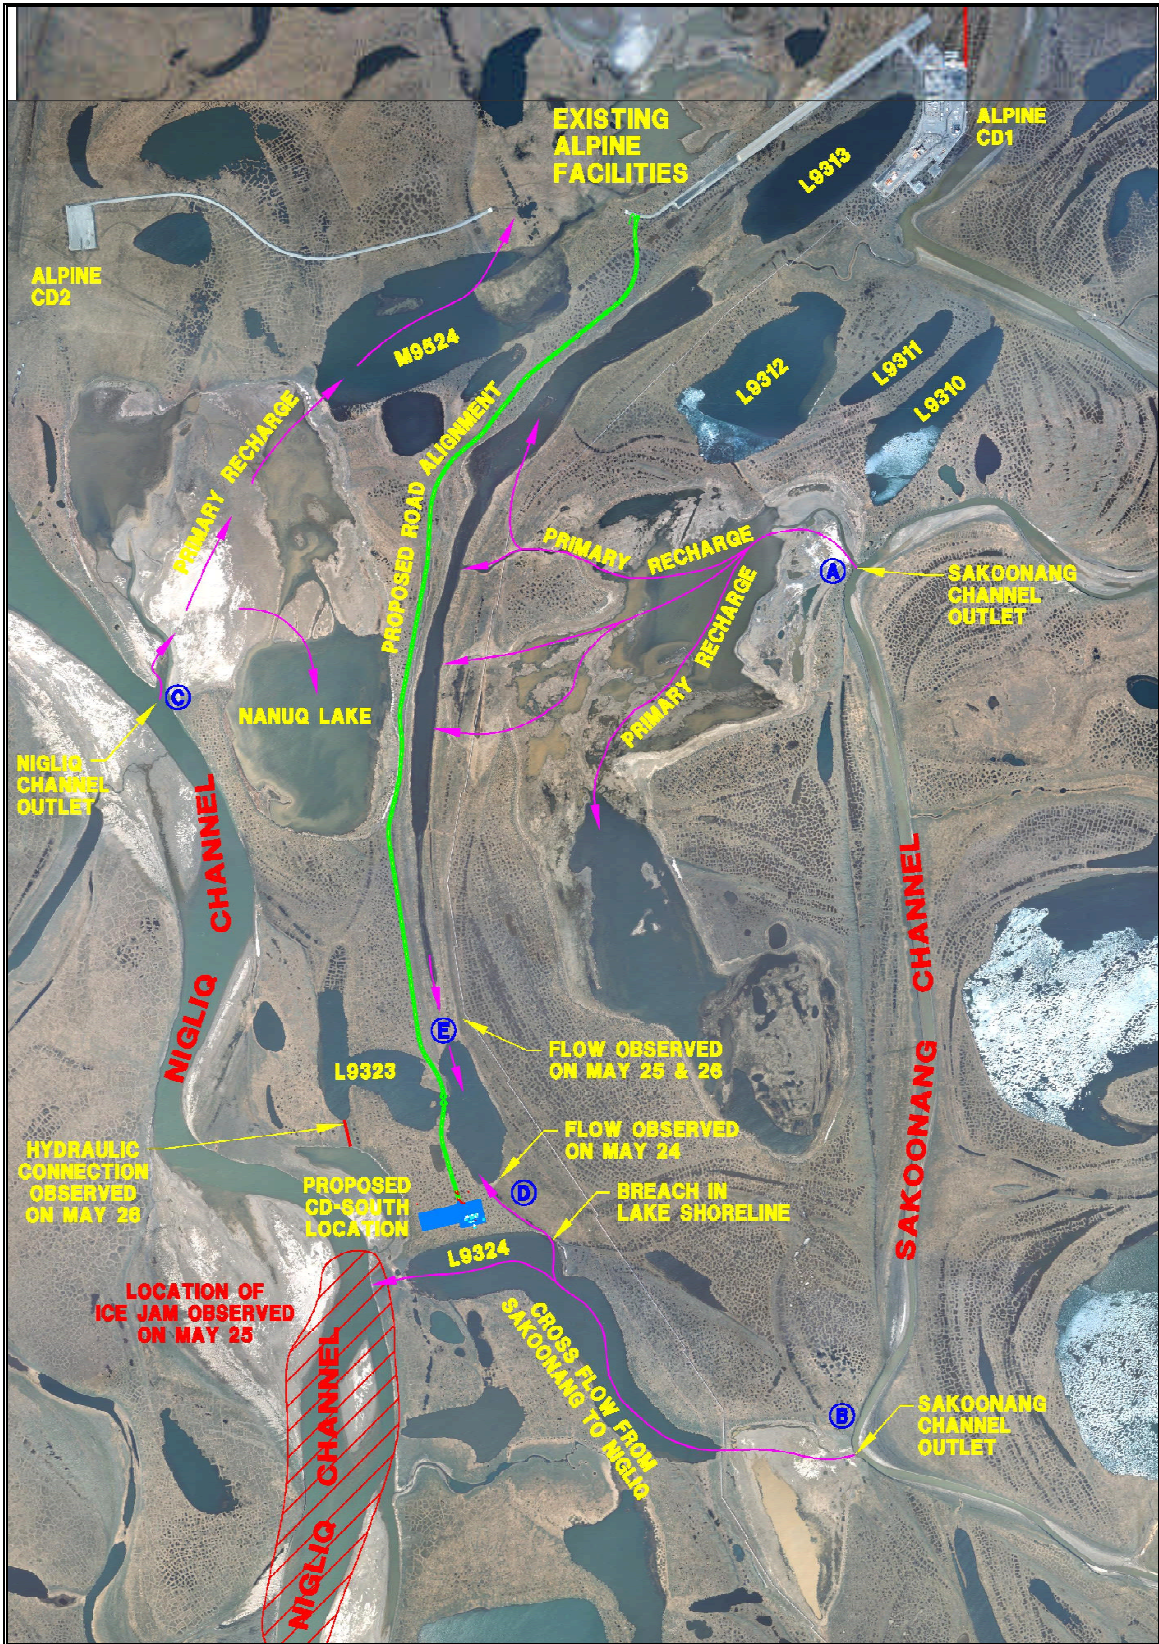
Figure 3-2 CD-South Road Alignment and Breakup Flooding 2002

The second breach is located to the east of the southern-most portion of Lake L9324 (Figure 1, Location B) at the 90° channel bend. Flow was observed through this breach into the adjacent shallow muddy lake, through Lake L9324, and into the Niqliq Channel (Photos 3-6, 3-7, 3-8, 3-9, 3-14, 3-15, and 3-16). Recharge contributions to the floodplains east of the proposed alignment from this second breach were negligible compared to the contributions observed from the breach located east of Lake M9525.

The area of the proposed CD-South drill pad and that portion of the proposed road that lies west of the paleochannel (Figure 3-2, Location D) is relatively high ground that will likely see flow only during large flood events. Local snowmelt was the only source of surface water noted in this area.

On the western edge of the paleochannel (Figure 1, Location D) a hydraulic connection between Lake L9324 and Lake L9323 was observed on 24 May. A similar connection was noted during the 2001 breakup field season. In 2002, flow through the connection was shallow and appeared to be moving from south to north (Photo 3-8). Water was again observed in the connection on 25 May, but the depth of water had decreased and flow was no longer apparent.(Photo 3-10). The proposed road realignment across Lake L9323 does not cross this paleochannel, and this observation is intended only to demonstrate similarities between 2001 and 2002 breakup characteristics in the vicinity of the proposed road.

A hydraulic connection was observed in the low area between Lake M9525 and Lake L9323 on 25 and 26 May (Figure 1, Location E, Photos 3-10 and 3-15). The direction of flow was from north to south and the source of the water was the Sakoonang Channel outlet at Location A. Again, this does not affect the proposed alignment, but is another similarity between 2001 and 2002.

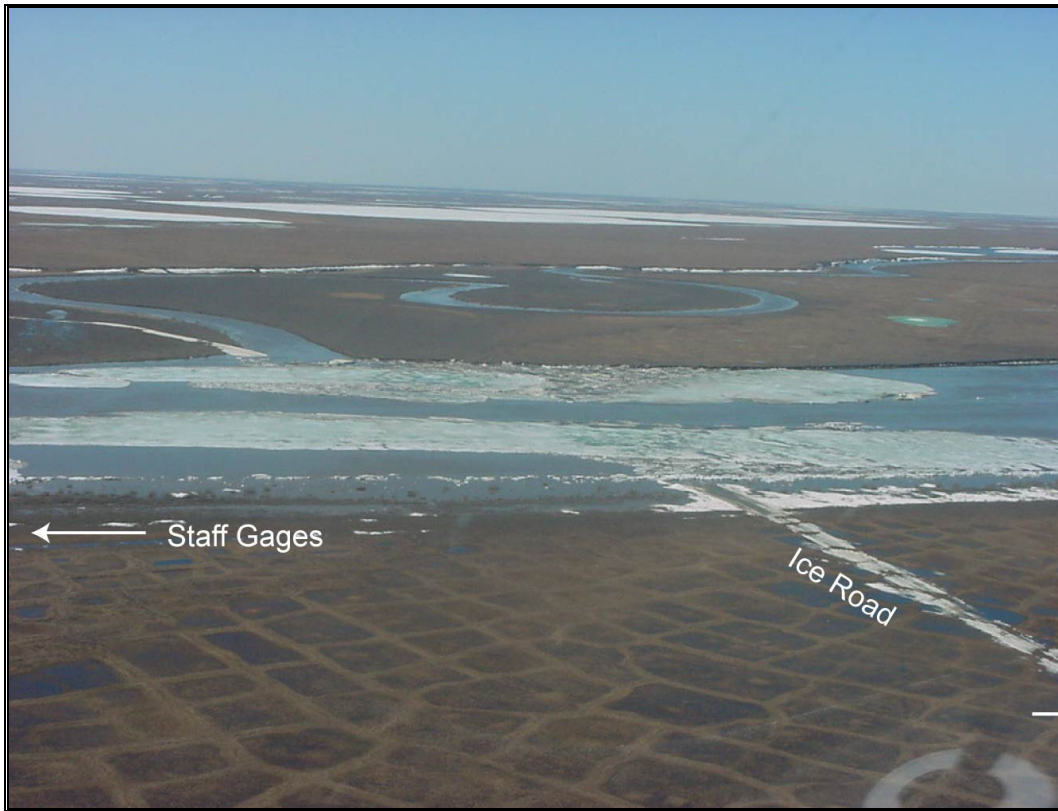
Photo 3-3 Looking west across the Nigliq Channel. Photo was taken just downstream from Monument 12. Note condition of ice road and channel crossing.

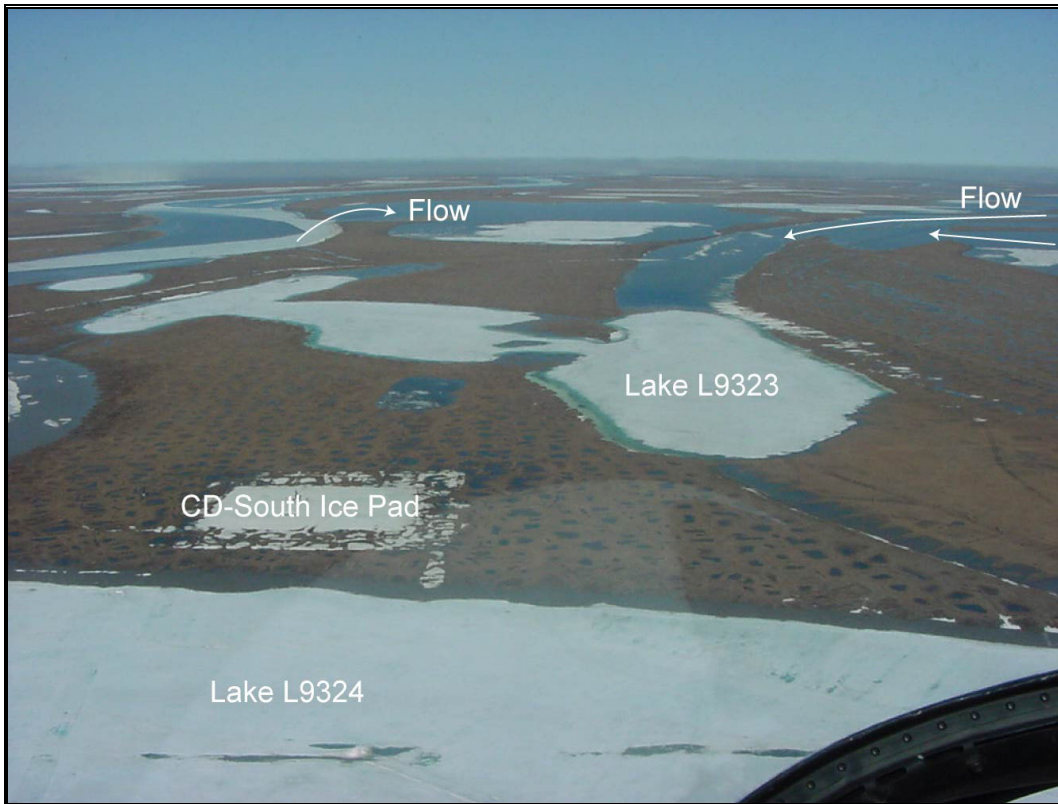
Photo 3-10 Looking north towards the proposed CD-South pad location.

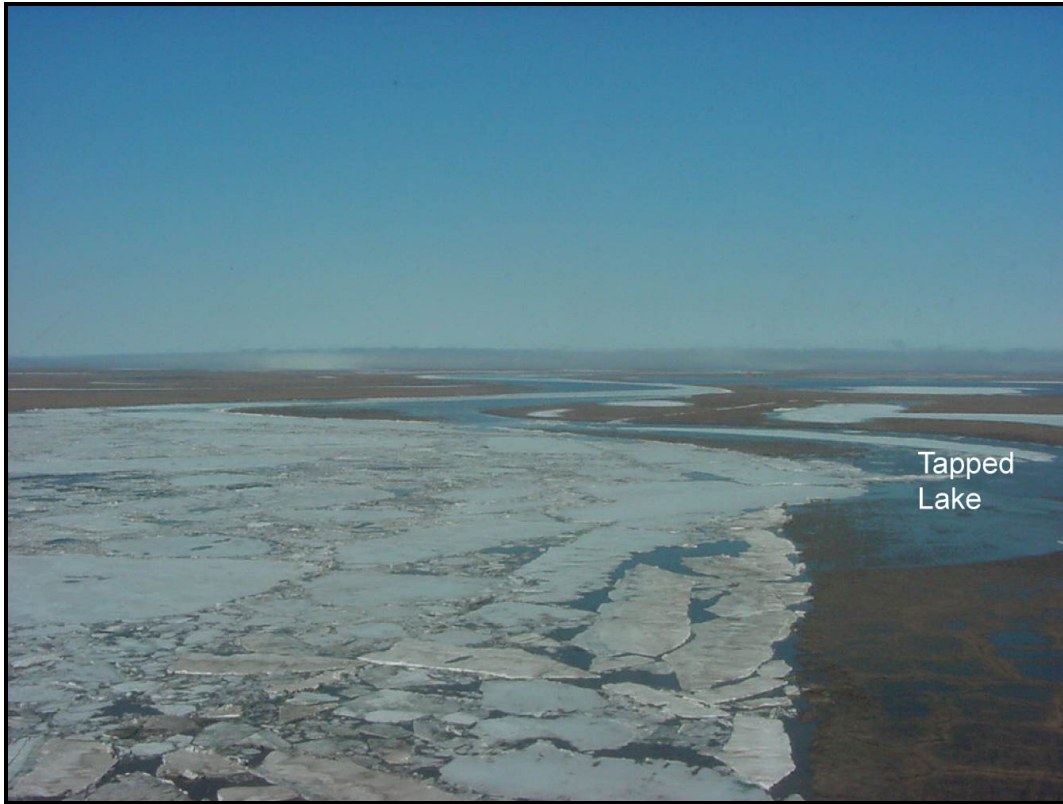
The Nigliq channel adjacent to the proposed CD-South facility was 80% free of ice on 24 May, though numerous large ice floes were noted floating by the gages. The only significant ice jam observed in the vicinity of CD-South was in the Nigliq Channel at the sharp channel bend adjacent to the proposed pad location on 25 May. The ice jam spanned the entire width of the channel and appeared to be a surface ice jam only. Large ice floes (some measuring over 6 feet thick) had been driven onto both banks of the channel, however, backwater effects from this ice jam did not appear significant and no observable effects on water surface elevations up or downstream were noted. See Photos 3-11 to 3-13. On 26 May, grounded ice chunks, up to 50 feet in diameter, deposited by high water were observed on the channel bank adjacent to the proposed facility location.

Photo 3-11 Looking north at an ice jam in the Nigliq Channel bend, directly west of the proposed CD-south pad location.

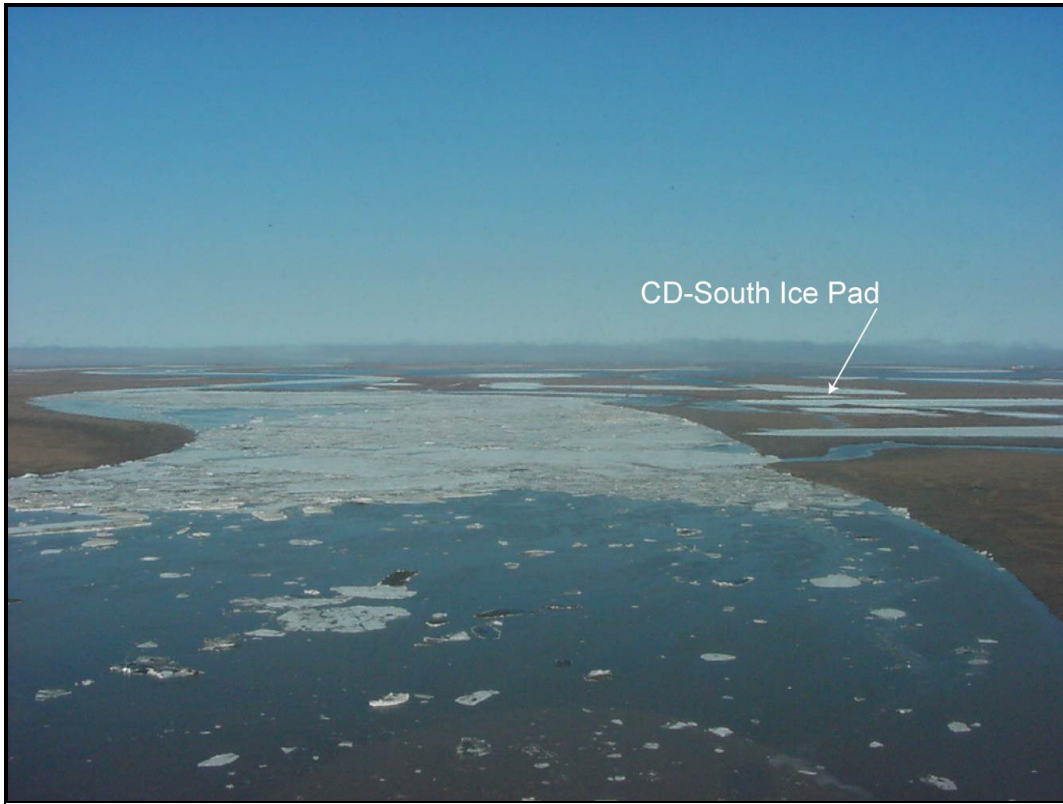
Photo 3-12 Looking north at the ice jam in the Nigliq Channel bend, west of the proposed CD-South pad location.

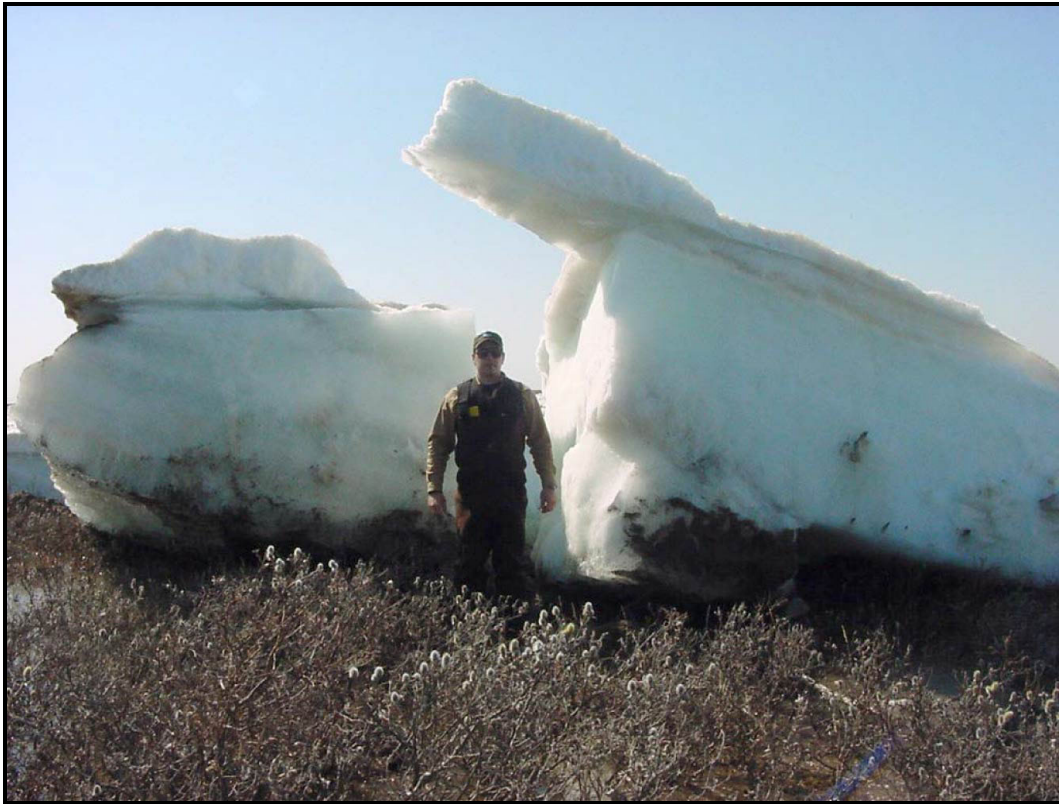
Photo 3-13 Ice floes forced up onto riverbank as a result of the ice jam shown in previous photos.

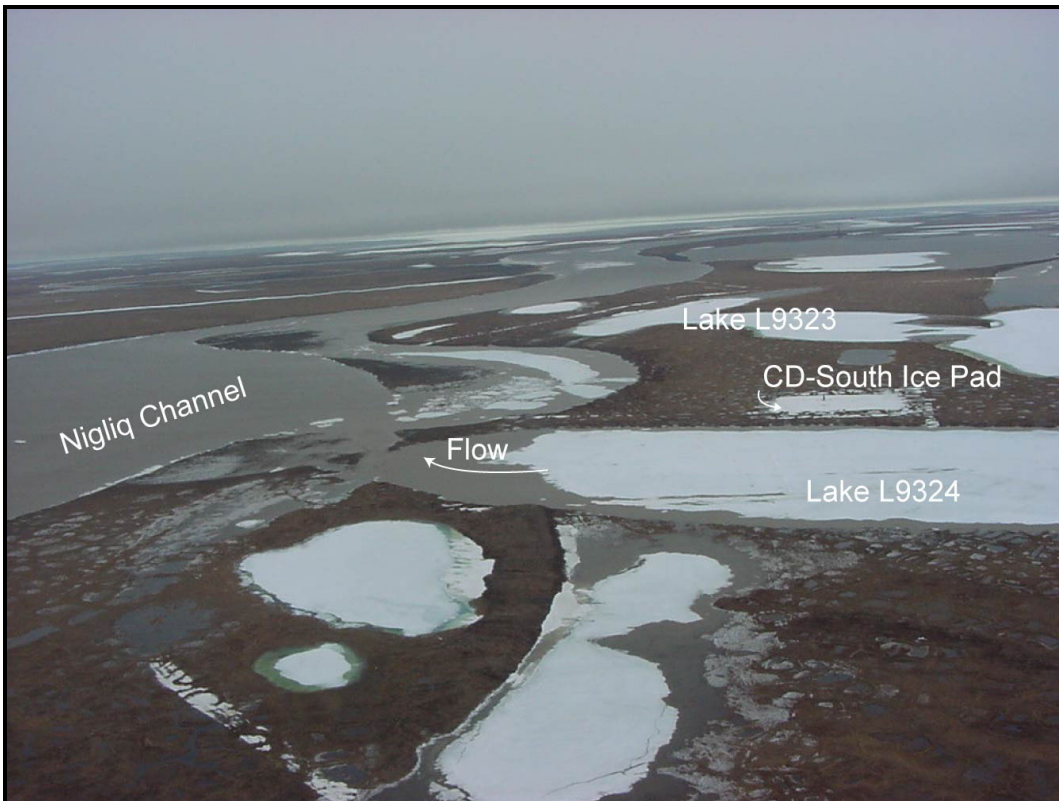
Photo 3-14 Looking north towards the proposed CD-South pad location. Note that the ice jam in the Nigliq Channel has cleared.

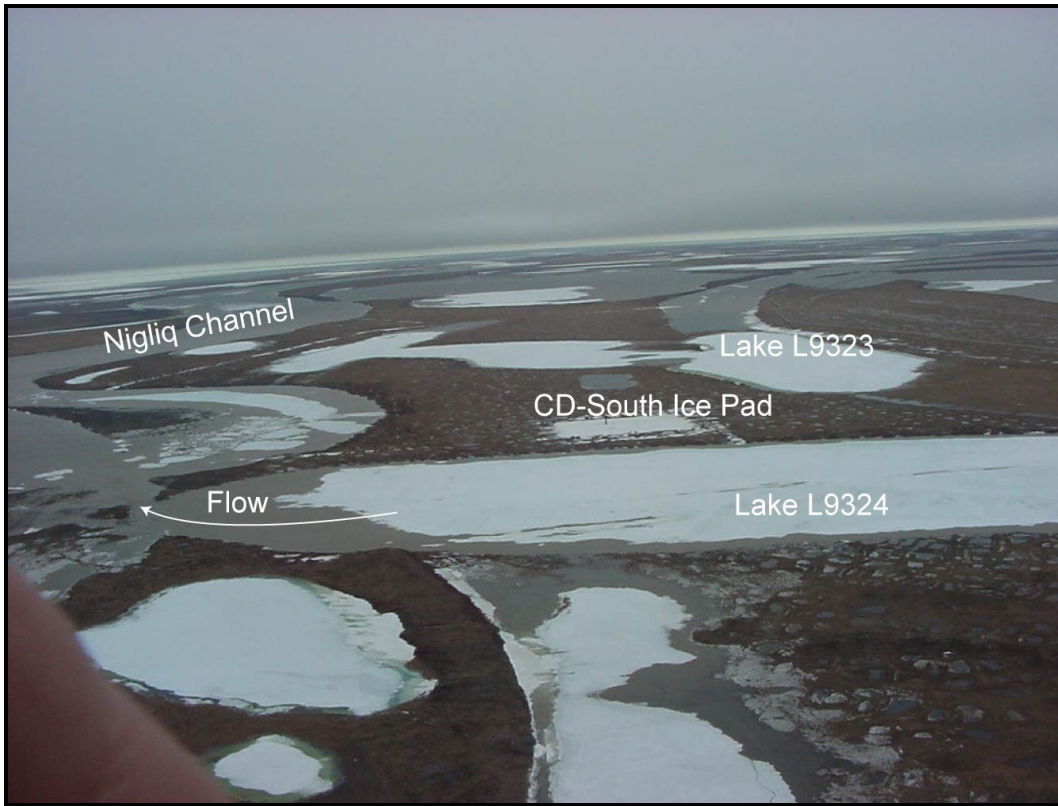
Photo 3-15 Looking north towards the proposed CD-South pad location.

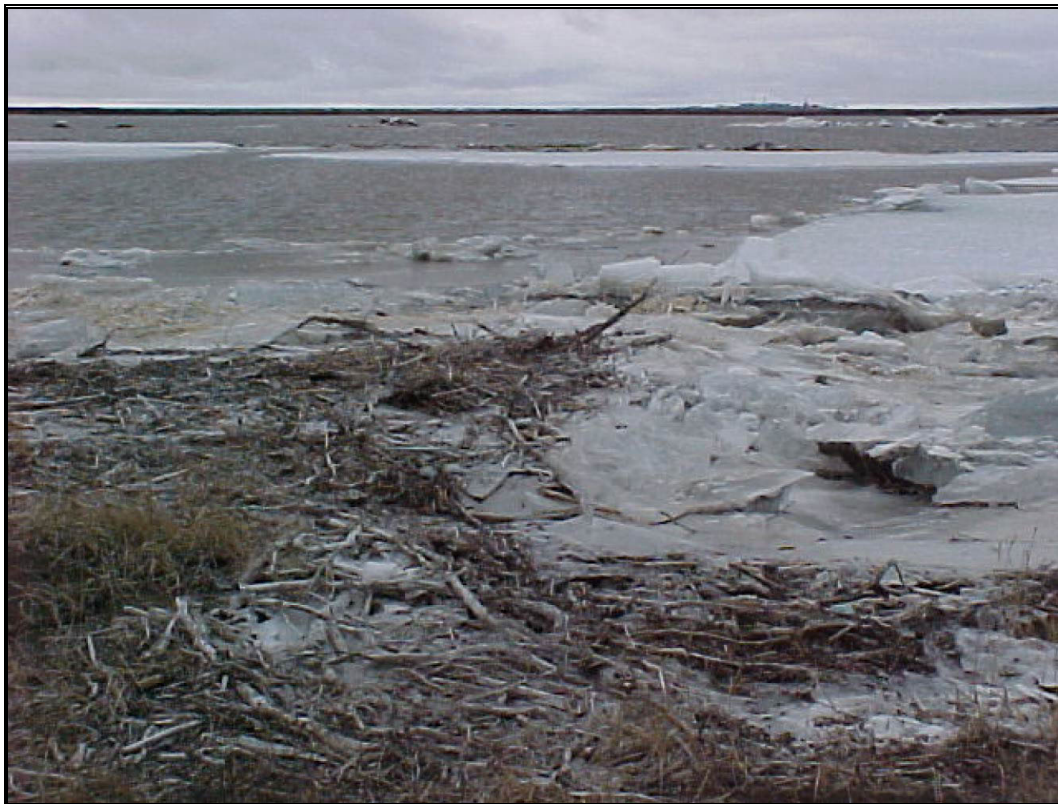
Photo 3-18 Monument 22. Ice grounded at temporary staff gage location. All staff gages have been destroyed by ice.
