COLVILLE RIVER DELTA SPRING BREAKUP 2009 HYDROLOGIC ASSESSMENT

ConocoPhillips Alaska, Inc.

December 2009
117011-MBJ-RPT-001

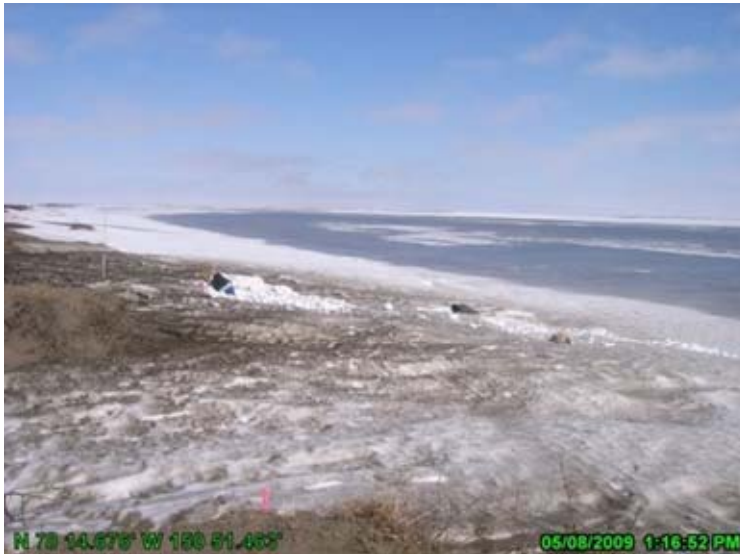
PHOTO 4.1: LOCAL MELT AND MON9. MAY 8, 2009.

As shown in Photo 4.1, localized melting of the Colville River was observed in the vicinity of MON 9 on May 8, likely due to local temperatures above freezing the previous day, as well as the sunshine. Connected open water, however, was not observed at this time. Leading edge did not arrive upstream at MON1 until May 20.

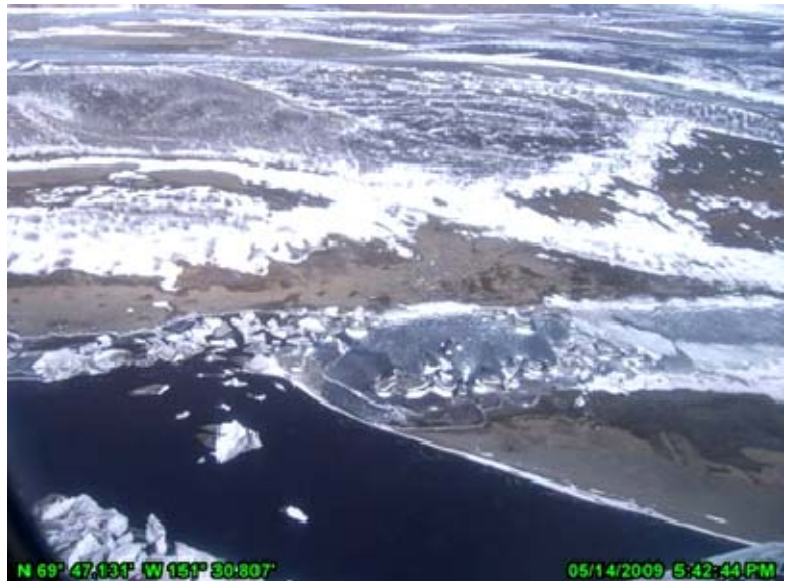
Anaktuvuk River confluence with the Colville River, which is located approximately 65 RM upstream of the head of the Delta (MON1) was conducted on May 14. Evidence of pre-breakup high water was observed; Photo 4.2 shows the presence of abundant grounded ice. Also present were large areas of open water and ice jams, as shown in Photo 4.3.

PHOTO 4.2: GROUNDED ICE IN THE ANAKTUVUK RIVER. MAY 14, 2009.

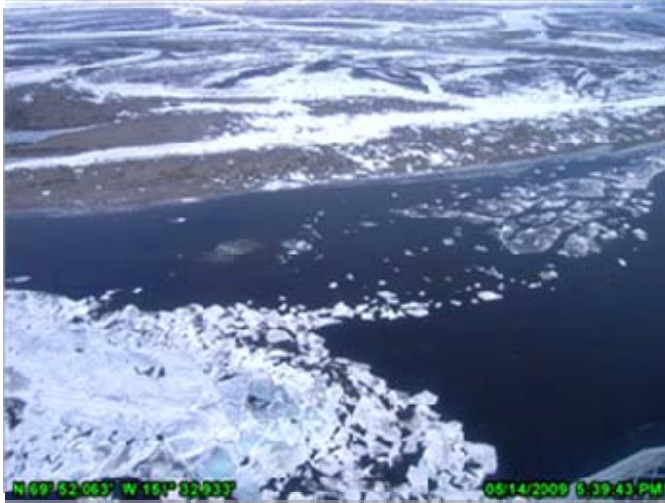
PHOTO 4.3: OPEN WATER AND ICE JAM IN THE ANAKTUVUK RIVER. MAY 14, 2009.

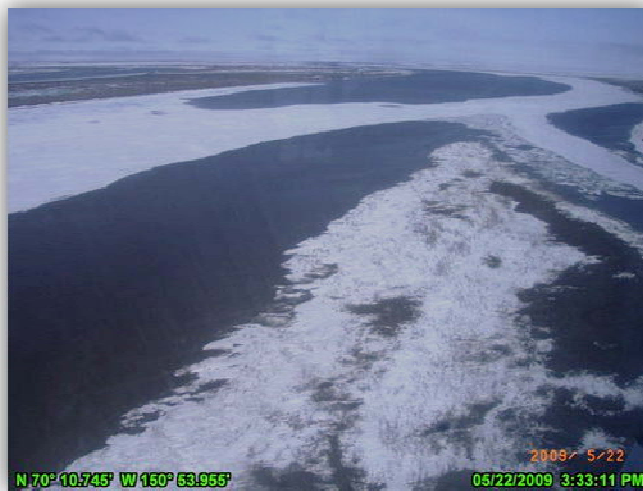
Ribbon ice was still present in the vicinity of MON1 on May 22, as shown in Photo 4.5. Significant ice jamming was also observed on May 22 in the area of the meander bends upstream of the Itkillik River confluence, located approximately 2.5 RM upstream of MON1 (see Photo 4.6). On May 22, ice jamming was also noted at the Anaktuvuk confluence. Breakup ice jams can be unstable events. Upon formation, water begins to back up behind the upstream edge of the ice jam. Upon release, often sudden and unpredictable, the stored water inundates downstream areas.

PHOTO 4.5: OPEN WATER AND RIBBON ICE IN MON1 VICINITY. MAY 22, 2009.

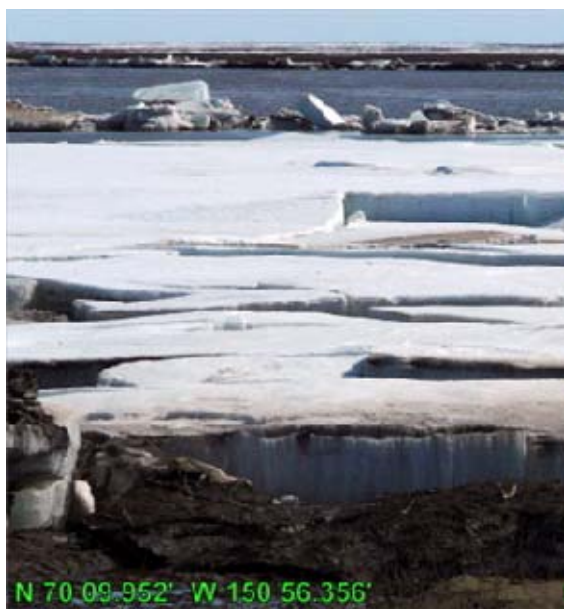
Peak high water at MON9 was also affected by the ice jam release; however little to no effect was seen further downstream at MON35. Ice-grounding began along the western banks of the MON1-MON 9 reach as a result of the ice jam release and subsequent drop in stage. Photo 4.7 shows stranded ice at the Colville River at MON1 gaging station soon after peak stage on May 23.

PHOTO 4.8: GROUNDED ICE, MON1. MAY 25, 2009.

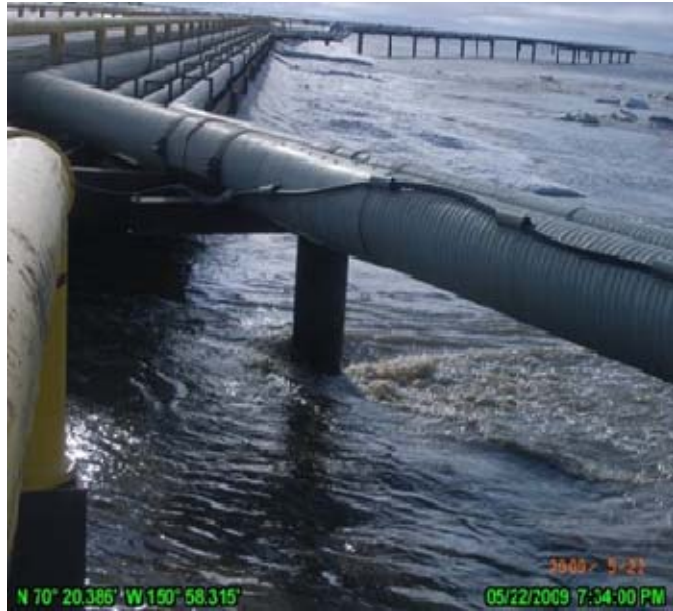
By May 22 significant flow was observed in the Sakoonang Channel at Gage G1, passing south to north under the CD2 access road 62-ft swale bridge and through nearby culverts. Flow was not observed under the 452-ft swale bridge the morning of May 22 due to a large ice and snow dam, as can be seen in Photo 2.5 and Photo 2.6. The dam held until the evening of May 22 (Photo 4.22). Photo 4.23 and Photo 4.24 show flow on the south and north sides of the CD2 access road in the vicinity of the smaller bridge on May 22. Direct discharge measurements were taken on May 26 at the 452-ft swale bridge and at selected culverts.

PHOTO 4.22: FAILURE OF ICE DAM UNDER THE 452-FT SWALE BRIDGE. MAY 22, 2009.

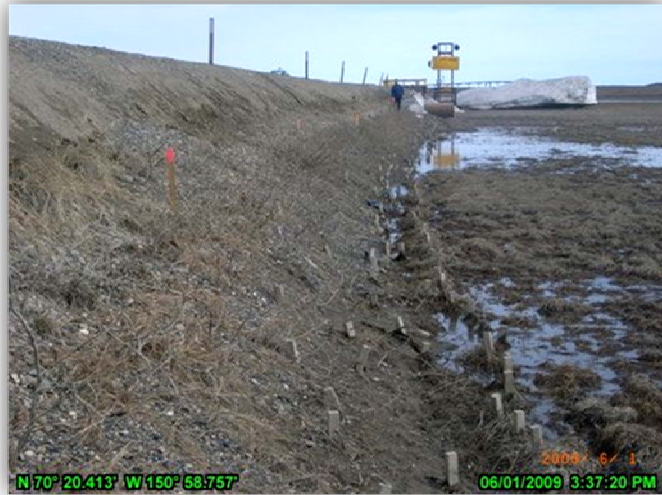
High water marks along the CD2 Access Road were identified by debris stranded on the gravel side slopes or by noting where silts and fine-grained sands were washed from the road prism. Orange-topped lath in the photos were placed to better show the location and elevation of high water. All lath placed to indicate erosion limits was removed after photos were taken. No indications of significant erosion due to breakup floodwater were observed anywhere on the Alpine gravel facilities.

PHOTO 4.26: SOUTH SIDE OF CD2 ROAD BETWEEN THE SWALE BRIDGES. JUNE 1, 2009.

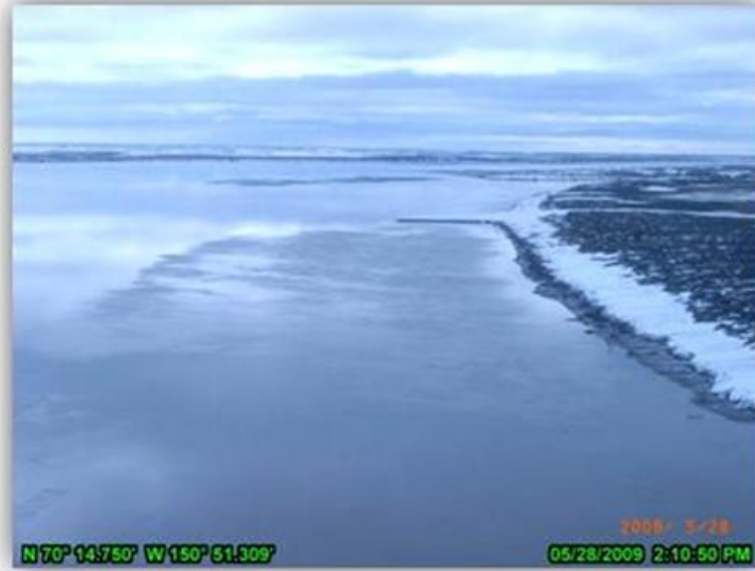
Photo 4.32 and Photo 4.33 show conditions at the Colville East Channel ice bridge crossing on May 18. Photo 4.34 shows the remnants of the western ramp on May 28.

**PHOTO 4.34: REMNANTS OF COLVILLE ICE BRIDGE, WEST BANK.
MAY 28, 2009.**

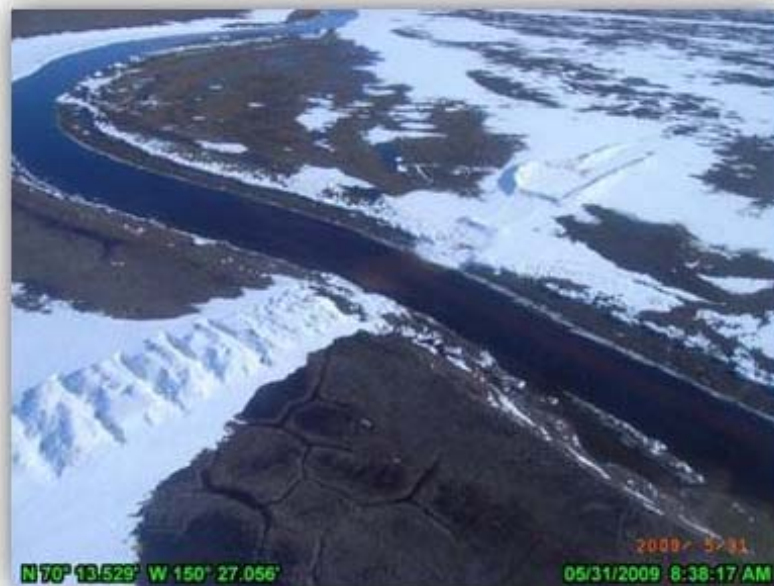
An aerial reconnaissance to the Kachemach River ice bridge crossing location was performed on May 31. Breakup processes were progressing smoothly. Melting conditions of the ice bridge at the Kachemach crossing are shown in Photo 4.35. No evidence of scour or erosion was observed at the Kachemach River during or after breakup.

PHOTO 4.35: REMNANTS OF KACHEMACH ICE BRIDGE. MAY 31, 2009.
