2020 Willow Spring Breakup and Summer Monitoring & Hydrological Assessment - Final

Michael Baker International
3900 C Street Suite 900
Anchorage, AK 99503

ConocoPhillips
Alaska

178179-MBI-HH-RPT-001

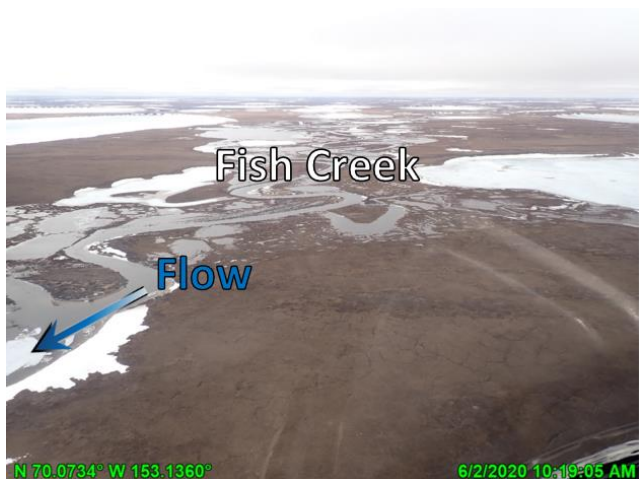
Photo 4.6: Minor overbank flooding near the headwaters of Fish Creek, looking west (upstream); June 2, 2020

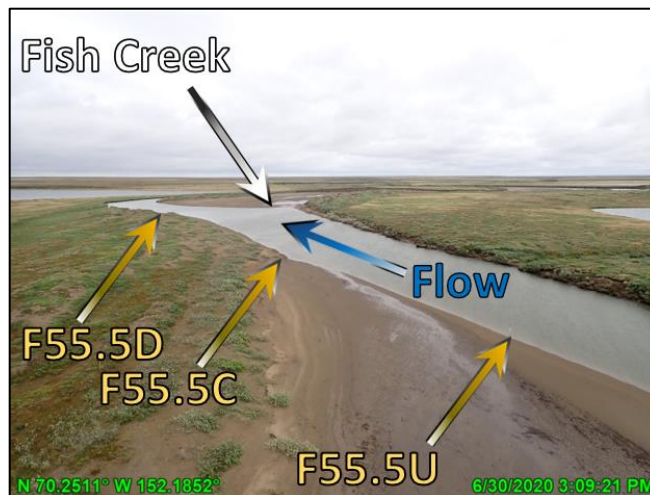
Summer stage was measured at F55.5D, just downstream of the proposed crossing location. Stage fluctuations associated with precipitation were recorded throughout the summer; water levels remained below peak spring stage levels (Photo 4.9). Summer stage at Fish Creek at F55.5 is presented in Graph 4.2.

Photo 4.9: Low-flow summer conditions at F55.5, looking northeast (downstream); June 30, 2020

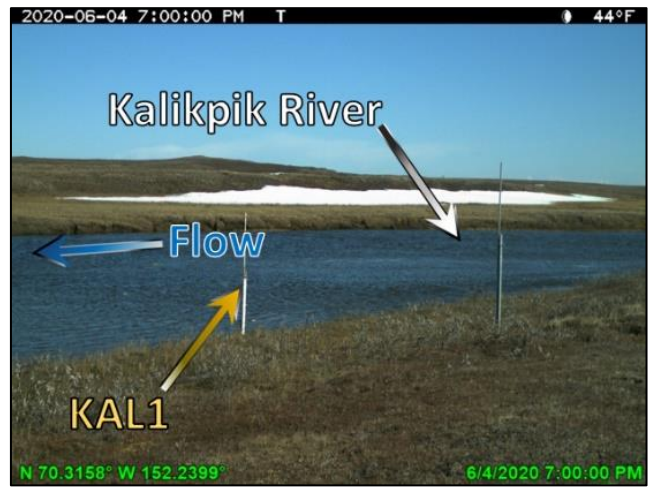
Photo 4.22: First sight of open water conditions at KAL1, approximately 3 days after peak; June 4, 2020

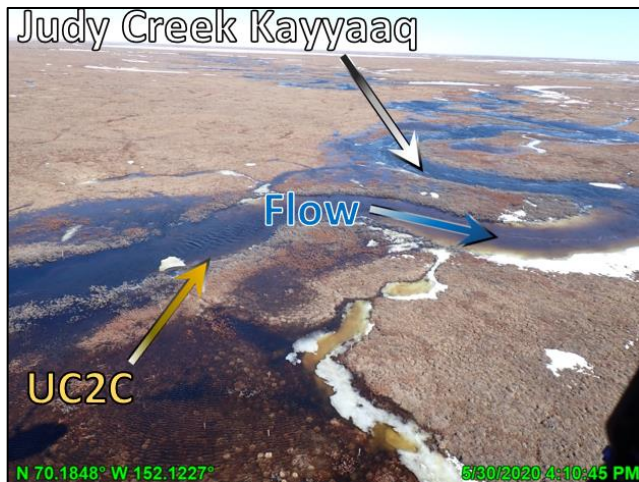
Meltwater was first recorded at Judy Creek Kayyaaq at the UC2C gage on May 28. Stage rose steadily over the next day. On the evening of May 29, a sharp stage increase of 3.8 ft was recorded between 8 and 10 PM. Stage remained elevated through June 1 and reached peak on May 30. Aerial observations at peak stage on May 30 showed stage above bankfull (Photo 4.23). Overbank flooding was observed in low-lying areas near UC2C. Overbank floodwater filled tundra depressions and low lying area along the south bank at the crossing alignment. Minimal ice or saturated snow remained in the channel and along the banks during peak stage. Aerial observations from May 31 show stage had receded to back to bankfull levels (Photo 4.24). Stagnant pools of floodwater remained in low-lying areas near the banks at UC2C. Stage began to steadily decline on the morning of June 1 (Photo 4.25). Stage continued to recede through the rest of the spring monitoring period.

Photo 4.23: Stage above bankfull in Judy Creek Kayyaaq at UC2C, looking east (downstream); May 30, 2020

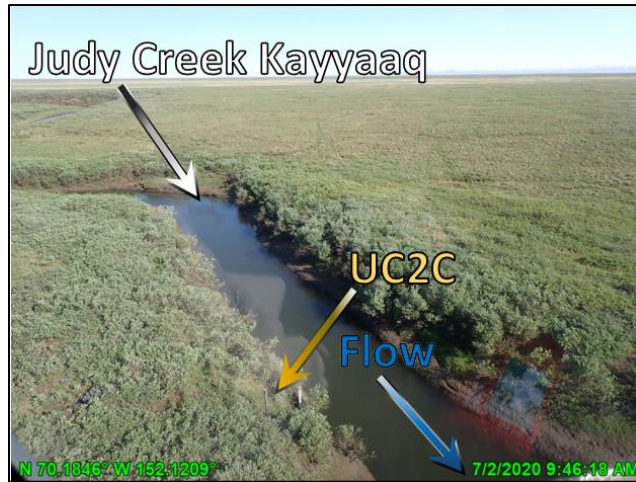
Small stage fluctuations associated with summer precipitation were recorded in the PT data; water levels remained below spring breakup peak stage (Photo 4.28). Summer stage in Judy Creek Kayyaaq at UC2C is presented in Graph 4.8.

Photo 4.28: Summer conditions at UC2C, looking northwest (upstream); July 2, 2020

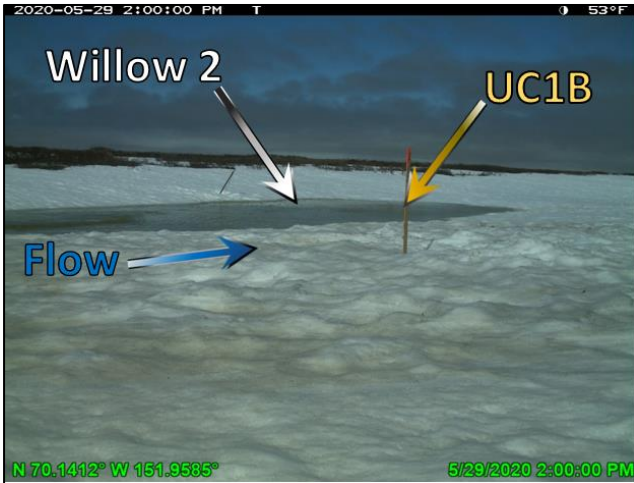
Willow 2 was filled with wind-driven snow at the onset of spring breakup. The leading edge of floodwater was observed through game camera images on May 29 as flow overtop of saturated snow (Photo 4.34). Peak stage quickly followed on May 29 as stage was elevated by saturated snow in the channel and along the banks. Stage remained elevated through May 30. Aerial observations from May 30 show stage below bankfull, and beginning to cut through the saturated snow pack. Snow cover on surrounding tundra was approximately 10% near the Willow 2 drainage (Photo 4.35). Stage began to steadily decline on May 31 as flow continued to cut through the snow pack. Aerial observations from May 31 show saturated snow remaining in the channel and on the banks near UC1B. No stranded ice or other evidence of overbank flooding was observed (Photo 4.36). Meltwater continued to cut through the snowpack in the channel through June 2 (Photo 4.37 and Photo 4.38). Stage receded through the rest of the spring monitoring period.

Photo 4.34: Leading edge of floodwater in Willow 2 at UC1B, looking north (downstream); May 29, 2020

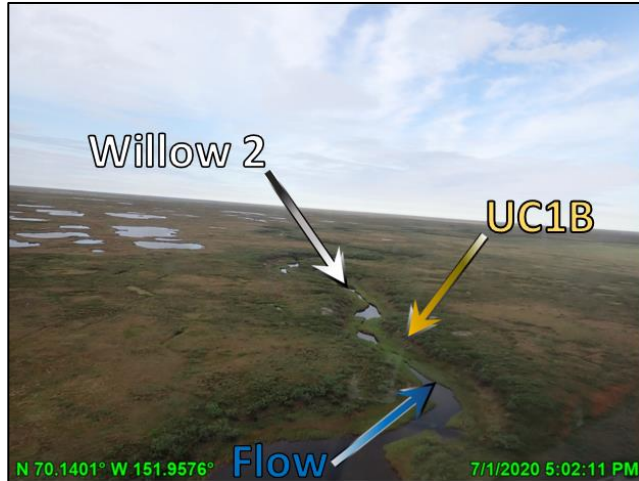
Summer stage was measured at UC1B. Stage fluctuations associated with summer precipitation events were recorded in the PT data; water levels remained below spring breakup peak stage at all locations (Photo 4.39). Summer stage in Willow 2 at UC1B is presented in Graph 4.12.

Photo 4.39: Summer conditions at UC1B, looking north (downstream); July 1, 2020

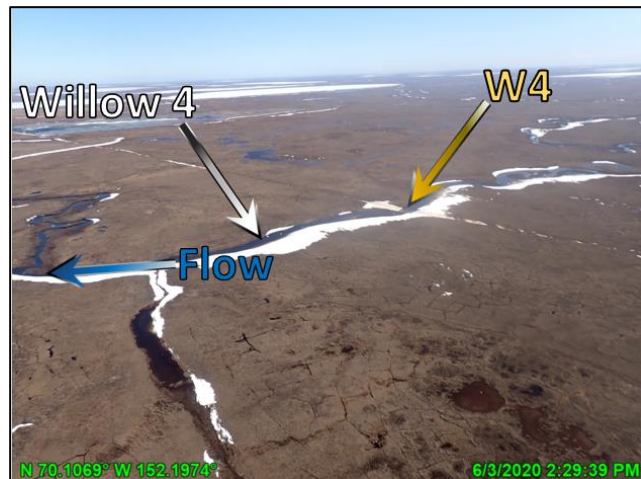
Photo 4.50: Conditions near W4 four days after peak stage, looking southeast (upstream); June 3, 2020

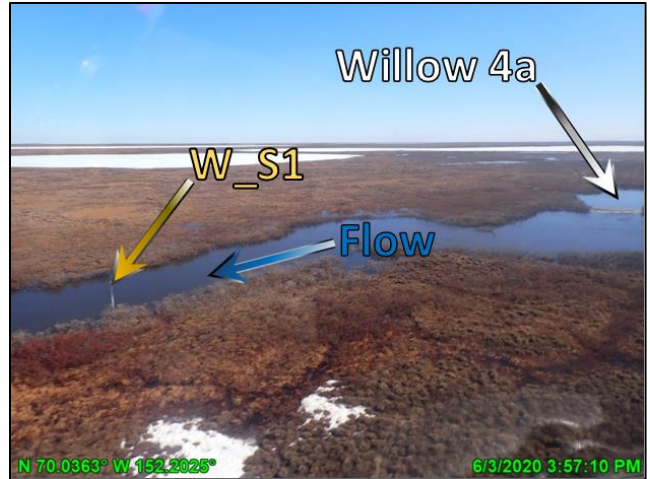
Photo 4.56: Ice free conditions in the W_S1 reach on the day of the discharge measurement, looking south (upstream); June 3, 2020

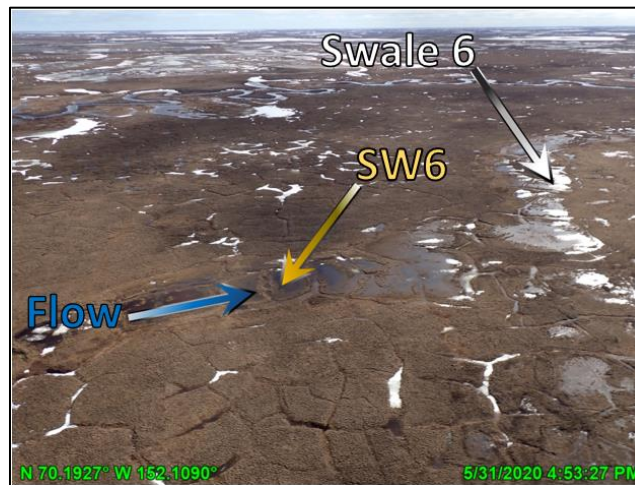
Swale 6 is a swale consisting of low-centered polygons connecting a series of paleolakes to Judy Creek Kayyaaq. Aerial imagery reveals two possible outlets for meltwater from this system. The first outlet is a beaded swale running south through the south end of the southern-most paleolake and into Judy Creek Kayyaaq, upstream of the UC2C gage station. The second outlet is a swale depression running east through the eastern end of the same paleolake and into Judy Creek Kayyaaq, downstream of the UC2C gage station. The SW6 monitoring station is situated in the eastern swale depression at its apparent outlet from the paleolake. 2019 was the first year of monitoring at the SW6 gage station. Limitations due to COVID-19 prevented the MBI field teams from reaching SW6 for set up and monitoring during the 2020 monitoring season. Aerial observation of the site on May 31 shows the low centered polygons with standing water and limited connectivity between (Photo 4.78).

Photo 4.78: SW6 drainage near peak conditions, looking northwest (downstream); May 31, 2020

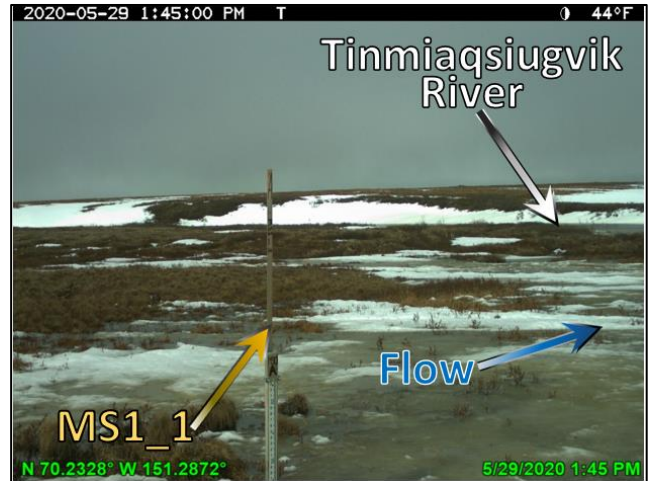
Photo 4.91: Game camera image of MS1_1 at peak conditions, meltwater over saturated snow and bottomfast ice, May 29, 2020

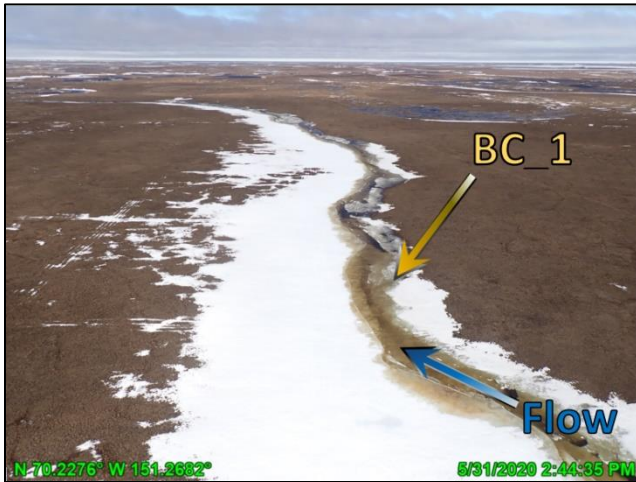
Photo 4.93: Meltwater flowing over saturated snow near BC1, looking north (downstream); May 31, 2020

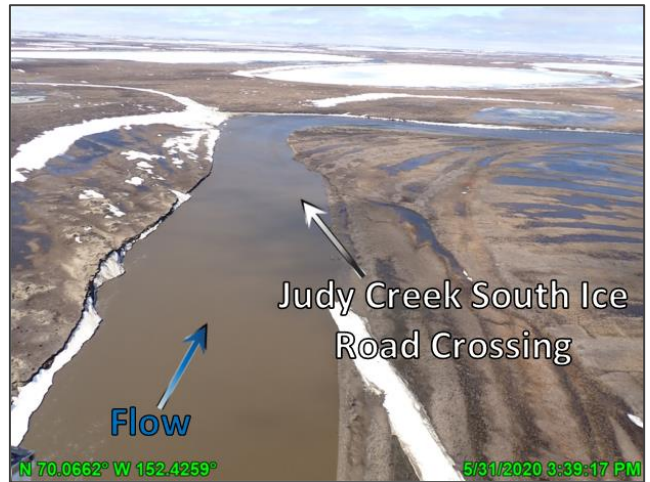
Photo D.4: Peak stage at the Judy Creek South ice road crossing, looking west (downstream); May 31, 2020

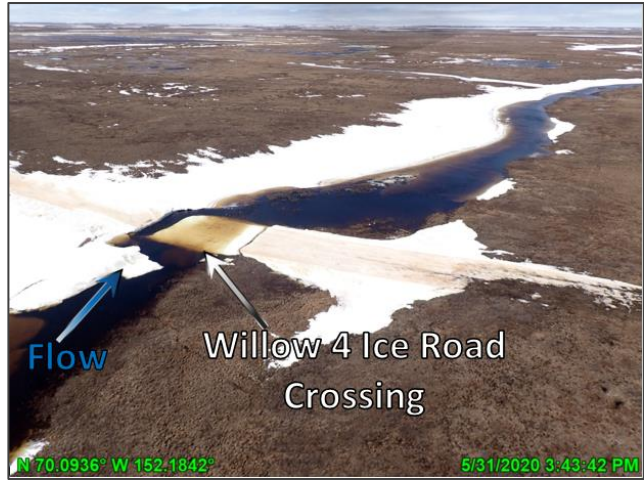
Photo D.10: Peak stage at the Willow 4 ice road crossing, looking north (downstream); May 31, 2020
