Project Note:

2007 Lake L9323 Monitoring and Analysis

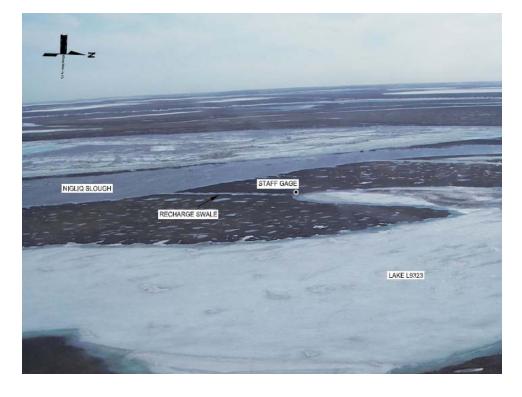
Figure 3: Western recharge swale of Lake L9323 taken June 4, 2007.

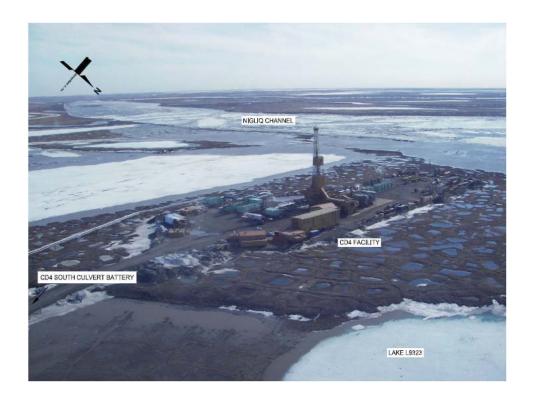
Floodwater recharge of L9323 was first observed on June 4. A small ice jam on the Nigliq Channel increased local water surface elevations, directing water overbank into the west recharge swale and south CD4 culvert battery (Figure 4). Recharge via the Nigliq Channel floodwaters resulted in a peak lake water surface elevation of 9.66 feet. By the morning of June 5 water was draining back into the Nigliq Channel via the recharge swale. Additional drainage was observed through the north CD4 culvert battery from L9323 into Lake M9525 (Figure 5). By June 6 L9323 was hydraulically disconnected from the Nigliq Channel. Lake ice was intact throughout the monitoring event with recharge water surrounding the entire lake periphery. A water surface elevation was surveyed at 8.46 feet on June 10.

Figure 4: South culvert battery (out of picture) flow entering Lake L9323(June 4, 2007)

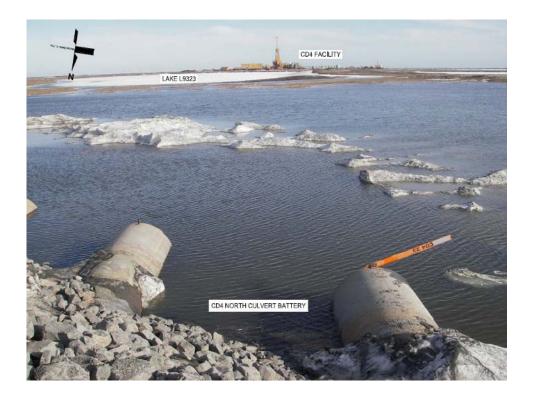
Figure 5: Lake L9323 from north Culvert battery (June 4, 2007)
