COLVILLE RIVER DELTA NORTH SLOPE, ALASKA

October, 1998

**1998 SPRING BREAKUP AND HYDROLOGIC ASSESSMENT
COLVILLE RIVER DELTA
NORTH SLOPE, ALASKA**

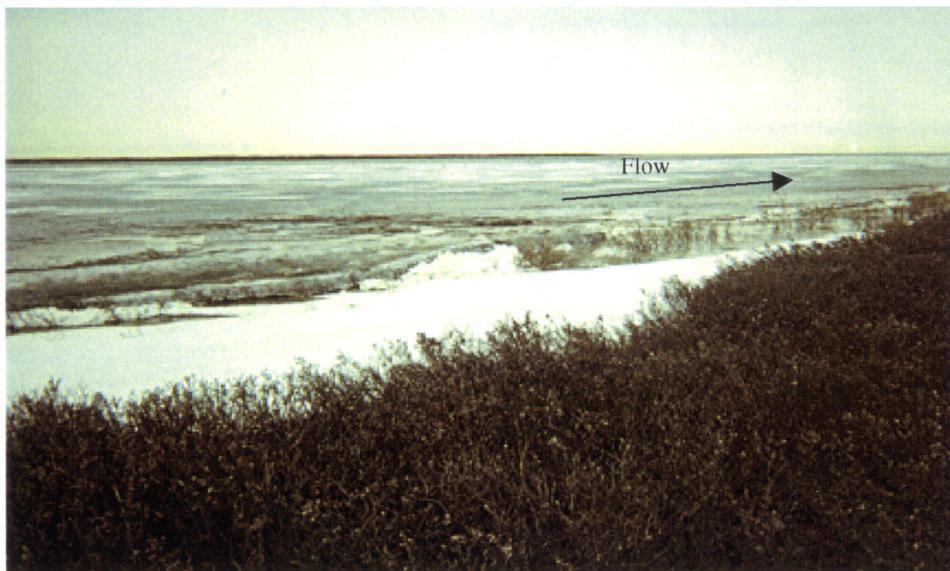
Breakup of the ice cover began in the afternoon of 27 May, at approximately 3:58 PM, when the low-flow-channel ice in the East Channel at the head of the delta broke loose and began floating downstream (Photo 1, Appendix C). Observers at Monument 3 and TBM 1U observed a rapid rise in water surface elevation at these locations. At Monument 3, the water level increased 1.11 ft in the 34 minutes between 3:51 PM and 4:25 PM.

Photo 1: Looking downstream from Monument 3 on the East Channel, at the time the low-flow-channel ice broke loose. (5/27/98 16:00)

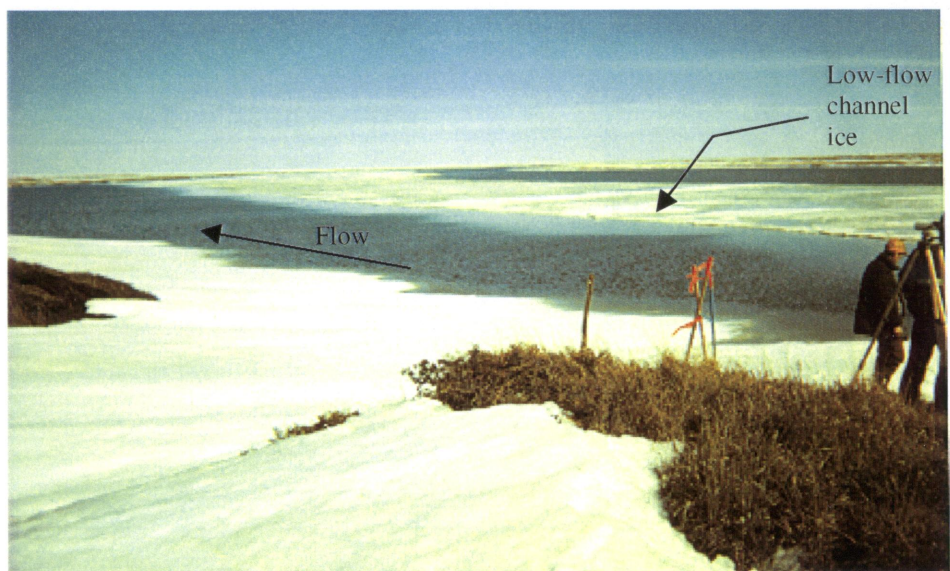
The low-flow-channel ice in the Sakoonang Channel was floating in place on 27 May and remained floating in place throughout the breakup event (Photo 2, Appendix C). There was little change in the Sakoonang over the course of the day. Water surface elevations rose 0.18-feet between 11:49 AM and 5:49 PM at Monument 16 and rose 0.07-feet between 5:25 PM and 8:45 PM at Monument 27.

Photo 2: Looking downstream from the staff gage at Monument 24 on the Sakoonang Channel. Low-flow-channel ice floating in place. (5/27/98 12:45)

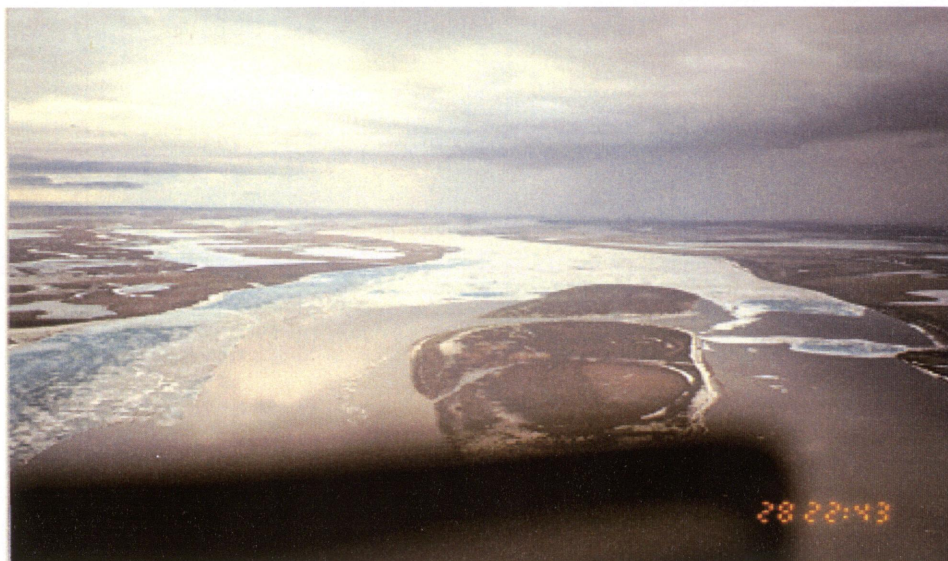
Photo 5: Looking upstream from below the surface ice jam on the East Channel. The ice jam extends above the Putu Channel. The low-flow- channel ice is floating in place in the vicinity of the jam. (5/28/98 21:43)

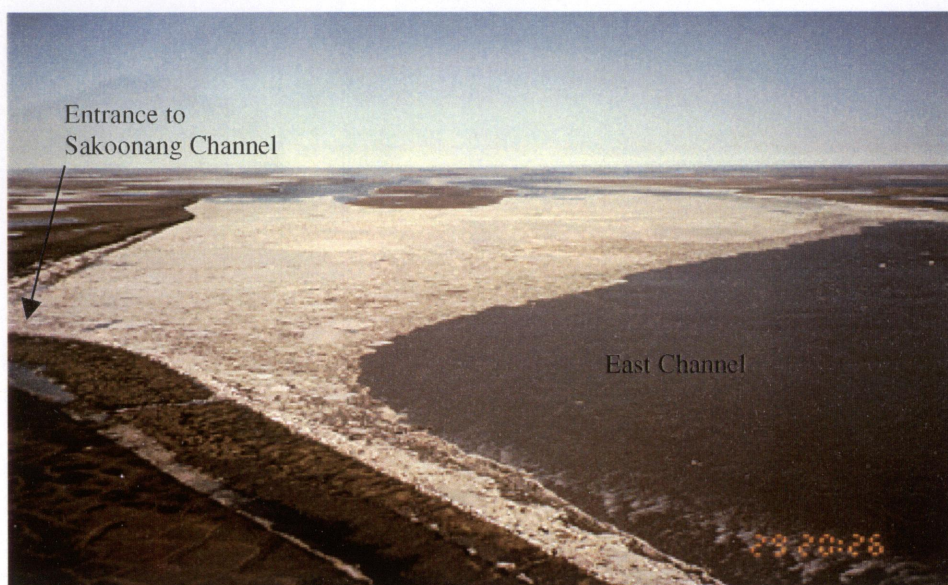
The morning of 29 May began as sunny with little to no wind. Lake 93-13 was receiving floodwaters from the Nechelik Channel. The ice jam in the East Channel was at the same location as the night before. By afternoon, however, the upstream limit of the jam had moved downstream to approximately the entrance of the Sakoonang Channel (Photo 6, Appendix C).

Photo 6: Looking downstream at the surface ice jam in the East Channel. The entrance to the Sakoonang Channel is on the left edge of the photo. The low-flow-channel ice is present in the vicinity of the jam. (5/29/98 19:26)

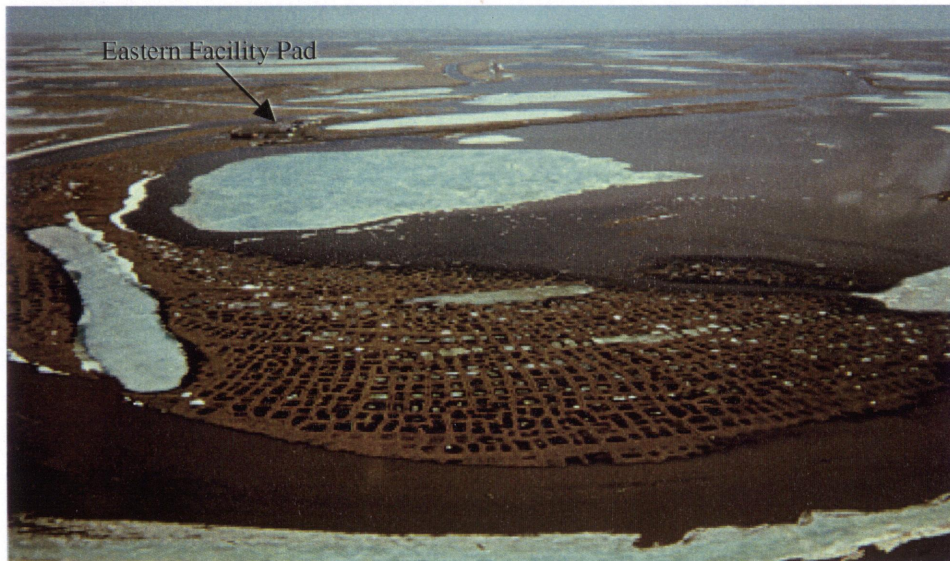
Photo 9: Looking south across the proposed airstrip. The Sakoonang Channel is in the foreground, the low-flow-channel ice is floating in place. (5/29/98 approx. 20:00)

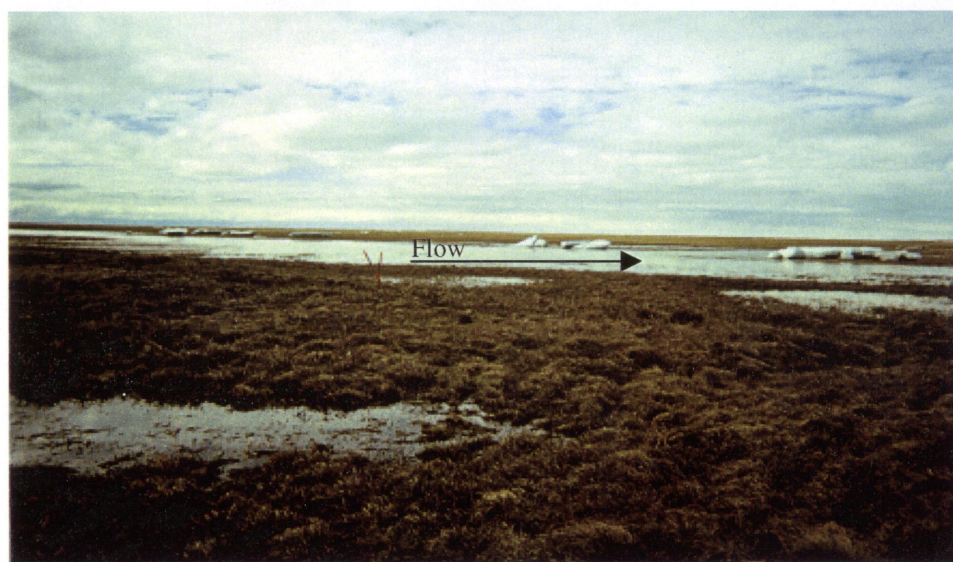
Ice blocks were floating in the swale at the proposed facility. Some were grounded on a high area across from TBM 100U (Photos 12 and 13, Appendix C). Others were passing through. After the water in the swale had receded (31 May 1998), one of the ice blocks was measured as being 5.2 ft thick.

Photo 12: Looking across the swale. Note the ice floes deposited in the swale. (6/1/98 15:25)

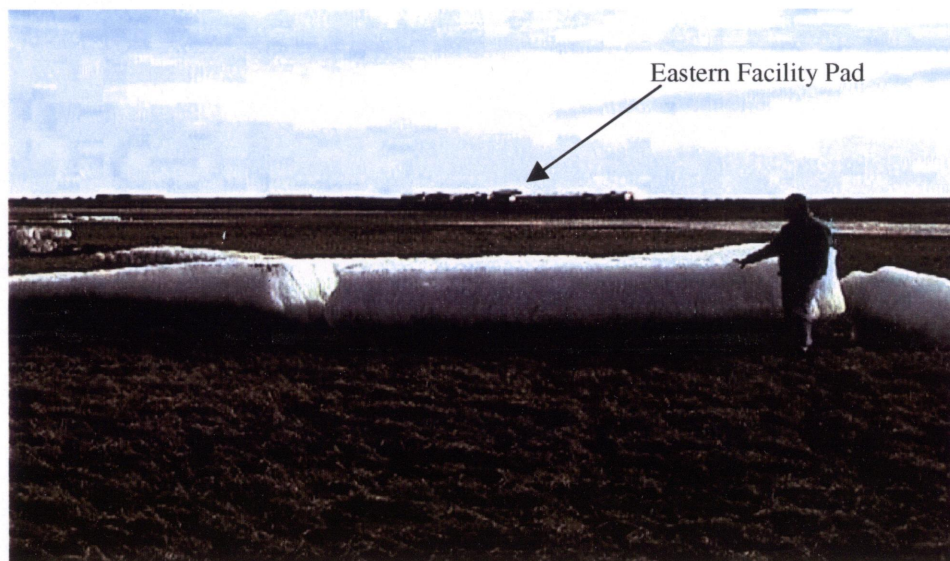
Photo 13: Ice floes deposited in the swale near the proposed facility.

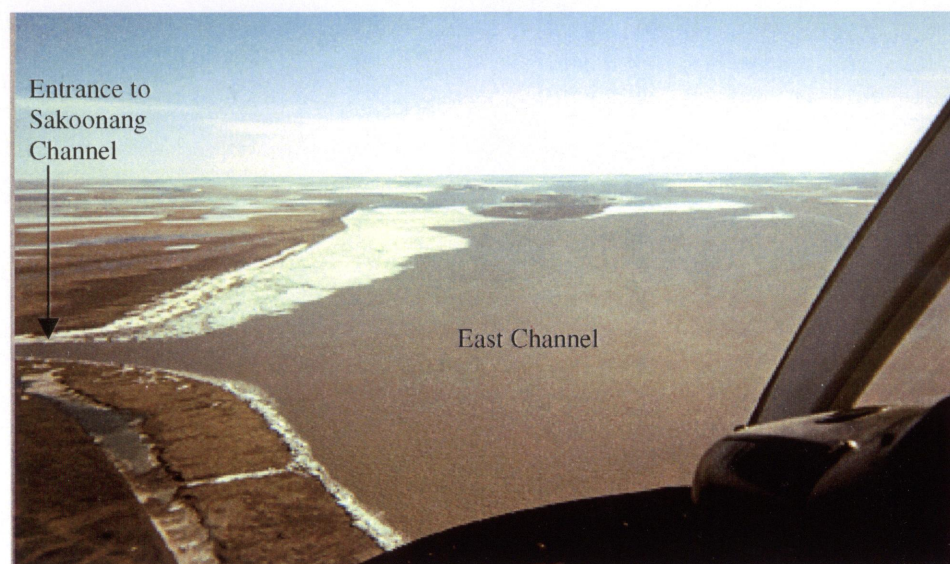
By the morning of 30 May, the ice jam in the East Channel had partially cleared. The channel on the east side of the island near River Mile 19 was approximately half open, and the low-flow-channel ice had broken free. However, the ice jam was still present in the channel on the west side of the island and partially obstructed the entrance to the Sakoonang Channel (Photo 14,

Photo 14: Looking downstream on the East Channel. The entrance to the Sakoonang Channel is on the left. The low-flow-channel ice has broken loose in the East Channel. The ice jam has cleared on the eastern side of the East Channel but is still present on the west side of the sand bar. (5/30/98 9:03)

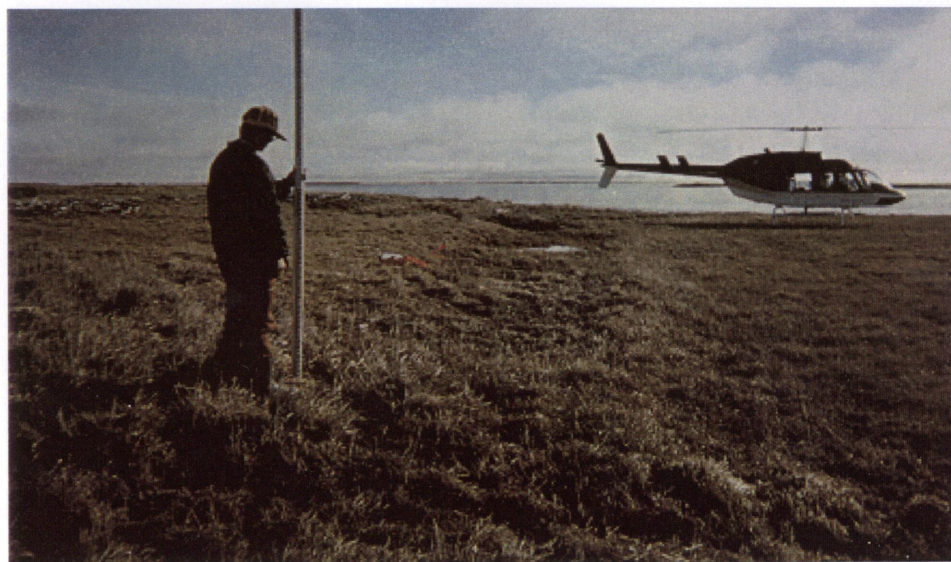
Peak water surface elevations were recorded based on high water marks (Photos 16 and 17, Appendix C) and periodic water surface elevation measurements at selected locations within the delta. The elevations are based on British Petroleum Mean Sea Level (BPMSL) and the data are summarized in Tables 3 through 19 (Appendix A).

**Photo 16: Surveying high water marks at TBM 28HWM. Looking west. (6/5/98
20:00)**

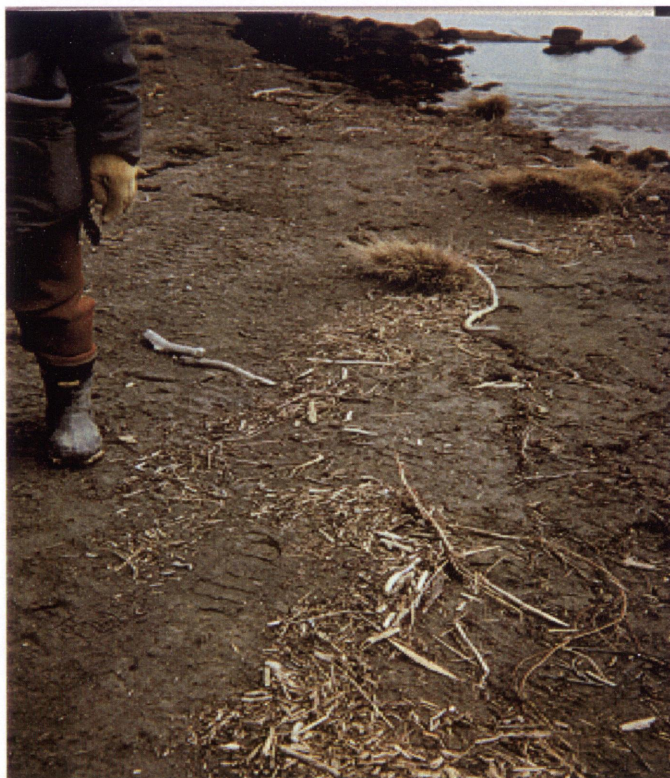
**Photo 17: Looking at debris line near Monument 35.
(6/6/98 9:40)**
