## 2000 Spring Breakup and Hydrologic Assessment

#### Nechelik Channel, Colville River Delta, Alaska

## **CD-South Development Project**

24531-MBJ-DOC-001

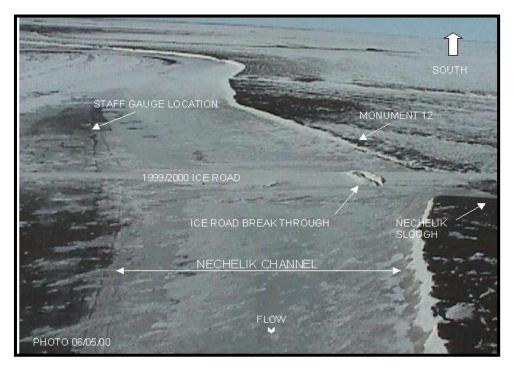
Figure 2-2 Nechelik Channel Aerial View at Monument 12

The winter ice road constructed across the Nechelik Channel near Monument 12 did not appear to have hindered breakup or caused ice jamming. A "break through" channel was excavated prior to abandonment of the ice road. It is believed that this was a significant factor in preventing breakup ice jamming problems due to the ice road (see Figure 2-2 and Figure C-1, Appendix C). In contrast, an ice jam was observed in the Tamayayak Channel (near Monument 25) where a "break-through" channels should be encouraged.

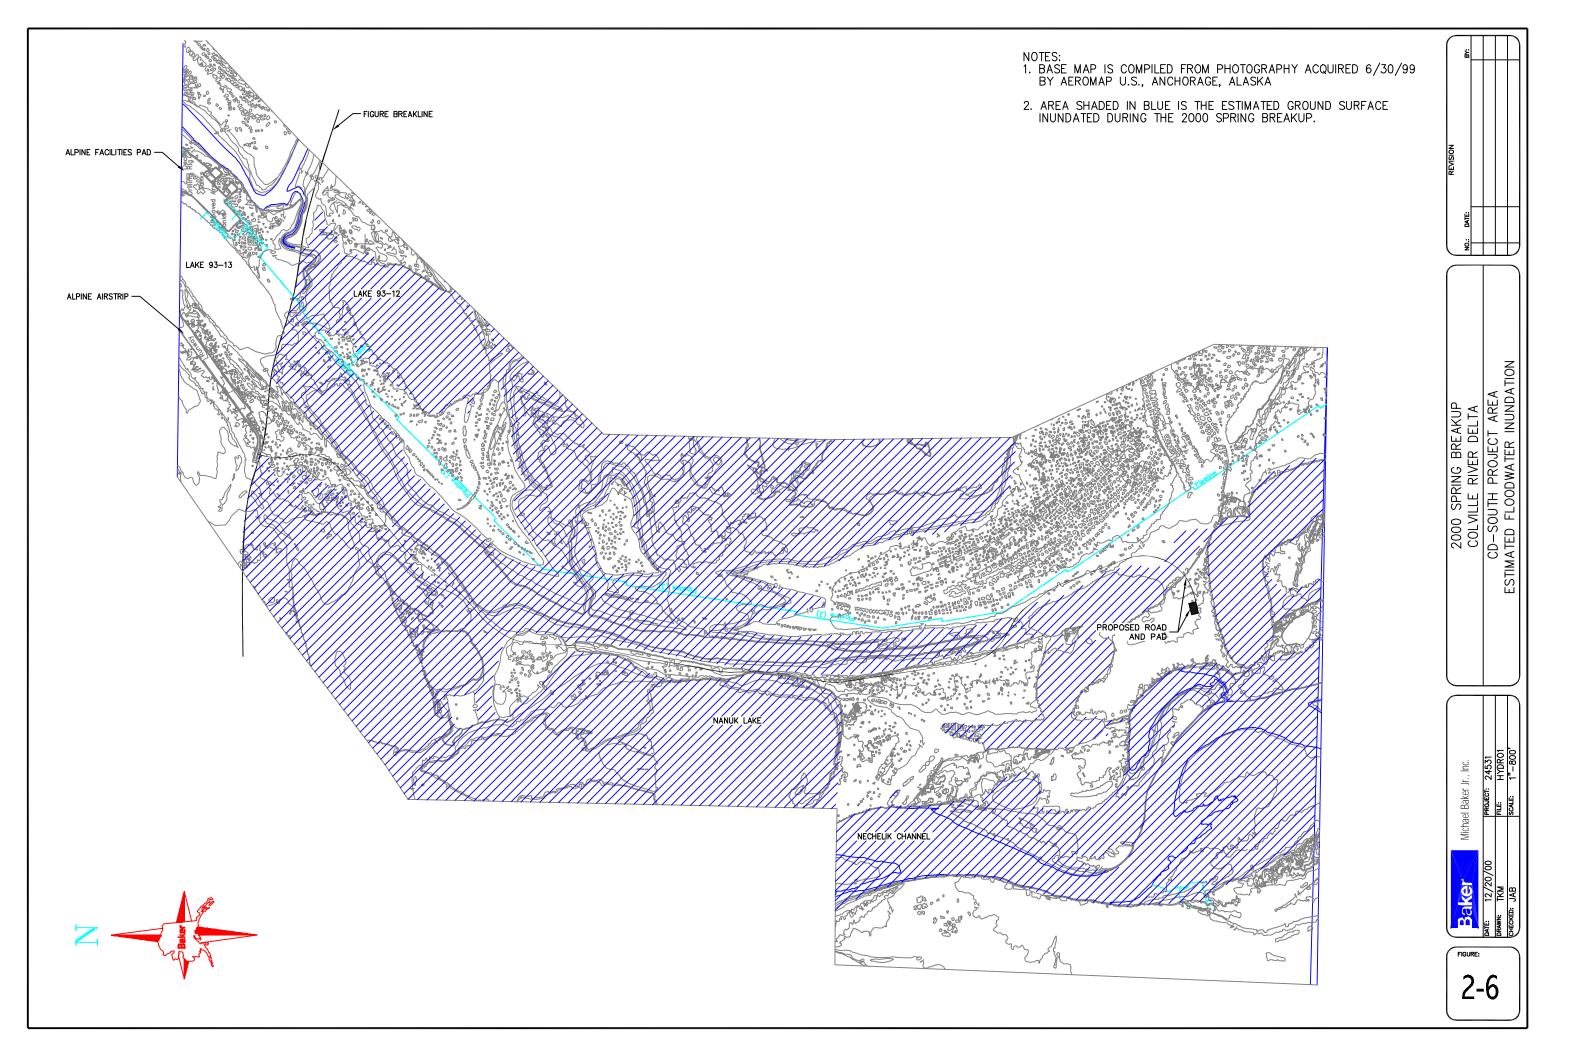
The ground surface in the CD-South area inundated by the 2000 peak water surface elevation was estimated and is presented in Figure 2-6. The estimate is based on the water-surface elevation measurements at Survey Monuments 12 and 22, and the two-dimensional surface water model developed for the Colville River Delta (Michael Baker Jr., 1998; and Shannon & Wilson, Inc., 1997). Specifically, the water-surface profile developed for the 30-year peak discharge was adjusted using the peak water-surface elevations observed during the 2000 spring breakup. The resulting water surface, in conjunction with topographic mapping was used to estimate the ground surface inundated near CD-South.

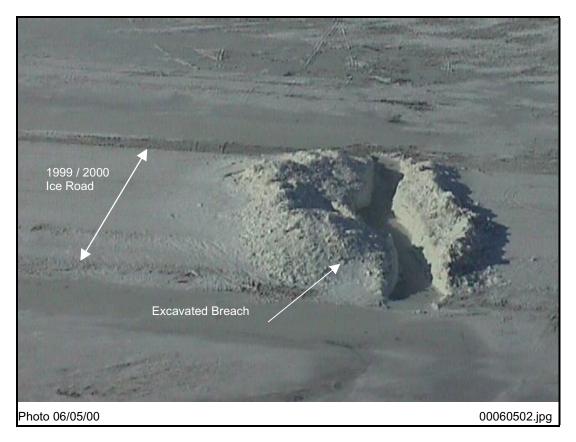
Figure C-1 Breach in Ice Bridge Across Nechelik Channel

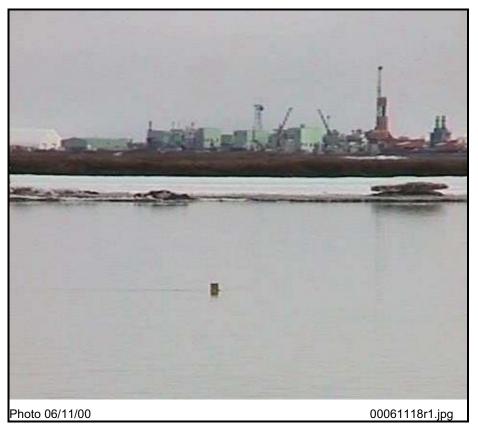
Figure C- 21 Looking Northeast From Monument 22 Monitoring Site. Note Staff Gage A Submerged.

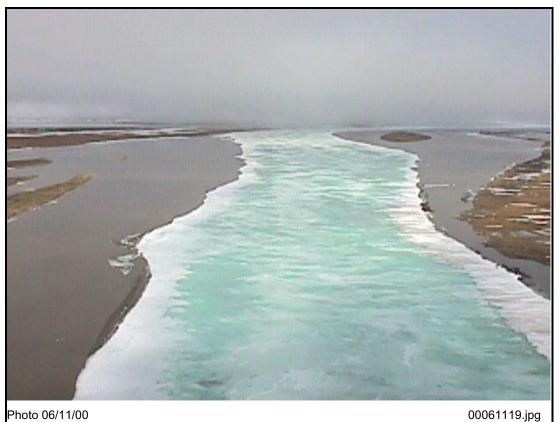
Figure C- 22 Looking North From CD-2 Pad at Nechelik Channel Low Water Channel Ice. Photo From Helicopter.
