2019 Colville River Delta Spring Breakup Monitoring & Hydrological Assessment

Michael Baker International 3900 C Street Suite 900 Anchorage, AK 99503

MSA Contract No. 296937

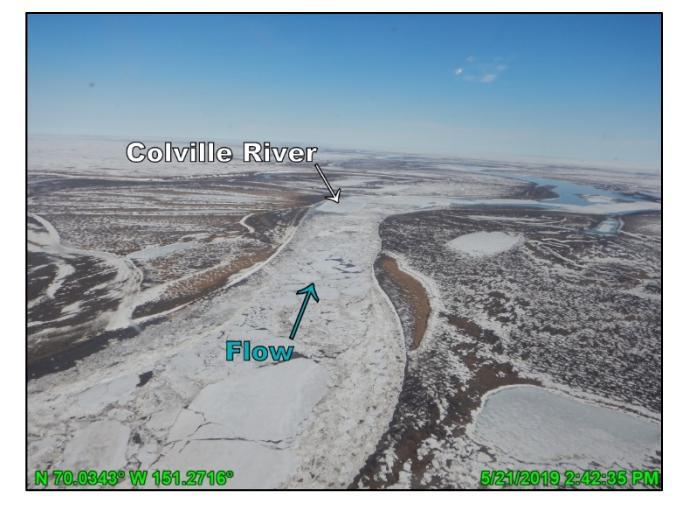
On May 21, a 10-mile-long ice jam was observed near Ocean Point with the downstream extent approximately 12 RM south (upstream) of MON1 (Photo 3.3). No substantial backwater was visible and water levels remained below bankfull stage behind the jam.

Photo 3.3: Ice jam on the Colville River approximately 12 RM upstream of MON1, looking northeast (downstream); May 21, 2019

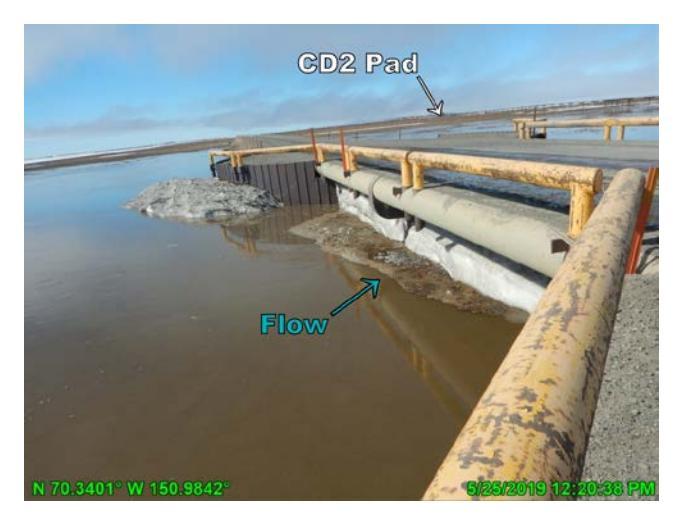
Photo 4.15: Drifted snow upstream of the CD2 road short swale bridge, looking west; May 25, 2019

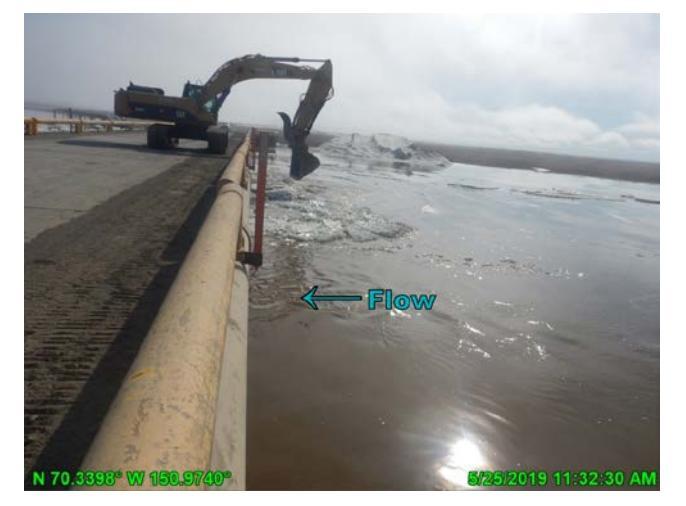
Photo 4.21: Excavator removing accumulated ice floes from the long swale bridge prior to discharge measurement, looking east; May 25, 2019

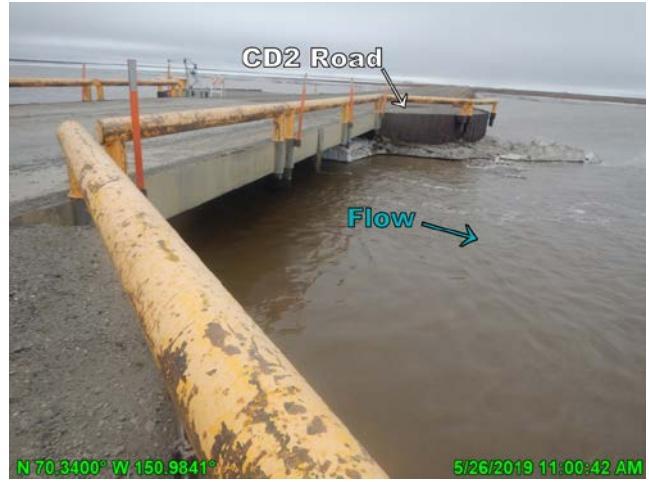
Photo 4.22: Limited snow on the downstream side of the short swale bridge affecting flow during discharge measurement, looking southwest (upstream); May 26, 2019

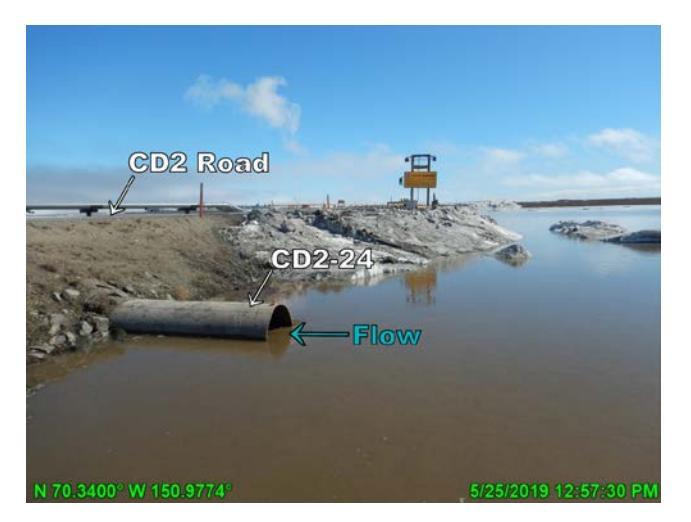
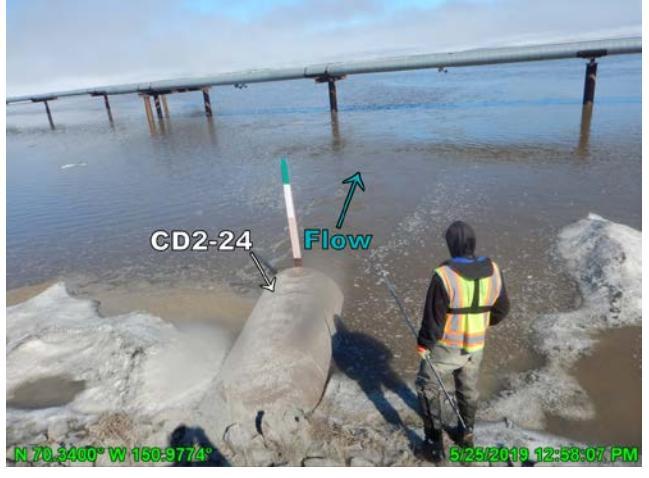
All culverts along the CD2 road in the presence of floodwater performed as designed (Photo 4.23 and Photo 4.24). Peak discharge through area drainage structures occurred on May 25 during peak stage differential across the CD2 road as measured at gages G3 and G4. This is consistent with the conditions under which peak discharge typically occurs. Peak discharge at the CD2 road bridges and culverts was calculated using the measured velocity and adjusting the hydraulic depth for peak conditions.

Photo 4.23: Culvert CD2-24 passing flow as designed, south (upstream) end, looking east; May 25, 2019

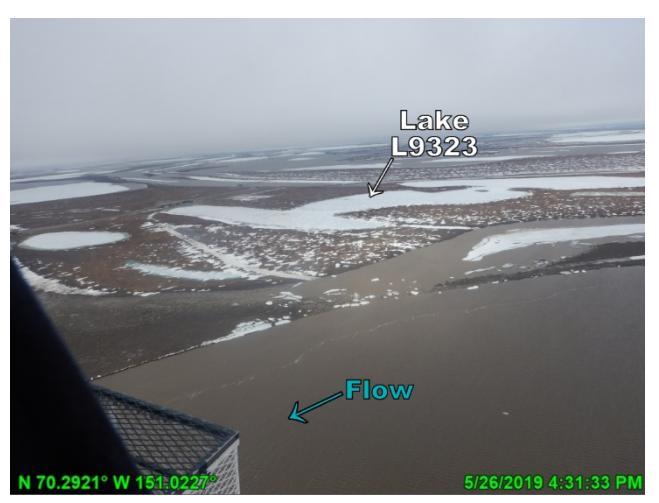
Photo 4.32: No hydraulic connection through Lake L9323 bridge during peak conditions at Alpine facilities, looking northeast (upstream); May 26, 2019

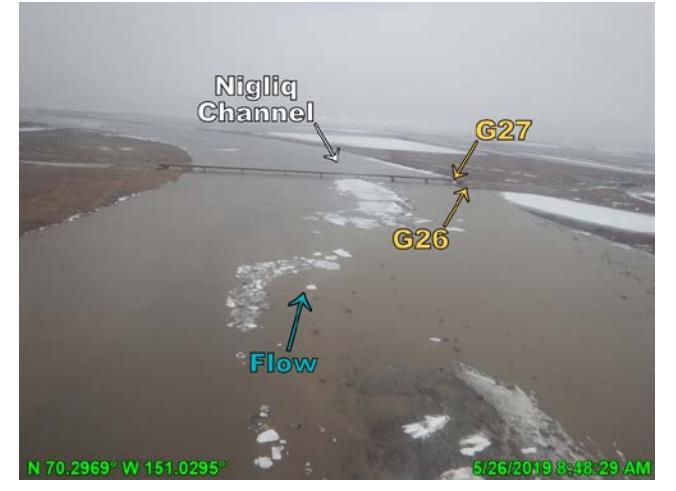
Photo 4.37: Floes caught or grounded upstream of the Nigliq Bridge, looking north (downstream); May 26, 2019

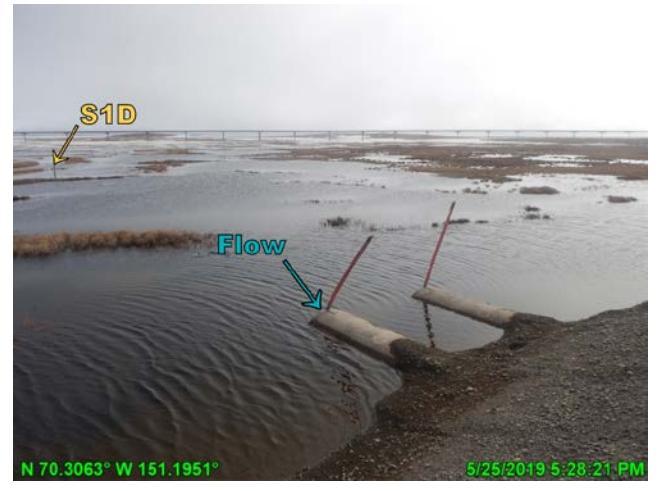
Stage remained below the PT elevation at gages S1/S1D throughout breakup. Flow was observed (Photo 4.43) and measured at two culverts along the CD5 road west of the Nigliagvik Channel twice during breakup monitoring. Peak discharge was not calculated for either location; there are no gages at the CD5-04 vicinity and stage at S1/S1D was too low for PT recordings at the CD5-07 vicinity. Gages S1/S1D stage and discharge data is provided in Graph 4.17. Measured discharge at CD5 road culverts conveying flow is summarized in Table 4.4. Additional culvert discharge data is provided in Appendix C.

Photo 4.43: South to north (downstream) flow through culverts at S1/S1D gages, looking south; May 25, 2019

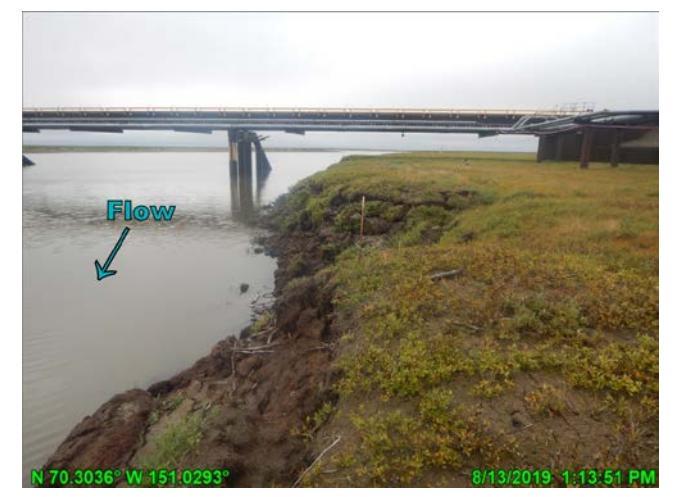
Site conditions during the bank erosion survey at the Nigliq Bridge and Nigliagvik Bridge are presented in Photo 6.1 through Photo 6.4. Maximum incremental and cumulative erosion at the Nigliq Bridge and Nigliagvik Bridge and maximum incremental, maximum cumulative, and average erosion along the top of bank, upstream and downstream of the bridges, is presented in Table 6.3. Bank erosion tabulated data is presented in Appendix E (UMIAQ 2019b).

Photo 6.1: West bank of the Nigliq Channel near the Nigliq Bridge, looking south (upstream); August 13, 2019

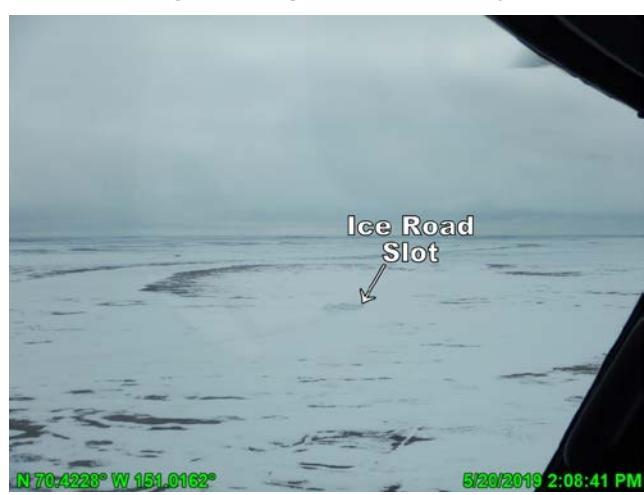
Photo D.40: Slotting at Slemp Slough ice road crossing; May 20, 2019

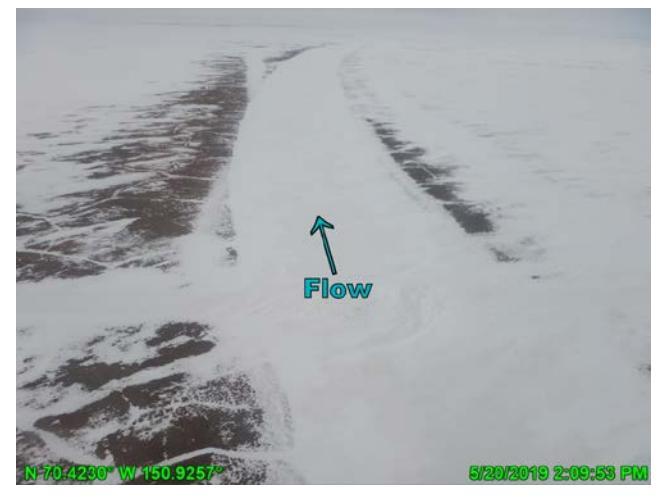
Photo D.43: Slotting at Pineapple Creek ice road crossing, looking north; May 20, 2019

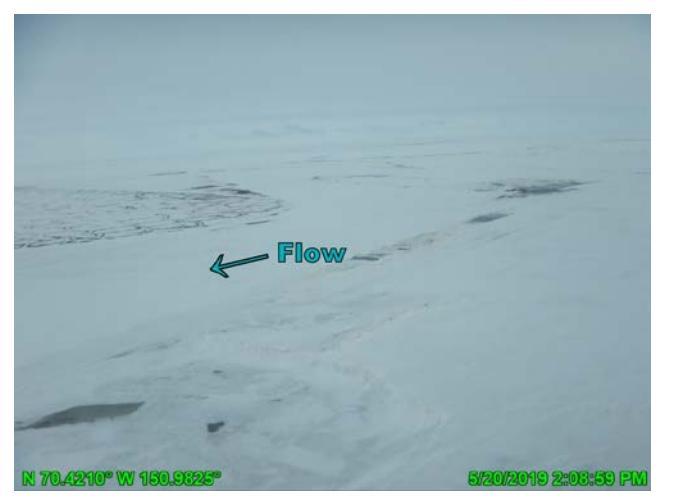
Photo D.45: Slotting at Tamayayak ice road crossing #1, looking south; May 20, 2019
