# CD-North

## Development Project

### 2002 Spring Breakup and Hydrology Assessment

25436-MBJ-DOC-003

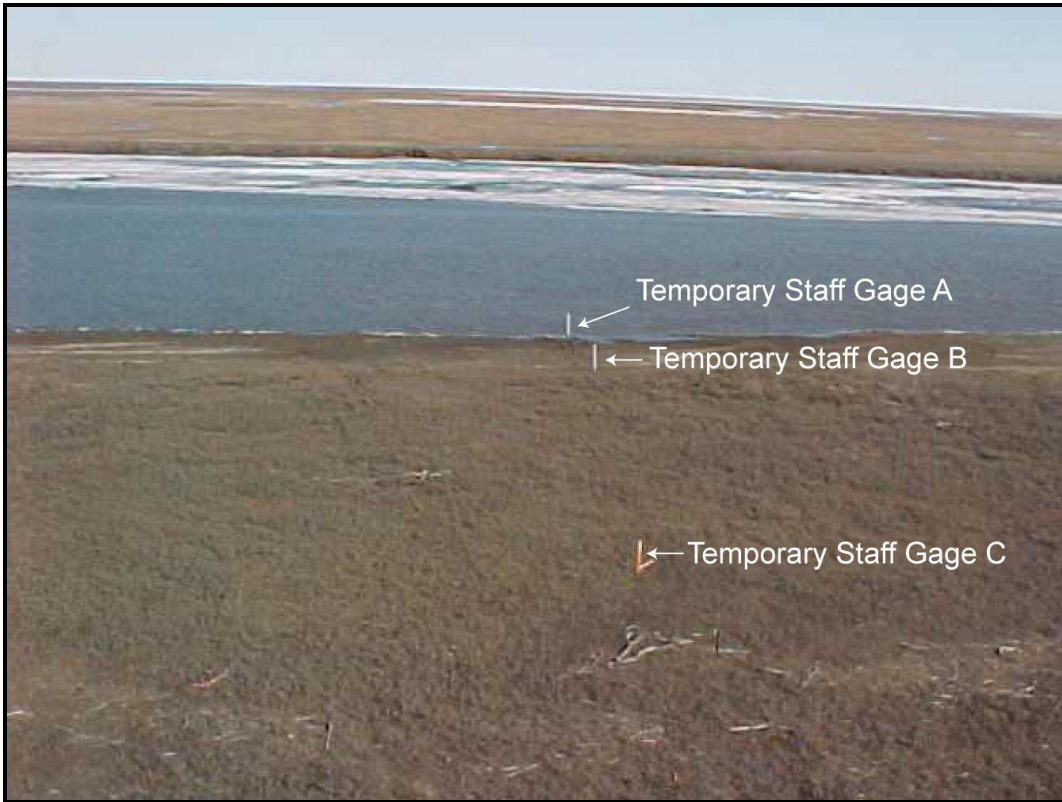
**Photo 3-4 Tamayagiaq Channel. Looking north at the upstream gages.**

In the Tamayagiaq channel, flowing water was first observed on 23 May. Water surface elevations peaked at 6.5 feet and 6.0 feet at the upstream and downstream monitoring sites, respectively. In the vicinity of the proposed pipeline crossing the peak water surface elevation was estimated at 6.4 feet. Peak water surface elevations occurred between 26 May at 1:30 p.m. and 27 May at 11:25 a.m. The channel was free of ice at both gage locations on 27 May.

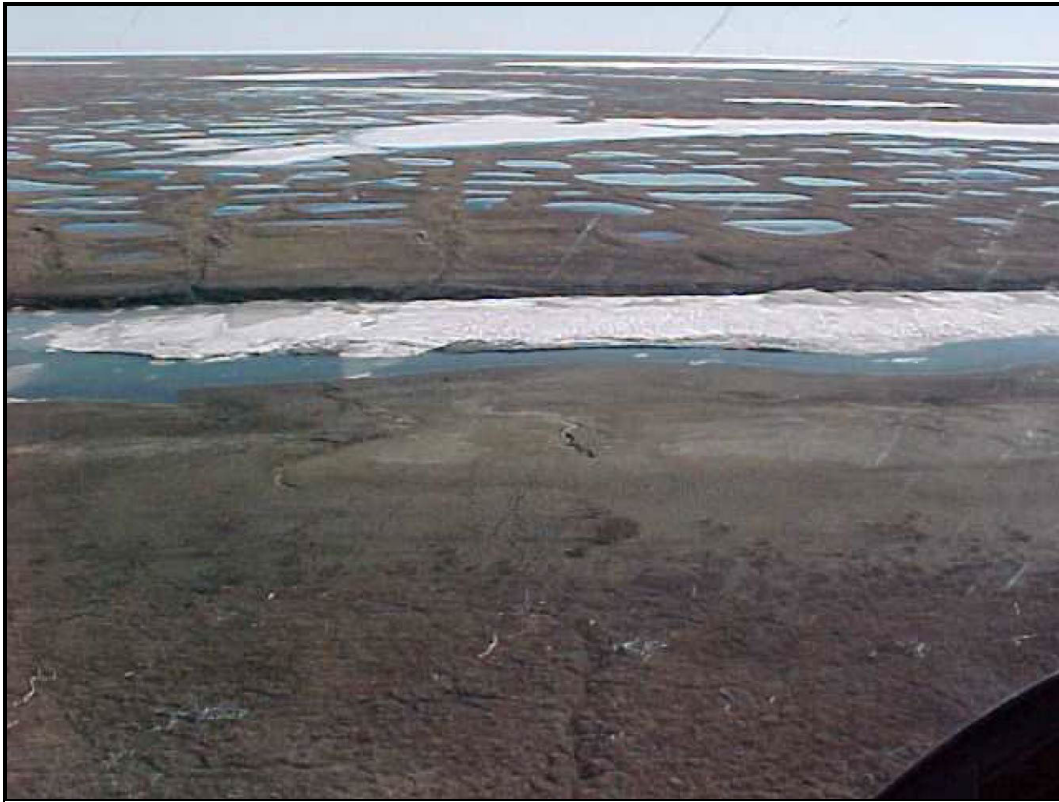
**Photo 3-7 Ulanigniaq Channel. Looking south at the downstream gages.**

Flowing water was first observed on the Ulamnigiaq Channel on 23 May. Water surface elevations peaked between 26 May at 1:00 p.m. and 27 May at 11:00 a.m. at an estimated 6.5 feet at the upstream monitoring site and 6.3 feet at the downstream monitoring site. In the vicinity of the proposed pipeline crossing the peak water surface elevation was estimated to be 6.3 feet. At the time of peak water surface elevation, ice flows were observed at the upstream monitoring location. The channel was free of ice at the downstream monitoring location.

It was estimated that at the time the peak water surface elevation occurred, discharge on the Ulamnigiaq channel at the proposed pipeline crossing was approximately 6,900 cfs with an average velocity of 1.8 ft/sec. A peak discharge of 7,700 cfs, average velocity of 2.7 ft/sec, was observed on 26 May. The peak discharge occurred at a water surface elevation of 4.4 feet. Water surface elevation and observations for the Ulamnigiaq channel are summarized in Table 3-4. Photos 3-7, 3-8, and 3-9 shows conditions at the Ulamnigiaq channel on 23, 26 and 27 May, respectively.

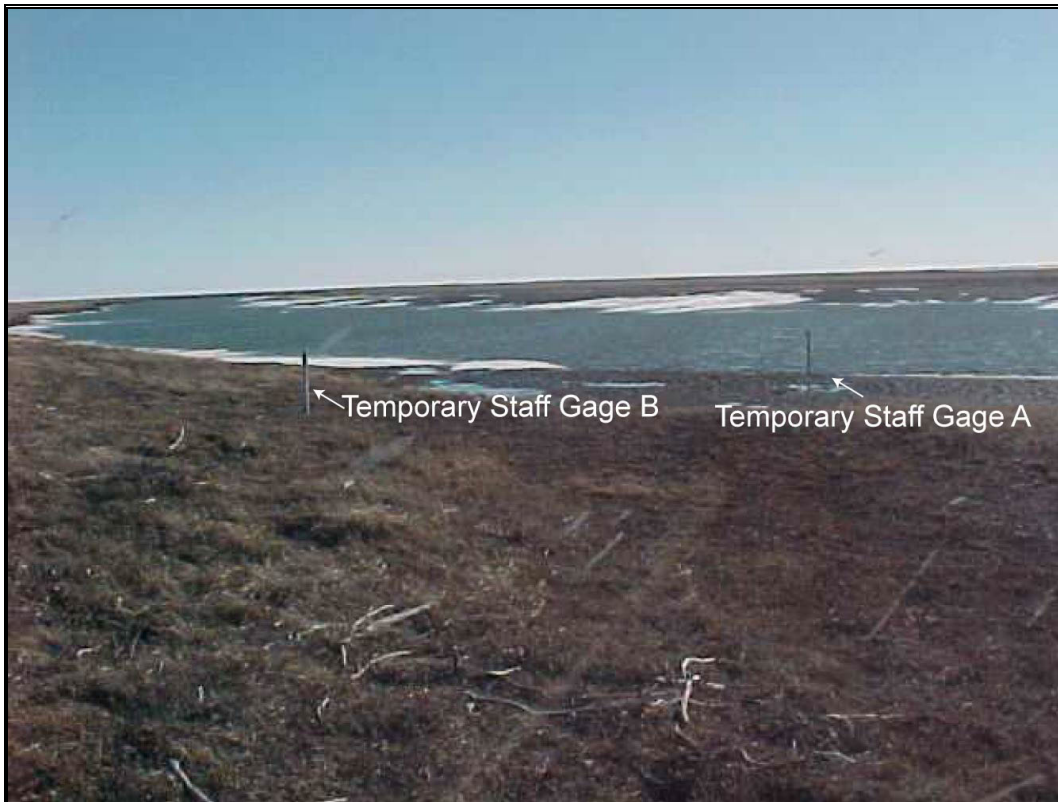
**Photo 3-10** West Ulamnigiq Channel. Looking southwest at the downstream gages.

Flowing water was not observed on the West Ulamnigiq Channel until 25 May. Water surface elevations peaked at 5.79 feet and 5.33 feet at the upstream and downstream monitoring sites, respectively. In the vicinity of the proposed facility water surface elevation was estimated to be 5.6 feet. Peak water surface elevations occurred between 26 May at 12:55 p.m. and 27 May at 10:00 a.m. At the time of peak water surface elevation, ice flows were observed at the upstream monitoring location. The channel was free of ice at the downstream monitoring location.

It was estimated that at the time the peak water surface elevation occurred, peak discharge on the West Ulamnigiq channel at the proposed facility was approximately 2,200 cfs with an average velocity of 2.4 ft/sec. Water surface elevations and observations for the West Ulamnigiq channel are summarized in Table 3-5. Photos 3-10, 3-11, and 3-12 show conditions in the West Ulamnigiq channel on 23, 26, and 27 May, respectively.

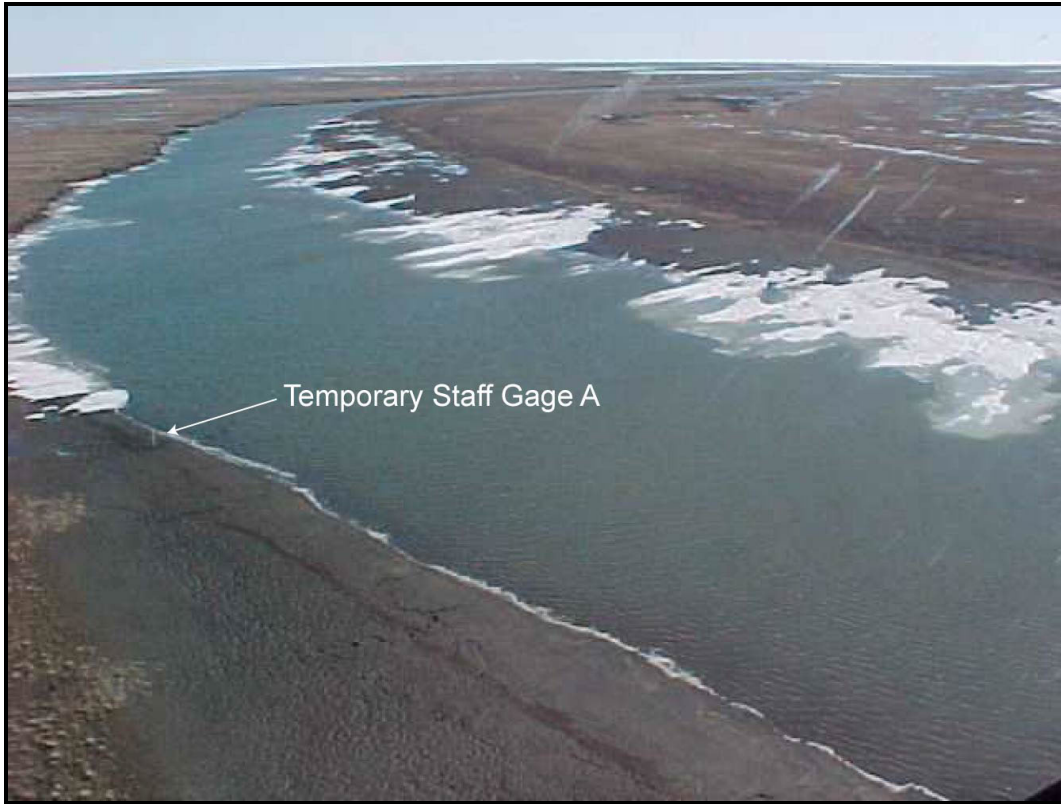
**Photo 3-13** East Ulamnigiq Channel. Looking northeast, downstream at the temporary staff gage location.

A monitoring site was installed in the East Ulamnigiq channel adjacent to the southeast end of the proposed CD North airstrip. Flowing water was observed on the East Ulamnigiq channel on 23 May. A peak water surface elevation of 5.64 feet was observed between 26 May at 12:45 p.m. and 27 May at 10:00 a.m. The channel was free of ice at the time of the peak water surface elevation. Water surface elevations and observations for the East Ulamnigiq channel are summarized in Table 3-6. Photos 3-13 and 3-14 shows conditions in the East Ulamnigiq channel on 23 and 26 May, respectively.
