Alpine Satellites Development Plan 2003 Spring Breakup and Hydrologic Assessment

December 2003

Michael Baker Jr., Inc.
4601 Business Park Blvd., Suite 42
Anchorage, Alaska 99503
907-273-1600

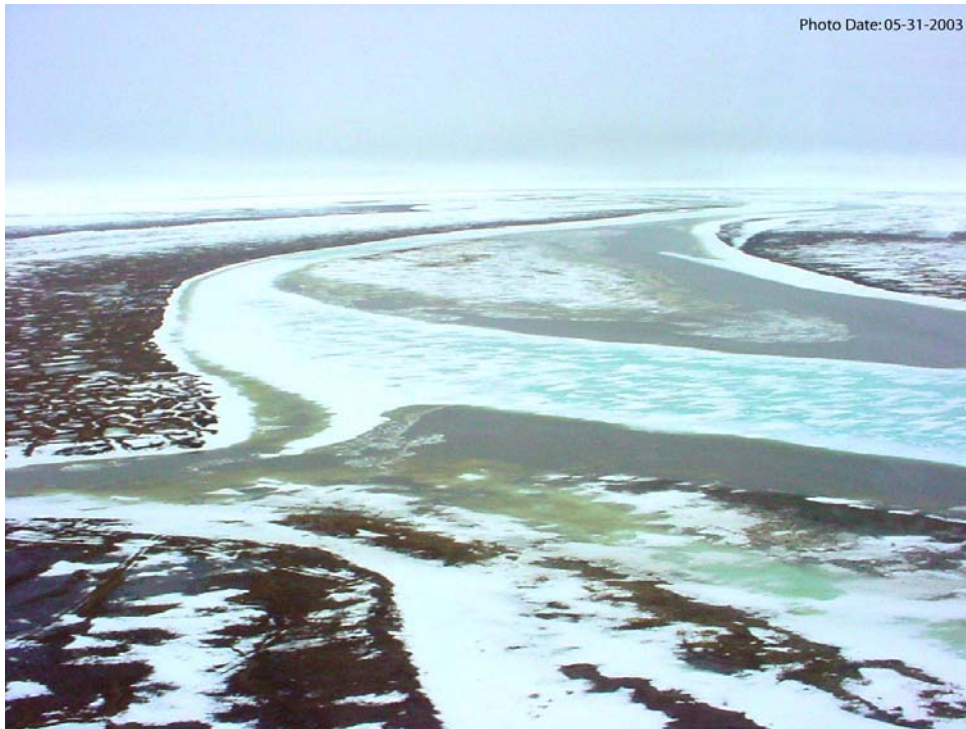
Photo 3-1 Early breakup conditions on the Nigliq Channel near the proposed bridge crossing site on 31 May. Photo taken near the Monument 22 monitoring site, looking downstream and northeast towards the Monument 23 monitoring site. The mouth of the Nigliq Slough is at the left-hand center of photo.

Photo 3-1 shows early breakup conditions on the Nigliq Channel near the proposed bridge site. Photo 3-2 shows conditions near the bridge site at about the time of the peak water surface elevation in the channel.

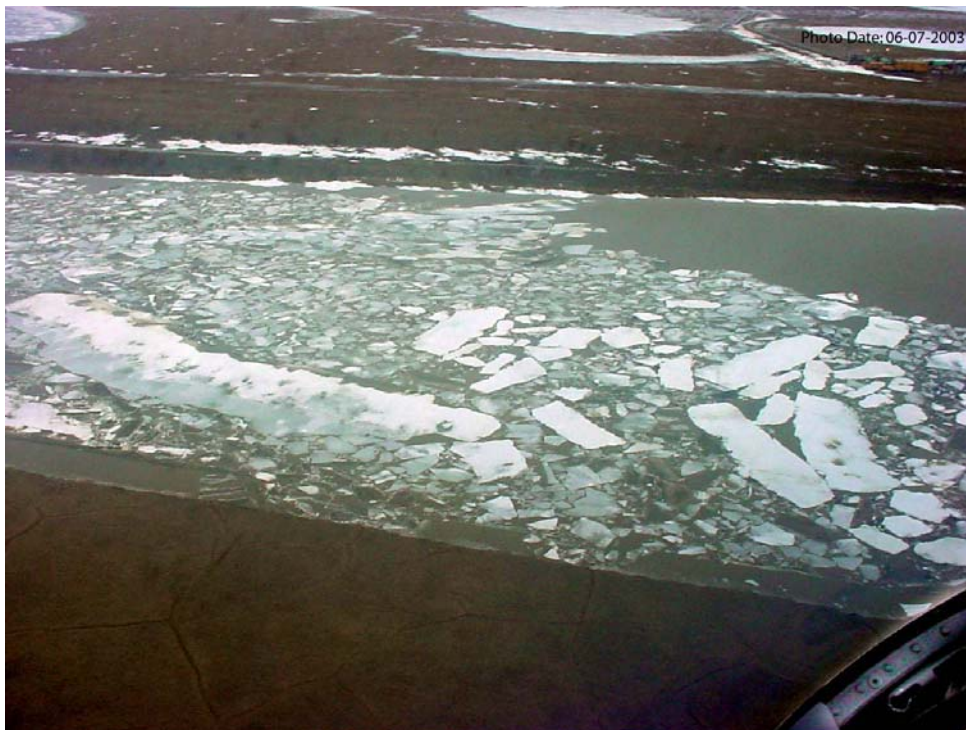
Photo 3-2 Breakup conditions on the Nigliq Channel near the proposed bridge crossing site on 7 June. Conditions shown are several hours prior to the occurrence of the breakup peak water surface elevation in the channel. View looking west. CD-2 is in upper right corner of photo. Flow is from right to left.

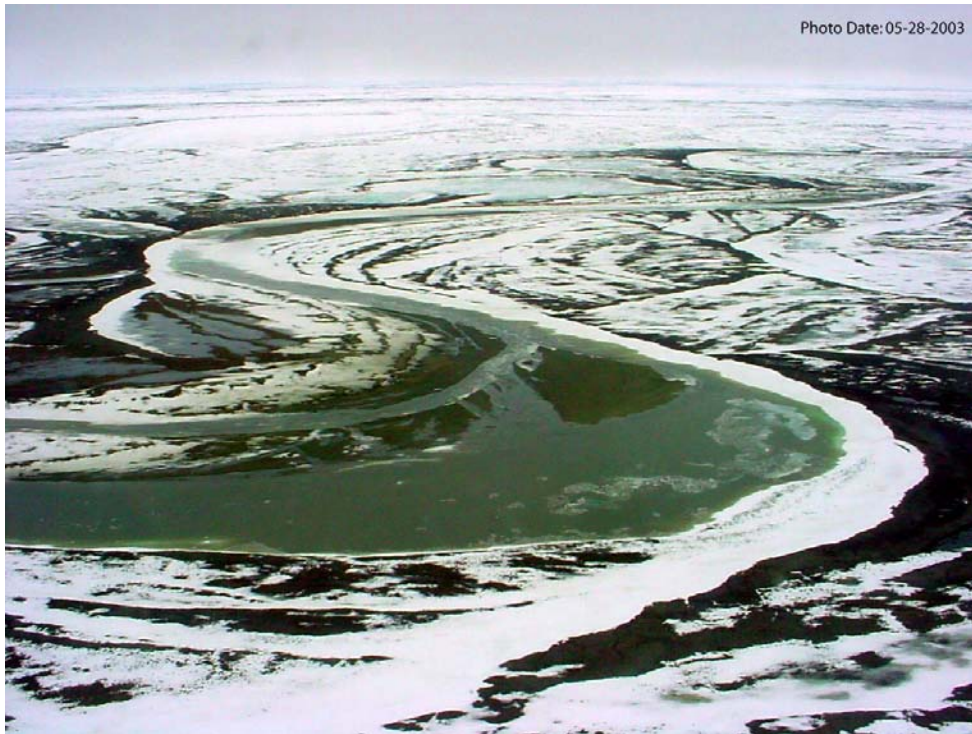
Photo 4-1 Leading edge of flowing water on Judy Creek on 28 May, approximately 20 air miles upstream of the Judy Creek RM 13.8 monitoring site. This represents the leading edge of breakup flows within the Fish Creek basin. View looking north.

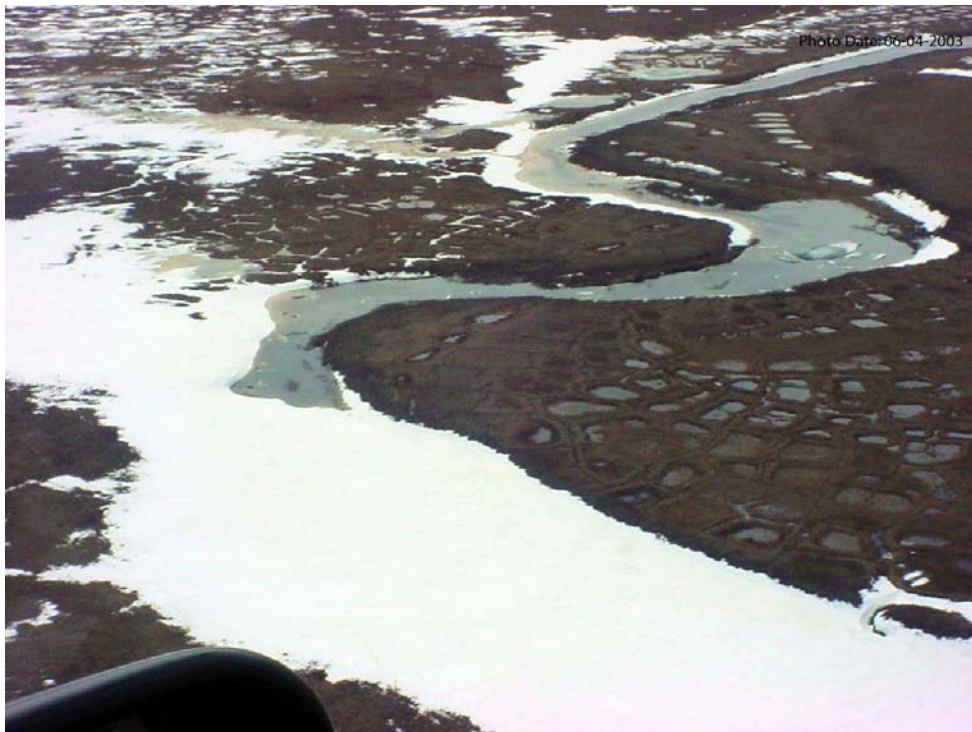
Photo 4-2 Leading edge of flow on the Ublutuoch River on 4 June, approximately 15 air miles upstream of the Ublutuoch River RM 6.8 monitoring site. View looking southwest.

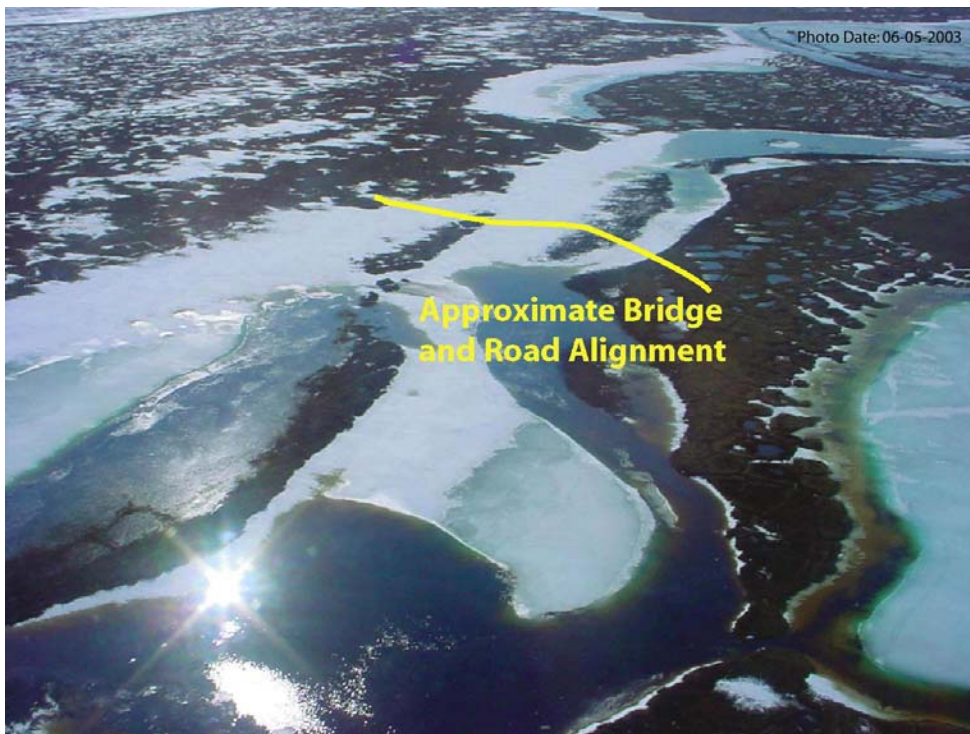
Photo 4-3 Arrival of the breakup melting front at the Ublutuoch River RM 6.8 monitoring site and proposed bridge location on 5 June at roughly 9:50 a.m. View looking southeast and upstream

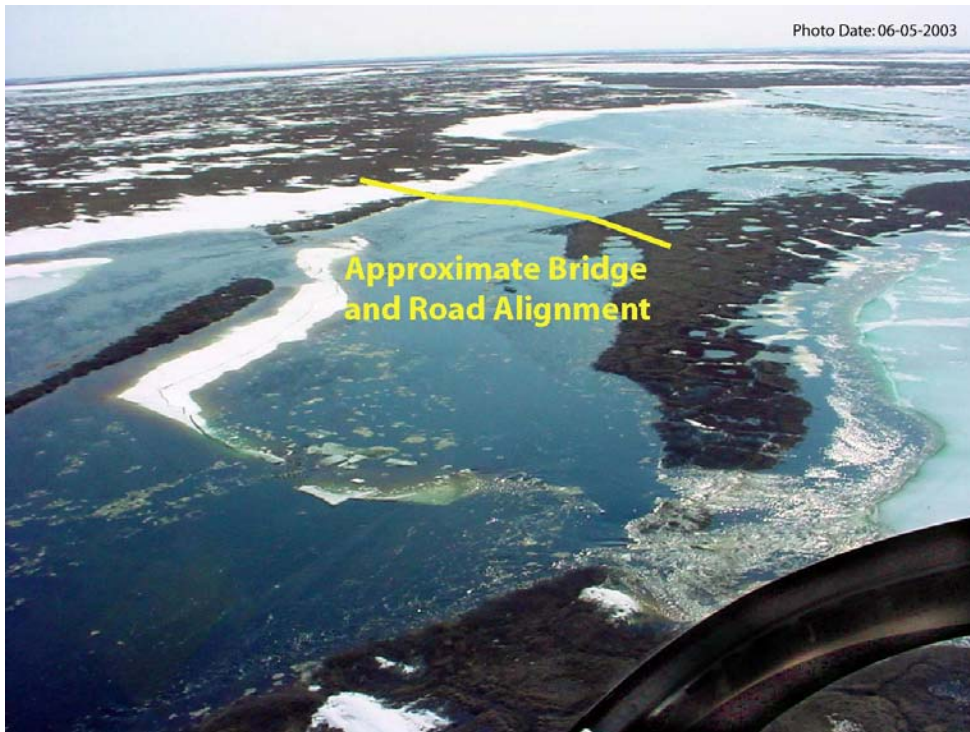
Photo 4-4 Breakup floodwaters at the Ublutuoch River RM 6.8 monitoring site and proposed bridge location on 5 June at roughly 12:00 noon. View looking southeast and upstream. Compare to Photo 4-3 above, taken from a similar perspective approximately two hours earlier.

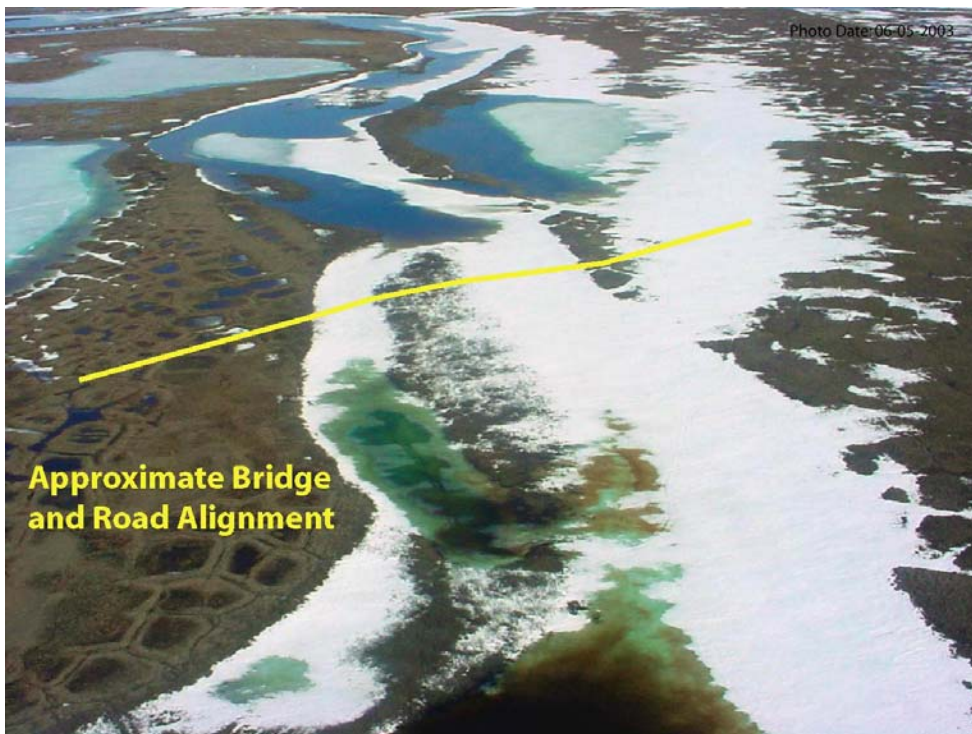
Photo 4-5 Arrival of the breakup melting front at the Ublutuoch River RM 6.8 monitoring site and proposed bridge location on 5 June at roughly 9:50 a.m. View looking northwest and downstream.

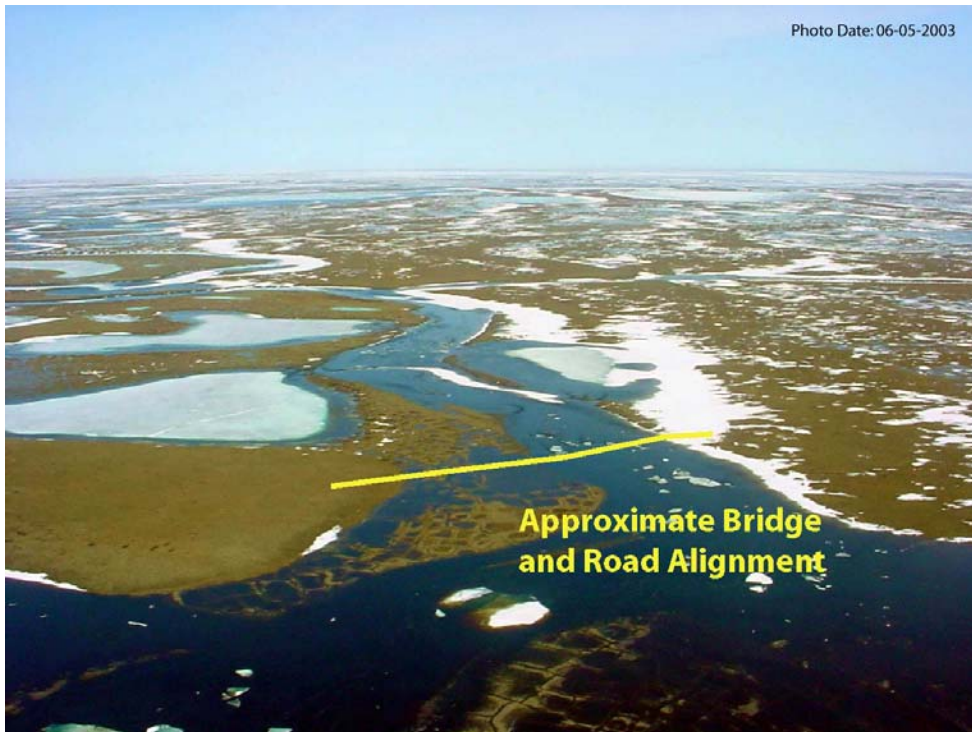
Photo 4-6 Breakup floodwaters at the Ublutuoch River RM 6.8 monitoring site and proposed bridge location on 5 June at roughly 12:00 noon. View looking northwest and downstream. Compare to Photo 4-5 above, taken from a similar perspective approximately two hours earlier.

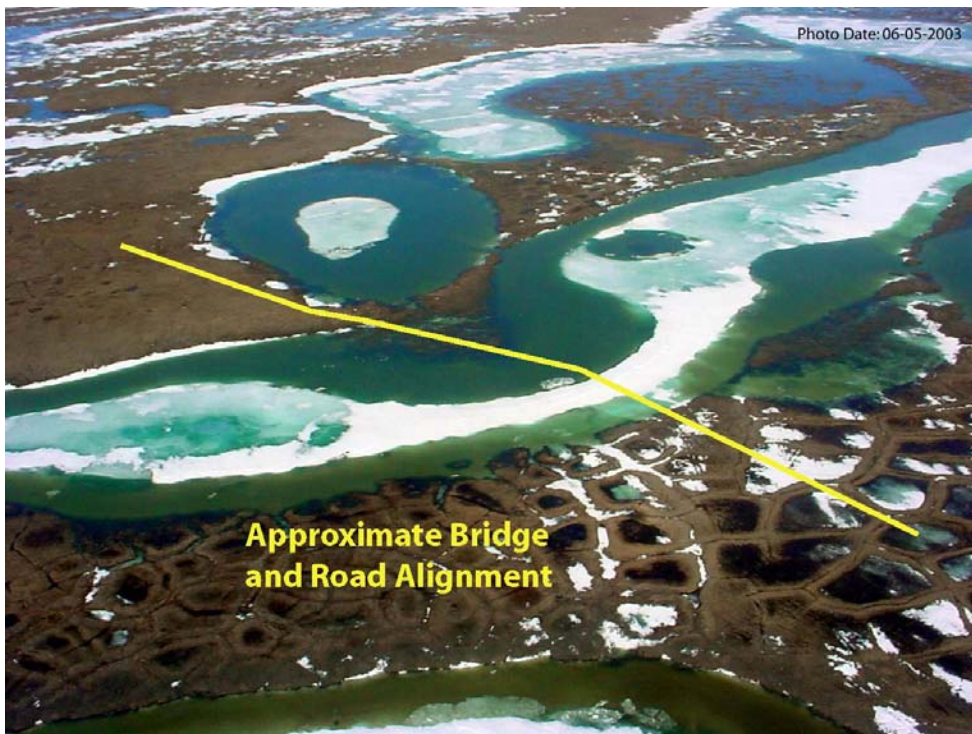
Photo 4-7 Ublutuoch River RM 1.9 monitoring site and proposed bridge location on 5 June prior to the arrival of breakup flows. Water in channel and nearby lake basins is from local melt and influx from minor tributaries. View looking northwest.

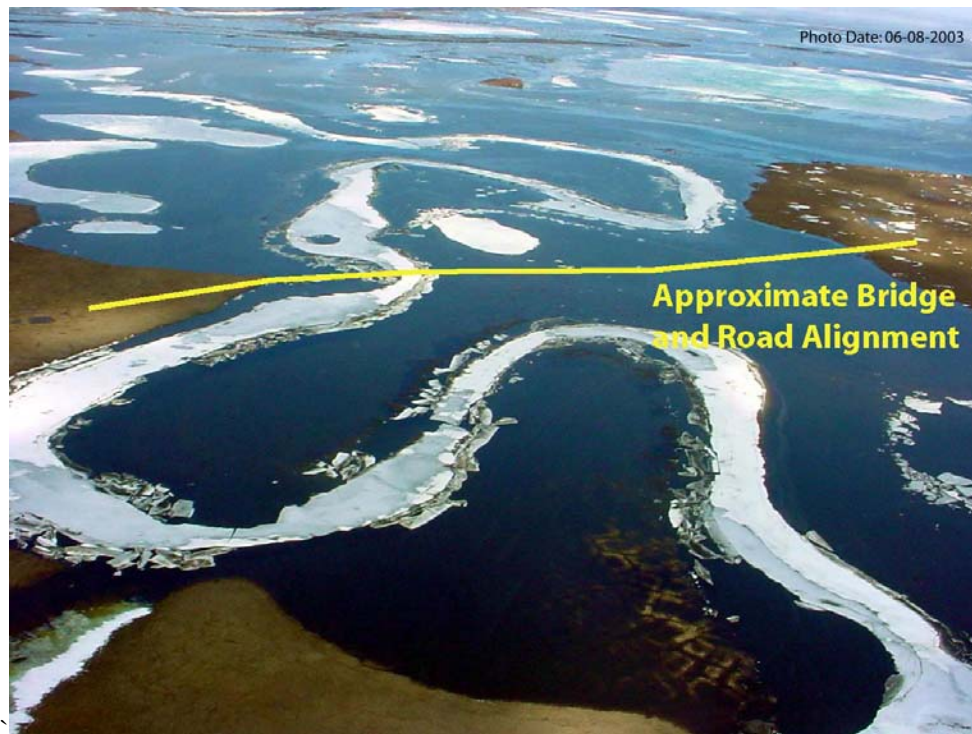
Photo 4-8 Ublutuoch River RM 1.9 monitoring site and proposed bridge location on 8 June. Conditions shown are near the time of the breakup peak water surface elevation and peak discharge. View looking northwest and downstream.

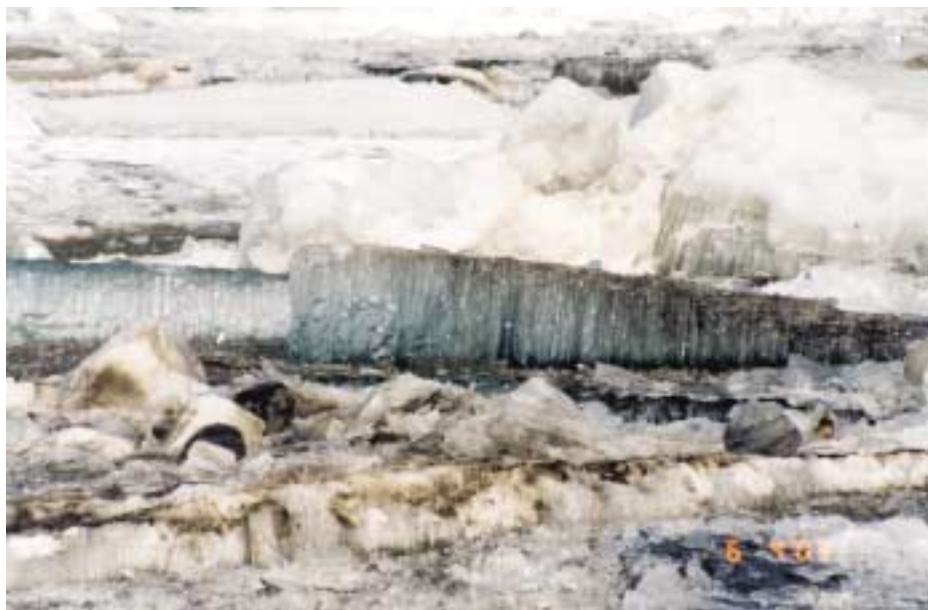
4. Ice is "canded" indicating significant deterioration from strong ice conditions which exist at the beginning of breakup.

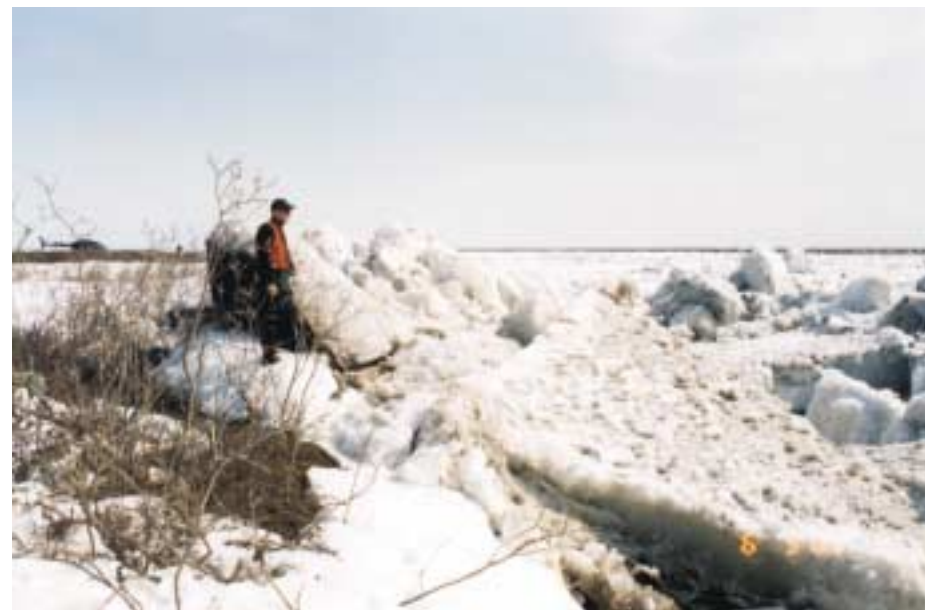
5. Ice shove on banks of main channel of Colville River near Ocean Point.

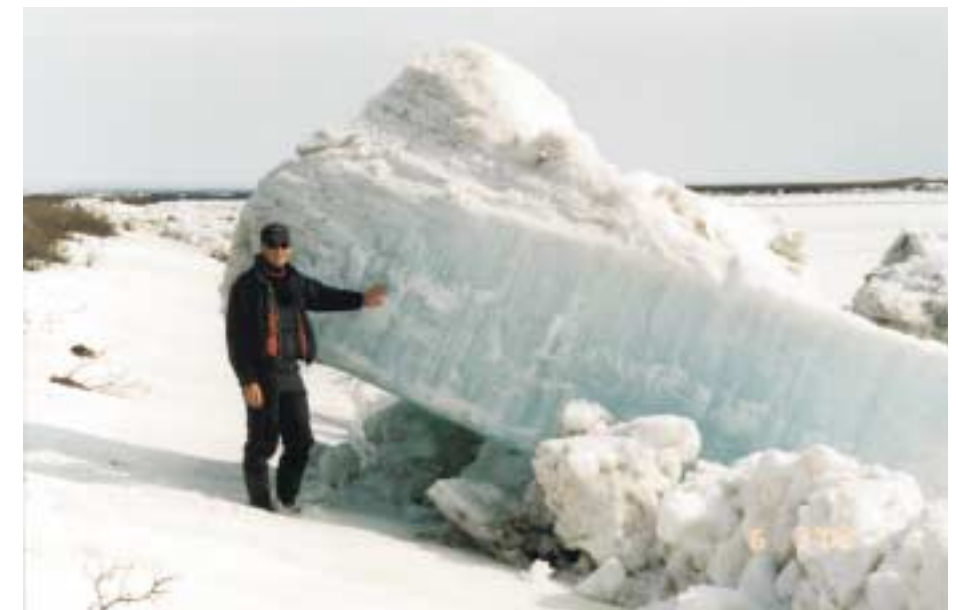
6. Ice shove on the west bank of the Colville River near Ocean Point. Banks in this area, particularly on the outside of bends, generally have a relatively uniform 2H:1V to 3H:1V slope indicative of ice shove.

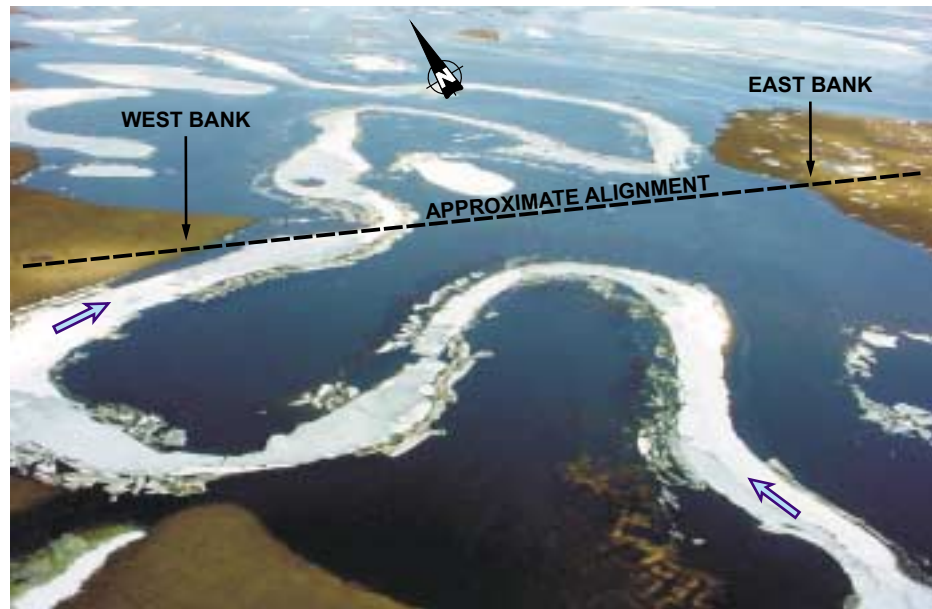
1. Water level increase and/or deterioration of the ice sufficient to lift the winter ice which was likely ground-fast in some areas. Velocities are relatively low in the main channel thus ice movement is very limited. Floodplain depths and velocities are expected to be even lower as evidenced by the lack of ice movement across the floodplains. The wide east floodplain offers an "escape route" in the event of an ice jam, therefore the likelihood and magnitude of ice jams will be low at this crossing.

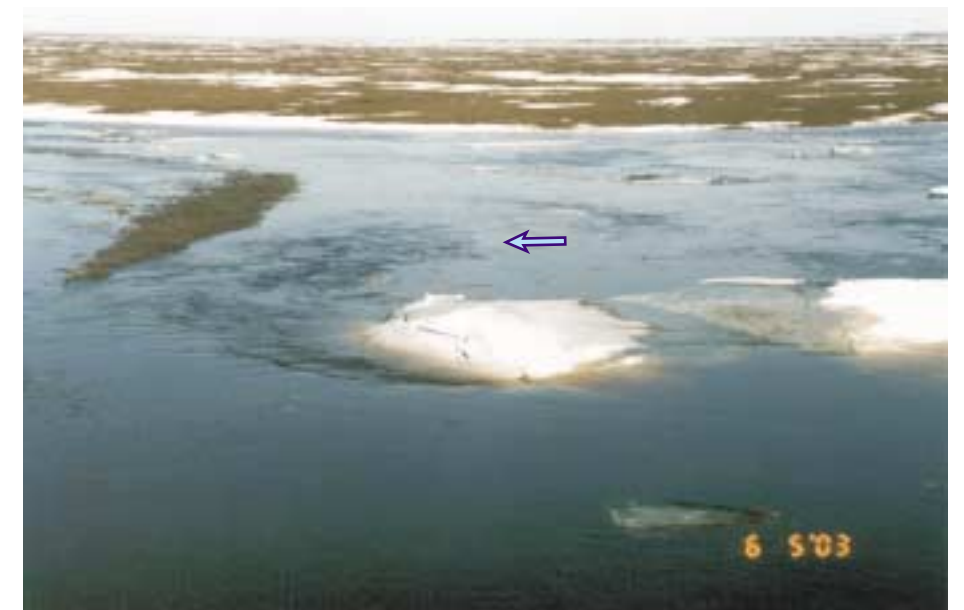
6. Low level view to the east (right) bank from the west side. Winter ice about to lift and move downstream.
