**GEOMORPHOLOGY OF THE NORTHEAST PLANNING AREA,  
NATIONAL PETROLEUM RESERVE—ALASKA, 2003**

THIRD ANNUAL REPORT

January 2004

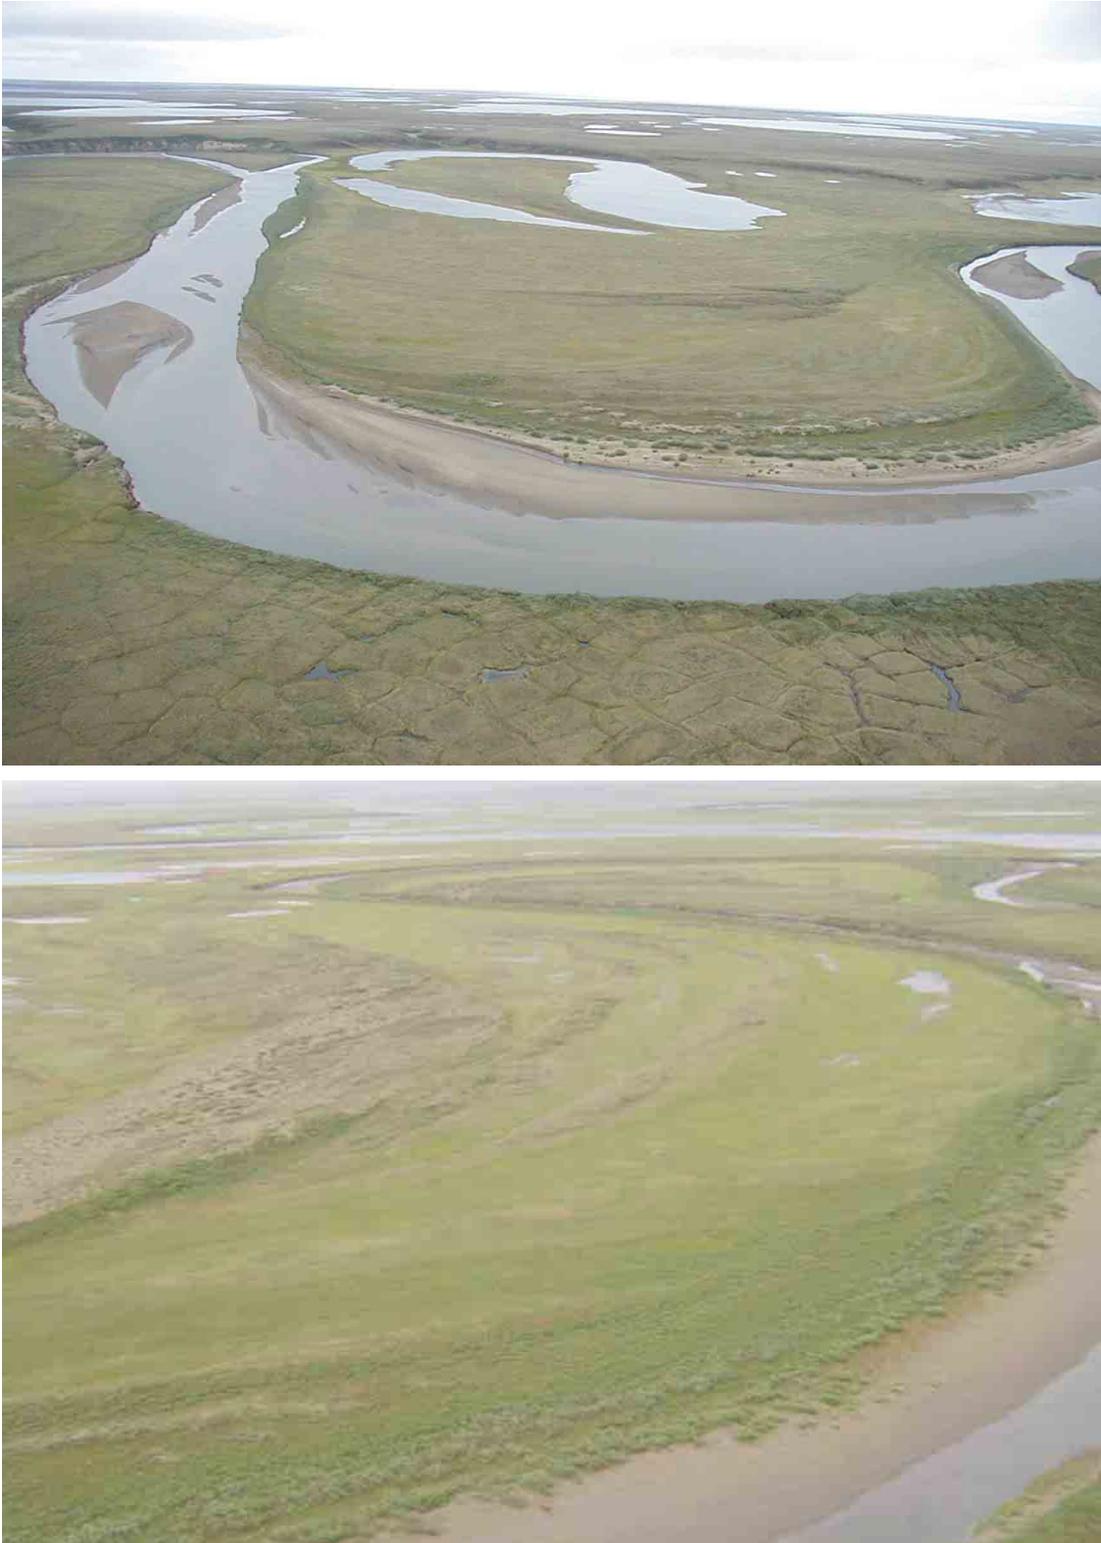
Figure 3. Oblique airphotos of the meander floodplain along Fish Creek in the Northeast Planning Area, NPRA, 2003. Upper photo illustrates complete floodplain development at Transect 6 and lower photo illustrates early floodplain development with large dunes that form behind point bars.

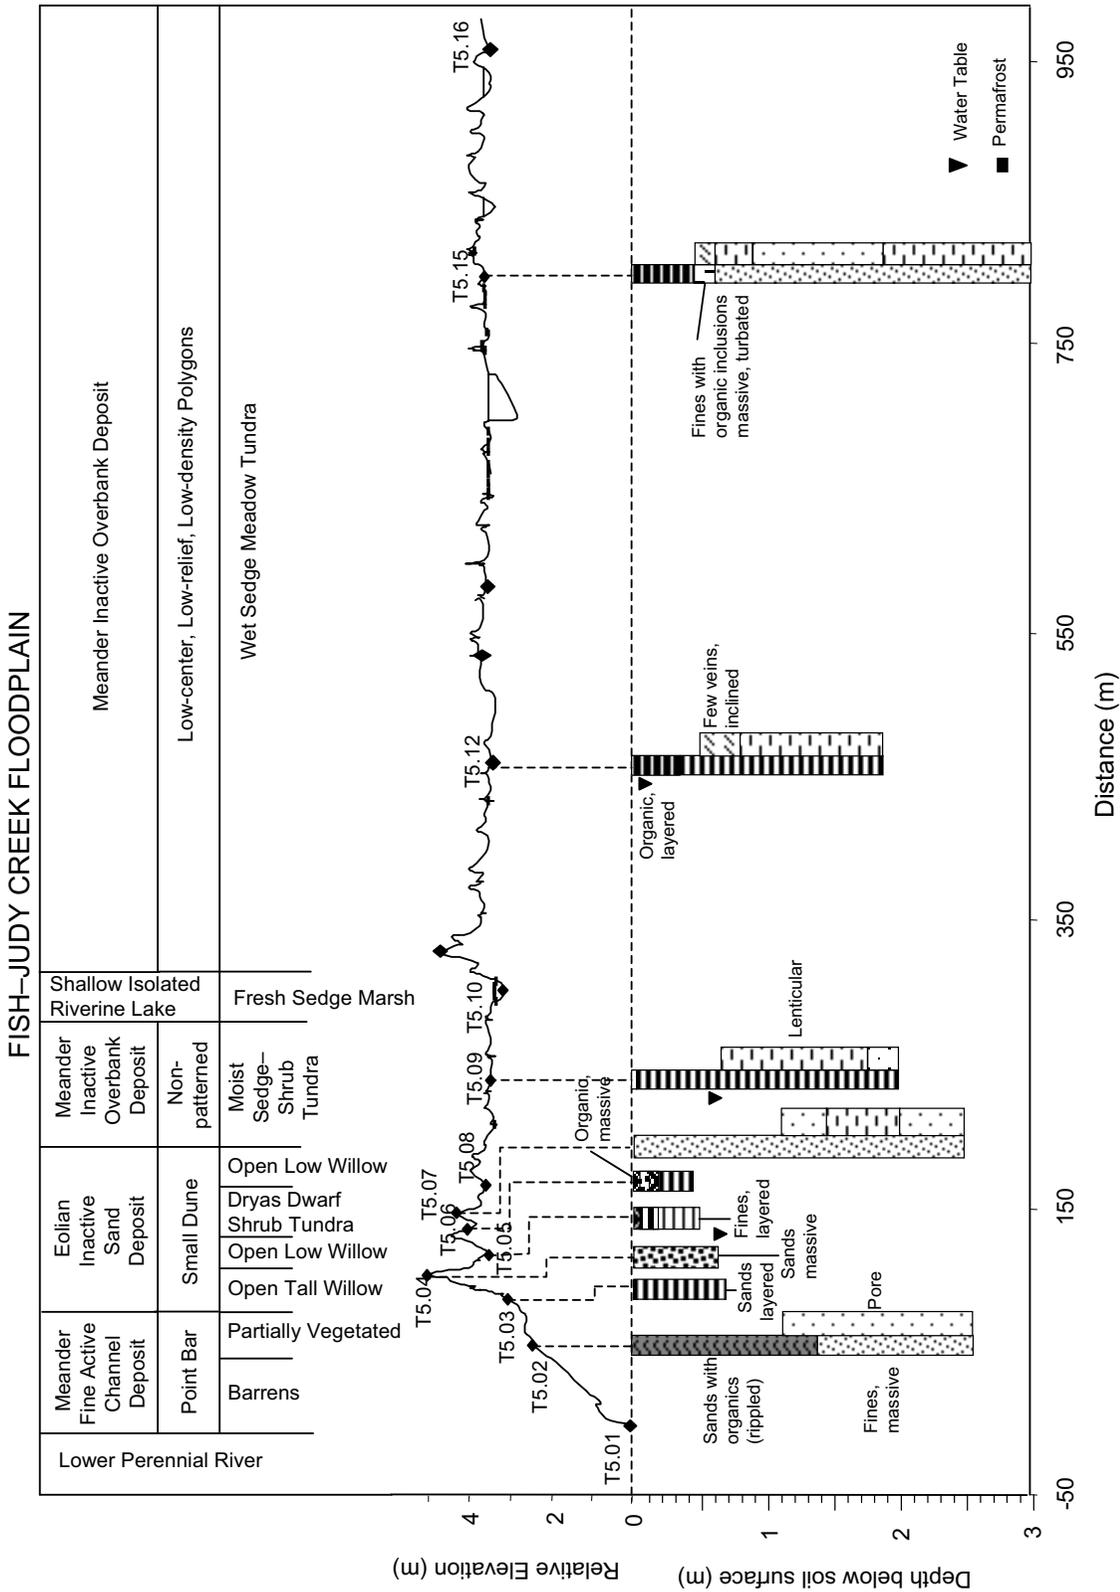
Figure 4. Soil stratigraphy along a floodplain toposequence (Transect 5) in the eastern portion of the Northeast Planning Area, NPRA, 2003.

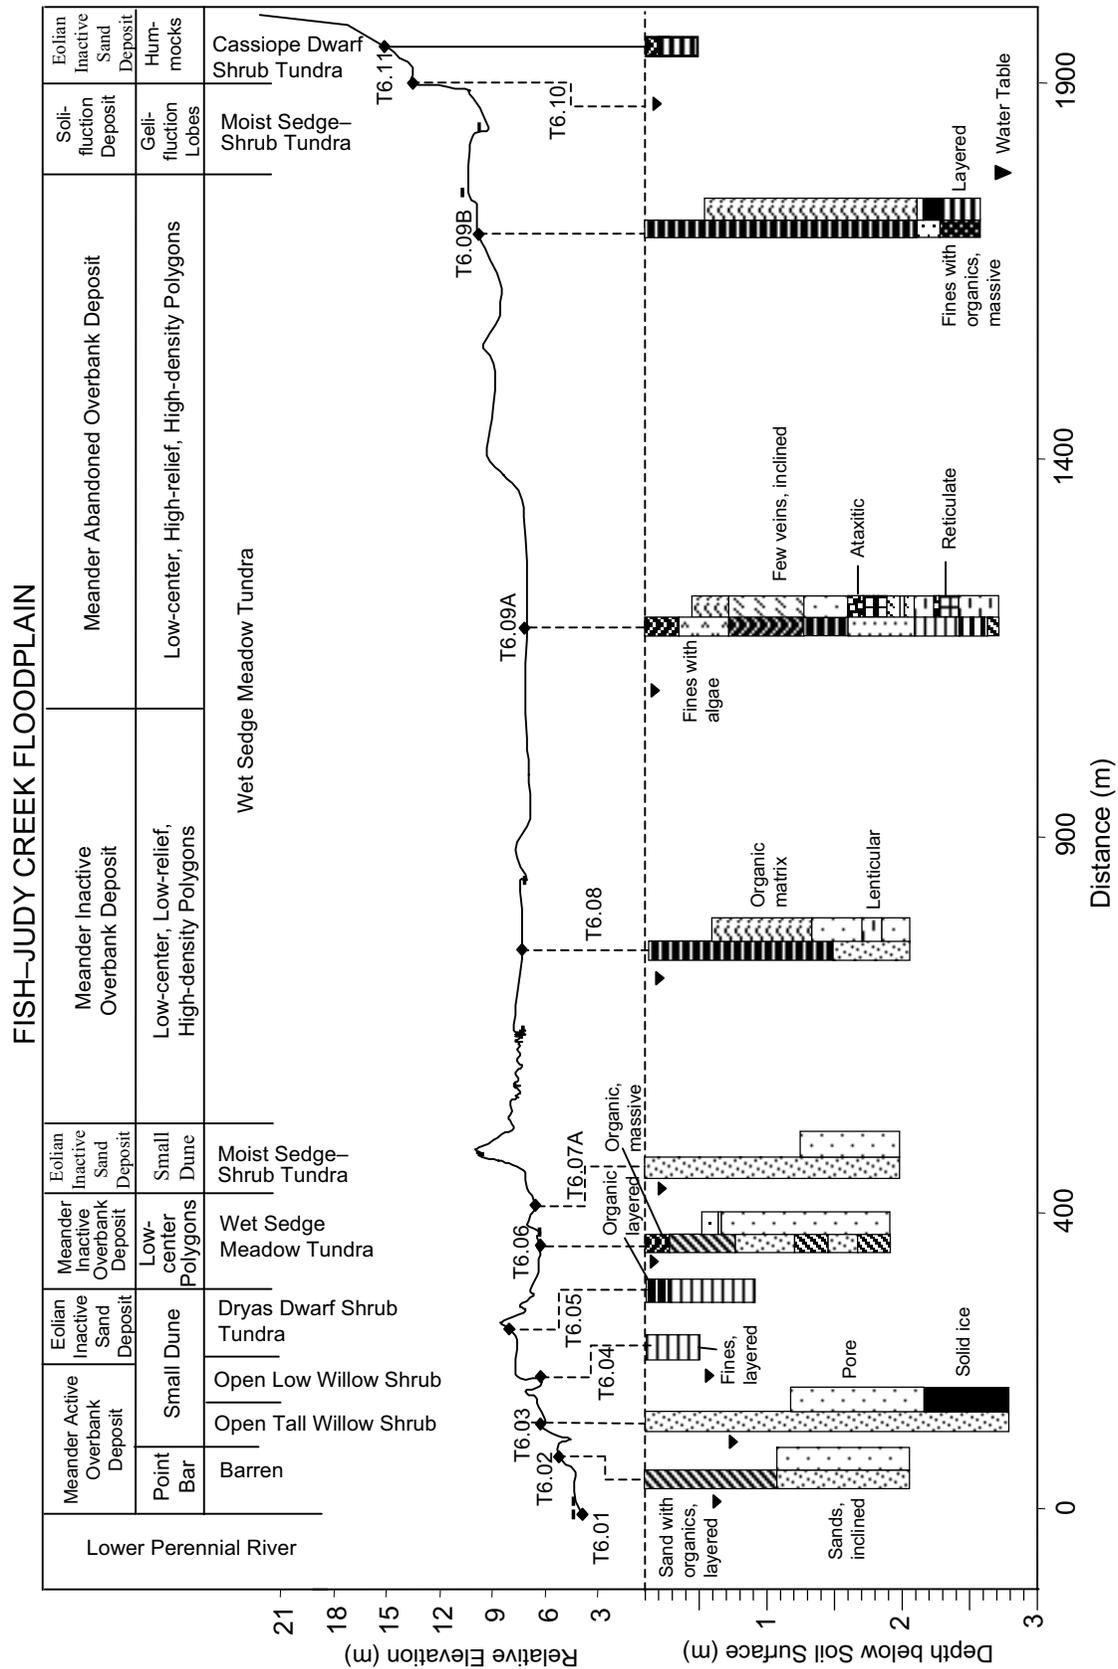
Figure 5. Soil stratigraphy along a floodplain toposequence (Transect 6) in the central portion of the Northeast Planning Area, NPRA, 2003.

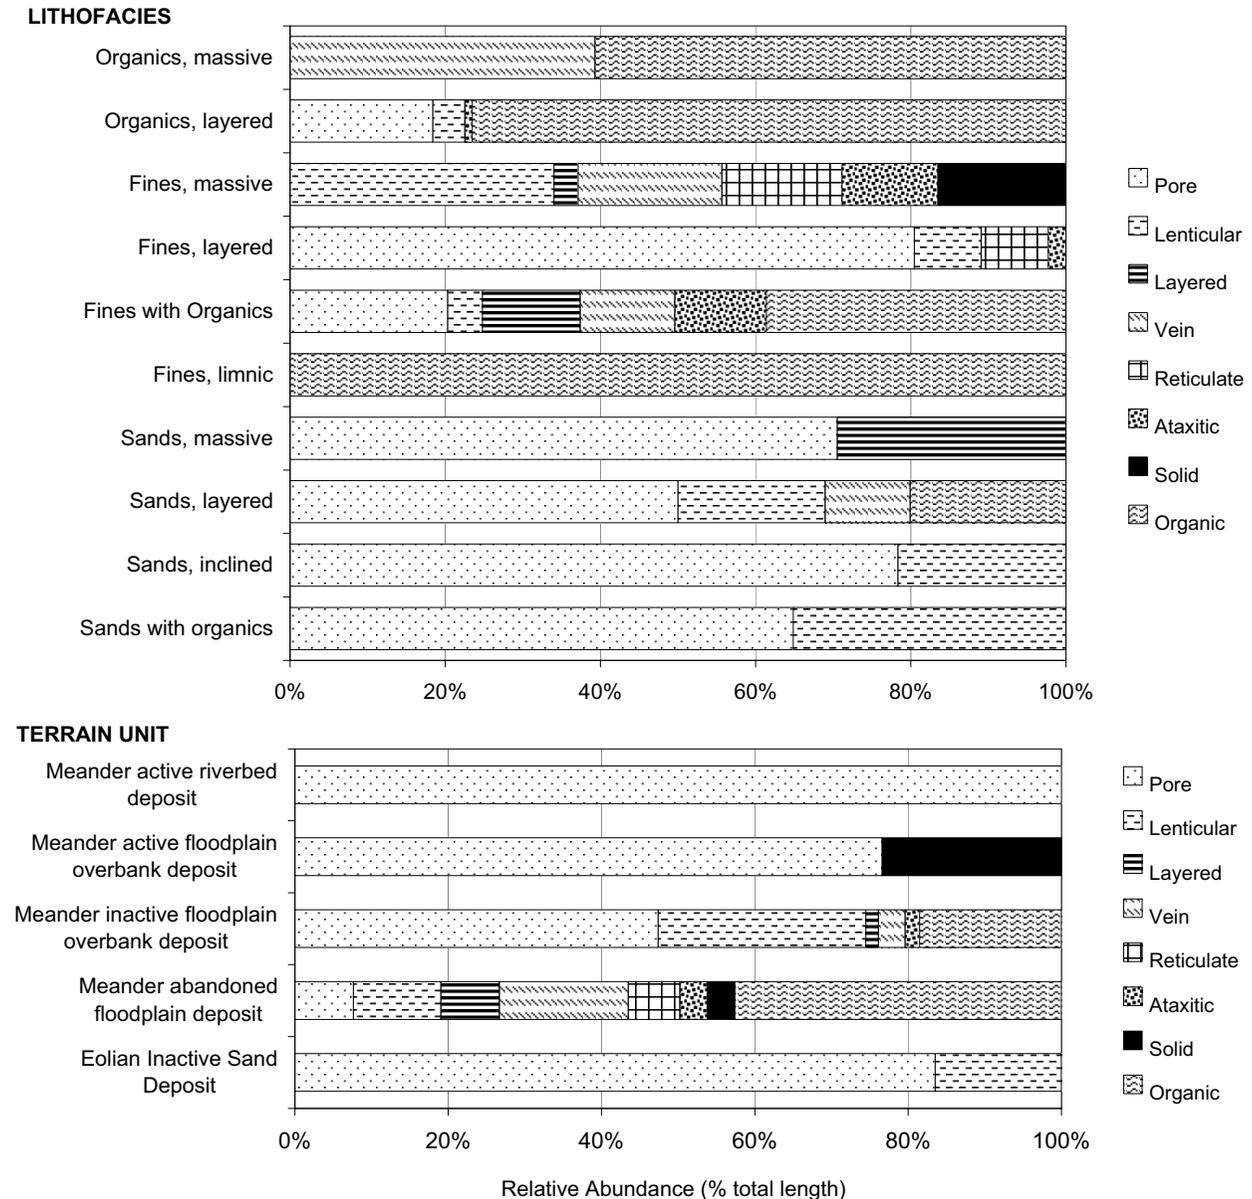
Figure 6. Relative distribution (% of total core length) of ice structures by lithofacies (top) and by surface terrain unit (bottom) for fluvial soils in the Northeast Planning Area, NPRA, 2003..

Eolian active and inactive deposits usually occurred as distinct streaked dunes comprised of massive and inclined sands. They typically were found in close association with active channel deposits that provided the source areas for the wind blown sand. Active eolian deposits lacked organic matter accumulation at the surface, indicating frequent sand deposition, whereas, inactive deposits had thin organic material horizons or a distinct A soil horizon indicating greater age and lack of active eolian input. Ice structures in the frozen subsurface were dominated by visible and non-visible pore ice and some lenticular ice (Figure 6).

Abandoned overbank cover deposits generally had complex and well-developed subsurface cryostructures. Ice structure was dominated by organic-matrix ice, but all eight primary structures were observed in soils in this terrain type (Figure 6). Mean volumetric ice content was 78% and ranged from 64.1 to 100% (Figure 8). Ice volumes were generally highest just below the active layer in organic and silt-dominated sediments (Figure 9).

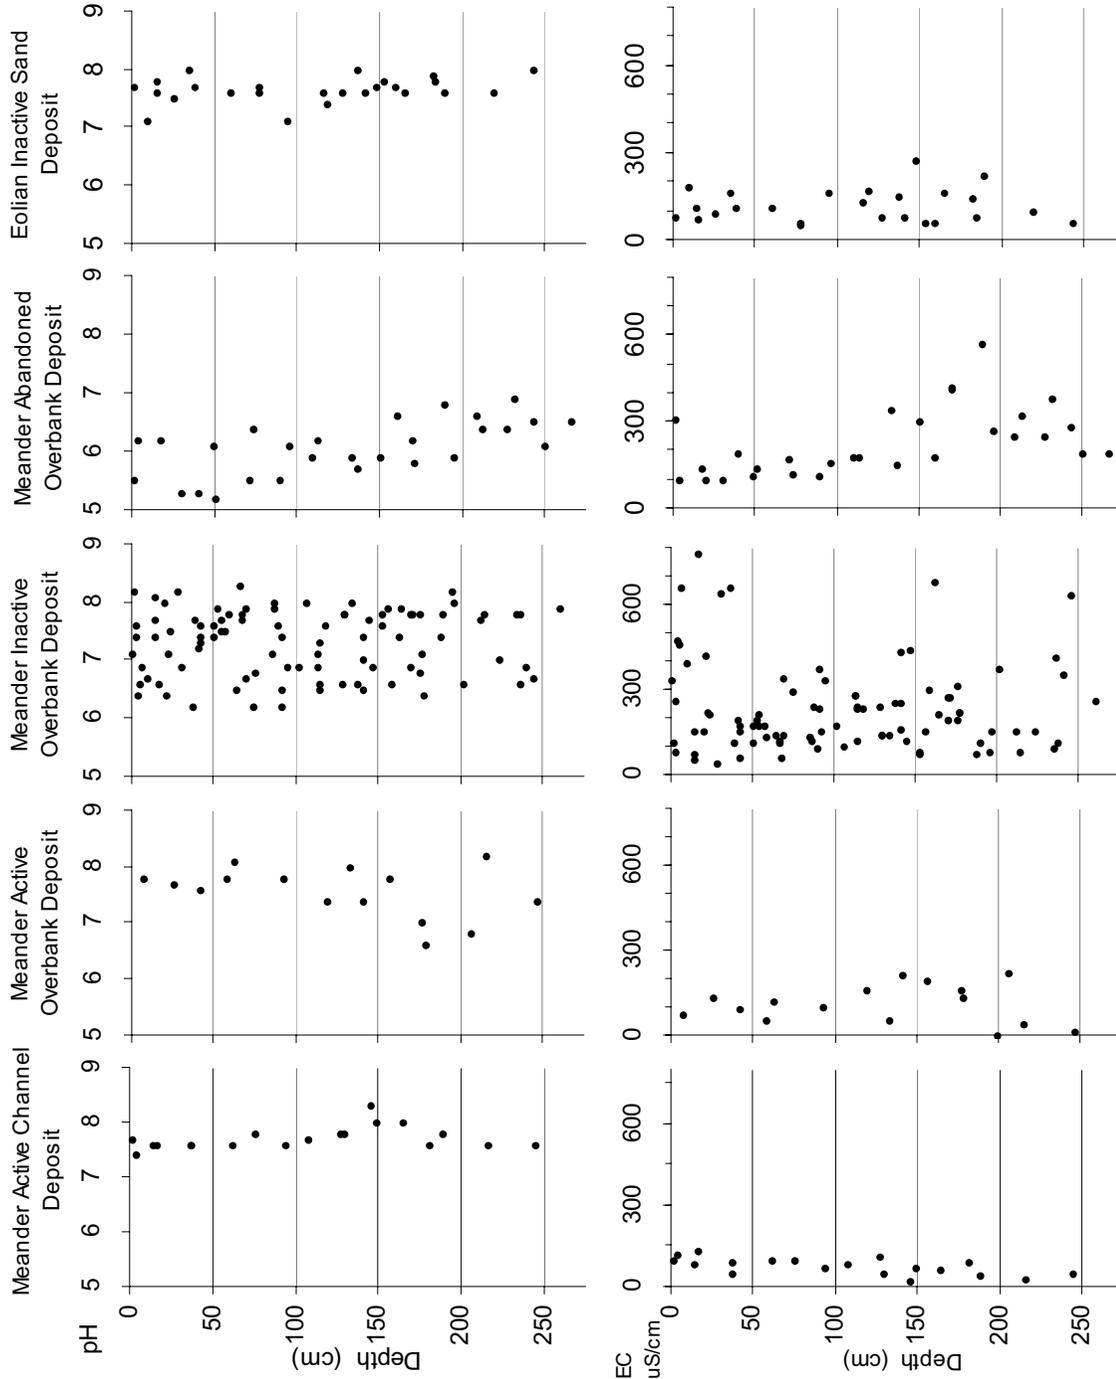
Figure 7. Depth profiles of electrical conductivity (EC) and pH by surface terrain unit, Northeast Planning Area, NPRA, 2003.

associated with sediment deposition during early floodplain development cause soils to be alkaline, but as deposits become thicker, receive less flooding and sedimentation, and leach over time, the soils become circumneutral to strongly acidic. Inactive eolian sand deposits had pH values ranging from 7.1 to 8.0 and values varied little with depth (Figure 7).

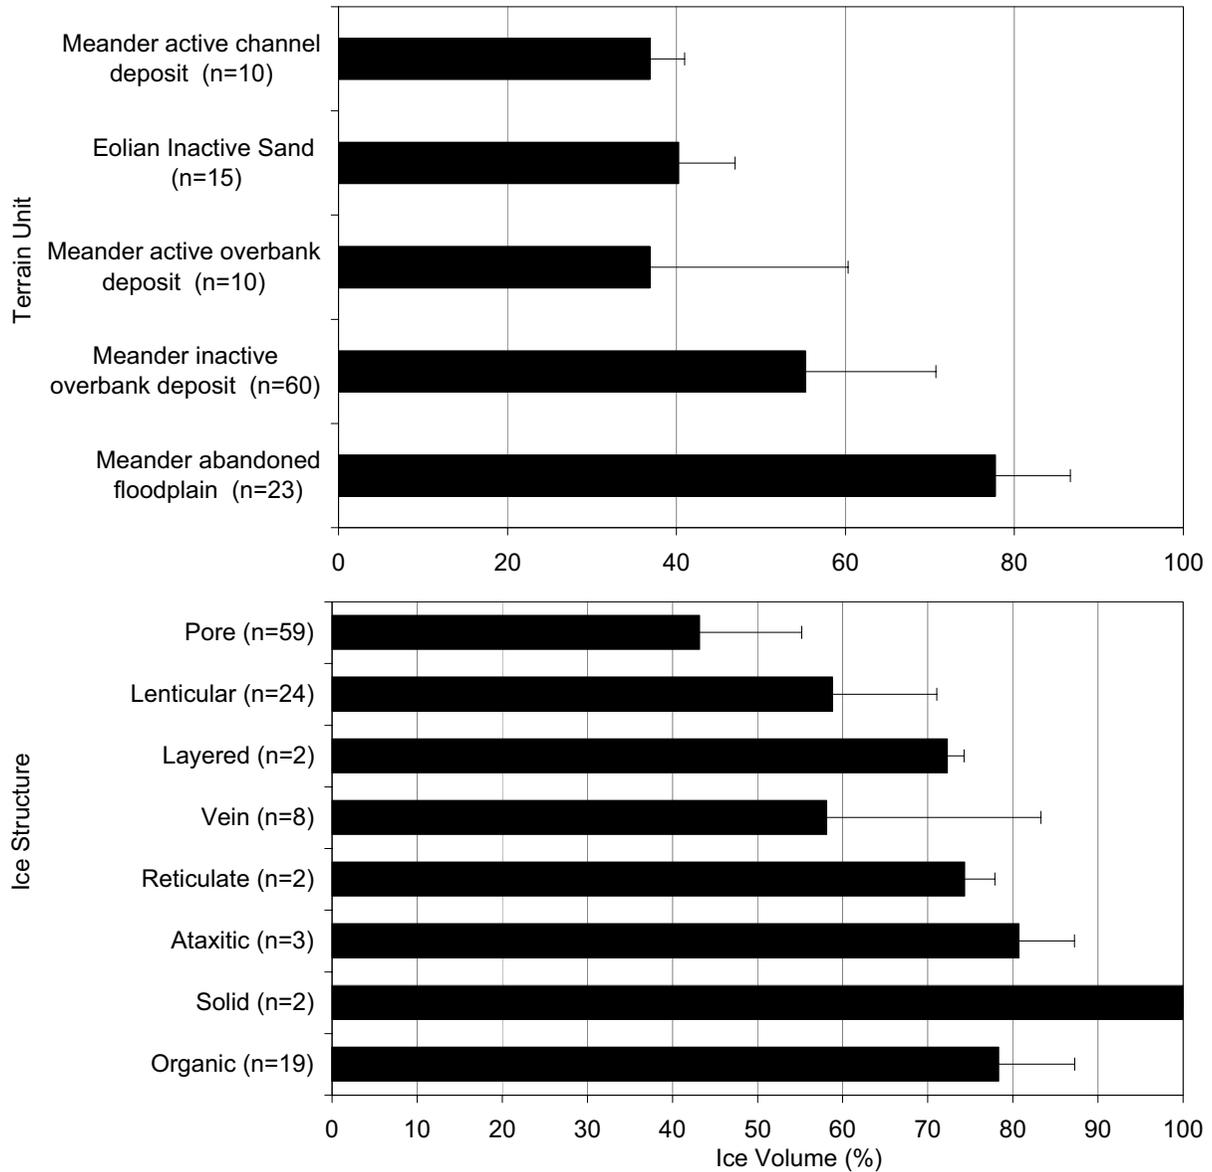
Figure 8. Mean ( $\pm$  SD) volumetric ice contents grouped by primary ice structure (top), lithofacies (middle), and surface terrain unit (bottom), Northeast Planning Area, NPRA, 2003.

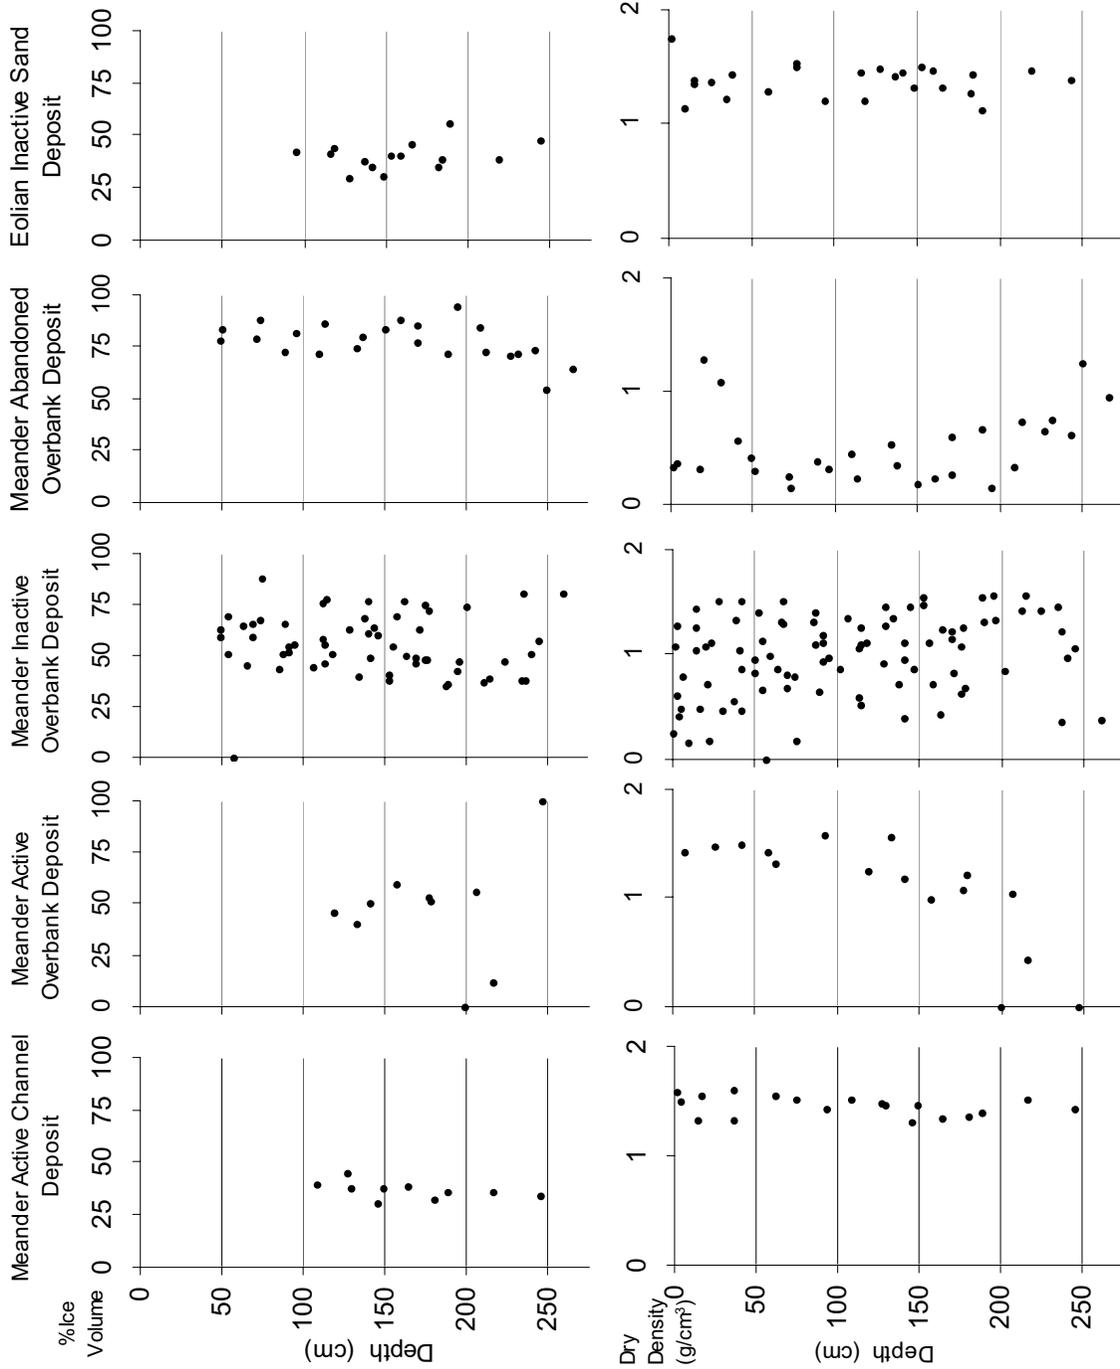
Figure 9. Depth profiles of volumetric ice and dry density by surface terrain unit, Northeast Planning Area, NPRA, 2003.

Meander fine active channel deposits contained only visible and non-visible pore structures (ice within the pores of the soil matrix) with ice volumes rarely exceeding the soil pore space. Soil ice development in this terrain is limited due to the young age of the deposit and the coarse size of the sediment (medium to fine sands). Mean ice volume was 37% and ranged from 30.7–47.3% (Figure 8). Soil ice content showed little change with depth in the top 2.5 meters (Figure 9).

Meander active floodplain overbank deposits contained mostly visible and non-visible pore ice, although one core (T6.03) collected from this terrain unit included an occurrence of solid ice of uncertain origin (Figure 6). Pore ice in this terrain unit was generally more developed and visible compared to the active channel deposits. Mean ice volume was 37% and ranged from 12–59%, with the exception of 100% in the one core with solid ice (Figure 8). Soil ice content generally increased with depth to 2.5 m (Figure 9).

Inactive overbank cover deposits begin to show more advanced ice aggradation as a result of the accumulation of organic material and slackwater deposition of silts and very fine sands. Soil profiles were still dominated by pore ice, but lenticular, layered, vein, ataxitic, and organic-matrix ice structures also occurred (Figure 6). Mean volumetric ice content was 55% and ranged from 38.1 to 72.7% (Figure 8). Ice content was highly variable and showed no trend with depth (Figure 9). Polygonal rims indicating

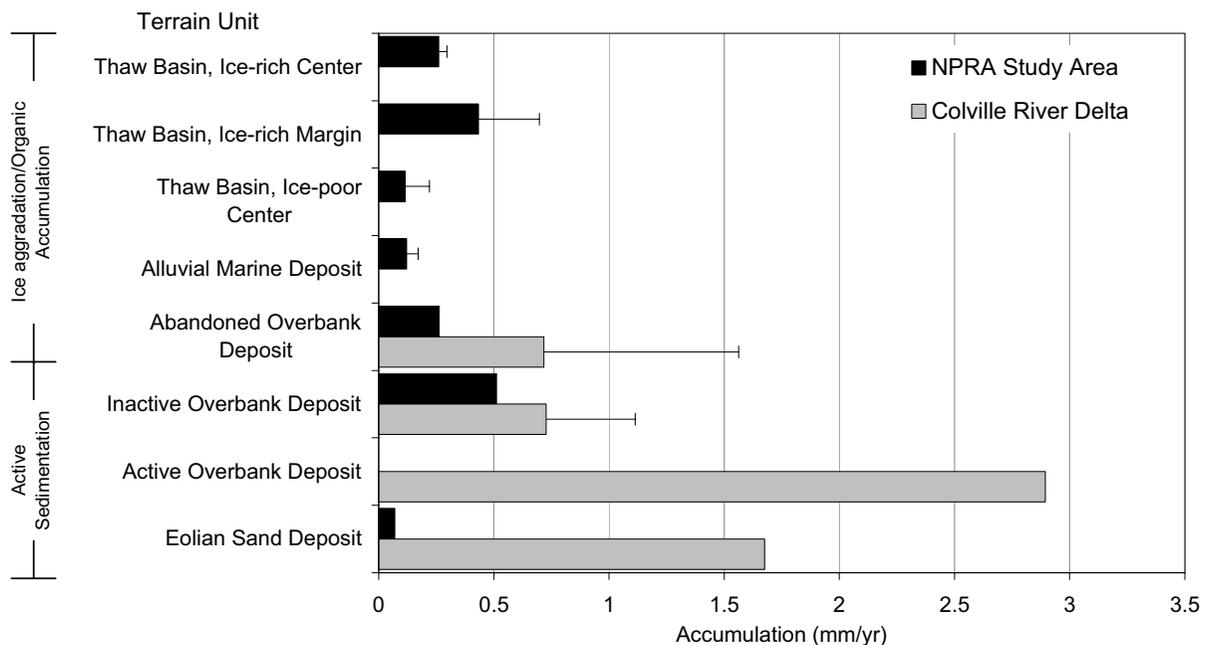
Figure 10. Mean accretion rates (mm/yr) of surface materials (organic, mineral, ice) on inactive and abandoned floodplains along Fish Creek, Northeast Planning Area, NPRA, 2003. Accretion rates were calculated by dividing depth by calibrated radiocarbon age.

from core sections and bank exposures. One inactive overbank deposit (E10) had a mean accumulation rate of 0.5 mm/yr, about double that on an abandoned overbank deposit (T6.09b), which had a mean accumulation rate of 0.26 mm/yr (Figure 10).

Accumulation rates were lower than those than the mean rates observed for similar floodplain deposits in the Colville Delta (Jorgenson et al. 1995) (Figure 10). However, the accumulations rates in the Fish and Judy Creek floodplains were greater than many rates observed in other terrain types.

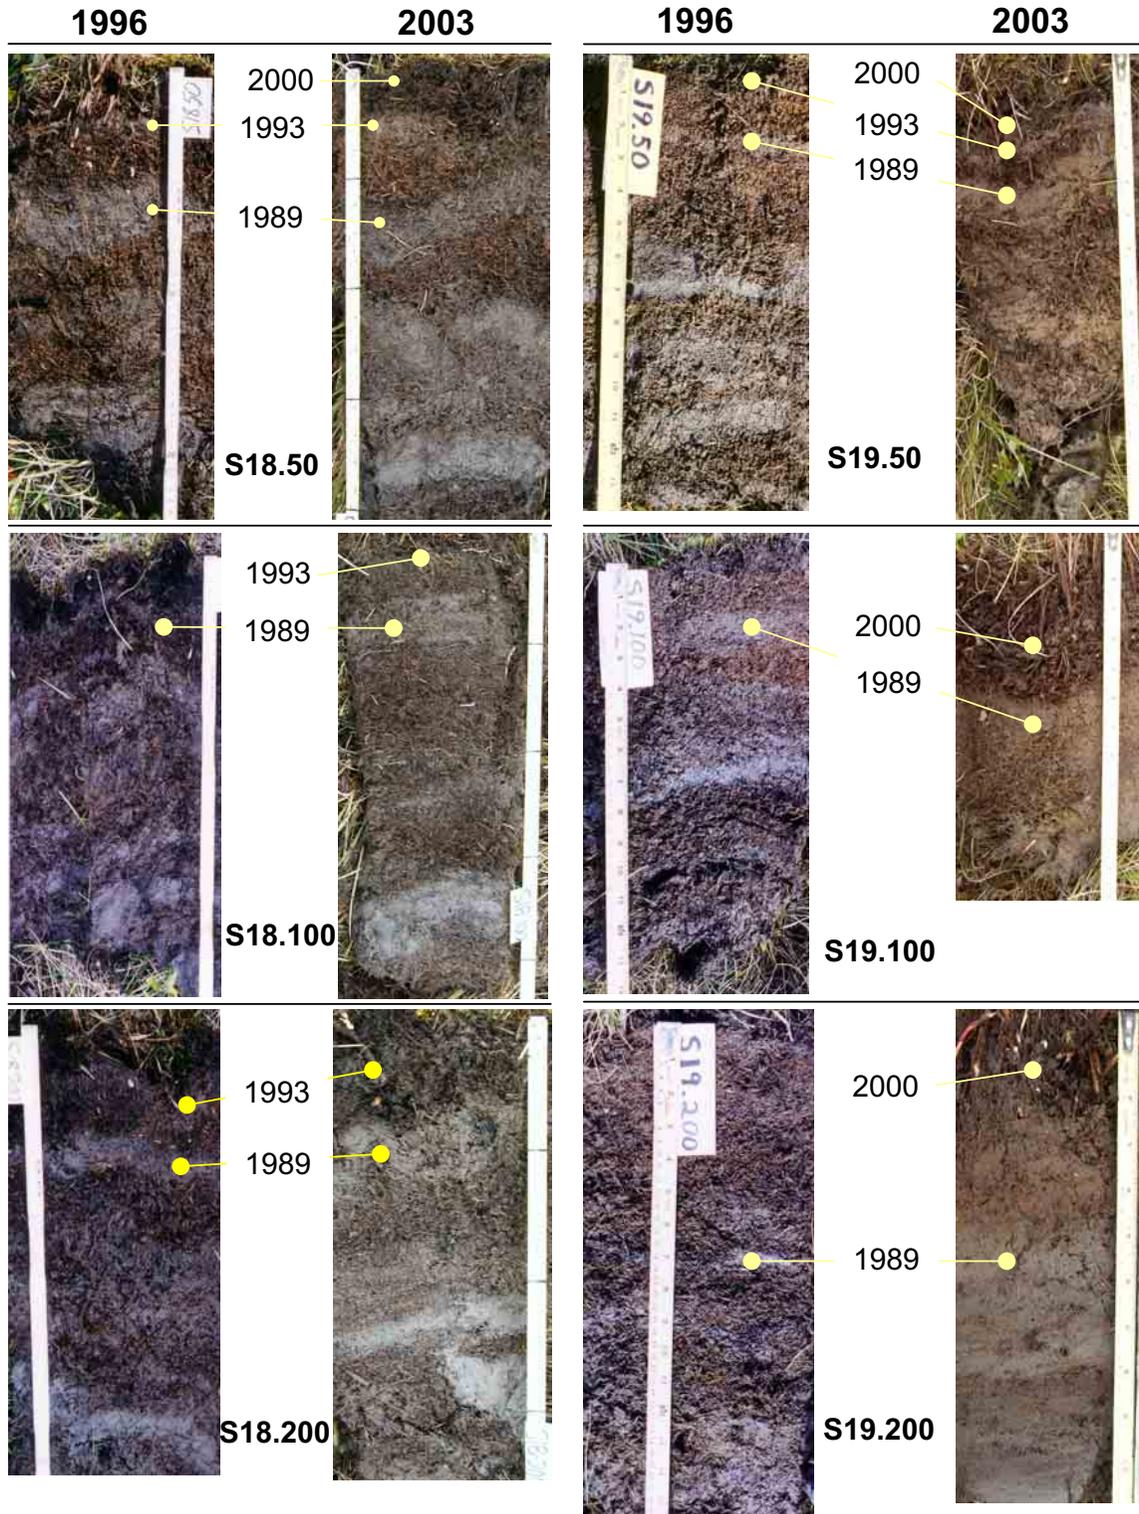
Figure 11. Photographs of soil profiles taken in 1996 and 2003 illustrating sediment deposits associated with overbank flooding in 1989, 1993, and 2000 along the Negliq Channel in the Colville Delta, 2003.

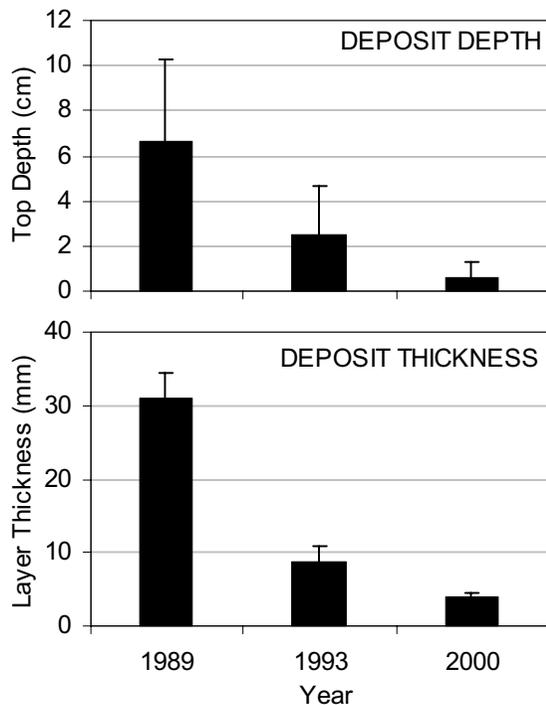
Figure 12. Mean depth to and thickness of sediment deposits associated with overbank flooding in 1989, 1993, and 2000 along the Negliq Channel in the Colville Delta, 2003.

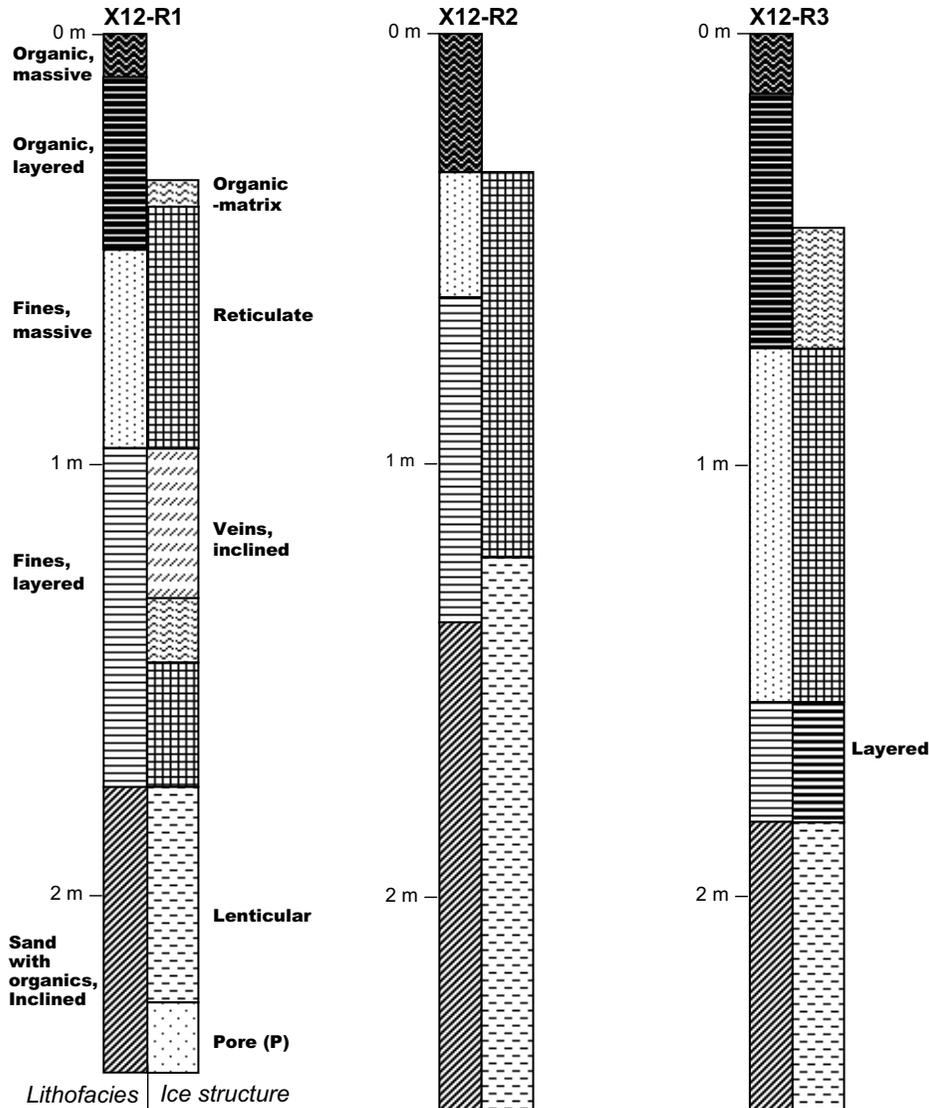
Figure 13. Soil and ice stratigraphy of three cores obtained along the proposed road alignment across the Nigliq Channel, western Colville Delta, 2003.

proposed road alignment near the Negliq Channel reveal thick accumulations of layered and massive fine-grained sediments (silt and very fine sand) (Figure 13). Mean ice contents in the three profiles ranged from 60–90%, indicating soils are very ice-rich due to the formation of segregated ice associated with the fine-grained sediments.

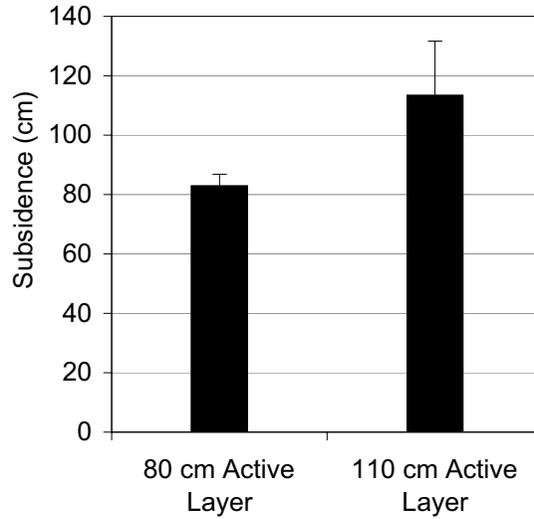
Figure 14. Potential mean ( $\pm$  SD,  $n = 3$ ) thaw settlement estimates for delta inactive floodplain deposits if the active layer increased to either 80 or 110 cm after severe surface disturbance, Colville Delta, 2003.

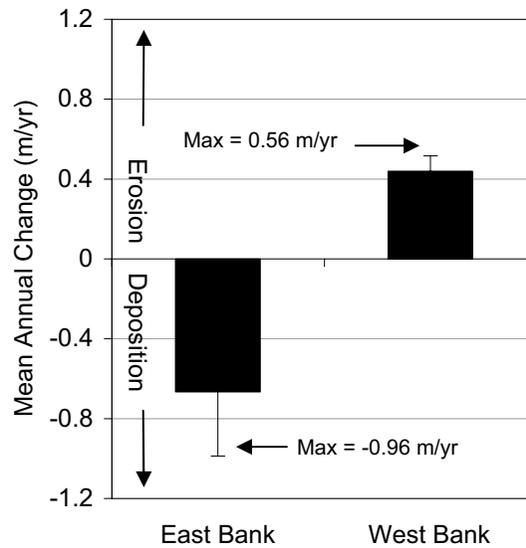
Figure 15. Rates of bank erosion near the proposed road alignment across the Nigliq Channel, western Colville Delta, 2003.

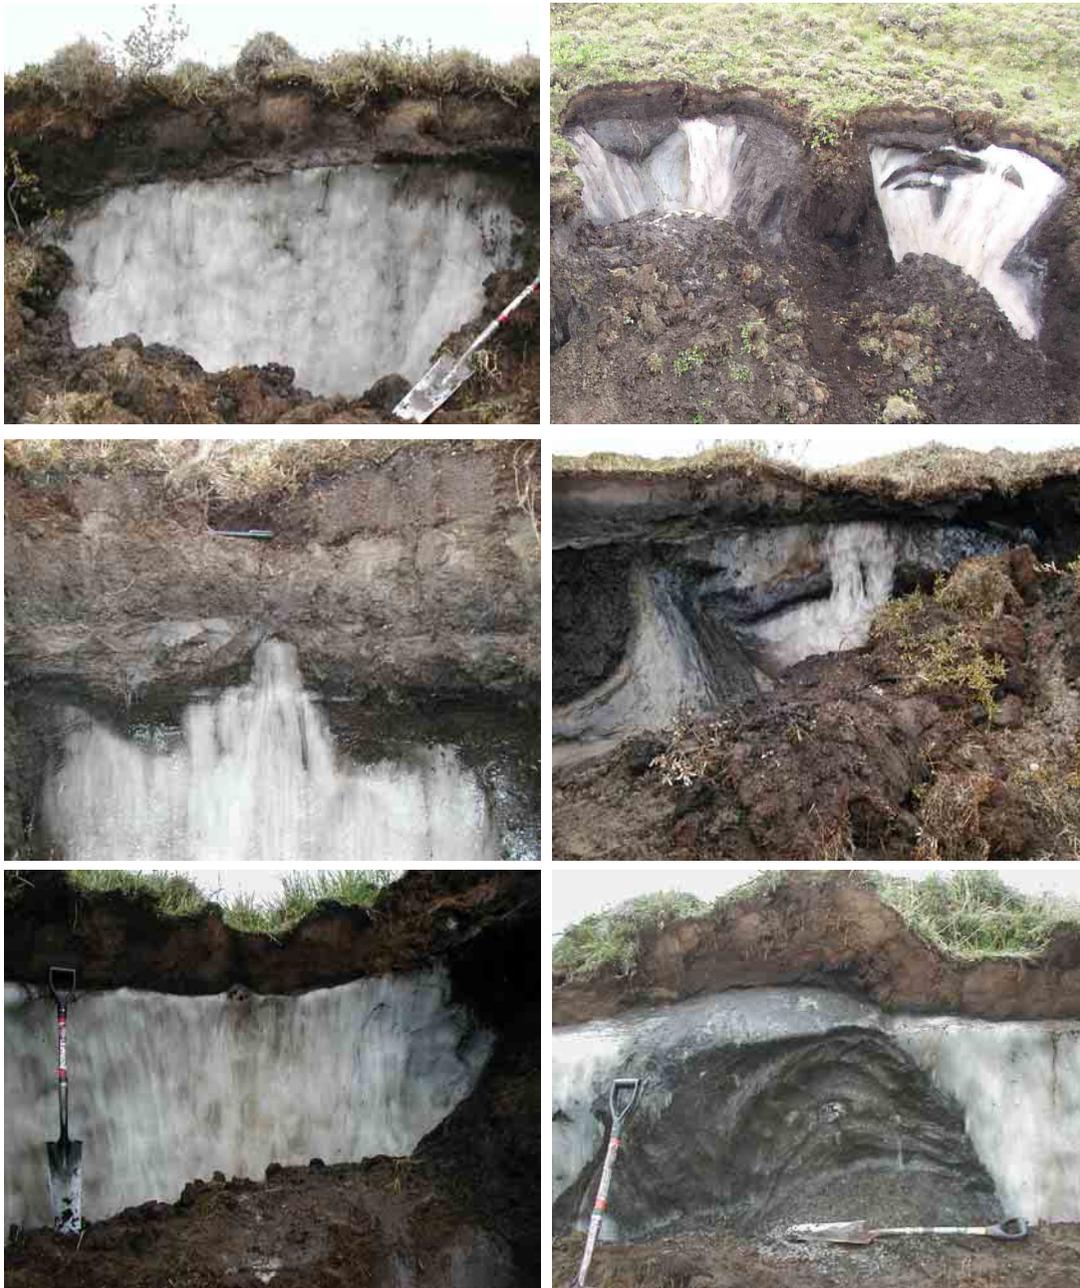
Figure 16. Views of ice wedges at bank exposures illustrating the thin layer of organic and mineral material over massive ice, and sediment deformation between ice wedges, Northeast Planning Area, NPRA, 2003.

Ice wedges in old upland terrain (alluvial-marine deposits, old alluvial terraces) typically were 2.5–3 m across at the top (Figure 16). Lengths of the ice-wedges were not determined, but we estimated the wedges were 3–4 m in length. The ice wedges were capped by 35–45 cm of organic and mineral soil. The active layer above the wedges typically was 30–40 cm, leaving 5–10 cm of frozen soil above the wedge ice. We estimate the wedges are at least 3,000 years old based on rates of wedge development quantified for the Colville Delta (Jorgenson et al. 1997a) and because the upland surfaces have been stable for ~8–10 thousand years based on radiocarbon dating of basal peat layers (Jorgenson et al. 2003a). Based on the stratigraphy at these exposures and the estimated age of the ice, we

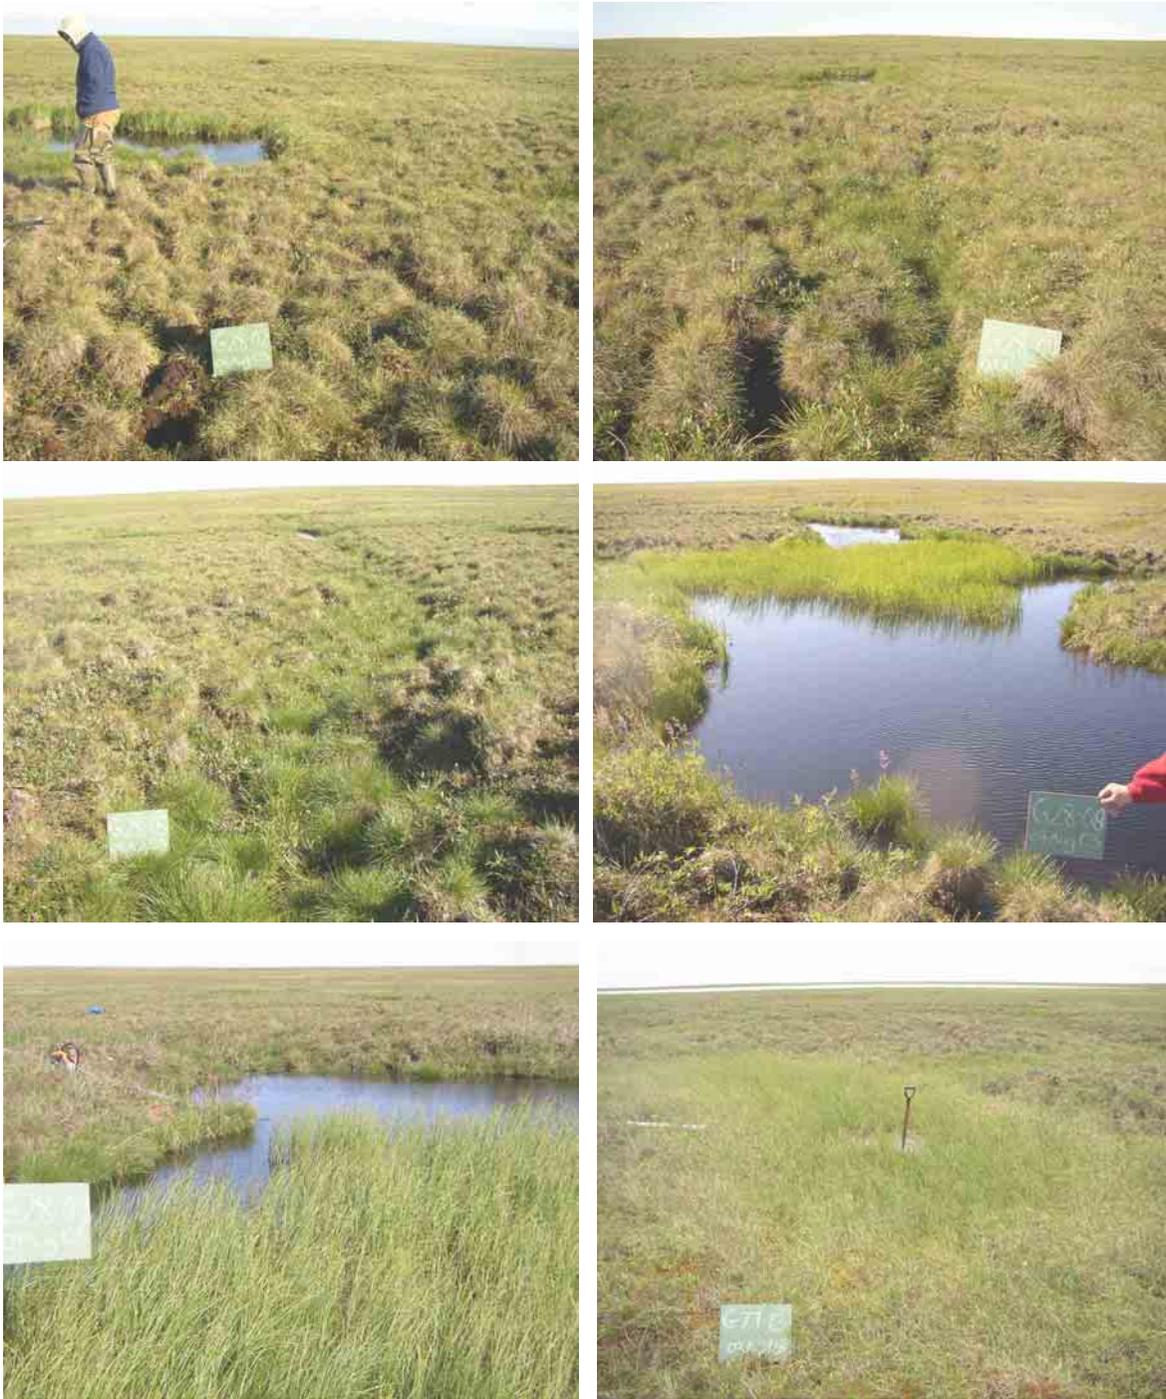
Figure 17. Ground views of six stages of ice-wedge degradation. Stages are: undegraded troughs (upper right), initial (upper left), intermediate (middle left), and advanced degradation (middle right), initial (lower left), and advance stabilization (lower right). Northeast Planning Area, NPRA, 2003.

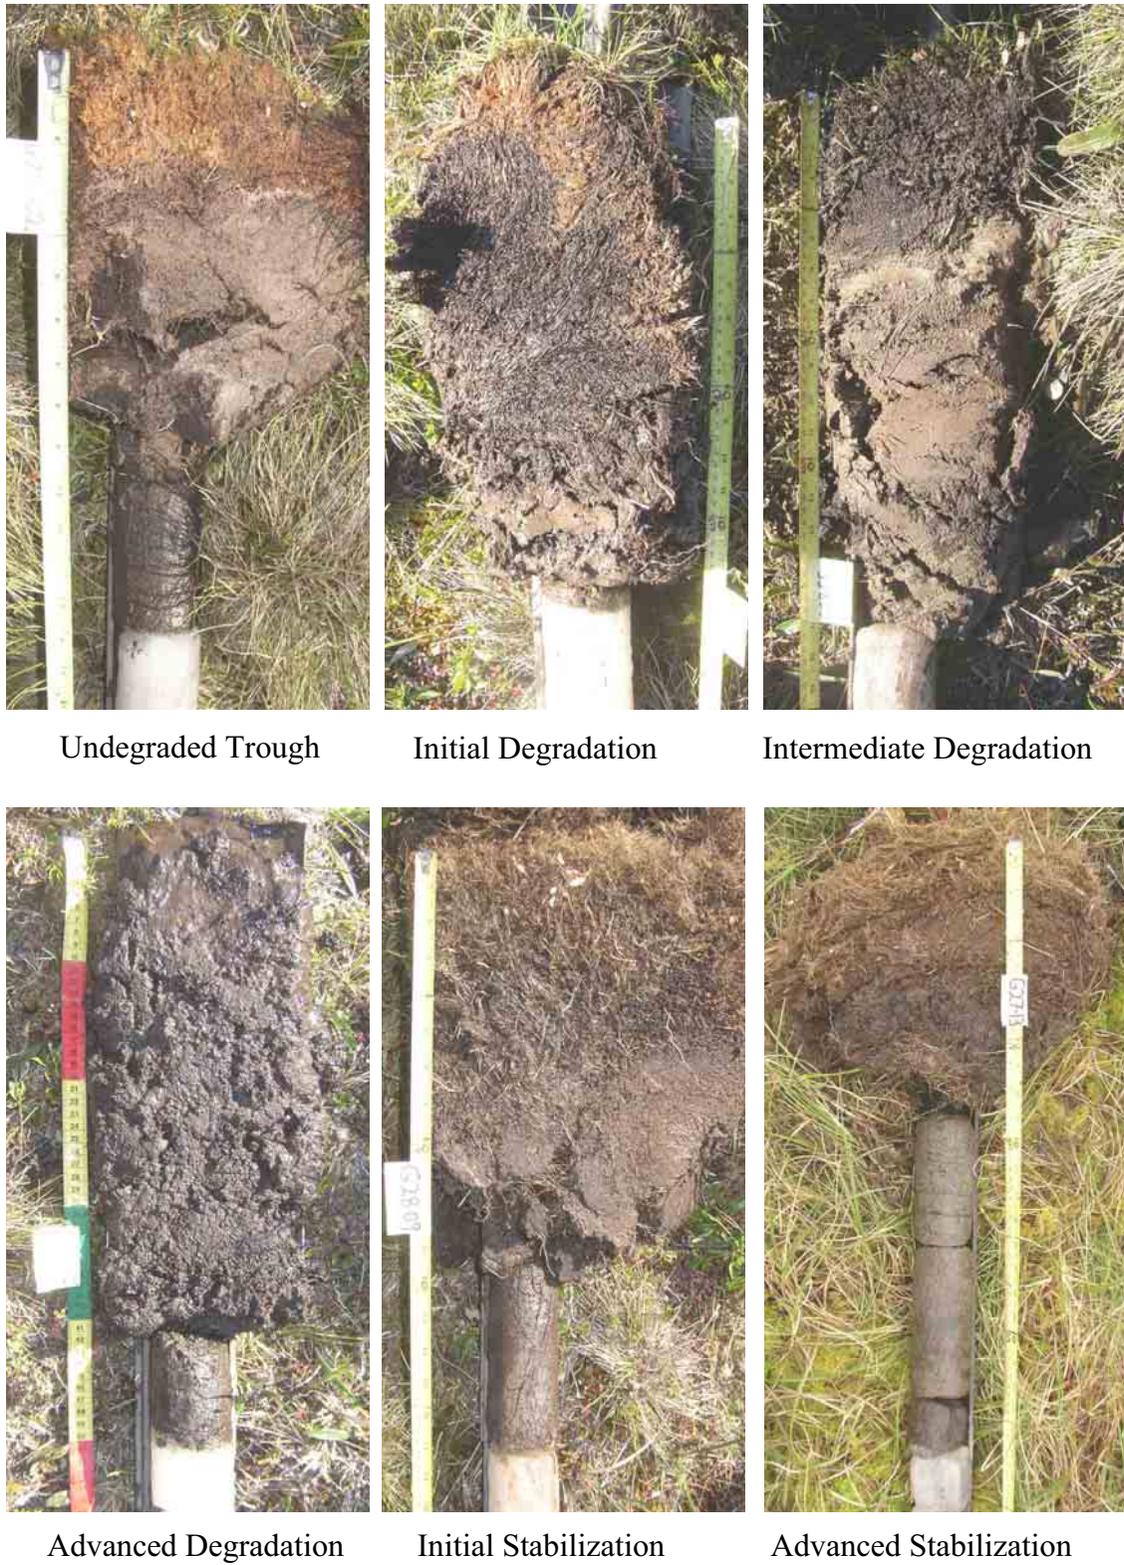
Figure 18. Photographs of soil profiles illustrating changes in soil stratigraphy and ice structures associated with six stages of ice-wedge degradation, Northeast Planning Area, NPRA, 2003.

Finally, ice structures in the frozen soil above the wedge ice changed radically between degradation and subsequent stabilization (Figures 18 and 19). During the undegraded and

initial-degradation stages, the frozen soil had mostly fine, wavy lenticular ice, with lesser amounts of medium thick (3–5 mm) layered ice and organic-matrix ice. During advanced degradation, the frozen soil had mostly organic-matrix ice, while new solid ice (horizontal oriented transparent ice with small amounts of soil inclusions; also referred to as congelation ice) developed as a thin layer and aggraded to 8 cm during initial stabilization. The thickness of the new ice was highly variable, however, indicating the sensitivity of the aggradation process to site-specific conditions. The new ice presumably formed during rapid freezeback because water is readily available to move to the upward freezing front through the disrupted soils. Finally, during advanced stabilization more complex ice structures developed, including reticulate and layered ice. The reticulate ice presumably developed in response to slow adjustment and thinning of the active layer as new sedge peat accumulated at the surface. The bedded ice presumably developed in response to rapid freezeback in the fall after particular seasonal thawing events.
