**GEOMORPHOLOGY OF THE NORTHEAST PLANNING AREA,  
NATIONAL PETROLEUM RESERVE—ALASKA, 2003**

THIRD ANNUAL REPORT

January 2004

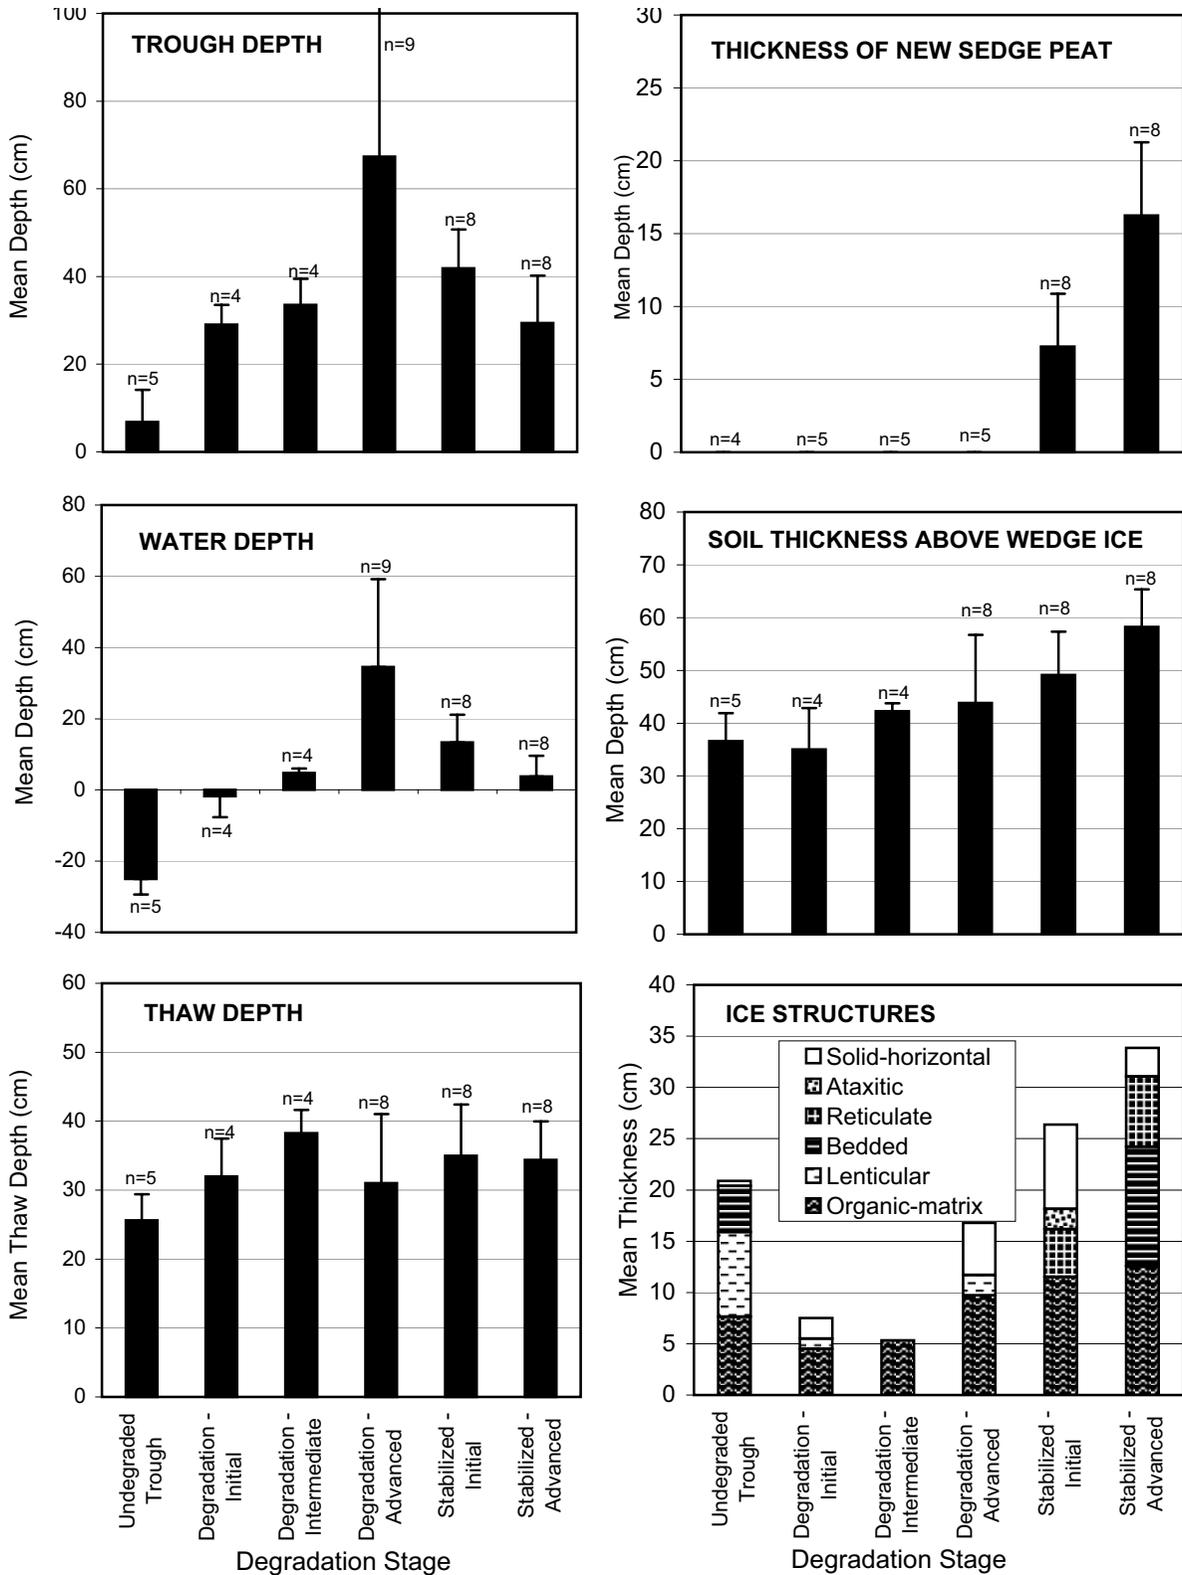
Figure 19. Changes in mean ( $\pm$  SD) trough depths, water depths (negative indicates water is below surface), thaw depths, thickness of new sedge peat, thickness of soil above wedge ice, and thickness of various ice structures associated with six stages of ice-wedge degradation, Northeast Planning Area, NPRA, 2003.

Finally, ice structures in the frozen soil above the wedge ice changed radically between degradation and subsequent stabilization (Figures 18 and 19). During the undegraded and

initial-degradation stages, the frozen soil had mostly fine, wavy lenticular ice, with lesser amounts of medium thick (3–5 mm) layered ice and organic-matrix ice. During advanced degradation, the frozen soil had mostly organic-matrix ice, while new solid ice (horizontal oriented transparent ice with small amounts of soil inclusions; also referred to as congelation ice) developed as a thin layer and aggraded to 8 cm during initial stabilization. The thickness of the new ice was highly variable, however, indicating the sensitivity of the aggradation process to site-specific conditions. The new ice presumably formed during rapid freezeback because water is readily available to move to the upward freezing front through the disrupted soils. Finally, during advanced stabilization more complex ice structures developed, including reticulate and layered ice. The reticulate ice presumably developed in response to slow adjustment and thinning of the active layer as new sedge peat accumulated at the surface. The bedded ice presumably developed in response to rapid freezeback in the fall after particular seasonal thawing events.

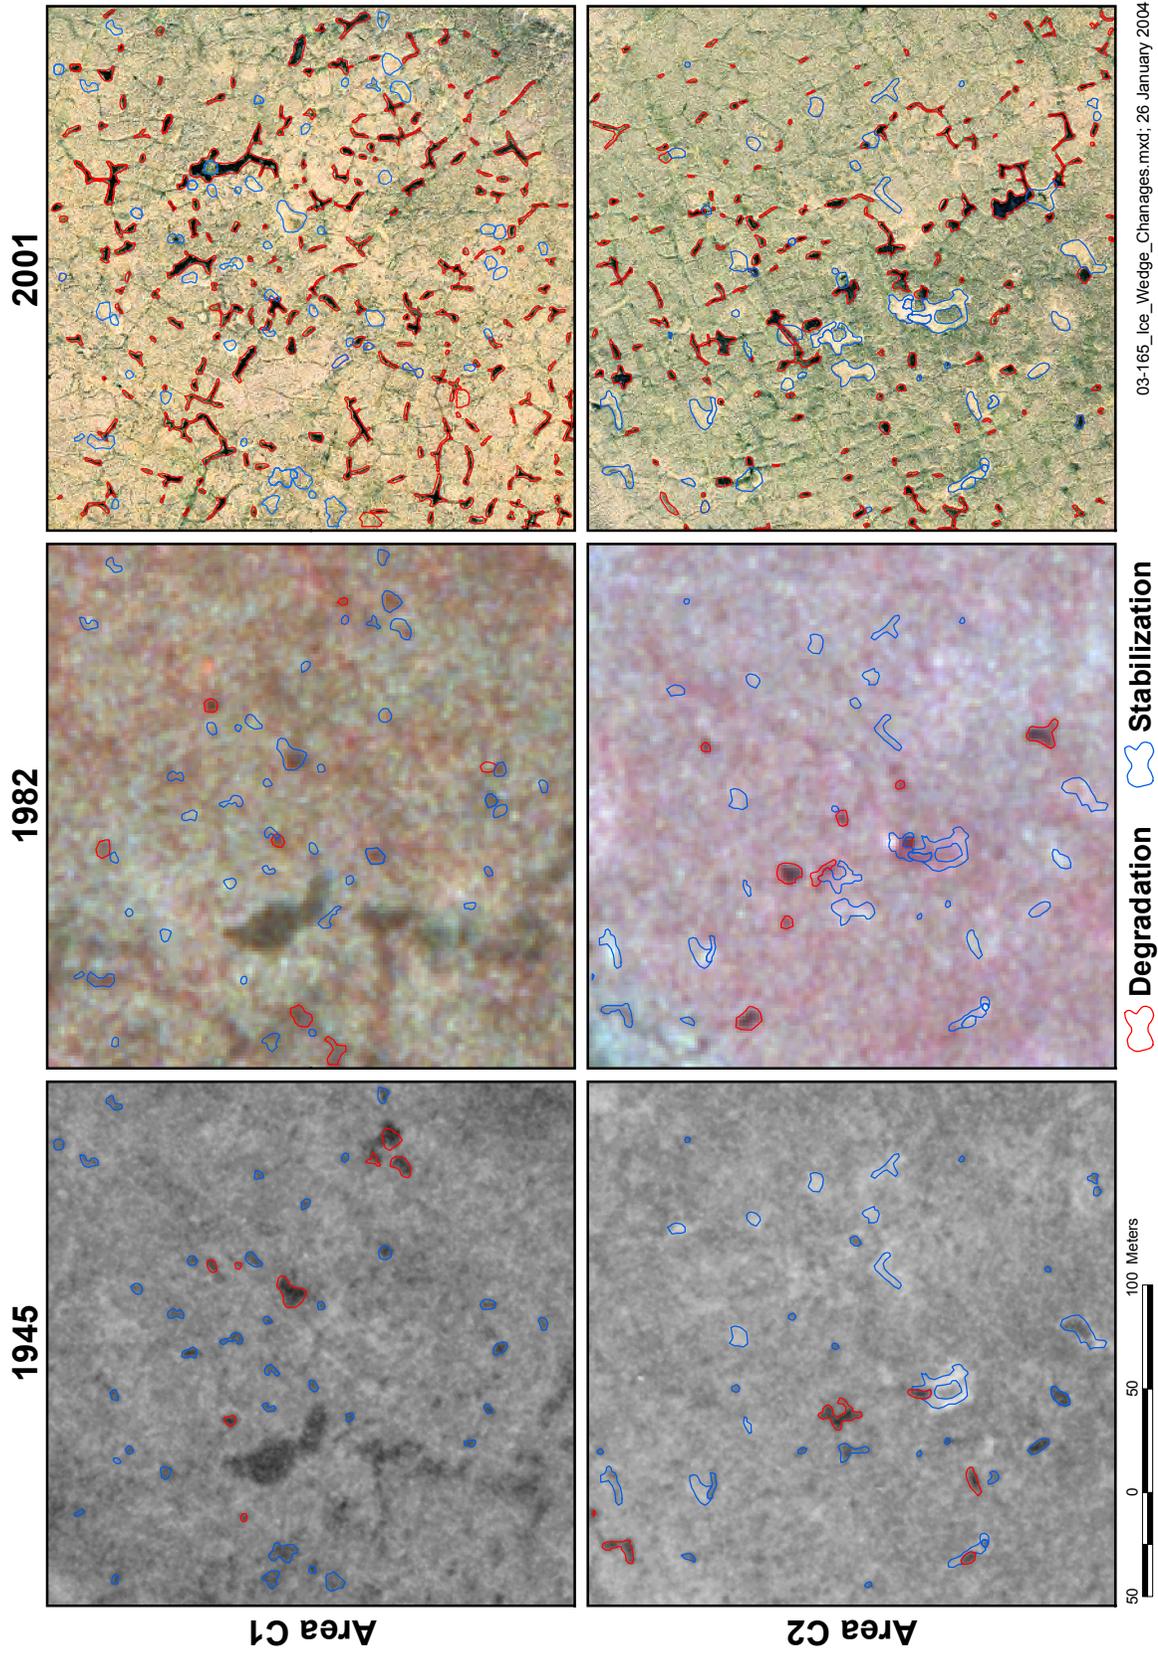
Figure 20. Abundance of thermokarst pits on airphotos taken in 1945, 1982, and 2001 within two 250 × 250 m areas, Northeast Planning Area, NPRA, 2003..

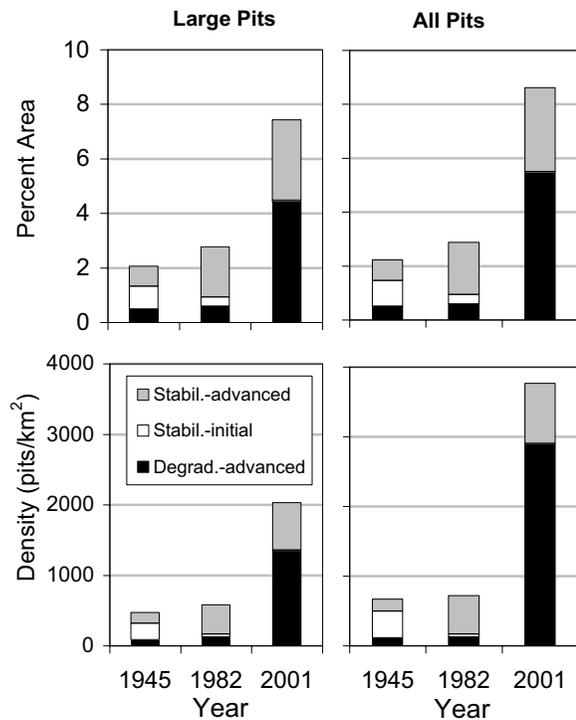
Figure 21. Percent area and density of thermokarst pits associated with ice-wedge degradation evident on airphotos taken in 1945, 1982, and 2001 for two small map areas (6.25 ha), Northeast Planning Area, NPRA, 2003. Comparisons are presented for only large ( $>12 \text{ m}^2$ ) pits, which are consistently evident across all scales of airphotos, and for all pits, which more completely enumerates the degradation evident on the large-scale airphotos from 2001.

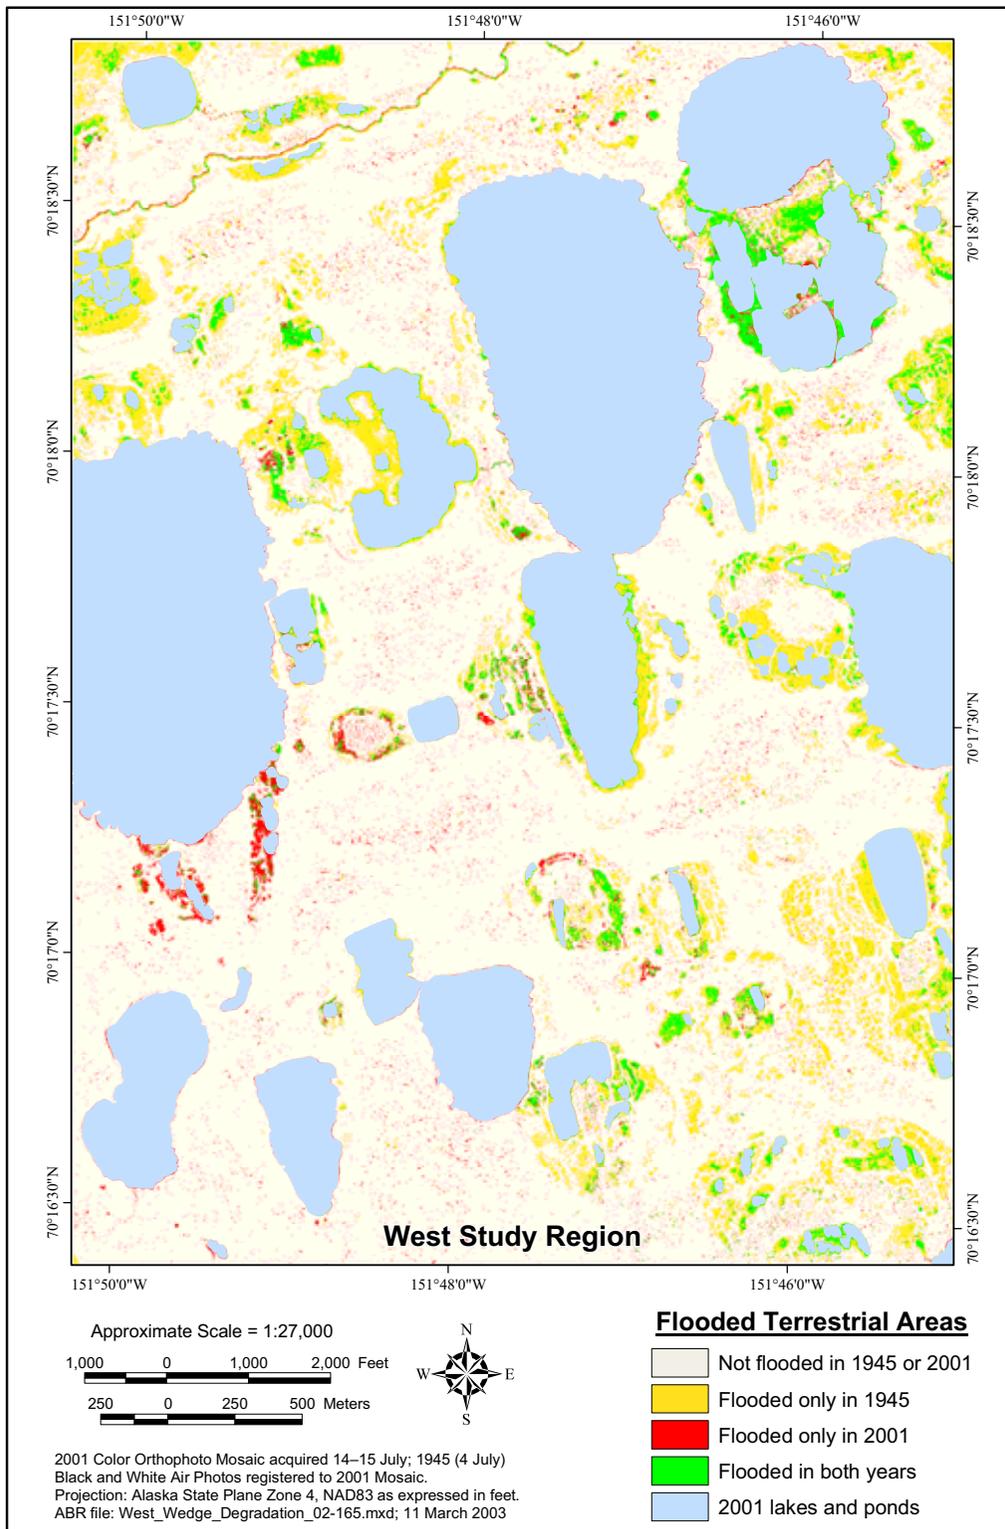
Figure 22. Changes in flooded areas in the west change study region 1945 and 2001 used to differentiate areas of thermokarst, Northeast Planning Area, NPRA, 2003. Small waterbodies (red) present only in 2001 are attributed to thermokarst.

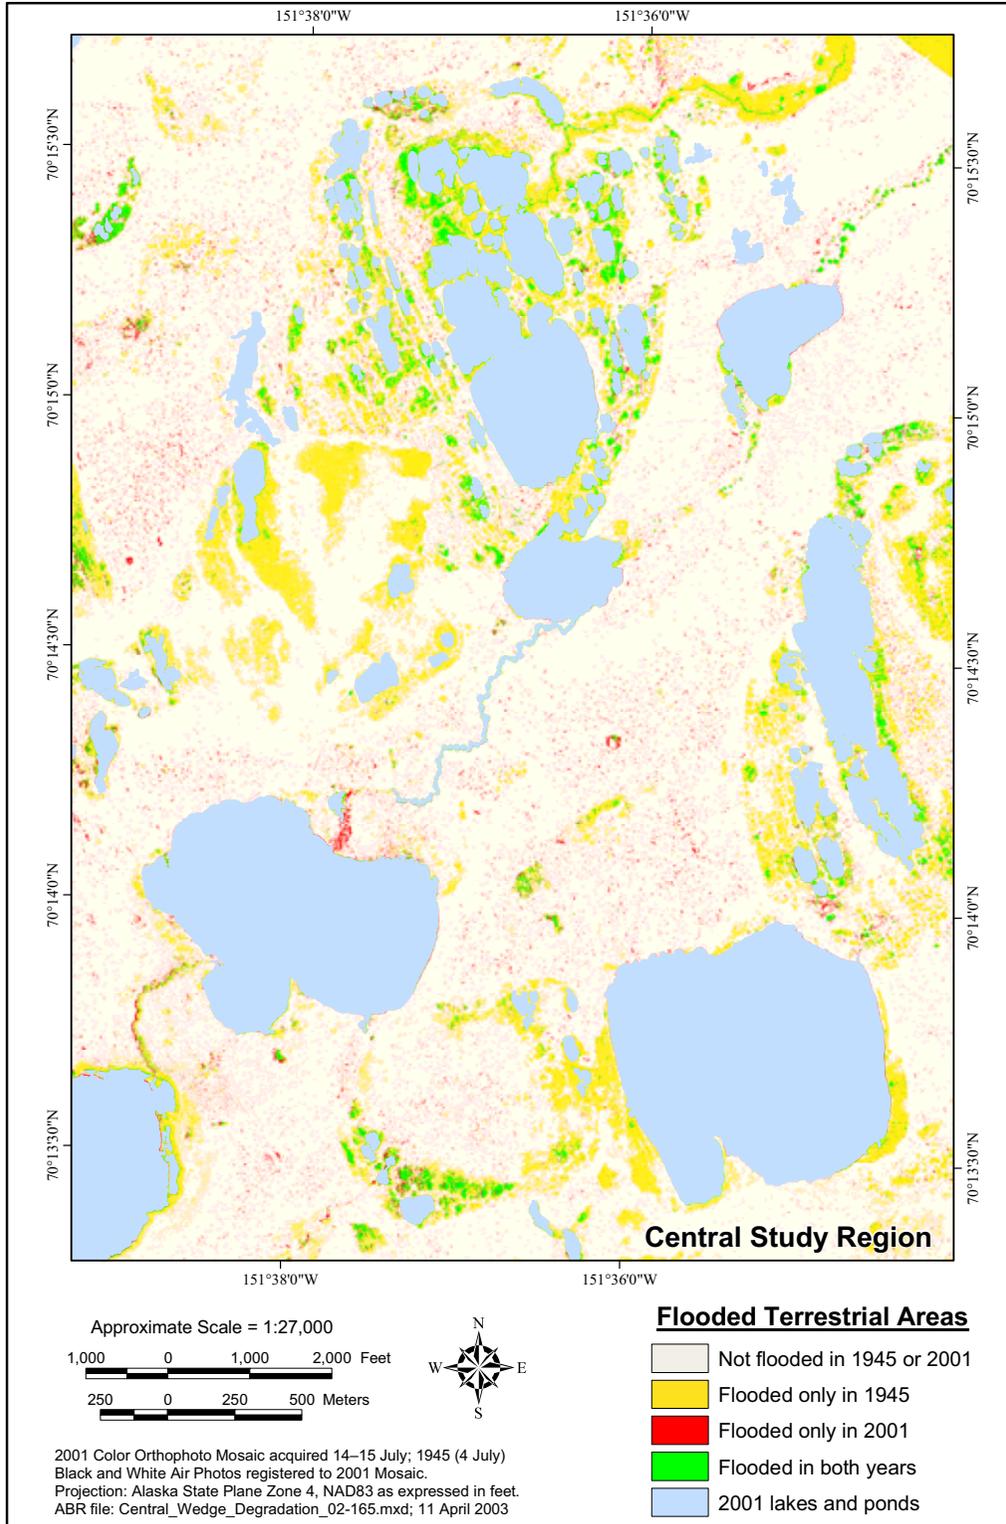
Figure 23. Changes in flooded areas in the central change study region between 1945 and 2001 used to differentiate areas of thermokarst, Northeast Planning Area, NPRA, 2003. Small waterbodies (red) present only in 2001 are attributed to thermokarst.

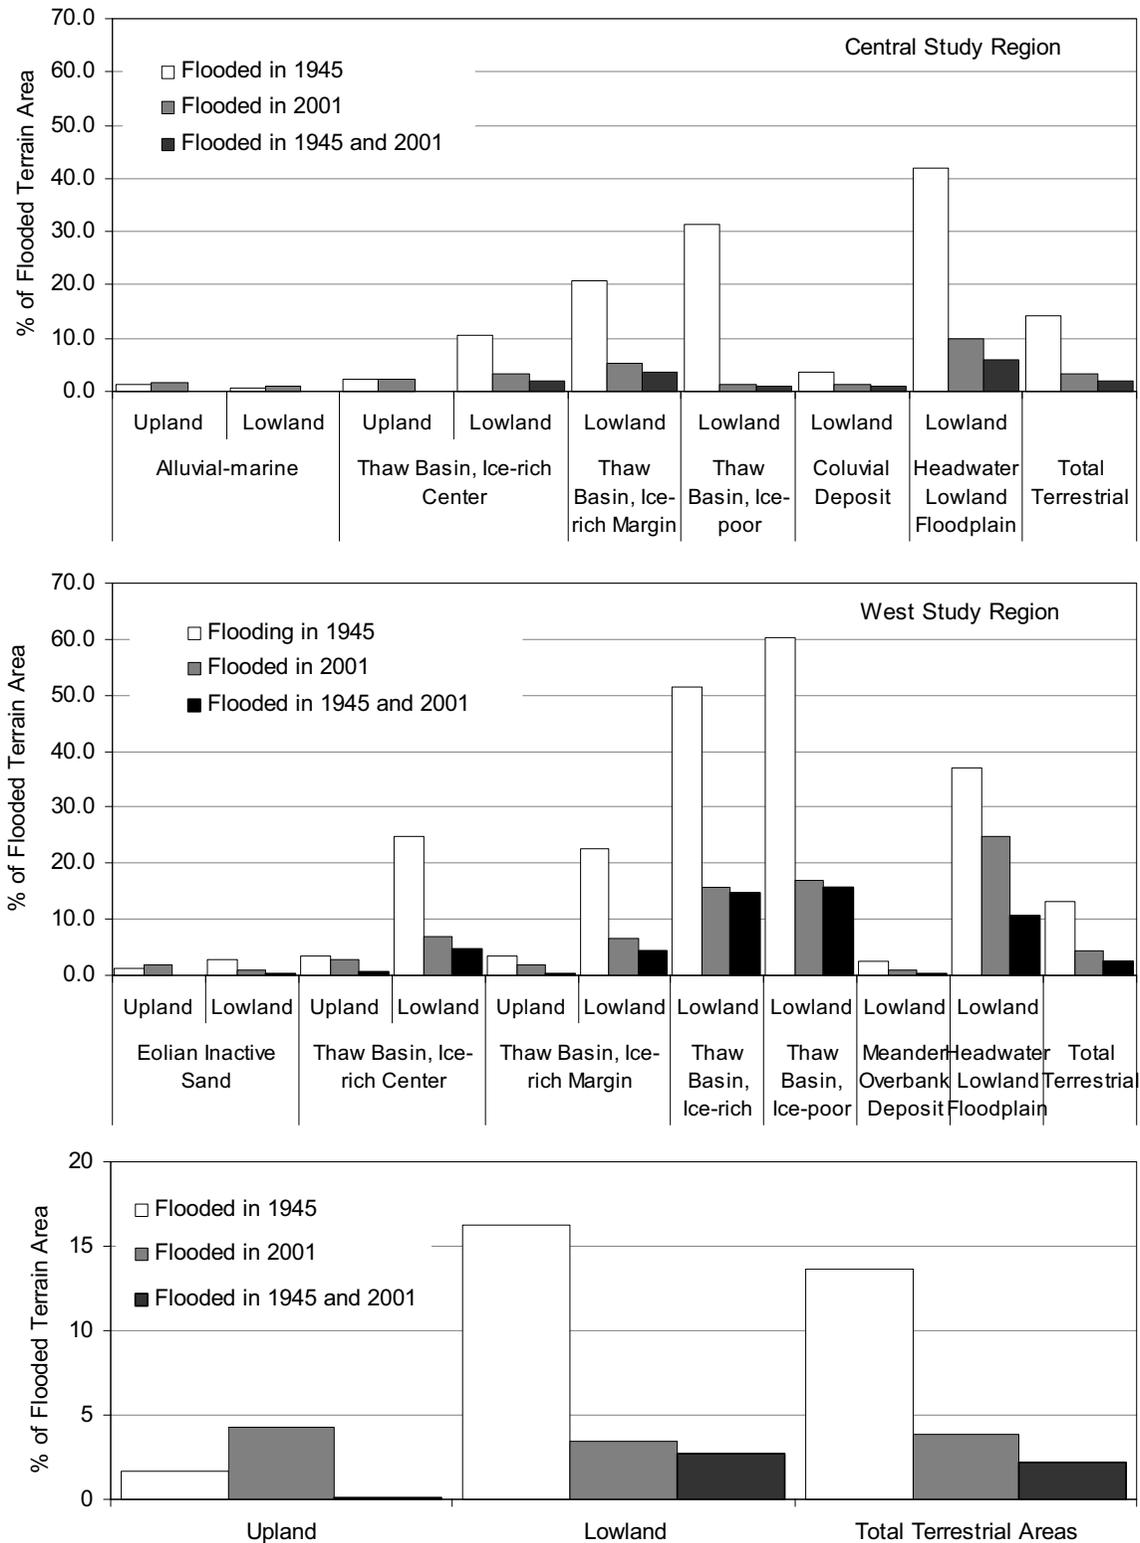
Figure 24. Summary of changes in flooded areas between 1945 and 2001 by terrain unit and physiography for the central and western map areas, Northeast Planning Area, NPRA, 2003.

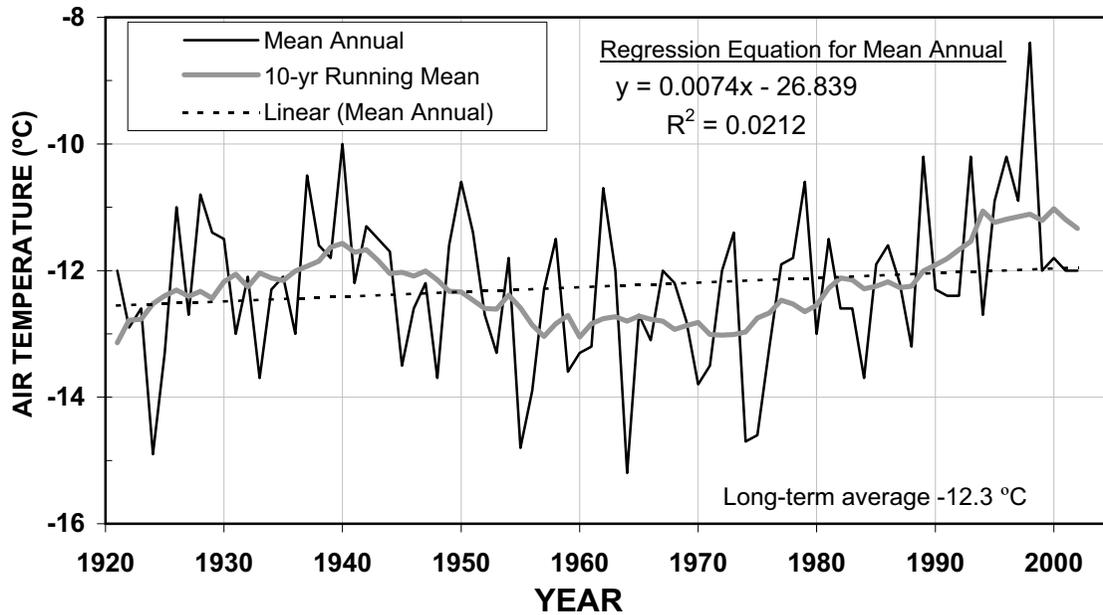
Figure 25. Mean annual air temperatures for Barrow Alaska, 1921–2003.
