2005
Colville River
Delta
and
Fish Creek
Basin

Spring
Breakup
and
Hydrological
Assessment

105756-MBJ-RPT-001

December 2005

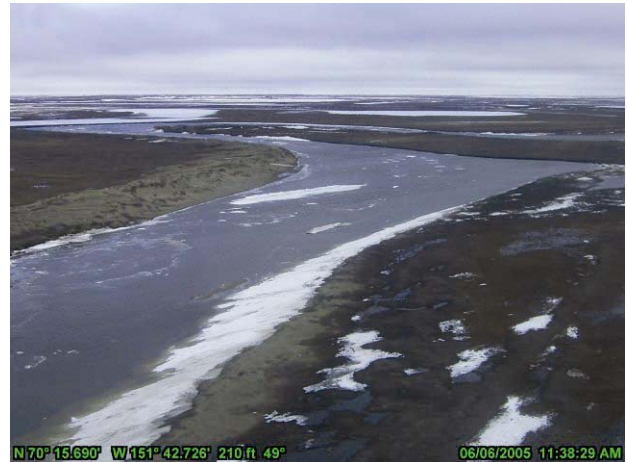
Photo 3-6 Flood waters on Fish Creek, June 6, 2005

Fish Creek lies west of the Colville River Delta (Photo 3-6). The sinuous, relatively low-gradient channel flows northeast into Harrison Bay. Fish Creek channel banks and bed consist of silt and sand sized particles. Meander bends commonly have undercut banks and bank sloughing along their outer edges.

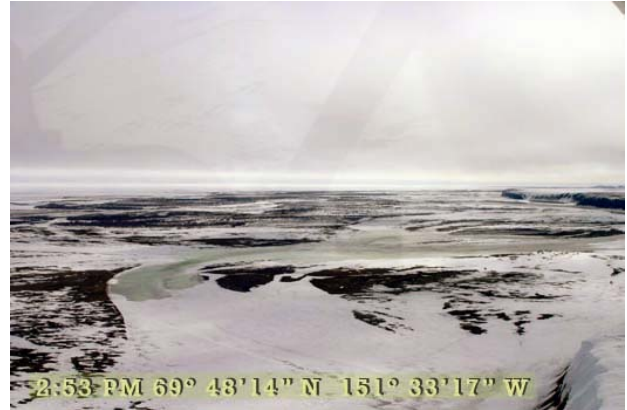
Photo 4-1 Leading edge of Colville River breakup, May 13, 2005

The start of the 2005 spring breakup at the USGS gage at Umiat began relatively early, but its arrival and advance in the delta was slowed due to cool temperatures and predominantly cloudy skies. Jim Helmricks observed the leading edge of floodwater on May 13 on the Colville River approximately 50 air miles upstream from Monument 1 (Photo 4-1).

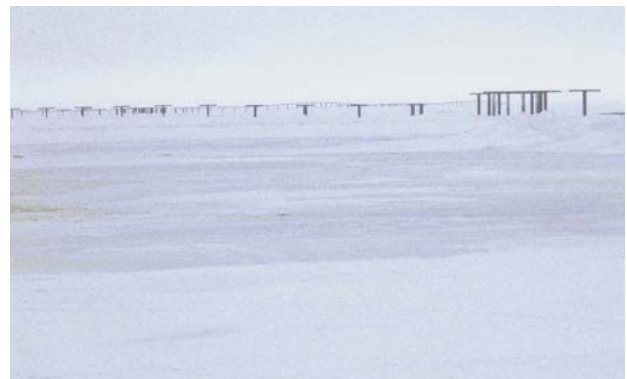
Photo 4-3 Tamayayak channel pipe bridge on CD3 pipeline, May 25, 2005

During the four-day period from May 17 through May 20, floodwater was slowed because of cold weather. On the afternoon of May 19, floodwater was observed in the Tamayayak Channel near the CD3 pipeline bridge (Photo 4-3).

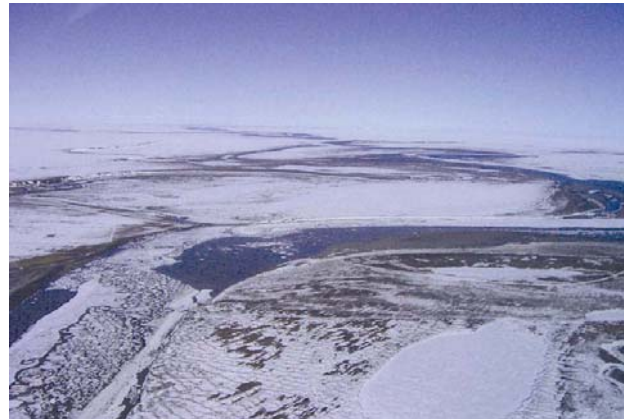
Photo 4-4 Ocean Point area, May 25, 2005

An overflight of the Ocean Point area south of Monument 1 on the morning of May 21 showed significant broken ice in the channel. However, no significant ice jam formations were observed due to slow flow velocities. The channel upstream from Ocean Point appeared to be relatively more open with channel ice appearing to have lifted, but did not move much downstream, again due to slow water velocities. Subsequent flights to the Ocean Point area on May 24 and May 25 showed that though small ice jams were forming, they posed no impediment to flow and had caused no overbank flooding (Photo 4-4).

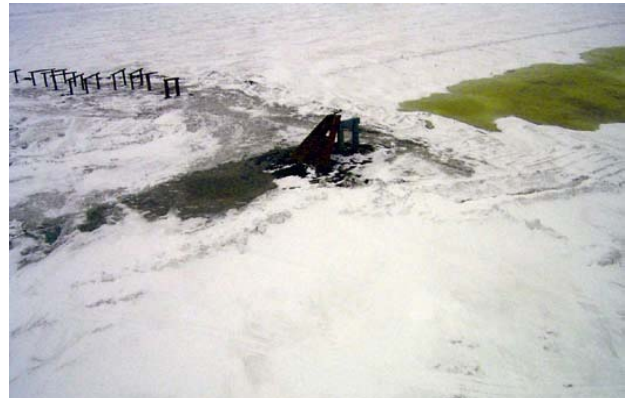
Photo 4-5 Sakoonang channel pipe bridge on CD3 pipeline, May 22, 2005

May 21 marked the first day that floodwater entered into the Ulamnigiq Channel. On May 22, although floodwater had yet to enter the Sakoonang from the East Channel, water was observed in the Sakoonang Channel just downstream from Alpine (Photo 4-5).

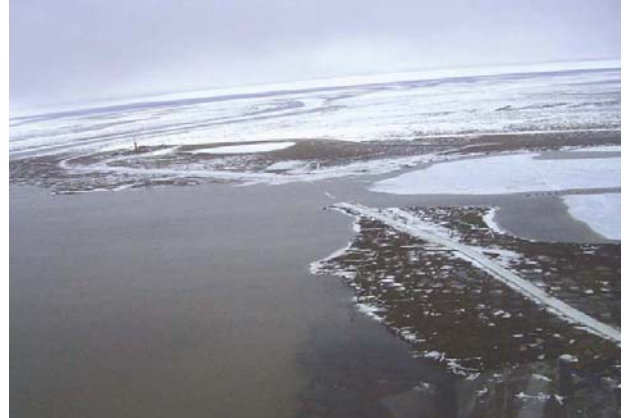
Photo 4-6 Nigliq channel flow reaching Nanuq Lake, May 31, 2005

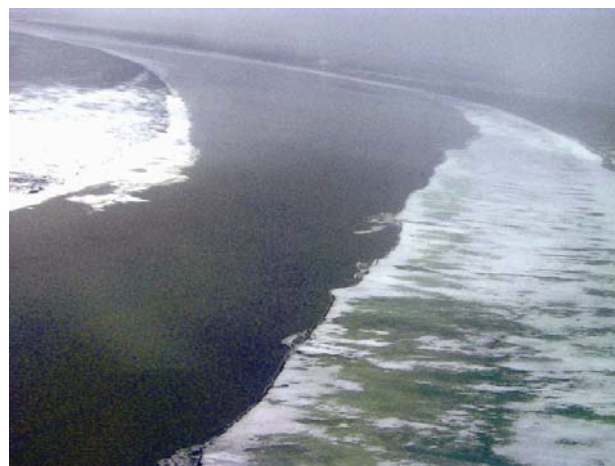
Photo 4-9 Peak stage on Nigliq channel at Monument 23, June 1, 2005

A peak recorded stage at Monument 23 was 5.95 feet and occurred on the morning of June 1 with intact ice still floating along the left bank (Photo 4-9). However, a minor secondary peak stage occurred at Monument 23 on June 3 similar to observations at Monuments 20 and 22.

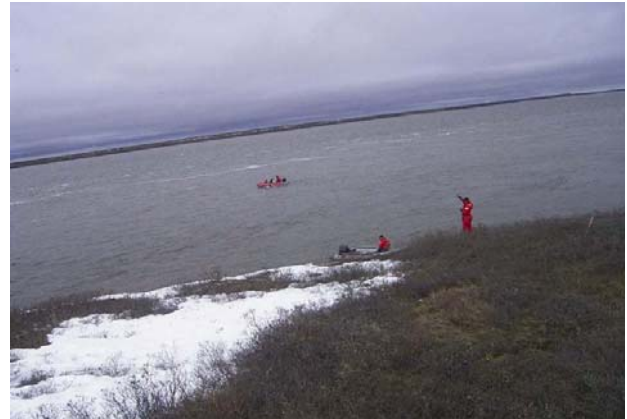
Photo 4-18 Direct discharge measurement at Monument 1, June 10, 2005

Table 4-19 summarizes the details of each discharge transect, Appendix C presents the WinRiver ADCP software Velocity Magnitude Contours and Ship Track output graphics for each of the four Monument 1 Transects. Due to conditions at Monument 1 at the time of the measurement, moving bed test results were inconclusive.

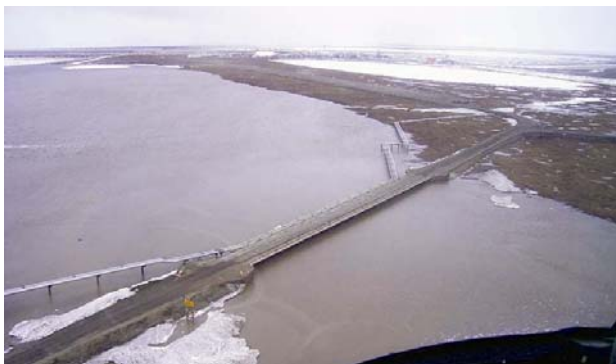
Photo 4-19 Conditions during direct discharge measurement at 452-foot swale bridge, June 2, 2005

Discharge was measured at the 452-foot bridge on June 2 at 1,140 cfs (Photo 4-19). The average velocity was 1.4 fps and the maximum water velocity was 2.0 fps. The peak flow through the 452-foot bridge is estimated to be 1,400 cfs and is assumed to have occurred at the time of the peak stage at permanent staff gage 3 on May 31. Flow of any significant quantity was not observed in the 62-foot bridge due to presence of snow beneath the bridge deck (Photo 4-20). Table 4-23 presents a tabulation of historical measured and estimated peak discharges at the Alpine swale bridges between 2000 and 2005.

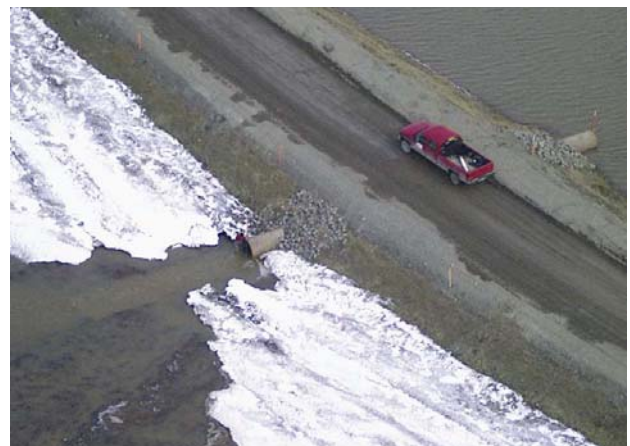
Photo 4-21 CD2 road culverts direct discharge measurement, June 2, 2005

CD2 and CD4 road culvert water depths and velocities were measured on June 2 (Photo 4-21). On the CD2 road, water levels reached culverts CD2-21, CD2-22, CD2-23, and CD2-24 (Figure 4-3).

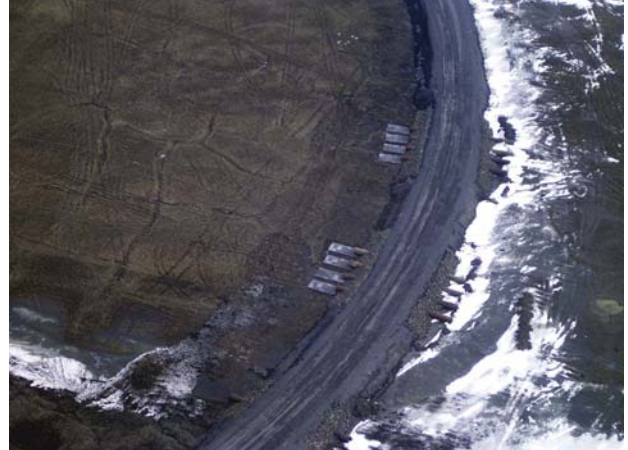
Photo 4-22 CD4 road southern Paleo culverts during peak stage, June 1, 2005

The measured discharge is presented in Table 4-24 and ranged from 1.1 in culvert CD2-21 to 14.9 cfs in culvert CD2-24. Flow of any significant quantity was not observed in culvert CD2-22 due to snow inside the culvert. The estimated peak flow through the CD2 culverts is presented in Table 4-25 and is estimated to range from 1.5 cfs in culvert CD2-21 to 20 cfs in culvert CD2-24 and is assumed to have occurred at the time of the peak stage at permanent staff gage 4 on June 1. Floodwater did not reach culverts along the CD4 road (Photo 4-22 and Photo 4-23).

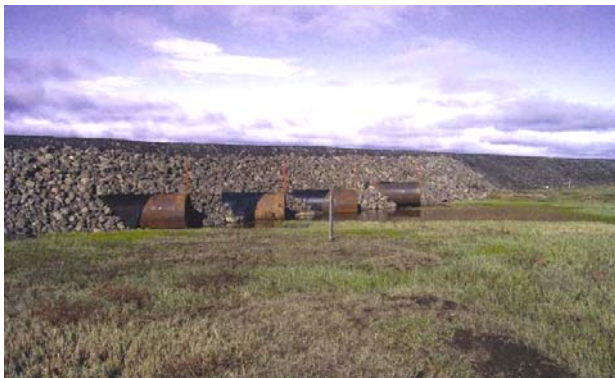
Photo 4-24 CD4 road alignment after recession of flood at the north Paleo culvert battery, July 10, 2005

The Alpine gravel pads and access roads were inspected for erosion before, during, and after breakup. Photographic documentation of the condition of the gravel facilities was recorded on July 9 and 10 (Photo 4-24 and Photo 4-25). Floodwater did not reach the gravel embankments at CD1, CD2, CD3, or CD4 pads or the CD4 gravel road.

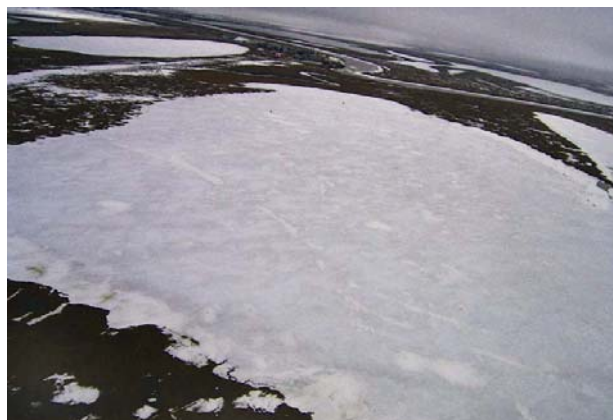
Photo 4-27 Lake L9312 near peak stage indicating lack of river recharge, June 7, 2005

Recharge flow into Lake L9312 from outside its own drainage sub-basin was not observed during the 2005 spring breakup because overflow via the Colville River did not reach the lake. Recharge to this lake was by means of local melt within the immediate sub-basin only (Photo 4-27).

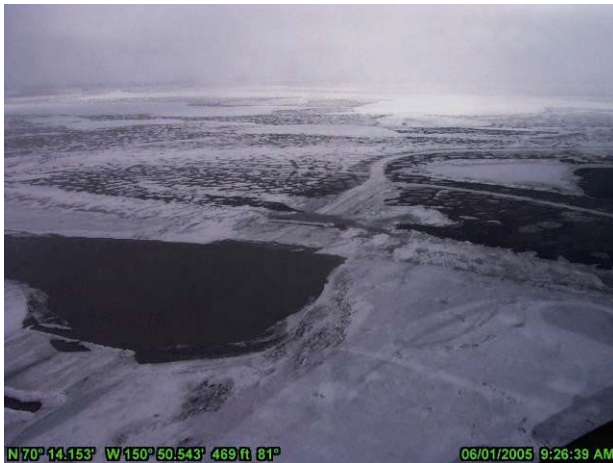
Photo 4-29 Colville East Channel Ice Bridge during breakup with the ice road in place, June 1, 2005

No erosion, scour, or significant increase in water surface elevation was observed during breakup at or near the ice bridges at the Colville River East Channel or Nigliq Channel crossings. The slotted portions of the bridges conveyed flow adequately and the decay of the ice bridge was relatively quick once floodwaters began their advance. Photo 4-29 and Photo 4-30 represent conditions of the East Channel of the Colville River at the ice bridge crossing during and after breakup. Photo 4-31 and Photo 4-32 represents conditions of the Nigliq Channel at the ice bridge crossing during and after breakup.

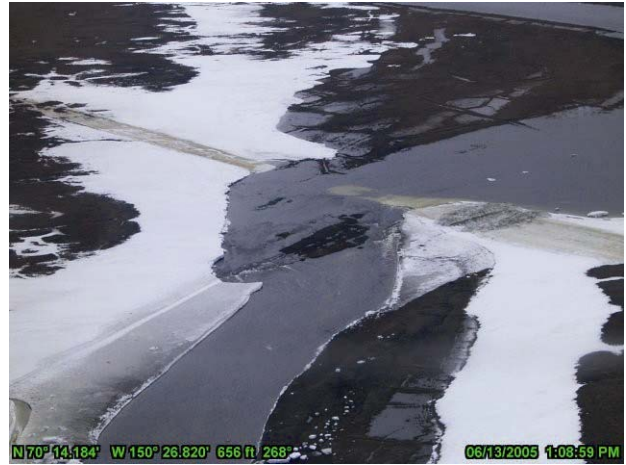
Photo 4-33 Kachemach River Ice Bridge during breakup with the ice road in place, June 13, 2005

At the Kachemach River ice bridge crossing, the ice bridge appeared to have diverted a portion of the flow during breakup from the natural channel and directed it towards the east bank of the river as shown in Photo 4-33. At the ice bridge crossing, the east bank experienced erosion as a result of this diversion of flow.

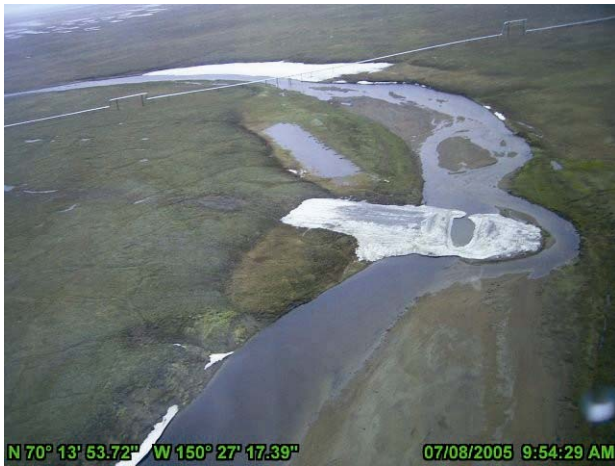
Photo 4-34 Kachemach River Ice Bridge after breakup with remnants of the ice road still in place, July 8, 2005

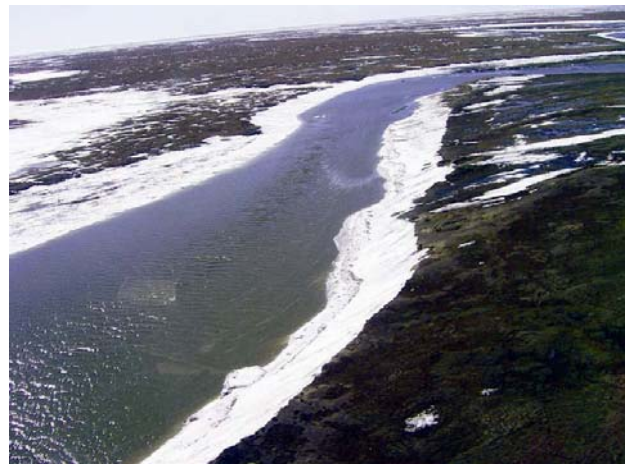
Photo 5-1 Judy 13.8 near Peak stage, June 5, 2005

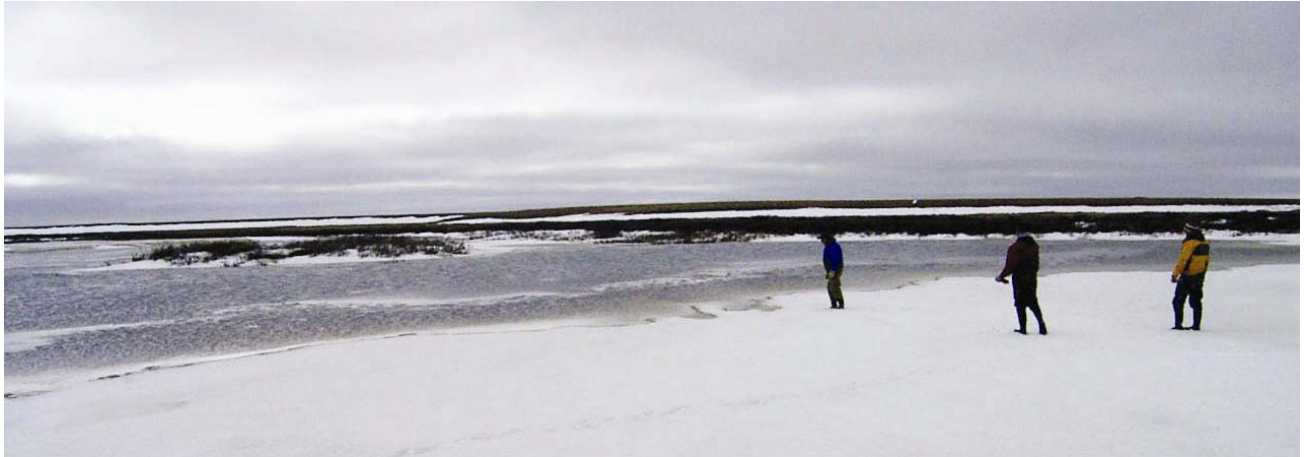
Photo 5-6 Leading edge of breakup flow at Ublutuoch River 6.8, June 6, 2005

In 2005, the Ublutuoch River was the last study stream to break up within the Fish Creek basin. Similarly to Fish and Judy Creeks, localized melt and standing water along the Ublutuoch River was noted several days prior to occurrence of floodwater. The leading edge of the flood moved through the proposed bridge crossing location at the Ublutuoch 6.8 monitoring site on the afternoon of June 6 (Photo 5-6).

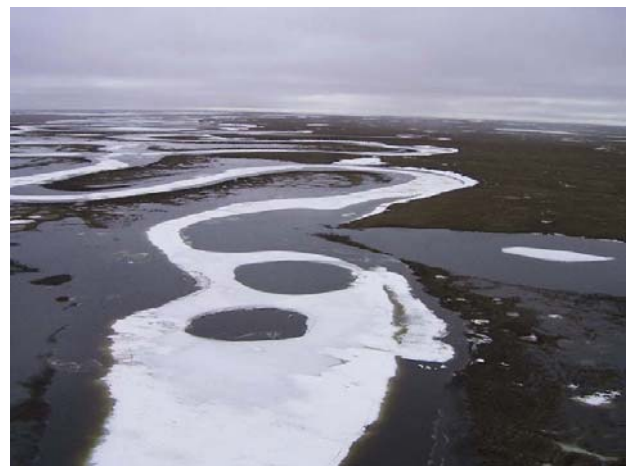
Photo 5-7 Water levels at Ublutuoch River 1.9, June 7, 2005

Backwater flooding from Fish and Judy Creeks was again noted at gages located in the lower portion of the Ublutuoch River at river mile 1.9 (Photo 5-7). Monitoring of the backwater at Ublutuoch 1.9 gages began on June 6 and continued through June 13. By the afternoon of June 8, Ublutuoch River was actively flowing from upstream.

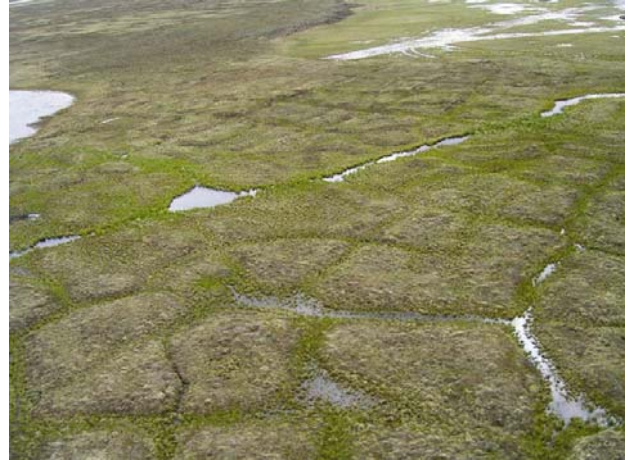
Photo 5-8 Aerial view of Site 1, July 8, 2005

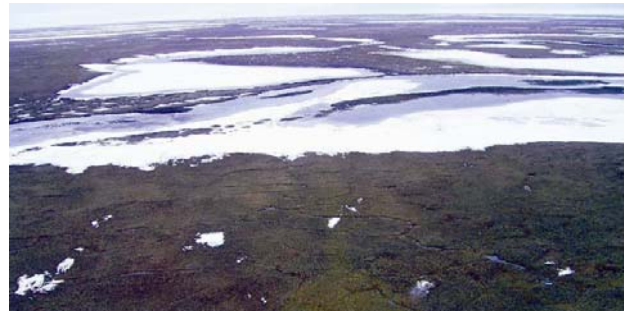
Photo 5-15 Ublutuoch River at 6.8 near peak stage, June 6, 2005

Peak stage at Ublutuoch 6.8 occurred on June 7, one day after the leading edge was observed flowing through the area at an elevation of 10.01 feet (Photo 5-15).

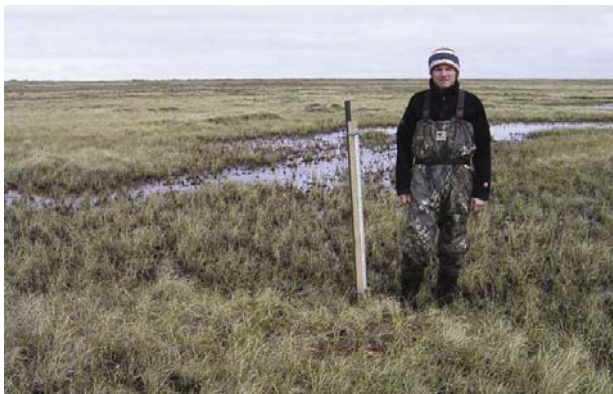
Photo 5-16 Site 2 after breakup, July 8, 2005

At Sites 2 and 7, surface water flow was not observed and water levels at each of these locations represents shallow local melt (Photo 5-16 and Photo 5-17, respectively). Peak water surface elevations at Site 2 and Site 7 were 19.62 feet and 24.44 feet, respectively.

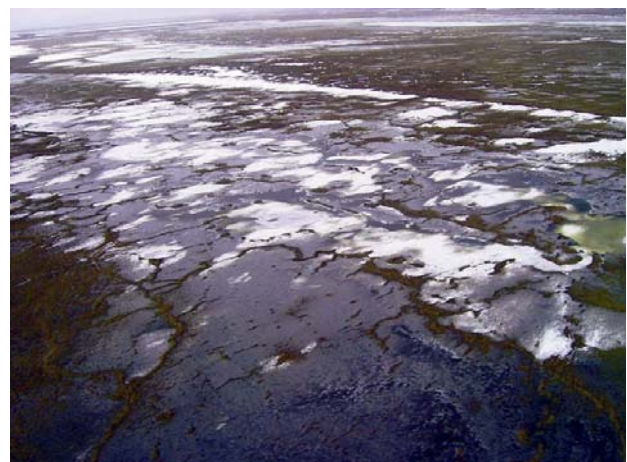
Photo 5-18 Site 3 near peak stage, June 6, 2005

At Site 3, a peak water surface elevation was recorded on June 5 at an elevation of 10.67 feet (Photo 5-18) with approximately 0.1 feet of change recorded between June 5 and June 8.

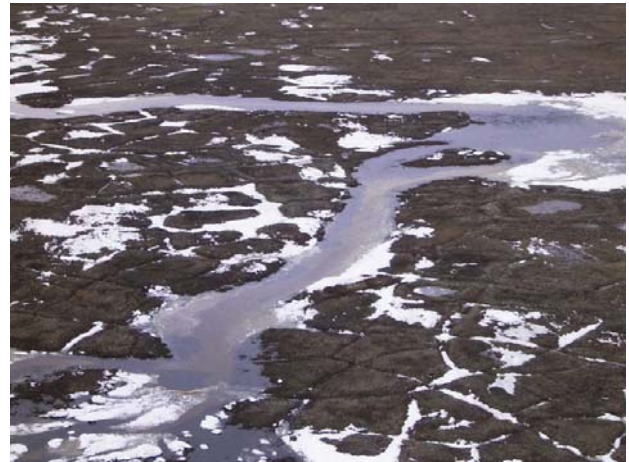
Photo 5-19 Site 8 near peak stage, June 7, 2005

At Site 8, a peak water surface elevation was recorded on June 6 at an elevation of 26.13 feet (Photo 5-19) representing a relatively dramatic rise and fall of the hydrograph.

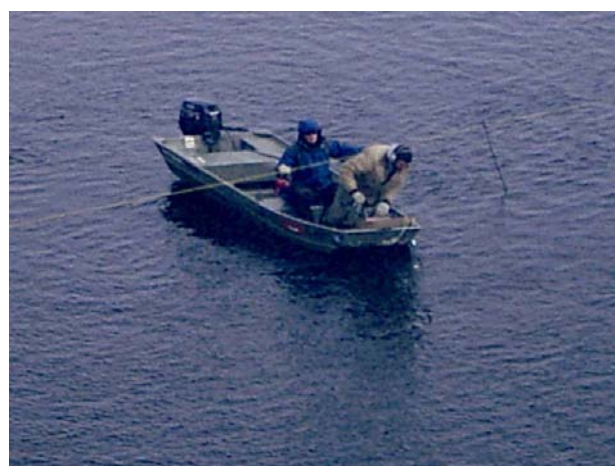
Photo 5-20 Ublutuoch River discharge measurement, June 9, 2005

Discharges were measured directly at Ublutuoch 6.9 on June 8, June 9, June 10, and June 11 and are summarized in Table 5-21. The peak discharge was recorded in the morning of June 9 to be 1,680 cfs with an average velocity of 1.2 fps (Photo 5-20). Refer to Appendix B for complete field measurement notes. Discharge between June 8 and June 11 was measured over a frozen channel with intact low-water bottomfast snow and ice. Soundings conducted during discharge measurements documented the degradation of the snow and ice concluding a continuous change in channel geometry.

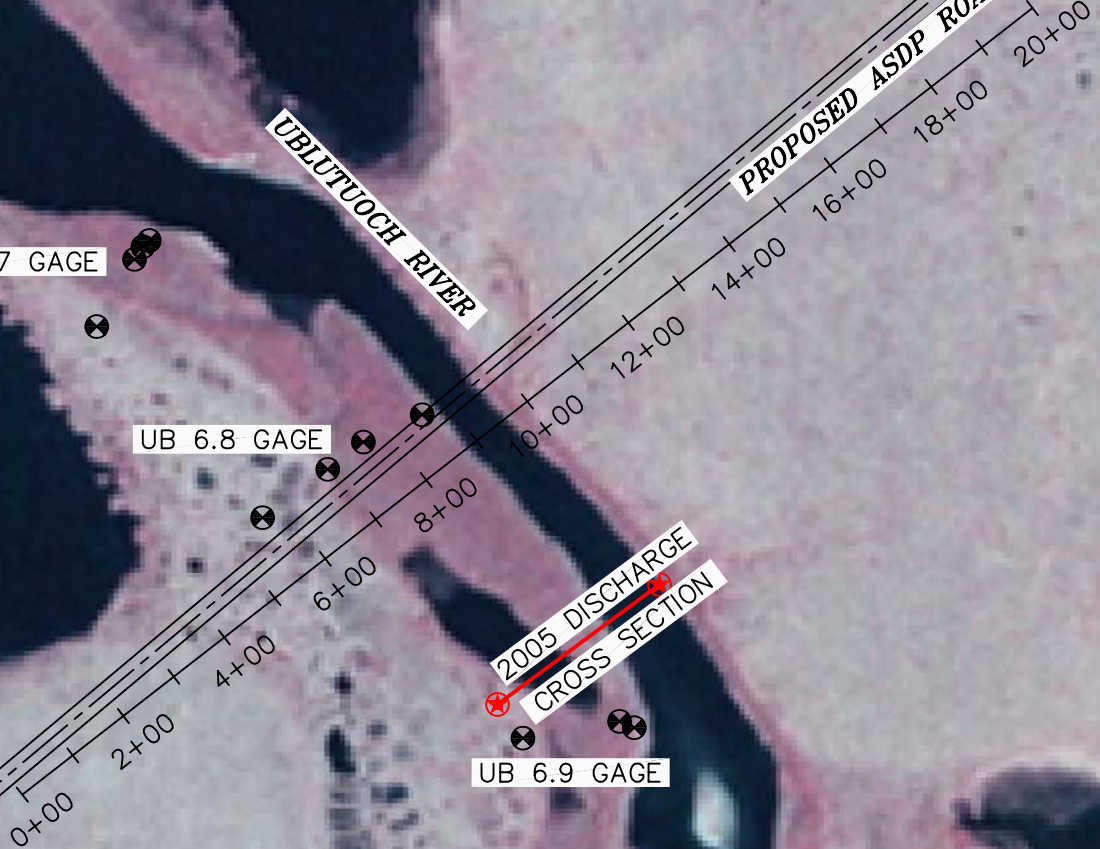
2005 DISCHARGE
CROSS SECTION

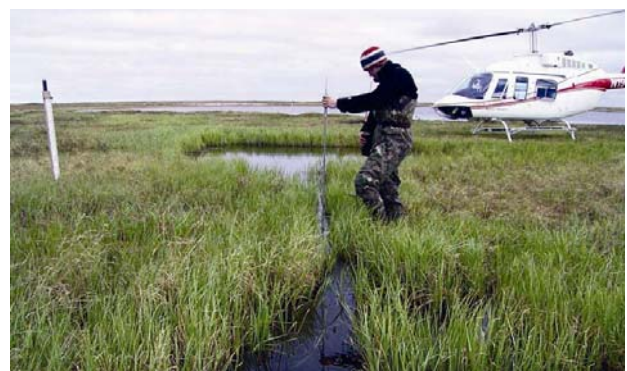
Photo 5-21 Measurement of discharge at Site 1, July 8, 2005

At Site 1, discharge was 1.5 cfs with approximately 90–95% of flow confined to a single 30-foot wide channel having an average velocity of less than 0.1 fps (Photo 5-21).

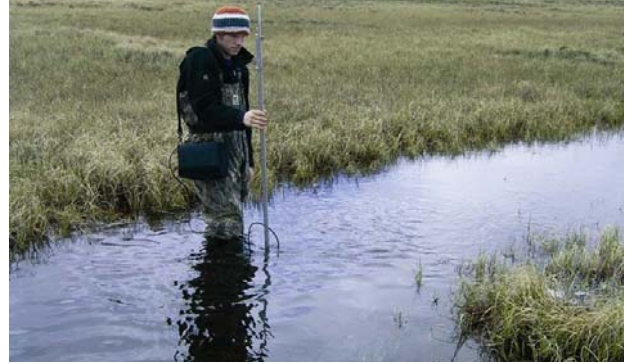
Photo 5-22 Measurement of discharge at Site 3, July 8, 2005

The discharge at Site 3 of 0.3 cfs and an average velocity less than 0.1 fps was measured downstream from the lake outlet, running south to north, over grasses and moderately irregular ground through the 17-foot wide channel (Photo 5-22).

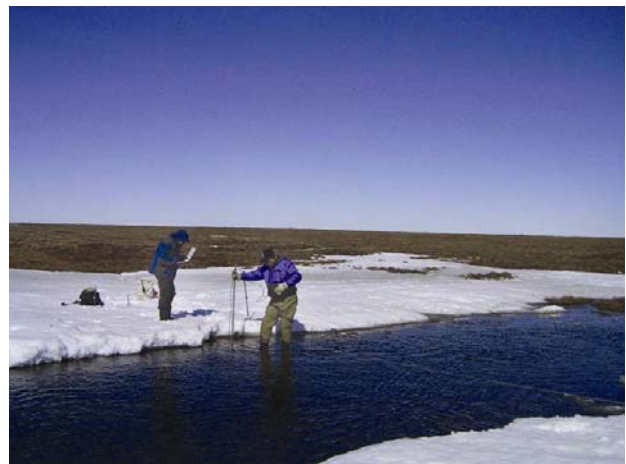
Photo 5-23 Measurement of discharge at Site 5, June 5, 2005

The discharge at Site 5 was 4.6 cfs with an average velocity of 0.3 fps across a channel width of 22 feet (Photo 5-23).

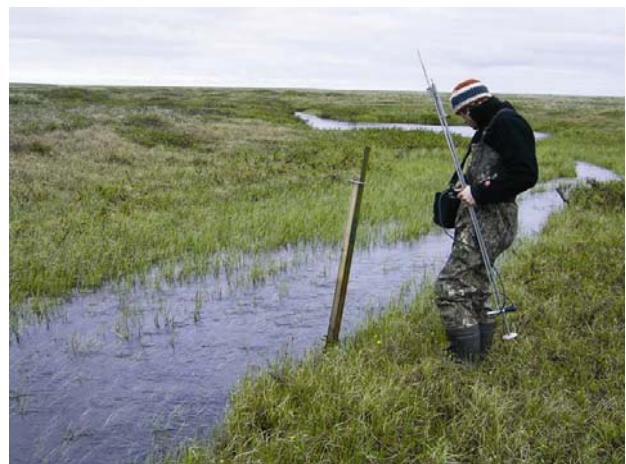
Photo 5-24 Measurement of discharge at Site 8, July 8, 2005

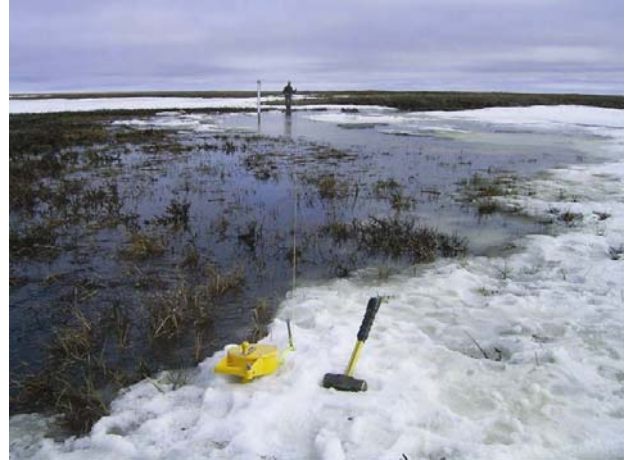
Photo 5-25 Measurement of discharge at Site 10, June 9, 2005

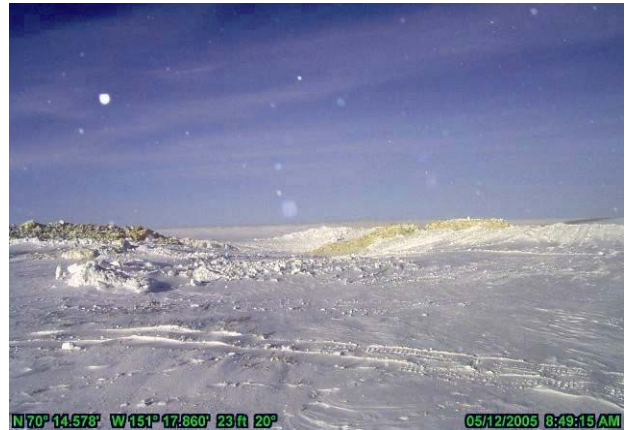
Photo 5-26 Ublutuoch River Ice Bridge prior to breakup with the ice road essentially removed from the drainage channel, May 12, 2005

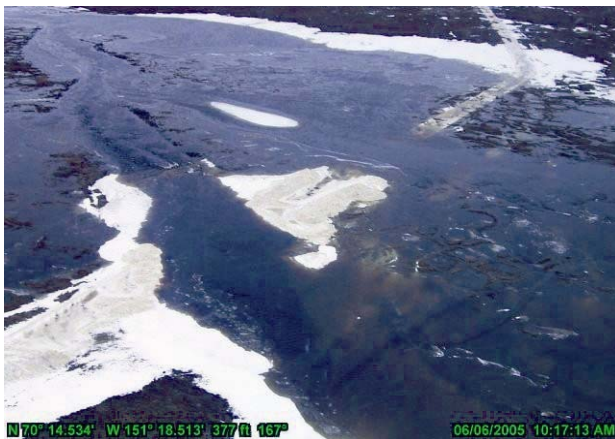
Photo 5-27 Ublutuoch River Ice Bridge during breakup with the ice road remnants in place, June 6, 2005

No erosion, scour, or significant increase in water surface elevation was observed during breakup at or near the 2005 ice bridge locations at the Ublutuoch River (Photos 5-26, 5-27, and 5-28) or Fish Creek (Photos 5-29 and 5-30) crossings.

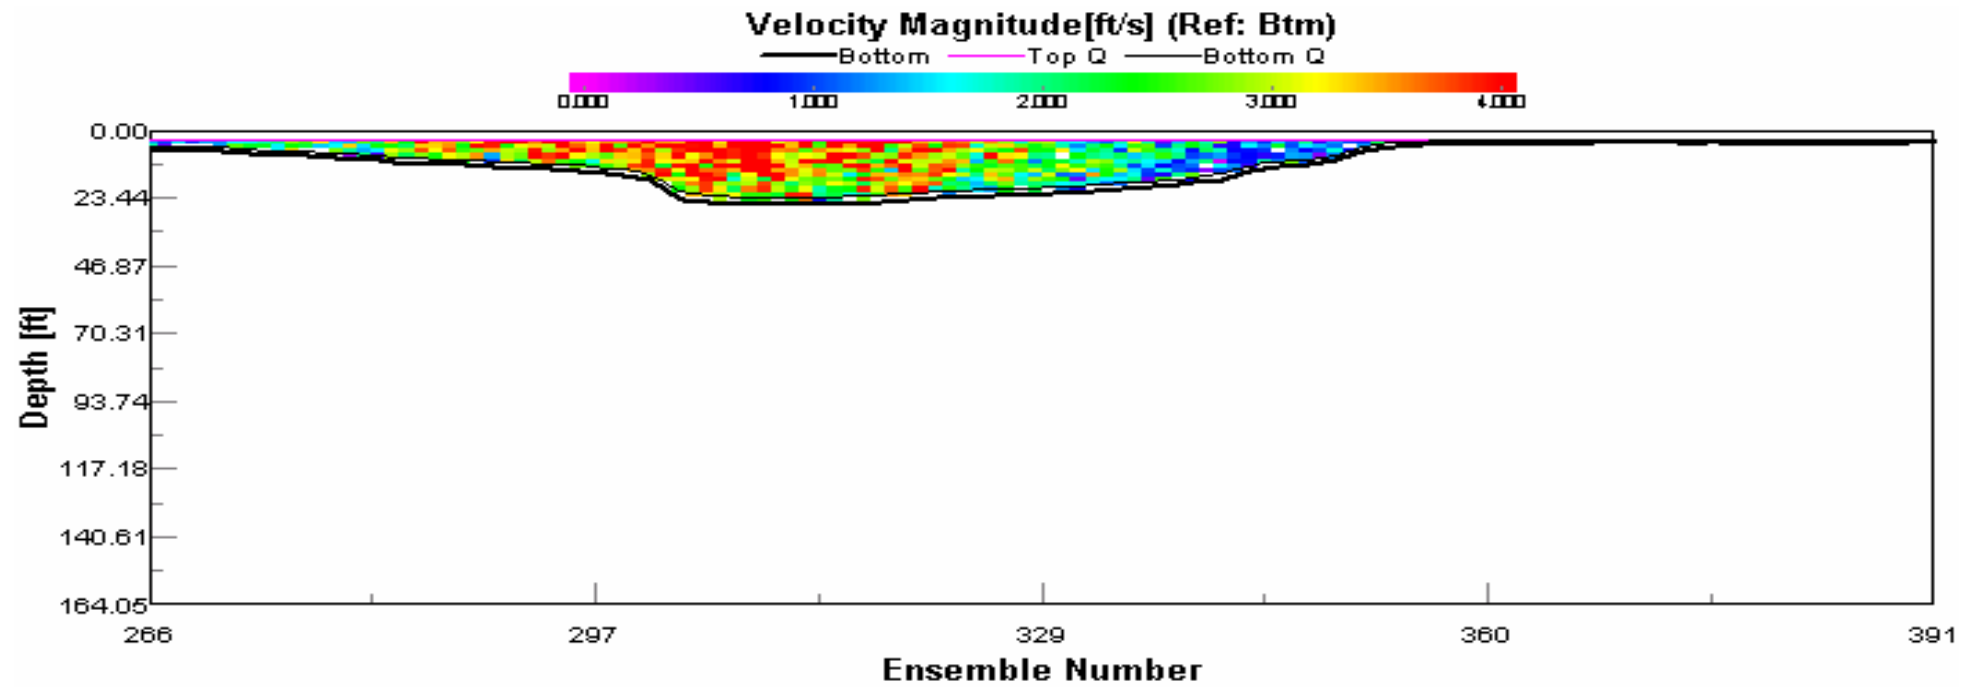
Monument 23 Discharge Transect 1, WinRiver Velocity and Ship Track Plots

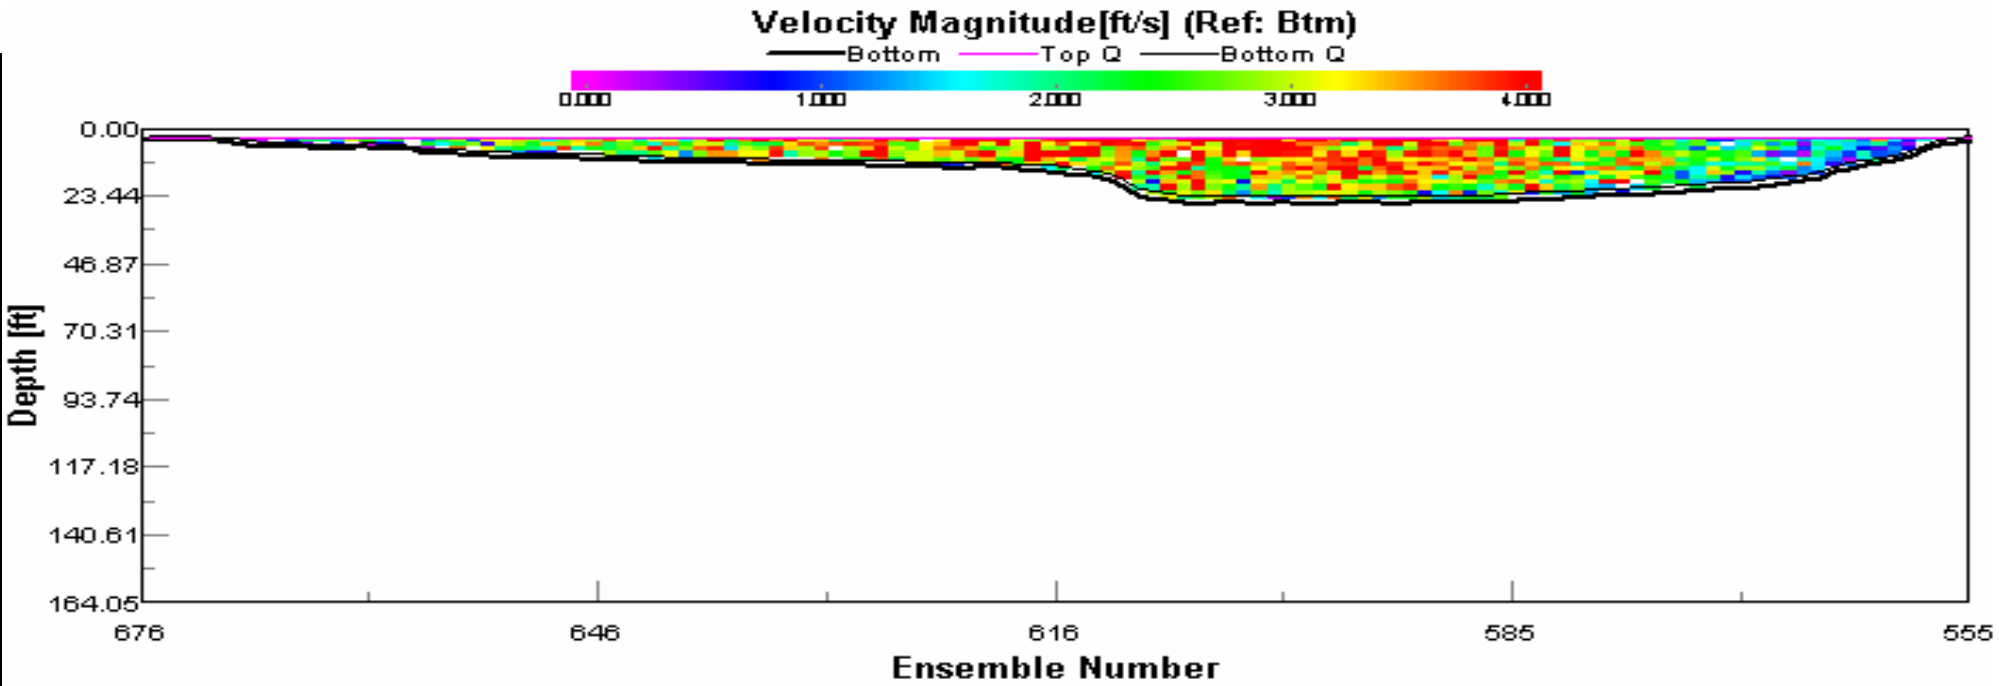
Monument 23 Discharge Transect 2, WinRiver Velocity and Ship Track Plots

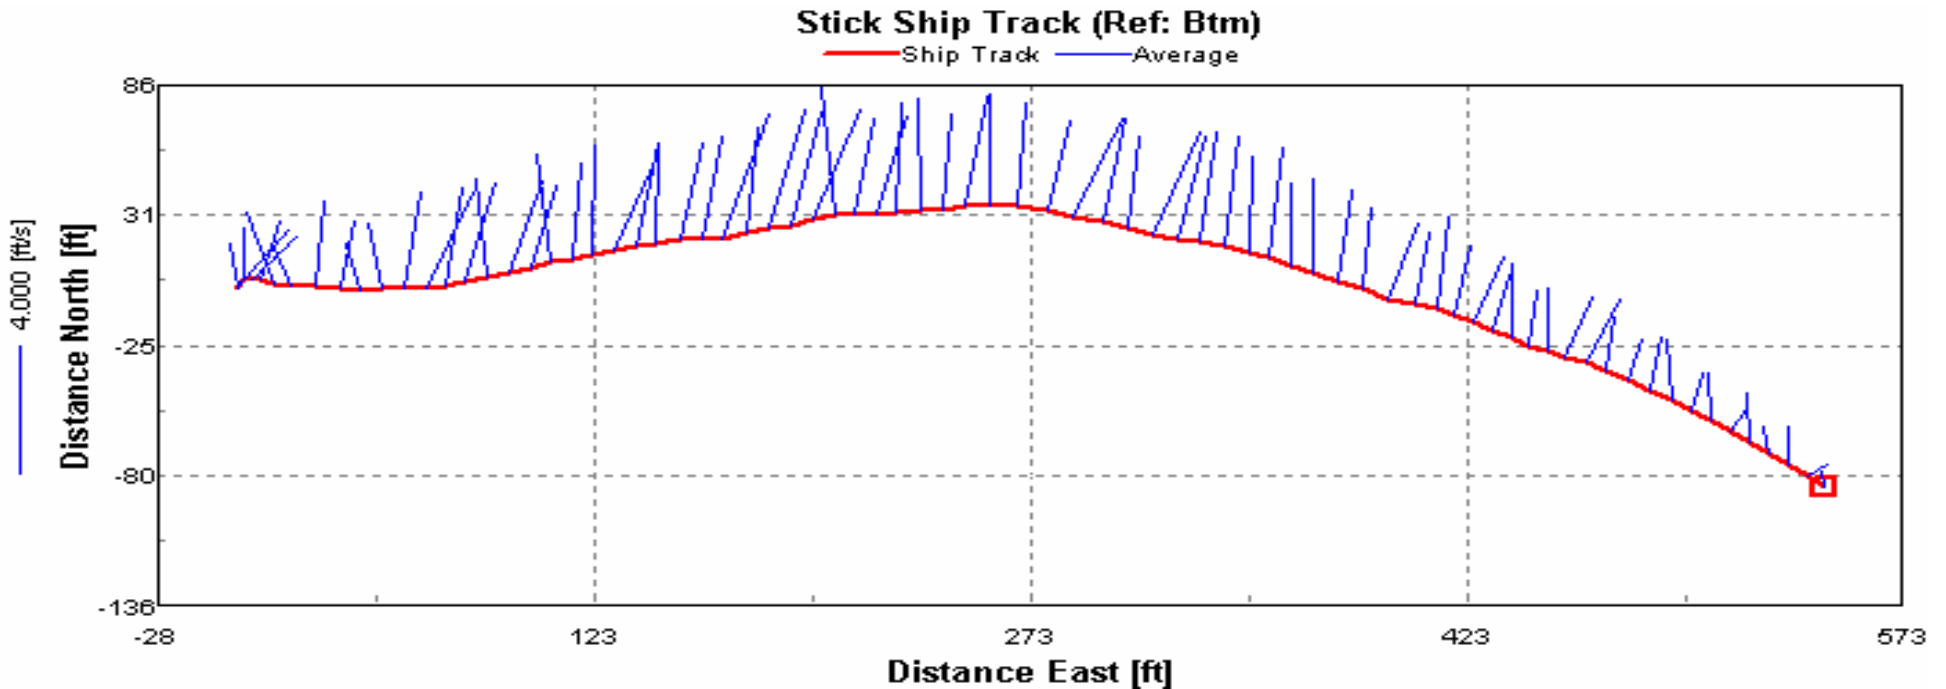
Monument 23 Discharge Transect 3, WinRiver Velocity and Ship Track Plots

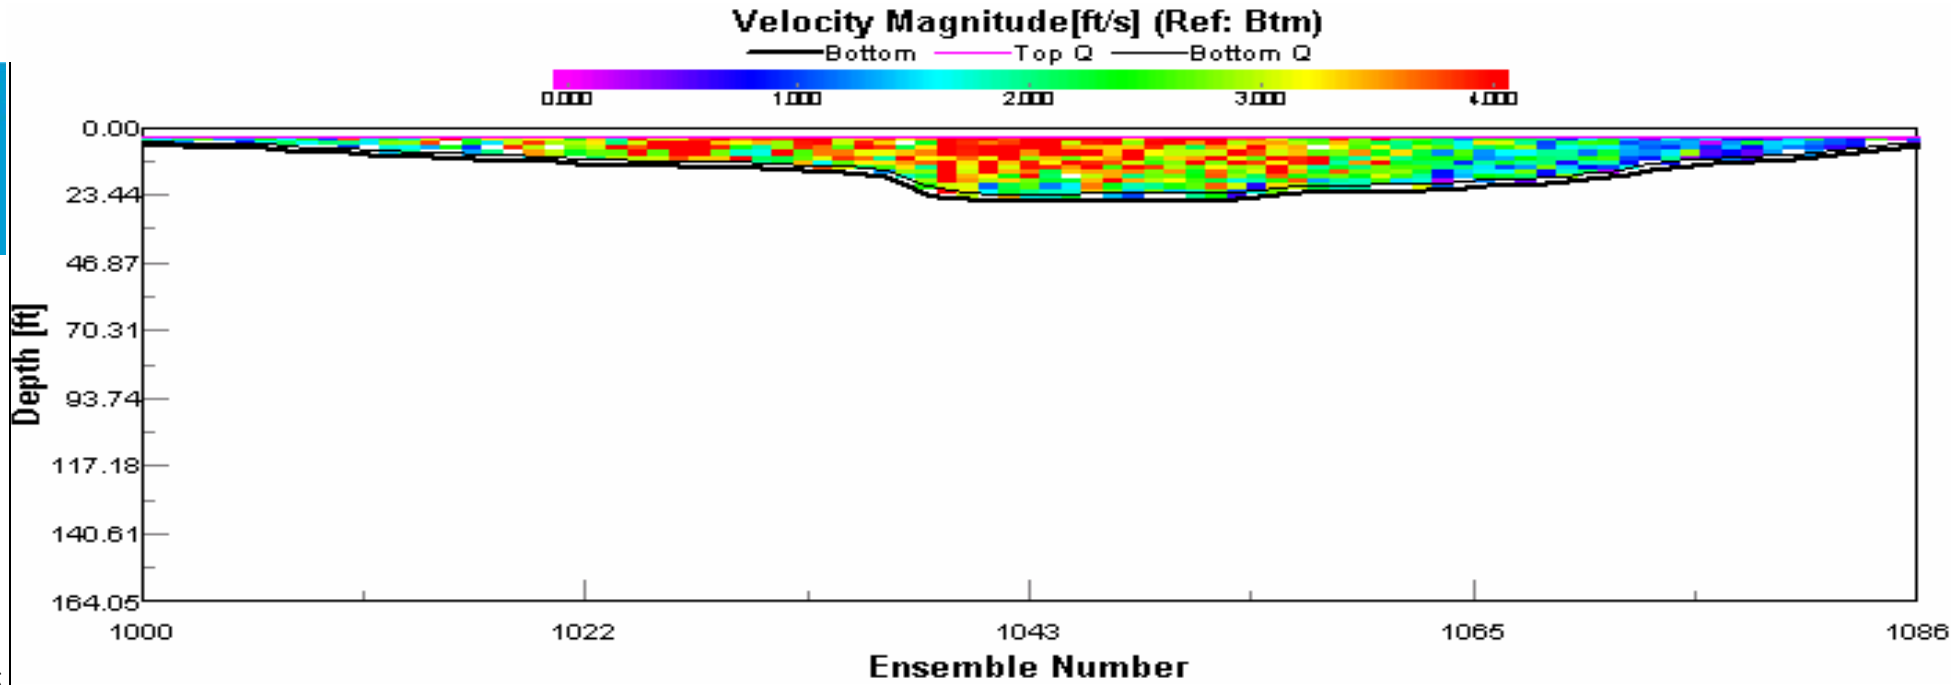
Monument 23 Discharge Transect 5, WinRiver Velocity and Ship Track Plots
