2007 Colville River Delta Spring Breakup and Hydrologic Assessment

Michael Baker, Jr., Inc.
111335-MBJ-RPT-001

November 2007

This report presents observations and findings of the 2007 Colville River Delta spring breakup and hydrologic assessment. The assessment was conducted in support of the Alpine Development Project and Alpine Satellite Development Plan, representing the sixteenth consecutive season of study.

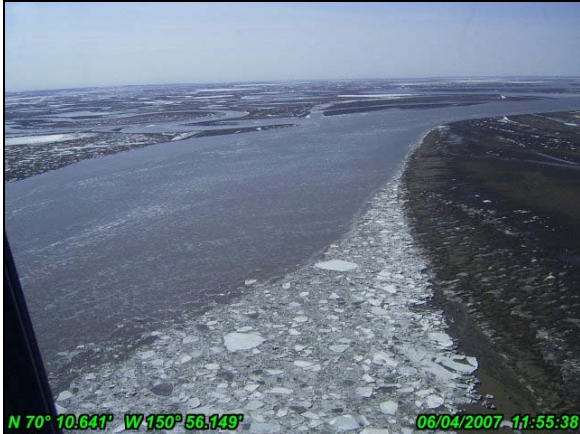
The peak water surface elevation at Monument 1 occurred in the early morning on June 4. Peak stage at Monuments 1 and 9 was 18.97 feet and 14.27 feet, respectively (noted as highwater marks). By mid-morning on June 4, ice jams in the Nigliq (Photo 4-9) and East Channels had released and stage at Monuments 1 and 9 was decreasing. As stage decreased, the Nigliq Channel ice jam reformed downstream near CD4, while the East Channel ice jam reformed downstream of the Tamayagiaq distributary. The reach at Monument 1 began to clear of ice on the afternoon of June 4 (Photo 4-10).

<p>N 70° 10.641' W 150° 56.149' 06/04/2007 11:55:38</p>
<p>Photo 4-9 Ice Jam at Nuiqsut, June 4, 2007</p>	<p>Photo 4-10 Monument 1 Nearly Clear of Ice, June 4, 2007</p>

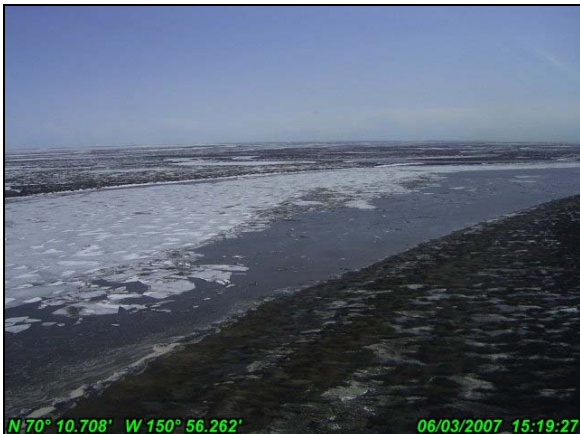
Stage and observation records for the Monuments in the East Channel are presented in Table 4-21 through Table 4-24 (beginning on page 4-53); Photo 4-11 through Photo 4-14 show breakup conditions in the East Channel at Monument 1. Stage and observation records for monuments in the Nigliq Channel are presented in Table 4-25, Table 4-26, Table 4-27, and Table 4-28. Chart 4-1 (page 4-9) is a timeline of the major 2007 breakup events in the Delta.

<p>N 70° 10.708' W 150° 56.262' 06/03/2007 15:19:27</p>
<p>Photo 4-11 Colville East Channel at Monument 1, May, 28, 2007</p>	<p>Photo 4-12 Colville East Channel as Ice Flow Began, June 3, 2007</p>

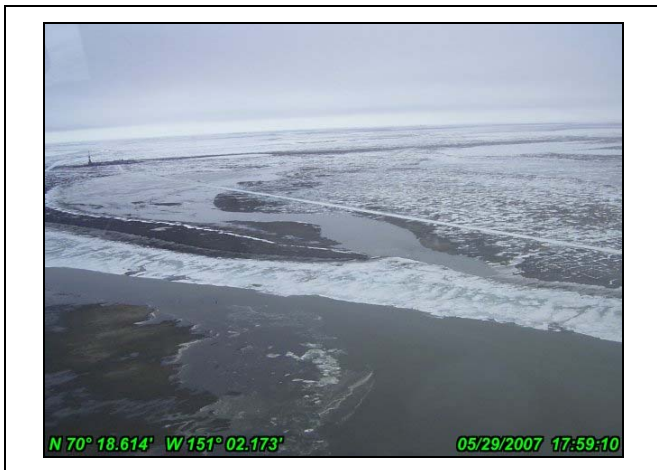
Breakup floodwaters first reached the Alpine facilities on May 29 when flow began to enter Nanuq Lake from the Nigliq Channel (Photo 4-15). At this time, floodwaters also began to arrive at the CD3 pipeline bridge crossings. The leading edge first reached the Ulamnigiaq crossing on May 29 (Photo 4-16) followed by the Sakoonang and Tamayagiaq crossings on May 30. However, it was not until June 3, when the initial ice jams in the Nigliq and East Channels began to clear, that floodwater inundated the area around the Alpine facilities. The ice jam in the Nigliq Channel released on June 4 and reformed near the CD4 pad. As a result, peak stage at the CD4 south culvert battery occurred that evening with peak elevations at Gage 17 of 10.23 feet and at Gage 18 of 10.62 feet.

Photo 4-15 Early Floodwaters Entering Nanuq Lake from the Nigliq Channel, May 29, 2007

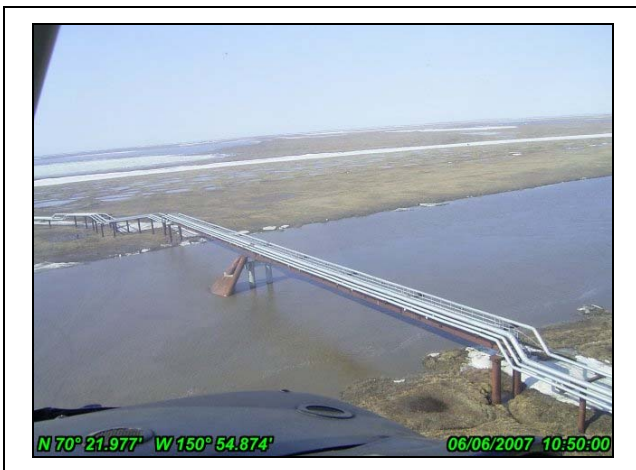
Photo 4-17 Sakoonang Pipeline Crossing After Peak Stage, June 6, 2007

Peak stage at the pipeline bridge crossings of the Sakoonang (Photo 4-17), Tamayagiaq (Photo 4-18), and Ulamnigaiq (Photo 4-19) also occurred in the early morning on June 5. The Sakoonang, Ulamnigaiq, and Tamayagiaq Channel crossings reached elevations of 6.25 feet, 7.05 feet, and 7.75 feet, respectively. The Sakoonang crossing experienced the greatest differential between peak stage and initial gage reading (5.25 feet), while the Ulamnigaiq and Tamayagiaq crossings increased 3.53 feet and 2.95 feet, respectively.

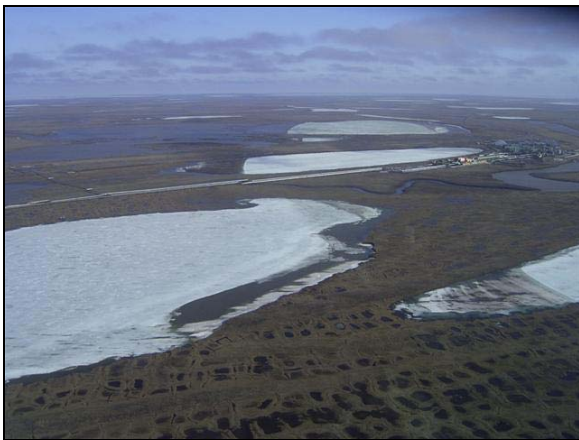
Table 4-29 and Table 4-30 present the stage and observation records for Gages 1, 9, and 10 near CD1. (Tables for the Alpine Gages begin on page 4-62.) Photo 4-20 illustrates the conditions around CD 1 gages following peak floodwaters on July 9. Table 4-31 presents the stage and observation records for Gages 3 through 7, near CD2. CD2 post breakup is shown in Photo 4-21. Photo 4-22 and Photo 4-23 show the receding floodwaters at the CD2 access road 62-foot and 452-foot swale bridges, respectively.

Photo 4-20 CD1 Gages Post Breakup, June 9, 2007

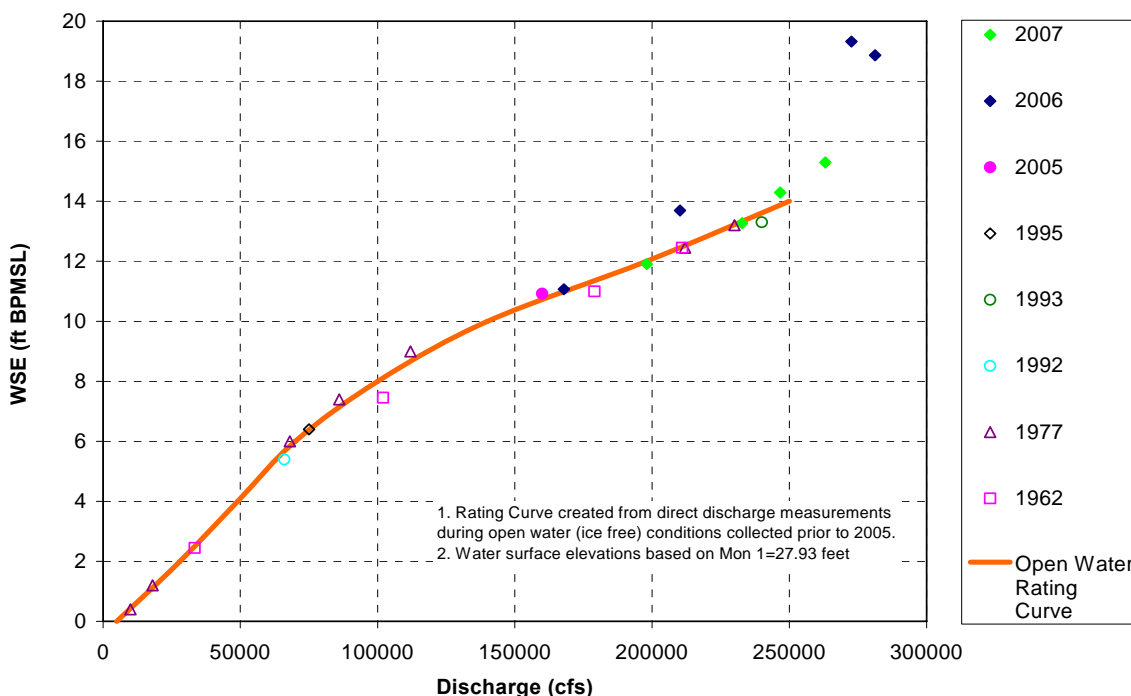
Measurement ratings are based on the relationship of corrected mean discharge with the stage-discharge rating curve, expressed as a percent error. Channel ice and flowing debris caused a backwater effect and measured discharge values were slightly above the rating curve (Graph 4-1) on June 4 and 5 resulting in a fair and good rating, respectively. The June 6 and 7 measurements are considered excellent, based on the presence of open water conditions, calm water, and relationship to the stage-discharge rating curve (Graph 4-1).

Graph 4-1 Monument 1 Stage-Discharge Rating Curve with Direct Discharge Values

Due to the ice affected cross section, the discharge at the time of the peak stage plots well above the stage-discharge rating curve developed for open water conditions. Using the stage-discharge curve, Graph 4-1, to estimate discharge during ice affected conditions would over estimate discharge.

The June 6 and June 7 direct discharge measurements were collected during open water conditions with corrected discharges plotting within 1% of the stage-discharge rating curve. This suggests that the rating curve and channel at Monument 1 have not shifted significantly over time. The 2007 measurement is considered a verification of the rating curve, given that the June 6 and June 7 discharge measurements plot within 5% of the rating curve (USGS 1982, Vol. 2 pg 346).

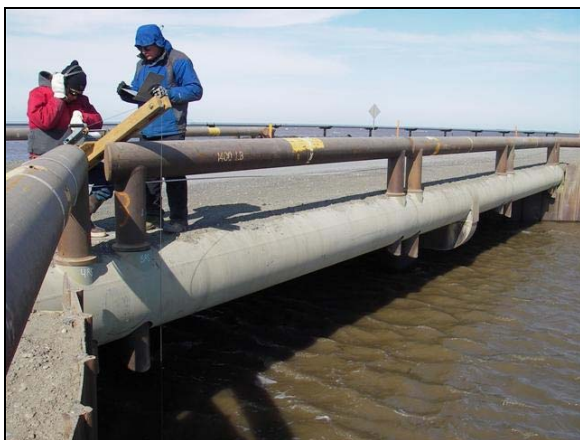
Photo 4-28 Discharge Measurement at 62-foot Swale Bridge, June, 5, 2007

To monitor the performance of drainage structures and to comply with stipulated monitoring requirements outlined in USACE Permit No. POA-2004-253, direct discharge measurements at the swale bridges were conducted. Peak stage discharge was also estimated. On June 5, discharges at the 62-foot (Photo 4-28) and 452-foot (Photo 4-27) swale bridges were measured at 345 and 1,240 cfs, respectively. Table 4-4 presents a summary of the 2007 discharge measurement data at the Alpine swale bridges. The complete discharge notes are presented in Appendix C.

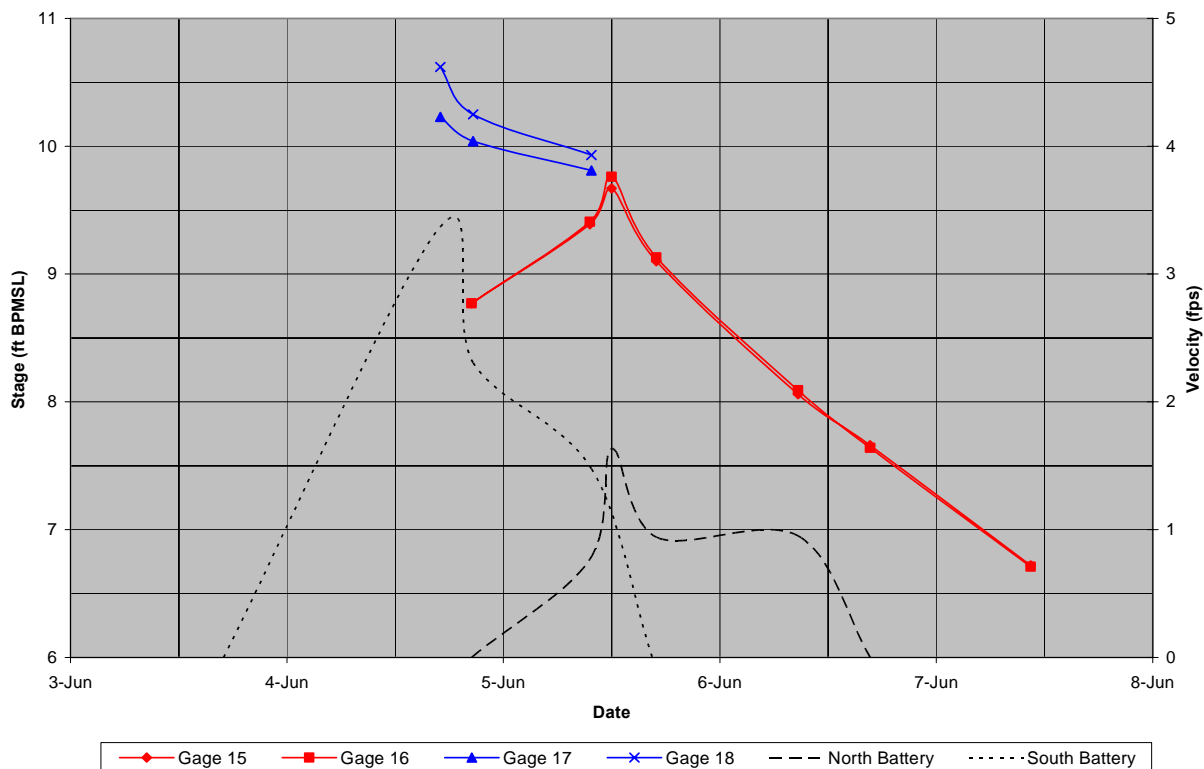
Graph 4-5 CD4 Road Culverts Estimated Average Velocity vs. Stage

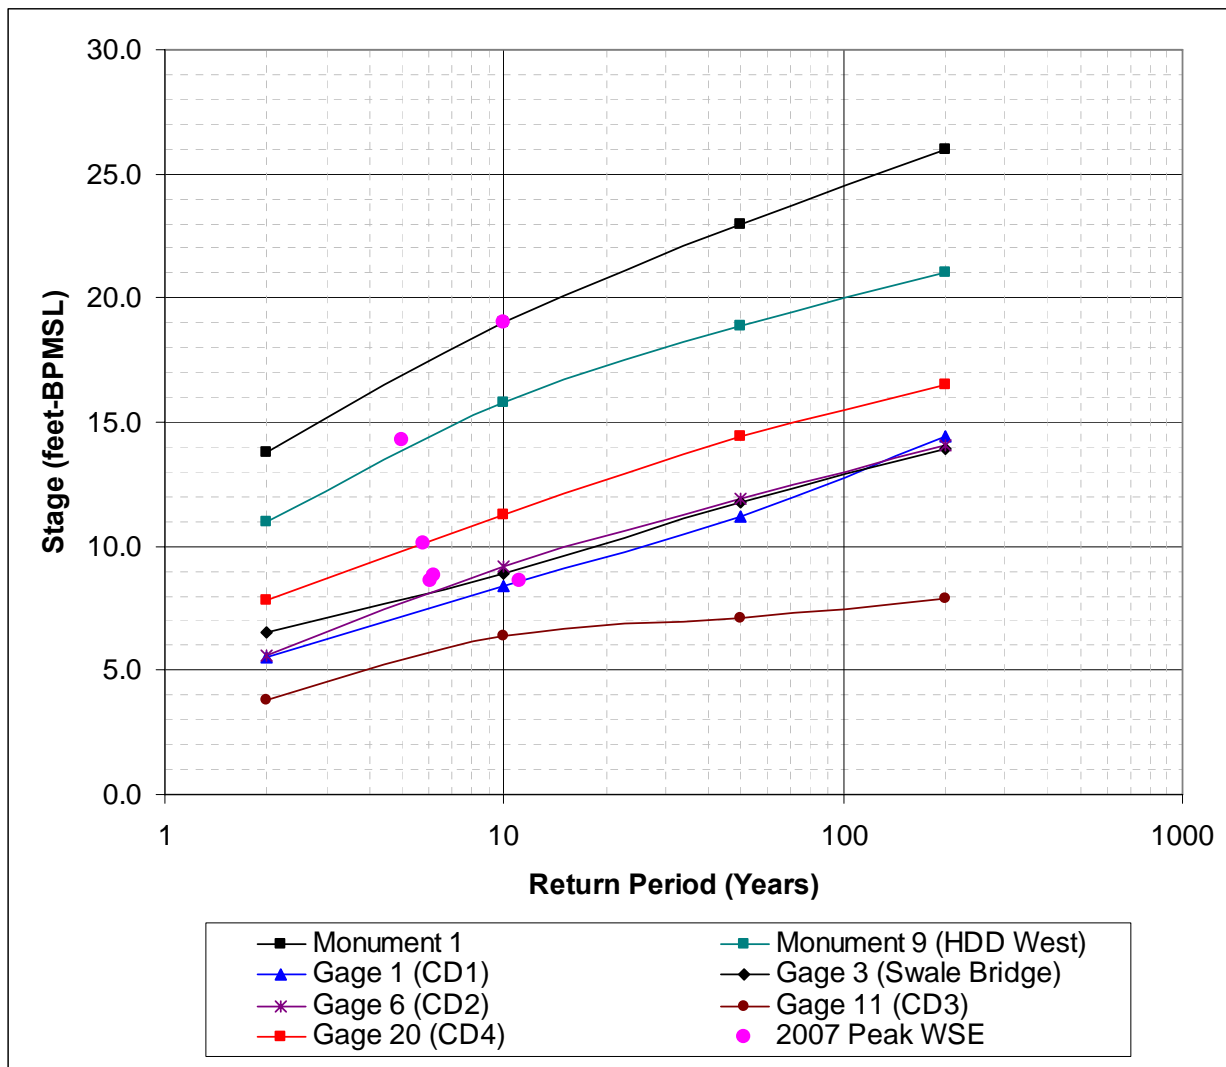
The 2D surface water model was developed to predict open water conditions during low frequency, high magnitude flood events having 50-, 100-, and 200-year recurrence intervals. To estimate the relationship between discharge and stage during lower magnitude flood events, 2- and 10- year flood events have been modeled. The model assumes open water, steady-state conditions, and does not account for snow, channel ice, or ice jams. Graph 4-7 presents predicted water surface elevations at selected locations for 2-, 10-, 50-, and 200-year floods and their respective 2007 peak stage.

Graph 4-7 Colville River Delta 2D Model Predicted Water Surface Elevation & Return Interval

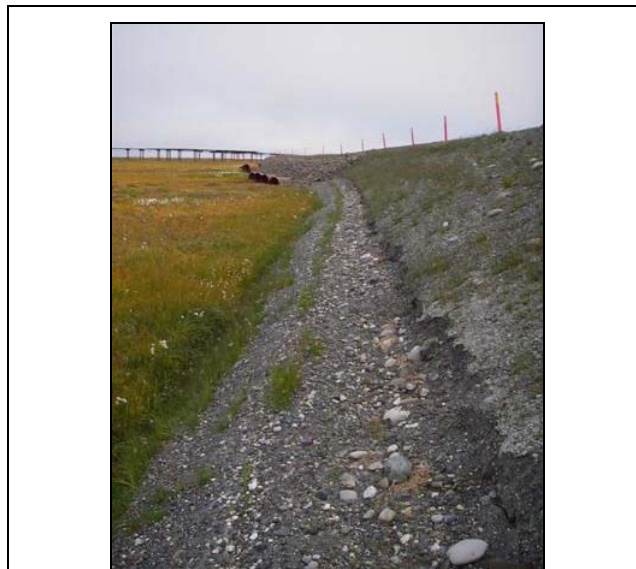
A relatively small volume of fine-grained sediment was washed from the CD4 eastern road embankments near the northern culvert battery due to the inundation. No slumping or side slope deterioration was observed. Photo 4-30 and Photo

Photo 4-30 Fine Grained Sediment Settlement on Eastern Side of CD4 Road at STA 160+00 Looking South, August 28, 2007

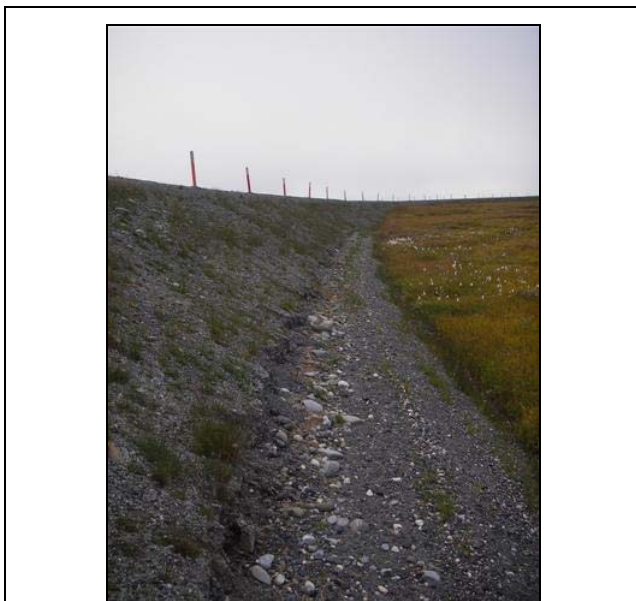
4-31 present the erosion observed on the east side of the CD4 road in the region of the north culvert battery which represents the only location along the CD2 and CD4 roads where erosion was observed. Photo 4-32 represents the condition of the majority of Alpine facility pads and roads after breakup. Pictures of the CD4 road were taken August 28, 2007.

Photo 4-31 Fine Grained Sediment Settlement on Eastern Side of CD4 Road at STA 160+00 Looking North, August 28, 2007

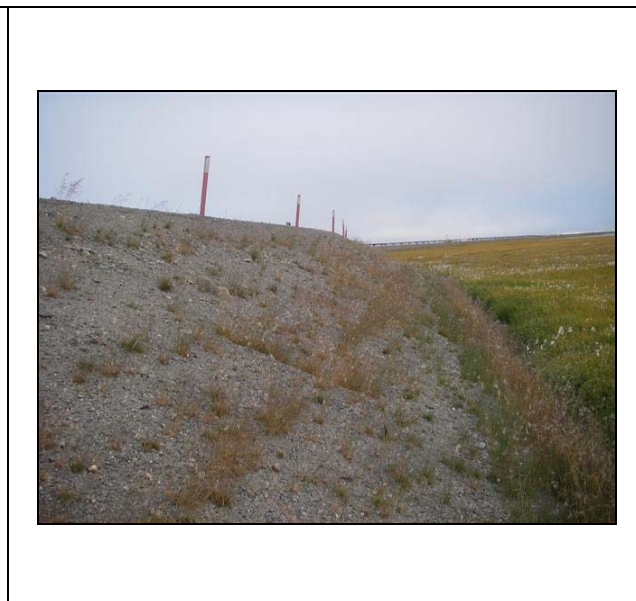
Photo 4-32 Western Side of CD4 Access Road after Breakup at STA 160+00 Looking South, August 28, 2007

Alpine’s gravel pads and access roads were inspected for erosion following spring breakup. At no location along the gravel structures was a significant amount of erosion observed. The edges of the Alpine facility pads (CD1, CD2, CD3, and CD4) were not inundated with or structurally affected by floodwater; however, the gravel bases along CD2 and CD4 were partially submerged (Photo 4-24).

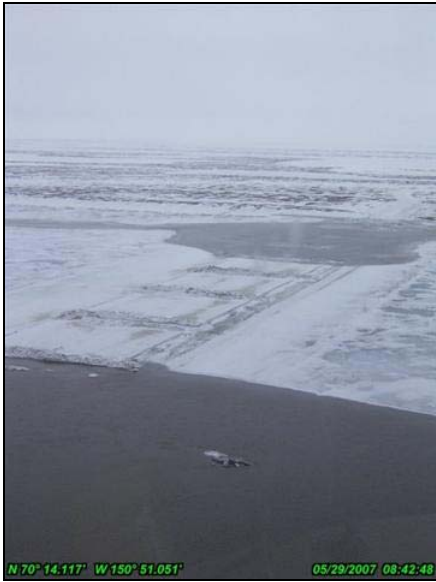
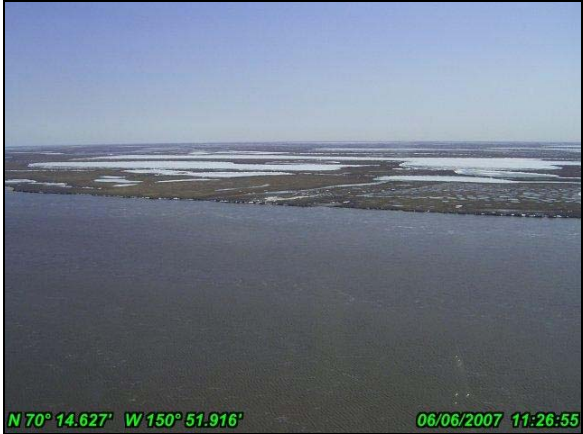
No significant erosion or scour was observed during breakup at or near the Colville River East Channel ice bridge crossing. Photo 4-35 through Photo 4-38 represent conditions at the ice bridge crossing during and after breakup.

<p>Photo 4-35 Colville East Channel Ice Bridge during Breakup (looking east), May 29, 2007</p>	<p>Photo 4-36 Colville East Channel Ice Bridge (east bank) after Breakup, June 9, 2007</p>

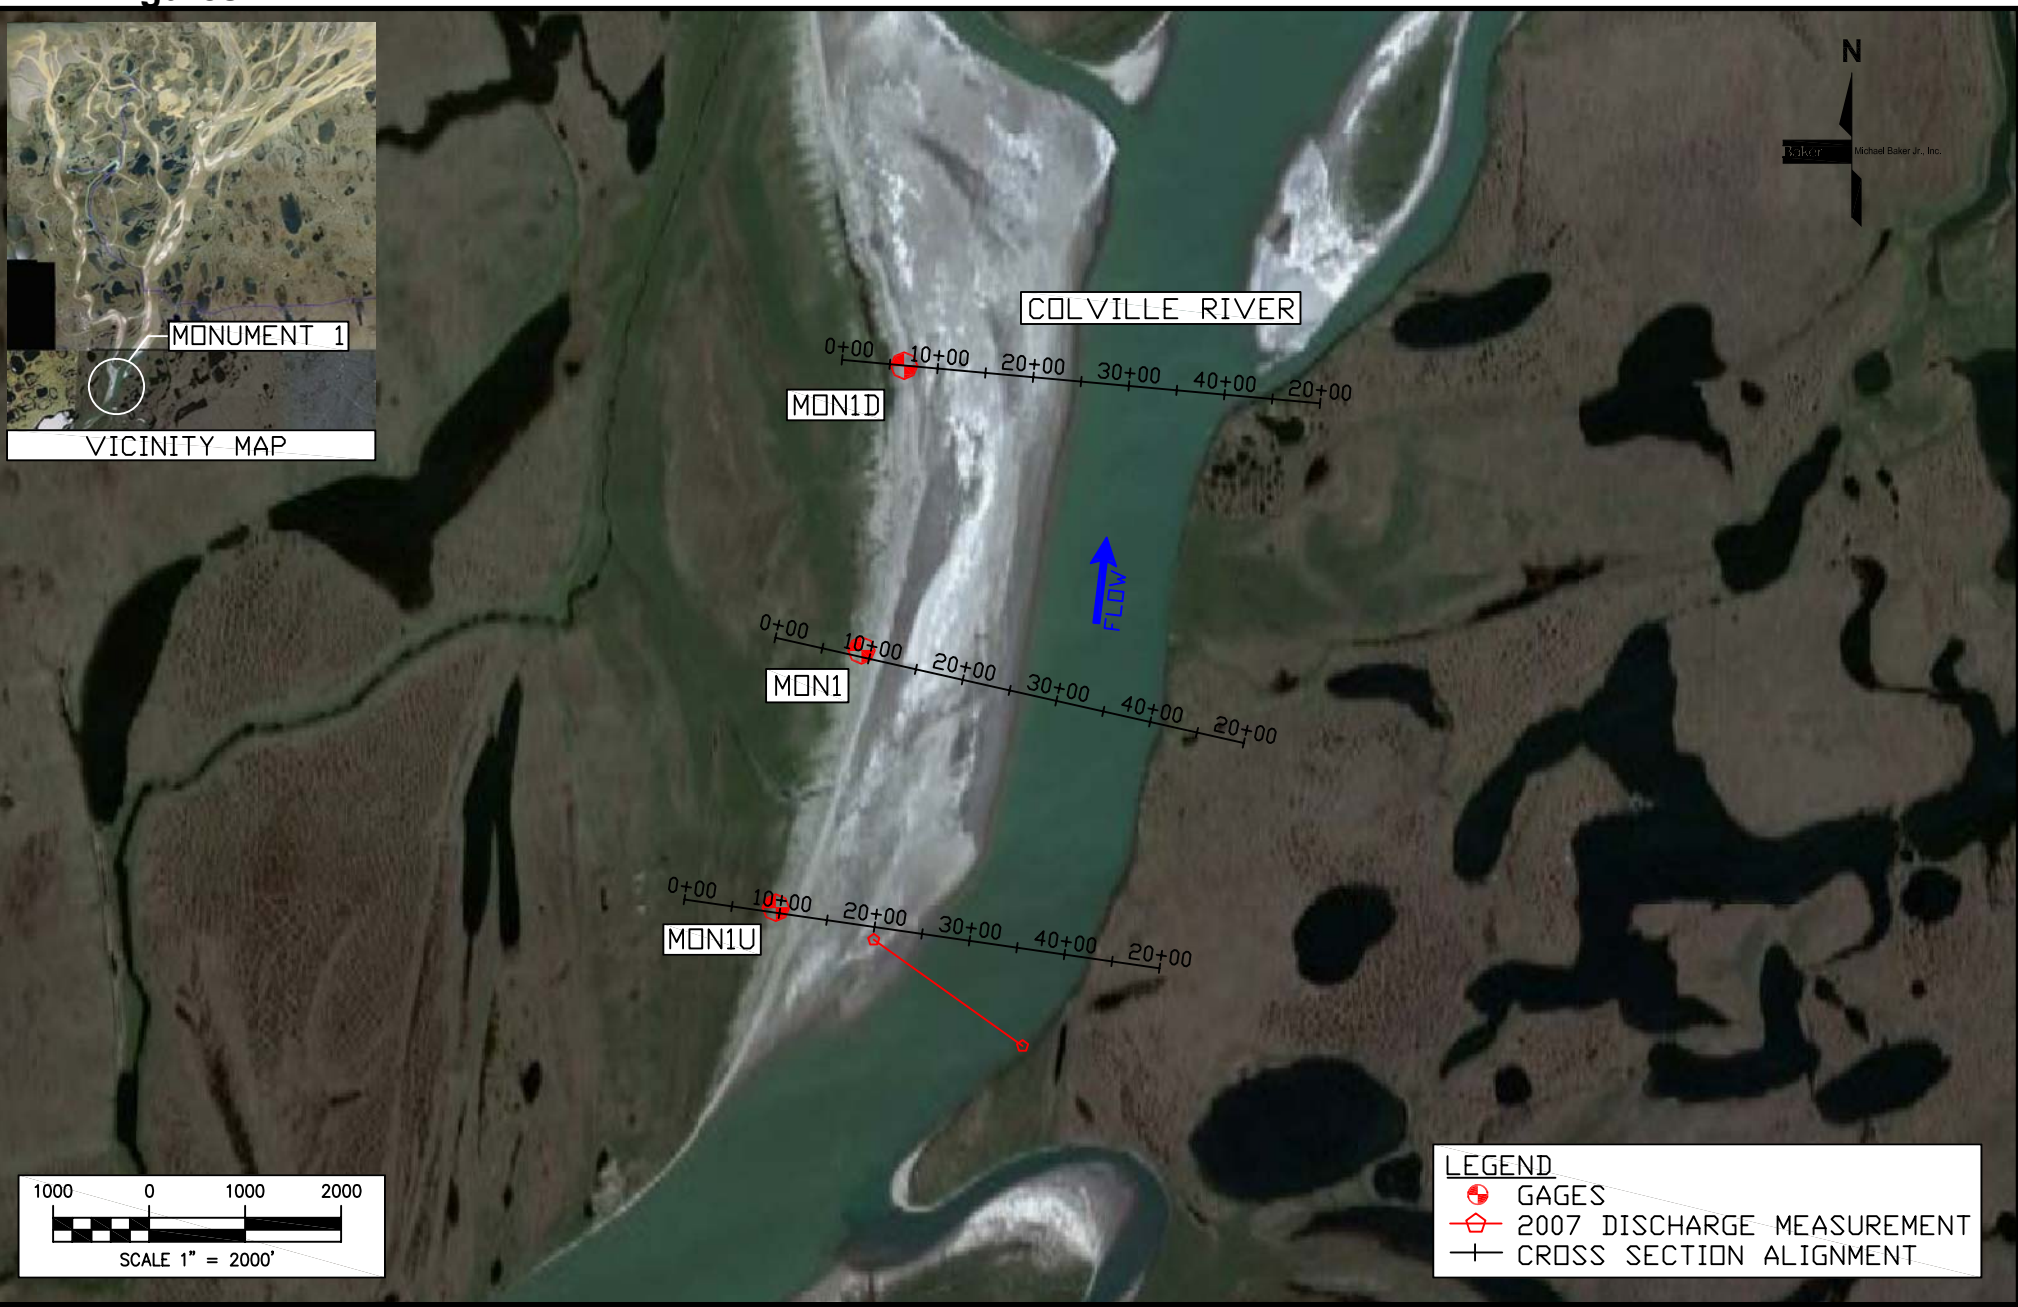
FIGURE 4-1

Measured discharge ranged from 198,000 to 263,000 cfs over the four day period. Mean discharge velocities ranged from 4.0 to 4.6 fps. The maximum mean velocity was measured on June 6 corresponding with the maximum observed water surface slope. Table 4-1 summarizes the 2007 discharge measurement data on the Colville River at Monument 1U and Figure 4-1 Sheet 1 presents the location of discharge measurements at Monument 1U.
