# FIORD WEST 2009 HYDROLOGIC ASSESSMENT

December 2009  
117214-MBJ-RPT-001-REV1

This report presents observations and findings of the Fiord West 2009 Hydrologic Assessment conducted by Michael Baker Jr., Inc. (Baker) at the request of ConocoPhillips Alaska (CPAI). This assessment supports the Alpine Development Project and Alpine Satellite Development Plan, and represents the second consecutive year of study in the Fiord West region.

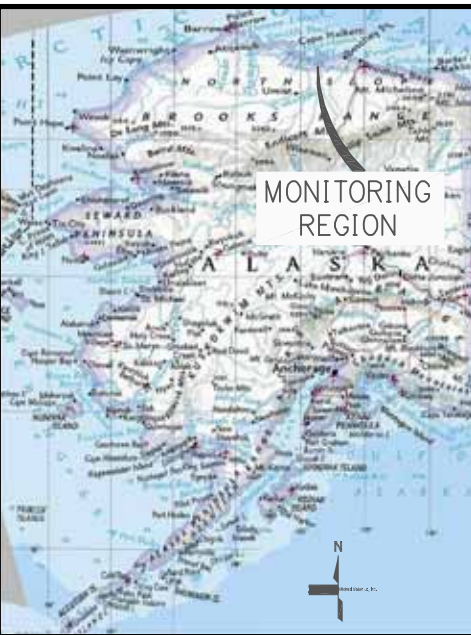
2009 FIORD WEST BREAKUP  
 EXISTING & PROPOSED FACILITIES  
 CRD & NPR-A  
 FIGURE 1.1 REV 1  
 (SHEET 1 OF 1)

ConocoPhillips Alaska (CPAI) has proposed the development of a drilling pad and access road in the Fiord West region of NPR-A as part of the Alpine Satellite Development Plan (ASDP). Figure 1.1, shows the proposed pad at the location under evaluation at the time of this study. Additional locations are currently under review. The Fiord West Pad, designated FWP, will be accessible via a gravel road extending north approximately 1.7 miles from an intersection with the proposed CD5 access road.

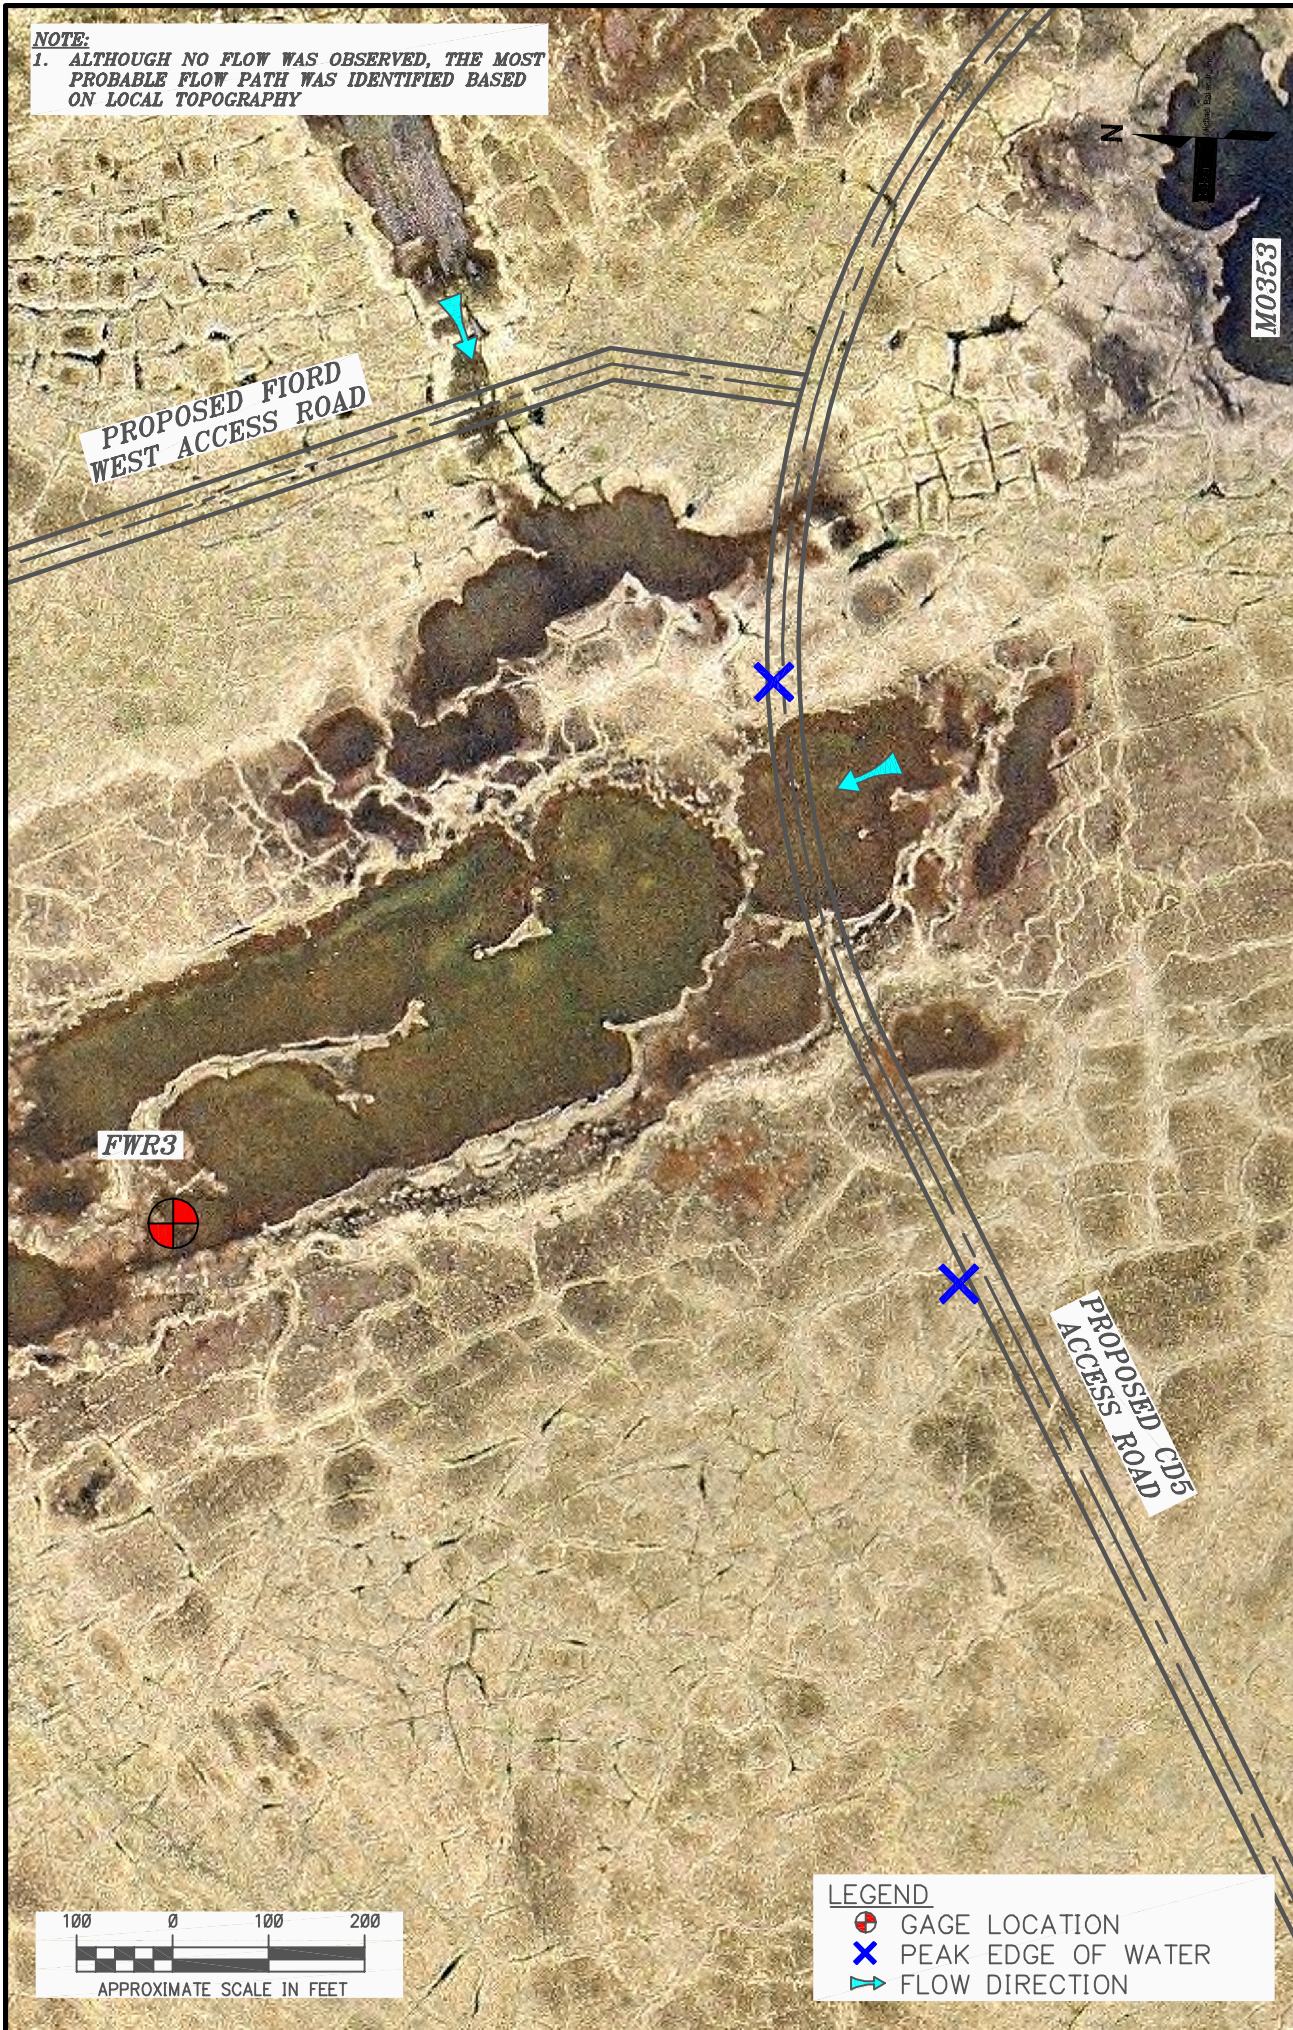
<b>ConocoPhillips</b> Alaska, Inc.	PROJECT: 117214
	FILE: FIGURE 2.3
	SCALE: APPROXIMATE
DATE: 12/17/09	DRAWN: SMC
	CHECKED: HLR

1. ALTHOUGH NO FLOW WAS OBSERVED, THE MOST PROBABLE FLOW PATH WAS IDENTIFIED BASED ON LOCAL TOPOGRAPHY

FWR3 is located near the proposed CD5/Fiord West access road intersection, between Lake MB0301 to the west and Lake M0353 to the south. Gage FW3 was originally established in 2005. Though not directly on the proposed alignment, limited topographic relief and a historic record justified its use as a monitoring location in 2009. Gage FWR3 was surveyed on May 28. Figure 2.3 shows the location of the FWR3 gage.

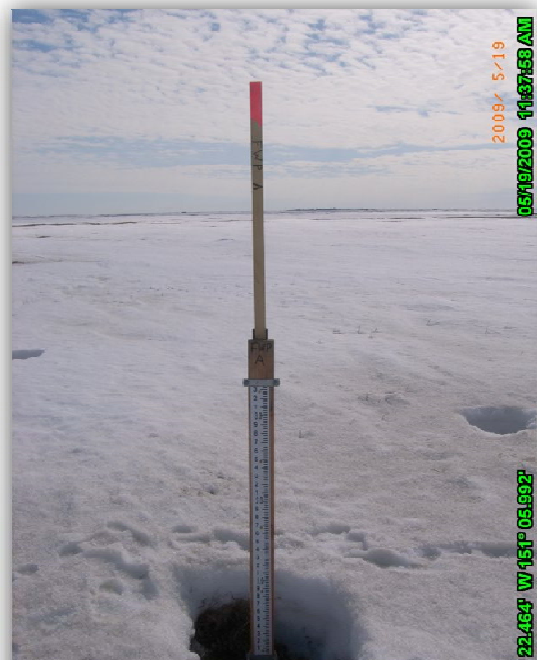
**PHOTO 3.1: STAFF GAGE INSTALLED AT SITE  
FWP, MAY 19, 2009**

Temporary staff gages were installed at each site as instruments to measure WSE. At those times when water levels were not high enough to be recorded on the staff gages, standard level loop survey techniques were used to measure WSE using the gage as the basis of elevation. Gages installed at Fiord West study locations consisted of one to four assemblies per site. Each gage assembly consisted of a metal gage faceplate mounted on a 2 x 4 timber attached with U-bolts to a 6-foot long 1.5-inch angle iron post driven approximately 2 feet into the ground. The horizontal position of each gage was recorded using a handheld Garmin 60CS GPSMAP in North American Datum of 1983 (NAD83). Photo 3.1 shows an example of a staff gage after installation.

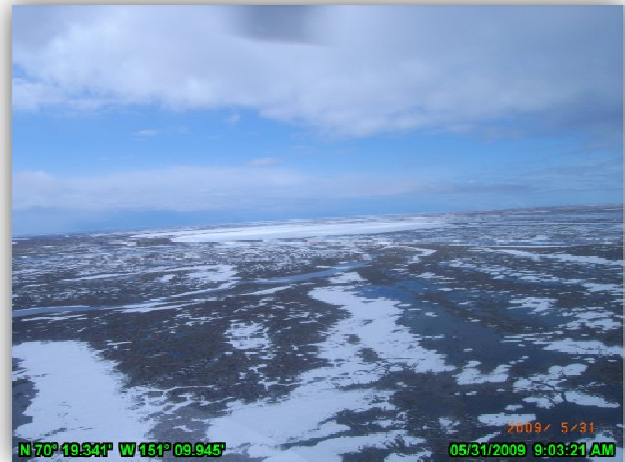
**PHOTO 4.1: AERIAL VIEW OF TYPICAL FIORD WEST ROAD LOCATION, MAY 31, 2009**

Photo 4.1 shows an aerial view of initial breakup conditions along the proposed Fiord West access road alignment on May 31. Photo 4.3 shows an aerial view of initial breakup conditions at FWR2 on May 31. Photo 4.2 shows an aerial view of initial breakup conditions at FWR1 on May 28.

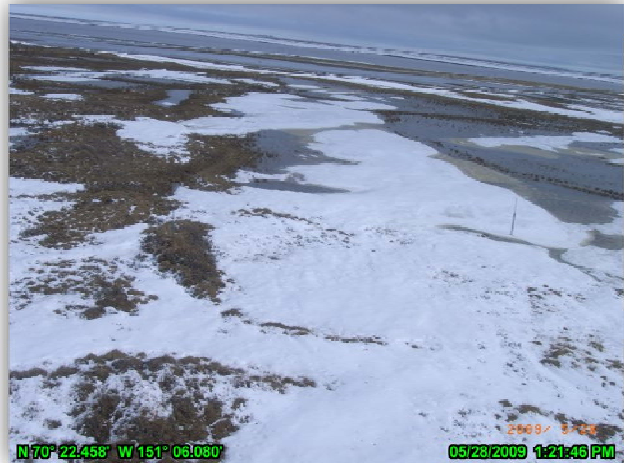
**PHOTO 4.4: AERIAL VIEW OF FWP, MAY 28, 2009**

Throughout the monitoring period, no defined drainage channels or significant flow was observed at the Fiord West pad location. Accumulation of water was determined to be the result of local melt only, with standing water occurring only in isolated troughs and depressions in the terrain. Photo 4.4 shows initial breakup conditions of the Nigliq Channel (in the background) at the FWP location on May 28.

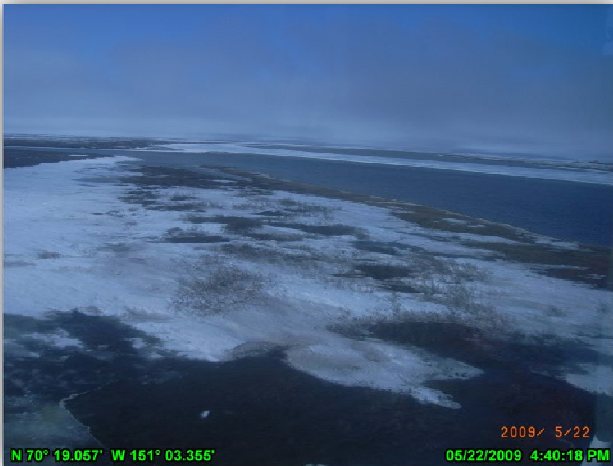
**PHOTO 4.5: NIGLIQ CHANNEL LEFT BANK AT MON22, MAY 22, 2009**

Localized melt and standing water in the Nigliq Channel near the Fiord West location was first observed on May 9. Open channel flow was observed on May 22. Flow attributed to breakup flooding was significant and steady until meltwater abated. No ice jams were recorded in proximity of the monitoring area. No hydraulic connectivity in the form of overland flow was observed between the Nigliq Channel and the Fiord West pad vicinity. Monitoring of the Nigliq Channel was discontinued on May 28. Photo 4.5 shows initial breakup conditions of the Nigliq Channel at the MON22 location on May 22.

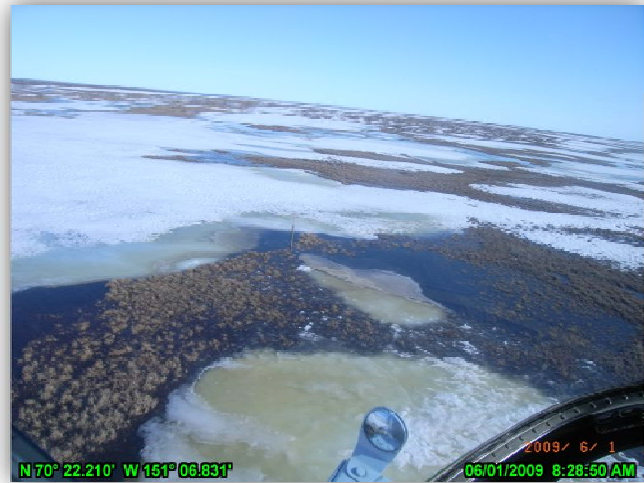
PHOTO 4.6: FWR1, JUNE 1, 2009

The June 1 conditions at FWR1 are shown in Photo 4.6. The June 1 conditions at FWR2 are shown in Photo 4.7.

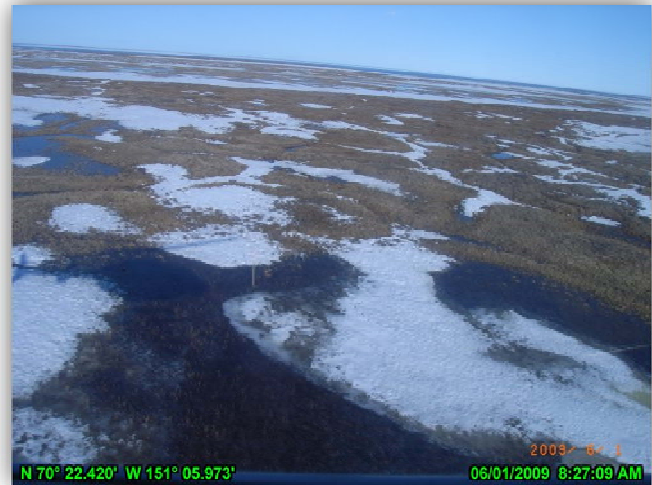
**PHOTO 4.8: FWP, JUNE 1, 2009**

Table 4.4 presents the observations and WSE recorded for FWP. The June 1 conditions at FWP are shown in Photo 4.8.

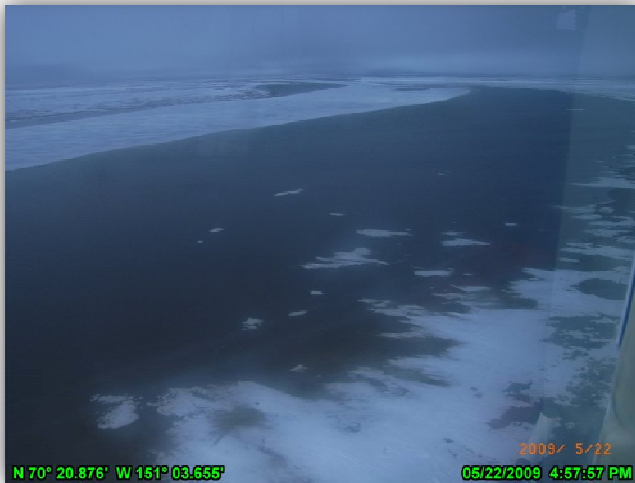
**PHOTO 4.9: NIGLIQ CHANNEL BANKRIGHT AT MON23, MAY 22, 2009**

Table 4.5 presents the observations and WSE recorded for MON22. Table 4.6 presents the observations and WSE recorded for MON23, including PT data. The May 22 conditions along the Nigliq at MON23 are shown in Photo 4.9.
