# Fish Creek Basin (FCB) 2010 Spring Breakup Hydrologic Assessment

December 2010  
120172-MBJ-RPT-001

This report presents observations and findings of the 2010 Fish Creek Basin (FCB) Alpine Satellite Project Spring Breakup and Hydrologic Assessment conducted by Michael Baker Jr., Inc. (Baker) at the request of ConocoPhillips Alaska. The assessment supports the Alpine Development Project and Alpine Satellite Development Plan, and is Baker's sixth year of study in the Fish Creek Basin.

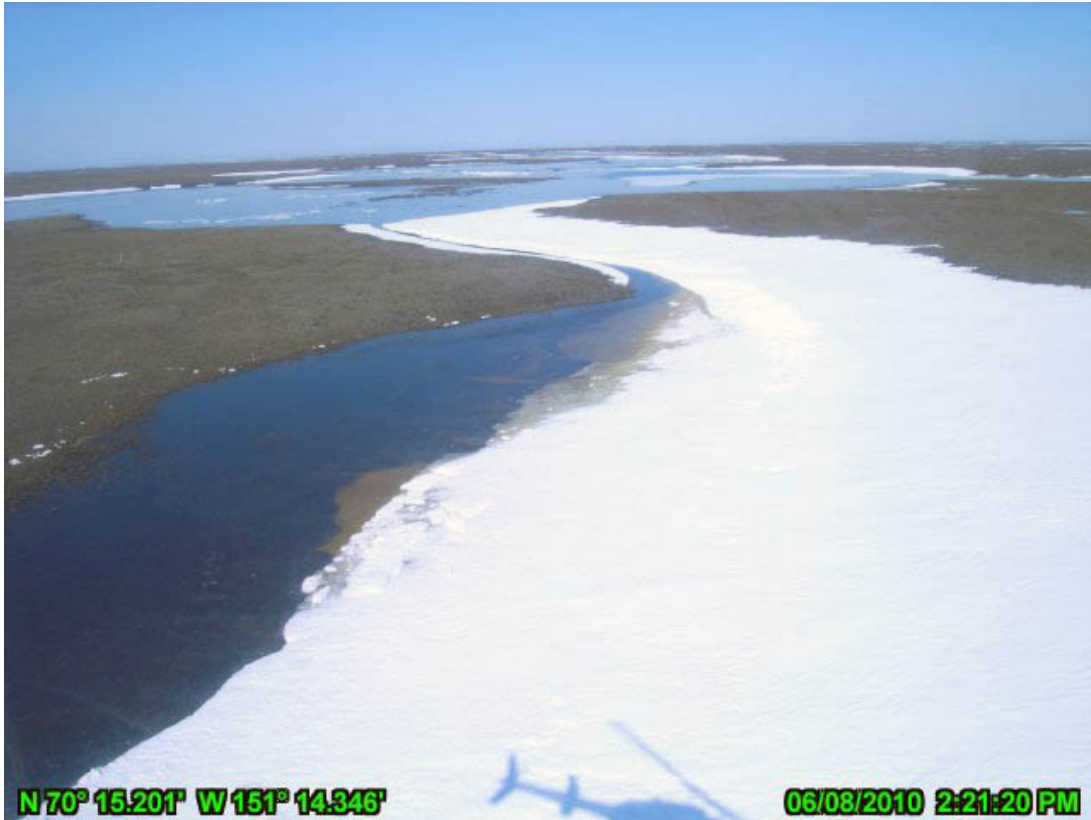
Photo 2.1: Aerial Photo near CMS2-B Monitoring Location, June 8, 2010

Four locations were identified as monitoring sites in 2010, representative of the general CMS area. Site location was based on a preliminary map of the CMS area showing a “Clover Site 1” and “Clover Site 2” boundary. Figure 1.3 shows the FCB breakup gage locations. The four monitoring locations were established based on topography and aerial imagery. A single gage was established at each site. Photo 2.1 shows an aerial view of the CMS2-B location.

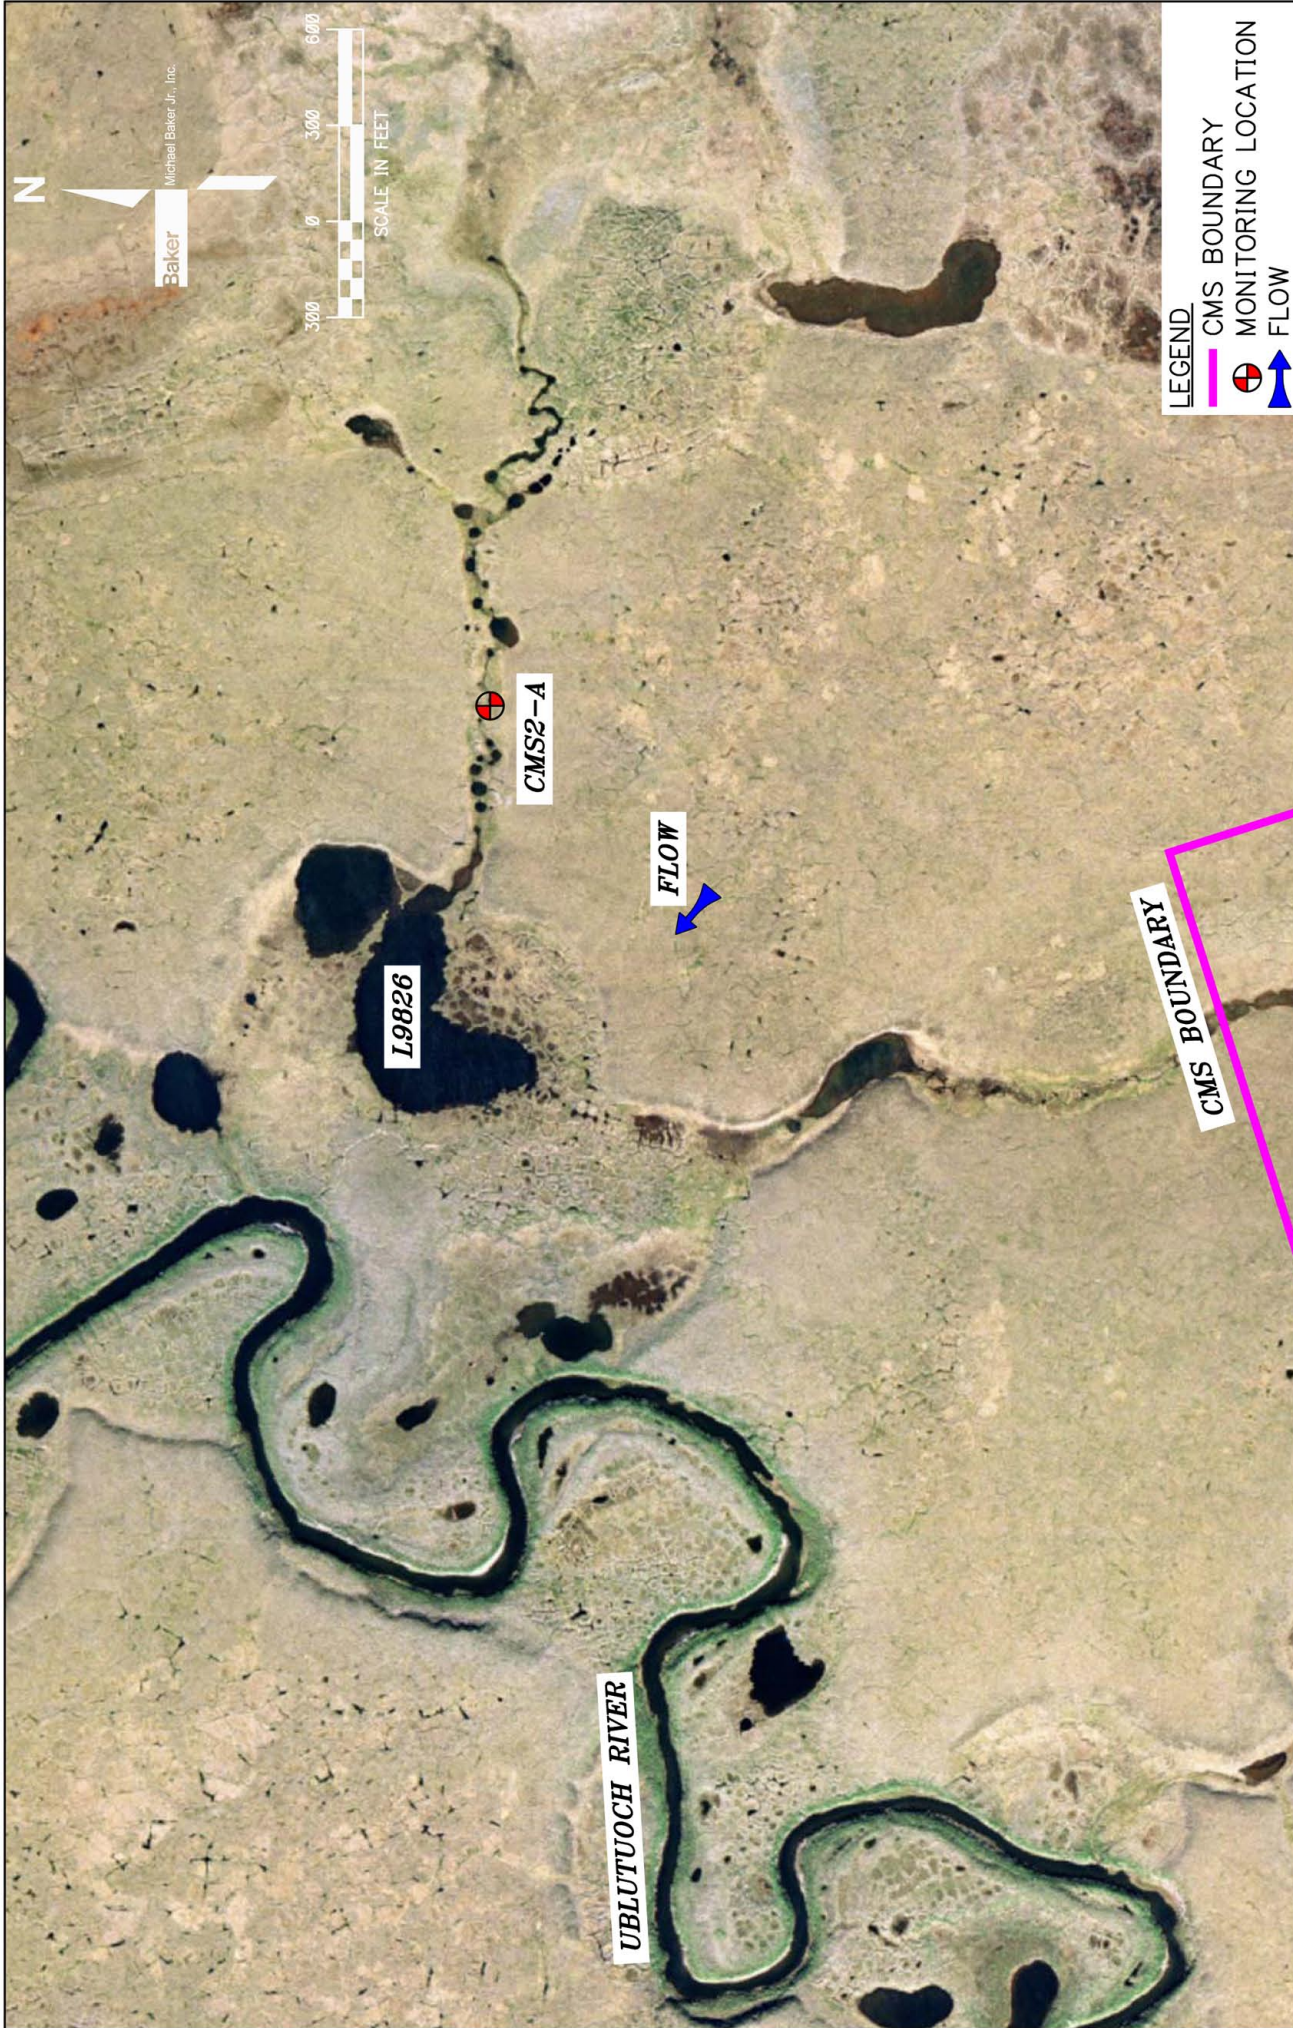
2010 FCB BREAKUP  
 CMS2-A  
 GAGE LOCATION  
 FIGURE 2.2  
 (SHEET 1 OF 1)

Gage CMS2-A is located approximately 0.4 mile north-northeast of the northeast corner of the CMS excavation boundary, and 0.3 miles southeast of the Ublutuoch River. The channel is well-defined, and is located along a series of beaded ponds. Tussocks dominated both overbanks, with dwarf willows and native grass in the channel. Lake L9826 lies approximately 0.1 mile downstream of the gage location between the gage and the Ublutuoch River. Figure 2.2 shows the location of the CMS2-A gage.

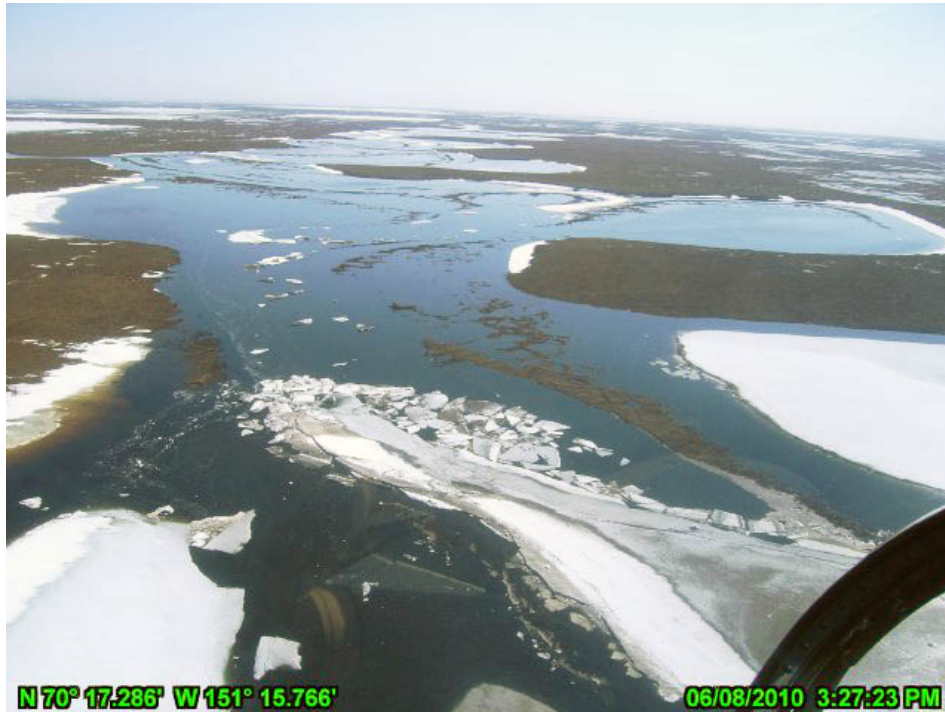
Photo 2.2: Ublutuoch River near Proposed GMT1 Road Crossing Site, UB 6.8, June 8, 2010

The Ublutuoch River monitoring sites were comprised of sets of three to four gages installed on the west bank of the Ublutuoch River at RM 6.7, 6.8, and 6.9, as shown in Figure 2.5. The RM location designations, UB 6.7, UB 6.8, and UB 6.9, refer to the distance in river miles from the confluence of the Ublutuoch River and Fish Creek. The gage locations were selected to monitor and document local breakup conditions at the proposed bridge location as well as upstream and downstream from the proposed crossing. The proposed Ublutuoch bridge location at UB 6.8 remains the same as it was in 2005 and 2006. An aerial view of the proposed bridge location is provided in Photo 2.2. At the proposed bridge site, the Ublutuoch River has a drainage area of approximately 228 square miles.

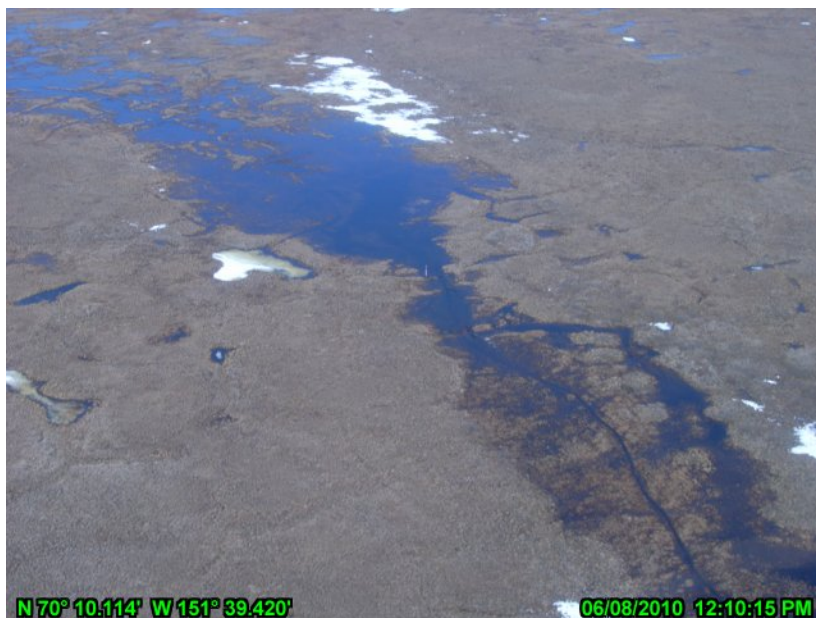
Photo 2.3: Aerial View GMT2 Drainage, June 8, 2010

Gage GMT2 is located approximately 0.7 miles northwest of the proposed pad. This drainage lies approximately 1.3 miles northeast of a tributary to the Ublutuoch River. The drainage is defined during breakup flow; later in the season flow ceased, and water depth was approximately 0.2 feet in the depression that remained of the channel. Tussocks and native grasses covered both overbanks and the channel. Figure 2.7 shows the location of the GMT2 gage. Photo 2.3 shows an aerial view of the GMT2 drainage area.

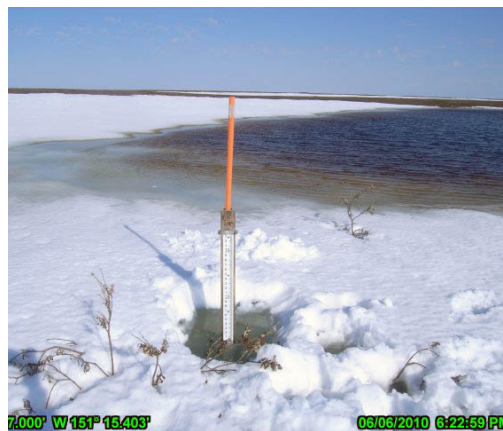
**Photo 3.1: Staff Gage Installed at UB6.9-A, June 6, 2010**

Temporary staff gages consisted of one to four gage assemblies per site. Each gage assembly contained a metal gage faceplate mounted on a two-by-four timber attached with U-bolts to a 6-foot long 1.5-inch angle iron post driven 2 feet into the ground. The horizontal position of each gage was recorded using a handheld Garmin GPSMAP 60CS in North American Datum of 1983 (NAD83). Photo 3.1 shows an example of a staff gage after installation.

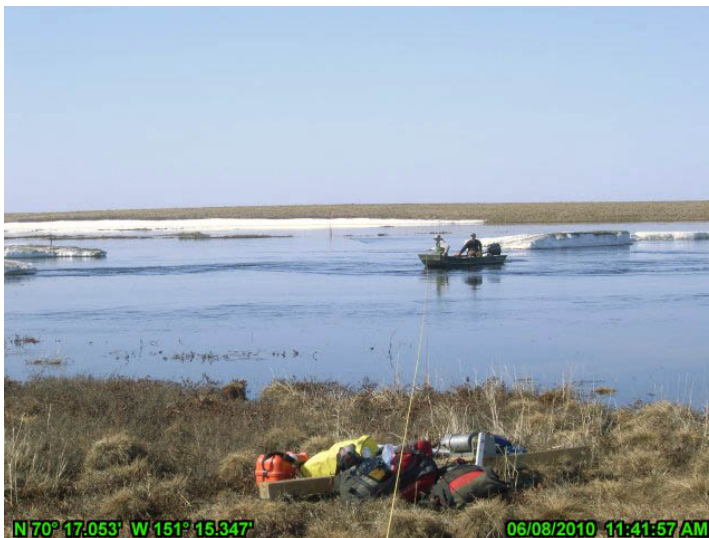
**Photo 3.2: Ublutuoch River Boat Discharge Measurement, June 8, 2010**

USGS at the Office of Surface Water (OSW) Hydraulic Laboratory in 2006. To ensure accurate performance of meters, procedures outlined in OSW Technical Memorandum No. 99.06 were followed. Photo 3.2 shows the

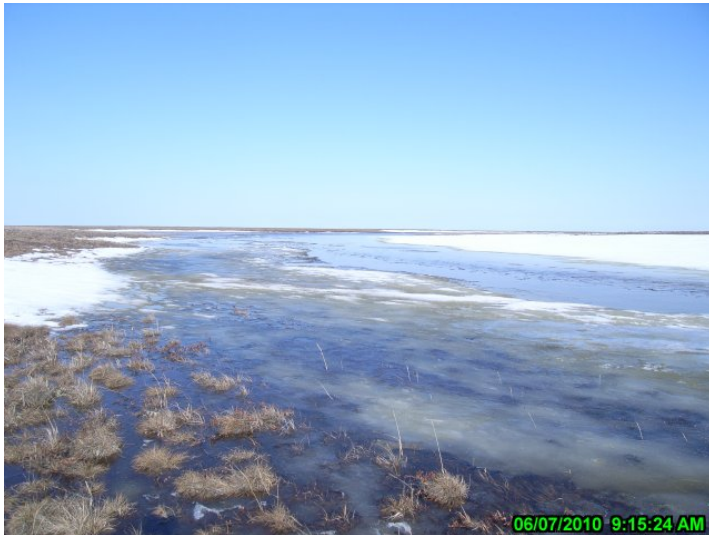
Photo 4.1: View near CMS1-A Gage Location, June 7, 2010

Water surface elevation measurements at CMS1-A began on June 7 (Photo 4.1). Daily monitoring during breakup was not possible in 2010 because of inaccessibility due to weather conditions. After breakup, monitoring continued at this location every two weeks through July. Flow was still present in this channel on July 29, after which observations were discontinued.

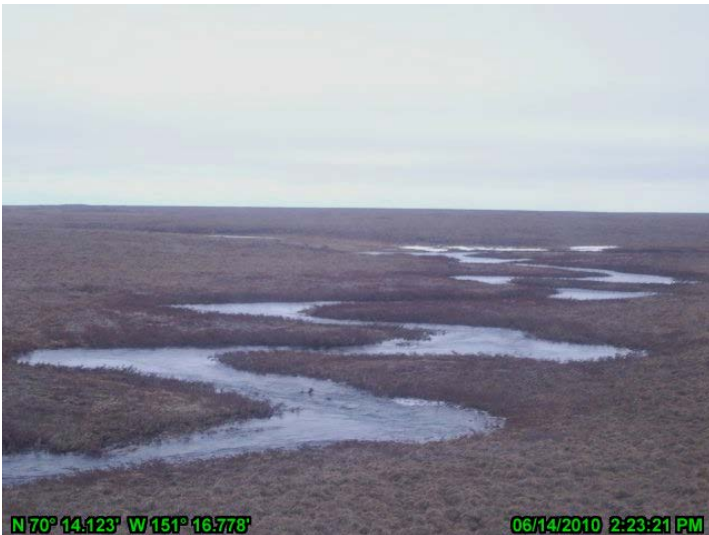
Photo 4.2: Aerial View, CMS1-A, June 14, 2010

Measured WSE increased from initial observations on June 7 to June 8, when peak stage is estimated to have occurred. Peak WSE at CMS1-A was 25.29 feet BPMSL. WSE are based on temporary benchmark TBM elevations set by handheld GPS, and are not tied to nearby monitoring locations or verified by survey to local control. WSE data for CMS1-A is provided in Table 4.1. Photo 4.2, Photo 4.3, and Photo 4.4 show the CMS1-A area at different times after breakup.

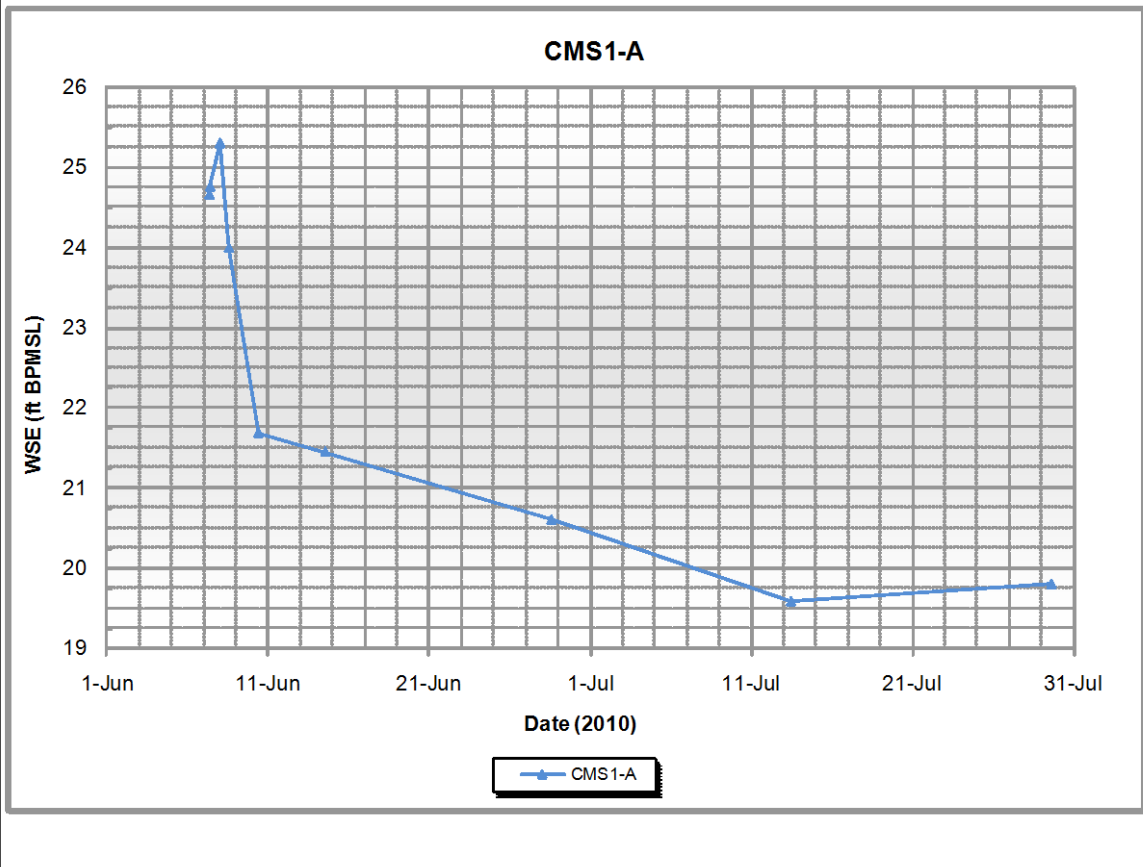
1. WSE are based on TBMs TUNDRA and CHICKEN, established by Baker in 2010. The elevations for these TBMs are set by handheld GPS, and are not tied to nearby monitoring locations or verified by survey to local control.
2. One discharge measurement of 51 cfs was taken on 6/7/2010 at 9:47 AM.

Measured WSE increased from initial observations on June 7 to June 8, when peak stage is estimated to have occurred. Peak WSE at CMS1-A was 25.29 feet BPMSL. WSE are based on temporary benchmark TBM

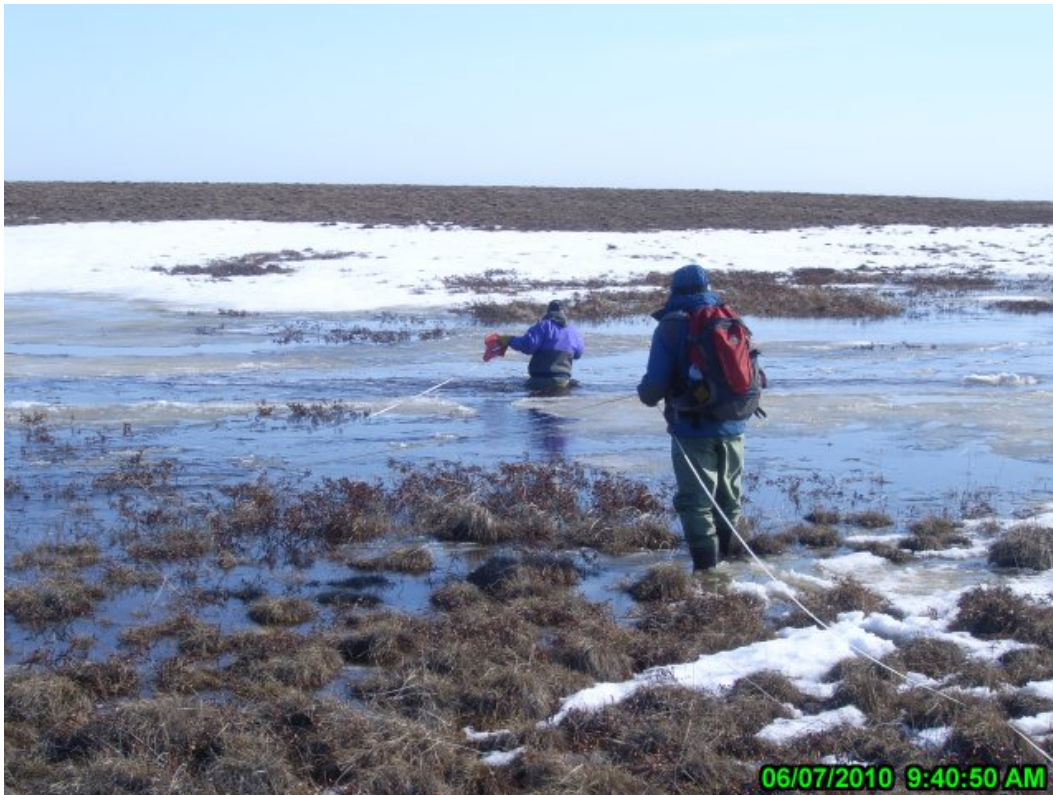
**Photo 4.5: CMSA-1 Direct Discharge Measurement, June 7, 2010**

A direct discharge measurement at CMS1-A was conducted on June 7 beginning at 9:47 a.m., as close to peak flow as possible (approximately 13 hours before peak) (Photo 4.5). Discharge was measured to be 51 cfs. The measurement was rated “poor” based on channel conditions; the channel cross section was irregular due to ice and it was partially constricted by snow.

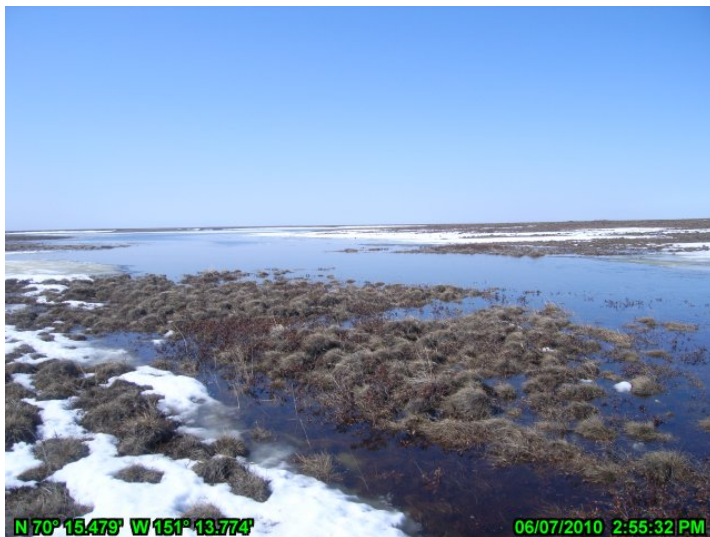
**Photo 4.6: CMS2-A Location, June 7, 2010**

breakup, monitoring continued at this location every two weeks through July. Flow was still present in this channel on July 29, after which observations were discontinued. Photo 4.6 shows the CMS2-A location on June 7.

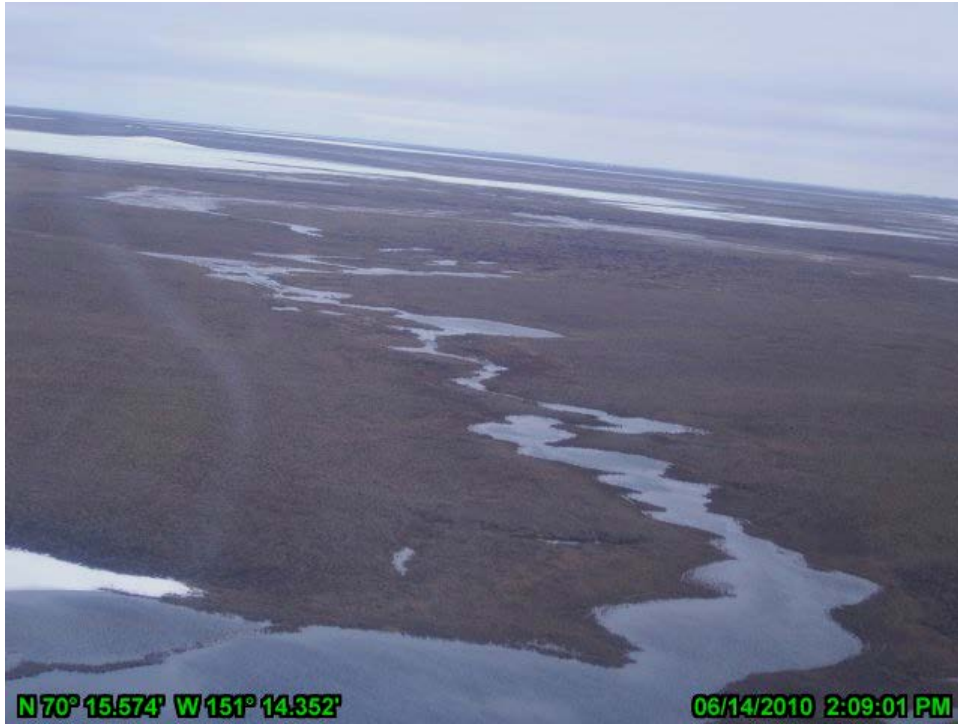
Photo 4.7: CMS2-A Aerial View, June 14, 2010

survey to local control. WSE data for CMS2-A is provided in Table 4.4. Photo 4.7, Photo 4.8, and Photo 4.9 show CMS2-A at various times following breakup. As shown in Photo 4.8, CMS2-A is a defined channel along a series of deep beaded ponds.

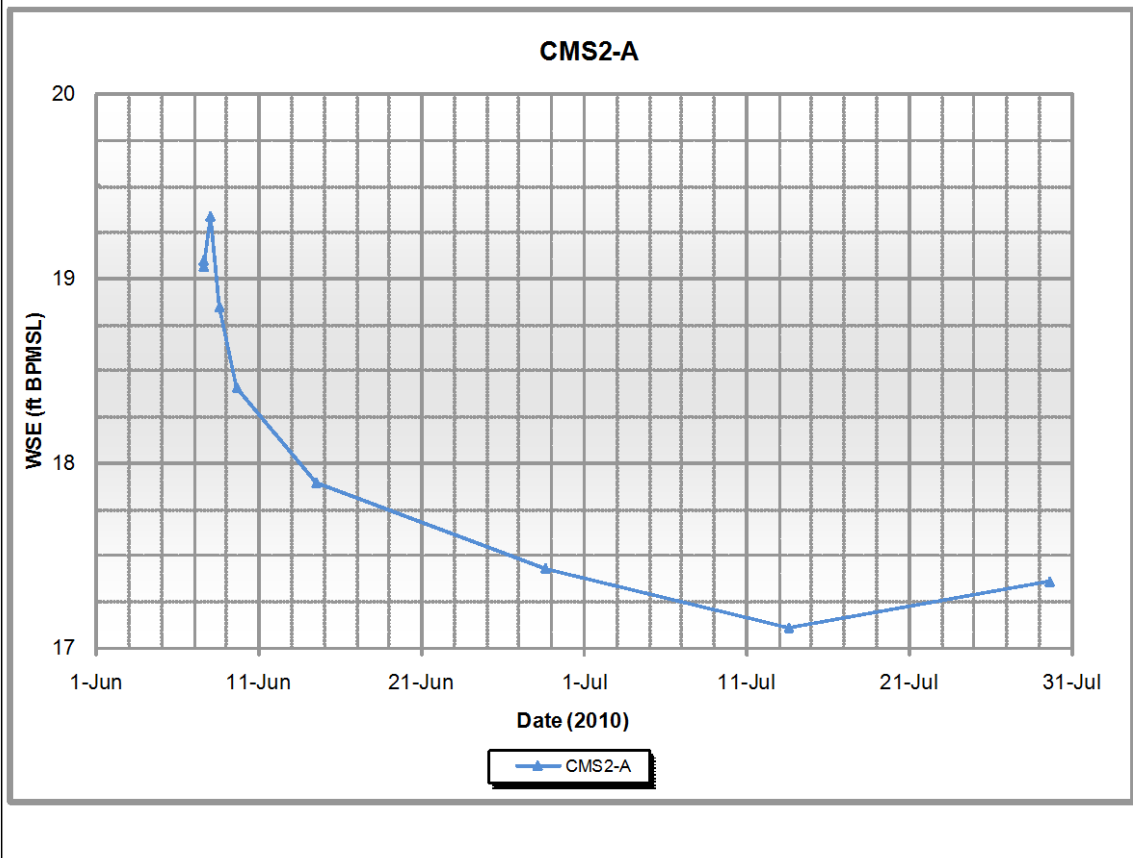
1. WSE are based on TBMs PENELOPE and RUST, established by Baker in 2010. The elevations for these TBMs are set by handheld GPS, and are not tied to nearby monitoring locations or verified by survey to local control.
2. One discharge measurement of 41 cfs was taken on 6/7/2010 at 3:00 PM.

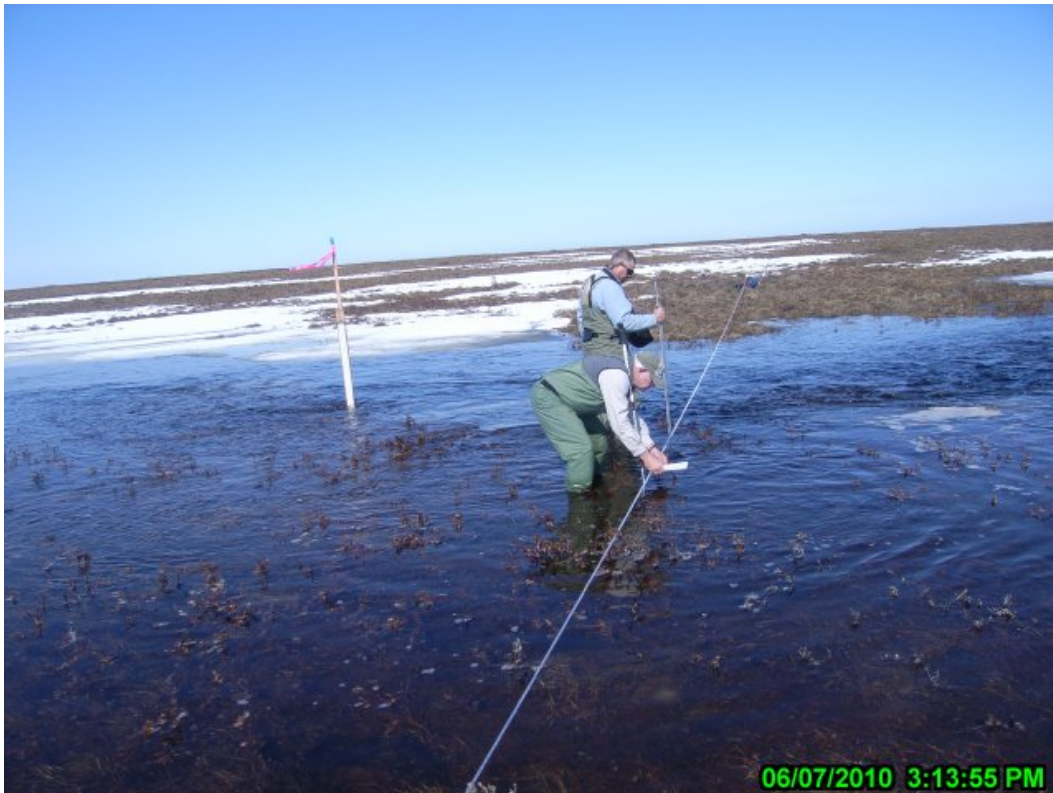
Photo 4.10: Discharge Measurement at CMS2-A, June 7, 2010

A direct discharge measurement at CMS2-A was conducted on June 7 beginning at 3:00 p.m., as close to peak flow as possible (approximately 10 hours before peak) (Photo 4.10). At that time, discharge was measured to be 41 cfs. The measurement was rated “poor” based on channel conditions; the channel was partially constricted by snow.

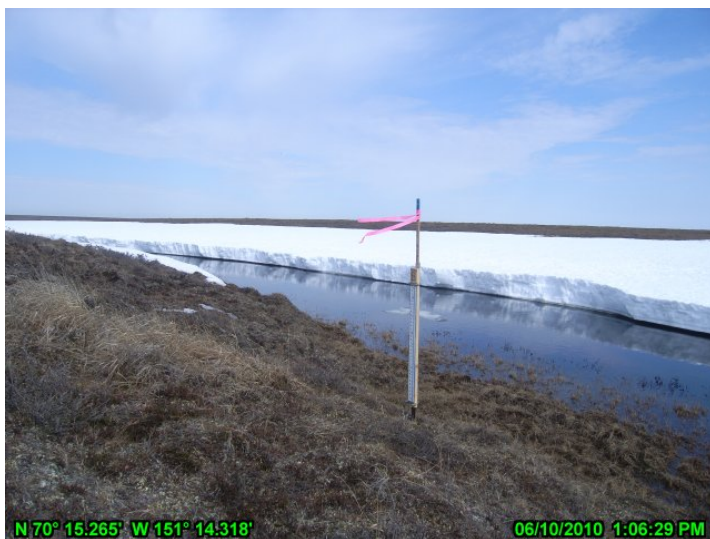
Photo 4.11: Gage at CMS2-B, June 10, 2010

Measured WSE decreased from initial observations on June 7, when the peak WSE was documented based on a drift line in the adjacent snow, measuring 41.82 feet BPMSL. WSE are based on TBM elevations set by handheld GPS, and are not tied to nearby monitoring locations or verified by survey to local control. WSE data for CMS2-B is provided in Table 4.7. Photo 4.12,

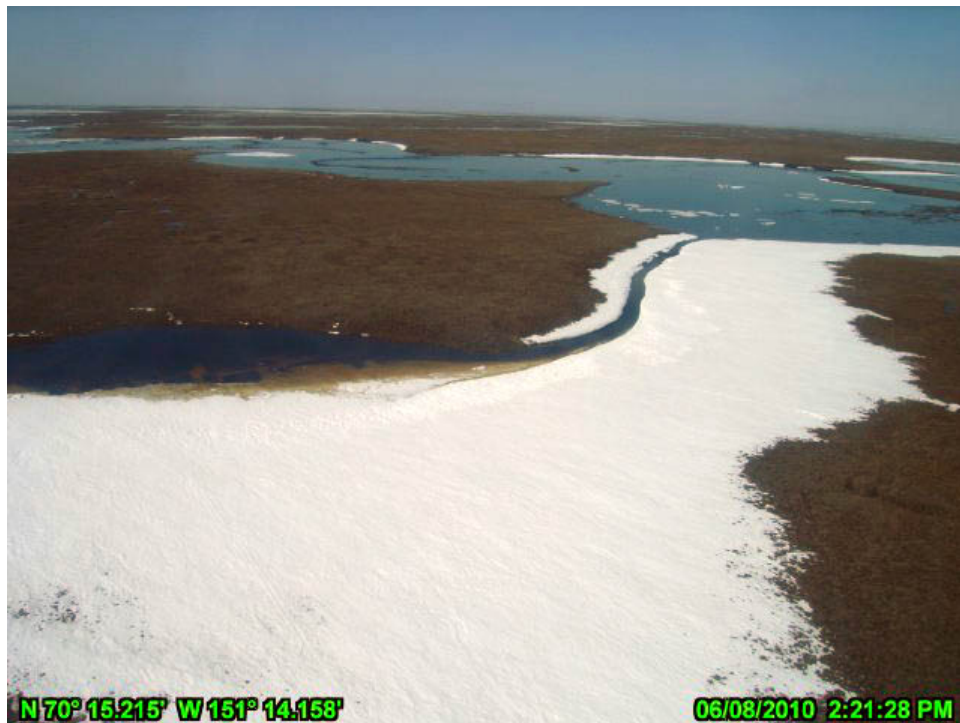
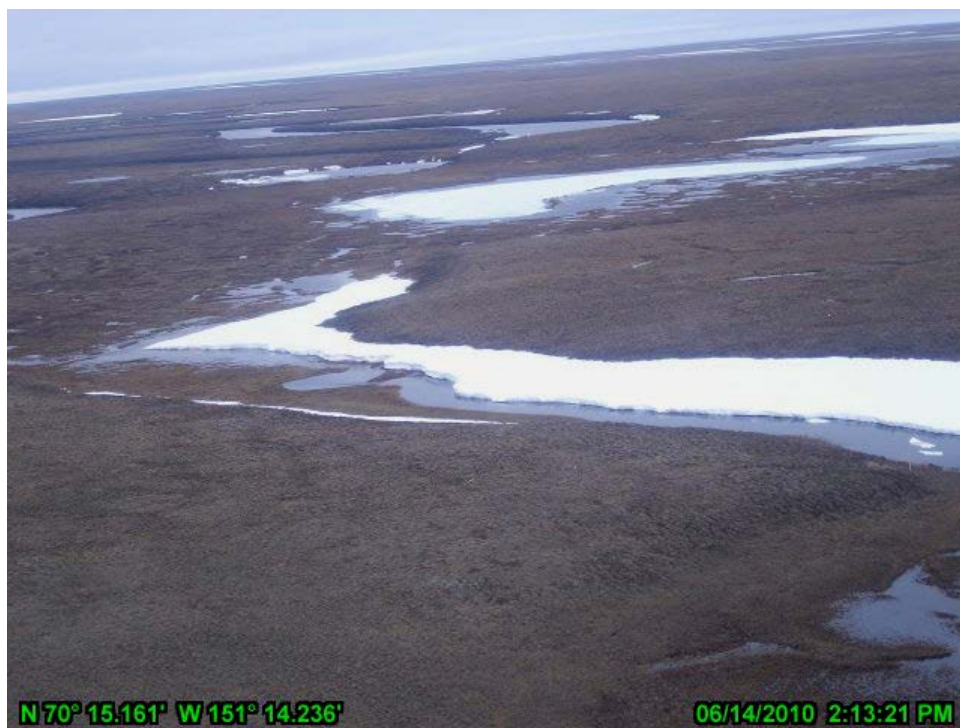
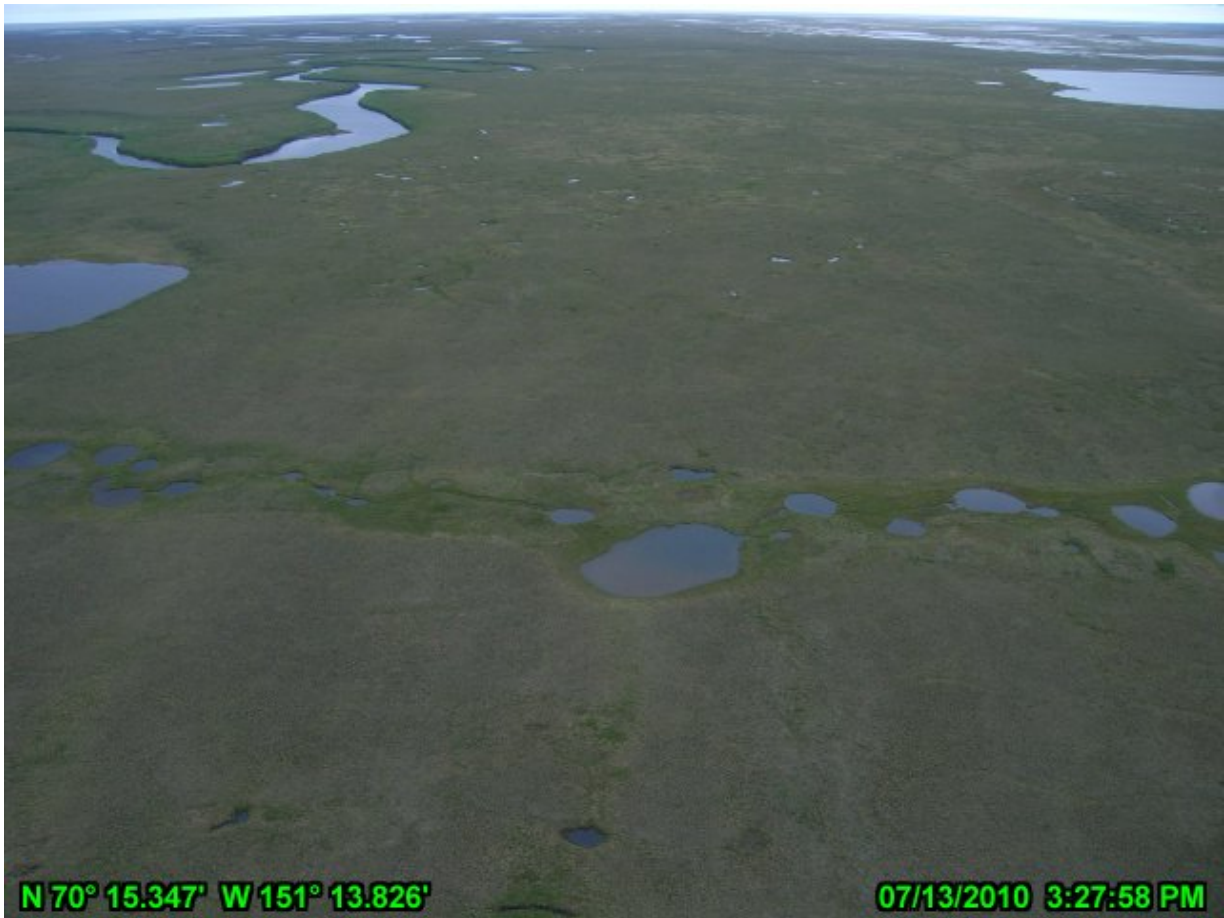
Photo 4.13, and Photo 4.14 show the CMS2-B area at various times during and following breakup.

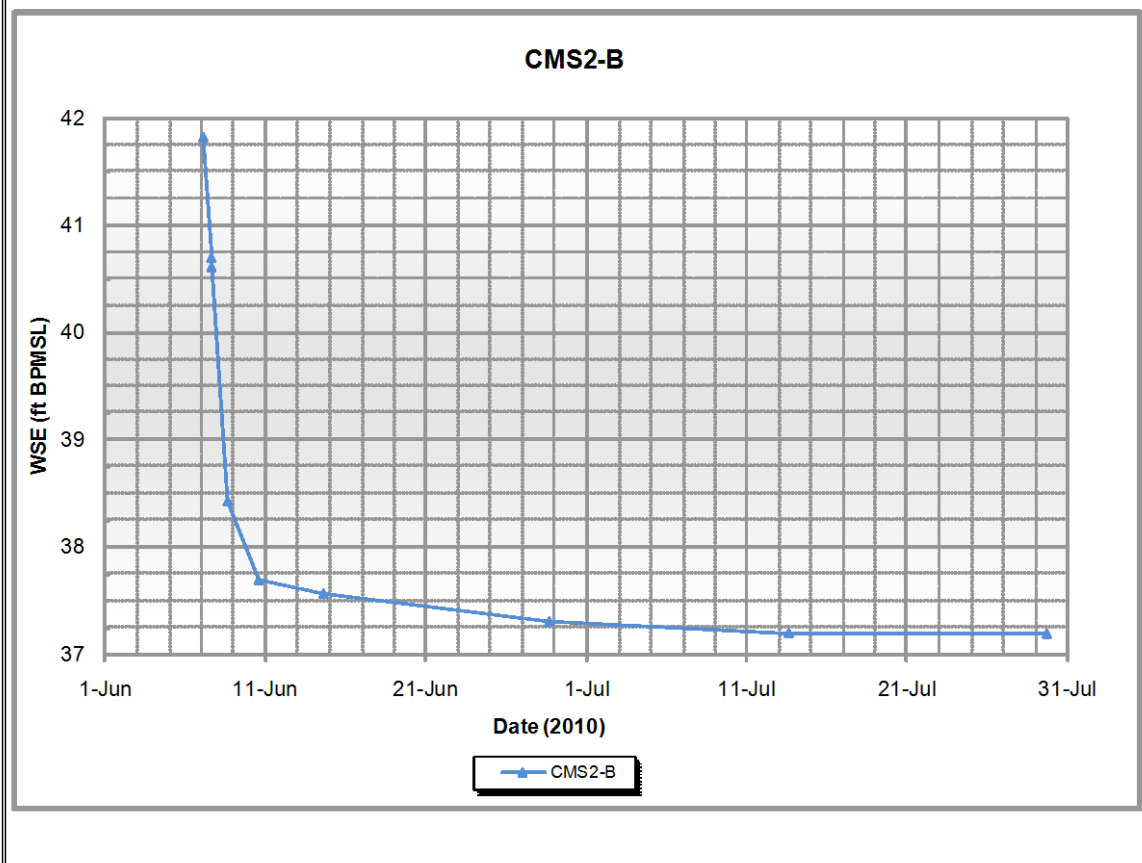
1. WSE are based on TBMs Baker CP3 and MEG, established by Baker in 2010. The elevations for these TBMs are set by handheld GPS, and are not tied to nearby monitoring locations or verified by survey to local control.
2. One discharge measurement of 59 cfs was taken on 6/7/2010 at 1:40 PM.

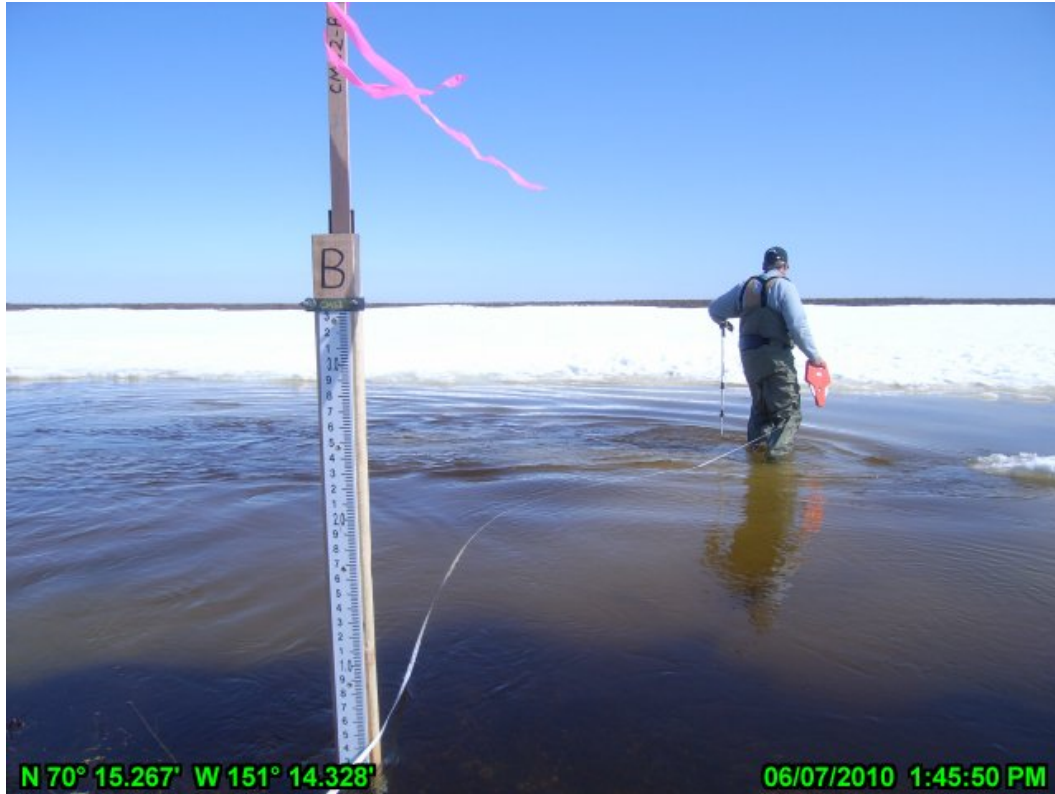
Photo 4.15: Discharge Measurement at CMS2-B, June 7, 2010

A direct discharge measurement at CMS2-B was conducted on June 7 beginning at 1:38 p.m., as close to peak flow as possible (although the timing of peak flow at this location is estimated). Discharge was measured to be 59 cfs. The measurement was rated “poor” based on channel conditions; snow and slush were present in the channel bed and the right edge of water was in a snow bank. Photo 4.15 shows the discharge June 7 measurement at CMS2-B .

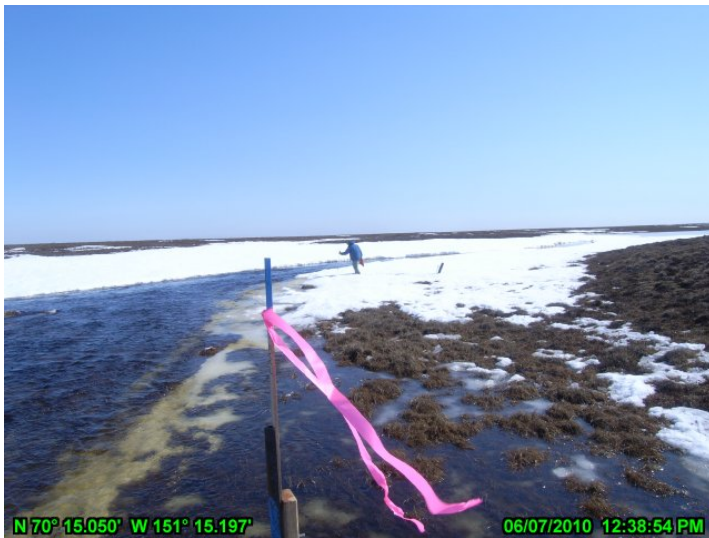
**Photo 4.16: Gage Location CMS2-C, June 7, 2010**

Water surface elevation measurements at CMS2-C began on June 7. Daily monitoring during breakup was not possible in 2010 because of inaccessibility due to weather conditions. After breakup, monitoring continued at this location every two weeks through mid-July. While some water was observed, seasonal flow was no longer present in this channel on July 13, after which observations were discontinued. Photo 4.16 shows the gage installed at CMS2-C on June 7.

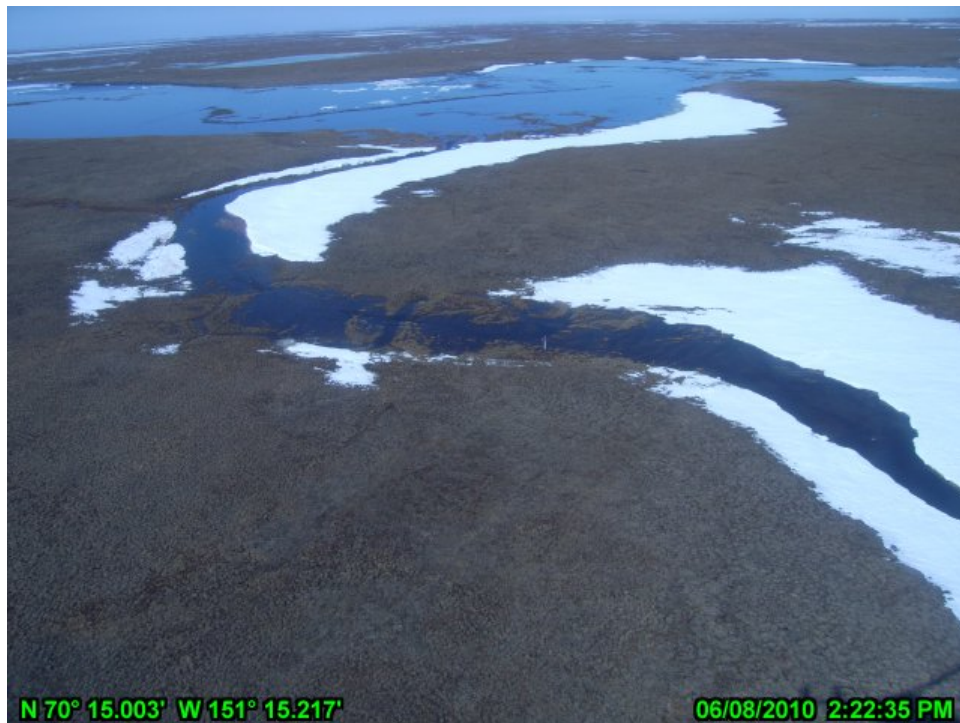
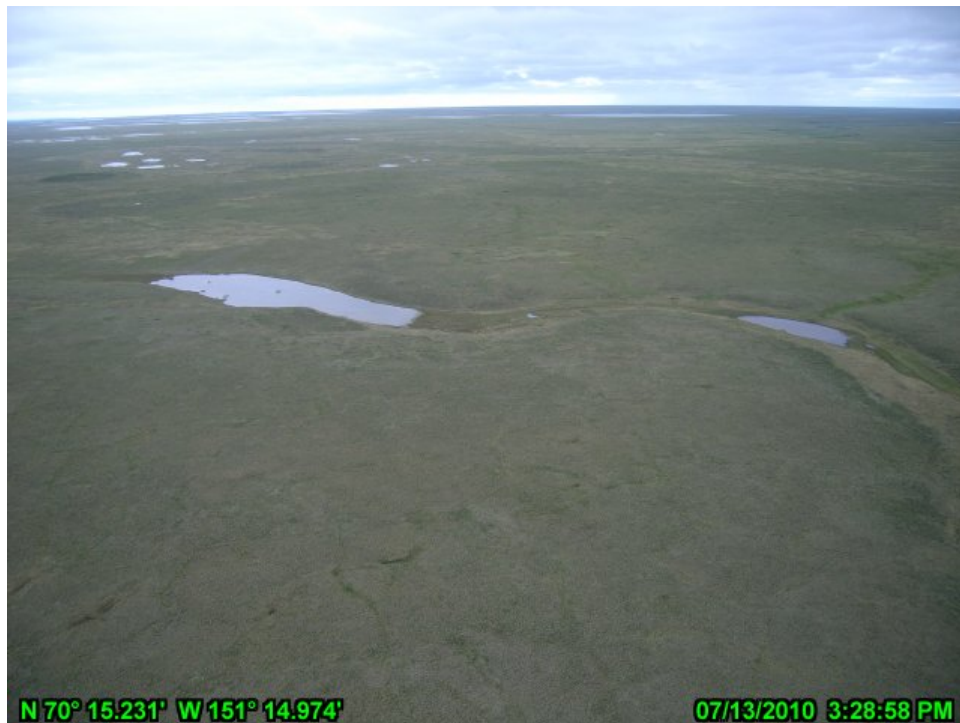
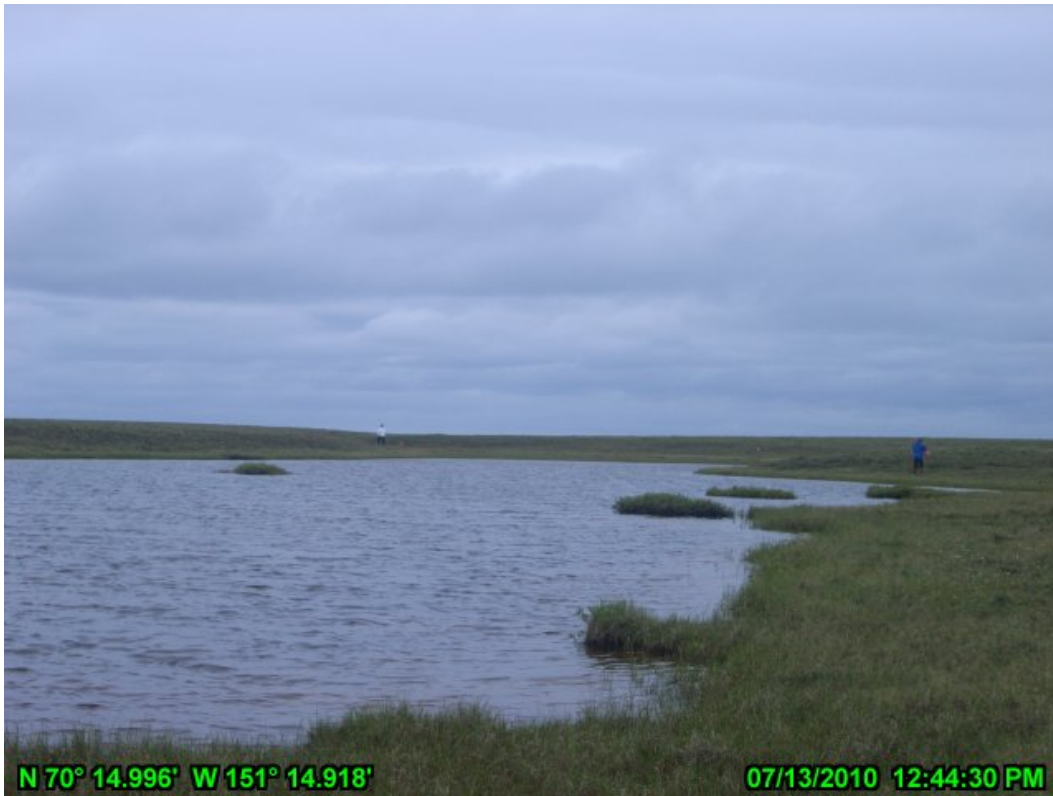
survey to local control. WSE data for CMS2-C is provided in Table 4.10. Photo 4.17, Photo 4.18, Photo 4.19 show aerial and ground views of the CMS2-C vicinity.

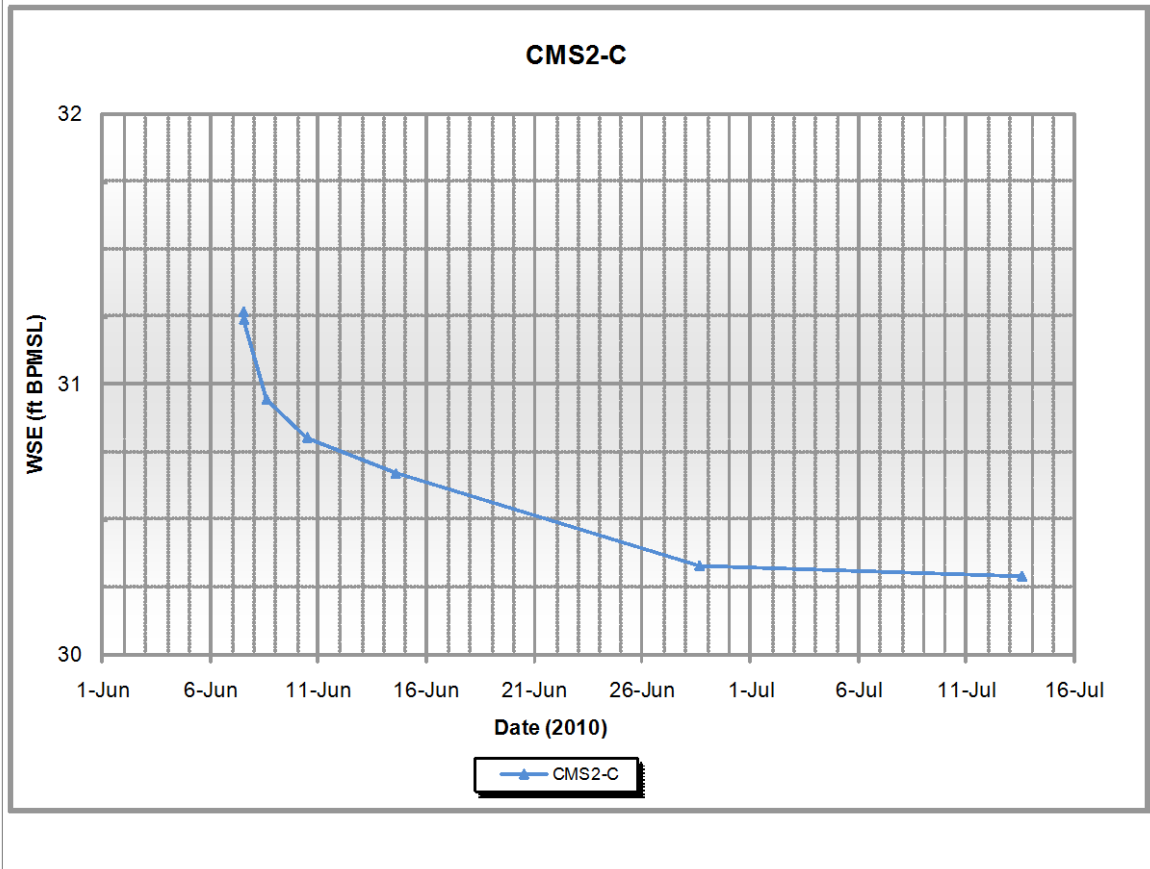
1. WSE are based on TBMs Baker CP2 and ECKELMAN, established by Baker in 2010. The elevations for these TBMs are set by handheld GPS, and are not tied to nearby monitoring locations or verified by survey to local control.
2. One discharge measurement of 25 cfs was taken on 6/7/2010 at 12:40 PM.

Measured WSE decreased from initial observations on June 7, making the initial gage reading the highest WSE noted at the CMS2-C drainage during spring breakup. Peak stage was not captured at this location. The highest documented WSE at CMS2-C was 31.27 feet BPMSL. WSE are based on TBM

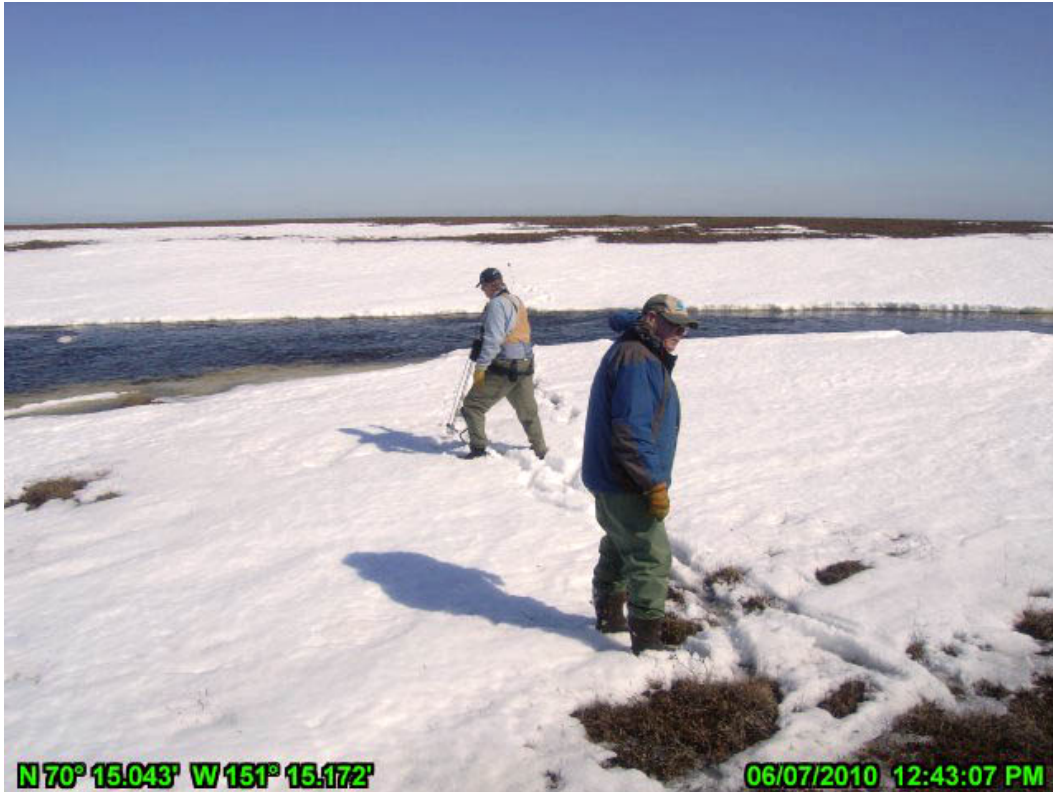
**Photo 4.20: Discharge Measurement Preparations at CMS2-C, June 7, 2010**

A direct discharge measurement at CMS2-C was conducted on June 7 beginning at 12:43 p.m., as close to peak flow as possible (as peak flow receded). At that time, discharge was measured to be 25 cfs. The measurement was rated “fair” based on channel conditions; the channel was fairly uniform, vertical snow banks were present along the right and left edges. Photo 4.20 shows the CMS2-C channel on June 7 prior to discharge measurement.
