# Fish Creek Basin (FCB) 2010 Spring Breakup Hydrologic Assessment

December 2010  
120172-MBJ-RPT-001

This report presents observations and findings of the 2010 Fish Creek Basin (FCB) Alpine Satellite Project Spring Breakup and Hydrologic Assessment conducted by Michael Baker Jr., Inc. (Baker) at the request of ConocoPhillips Alaska. The assessment supports the Alpine Development Project and Alpine Satellite Development Plan, and is Baker's sixth year of study in the Fish Creek Basin.

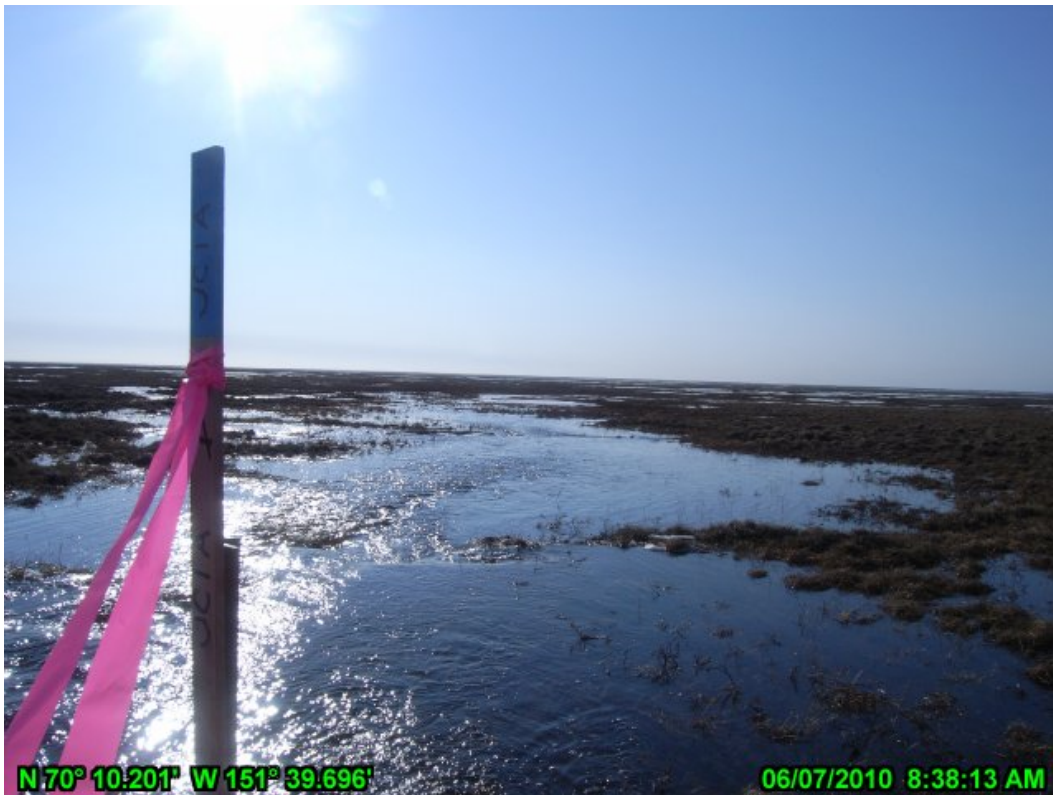
Photo 4.21: GMT2 Gage Vicinity, June 7, 2010

Due to poor weather and helicopter logistics, the first opportunity to reach GMT2 occurred on June 7. On June 7, a single gage was installed at the GMT2 drainage and a gage reading was made. The channel was flowing well. Photo 4.21 shows the vicinity at gage GMT2 on June 7.

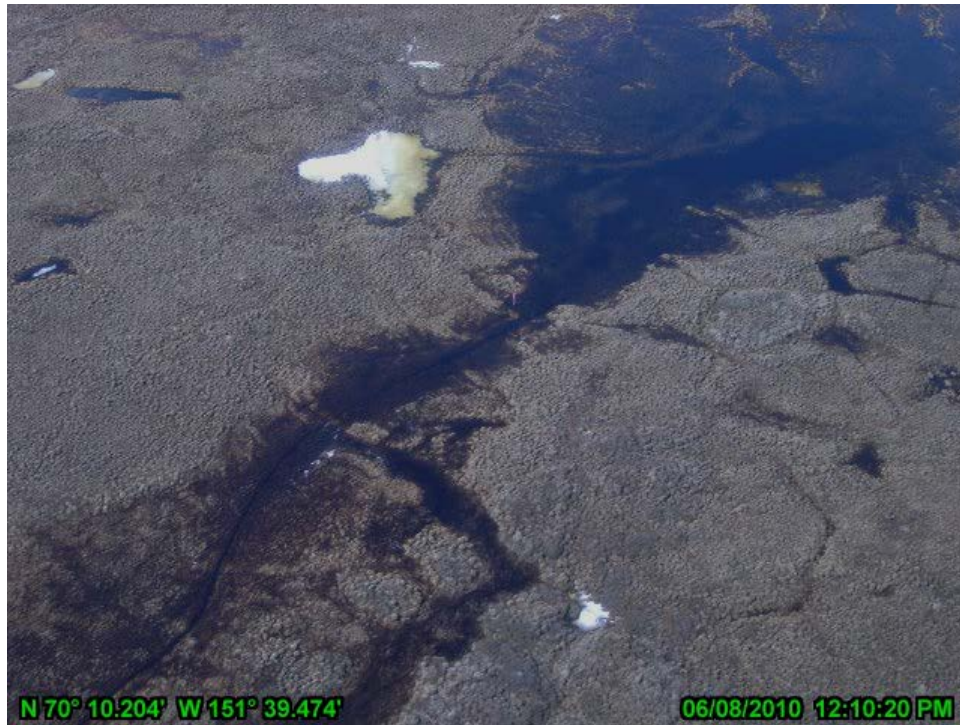
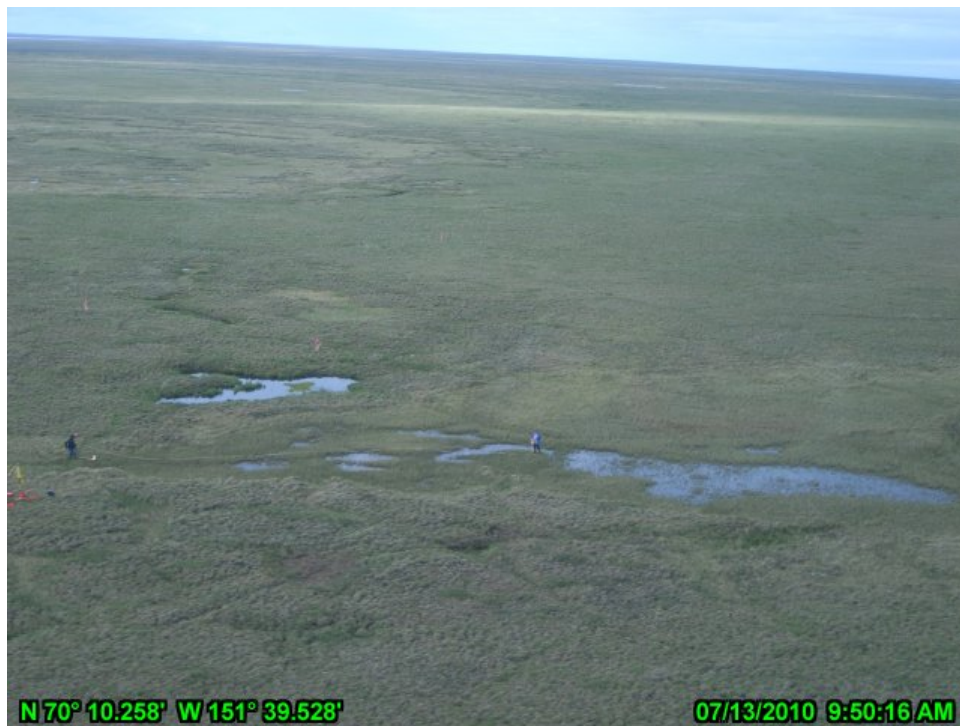
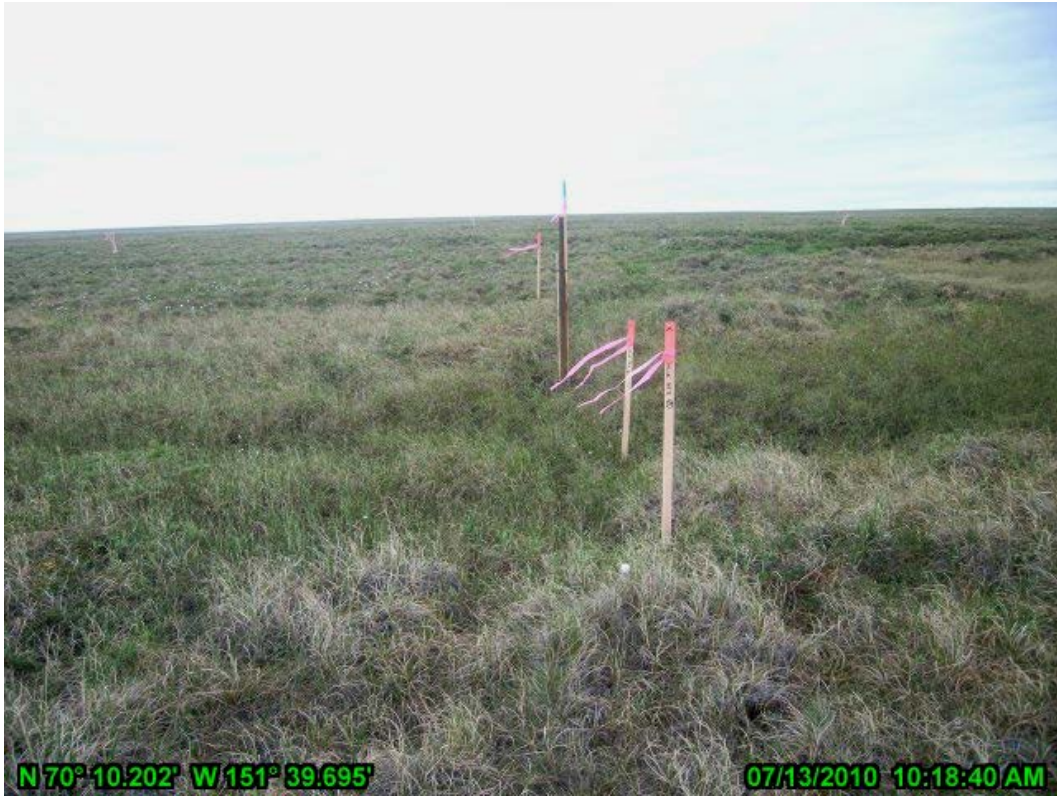
Peak WSE at GMT2 was 88.74 feet BPMSL on June 8. WSE are based on TBM elevations set by handheld GPS, and are not tied to nearby monitoring locations or verified by survey to local control. WSE data for GMT2 is provided in Table 4.13. Photo 4.22, Photo 4.23, and Photo 4.24 show the GMT2 vicinity at various times following breakup.

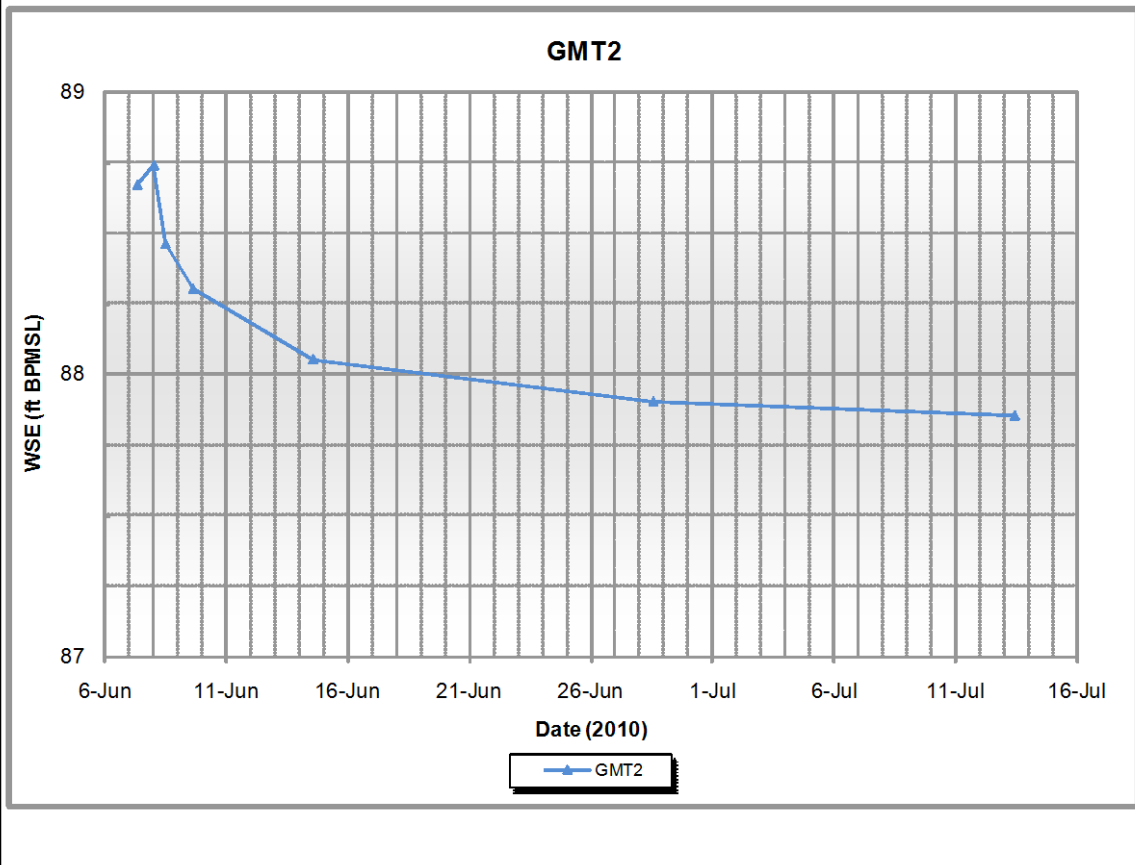
1. WSE are based on TBMs MADISON, BRYNN and LOGAN, established by Baker in 2010. The elevations for these TBMs are set by handheld GPS, and are not tied to nearby monitoring locations or verified by survey to local control.
2. One discharge measurement of 4 cfs was taken on 6/8/2010 at 12:25 PM.

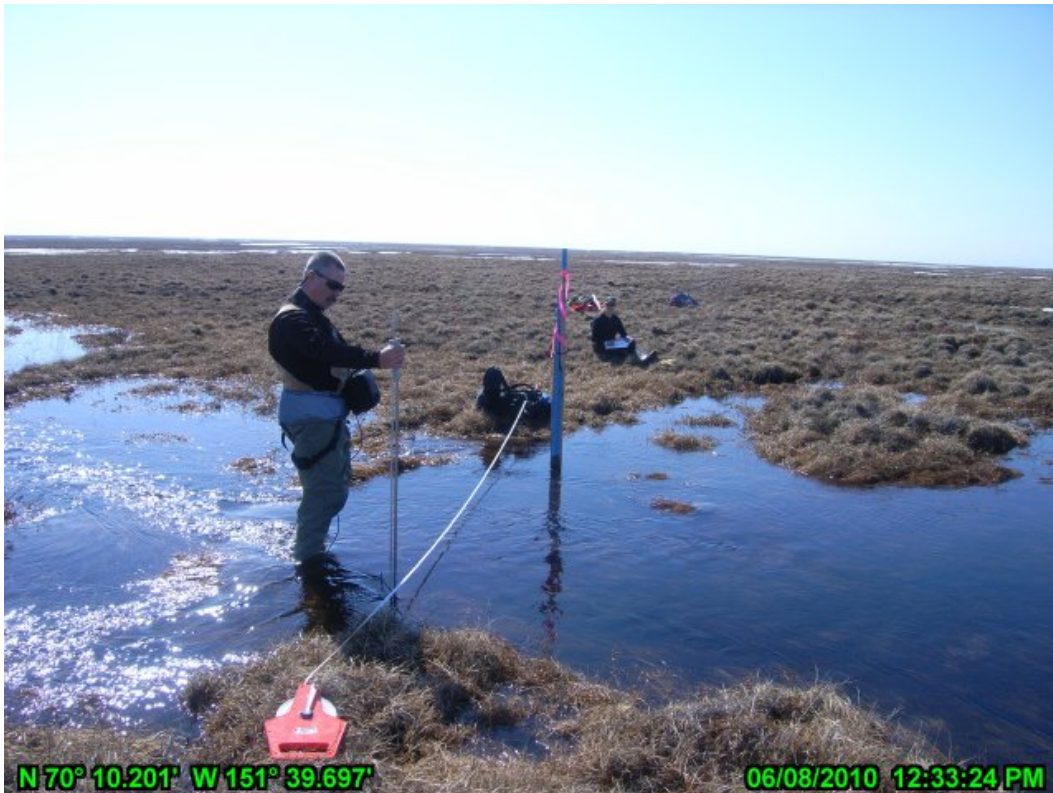
Photo 4.25: GMT2 Discharge Measurement, June 8, 2010

A direct discharge measurement at GMT2 was conducted on June 8 beginning at 12:25 p.m., approximately 11 hours after peak flow. Discharge was measured to be 4 cfs. The measurement was rated “fair” based on channel conditions; the channel was fairly uniform. Photo 4.25 shows the discharge measurement at GMT2.

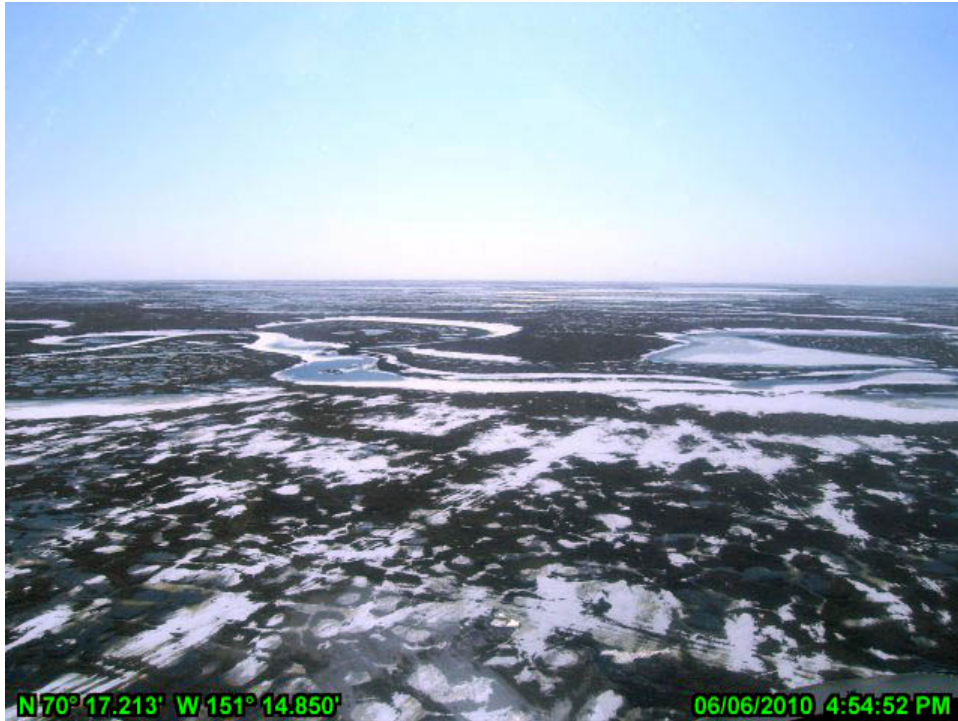
Photo 4.26: UB6.8 Aerial View, June 6, 2010

The UB6.7, UB6.8, and UB6.9 gages were dug out and chalked on June 6, and gages at UB6.8 were surveyed. UB6.9-C was also surveyed and tied to control on June 6. Photo 4.26 and Photo 4.27 show aerial views of the UB6.8 area surrounding peak stage.

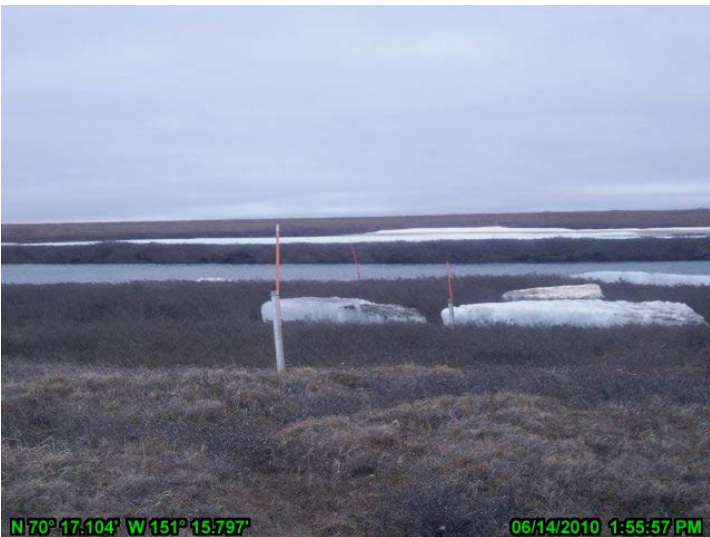
Photo 4.29: Gages at UB6.8, June 14, 2010

Water surface elevation measurements at Ublutuoch River gages began on June 6 and continued until June 14. Daily monitoring was not possible in 2010 because of inaccessibility due to weather conditions. Pressure transducers installed in the CRD were irretrievable during FCB breakup and therefore not installed at the Ublutuoch in 2010.

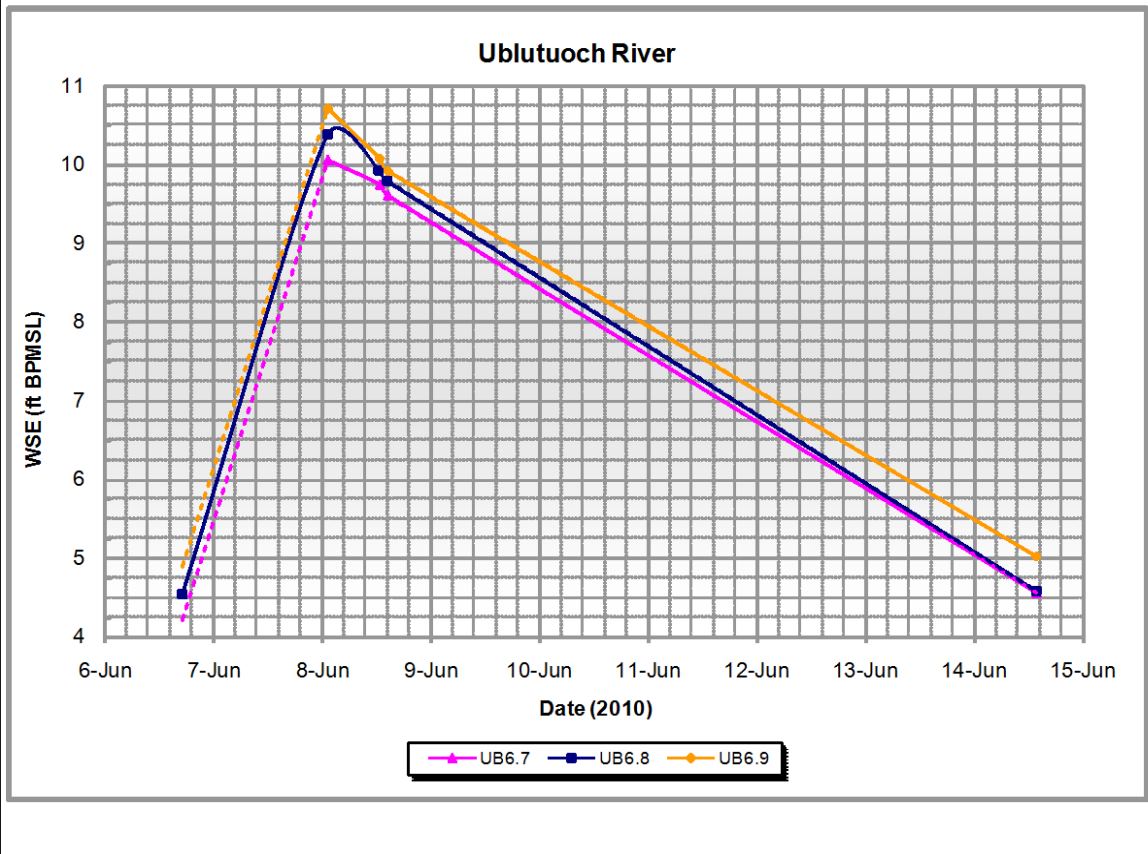
1. Elevations are based on CP09-11-09B, established by LCMF in 2009.
2. One discharge measurement was taken at UB6.8 of 3,217 cfs on 6/8/2010 at 12:55 PM.
3. Dashed lines indicate estimated WSE.

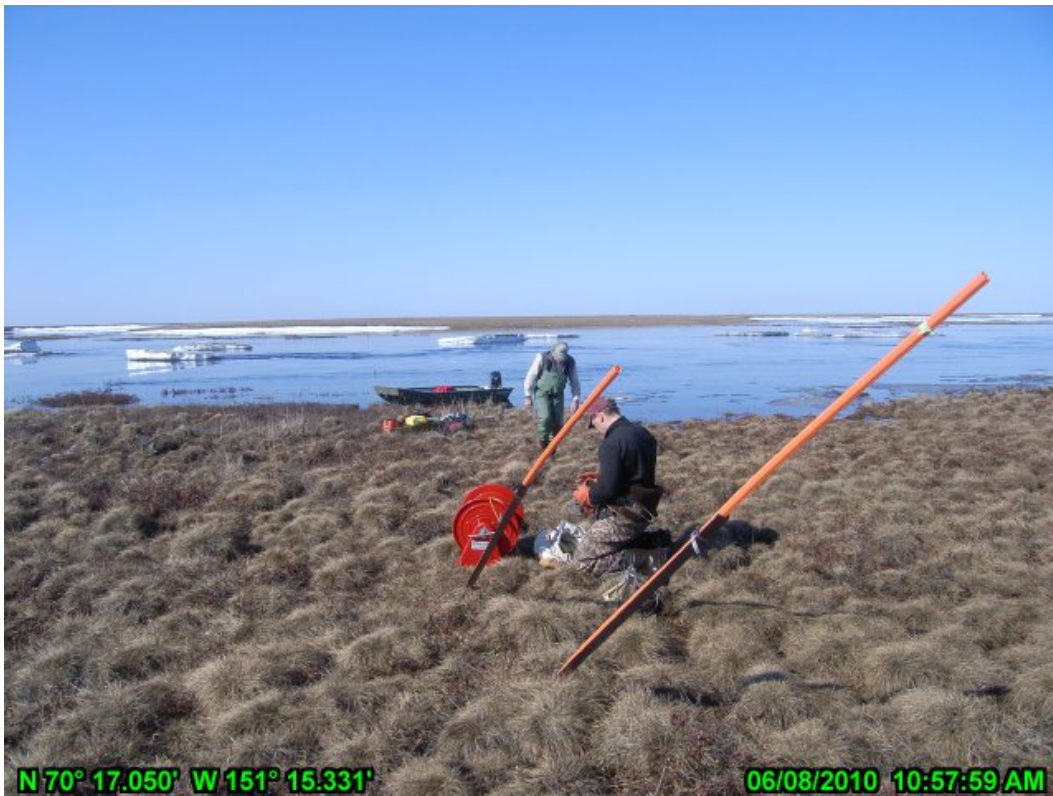
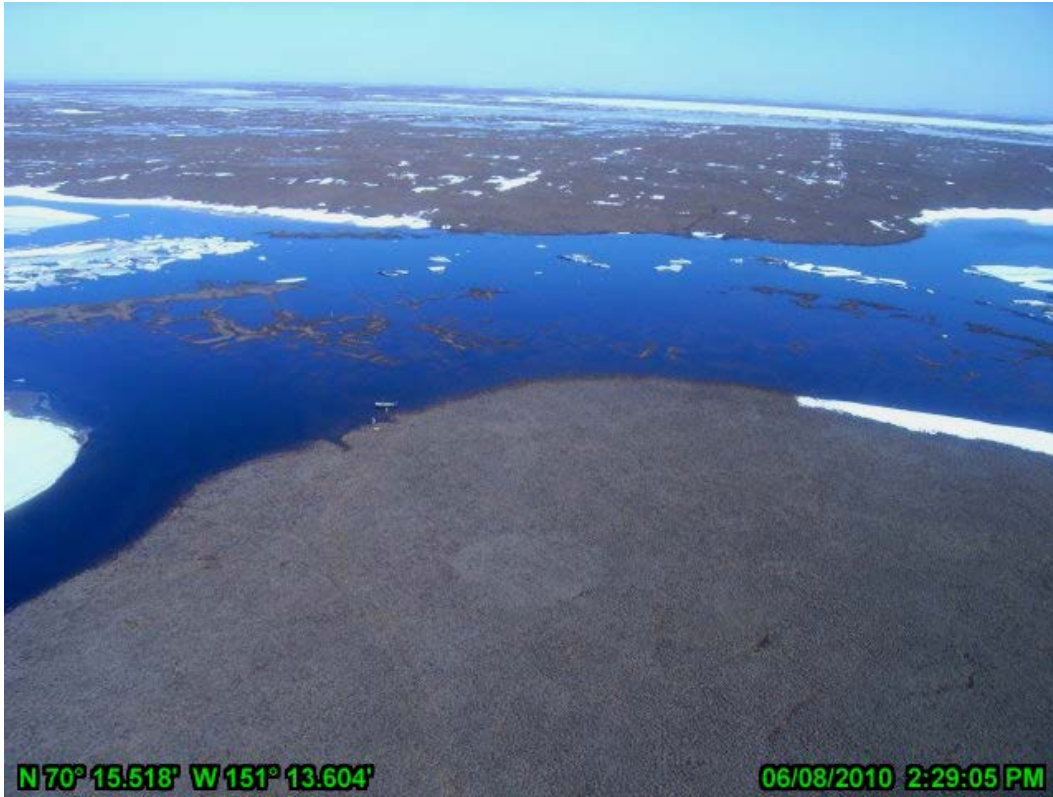
A direct discharge measurement in the Ublutuocho was conducted at UB6.8 on June 8 beginning at 12:55 p.m., approximately 12 hours after estimated time of peak flow. Discharge was measured to be 3,217 cfs. The measurement was rated “poor” based on channel conditions. The channel was not uniform; the left bank side was much shallower than the right bank side. Grounded ice was present in the channel upstream and downstream of the tagline during the discharge measurement, and an ice jam had formed approximately 1,000 feet downstream of the tagline, near the UB6.7 gages. This ice jam was causing flow to divert over the left bank into a swale west of and downstream from the measurement location. This ice jam also caused flow to back up, resulting in likely inflated WSE readings. Photo 4.30 and Photo 4.31 show the boat discharge measurements and aerial view on June 8, 2010.

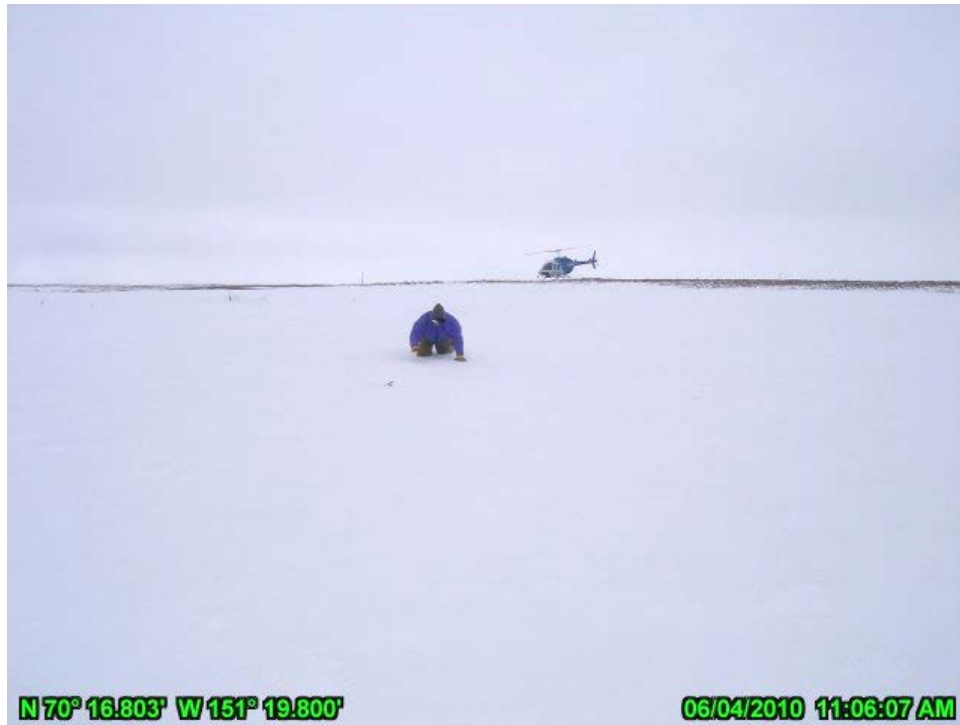
Photo 4.32: Snow in Vicinity of S5, June 4, 2010

During the preliminary reconnaissance flight on June 4, 2010, gages at small stream crossing S5 were chalked. Photo 4.32 shows the extent of snow in the area on June 4. Daily monitoring was not possible in 2010 because of inaccessibility due to weather conditions. On June 8, the S5 gages were surveyed. Photo 4.33 and Photo 4.34 show the S5 area on the day of the survey.

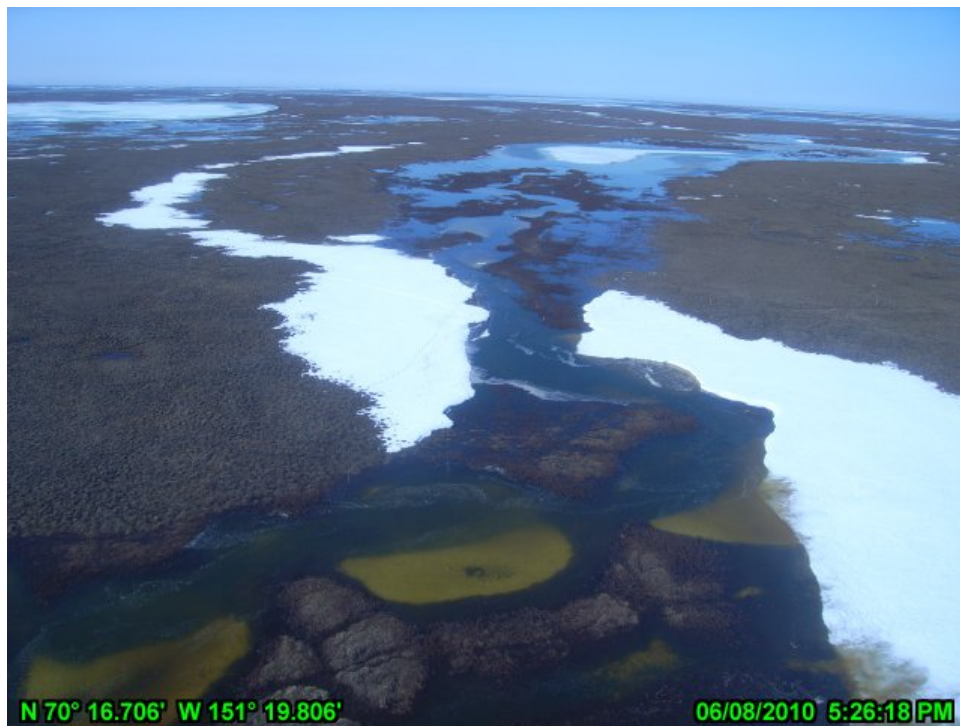
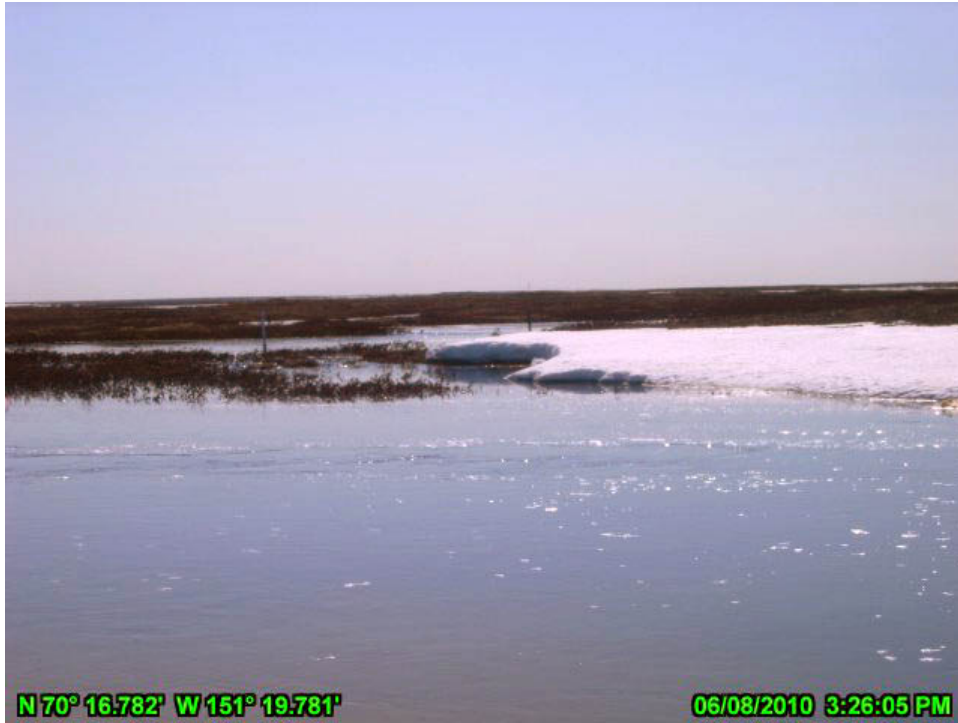
A high water mark was identified at the GMT1 bridge site (S5) during a site visit on June 8. Due to significantly reduced water surface elevation at S5 at that time, and decreased water surface elevation noted during the survey on June 8, monitoring was not conducted again at S5 until a site visit on June 14.

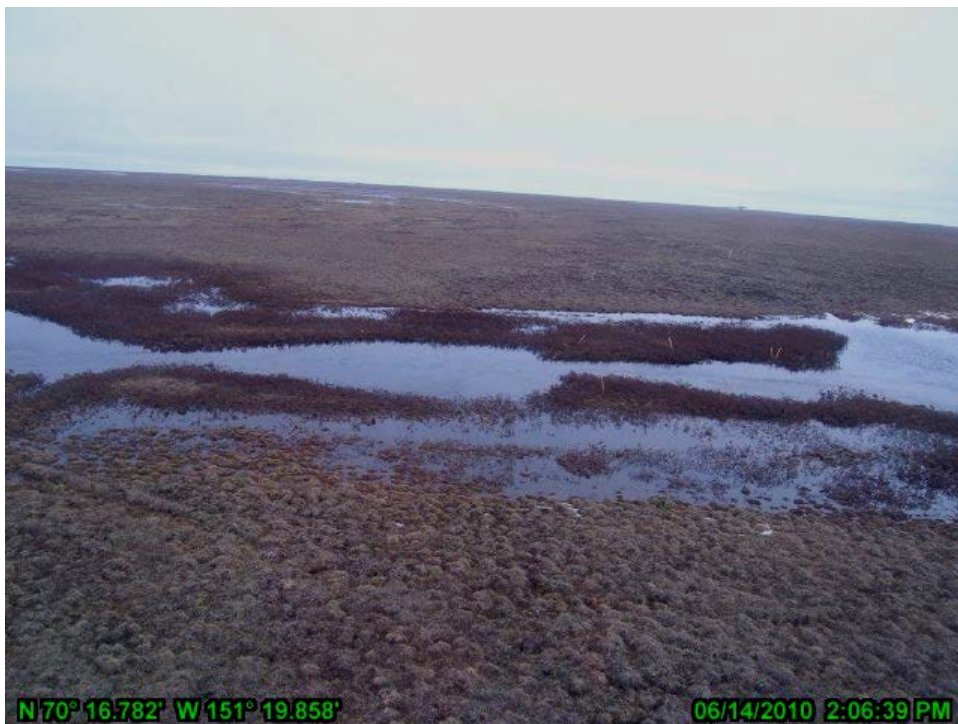
Photo 4.35: Aerial View S5, June 14, 2010

Measured WSE increased from initial observations on June 4 to June 8, when peak stage is estimated to have occurred. Peak WSE at S5-C was 19.63 feet BPMSL. WSE data for S5 is provided in Table 4.19. Photo 4.35 shows an aerial view of the S5 area on June 14.

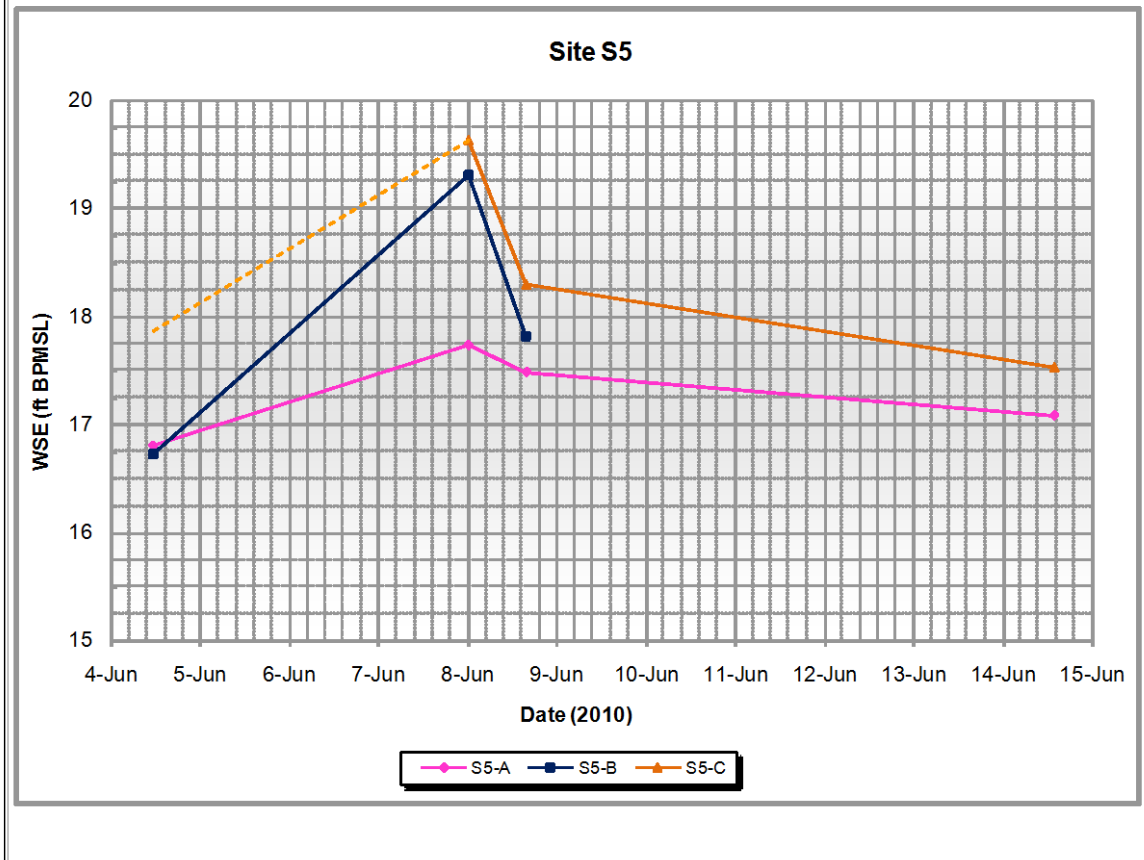
**Notes:**  
 1. Elevations are based on TBMs Alma and Clara, both updated by LCMF in 2009.  
 2. One discharge measurement of 103 cfs was taken at S5 on 6/8/2010 at 2:50 PM.  
 3. Dashed lines indicate estimated WSE.

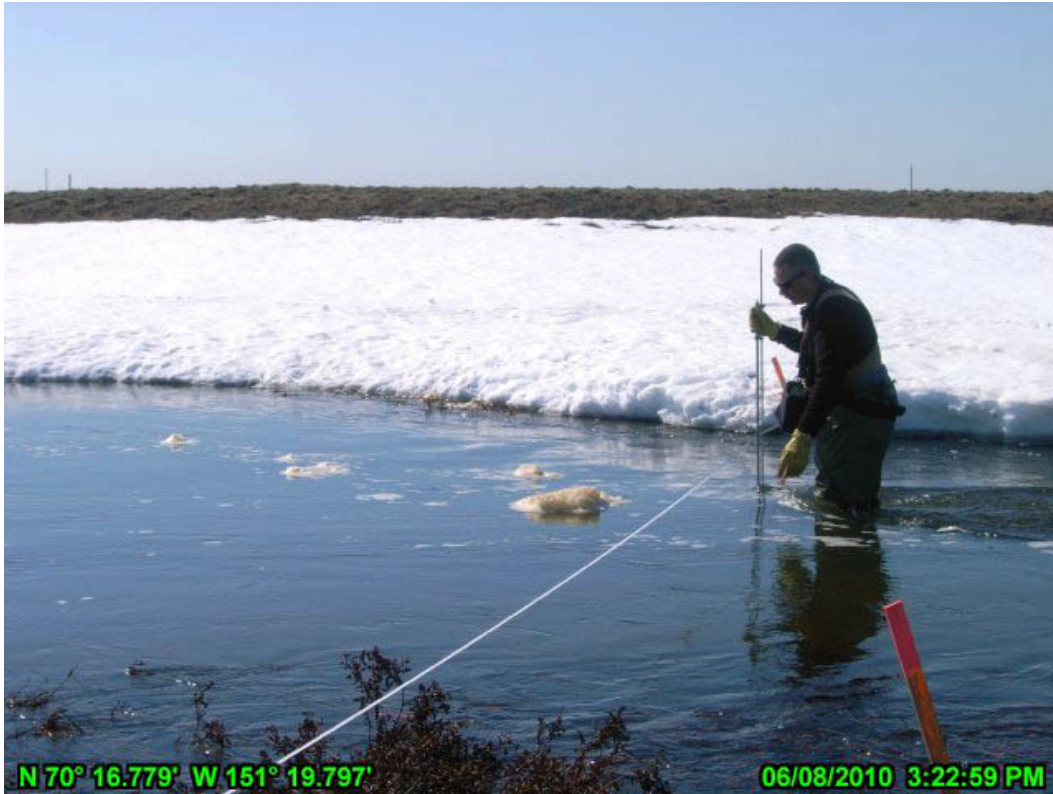
Photo 4.36: S5 Discharge Measurement, June 8, 2010

A direct discharge measurement at S5 was conducted on June 8 beginning at 2:50 p.m., as peak flow began to recede. Discharge was measured to be 103 cfs. The measurement was rated “poor” based on channel conditions; snow was present along the left bank and immeasurable flow was likely passing under the drift. The discharge measurement on June 8 is shown in Photo 4.36.

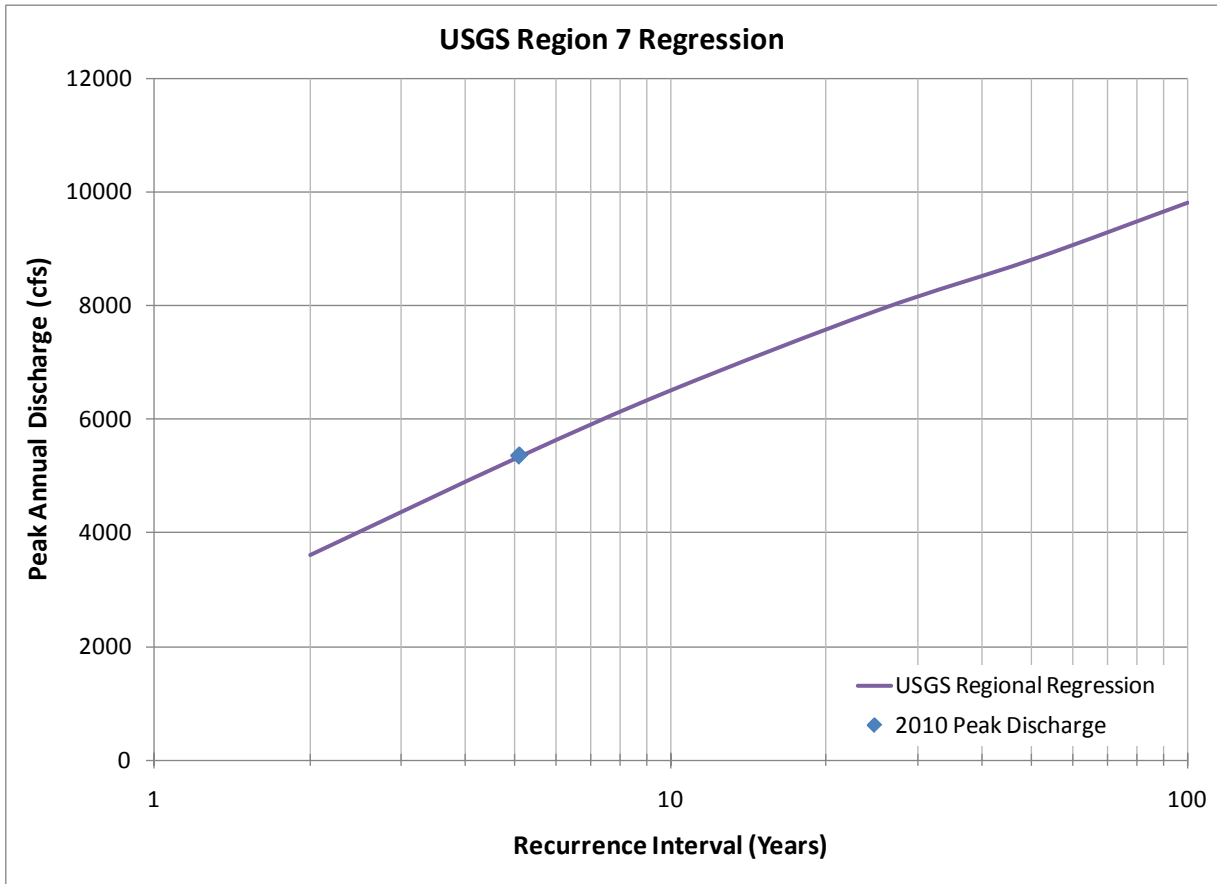
Graph 5.1: Ublutuoch River Flood Frequency Estimates (2009)

In 2009, a flood frequency analysis was performed for UB6.8. This analysis, using the USGS Region 7 regression equations, assumes open channel conditions and should be considered a conservative estimate, since breakup in the Ublutuoch is typically affected by snow and ice.

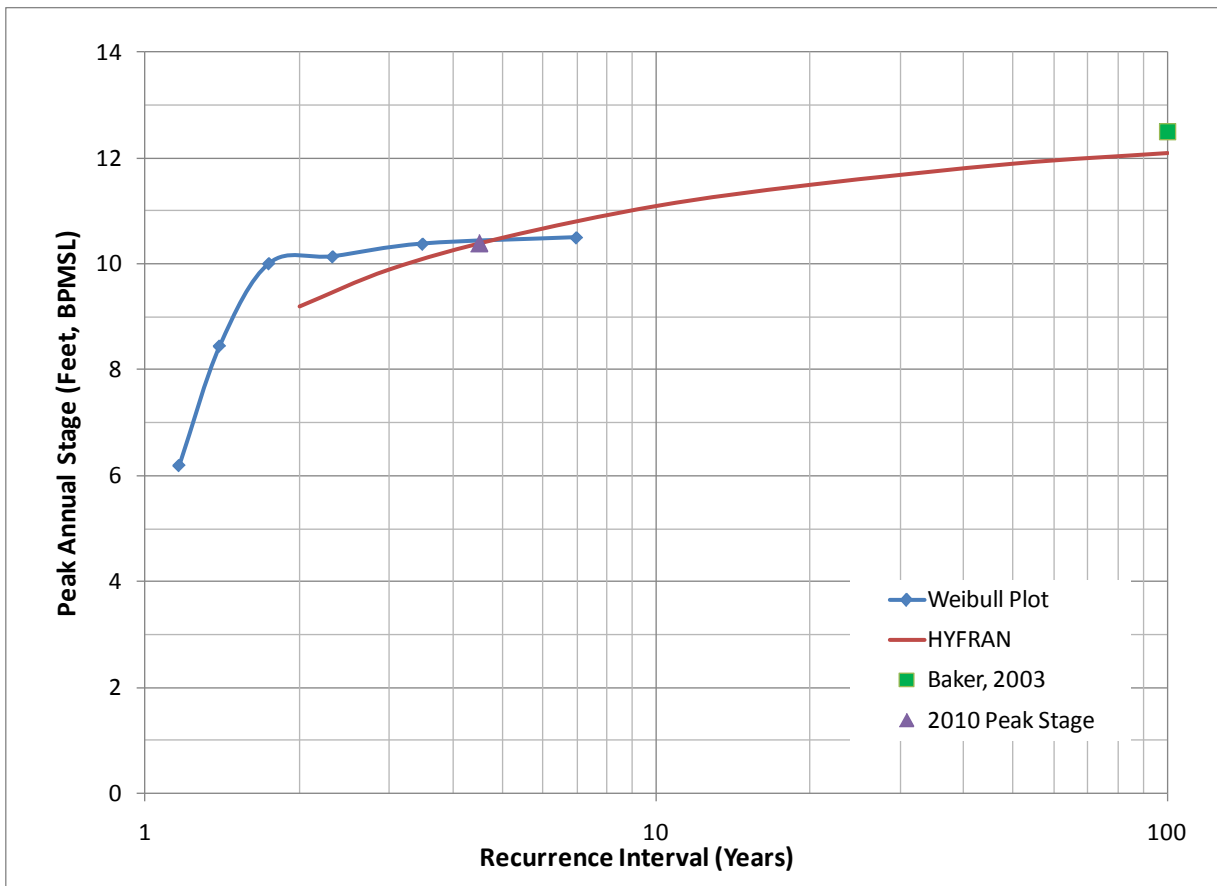
Graph 5.2: Ublutuoch Stage Frequency Estimates (2009)

In 2009, a stage frequency analysis (using HYFRAN - log Pearson type III) was performed at UB6.8 based on 5 years of breakup data. This analysis assumes open channel conditions and should be considered a conservative estimate, since breakup in the Ublutuoch is typically impacted by snow and ice. Additionally, a HEC-RAS model was designed by Baker in 2003 to estimate 100-year flood stage. Given the current stage frequency analysis and the 2003 HEC-RAS estimate, peak stage for a 100-year event is estimated to be 12.5 feet at RM 6.8.
